Visited 20.III.1993.

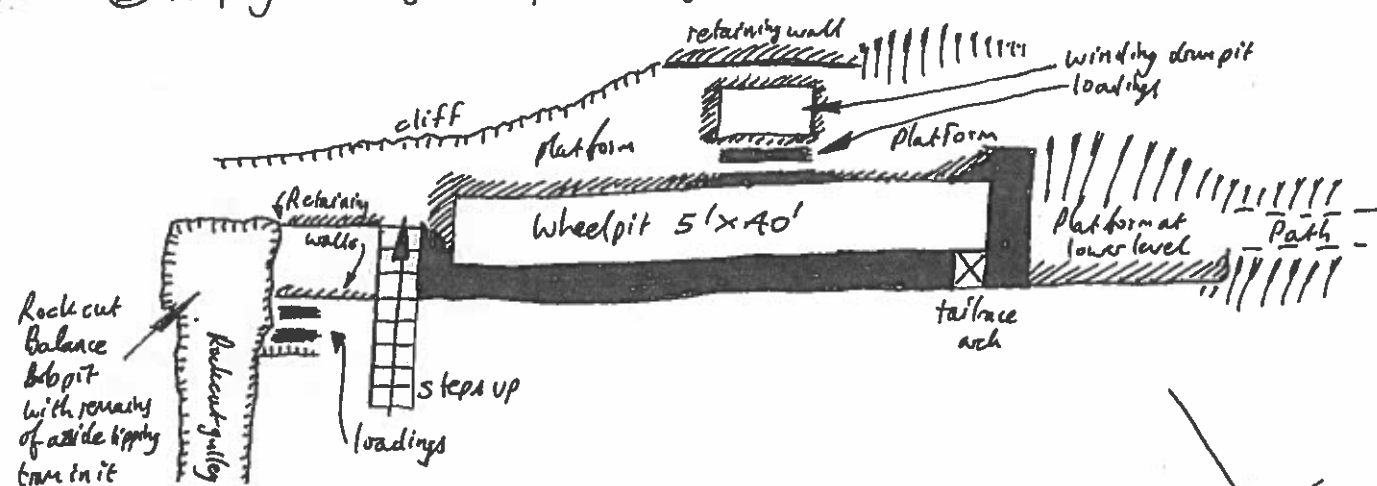
96074 ② Pumping & windy wheelpit in a good state of preservation:

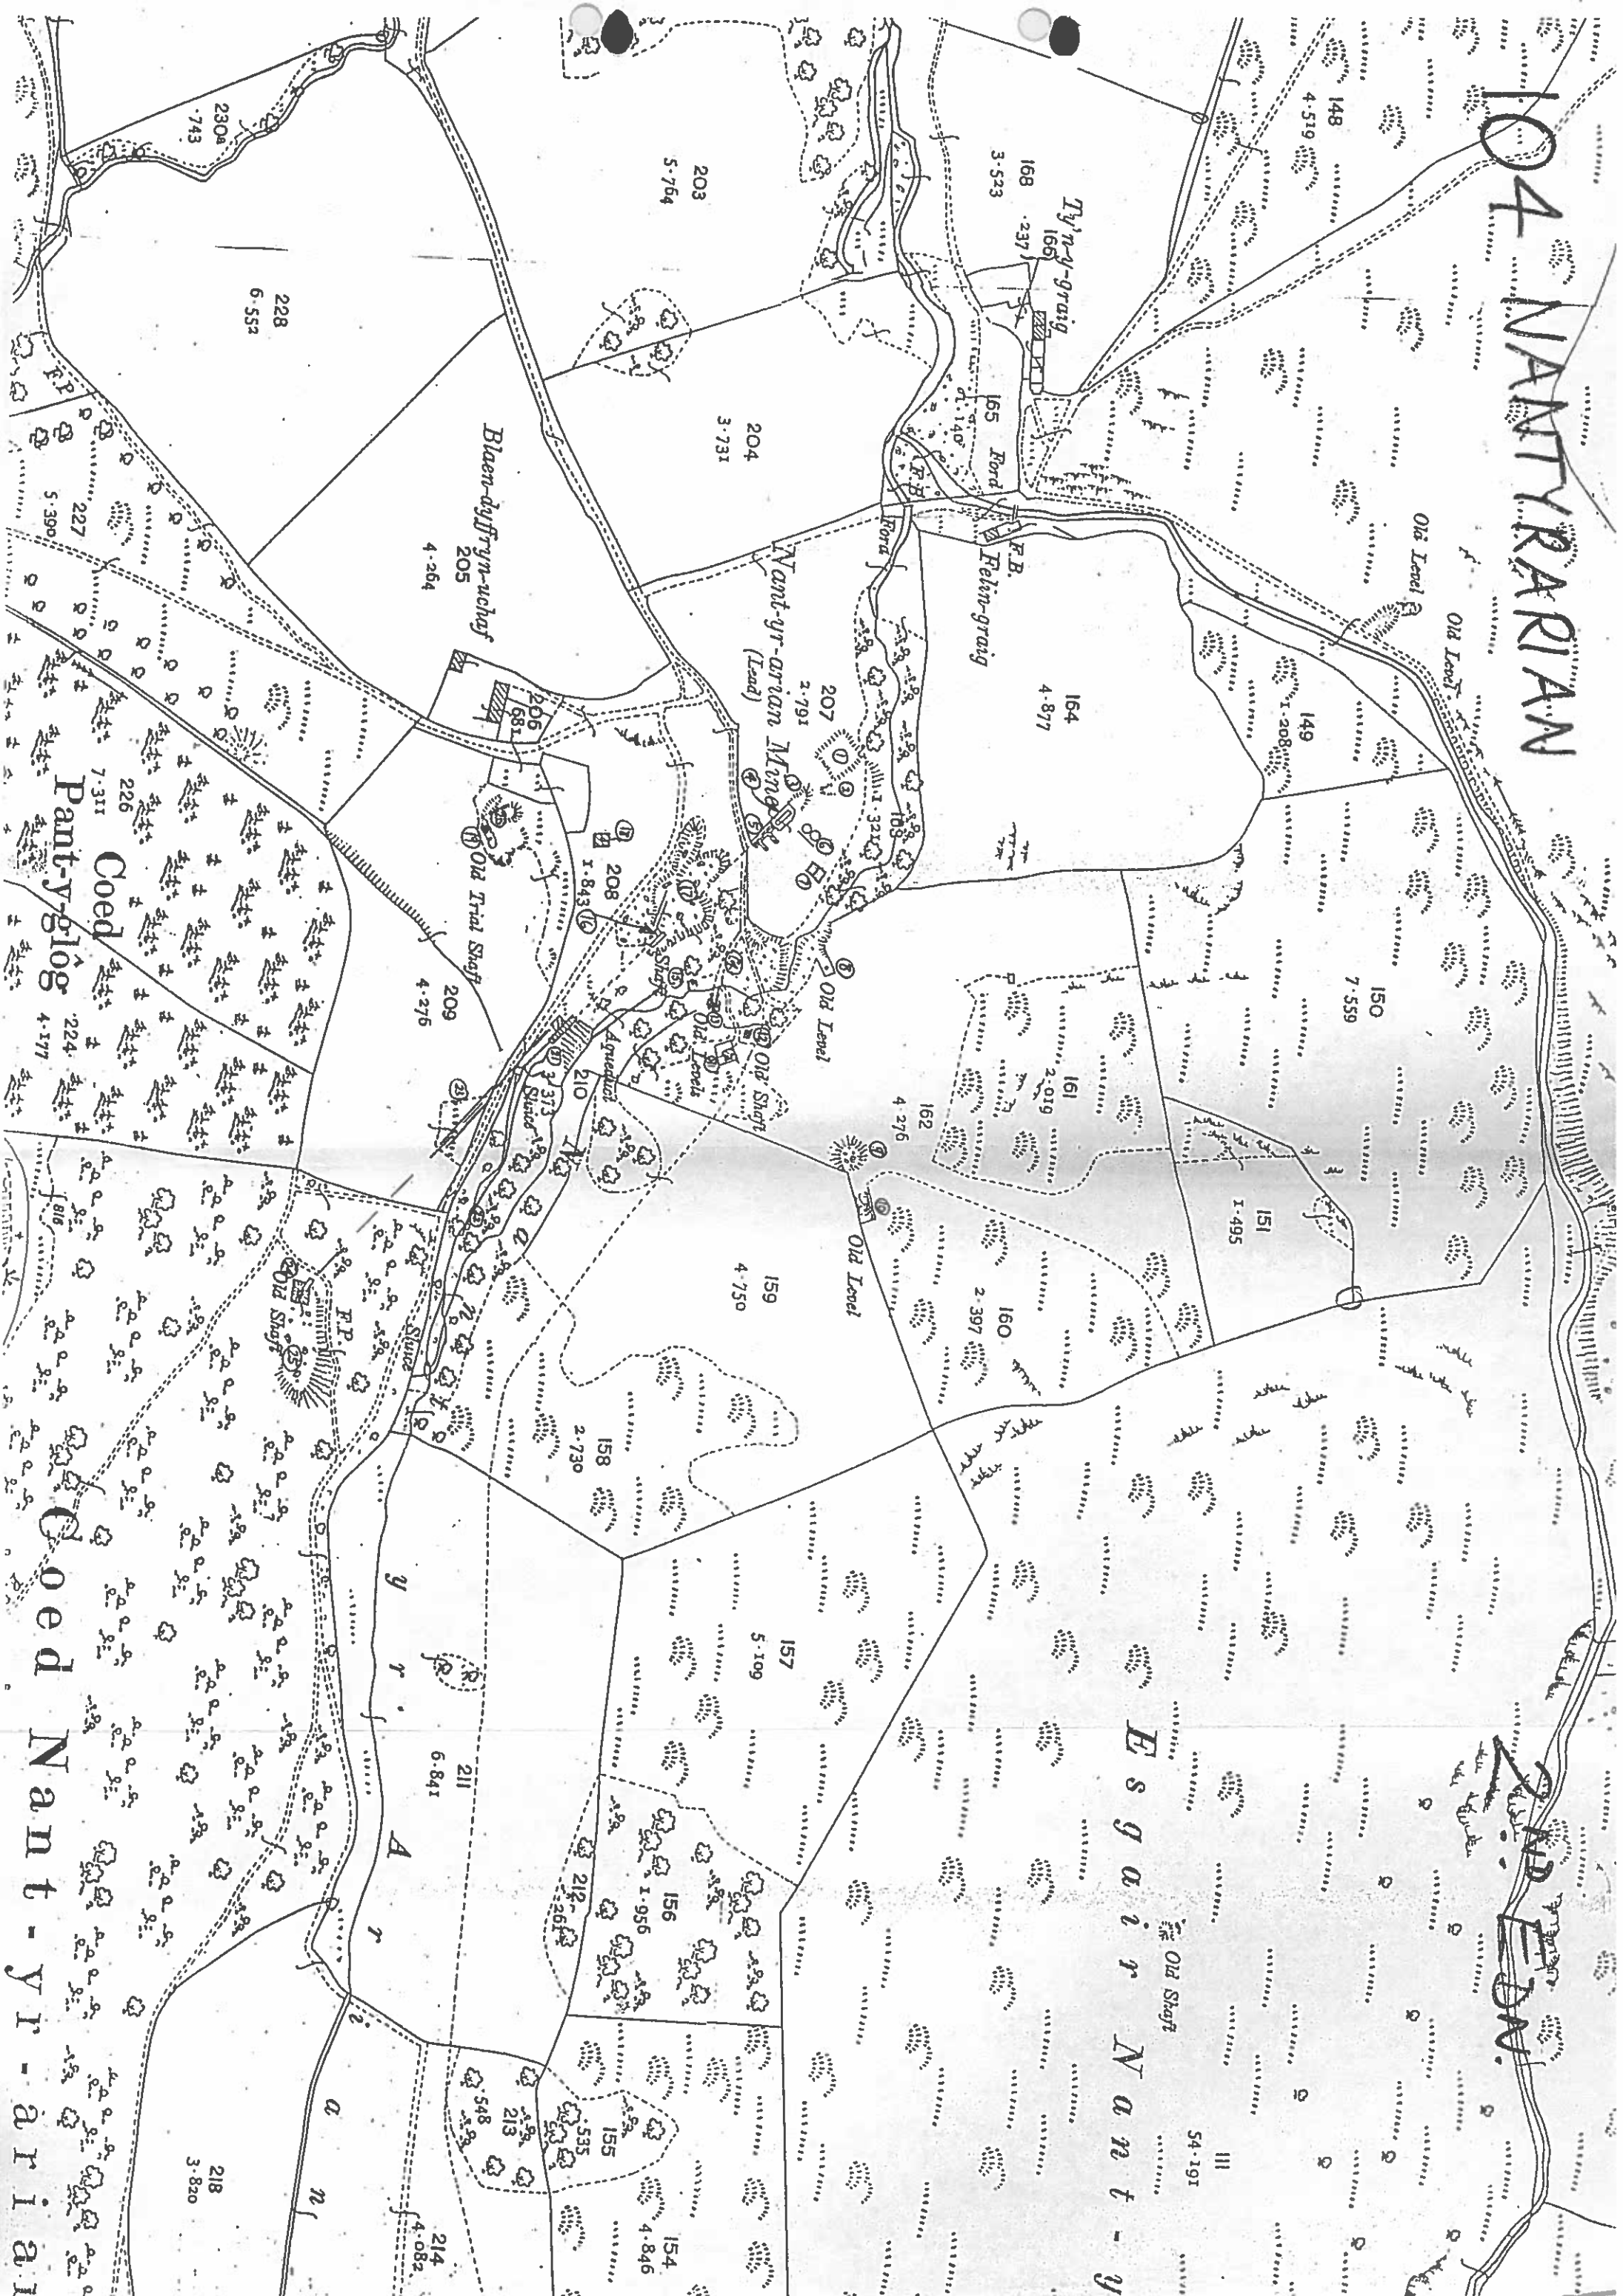
- 96054 ① Embanked mine pit; grass-grown.
- 96055 ② Gully on site of waterwheel tailrace
- 96056 ③ Crusher waste and grass-grown tip from excavation of wheelpits

- 96057 ④ Lower wheelpit 4'x18'; shaft completely infilled
- 96058 ⑤ Upper wheelpit 5'x22'; reasonable condition but broken down at SE end. Fragment of crusher house to NW. Two arched openings in NW end wall.

- 96059 ⑥ No trace of boulders
- 96060 ⑦ Building outlines
- 96061 ⑧ Rock cut level; open; wet; fairly large
- 96062 ⑨ Vegetated development rock tip
- 96063 ⑩ Rock cut level; open; wet; Branches into two at entrance. NE branch is a little small & only 10' long; NW branch is fairly large.

- 96064 ⑪ Barely tactile site of building
- 96065 ⑫ Slope come to surface; rock cut; irregular; open; 15' deep to infill but slopes off SW to a greater depth.

- 96066 ⑬ Rock cut level; open; 2' of water in entrance; remains of metal gate installed just inside entrance; ~~fairly large~~ <sup>moderate</sup> cross section.

- 96067 ⑭ Readily tactile tunnel alignment from level ⑬ towards crusher.
- 96068 ⑮ Rock cut level; open; dry; moderate cross section. Enters shaft ⑯
- 96069 ⑯ Engine shaft; rock cut; 11'x8'; remains of masonry angle bobpit to SE; some studs projecting from ground <sup>just</sup> to SW. Open but blocked by refuse at 25' depth, from which an 8" rising man projects by 4' adjacent to where level ⑮ enters shaft; pumpthy spear projects from man but has been bent down into refuse in shaft. Collapsed metalwork from a bob in W. corner of refuse infill in shaft.

- 96070 ⑰ Development rock tips; coarse; some cupriforous vein stuff and galena. No trace of a rod from lower wheelpit
- 96071 ⑱ Very ruinous remains of building.

- 96072 ⑲ Rocky gully; maximum depth 20'; average 10' width.
- 96073 ⑳ Grassy tips

19830 ② Well defined lead

96075 ③ Slight gully is only trace of flat rods/windy rope route to shaft to west or east

38166 { ④ Caved in crater and 12' x 16' rock cut shaft blocked by refuse at 20' depth; slight remains of angle bob pit to NE  
⑤ Vegetated large development rock tip
