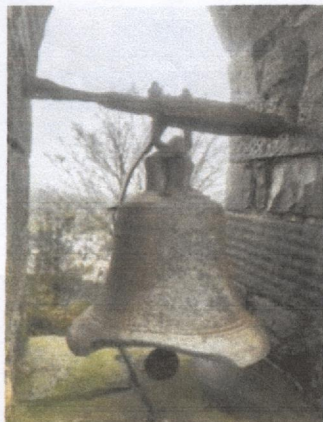
The Diocesan Bell Advisor, Peter Hayward has reported on the historic C15 bell. The bell and its hanging are in a seriously poor condition [see Photo 9, Photo 8]: the headstock holding the bell is severely corroded on one side and could bend and collapse at any moment, while the **gudgeon** on the N side of

Photo 9 view of bell showing the broken sound bow, and the headstock thinned on its S side by rust.

the headstock supporting the bell only engages some 10 mm with its bearing.

The bell should not be rung, and the bell should be taken down as soon as possible to keep it safe from falling. Its repair¹¹ and rehanging should then be planned, ideally within this coming quinquennium.

¹¹ This should include the specialist welding in of a new section of sound bow unless the fragment broken off has been found and kept safe, in which case that should be welded back in. The work will need to be done by Soundweld, a firm in Newmarket that specialise in this, the only firm in Europe who do this.

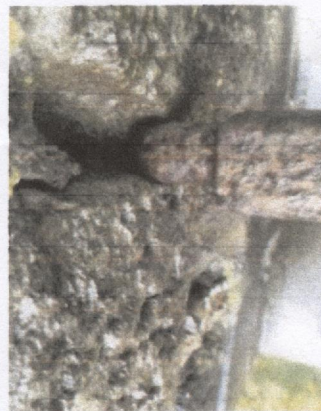
Photo 8 Detail of N side bearing of bell: the engagement with the bellcote masonry is minimal and precarious.
