Photographical Survey Report.

**Melin Glandy, Mynachlog-Ddu,
Carmarthenshire, SA66 7RS.**

21ST SEPTEMBER 2020

**Ken Morgan Design &
Building Management Ltd**

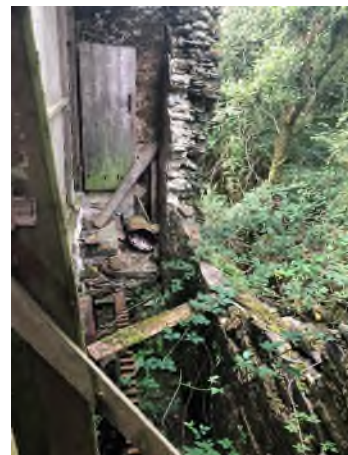
PHOTO 9: External image facing the waterwheel and damaged gable wall.

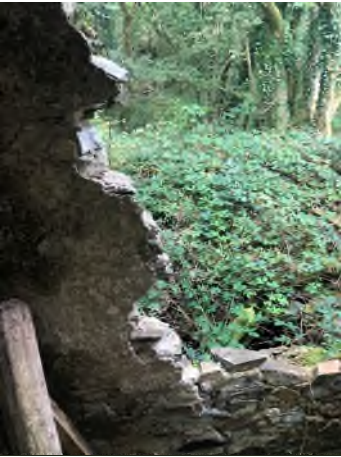
PHOTO 13: External image of the damaged stone north western facing gable wall.

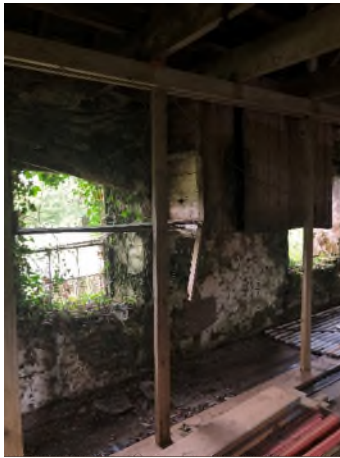
PHOTO 23: Internal image of the timber boxing between windows 02 and 03.

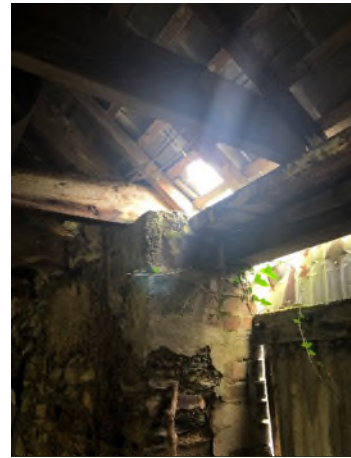
PHOTO 24: Internal image of where the roof joins the wall above the main door (door 01).

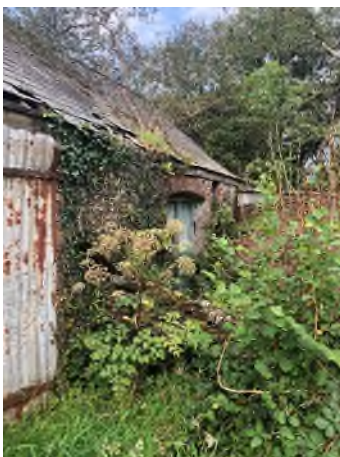
PHOTO 25: External image of the damaged south eastern facing store wall.

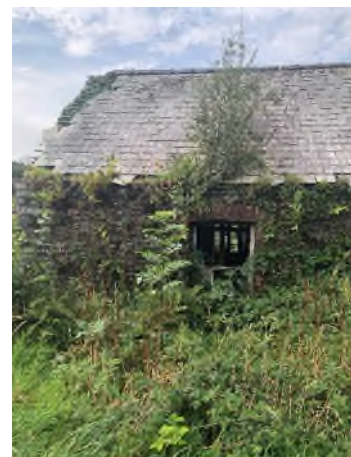
PHOTO 27: External image of window 08 and roof damage at eaves.

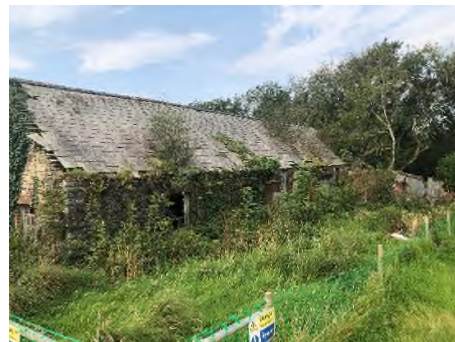
PHOTO 29: External image of the north eastern elevation with overgrown grass and landscaping hiding the store.

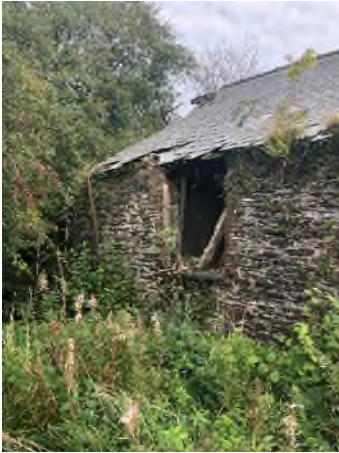
PHOTO 34: External image of window 05, roof damage at eaves and immediate surroundings.
