## Middleton, Dyfed: Historic Landscape Assessment - Proposed Botanic Garden and Country Park

**1.1** The following is an assessment of the landscape of Middleton, Dyfed. It has been prepared for the Planning Department of Dyfed County Council, in connection with proposals to develop Middleton as a Botanic Garden and Country Park.

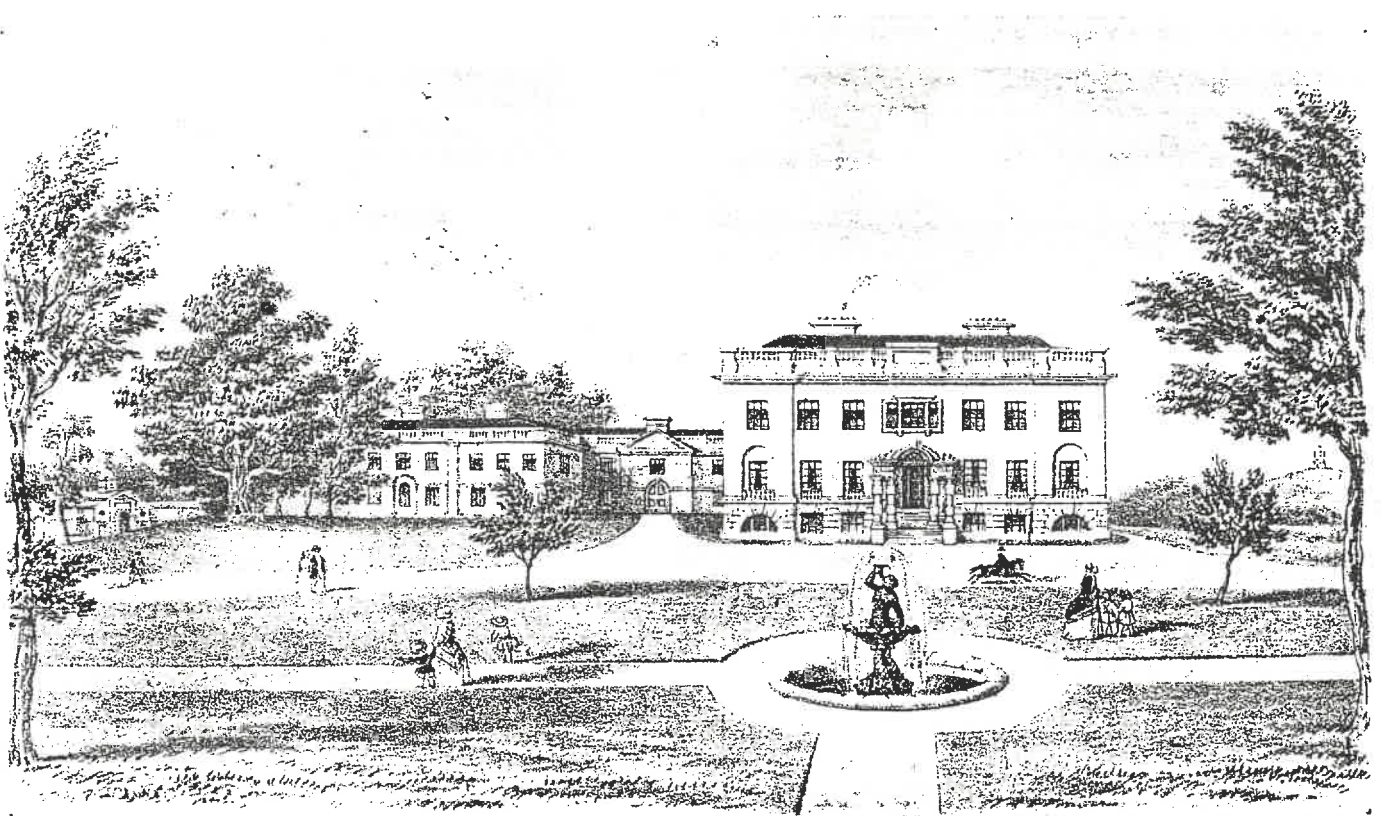
The front (south western) view of Middleton Hall in 1853, a lithograph by Augustus Butler (see also the companion view opposite paragraph 4.2.28). Note in particular the layout of paths in the foreground, the "plantation" of trees to the north west of the house, the stone pillars on the entrance portico and the views to the stable block and to Paxton's Tower in the distance.

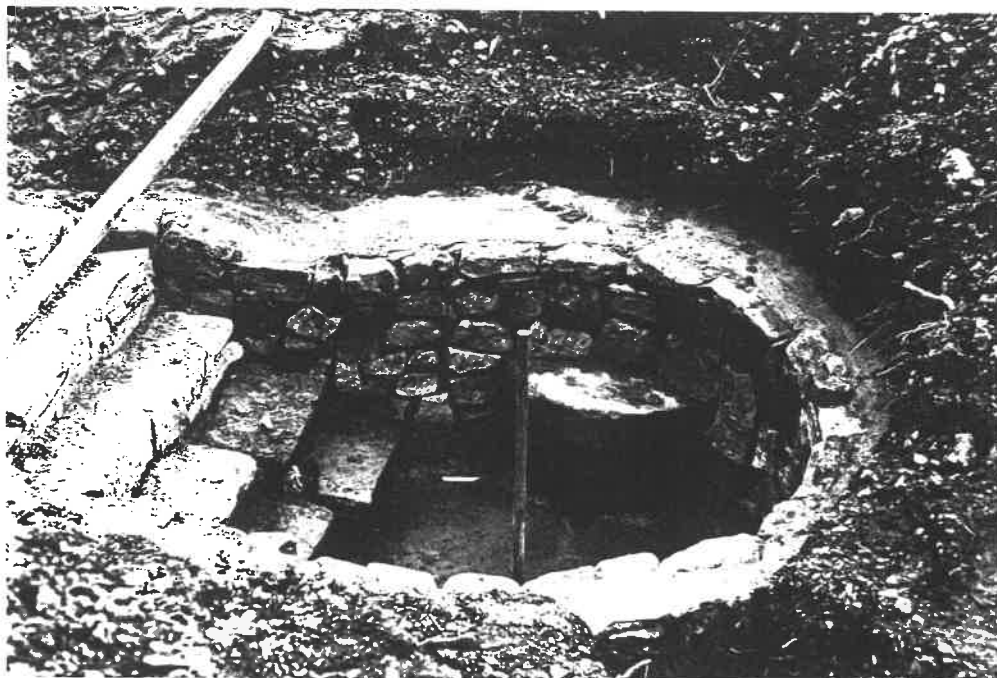
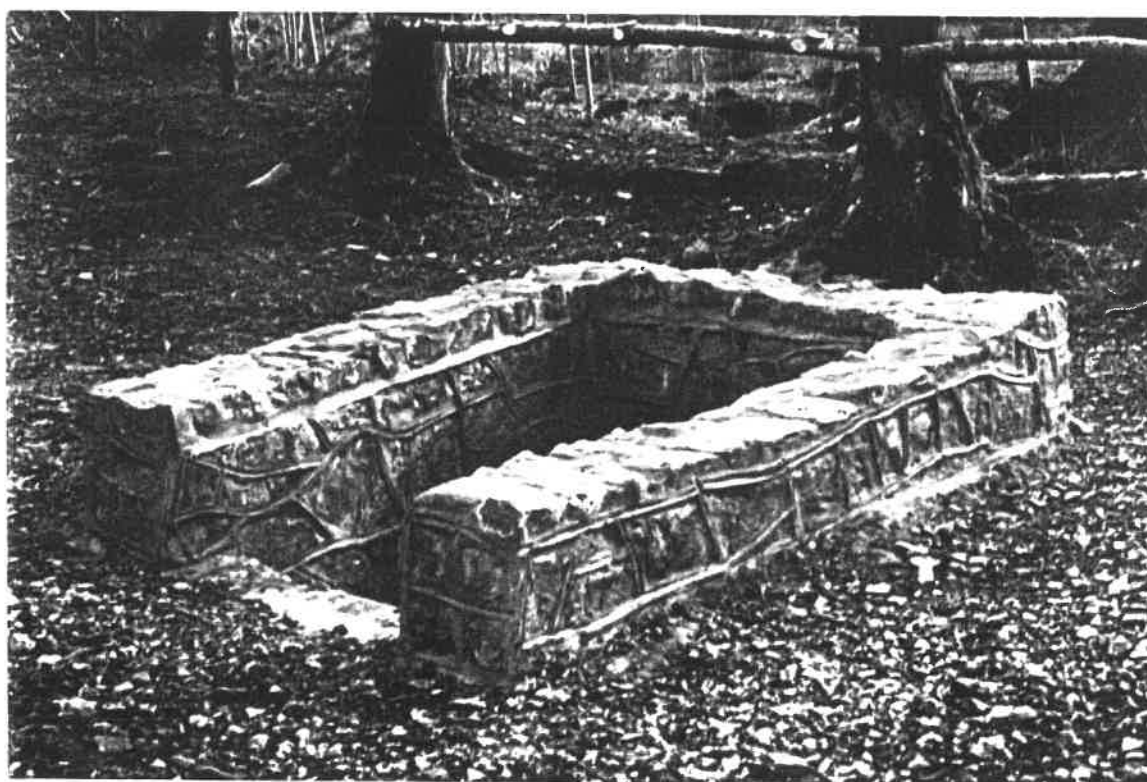
The Holy Well at Pont Felin-gat: photographs taken during and after rebuilding. In the upper photograph, the lower two steps and the stone wall were as found.

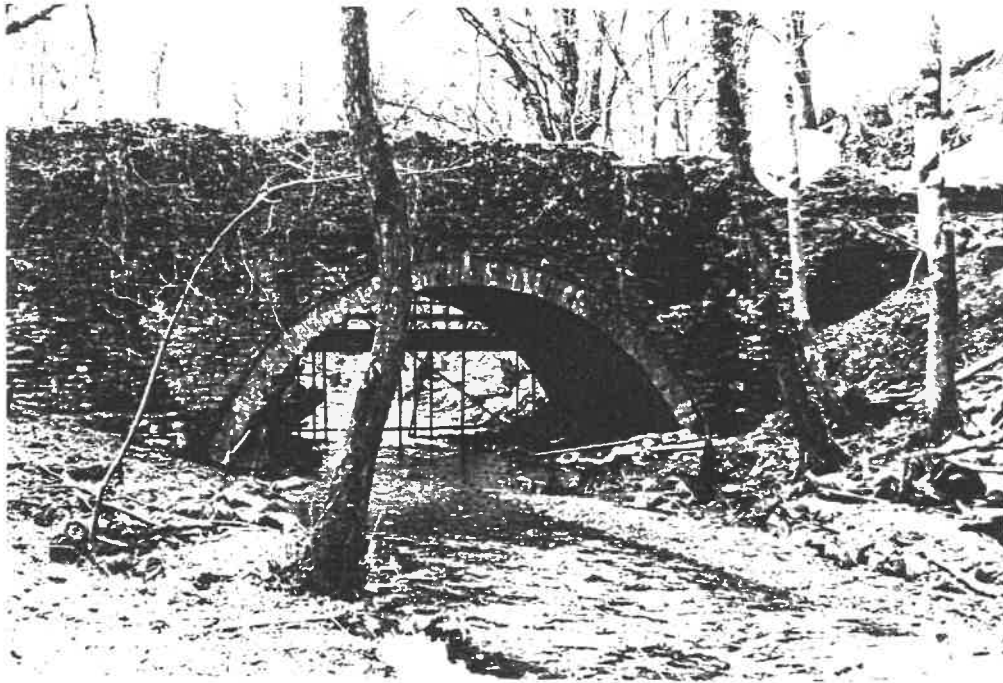
#### **4.2.52** The stone bridge here carrying the former approach road has been recently repaired and pointed, but once again hard cement mortar has been used: although the end result appears very solid it is unsympathetic to the structure itself. On the eastern face of the bridge, salts are being washed out of the mortar and disfiguring it.

- 1 Two problems are apparent here. The first is the seepage of water through the structure from above and the internal damage that this may be doing. This is an engineering problem: the expertise required to correct it may be found within the Council.
- 2 The second problem is one of the long-term stability and appearance of the facade. In common with many of the other restored features at Middleton, this bridge requires repairing and repointing with a lime-base mortar that will appear sympathetic to both its character and surroundings.
- 3 No archaeological report on this bridge prior to its rebuilding is available, although a photograph taken before work started is included in the Appendix.

The stone bridge above the Waterfall prior to rebuilding.

**4.2.53** It is recommended that all such works at Middleton be carried out under the supervision (however this is arranged) of a practising stone conservator or a person experienced in this kind of work.

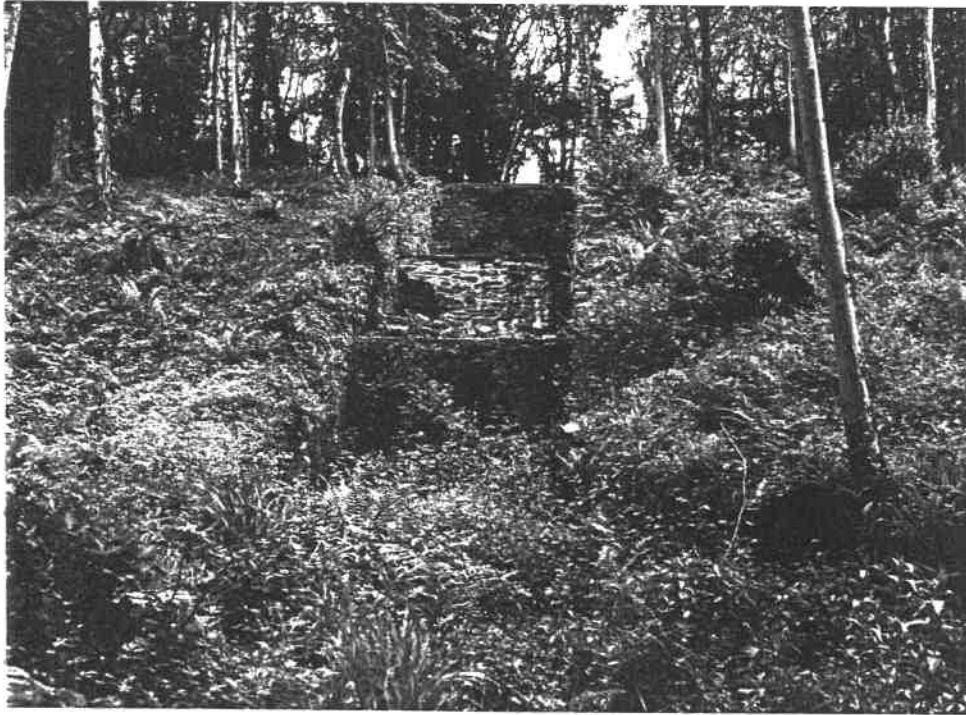
- 1 The Cascade itself is a stupendous thing when in full spate, with upwards of 60,000 tonnes per day thundering down it from Pond-du above. The damage that this amount of water would do to the dam in the absence of a suitable spillway is difficult to imagine, but is likely to be extensive. Proposals have been made above to redirect the bulk of flood waters away from this cascade (see paragraph 4.2.26), but its construction should still take into account a theoretical maximum flow. The great volume and force of water to date has undermined some of the Cascade's lower reaches and these require prompt action if this structure is not rapidly to deteriorate.

- 2 The present appearance of the Cascade, however, is inappropriate in its setting. Although photographs taken prior to restoration indicate that it does not appear to have been extensively remodelled (see Appendix), the style of pointing (in which this is given more prominence than the stone itself) and the use of hard cement mortar for this, has produced an effect which emphasises the engineering qualities of the cascade, rather than its ornamental characteristics. It is possible also that failure of the mortar used may also in part have been responsible for the collapse

of the lower sections. Repairs to the Cascade should be undertaken only after consultation with a qualified engineer.

The Cascade prior to rebuilding.

- 3 No archaeological investigations of the Cascade were undertaken prior to its rebuilding. As so little evidence is available concerning its former design, it is recommended that its present structure be maintained, subject to recommendations made above concerning the involvement of an engineer.
- 4 The rustic pillars at the bottom of the Cascade are thought to be from the south front of Paxton's house (see frontispiece). These should be removed to a protected environment: they are in any event inappropriate in their present location.

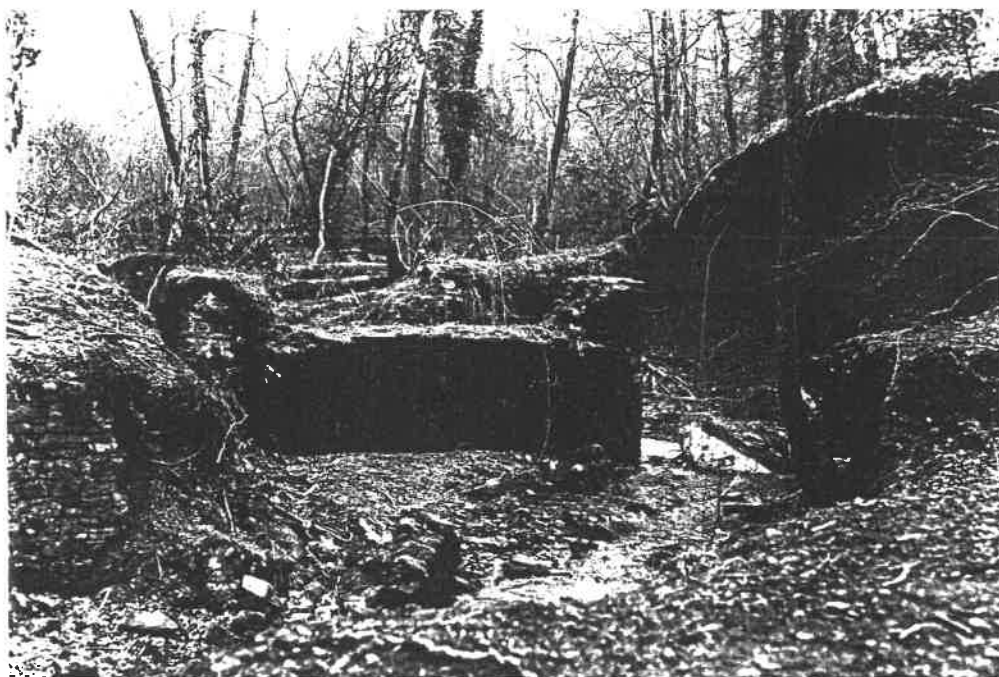
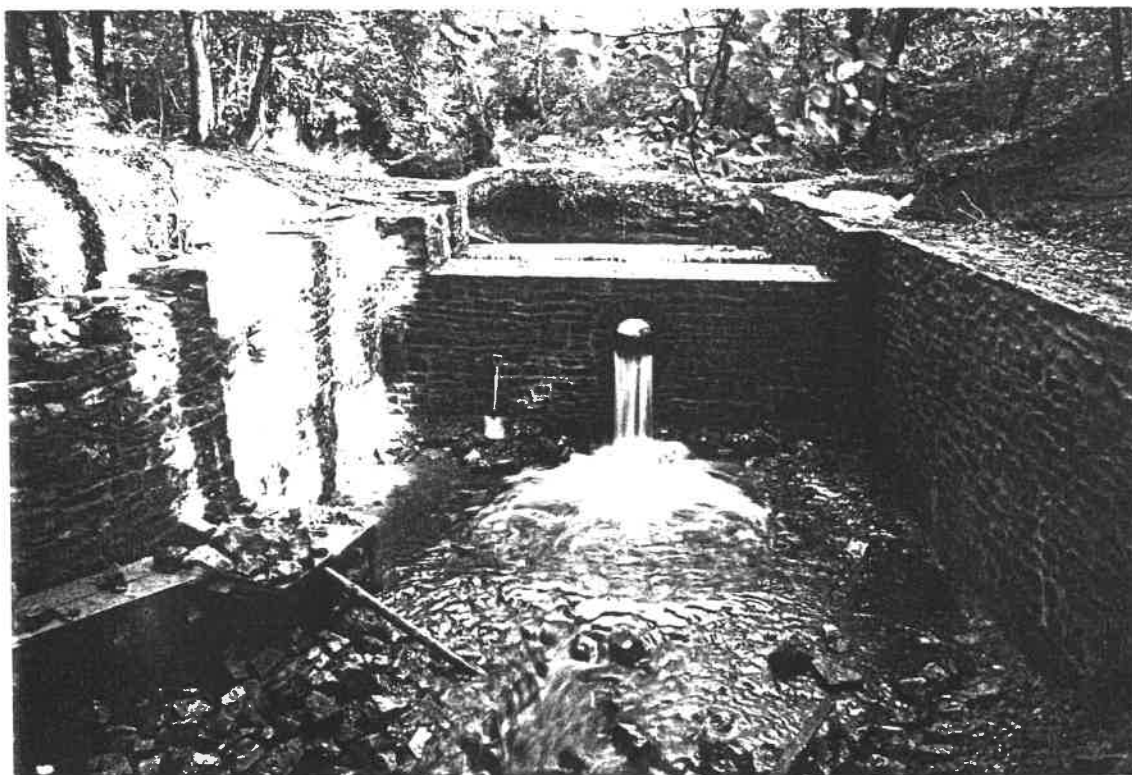
- 3        Some undermining and cracking of the north wall downstream of the cascade has taken place and should be repaired promptly. A drain in this wall carries water into the Afon Gwynon from another source, perhaps the road above to the north. This raises questions concerning the possibility of pollution of this watercourse.

The Fish Pond Cascade: photographs taken during and after rebuilding. The upper photographs clearly shows damage caused by floodwaters at this site. The double-weir arrangement of this feature is visible in the lower photograph.

- 2        It is recommended that the design and construction of the Cascade and of the pond behind it be integrated in any future restoration. For example, the former level of water in the pond, which is be apparent from its field archaeology and to which it should be restored, will determine the level of the first (upstream) weir. It is evident that this presently is too low, as very little water is being held in the pond behind it.

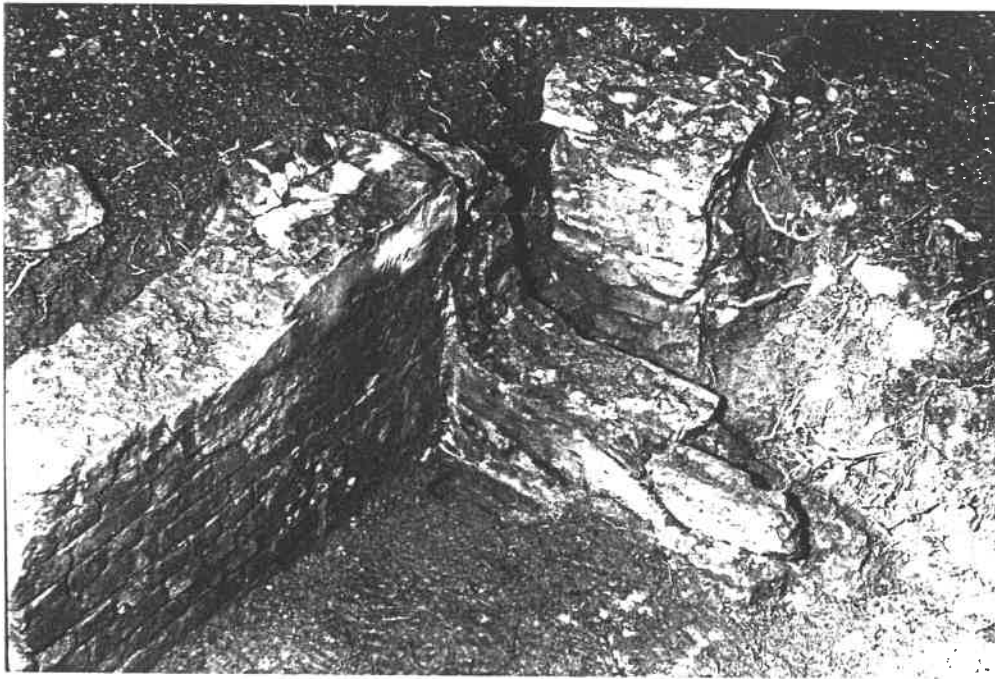
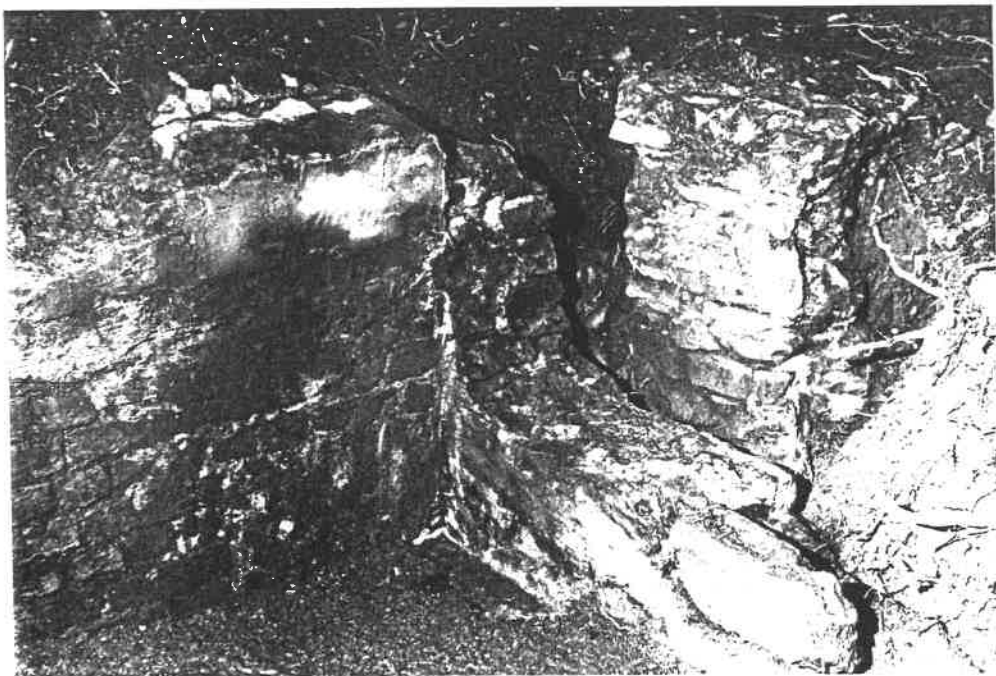
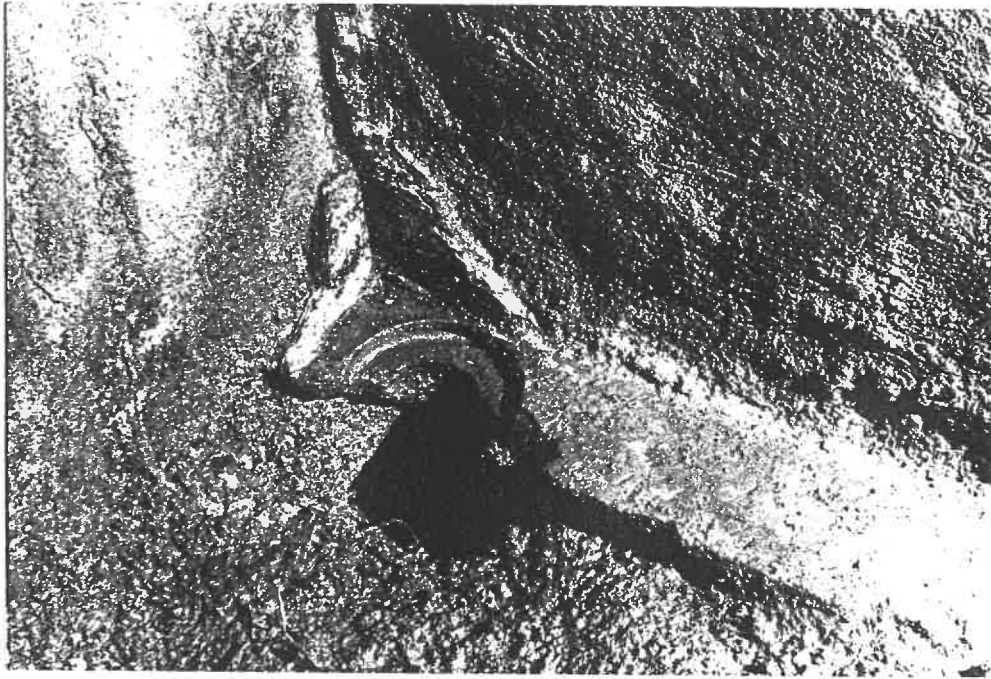
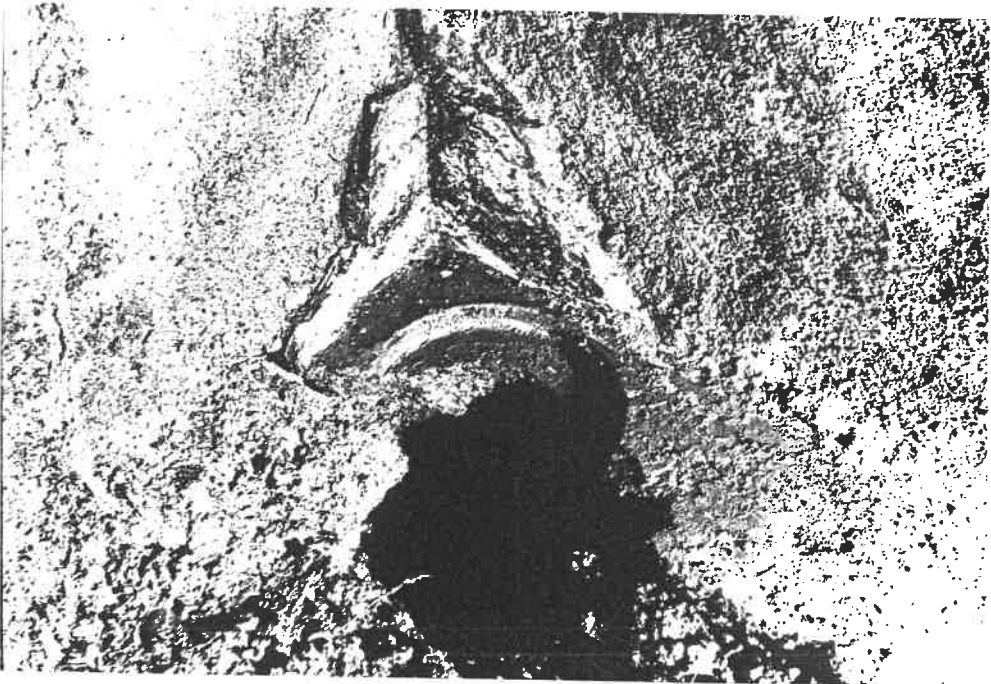
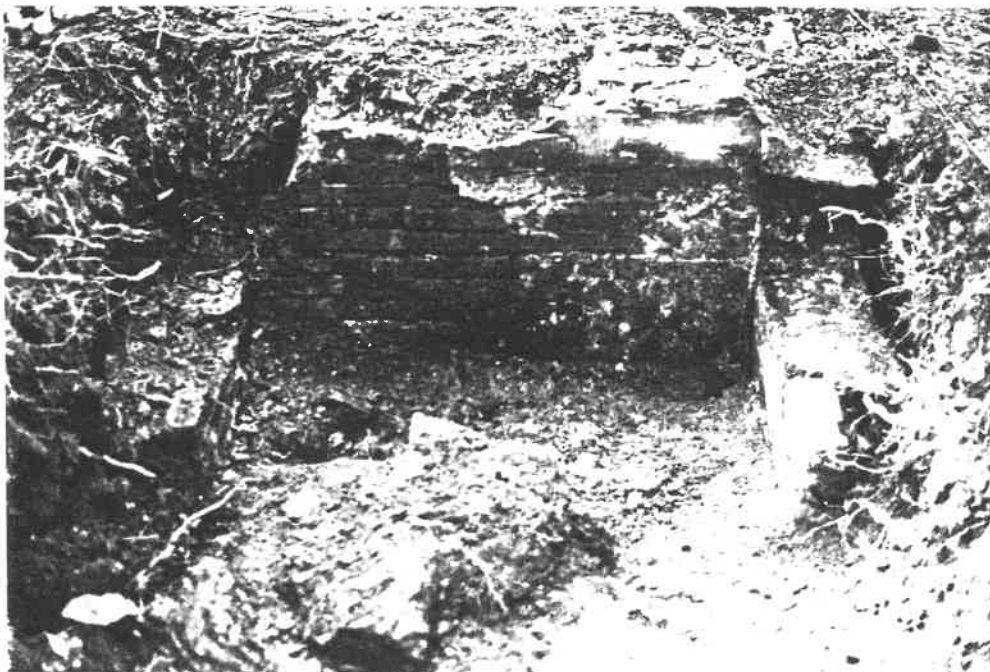
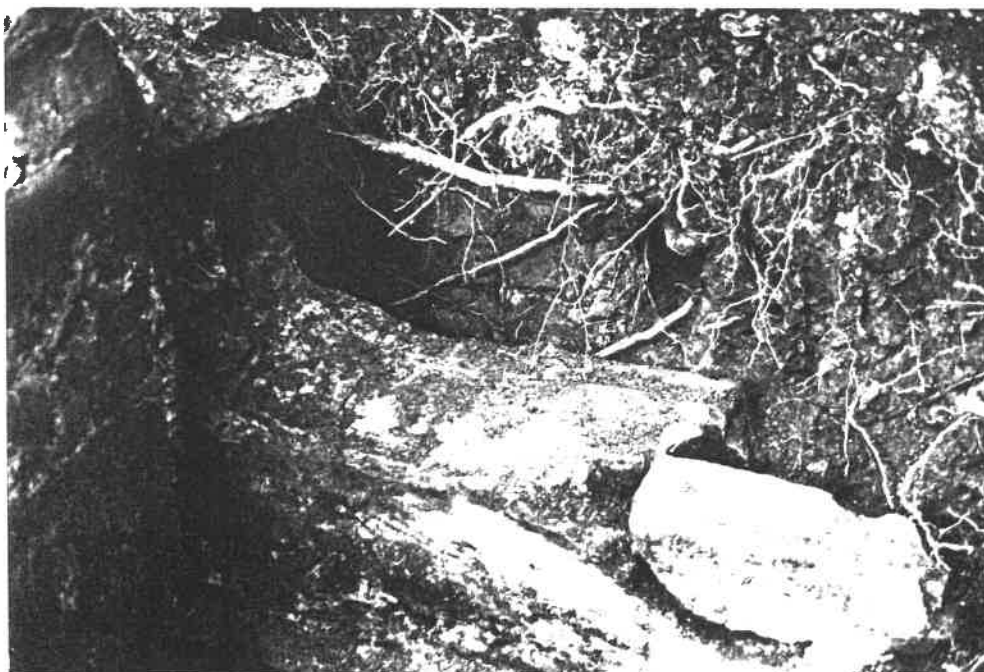
Also found a length of lead frame and small piece of window glass suggesting that the bath house had some windows.

(This page and following) The Bath House: photographs taken during excavation. See also the accompanying report.
