# **HAFOD 1994**

**AN ARCHAEOLOGICAL EXAMINATION  
OF THE  
'LADIES WALK'  
FOR  
THE WELSH HISTORIC GARDENS TRUST/  
YMDDIRIEDOLAETH GERDDI HANESYDDOL CYMRU  
BY  
D G PHILLIPS BA**

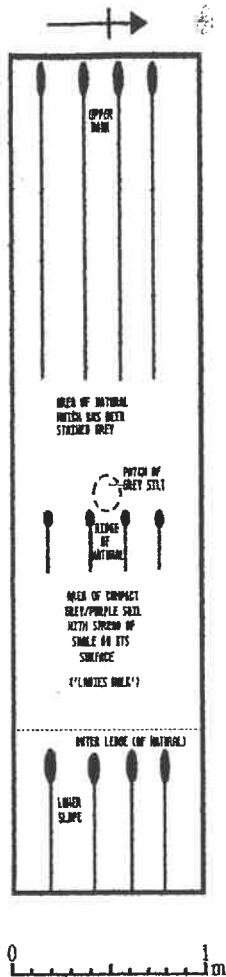
## TRENCH A

An area 4.2m x 1m was examined across the 'Church Walk' (east/west), which included the upper and lower banks of the ledge-cut track. The area was covered in moss and leaf mould which was first removed. This revealed several contrasting surfaces. The upper bank on the western side slopes up at approximately 45 degrees to the horizontal, and comprises an orange gritty clay, which appears to be the natural underlying surface. At the base of the bank is a 0.75m wide strip where the soil is similar to the natural but has been discoloured slightly grey. There are also small pockets of what appears to be a riverbed gravelly silt in this area, the thickest being 0.01m thick. To the east of this is a

slightly raised 0.15m wide area of the natural orange gritty clay. To the east of this is a further surface set slightly lower than the inner strip and comprising a compact grey/purple gritty soil 0.75m wide and 0.02m thick (a very small strip was removed to examine the depth and nature of the soil) with a thin spread of small pieces of shale material over the surface. The outer 0.3m of the ledge was again found to be the natural underlying material which then slopes off steeply downhill to the east.

From the evidence recovered there appear to be two phases of construction in the track. There is the outer part of the ledge comprising the 0.3m strip of natural and the compact grey/purple soil overlaid with a shale spread. This may well have been the original 'Ladies Walk'. The compact grey/purple material and shale surface comprise the walk with the natural outer lip giving some form of safety measure at the edge of the path. The path was then widened to form a track, whereby the inner (western) bank of the 'Ladies Walk' was cut away to form the wider 'Church Walk'. The surfacing of the 'Ladies Walk' must have continued in use as no overlying material was recovered, while the inner part of the ledge was covered with riverbed silts to form a metallised surface. As the centre of the ledge is a slightly raised area of natural it must be assumed that just the inner and outer metallised surfaces were in use. This would make it appear that the track may have been meant for the use of carts. As the track was never completed, it could not have been used very heavily by carts, which would mean

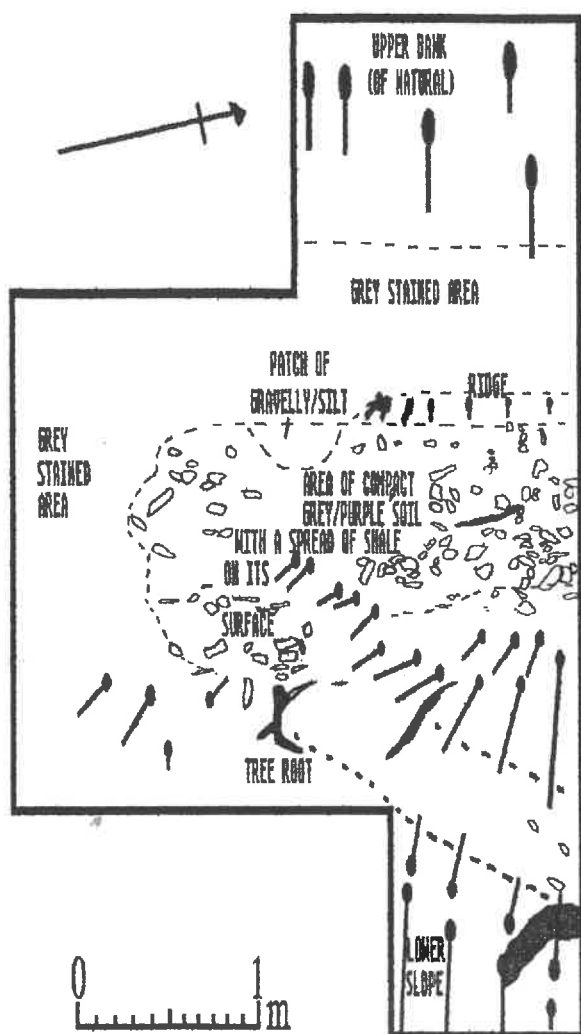
## TRENCH B

larger than those in trench A. This surface was approximately 1m wide and ran for 2.2m south before sweeping around to the east in a curve and continuing to follow the route of the ascending path. The path also banked slightly as it went around the curve, it sloped gently down towards the east then north as it turned, allowing for an easier turn. It was noticed that as this surface curved around, some of the grey silty material had spread over its western inner edge. Where traces of the grey/purple surface and shale could be seen on the ascending path it was much narrower, being approximately 0.5m wide but tree roots have caused a certain amount of damage to the path's edge on the final approach to the wider track.

The evidence points to a two phase construction in this area. The original 'Ladies Walk' ascends the hill from the north-east then curves tightly to run north towards the church. This can be seen by following the course of the compact grey/purple material with the spread of shale on its upper surface. This ascends the hill then curves around to follow the route of the 'Church Walk'. When the later wider track was cut the ledge formed by the 'Ladies Walk' was utilised: the inner (west) side of the track was metalled, the 'Ladies Walk' was not re-surfaced but used as it was. Where the 'Ladies Walk' did not exist a wider ledge had to be cut to form the track. This can be seen to the south beyond the area of the 'Ladies Walk' where the 'Church Walk' is uniform in its construction across its entire width. Here the surface of the track is consistent with the surrounding natural but has been stained grey. As a gravelly silt was used for metalling the second phase, some traces having been recovered, then it would have left a grey stain on the

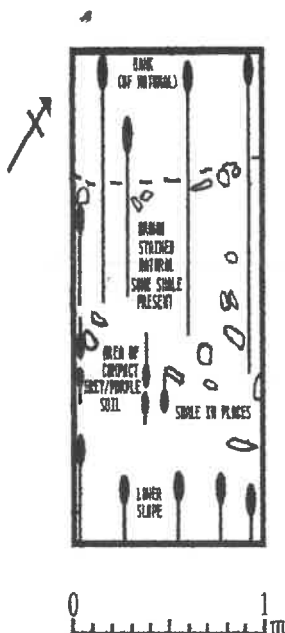
## TRENCH D

This was opened approximately 3m north-east of trench B on the ascending path and was 2.5m x 1m. On the western side of the trench was a sloping bank. The upper part of the bank was showing the brighter orange of the natural while the lower 0.5m was more of an orange/brown colour with some traces of shale lying on its surface. At the base of this, running north-east/south-west was a slight depression 0.015m deep x 0.3m wide which had a fill of the dark, grey/purple compact material with traces of overlying shale. To the east of this the ledge was still relatively flat, although it was sloping up towards the south-west, and was approximately 0.85m wide. Its surface was again the orange/brown colour similar to the lower half of the bank. Beyond this the ground fell steeply away.

In this trench obvious traces of the path's construction material have been found but not extending over the entire width of the path. That the natural has been stained a darker colour (orange/brown) over the outer, eastern, side of the ledge would seem to indicate this part of the ledge was once overlaid with some darker material which had eroded away. This darker staining, both on the bank and the ledge, may have been caused to some degree by disturbed material rolling down the slope and over the path during the

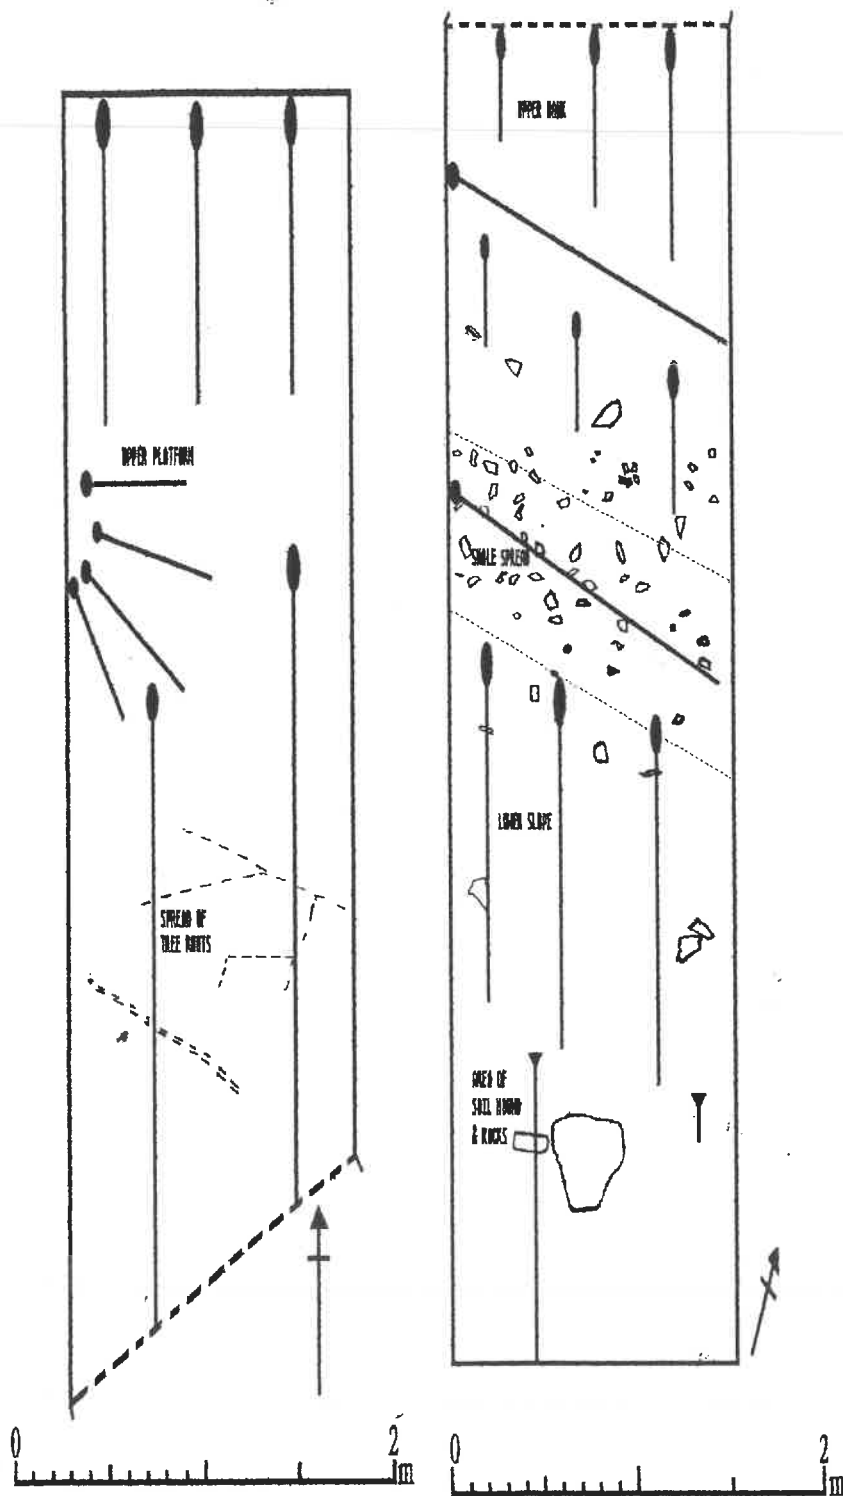
## TRENCH F

Clearance of the surface material on the platform soon revealed it to be the site of a large tree which must have toppled, cutting a slope in the hillside to the west and throwing up a bank on the eastern side. The routes of once large tree roots weaving their way through the centre of the platform could leave no doubt as to its nature.

The lower section of the trench presented a different picture. After descending the slope on the side of the platform a ledge was uncovered which had traces of the grey/purple material and a spread of shale over its surface. The ground then sloped away for some distance before reaching a raised area of soil and large stones. There was a short steep drop over the edge of this mound then the ground sloped away quite steeply again towards the forestry road.

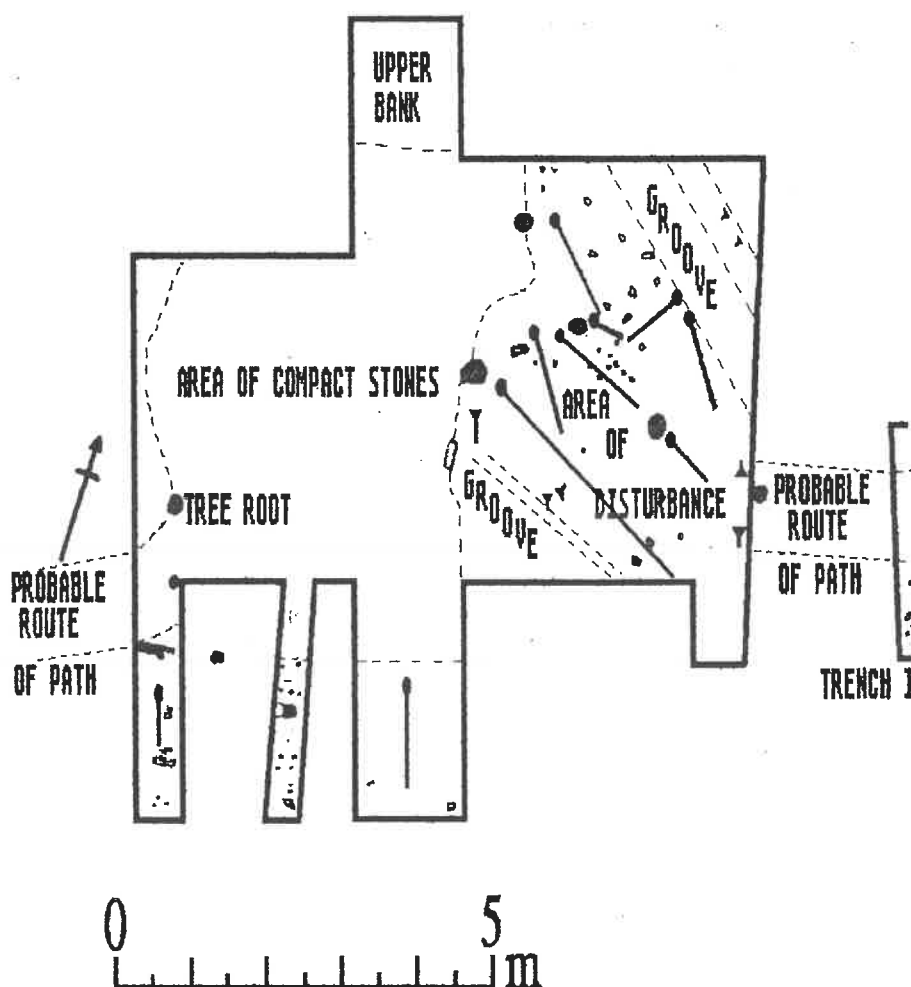
The compact stone surface covered some 4m (east/west) by 6.5m (north/south) with a rounded end to the west and it sloped gently to the south. The eastern end had been destroyed so it was impossible to find its full extent in this direction. The stones were rough and angular, very densely packed, none appeared to be very large, at the most 0.15m x 0.15m usually smaller, and had traces of a gravelly silt around them. The silting was more concentrated in the area of the spring and may have been a natural washing out due to the action of the spring rather than being laid down. On the south-west corner of the platform a number of trees and a large tree root had destroyed the junction between the path and the platform; as a result it was not possible to tell how the

two joined but it was clear that the path was directed on to the platform from its angle of approach. Likewise the junction between the path and platform on the eastern side was completely destroyed but it was clear that the path would have run on to the platform. There were no traces of the path to the south of the platform where the ground is reasonably level.

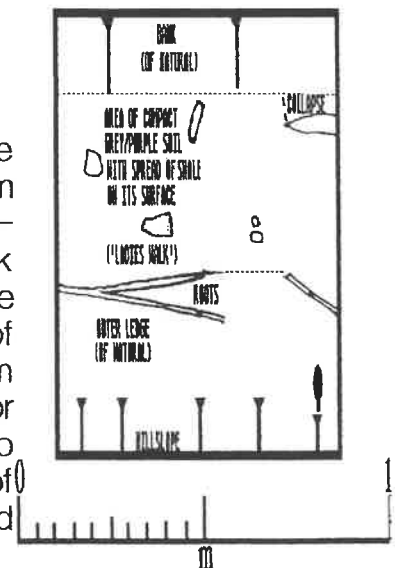
## TRENCH K

This trench was 1.5m x 2m, encompassing the bank above the excavation and the fall on the outer edge. This trench was 6m south-west of the stone revetment and ran north-east/south-west. Clearance of the humic overburden revealed that the bank (north-west) consisted of the natural orange gritty clay. There was then a strip 0.9m wide of loose shale. To the south-east of this on the outer edge of the ledge was an area of natural, 0.5m wide, which then fell at 90 degrees to the horizontal for approximately 0.6m. The ground then fell away very steeply to the valley floor. Owing to the danger created by the steepness of fall below the ledge not much of this area could be investigated but it was clear there was no stone revetment at this point.

As the shale surface was so loose, to confirm that it was the path and not just shale collapse, and to confirm the nature of the path's construction, it was removed. This revealed a dark grey/purple compact soil 0.9m wide, although its outer edge (south-east) was damaged by a tree root.

It seems clear from this trench that a ledge was cut into the hillside to accommodate the path. The path was 0.9m wide, its base was the compact grey/purple soil and this was overlaid by a loose shale surface. The outer edge of the ledge was not paved having a 0.5m outer edge comprising the natural. Due to the very compactness of the natural no revetting was needed on this section of the ledge/path.

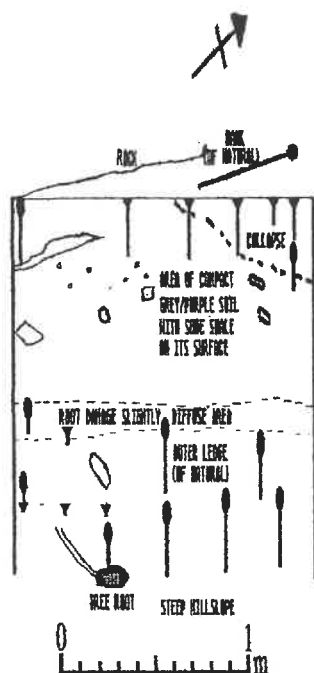
this had some traces of shale on its surface. This entire area of ledge was so overgrown with root mat that the path surface had been considerably disturbed. There was again an outer (south-east) strip of natural 0.5m wide although this was slightly browner than normal.

Below the outer lip of the ledge at the south-east end of the trench was a stone revetment 0.6m high. This revetment was moss-covered and as little as possible of the moss was removed. It was clear however that the revetment consisted of dry stone walling and appeared to be constructed of pieces of local shale stone, perhaps pieces cut from part of a cliff face during the construction of the ledge. The revetment was built on a small crescent-shaped platform. This was the only place where there was such a platform below the outer edge of the ledge, the rest of the outer edge of the ledge comprising the very steep hillslope. The north-east end of the revetment had been destroyed by a tree growing at this point, of which only a stump now remains, but where the revetment ended the bank of natural appeared to continue: beyond the tree stump the outer bank definitely comprised only the compact natural.

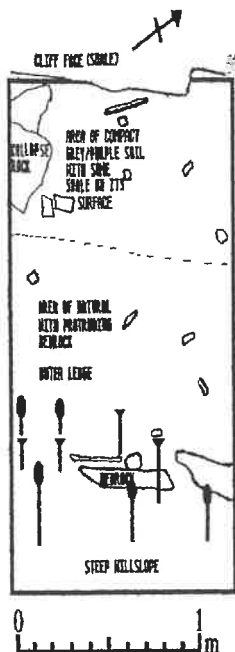
At this point the ledge had to cross a rock outcrop which sloped downhill at approximately 85 degrees to the horizontal. It was clear that the rock face on the inner

(north-west) edge of the ledge had been cut away to form a vertical face due to the alteration in angle of slope of the cliff face. Below the humic material the ledge was covered in rock debris up to 0.6m deep on the inner (north-west) edge of the ledge. The cliff face had obviously been frost damaged and fresh large pieces of shale were clearly ready to fall onto the ledge. The debris consisted mostly of shattered shale, pieces varying in size from small fragments to large rocks 0.5m x 0.5m x 0.05m, and some soil. This debris was removed to reveal the compact grey/purple soil which had some traces of shale surfacing, but it was difficult to differentiate between natural collapse and metalling, except where the collapse lay at irregular angles to the horizontal. The compact surfacing extended from the base of the cliff towards the outer edge of the ledge for 0.9m. The collapse and the path material had been heavily disturbed by root mat which had bound them together but the compact path material could still be differentiated. A narrow strip of this compact grey/purple material was removed and found to be some 0.02m in depth.

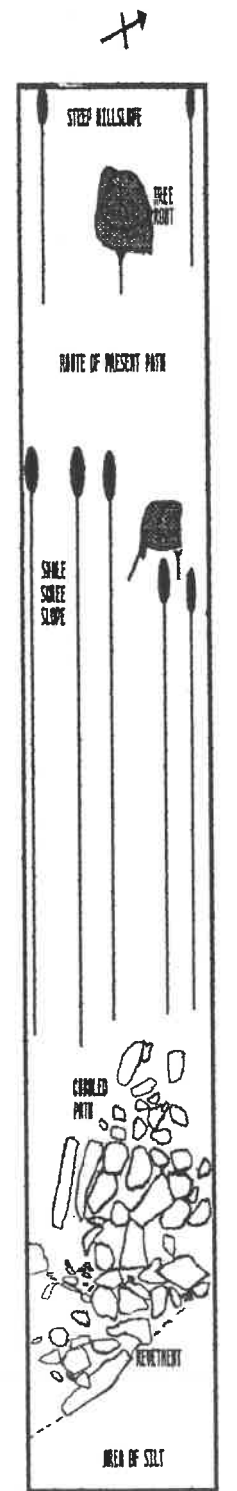
It would seem clear from the excavations that the present path is of more recent origins created to bypass the difficult scree slope and area undermined by the river. The original path was reveted on its outer (north) edge and the surface was created by using river-rounded stones which were probably packed with silt to form a better walking surface. It would seem most likely that the revetment was built at the base of the scree slope and filled in

behind to create a horizontal surface over the scree and then cobbled. Much of the revetment has been washed away and more scree has descended over this area of the path making it almost impassable in its present state, which would account for the newer present route of the path.

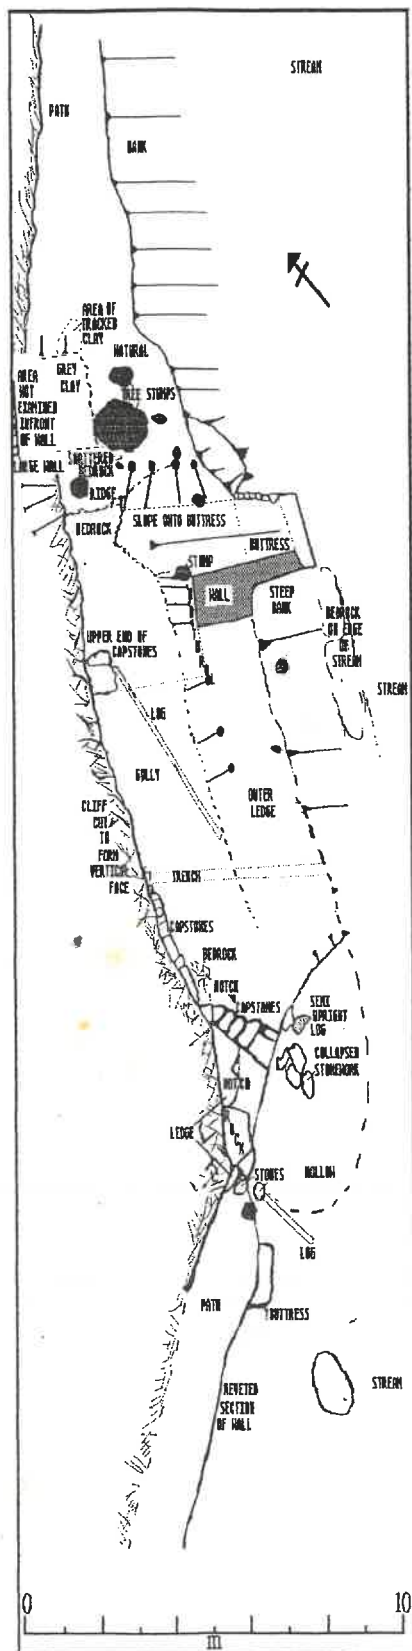
# THE AREA OF THE HOLLOW

The approach comprised a hollow or cut in the river bank on the route of the path. The floor of the hollow itself was in places a metre below the path's normal level. There was then an ascent in a gully obviously cut from the rock from the hollow to the Alcove. The area around the hollow was investigated, as well as the approach route on either side of it and two trenches were laid across the gully.

The hollow is approximately 6m x 3m and 1m below the level of the present path. The base of the hollow is above the normal running level of the stream but when the water is high it obviously pours through the hollow. The humic and river-washed material was removed from the hollow and its surrounds. This revealed on the north-eastern bank a stone-lined and capped culvert running across the route of the path (approximately north/south) which fed into the hollow. This section of culvert is 2m long with capstones up to 0.5m wide. The outer (south) end had collapsed into the hollow but it could still be seen that one side (north-east) had a dry stone lining while the other side (south-west) appeared to take advantage of the bedrock as a lining. None of the capstones were lifted so the fill or cut of the culvert could not be examined at this stage. On both sides of the culvert the ground surface is bedrock, except for its constructed outer edge where it feeds into the hollow. It must be assumed that the channel forming the culvert was cut through this bedrock and that the capstones must rest on the bedrock on either side of the channel, except for the area where it was built up.
