**GLAMORGAN-GWENT ARCHAEOLOGICAL TRUST
CONTRACTS SECTION**

**ARCHAEOLOGICAL RECORDING
EAST BLOCKHOUSE, ANGLE, DYFED**

SUPPLEMENT: RESEARCH AND EROSION ASSESSMENT

GGAT REPORT NO. 94/015

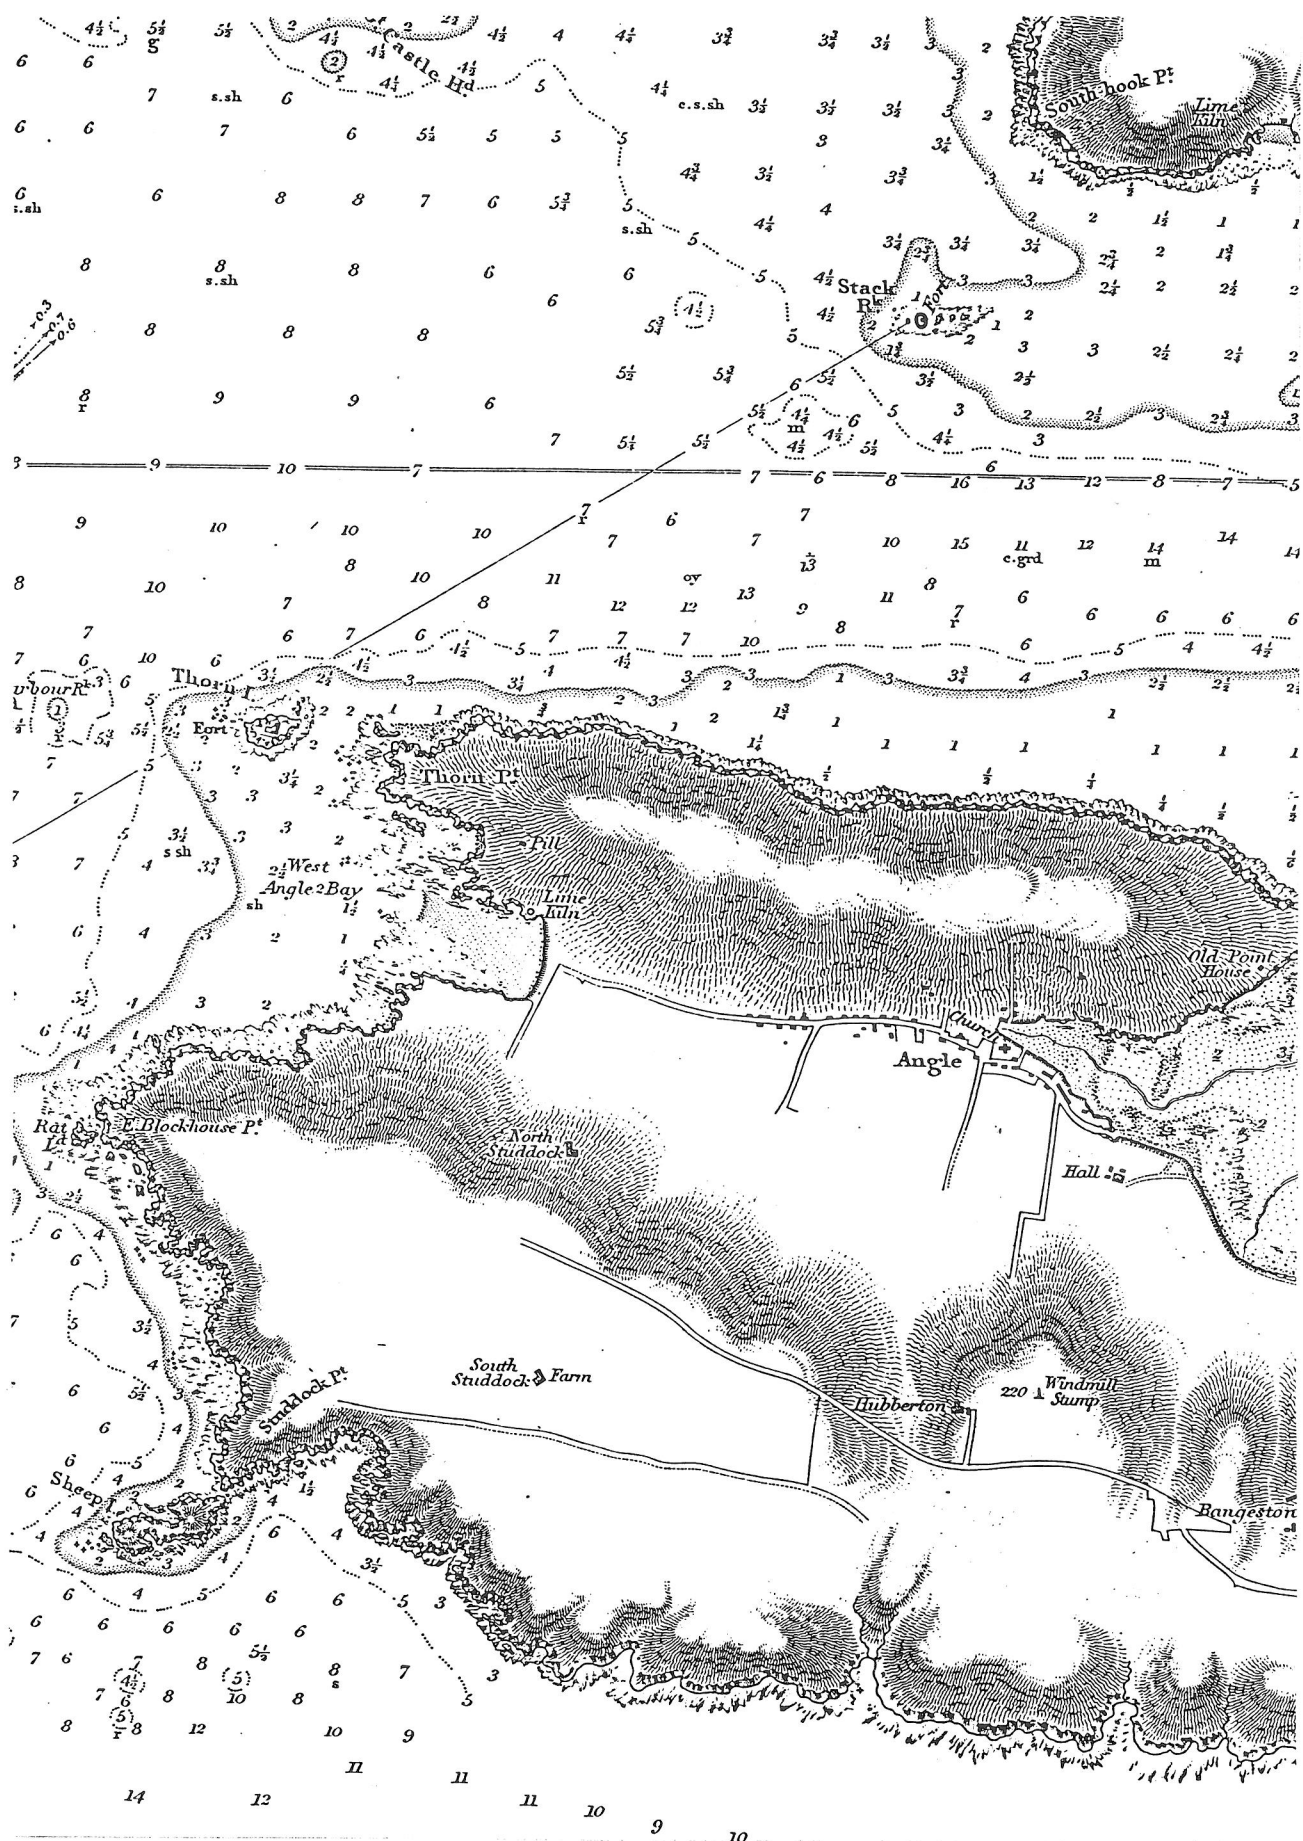
Figure Two: Denham's chart of Milford Haven, 1832

This chart is probably based on the same survey as that published in 1830, but was printed at a scale of c. 1:20,000. The East Blockhouse was shown as a solid square building, with a wall running northwest from the north corner of the building. The fact that the building was shown blacked-in may imply that it was roofed at the time. A possible further wall may be depicted to the south of the building, but the line may simply indicate the top of the cliff.

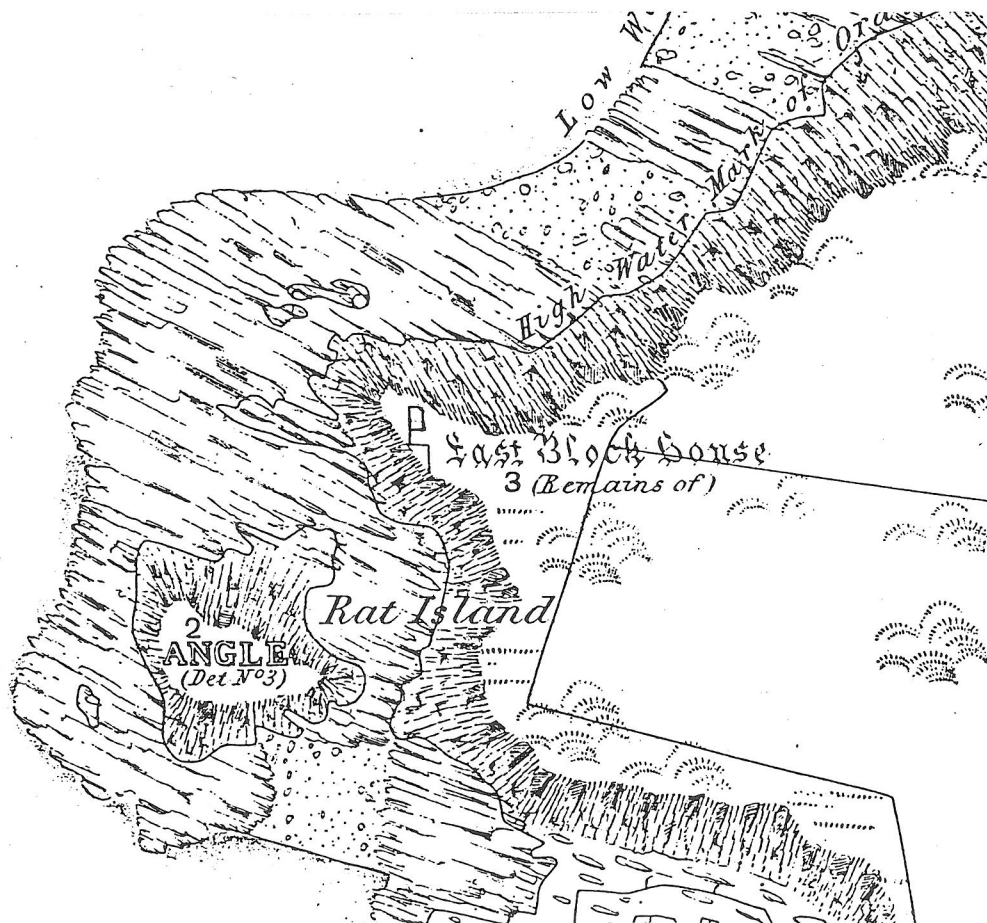
Figure Three: Ordnance Survey 25" (1:2500), 1st ed, 1870

This map is the best source of evidence for the now-lost parts of the site. It showed the surviving chamber as an unroofed shell. Running south from the southwest corner was a short wall, which then turns east and then south. There was no wall shown to the west of the building.

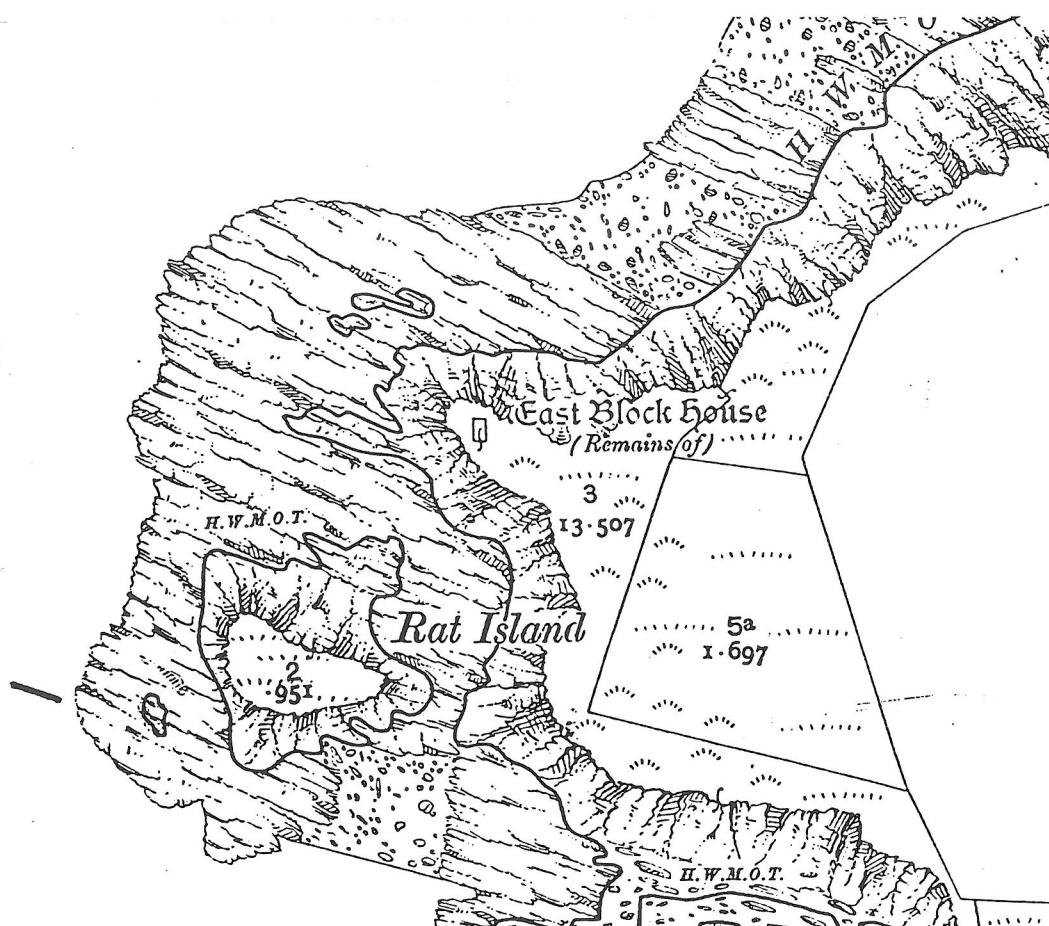
Figure Four: Ordnance Survey 25" (1:2500), 2nd ed, 1900

By this time, only the walls of the chamber itself were shown; all other walls were presumably not standing much above ground-level. The south wall of the chamber was still standing, though.

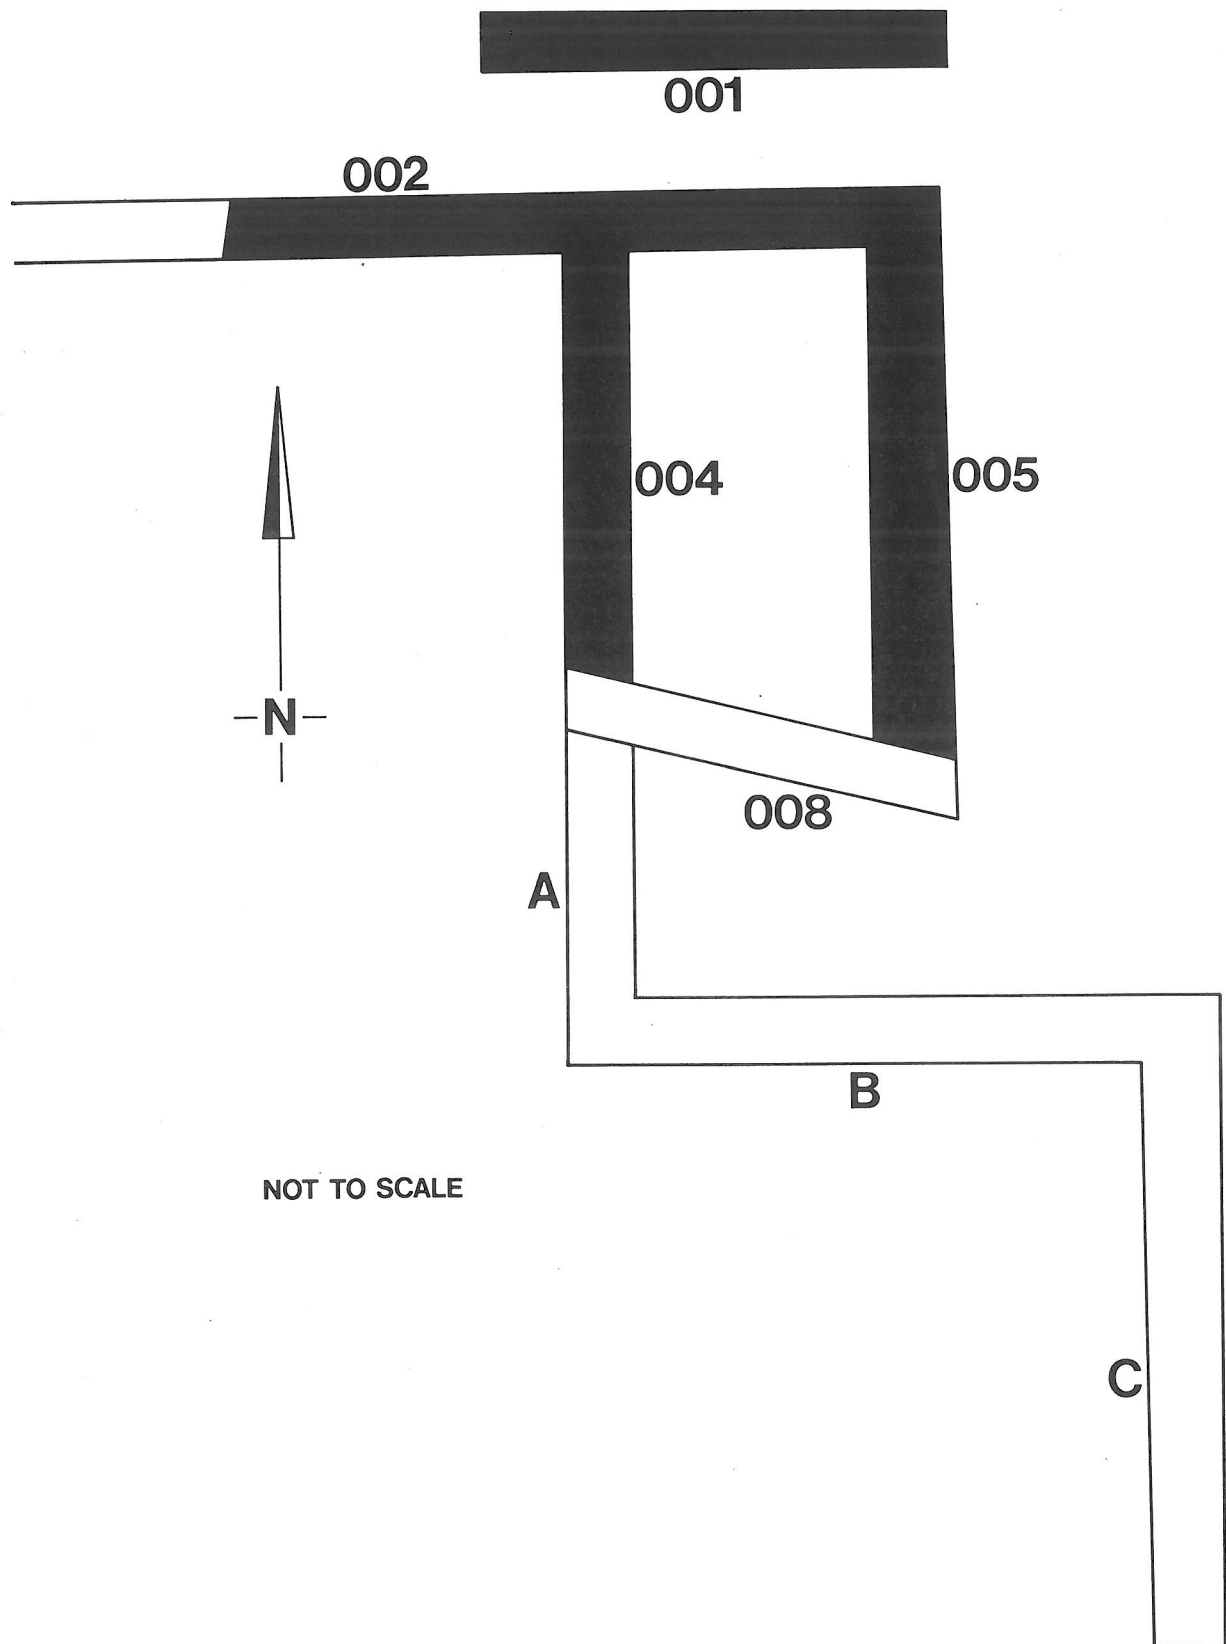
Figure Five: Schematic plan showing lost walls

The map evidence suggests that the site deteriorated significantly in the 19th century. It may have been relatively complete in 1832, but by 1900 most of the erosion (apart from the loss of the south wall) had occurred. The lost features are shown schematically on fig. 5.

In the survey report, the evidence for a second rectangular building to the southeast of the surviving structure was discussed. This feature was still traceable (and measurable) in the 1920s, but is no longer extant. The map evidence clarifies the sequence of decay and the probable interpretation (see fig. 5: lost walls are labelled A-C).

The map evidence implies that wall A ran south from the southwest corner of the building for c.3m; it then joined wall B, which ran east for c.10m, until turning south as wall C for c.10m. All of these walls were standing to some height in 1870, but by 1900 survived only as low walls. Wall C is likely to have been lost completely by 1907, leaving walls A and B to be incorrectly interpreted as a building by Laws and Owen (1907), followed by the Royal Commission (RCAMCWM 1925).

The lost walls A-B-C are likely to have been a curtain wall or breastwork protecting the less steeply sloping south side of the blockhouse; they may have supported insubstantial lean-to structures. Close defence for such artillery forts was a major concern in their design.

The scar to the south of the site has been responsible for a significant level of erosion to the structures. Over the period 1870-c.1907, all of wall C (10m long) was lost. Between 1920 and 1950, walls A and B were also lost (3m north-south), and further erosion has caused the collapse of wall 008. The scar has therefore eroded from the south at a rate of approximately 0.25m per year.
