Photographic Survey of Tirlan Farm, Bethania Road, Tumble.

Land at Tirlan Farm, Bethania Road, Tumble, Carmarthenshire

July 2020

S19.102

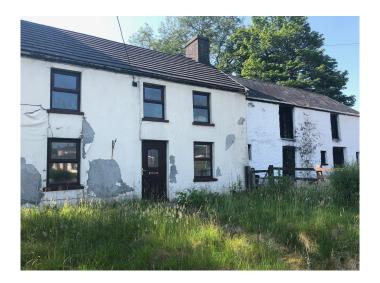
Photograph of house and former cowshed from Bethania Road.

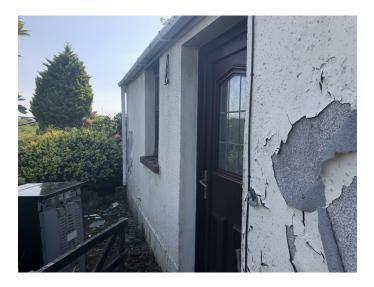
Front entrance to main house

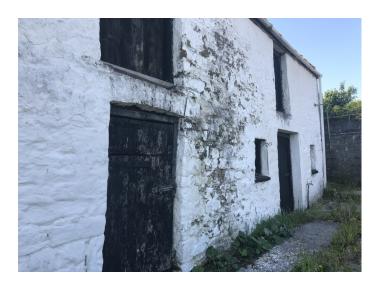
Front elevation to Cowshed building

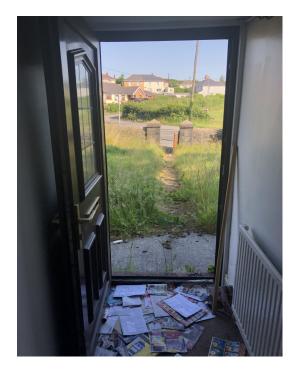
Front door to property

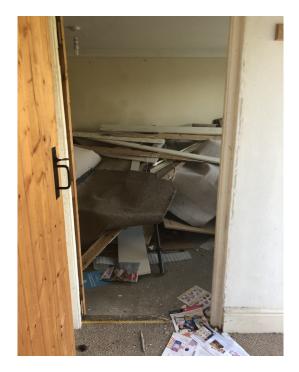
Entrance to ground floor room No.1

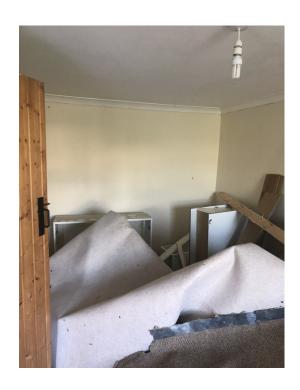
Ground floor room No.1

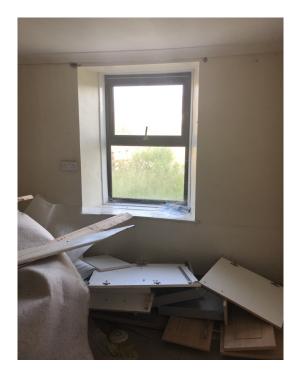
Ground floor room No.1

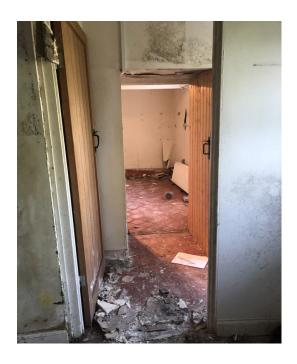
Connecting doorway to ground floor room No.2

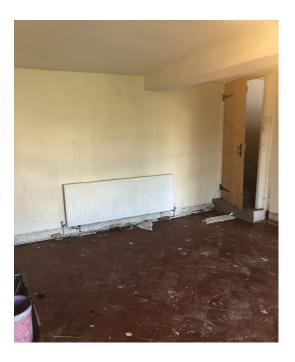
Ground floor room No.2 to rear elevation

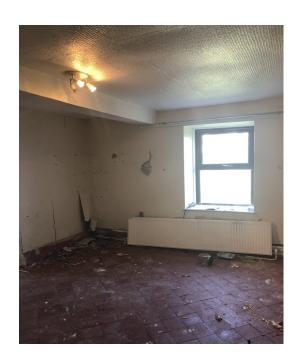
Ground floor room No.2 to front elevation

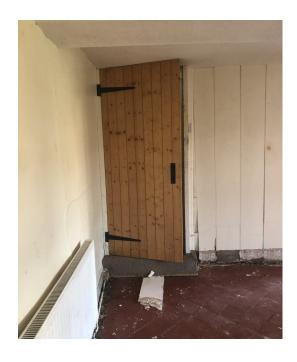
Internal door from ground floor room No.2 to staircase to first floor

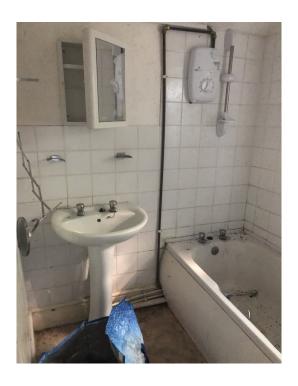
Ground floor rear bathroom

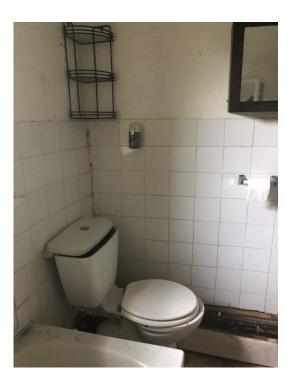
Ground floor rear bathroom

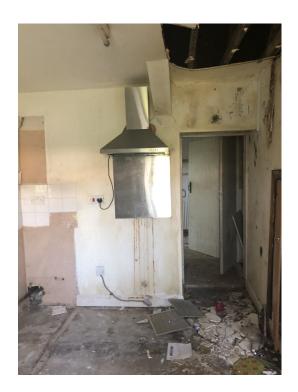
Ground floor front kitchen

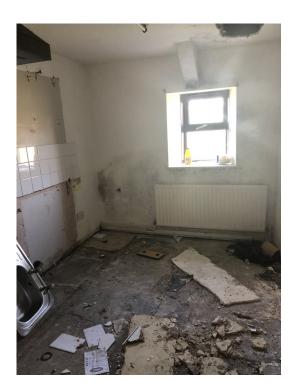
Ground floor front kitchen

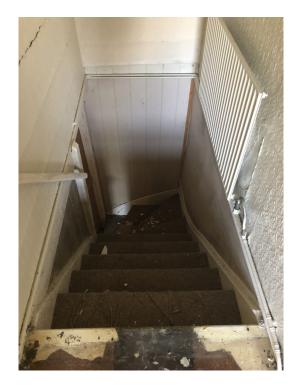
Staircase to first floor landing

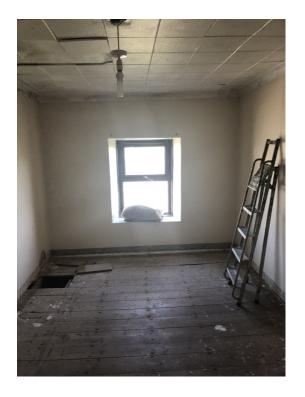
Bedroom No.1 to front elevation

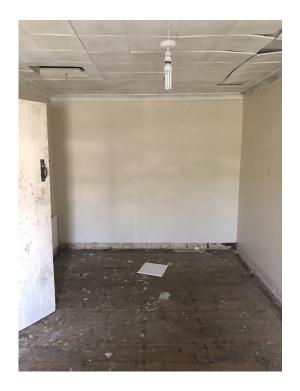
Bedroom No.1 to rear elevation

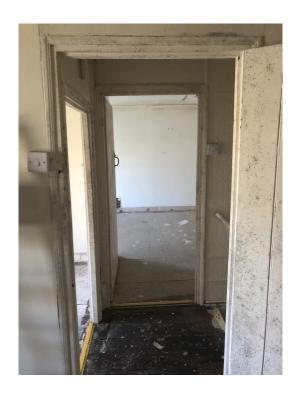
Interconnecting door from Bedroom No.1 to landing area

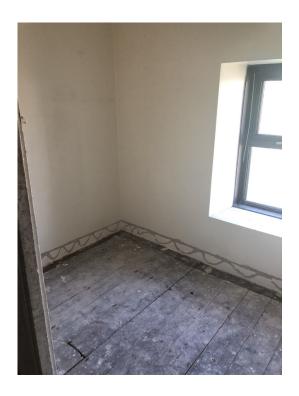
Bedroom No.2 to front elevation

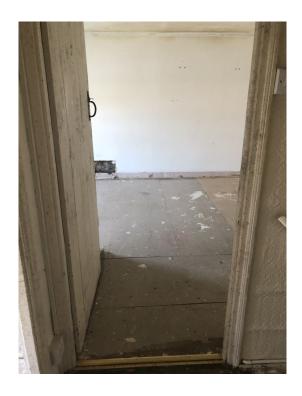
Interconnecting door from landing area to Bedroom No.3

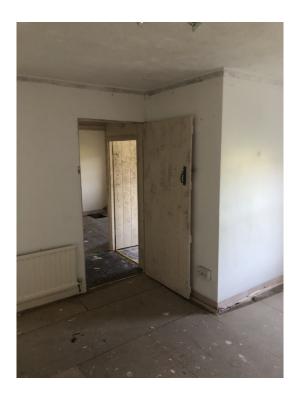
Interconnecting door from Bedroom No.3 to landing area

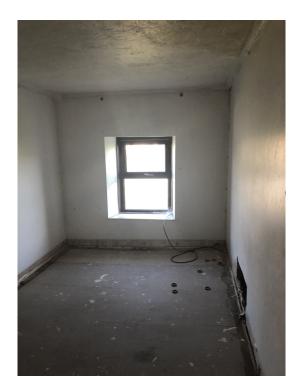
Bedroom No.3 to front elevation
