Frongoch Lead & Zinc Mine, Pontrhydygroes, Ceredigion.

Archaeological Watching Brief

HRS Wales
Report No: 259

DAT Event No. 129648

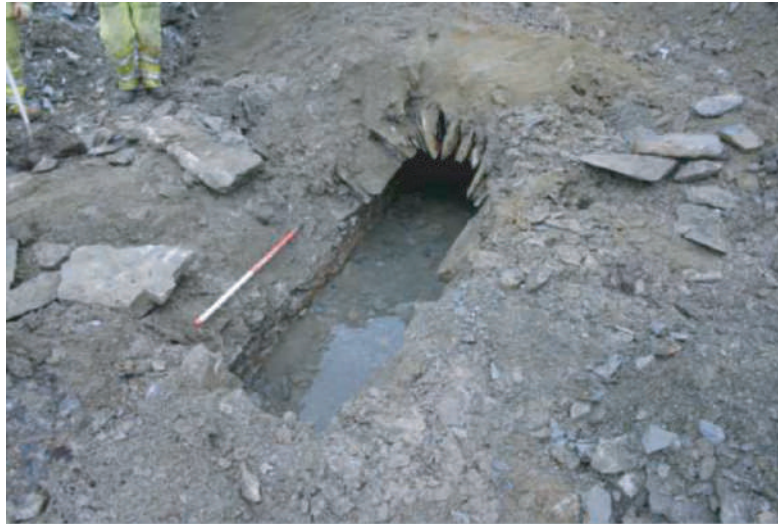
Photo 18: View of stone culvert (4000) following breach of arched roof.

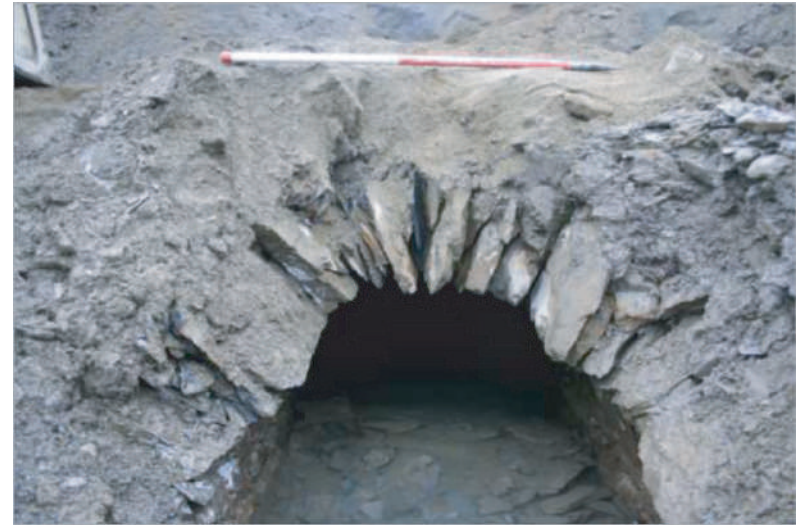
Photo 19: View southeast of arch in stone culvert (4000).

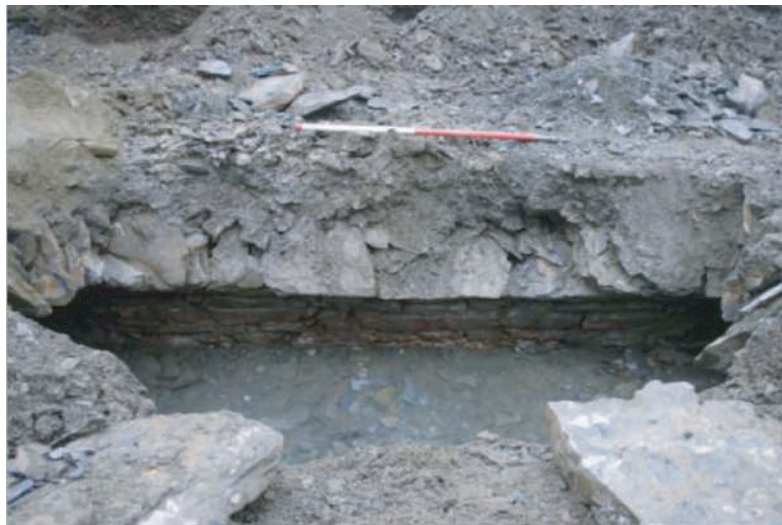
Photo 20: Linear view of stone culvert (4000). Looking northeast.

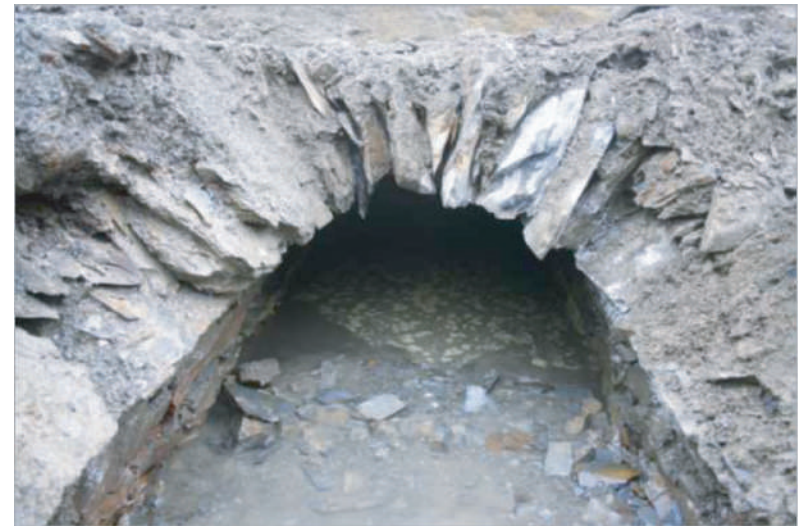
Photo 21: Looking northwest at arch in culvert (4000).

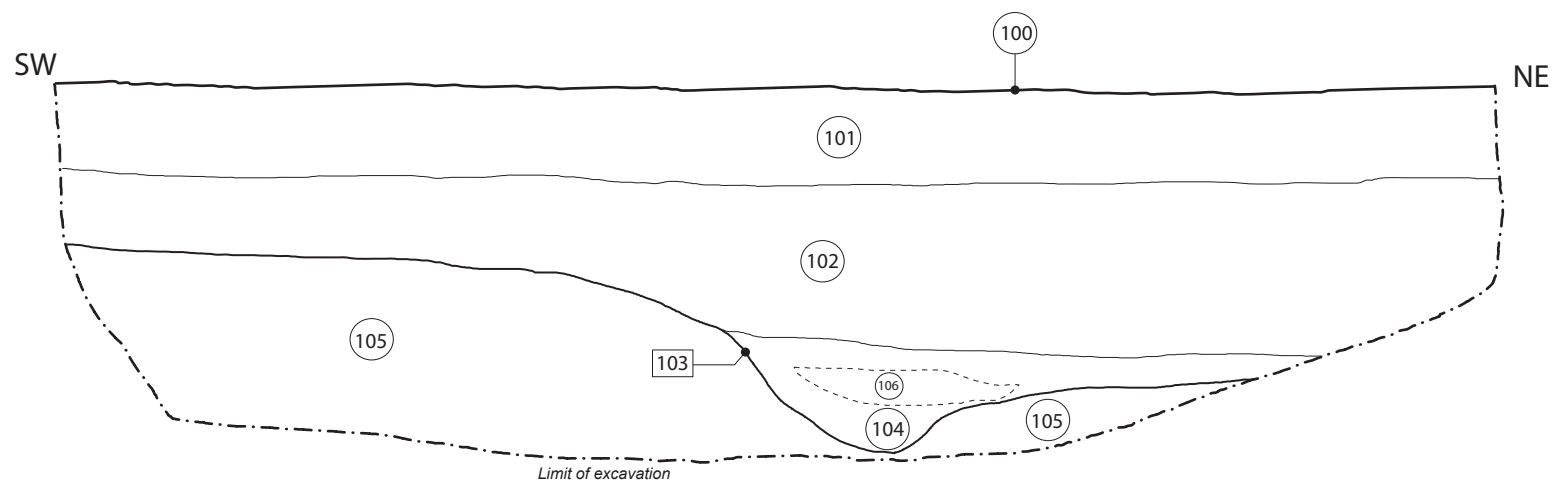
Figure 15.

- 4.4 Once the turf (100) had been removed, a top soil of mid brown earth intermixed with small stones and mudstone grit became exposed (101). Directly below this earth deposit was a modern white *cloth* sheet laid down in the 2013 phase of groundwork. This cloth sheet ran the whole length of the trench. Directly below this sheeting was a deposit of re-deposited mudstone intermixed with mudstone grit (102). This deposit measured approximately 0.60m in depth at the northern end and only 0.50m at the southern end. Directly below this re-deposited material was a natural mudstone bedrock (105), which had been cut (103) through by a shallow channel or leat filled with peat (104) intermixed with mudstone grit a clays, suggestive of a former leat or drainage ditch (*see Figure 12 – Southeast facing section drawing*). Once the natural bedrock was exposed across the entirety of Trench1 with no stone culvert forthcoming, excavation of this trench was stopped.

Southeast Facing Section from Trench 1 showing apparent early leat/channel immediately SW (SN 72299 74237) of culvert.

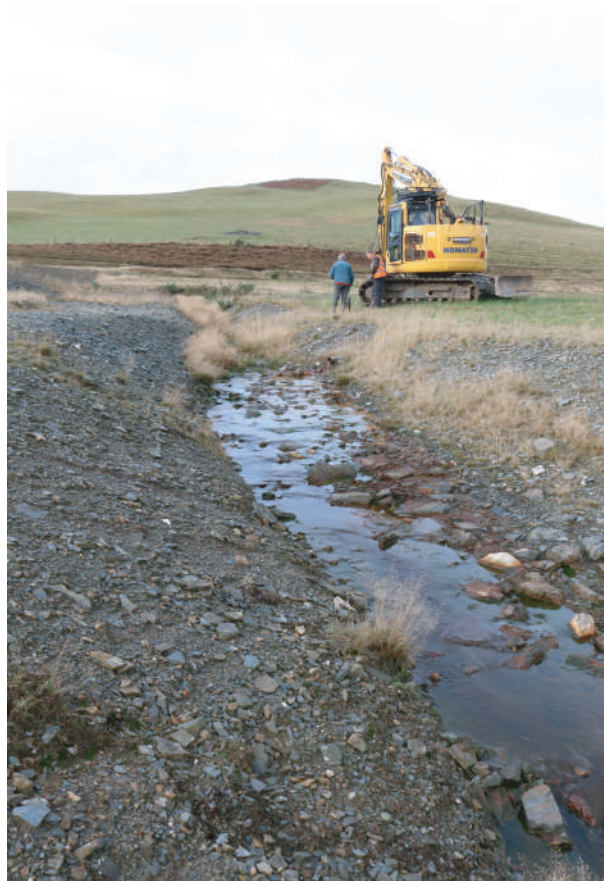
Plate 04. View of feeder channel from outflow feeding settling pond. Positioned between proposed monitoring flow chambers.

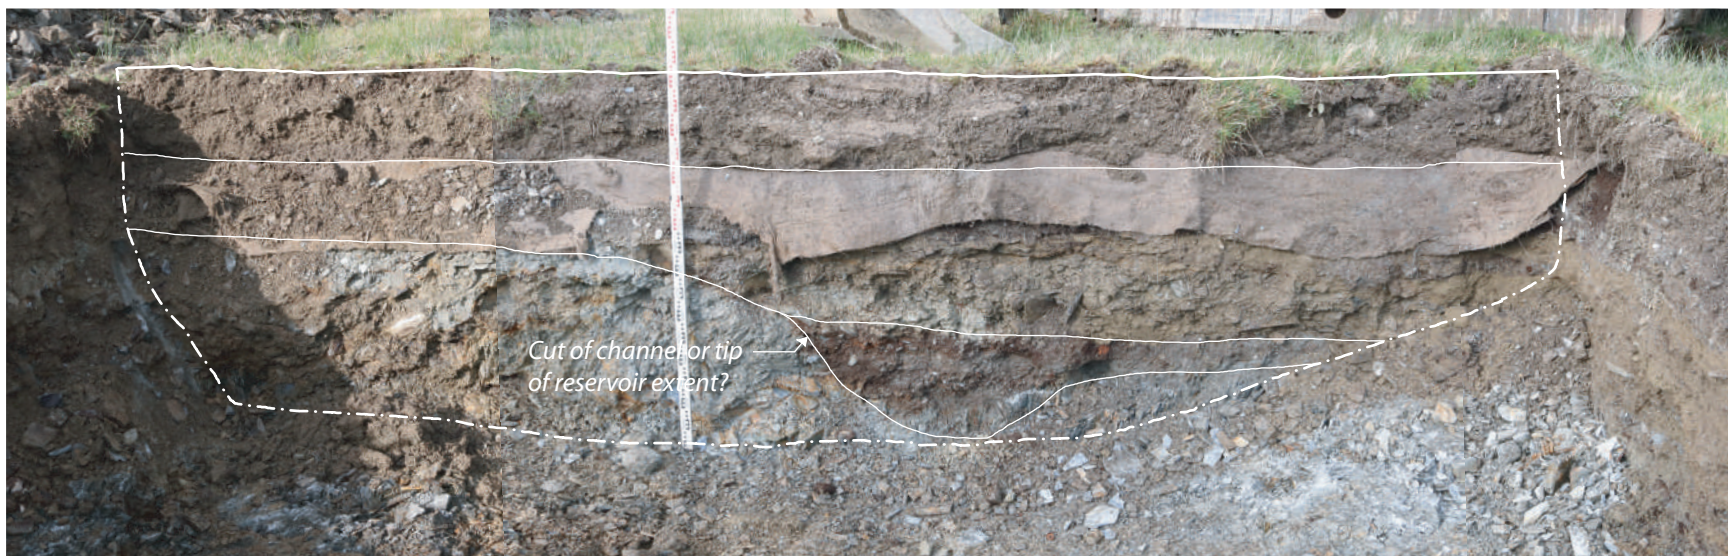
Plate 09. View of southeast facing section of initial Trench 1 when looking for culvert.

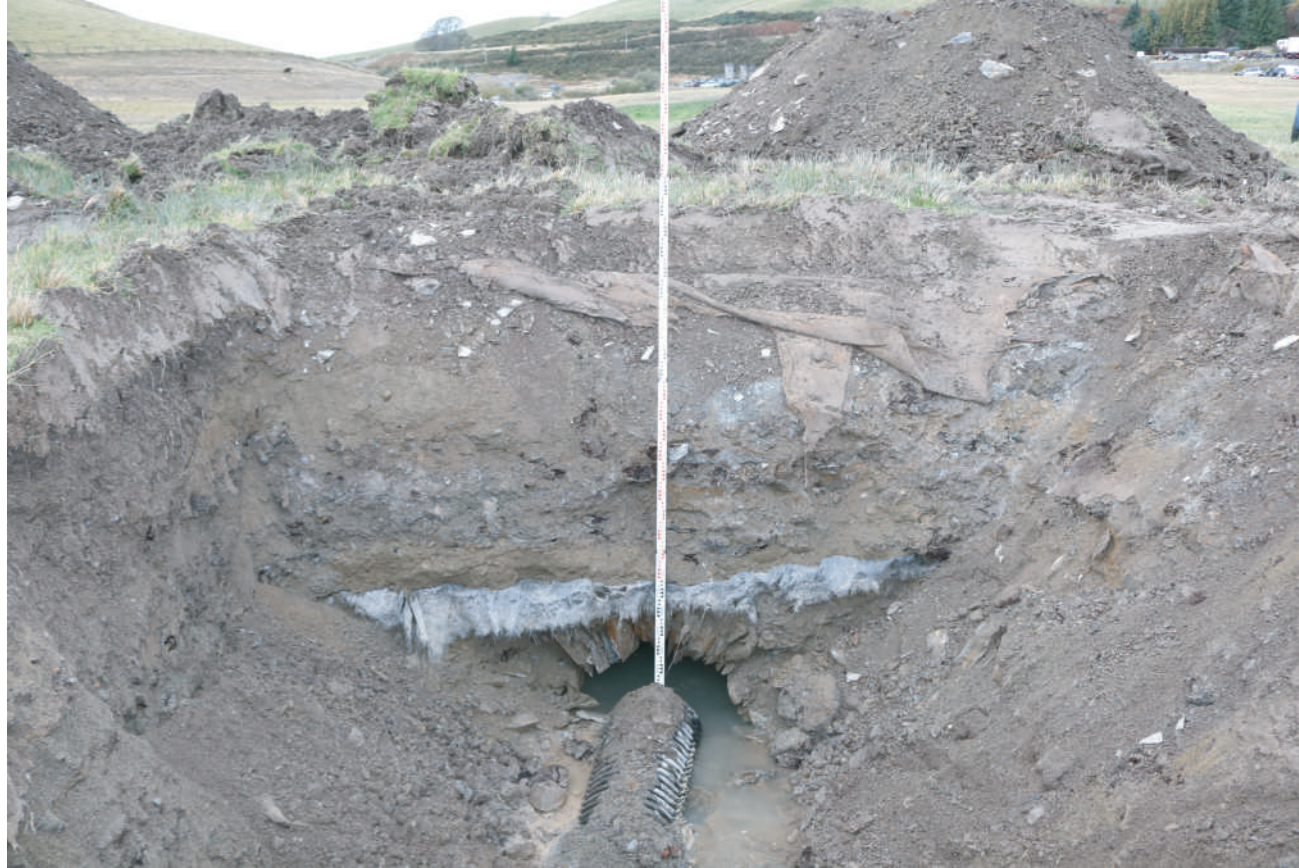
0.40m. Directly below this was the same modern *terram* sheeting exposed in Trench 1. Directly below this sheeting was a 1.5m deep deposit of layers of re-deposited mudstone grit and mine tailings/spoil (202). Directly below this re-deposited material was a black woven *terram* sheeting, which was found to be lying directly over the 19th Century stone culvert (203) that had already been exposed and breached in 2013. The culvert channel was still filled with clear water, but a modern plastic twin walled drainage pipe had been placed into the channel that was supposedly taking water below the drain bed leading to the settling pond. However, it soon became apparent that the water that was in the channel was not moving eastward through the pipe, suggesting that the culvert channel was either not continuing further eastward or else the channel was blocked. Only a photographic record was made of the culvert from the trench edge as the sides of the trench were too loose to enable safe and close inspection and recording. The NGR position of the stone culvert was SN 72303 74239 and the elevation height of the culvert from its voussoirs was recorded as 236.8m AOD.

Plate 14. Southeast facing section of Trench 2 with 19th Century culvert entrance exposed. Looking westward.

exposed channel did not appear to be flowing although there was some considerable water in the channel being directed below the surface drain via a 400mm modern twin wall polypropylene pipe running to the NE. Following the predicted route of the culvert channel to the NE, Trench 2, although having exposed the channel and water, did not expose a stone lined culvert. This would suggest that the stone culvert once terminated at around this point. However, given the amount of water in the trench, water is moving to the NE, and is probably following an early cut ditch or leat, as is suggested on the OS first edition map of 1887. However, landscaping in 2013 in the area to the NE appears to have covered over this ditch, which is causing some blockage in the water flow. Ideally this water channel needs to be reopened so that the polluted water can flow so that it can be captured and redirected toward a further settling pond.

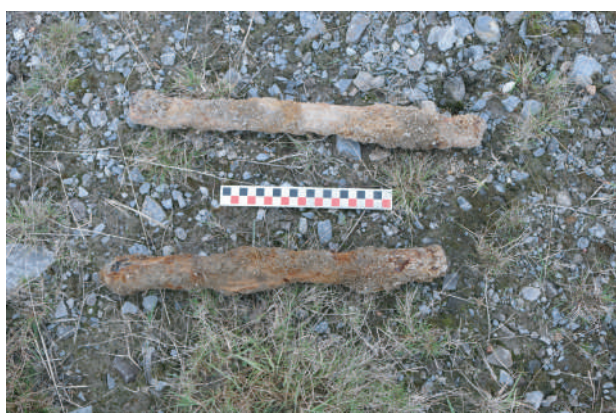
Plate 18. Iron(Fe) pins found in Trench 2 spoil/tailings.

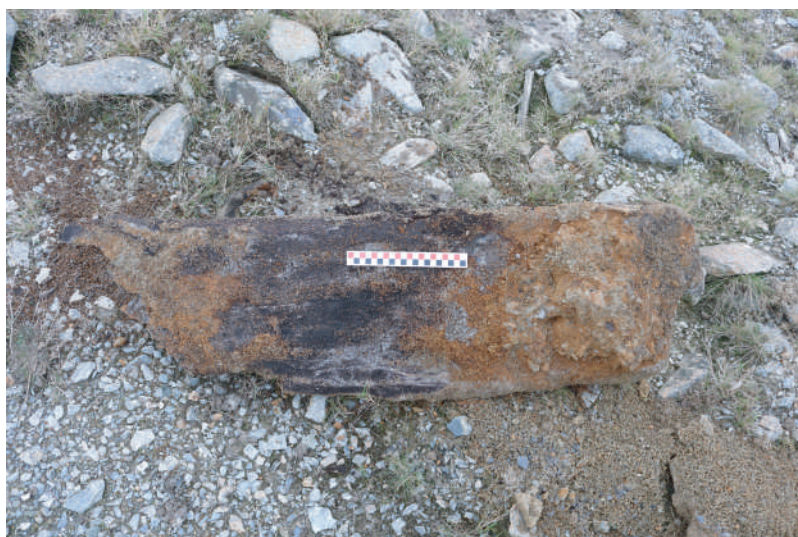
Plate 19. Remains of former timber tram rail sleeper recovered from Trench 3 within spoil/tailings.
