**Canolfan yr Urdd,
Pentre Efan, Velindre,
Crymych, Pembrokeshire, SA41 3XE**

**Archaeological Building Investigation & Recording
and Watching Brief**

HRSWales
Report No: 246

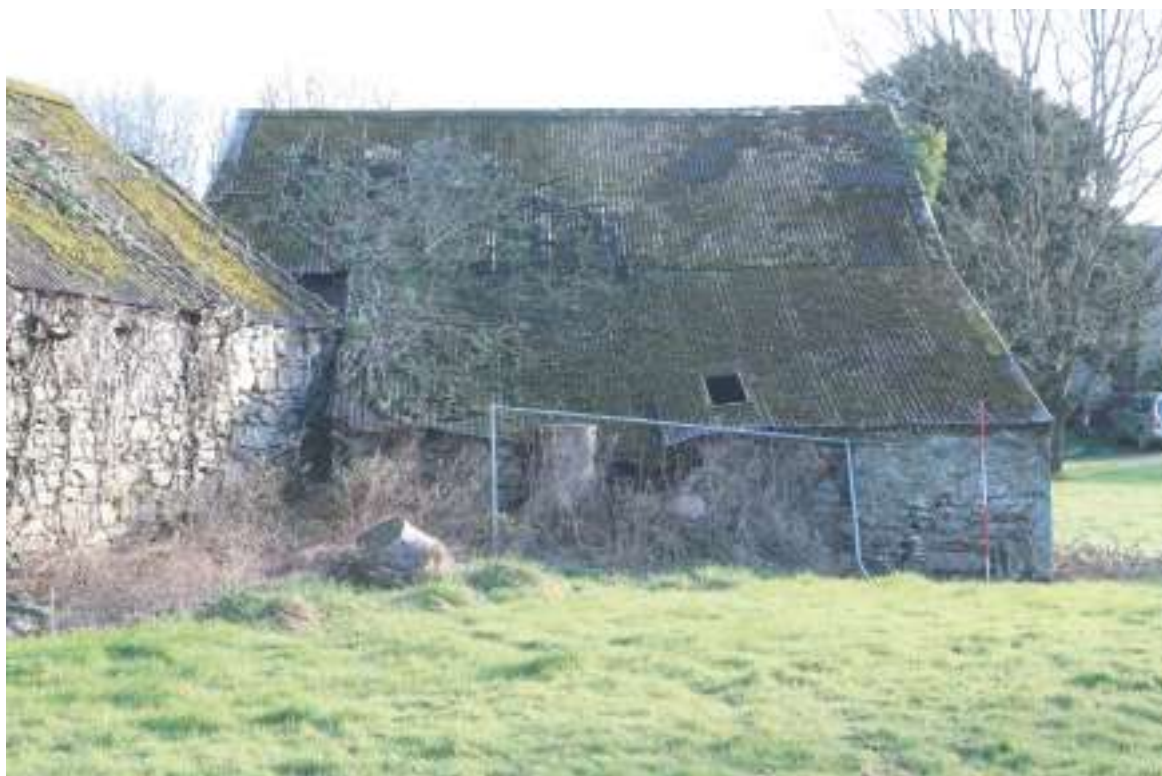
- 5.7 The west facing elevation is the rear elevation of the Milking Parlour. At the time of the recording and investigation, this elevation was the lower walling of a small 19th Century extension to the main building, the original building having been extended at some time in the late 19th Century. Unfortunately the fabric of this extension had suffered significantly from the roots of a mature tree which made closer inspection unsafe and impossible. However, once the tree stump and roots were removed later in the project, although this later west wall extension collapsed, it did allow safe access for the recording and investigation of the west wall of the original earlier building. This revealed that originally this west wall of the Milking Parlour once had a central doorway in the west wall as well as the front east facing elevation, suggesting that the Milking Parlour was very probably once a former small central aisle cottage with a Parlour and Living Room downstairs either side of the hallway.

Plate 13. Canolfan yr Urdd, Pentre Ifan - Milking Parlour. West facing elevation. Looking E.

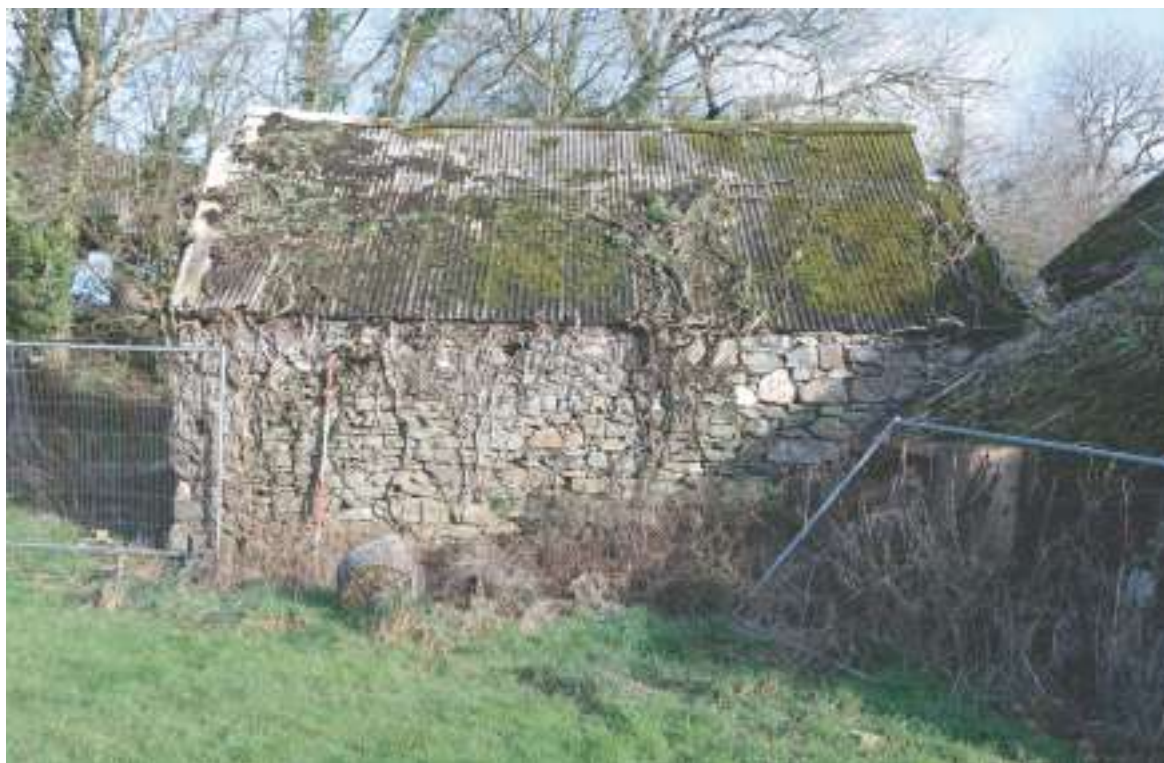
5.16 At the time of the initial investigation, the south facing elevation of the Cart Shed was covered extensively in ivy that was starting to penetrate into the walls. Other than an apparent area of repair at the far top eastern corner of this elevation, there were no obvious features visible within the fabric of the external south facing elevation.

Plate 24. Canolfan yr Urdd, Pentre Ifan - Cart Shed. South facing elevation. Looking N.

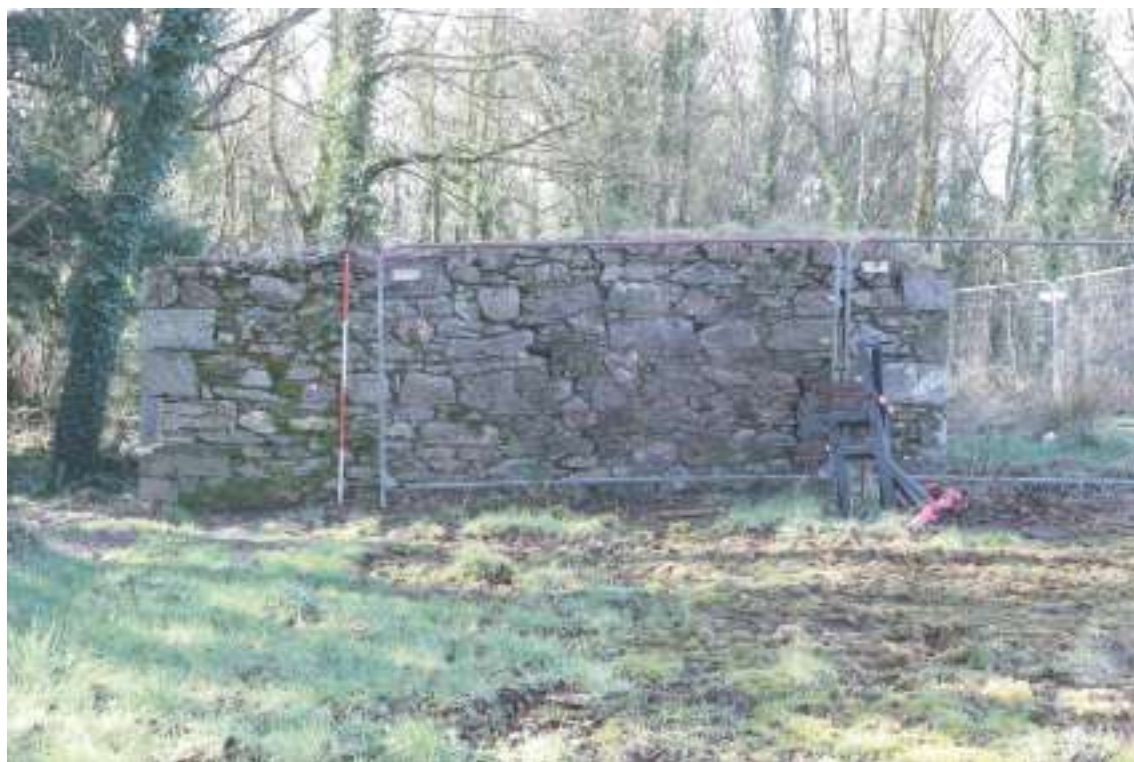
5.24 The east facing elevation is constructed from bare stone with large quoin stones at each corner. In general this side elevation is in fair condition, although two structural cracks are evident toward the northern end. No features are present in this elevation.

Plate 41. Canolfan yr Urdd, Pentre Ifan - Corn Mill. East facing elevation. Looking W.

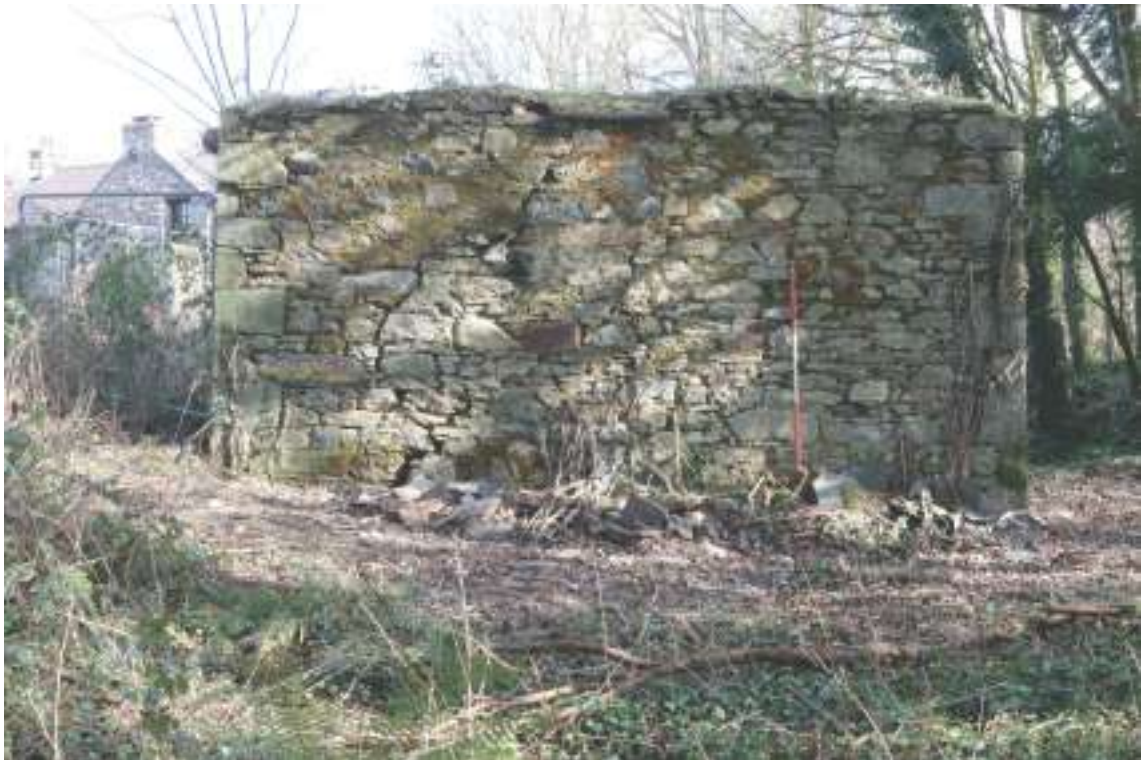
5.26 The west facing side elevation is again constructed from bare stone with large quoin stones at each corner. In general this side elevation is in poor condition, with two significant structural cracks in the central area of the wall. No features are present in this elevation.

Plate 44. Canolfan yr Urdd, Pentre Ifan - Corn Mill. West facing elevation. Looking E.

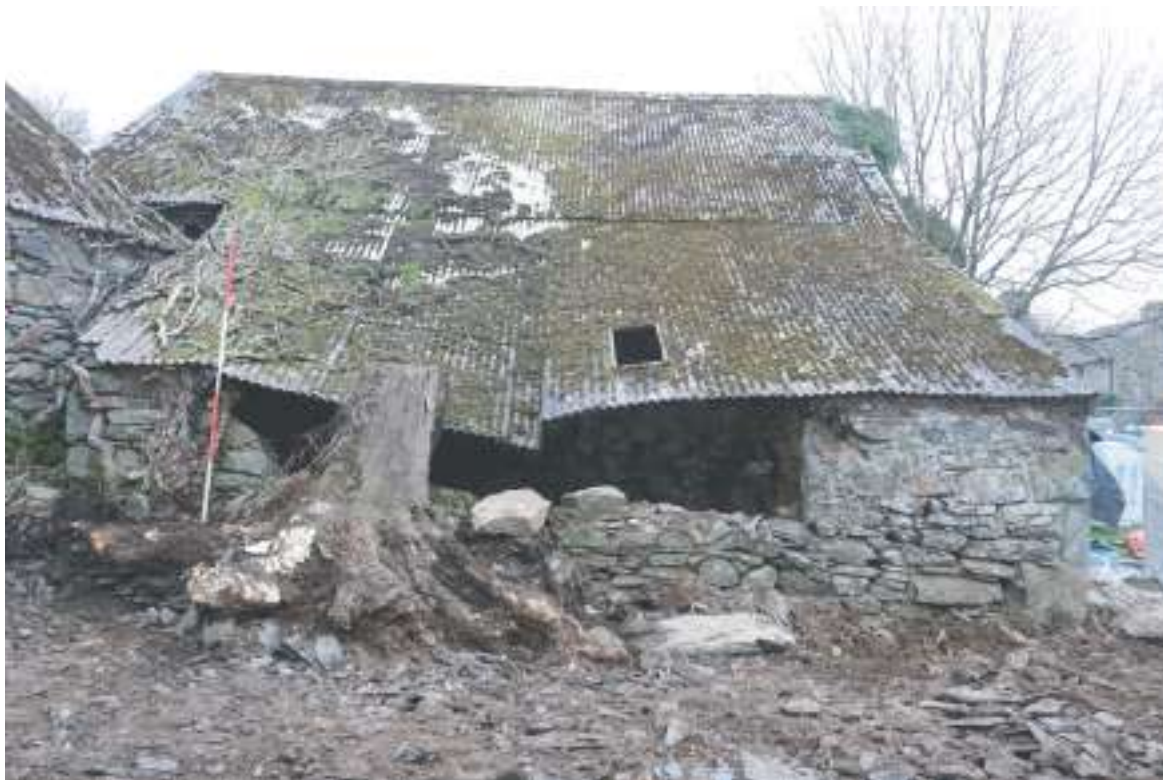
Plate 85. Canolfan yr Urdd, Pentre Ifan - Milking Parlour. View of west facing elevation of Parlour where tree rooting had compromised extension. Looking E.

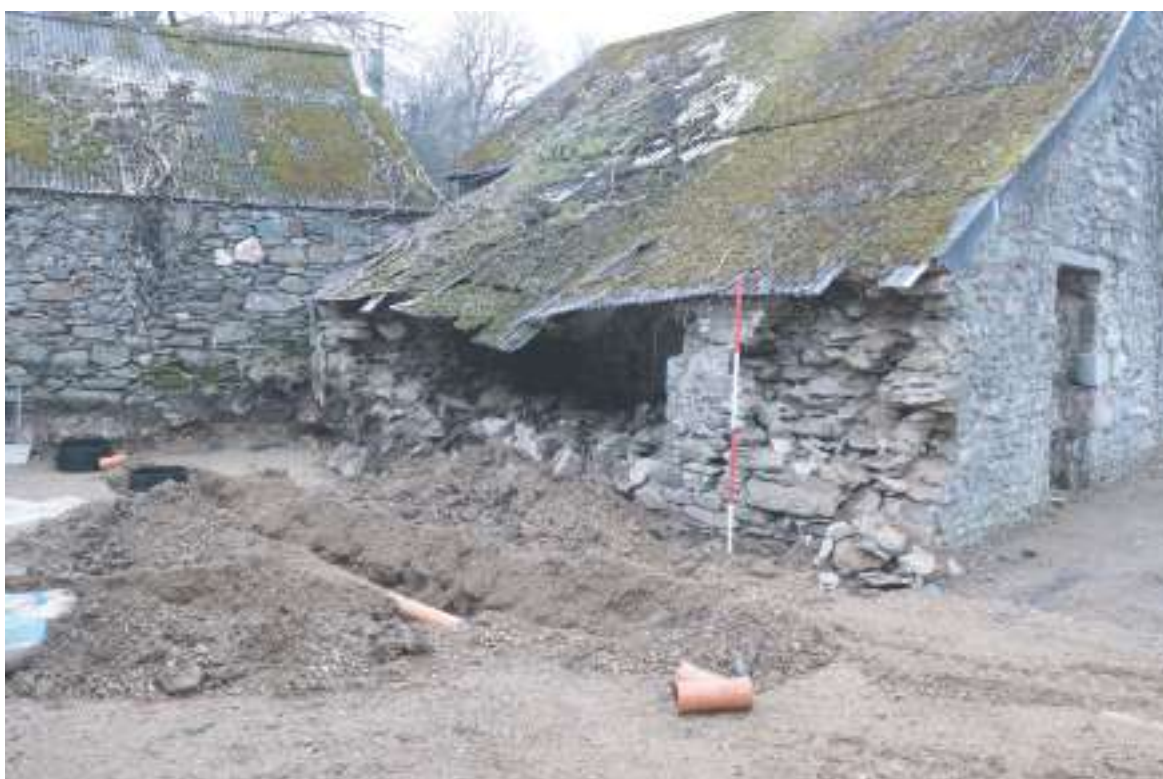
Plate 86. Canolfan yr Urdd, Pentre Ifan - Milking Parlour. View of west facing elevation of Parlour following removal of tree stump and excavation of drainage trench. Looking NE.
