PHOTOGRAPHIC SURVEY

Demolition of former Hotel to form Plot Layout for 3no.
Dwellinghouses, together with Formation of Access to facilitate a
Change of Use of former Rear Wing to 3no. Linked Dwellinghouses
At
Land at Gwenllian Court Hotel, Llangadog,
Mynyddygarreg, Kidwelly

REVISION A

Date: September 2016

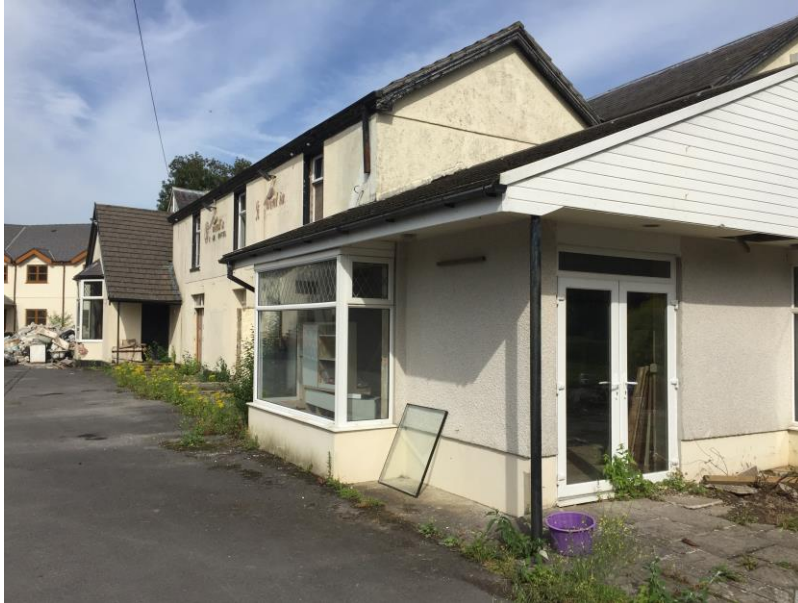
Photo 1 – south-west corner – the central entrance porch as shown in Figure 4 has been completely removed. The south-western corner comprises a modern addition with large upvc framed bay windows.

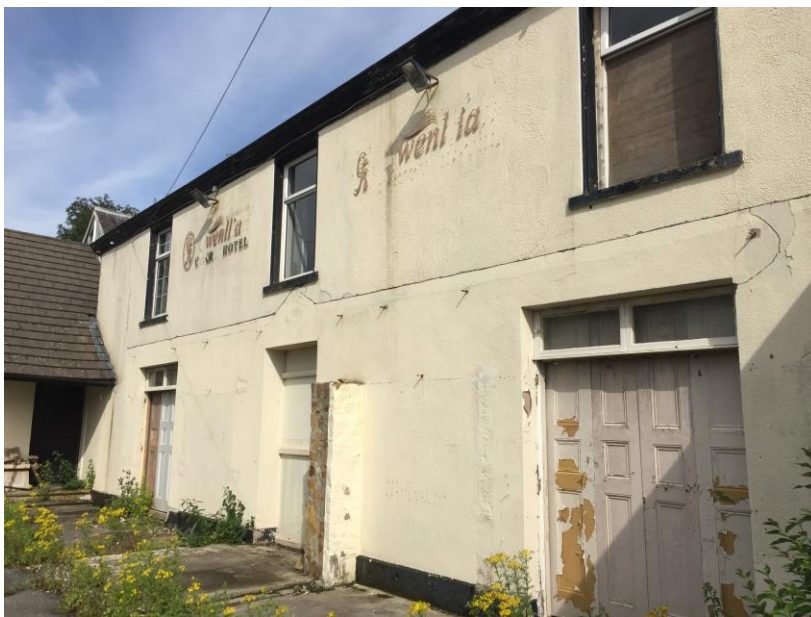
Photo 2 – west elevation – openings have been board up with temporary materials, as have fanlights above.

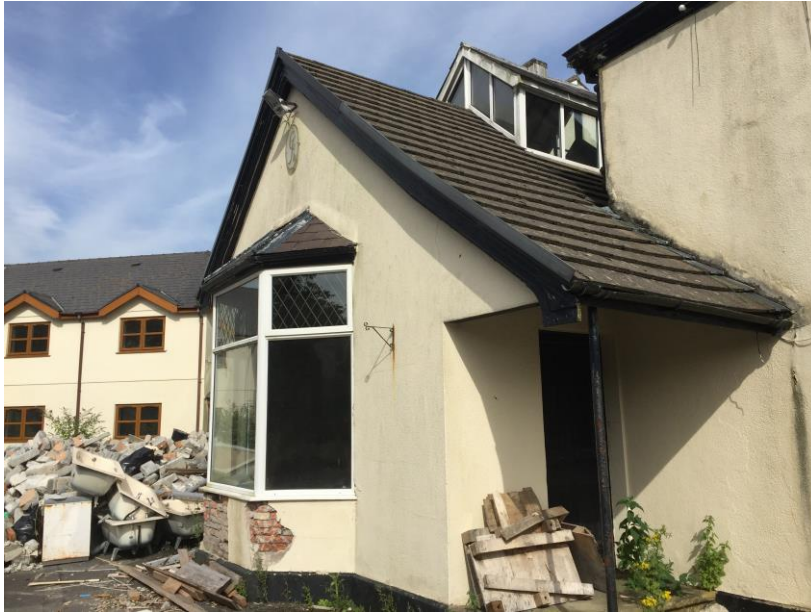
Photo 3 - west elevation –
modern bay window extension, with modern roof light, constructed of white upvc frame, with concrete
roof tile

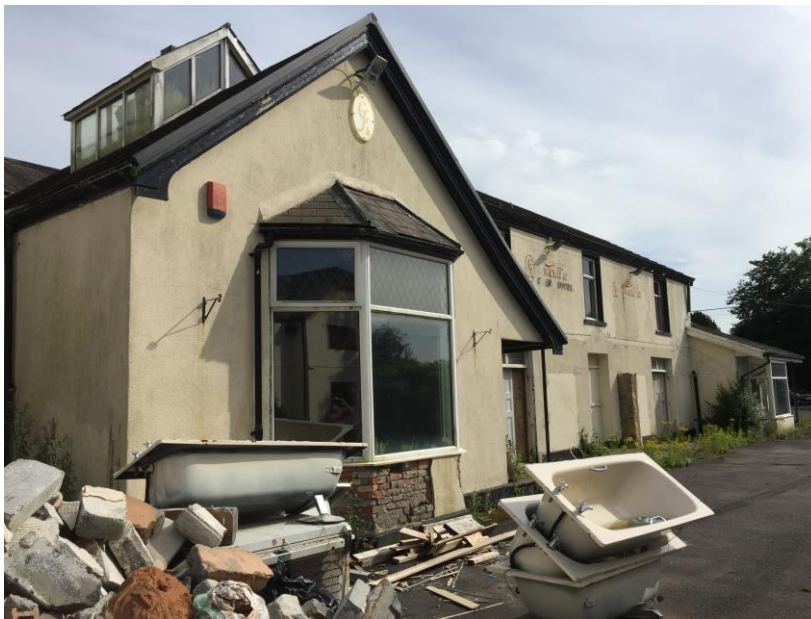
Photo 4 – north-west corner
- modern bay window extension, with modern roof light, constructed of white upvc frame, with concrete
roof tile

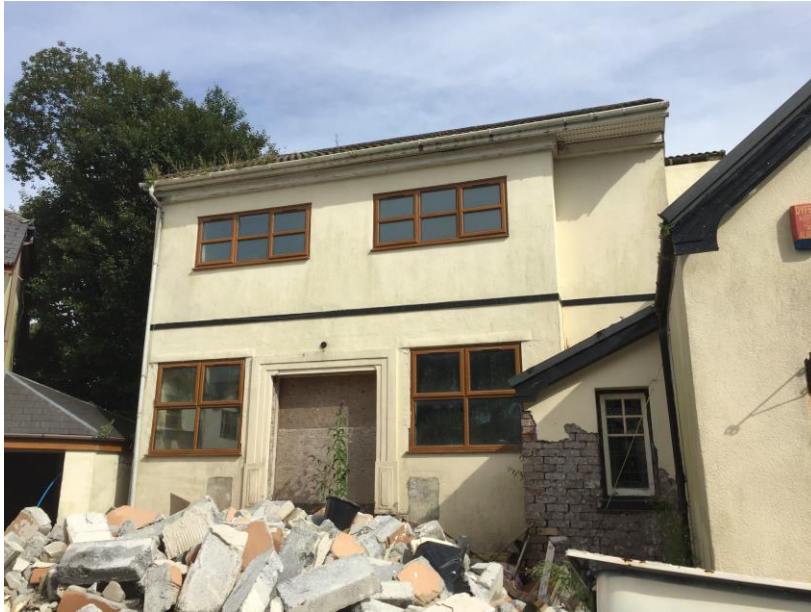
Photo 5 – north elevation – illustrating modern brown framed upvc windows at both floors with modern double doorway, temporarily blocked up. The former entrance steps and walling has been removed from that displayed in Figure 3.

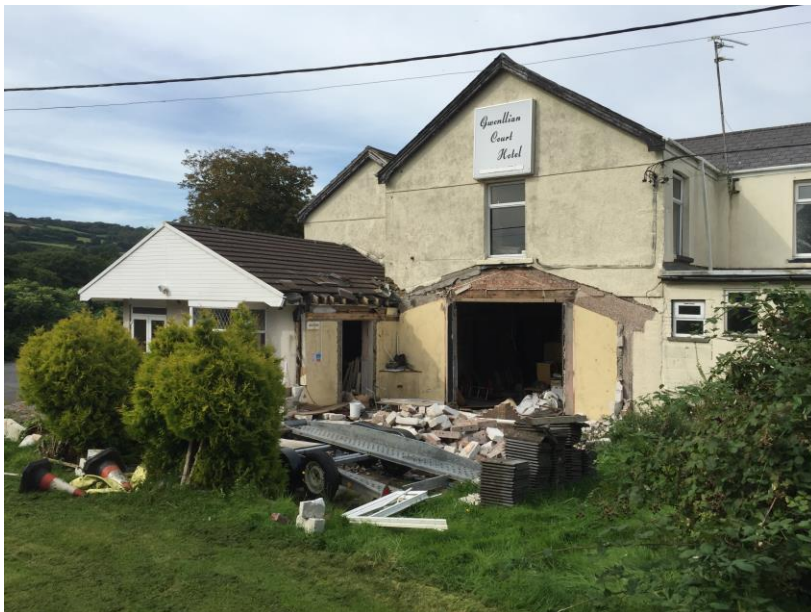
Photo 6 – south elevation – shows elements of modern extensions to front courtyard and south-east roadside, with flat roofed additions. First floor windows are modern white upvc replacements

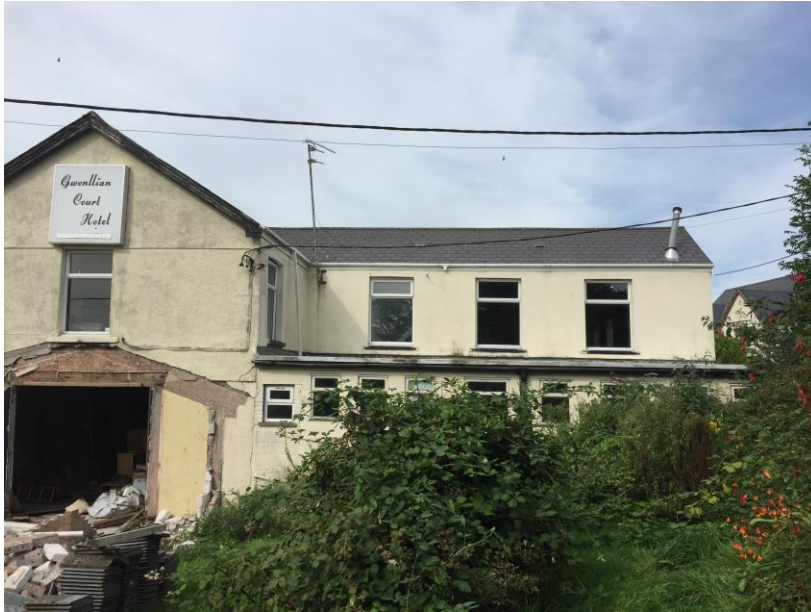
Photo 7 – south elevation - shows elements of modern extensions to front courtyard and south-east roadside, with flat roofed additions. First floor windows are modern white upvc replacements

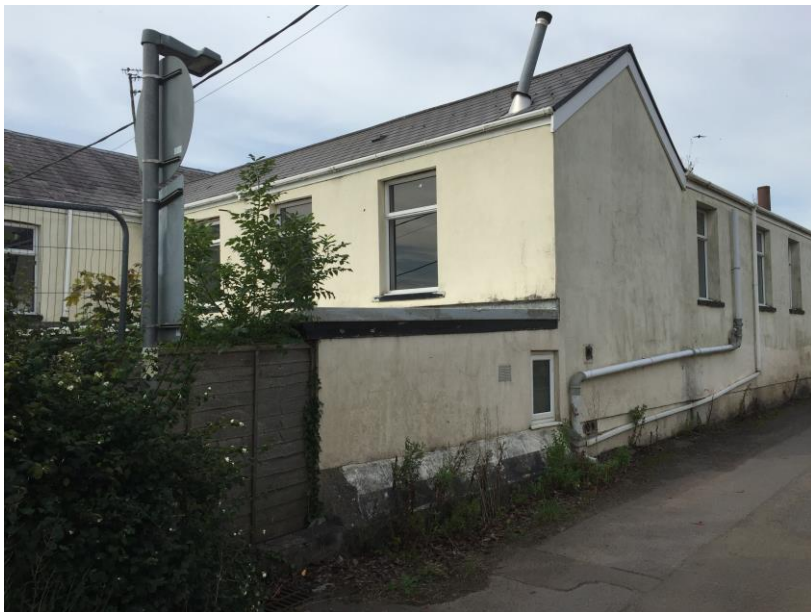
Photo 8 – south-east corner – modern flat roof toilet block to roadside with first floor former hotel accommodation over, comprising white framed upvc windows, cement tiled roof and plastic rainwater goods

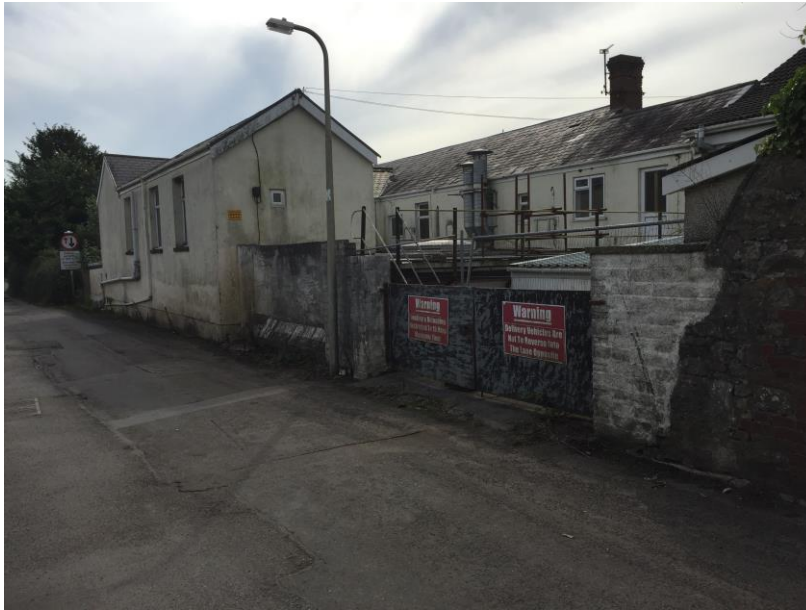
Photo 9 – north-east corner – modern extensions to rear of property, with flat roof over function room, and concrete block walls enclosures to service entrance.

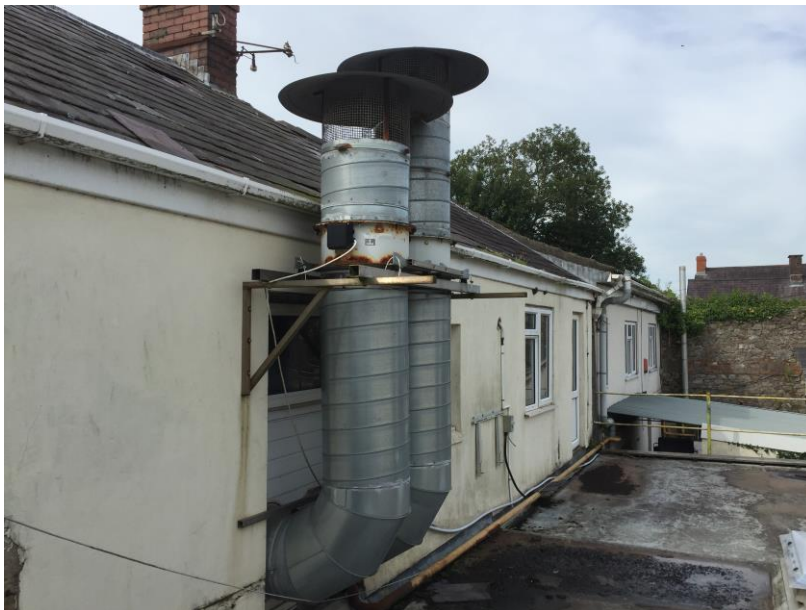
Photo 10 – flat roof over function room, illustrating modern skylights and extraction flues from ground floor kitchens. Former rear of old Gwenllian totally re-modelled with modern windows in white upvc frames

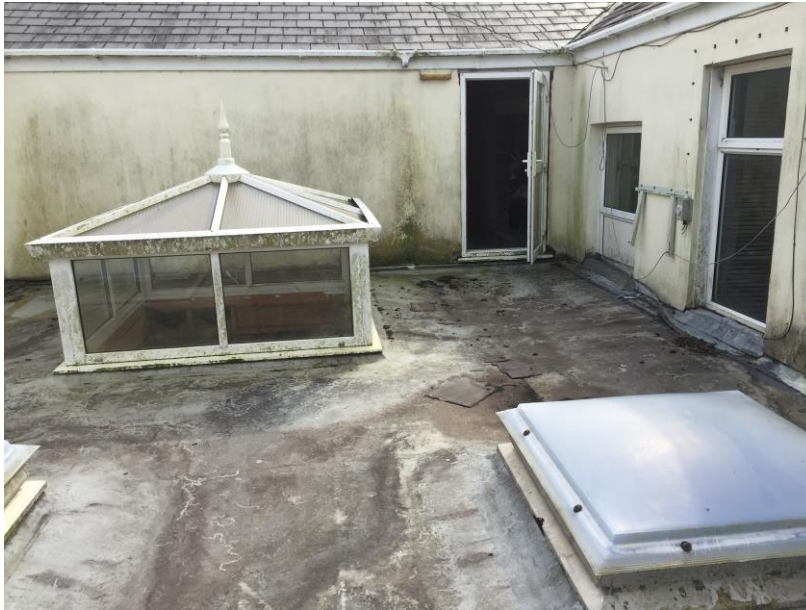
Photo 11 – flat roof to rear

projection with skylights over ground floor function room

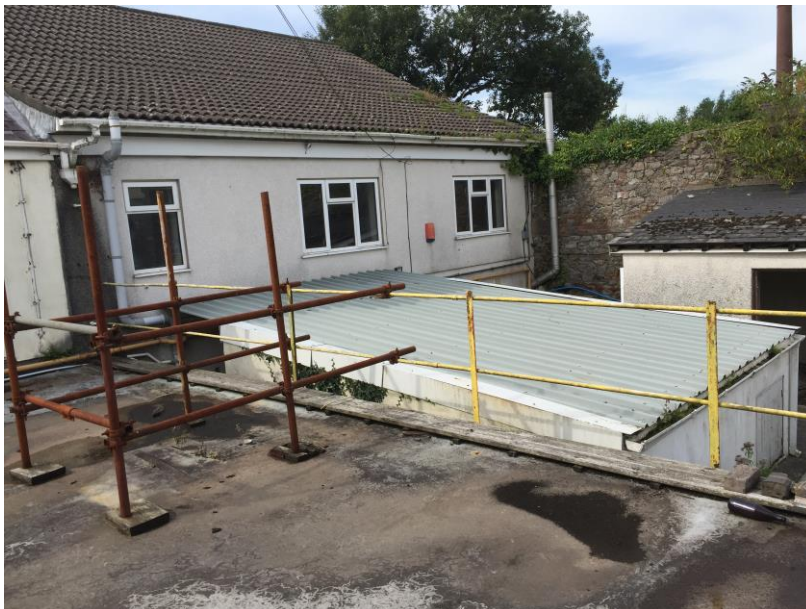
Photo 12 – rear first floor

elevation of northern modern wing, showing cement tiles to roof and modern white upvc window openings

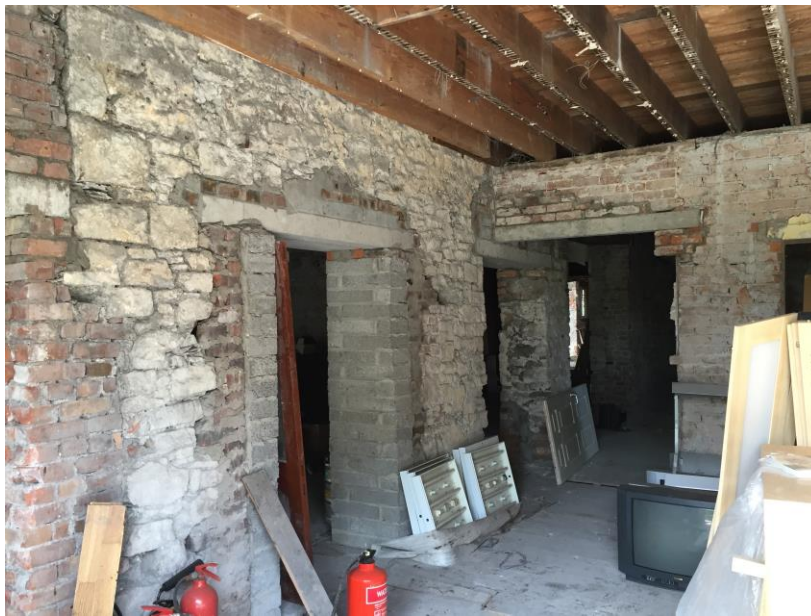
Photo 13 – new door openings from modern conservatories at south west corner of building into former original hotel building.

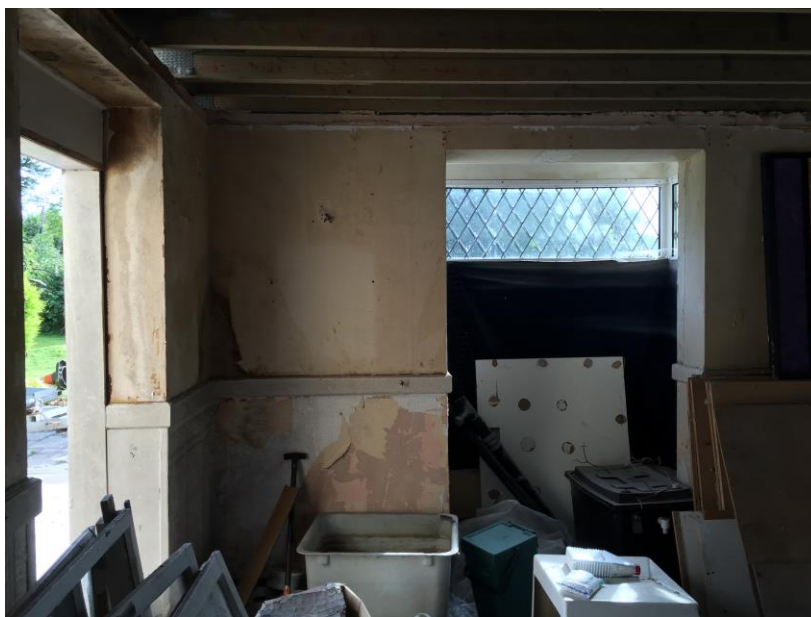
Photo 14 – modern white upvc windows with south-west conservatory

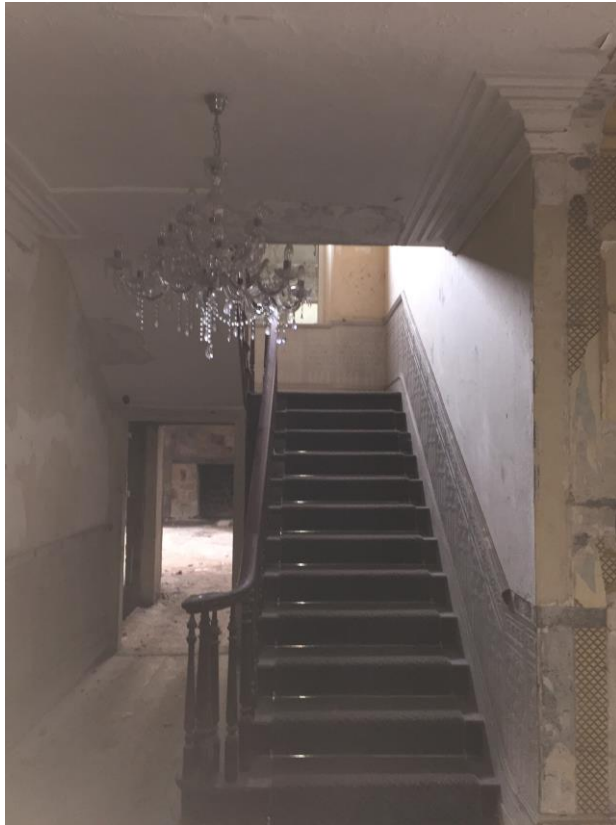
Photo 17 – central stairwell – remnants of original staircase with simple moulded treads, metal bannisters over stained wooden handrail. Light fitting is a modern replica consisting of plastic glass effect. Elements of original plaster evident, together with modern plaster applied over

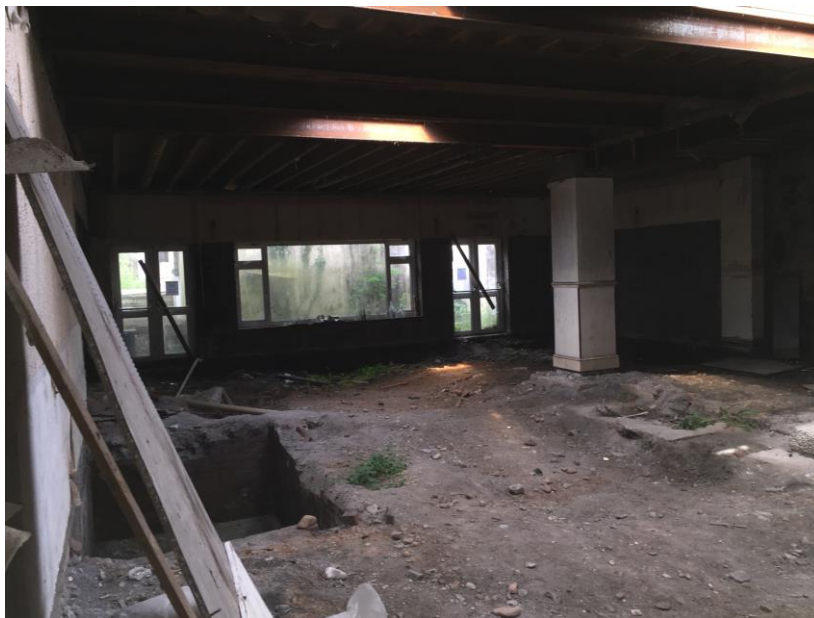
Photo 18 – remains of function rooms with floors removed, exposing modern support pillars.

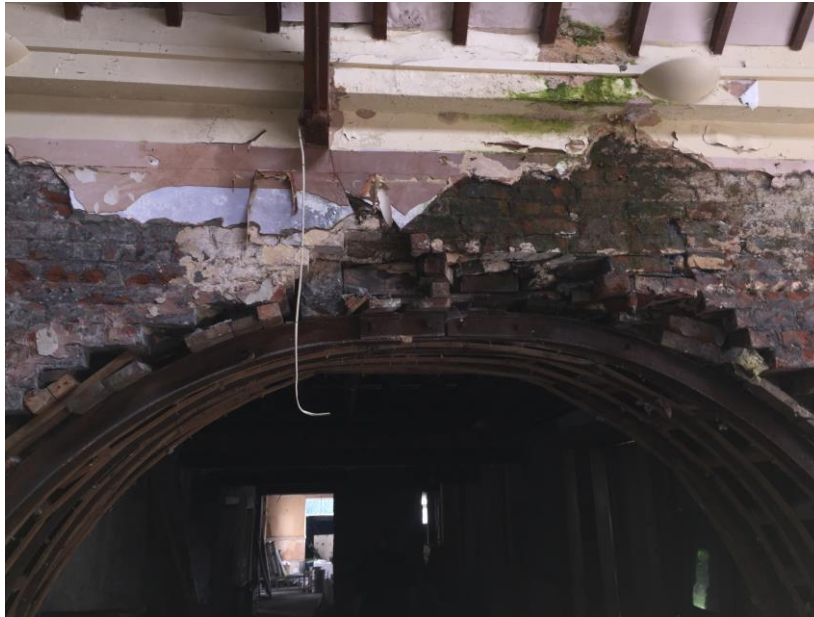
Photo 19 – archway to function room appears to be supported by metal framed lintel, which has largely decayed through exposure to water ingress

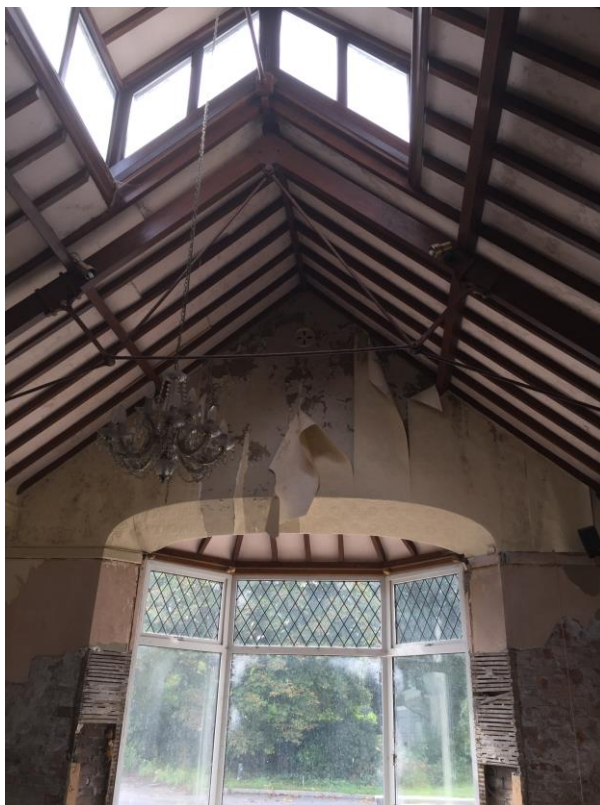
Photo 20 – view within ground floor dining room, illustrating bay window with modern replacement upvc frame. Vaulted ceiling with modern skylight, which projects above original roof ridge. Modern exposed roof trusses, stained for decorative effect

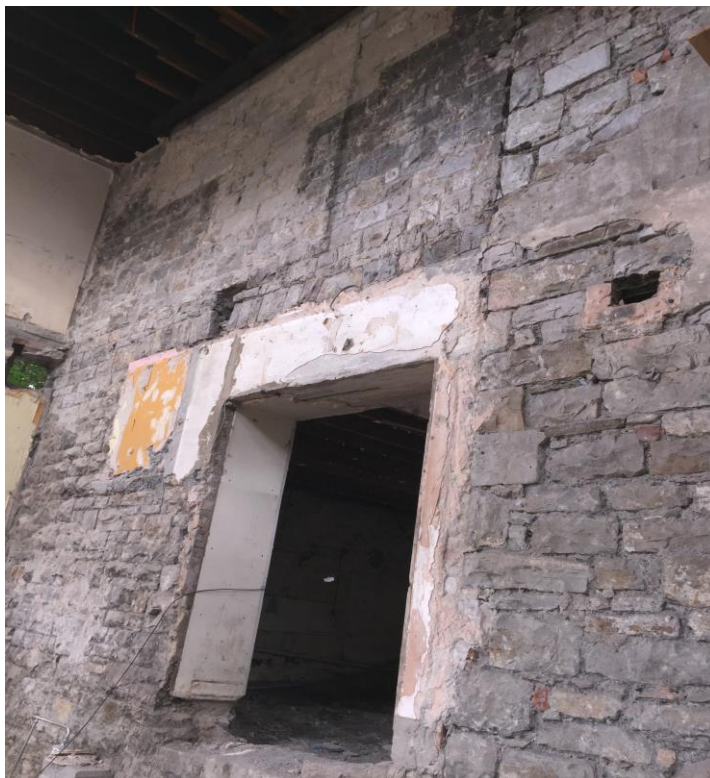
Photo 22 – example of walling with plaster ripped off to expose stone work. Simple concrete lintel above supporting opening

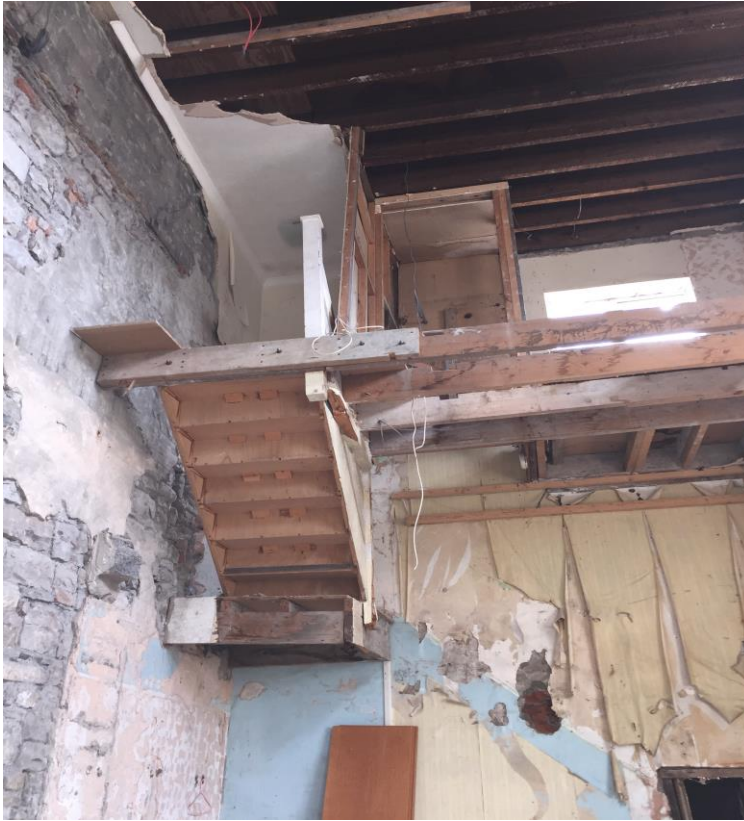
Photo 23 – removal of floor
between ground floor meeting room and hotel bedrooms above, exposing modern staircase

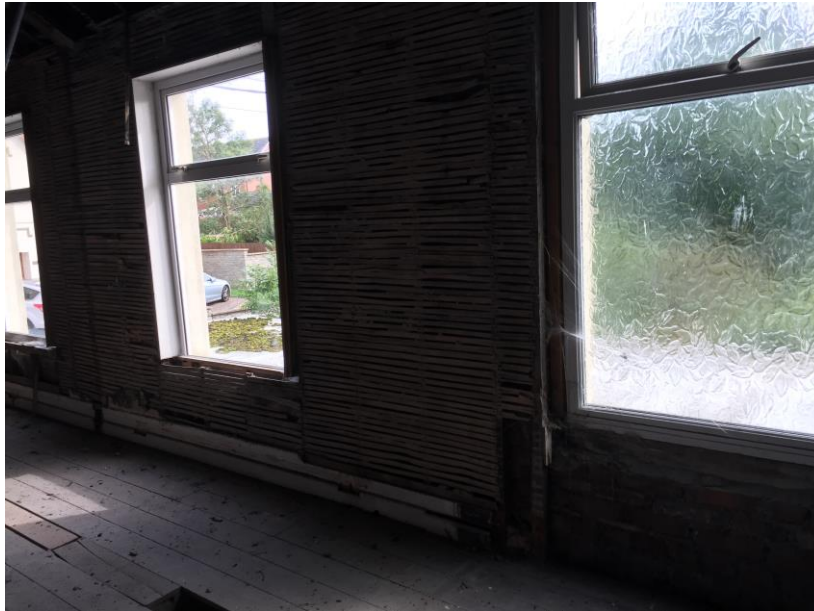
Photo 24 – modern window

openings at bedspace to first floor

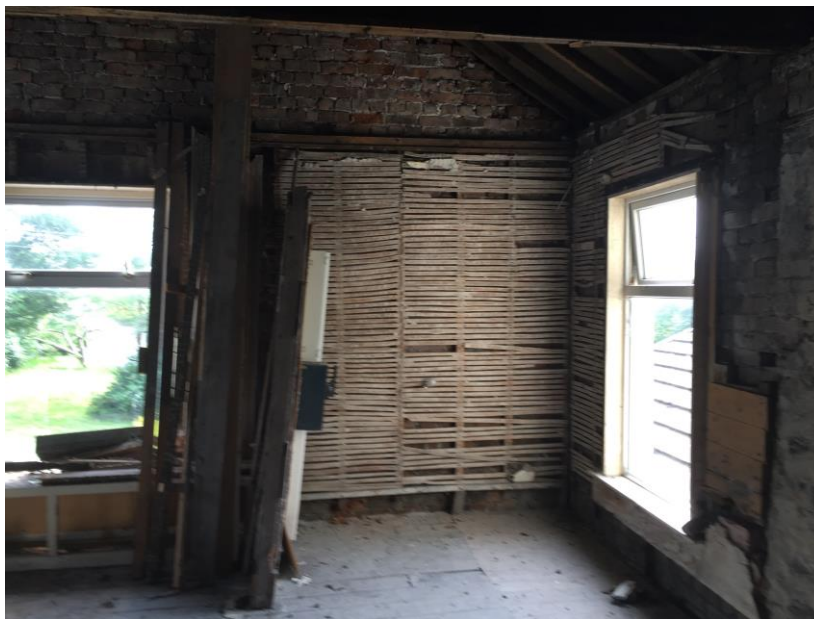
Photo25–internal

plasterboard removed to expose underlay set between modern windows with white upvc frame.

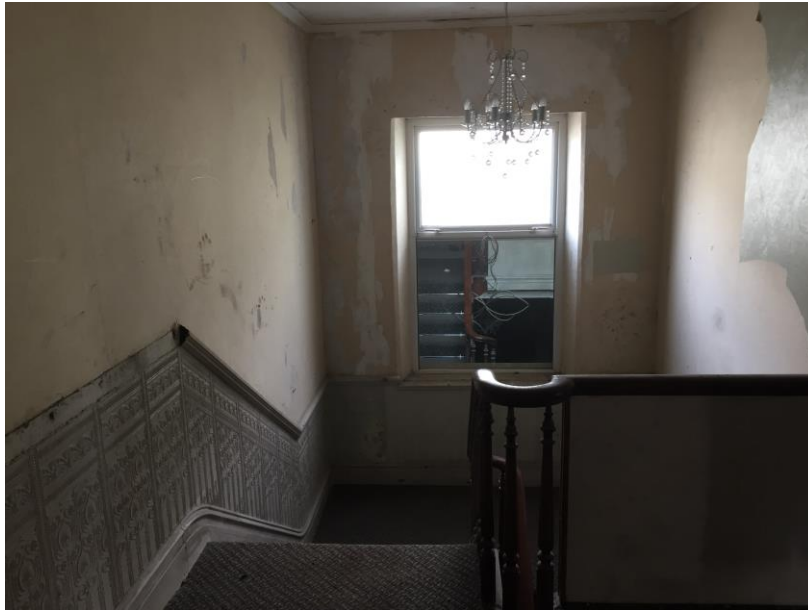
Photo 26 – first floor landing illustrating stairwell with simple moulded treads, painted metal bannisters and stained timber handrail. Decorative wallpaper to original plater elements with modern plaster overlaid above.

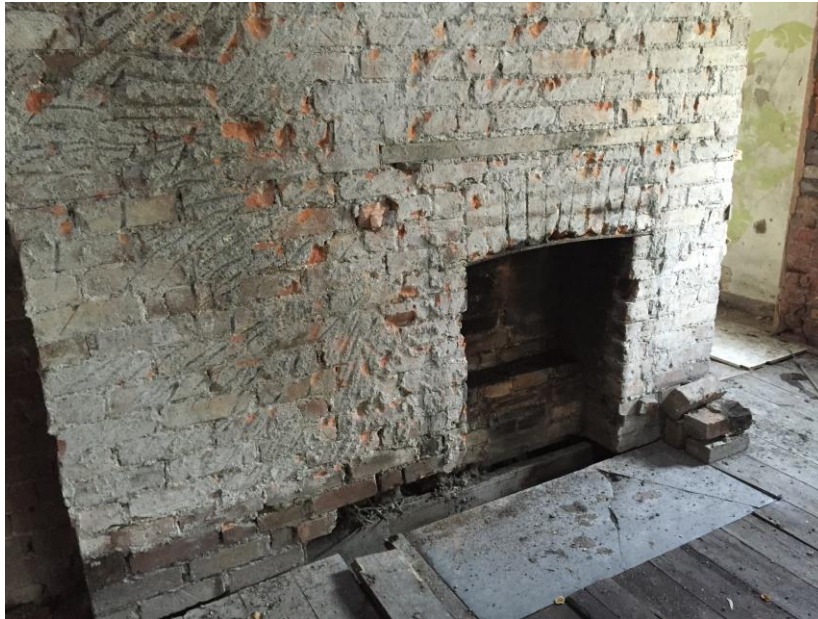
Photo 28 – fireplace
exposed within former hotel bedroom, comprising simple engineering brick surround, with thin, narrow
flue to roof chimney

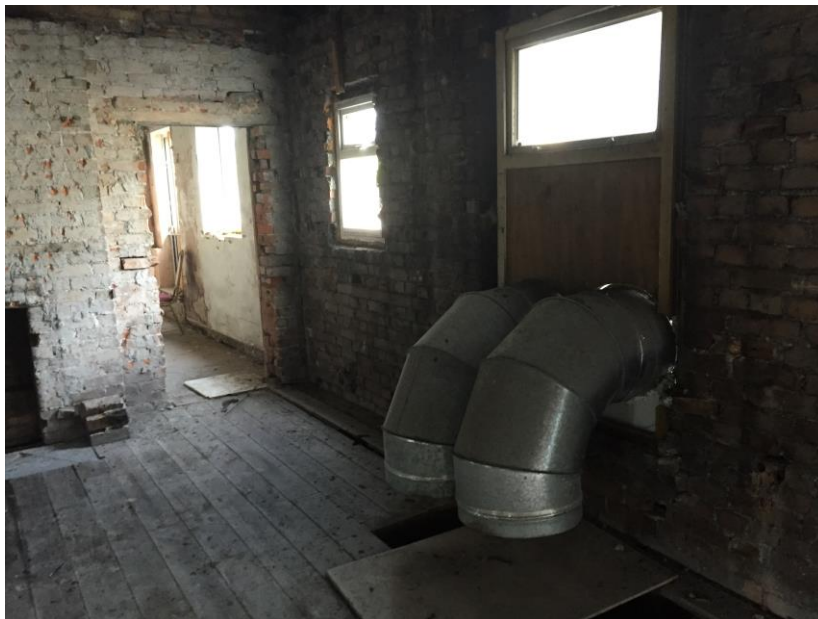
Photo 29 – first floor
elevation disrupted by insertion of extraction flues.

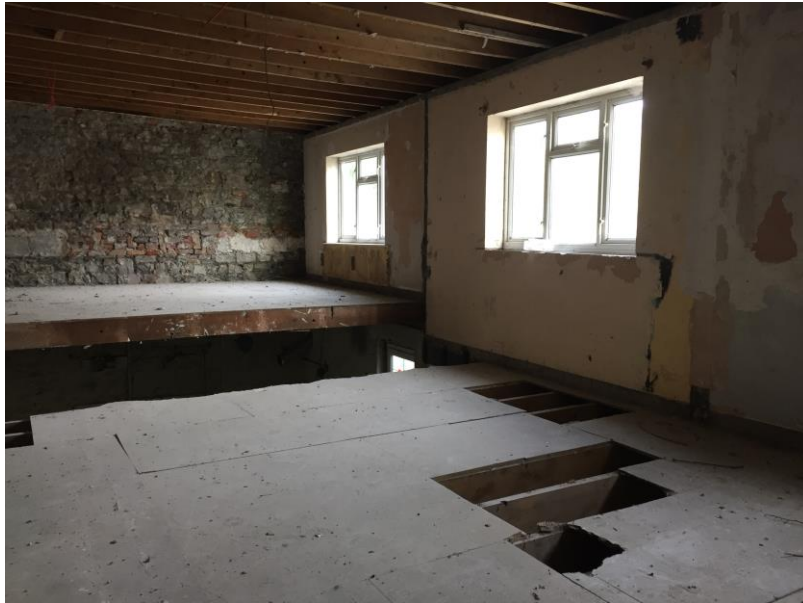
Photo 30 – rear elevation to roadside with floor boards exposed and modern window additions.
