PROJECT SUMMARY SHEET

<i>Client</i>	HALCROW GROUP LTD
<i>National Grid Reference</i>	SN 250397 201637
<i>Council</i>	CARMARTHENSHIRE
<i>Listed Building Consent Application No.</i>	TA/S/65091
<i>HAS No</i>	869
<i>Listing Category</i>	GRADE II
<i>Project Manager</i>	ANDY BOUCHER
<i>Text</i>	LISE BREKMOE
<i>Graphics</i>	CAROLINE NORRMAN & THOMAS SMALL
<i>Fieldwork</i>	LISE BREKMOE
<i>Schedule</i>	
<i>Fieldwork</i>	1ST FEBRUARY 2011
<i>Report</i>	4TH FEBRUARY 2011

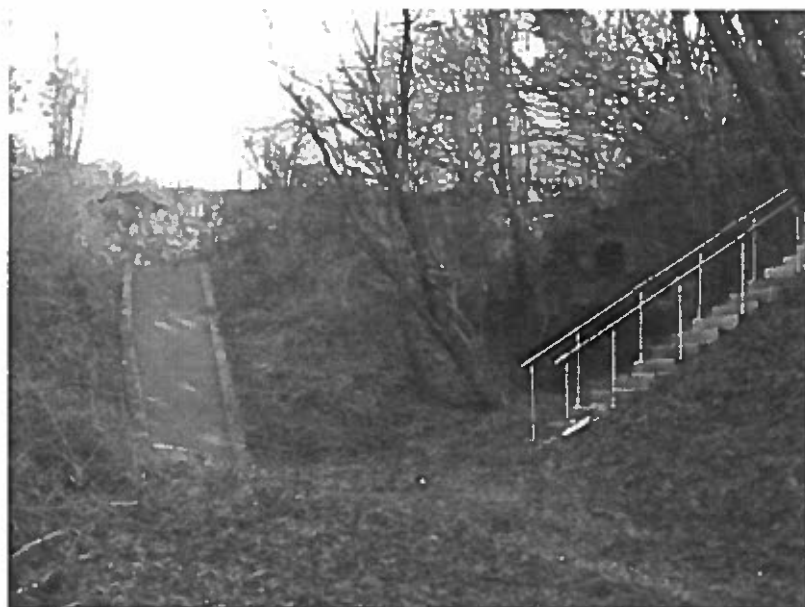
Illus 3
North-facing photograph showing downstream face of dam

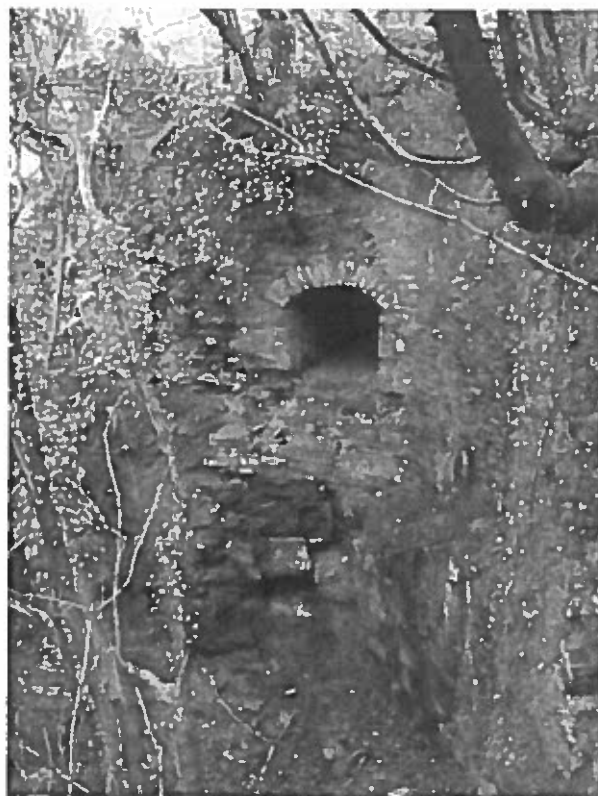
Considerable damage is visible in its eastern corner where the downstream end of the overflow culvert is positioned (Illus 4). Root penetration is likely to have caused the damage and movement directly to the west of the overflow culvert, causing the outward collapse of masonry and loss of pointing. There is also considerable damage below the overflow culvert, which is the area of leakage addressed by the construction of the new culvert in 1991 (Binnie & Partners 1991).

Illus 4
North-facing photograph showing overflow culvert and damage in eastern corner of downstream face of dam
