PEMBROKESHIRE COAST NATIONAL PARK TRADITIONAL BOUNDARIES SURVEY

For: Pembrokeshire Coast National Park

March 2020

Trysor Project No. 2020/709
DAT HER Event Record PRN 114831

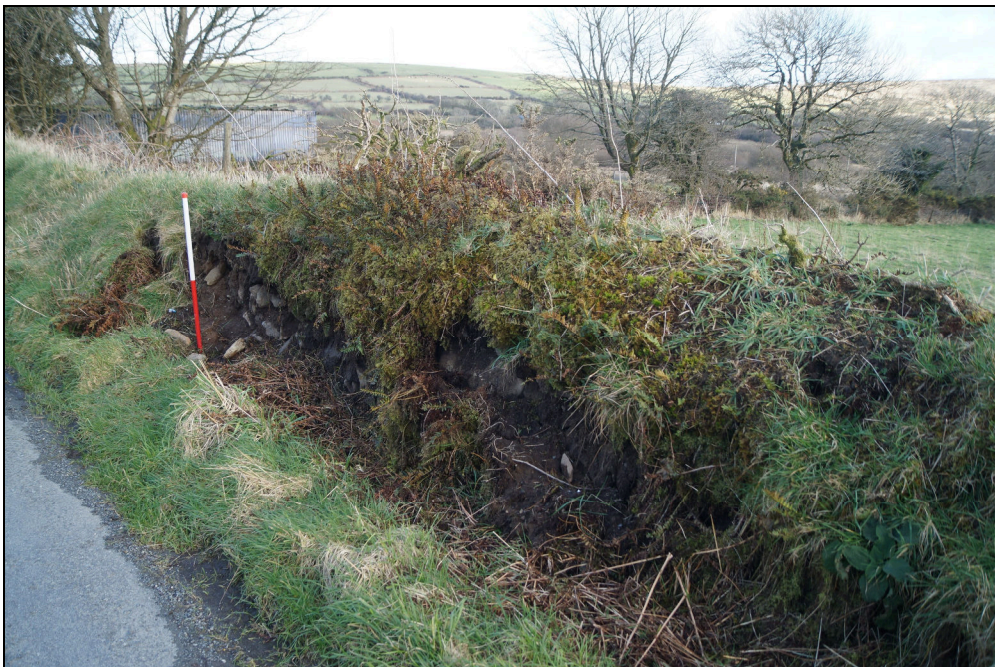
Plate 2. TBS2020_002: This damaged boundary bank, HER PRN 114833, is revealed to be a Cloddiau Variant when the earth which has built up against its side has been removed.

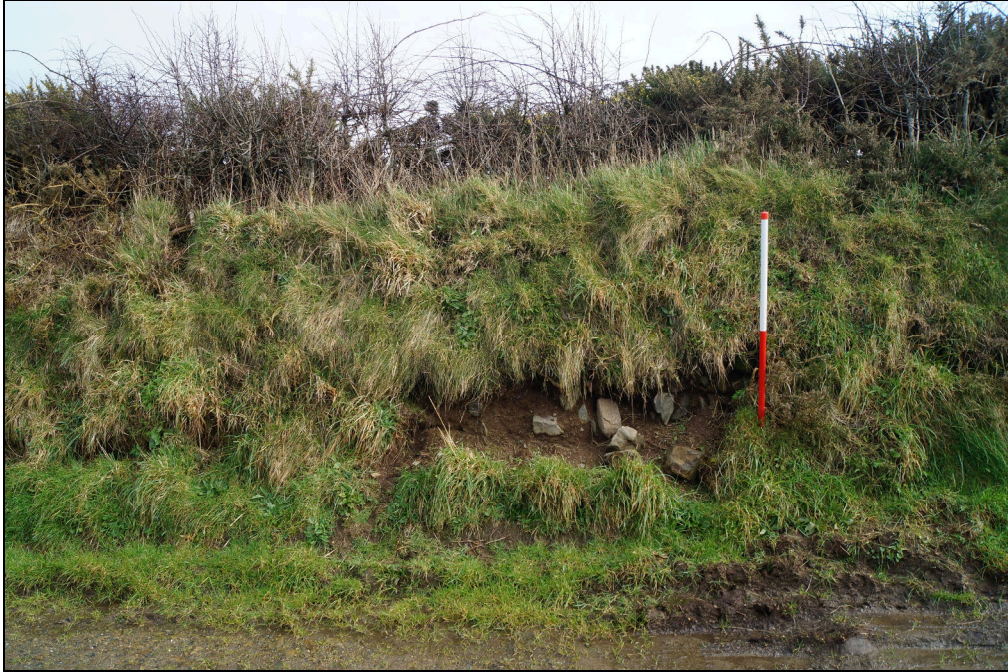
Plate 15. TBS2020_015: A damaged roadside boundary bank, no HER PRN, with exposed stonework revealing that it is a Cloddiau Variant, rather than a simple Hedgebank.

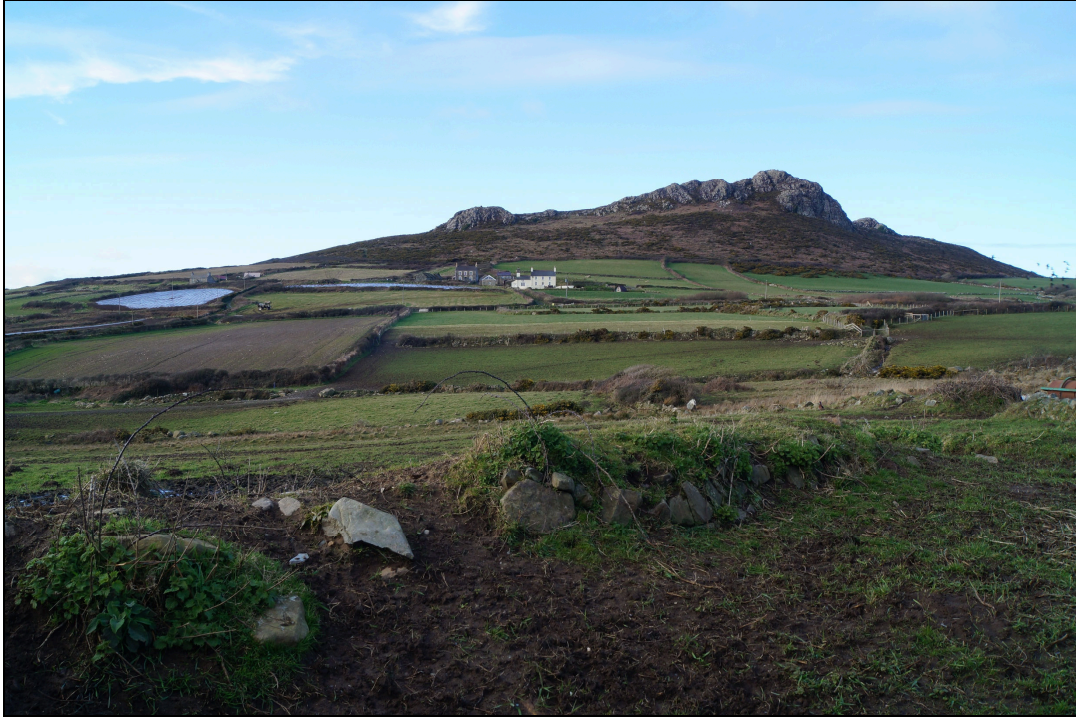
Plate 33. TBS2020_033: A view of the field system below Carn Llidi. A denuded bank in the foreground appears to be a Cloddiau Variant, HER PRN 114859.

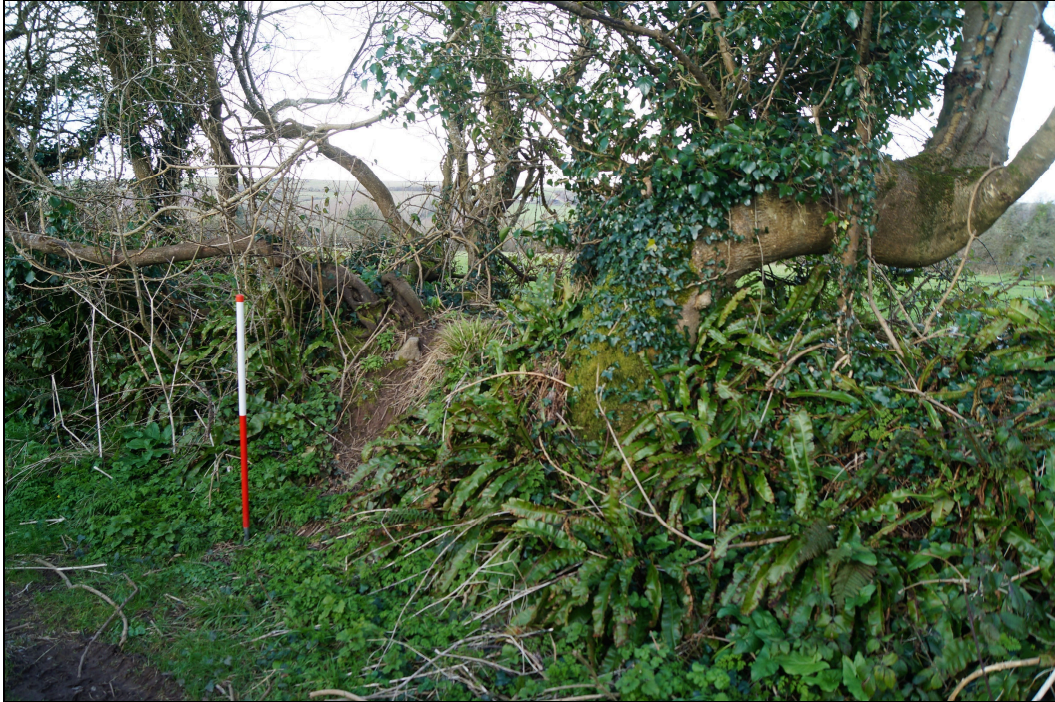
Plate 49. TBS2020_049: Animal erosion reveals an earth bank on this Hedgebank (not recorded)

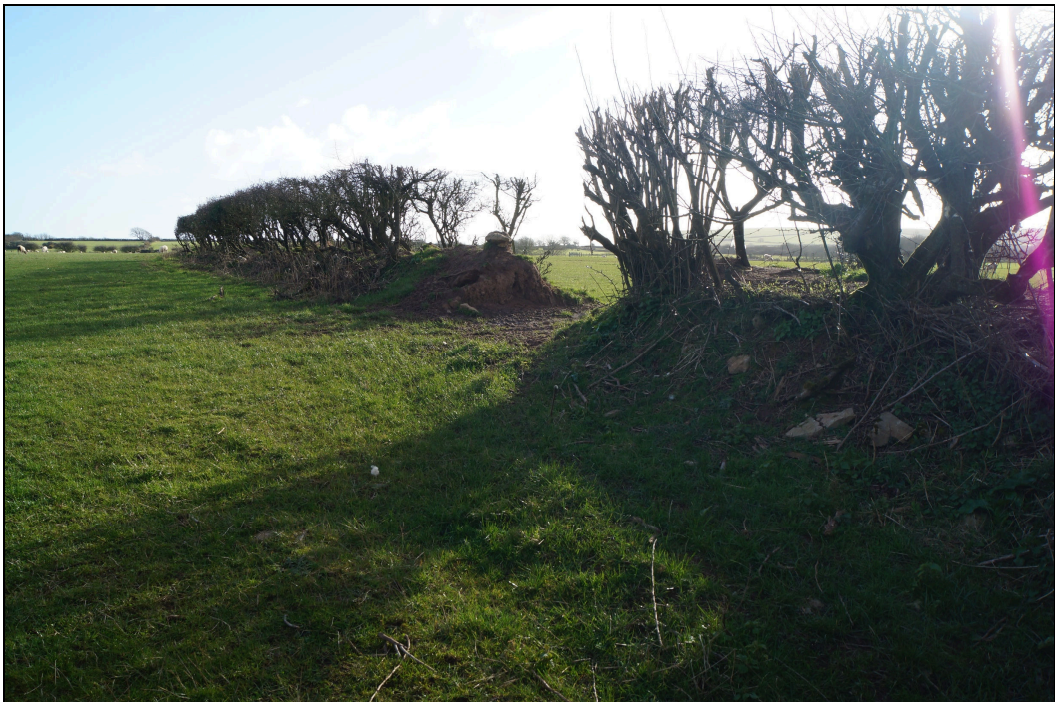
Plate 50. TBS2020_50: A Hedgebank with a recently brashed hedge (HER PRN 114873). The bank has been cut through revealing an earth bank. Some stone on the bank has been cast there, probably during post-ploughing stone clearance.

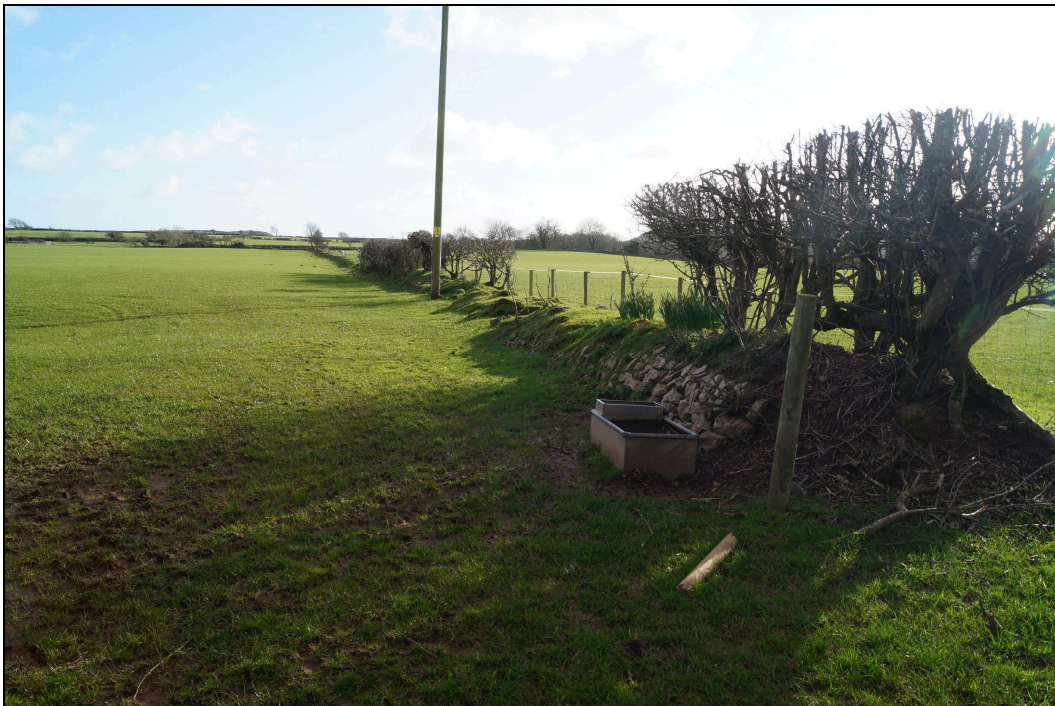
Plate 52. TBS2020_052: Another example of an earth Hedgebank, HER PRN 114874, which has sections of stone facing, with possibly a patched repair around the water trough where animals have damaged the bank.

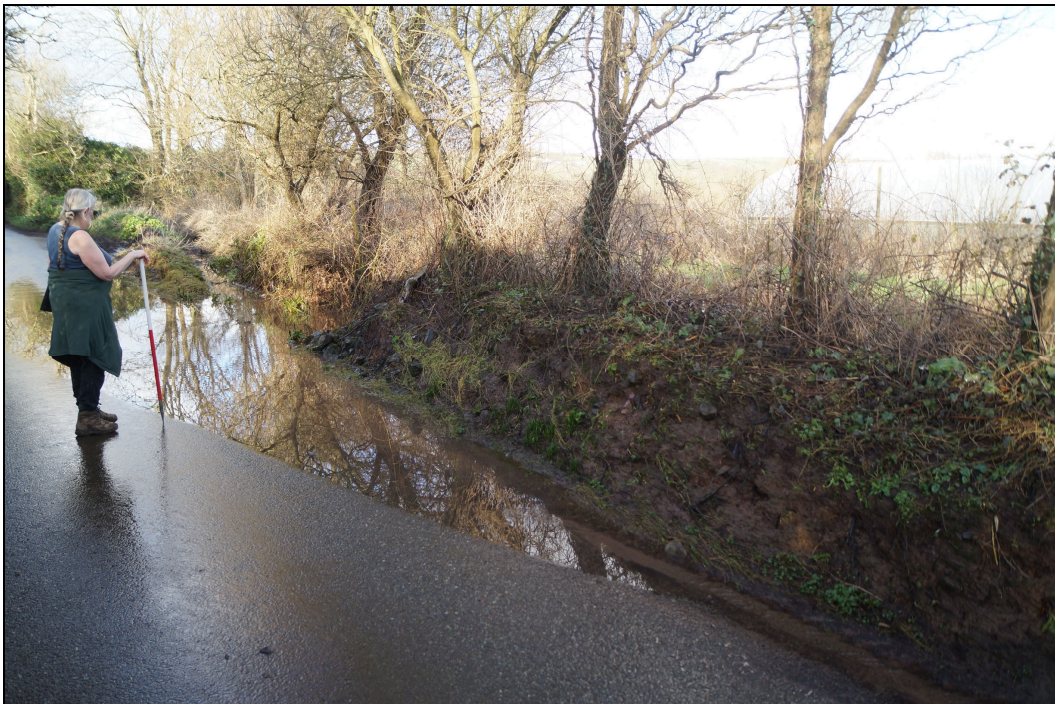
Plate 56. TBS2020_056: Recent flooding of this Hedgebank at SS0564199412, near Jameston has caused erosion and revealed an earth bank. The trees were small saplings in 2011. Hedgebank not recorded.

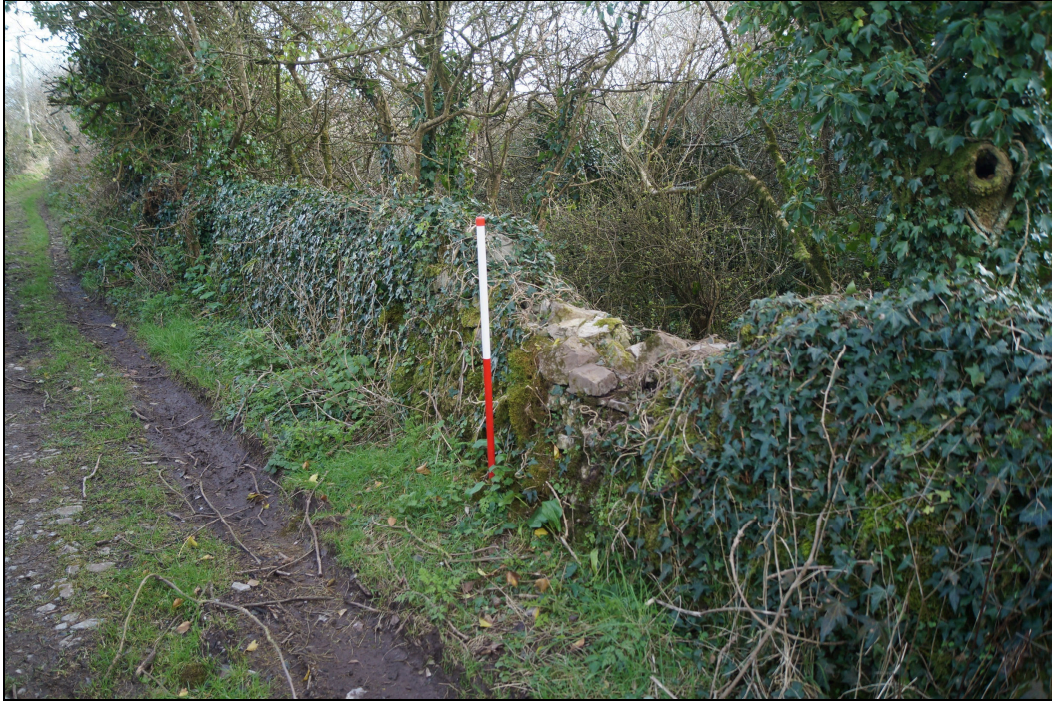
Plate 61. TBS2020_061: Mortared Walls, often relatively thin, are most commonly found along lanes and tracks. They are often slightly damaged. Here, HER PRN 114878, local limestone and lime mortar have been used, in this wall along side Haylands Lane, Jameston.

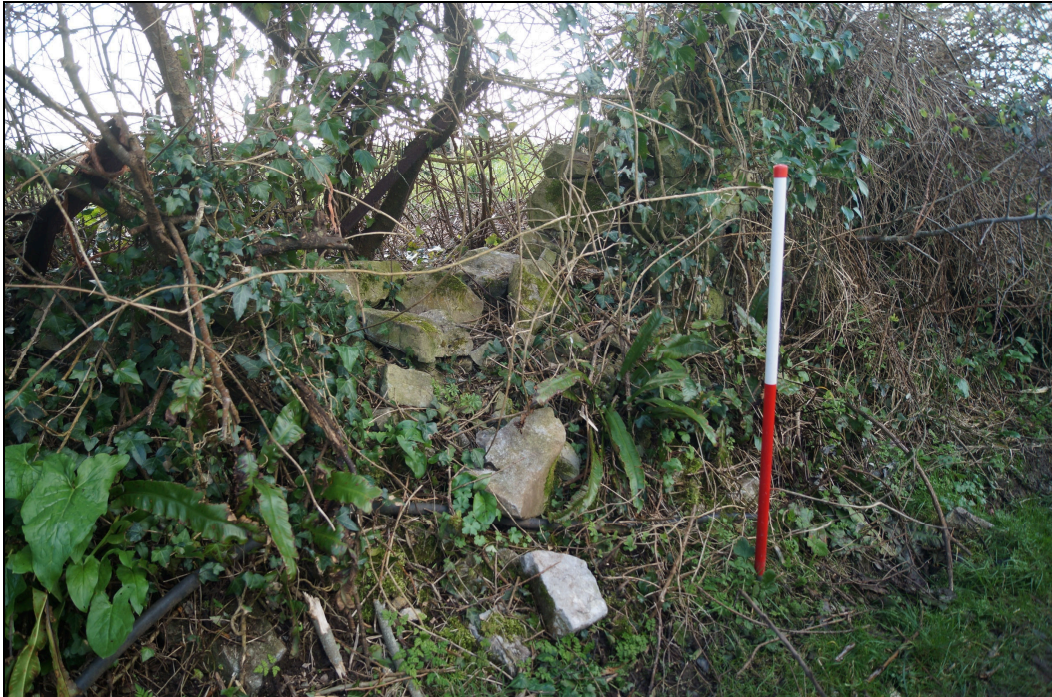
Plate 62. TBS2020_062: Another damaged Mortared Wall, HER PRN 114879, alongside the Haylands Lane, Jameston

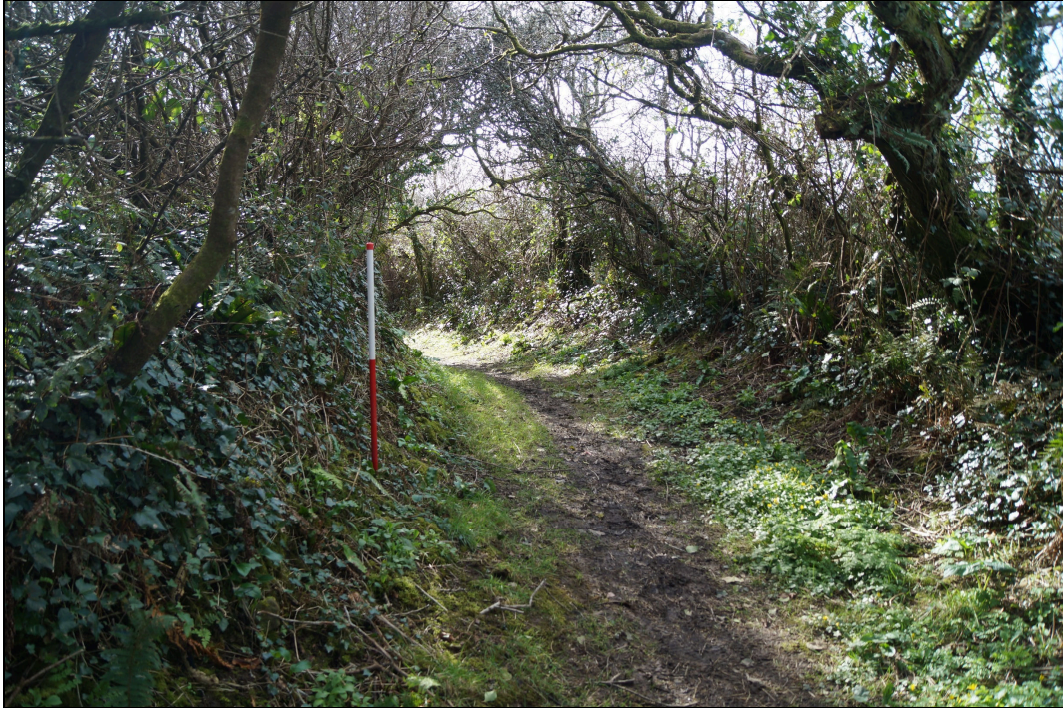
Plate 65. TBS2020_065: A section of footpath showing unmanaged Hedgebanks on Waterwynch Lane (not recorded)

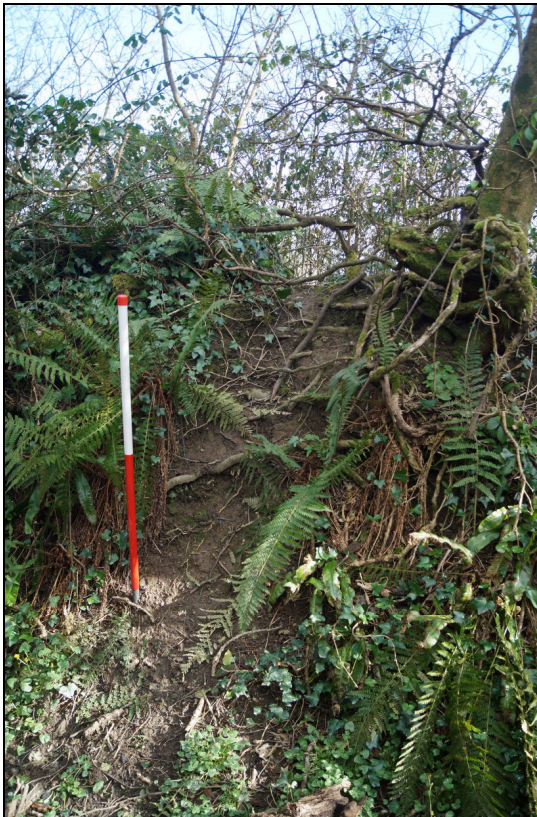
Plate 66. TBS2020_066: This example of erosion caused by animal tracks suggests there is no or little stone component to most of the Hedgebanks in this aspect area. This is likely to reflect the fact that there is little outcropping stone, and the local geology is of an often thinly laminated soft mudstone, hence suitable stones are not common. (Along Waterwynch Lane, not recorded)

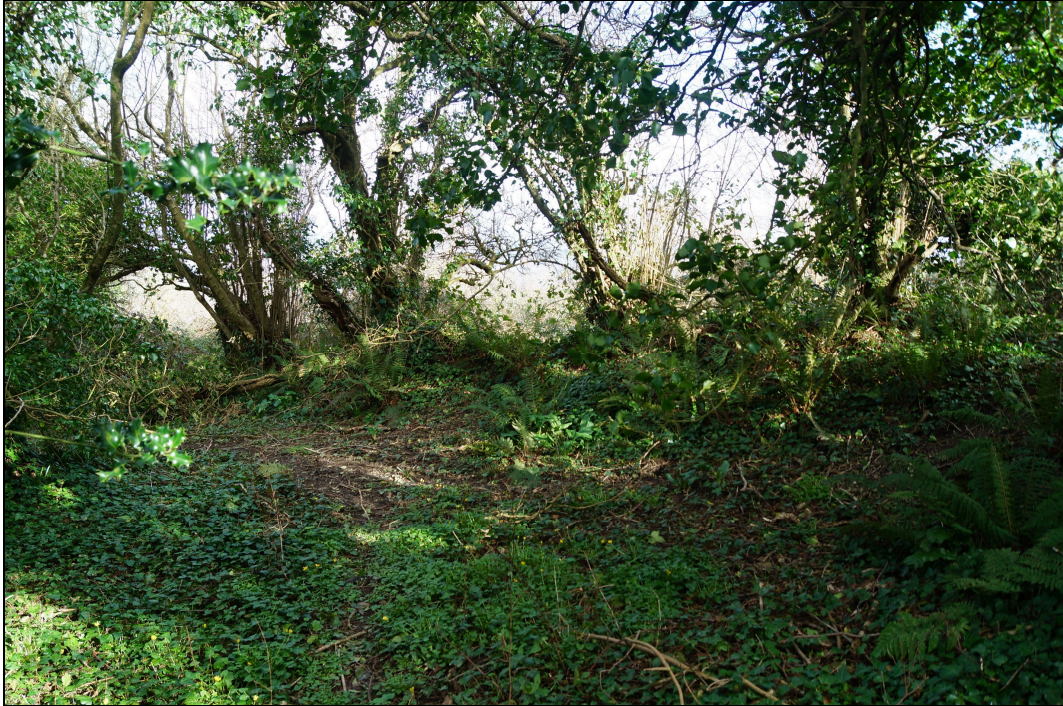
Plate 67. TBS2020_067: Another example of an unmanaged and overgrown Hedgebank, HER PRN 114882.
