PHOTOGRAPHIC SURVEY
CONVERSION OF FORMER AGRICULTURAL BARNs TO 6 NO.
HOLIDAY APARTMENTS WITH SURFACED PARKING, ACCESS
IMPROVEMENTS AND LANDSCAPING WORKS
AT
PENYGAU FARM, FERRYSIDE, CARMARTHEN, SA17 5UG

On behalf of
J.D. & M. Morgan Limited

Our Ref: LN/RAB
Date: July 2020
Prepared by: RAB

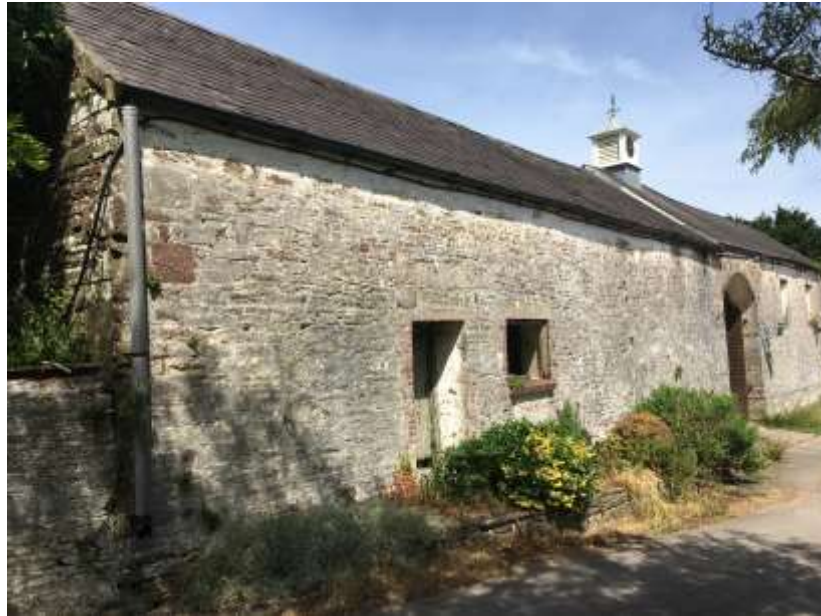
Figure 3 – front elevation of roadside barns

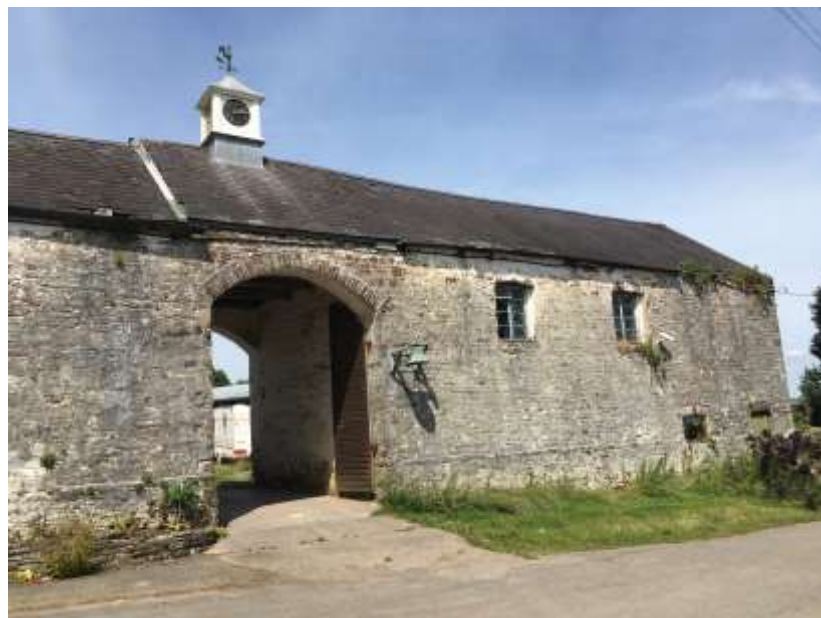
Figure 4 – front elevation to roadside displaying entrance archway

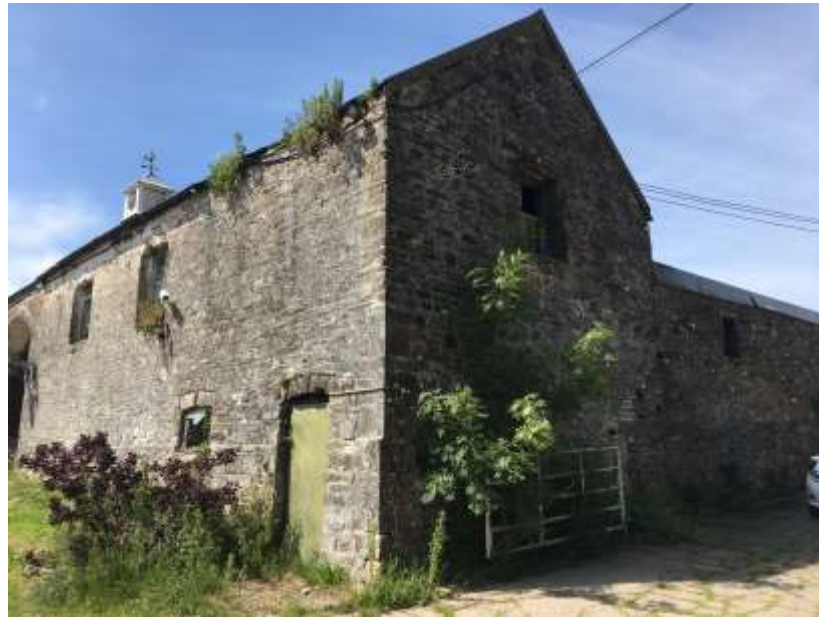
Figure 5 – south-west corner between front and eastern side barn elevations

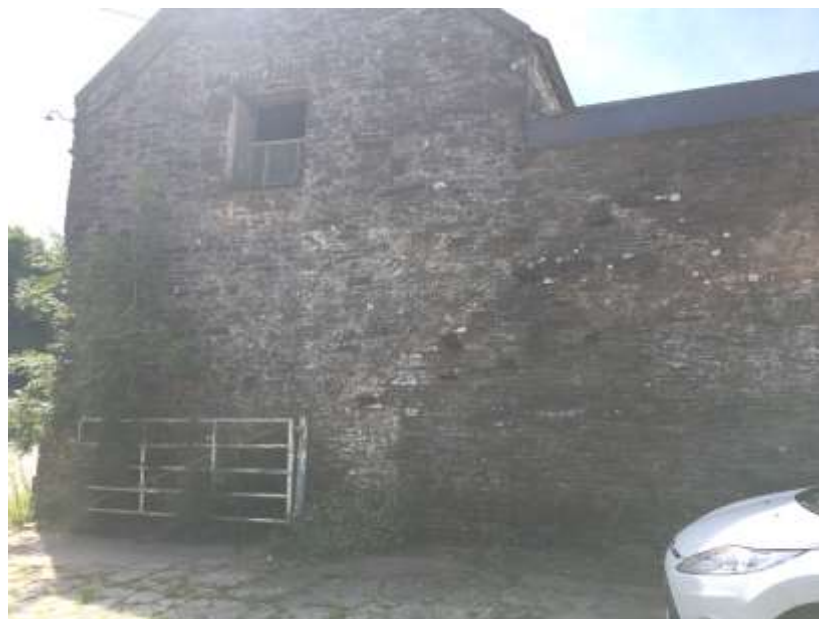
Figure 6 – south west corner

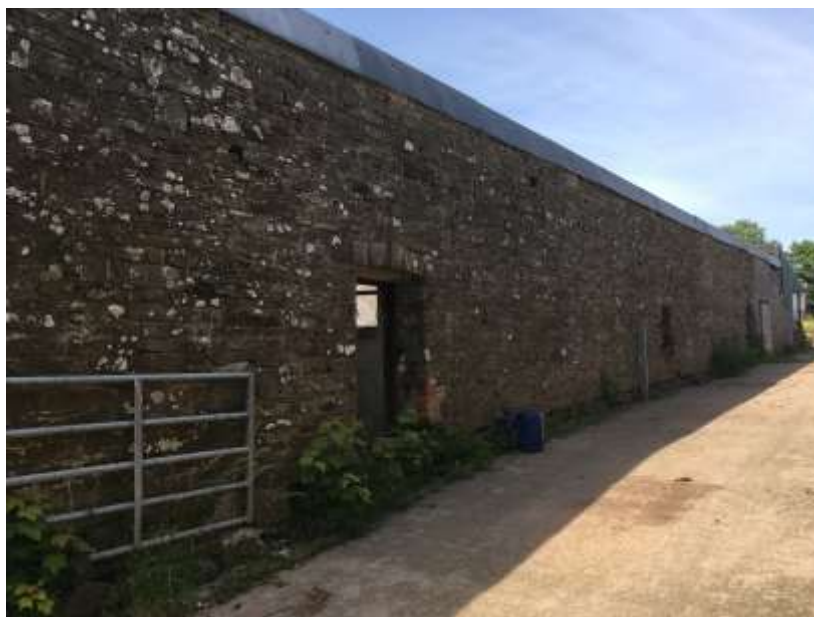
Figure 7 – long eastern elevation facing side farmyard

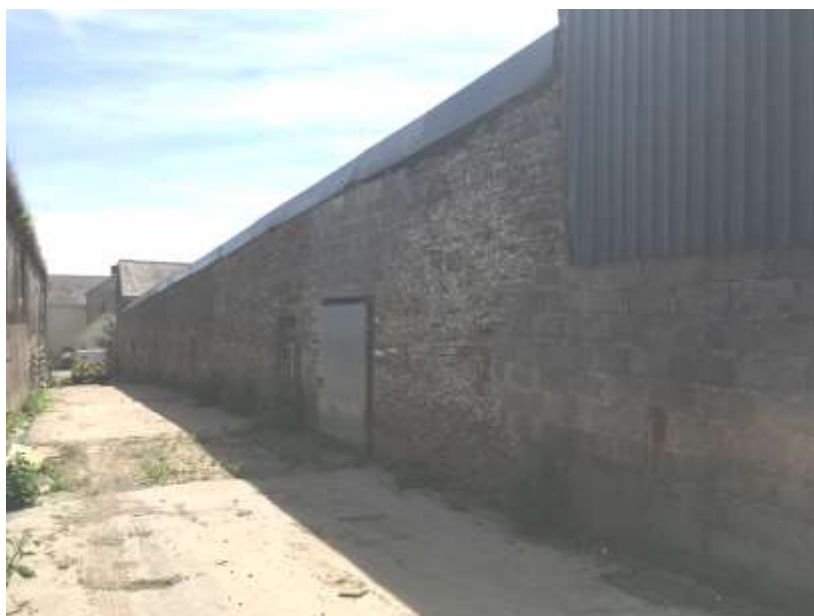
Figure 8 – long western elevation with modern farm sheds set opposite to the west

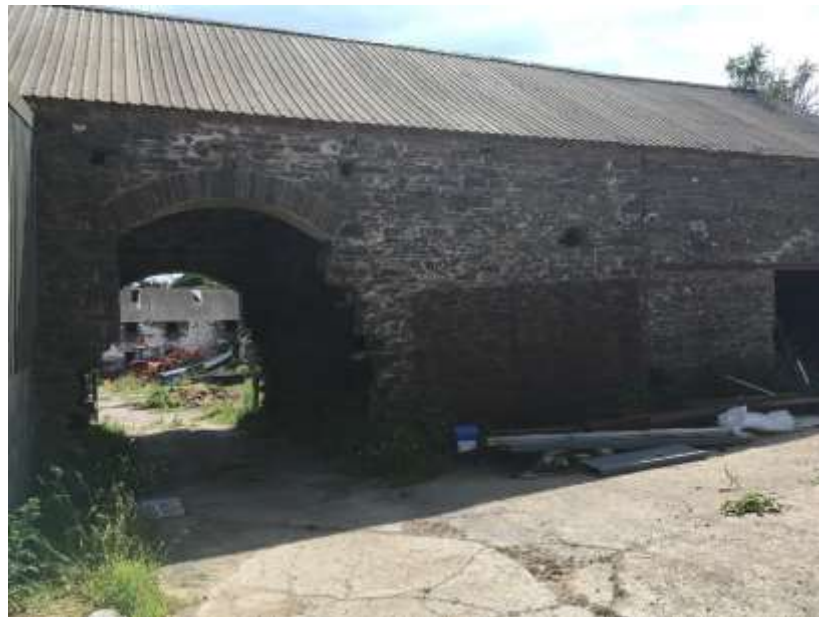
Figure 9 – image taken within inner courtyard looking back towards entrance archway

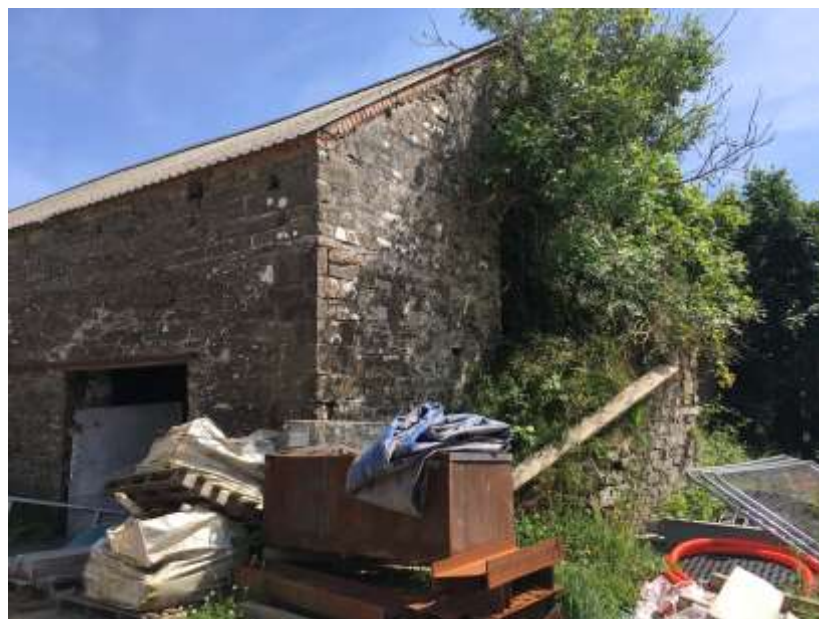
Figure 10 – taken from within inner courtyard and towards western wing of barn complex

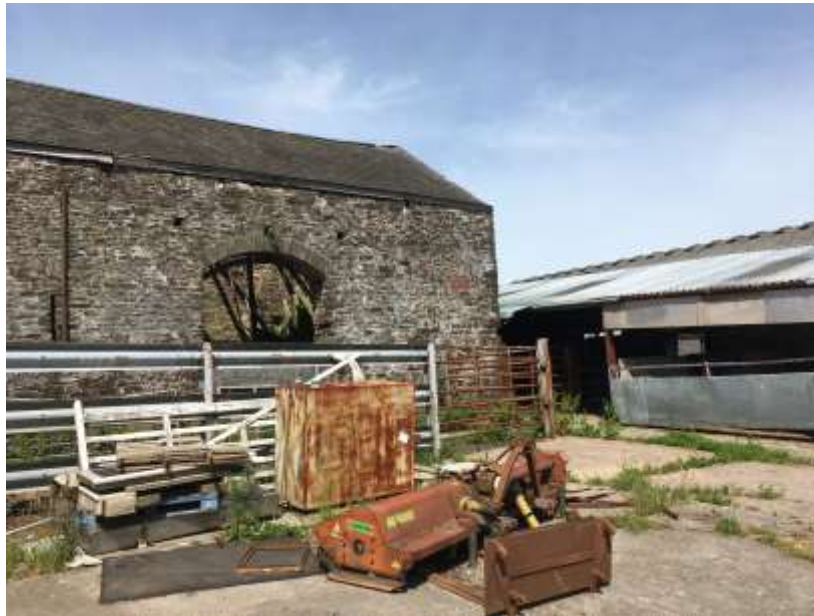
Figure 11 – external western wing and original archways over openings

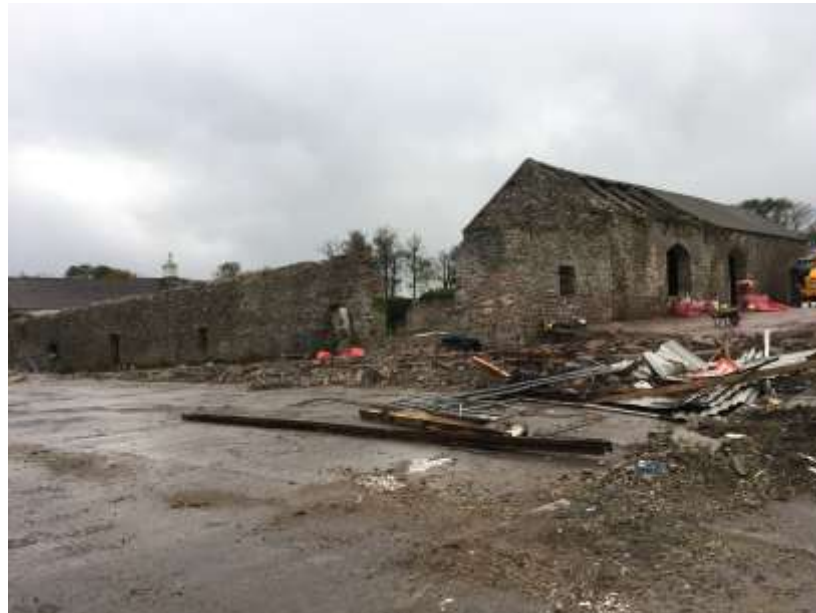
Figure 12 external view from adjoining farmyard looking towards north-east corner of barns

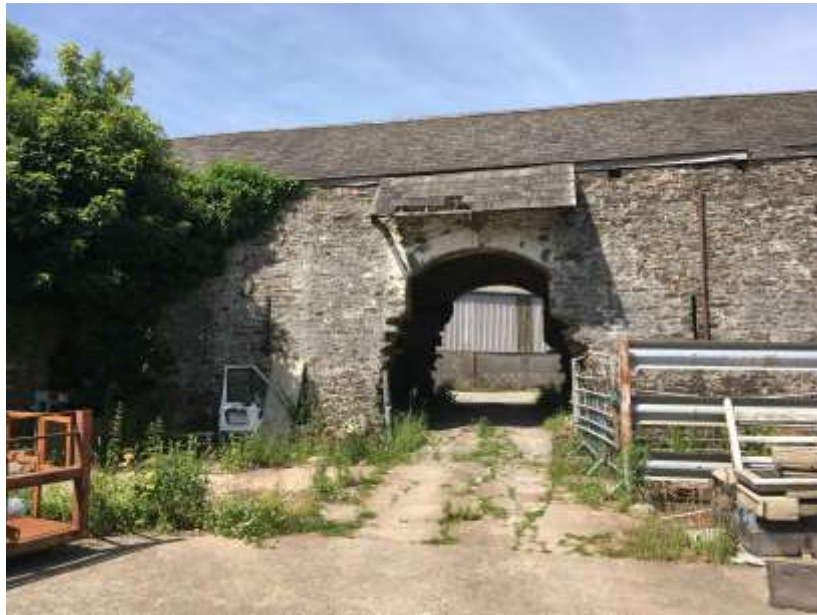
Figure 13 – northern wing looking from inner courtyard towards entrance archway

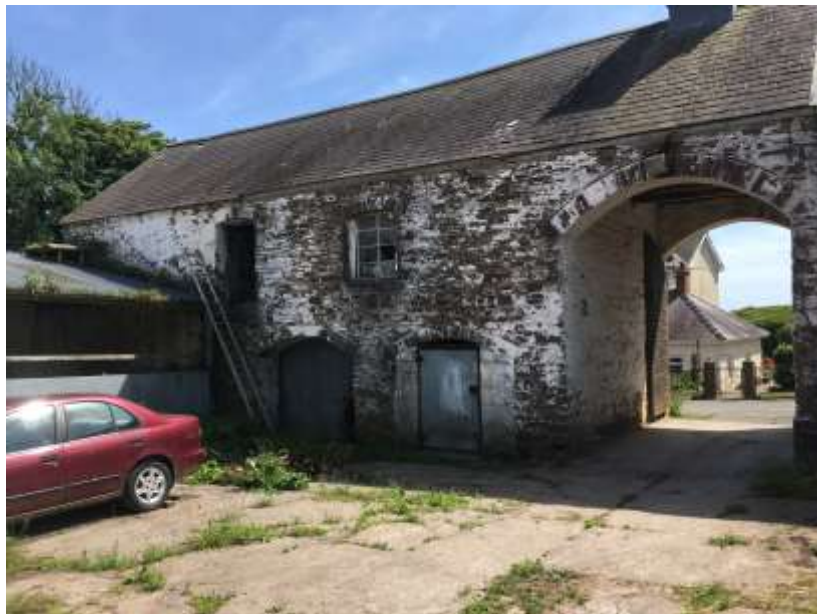
Figure 14 – view from within inner courtyard looking back through southern entrance archway and also south-eastern corner

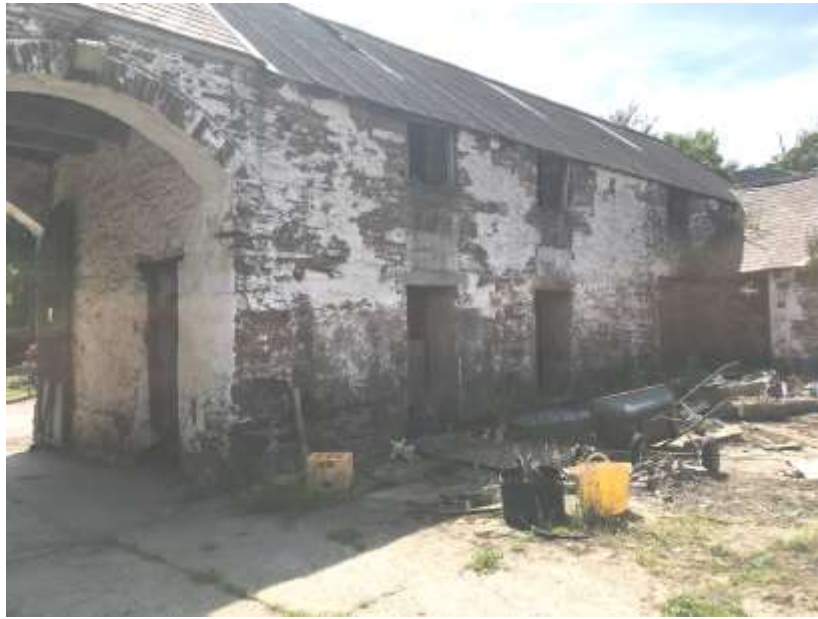
Figure 15 – southern wing from within inner courtyard looking at south-western corner

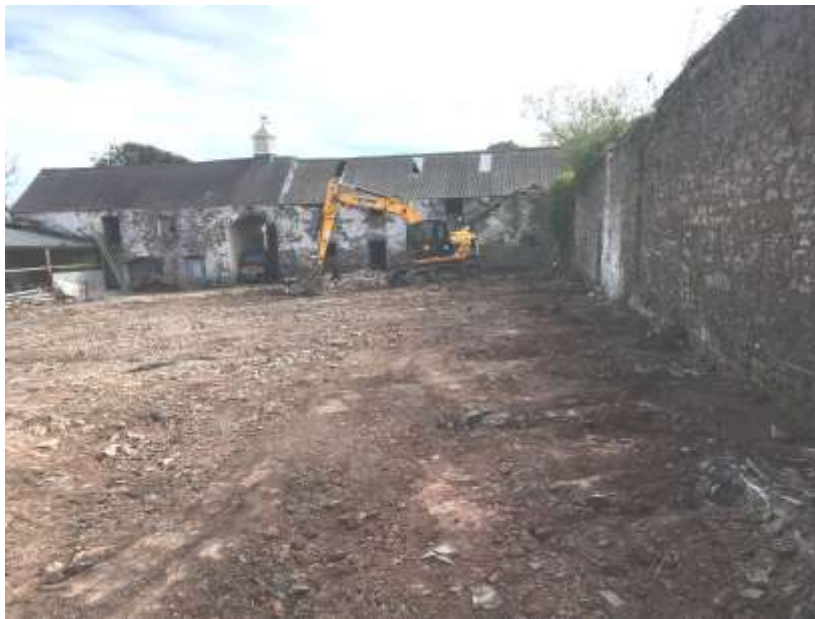
Figure 16 – inner courtyard view of long eastern elevation

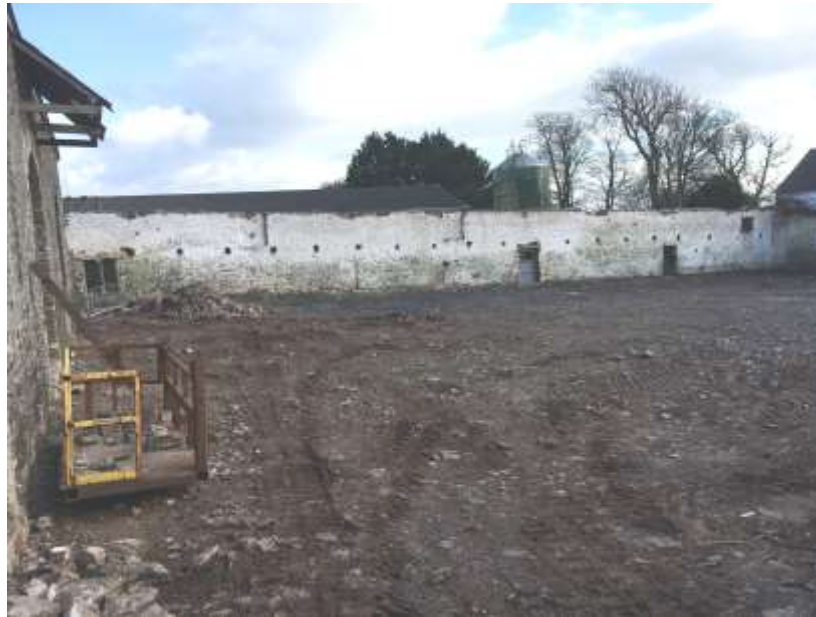
Figure 17 – inner courtyard view of long western wing

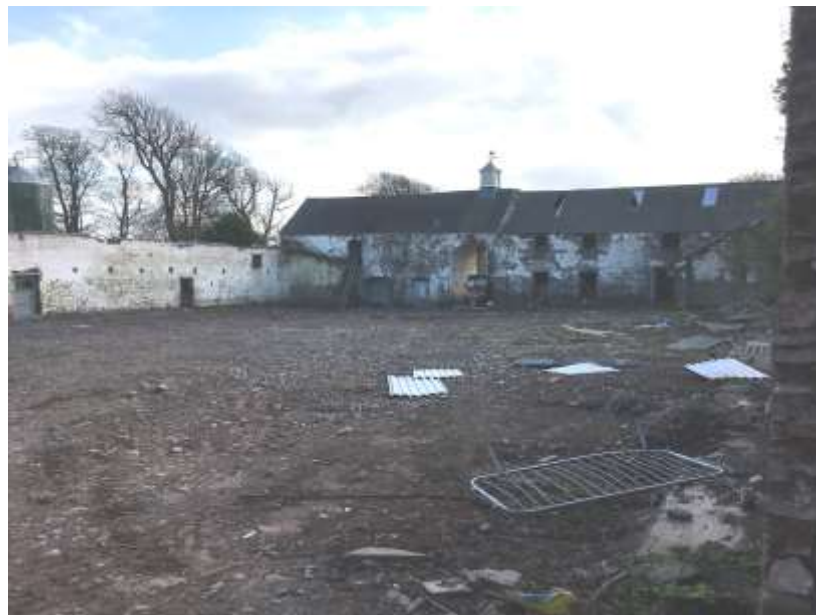
Figure 18 – view from inner courtyard towards northern rear wing

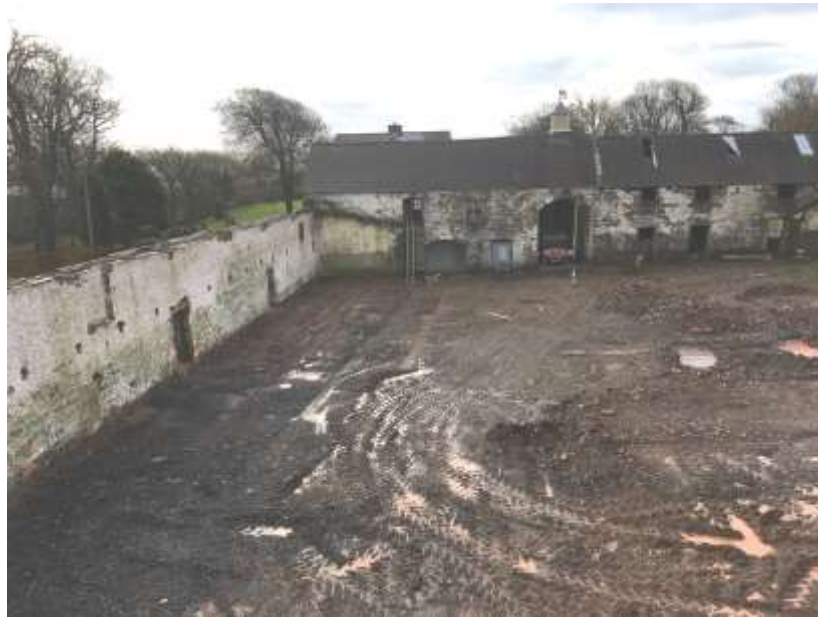
Figure 19 – view of inner western wing and northern wing in distance

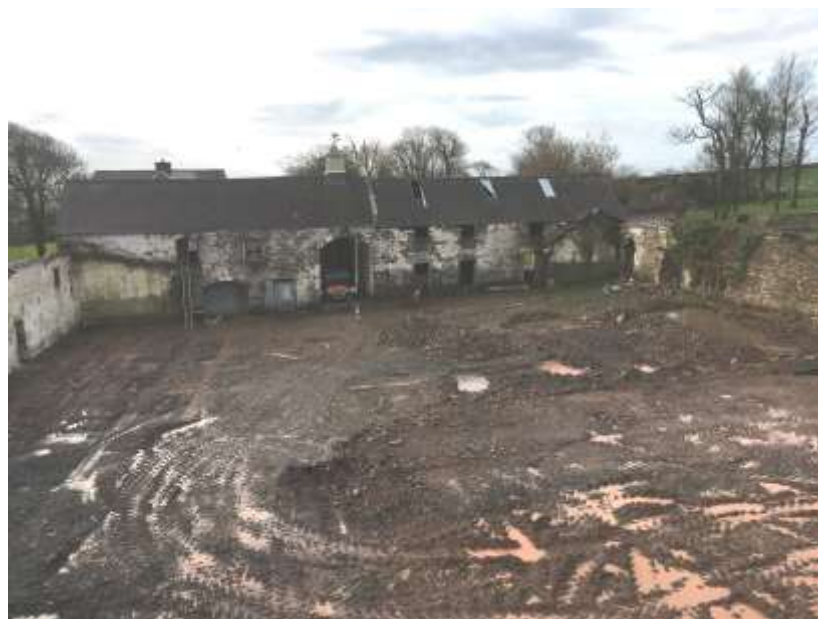
Figure 20 – extent of open inner courtyard with northern wing at distance
