CPAT Report No. 1794

Esgair Feithgen, Mydffai, Carmarthenshire

Building Survey

Project Name: Esgair Feithgen, Myddfai, Carmarthenshire

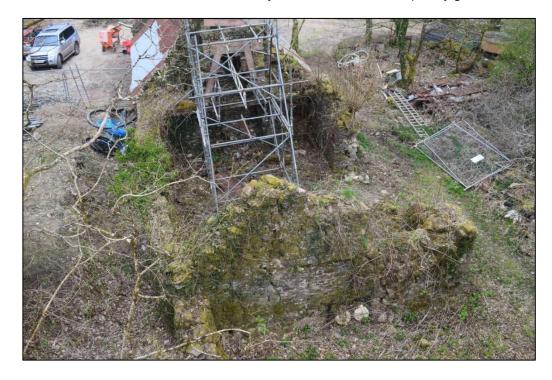
3.3. The house (Fig. 18, 1) measured approximately 10m by 7m and was built into the hillside on the south-east side (Figure 6). The stonework comprised random uncoursed lime mortared grey sandstone of variable size. Much of the mortar had washed out of the joints due to exposure to the elements. There were no quoins discernible on the corners of the building. A straight cut in the stonework indicated where the external doorway on the north-facing elevation was located (Figure 7). No window apertures were identified. An infilled doorway with a single stone header (Figure 11) between the house and the byre was located in the eastern gable end. No other internal details such as the flooring material or any internal subdivision were discernible at the time of the survey, and if the interior walls had been plastered or timber lined, no evidence survived. The chimney was located on the inside of the western gable end (Figure 8) and contained a large fire place measuring approximately 2m by 1m and height of 1.8m containing a bread oven on the south side (Figure 9). A chamfered oak beam formed a mantlepiece for the fireplace. There was originally a staircase to the upper floor located to the north side of the chimney stack but this had completely gone.

Fig. 6 House viewed from the north-east Photo CPAT 4910-049

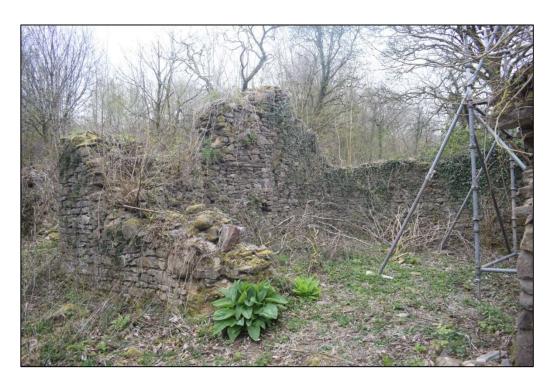
Fig. 7 House viewed from the south Photo CPAT 4910-011

3.4. The house was in poor condition with none of the roof structure remaining and much of the stonework missing especially on the eastern gable end and the north-facing elevation (Figure 7). The chimney stack was still upstanding, although it had been braced with scaffolding due to a collapse of the masonry on the north-east side of the stack.

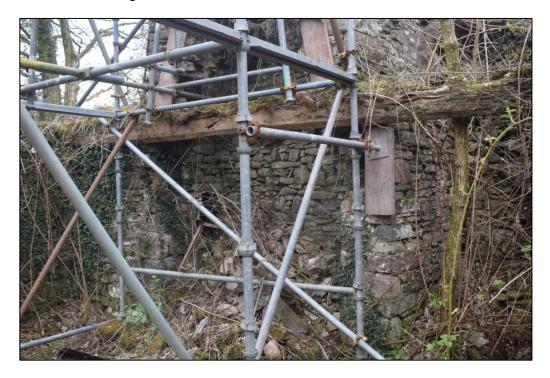
Fig. 8 Fireplace viewed from the north Photo CPAT 4910-050

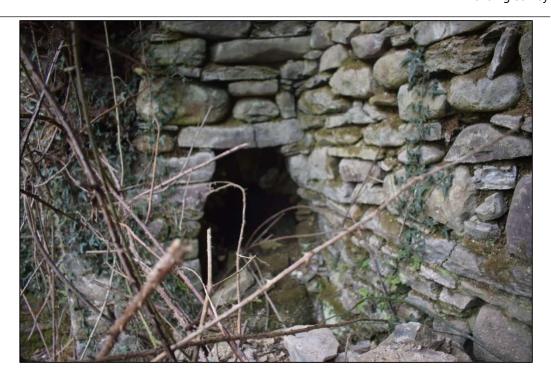
Fig. 9 Bread oven viewed from the north-west Photo CPAT 4910-015

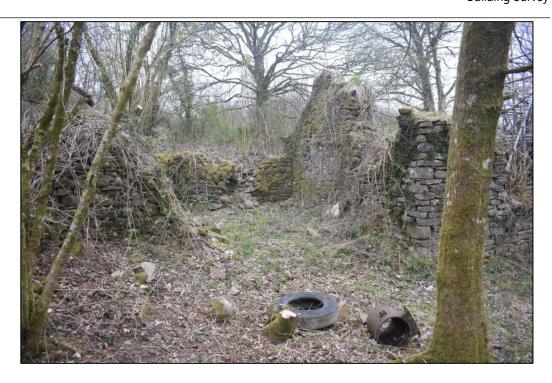
Fig. 10 Interior of the byre viewed from the north-west Photo CPAT 4910-026

3.6. It was not possible to identify any further internal or external details due to the extremely poor condition of the building. The interior of the building had become built up with soil and undergrowth so the flooring was not visible at the time of the survey. None of the roof structure had survived and the walls were in poor condition, with much of the upper structure completely missing.

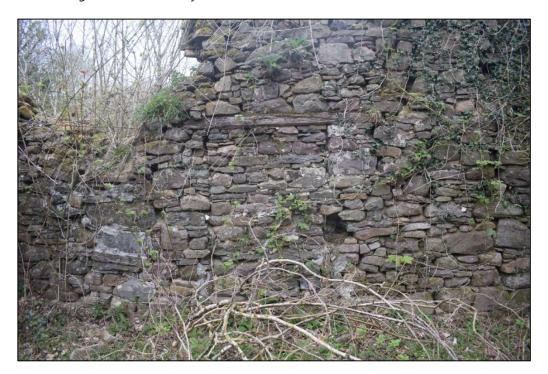
Fig. 11 Infilled doorway into the byre view from the south-west Photo CPAT 4910-012

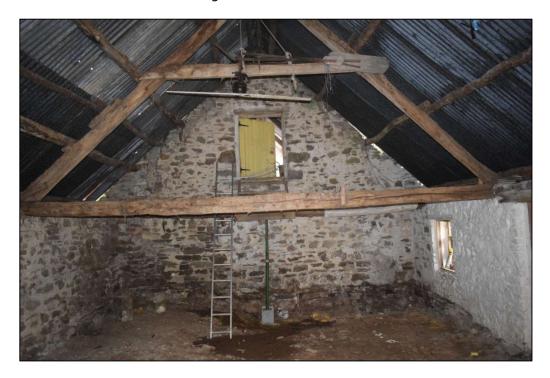
Fig. 12 Interior of the cowshed viewed from the north-east Photo CPAT 4910-009

3.8. The building was in reasonable condition, but much of the floor and most of the internal fixings had been removed (Figures 12 and 13).

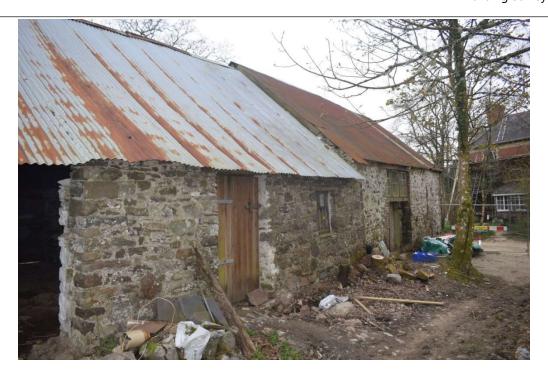
Fig. 13 Cowshed viewed from the north Photo CPAT 4910-007

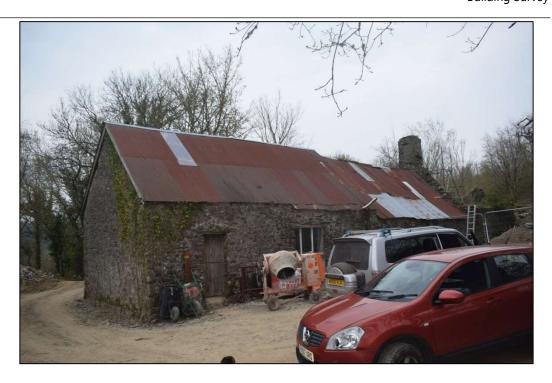
Fig. 14 Threshing barn viewed from the south Photo CPAT 4910-003

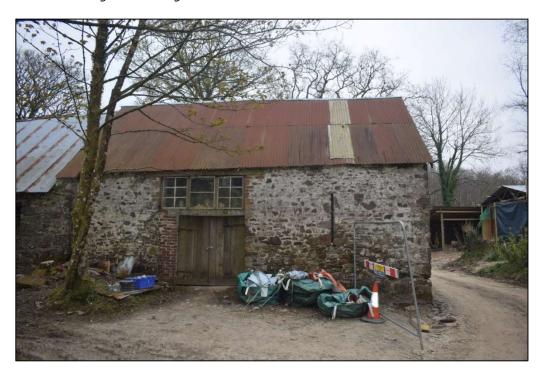
Fig. 15 Threshing barn viewed from the north-west Photo CPAT 4910-004

3.10. The grain store above the threshing barn was accessed via wooden steps in the adjacent cowshed. The flooring had been replaced with plywood. The roof frame was original and in good condition comprising a simple open frame, with ridge beam and purlins. The roof battens had been removed, probably when the roof was sheeted with corrugated iron (Figures 15 and 16).

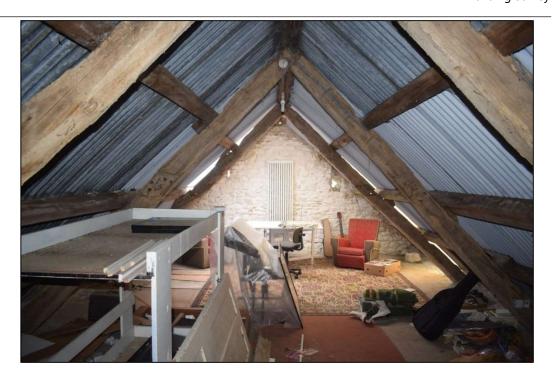
Fig. 16 Grain store viewed from the north-east Photo CPAT 4910-031
