Historic Building Record Level 2

Wood Farm,
Walwyn's Castle,
Pembrokeshire,
SA62 3DZ

May 2022 | Project Ref 07153C

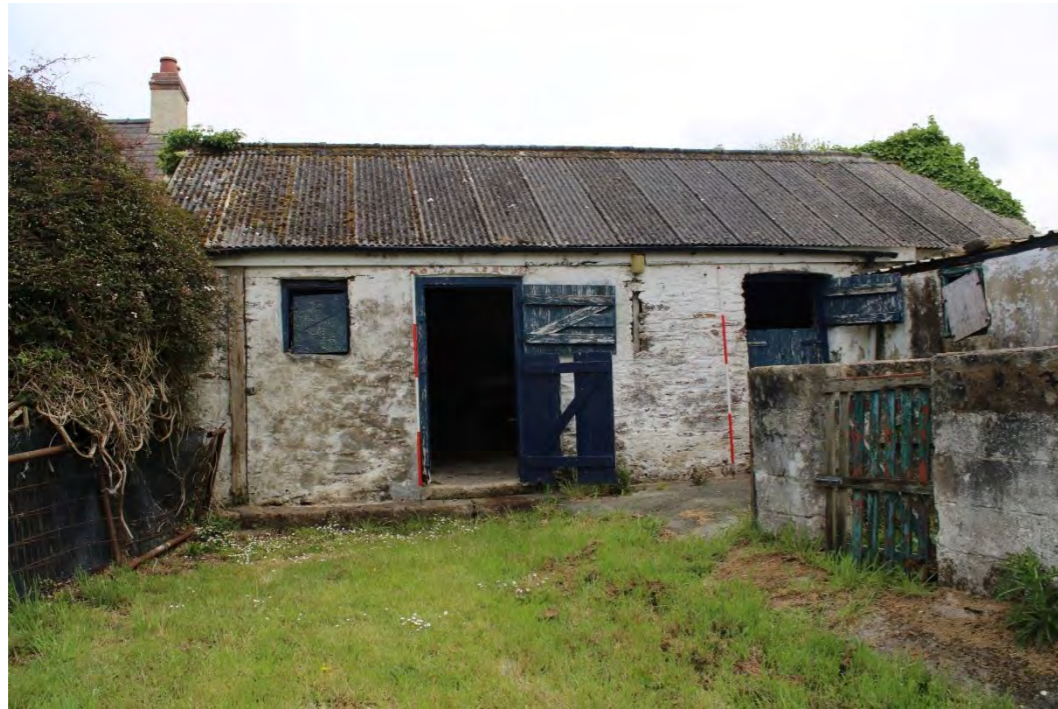
Photo 1: Southern façade of Building B

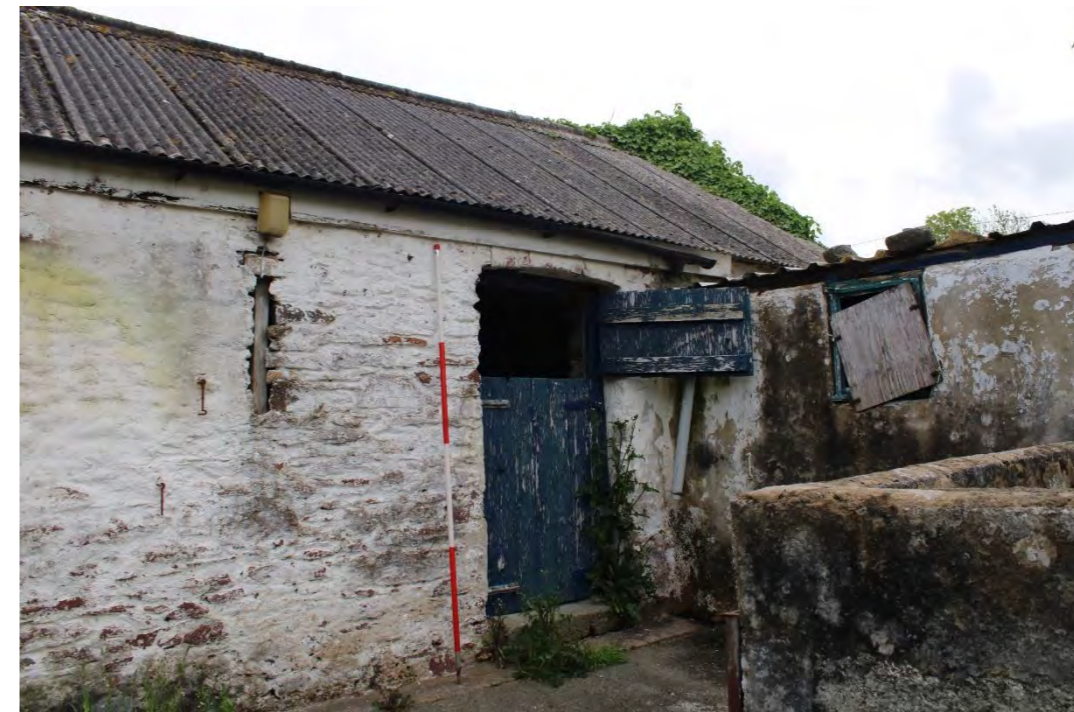
Photo 3: Eastern side of southern façade of Building B

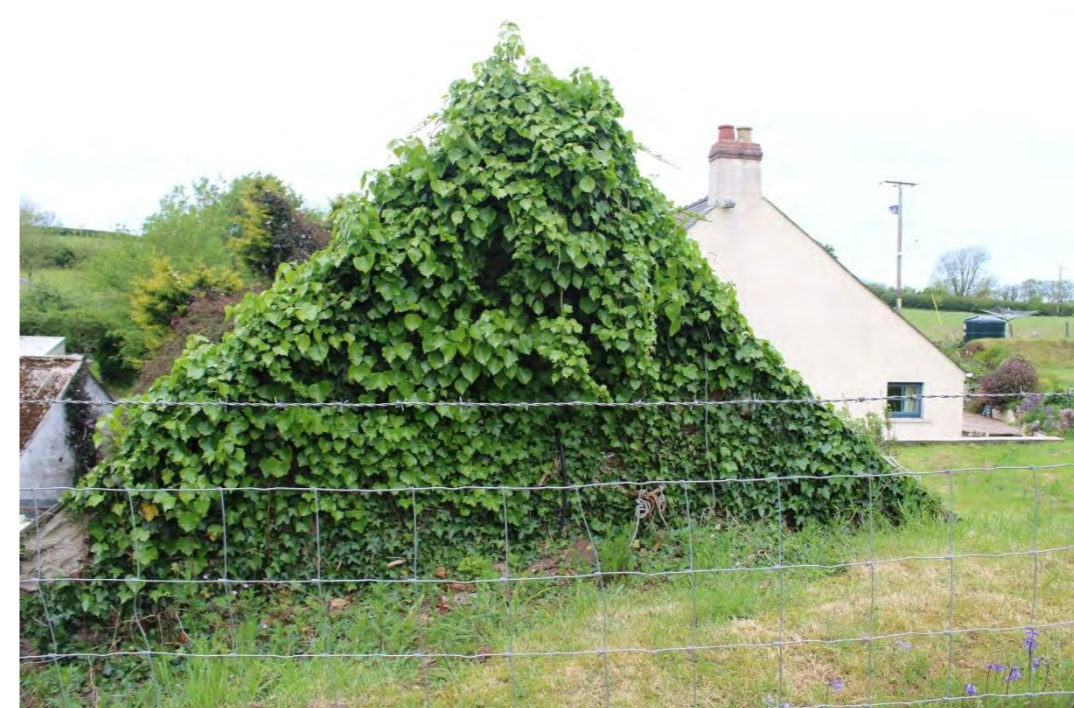
Photo 4: Top of eastern gable end of Building B above ground level

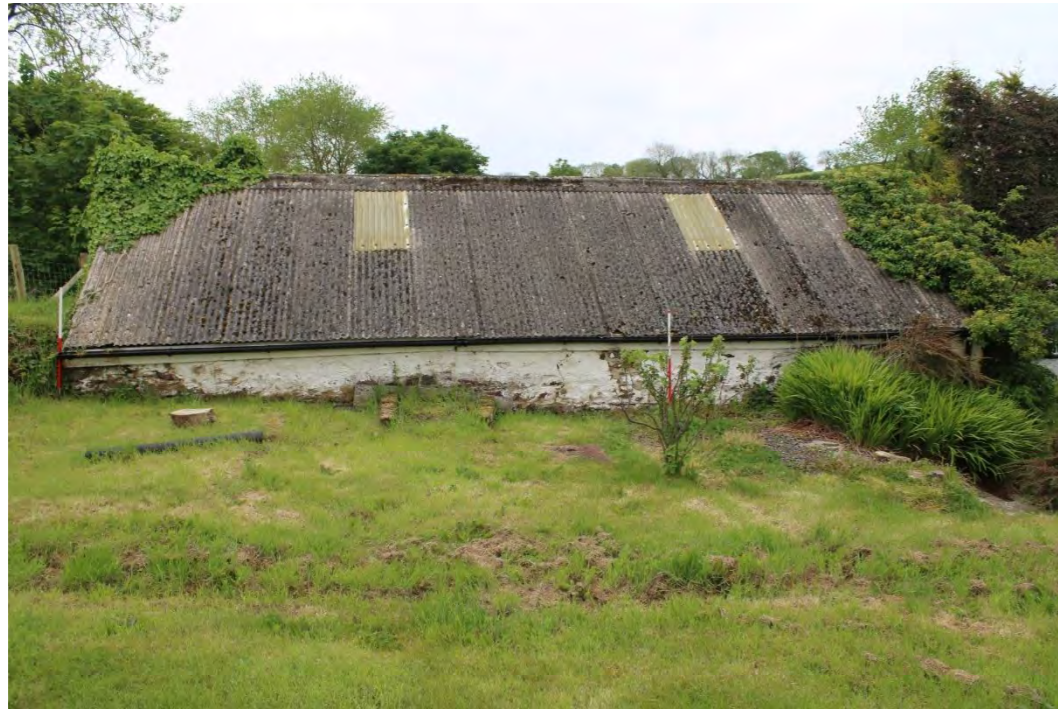
Photo 5: Northern elevation of Building B, showing it is terraced into the ground

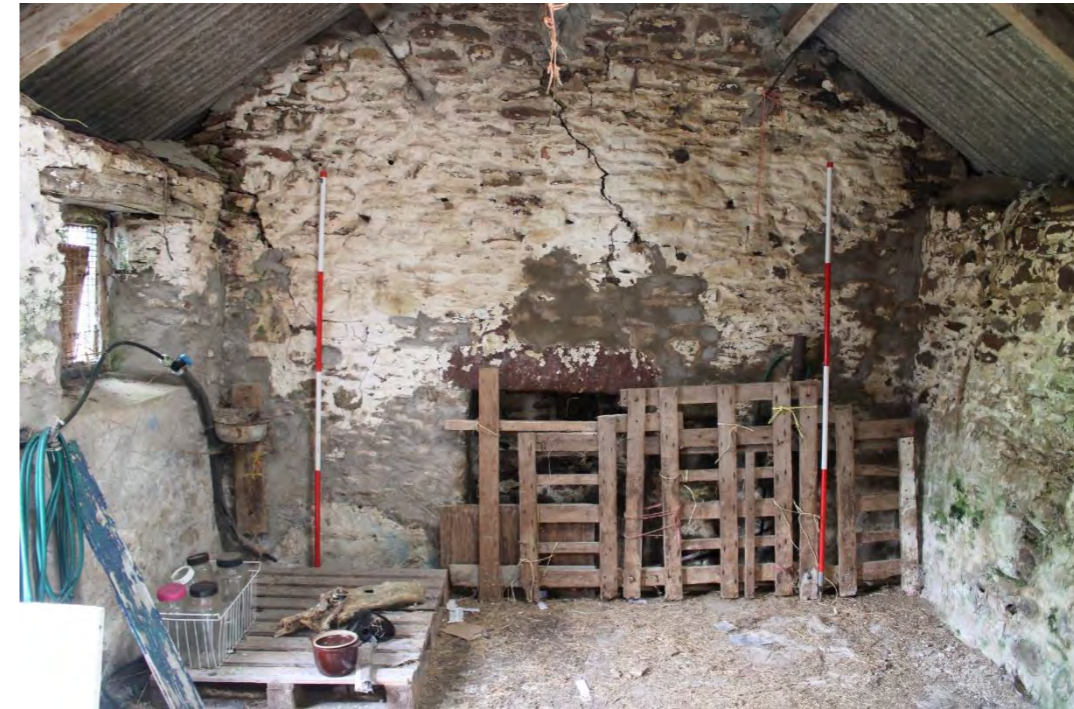
Photo 7: Western interior gable end showing fireplace and ground level of Building B

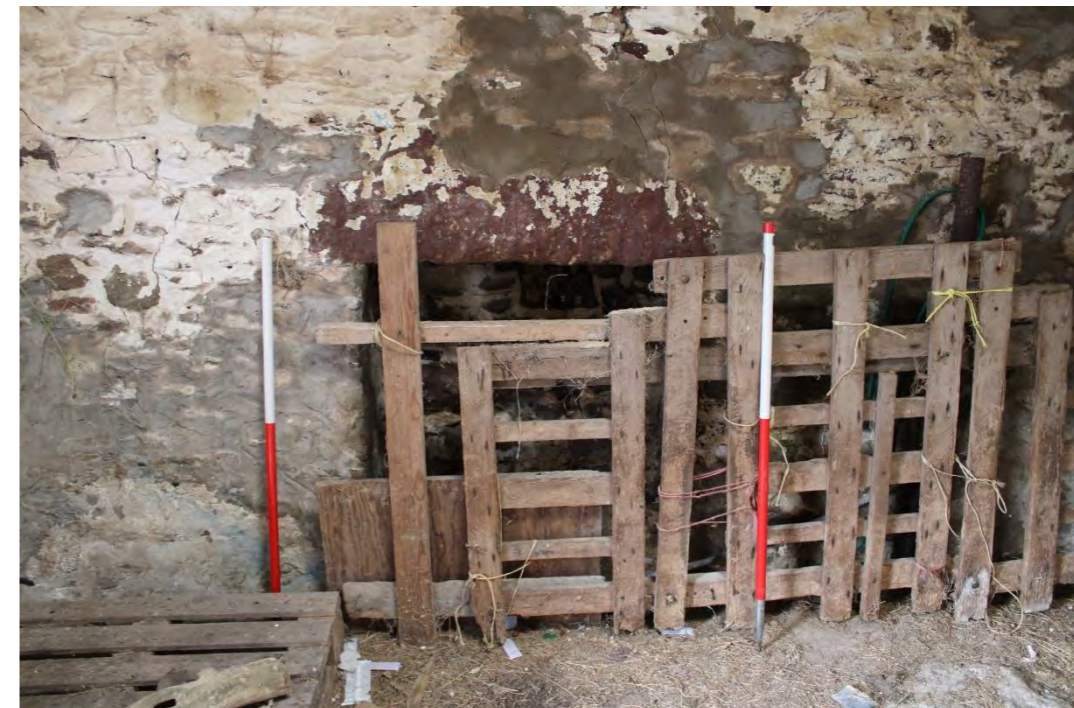
Photo 8: Detail of fireplace in western gable end of Building B

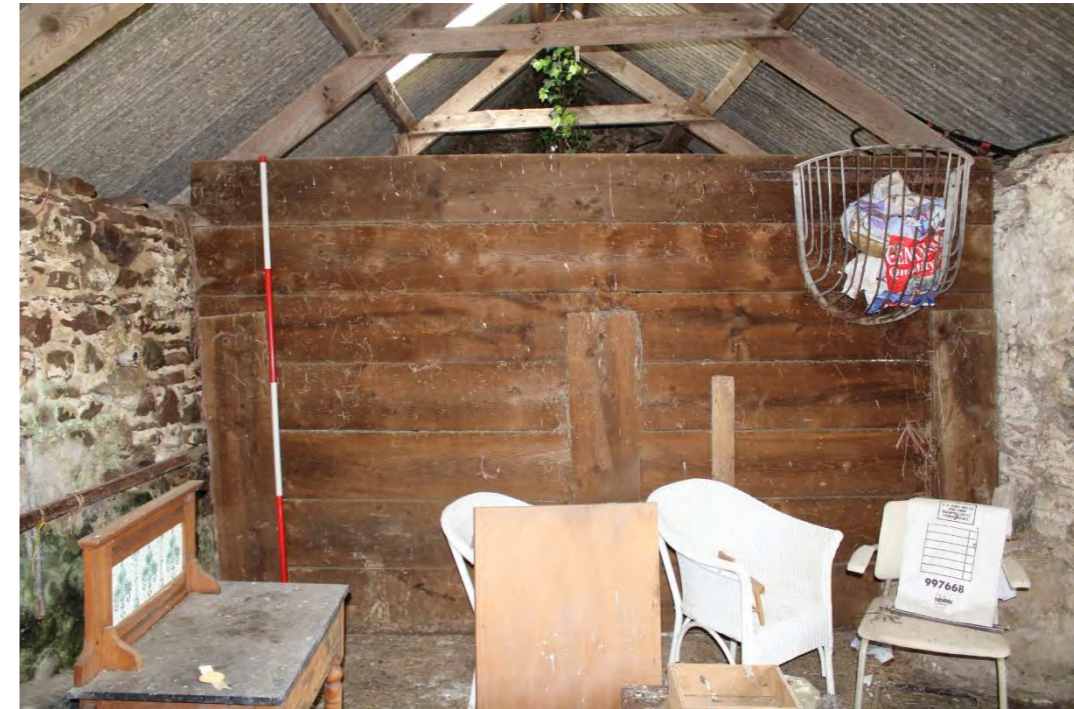
Photo 11: Wooden partition in centre of Building B, viewing east

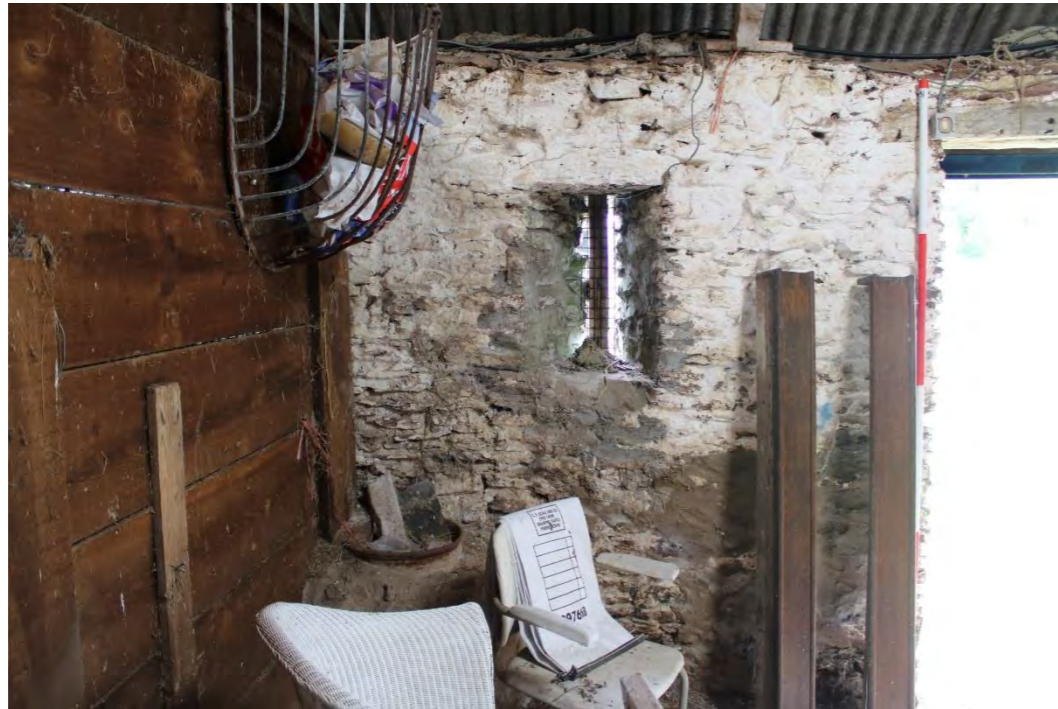
Photo 13: View of interior of southern wall of Building B showing doorway to right and central surviving splayed window with trough below and feeder above

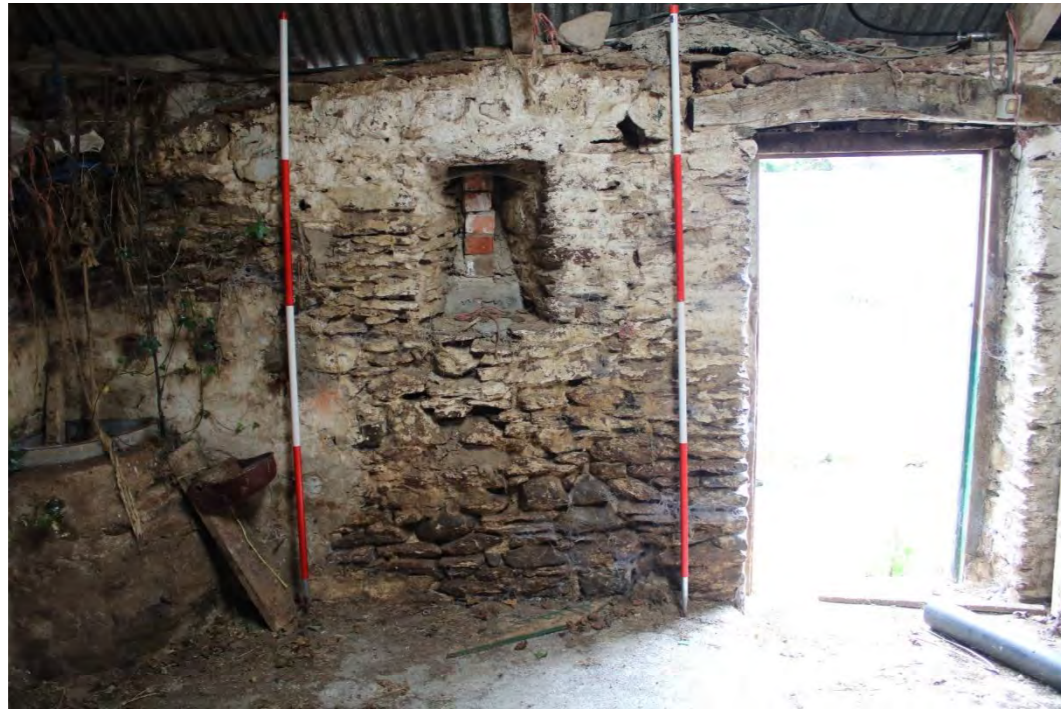
Photo 21: View of doorway and blocked splayed window in eastern half of southern interior wall of Building B

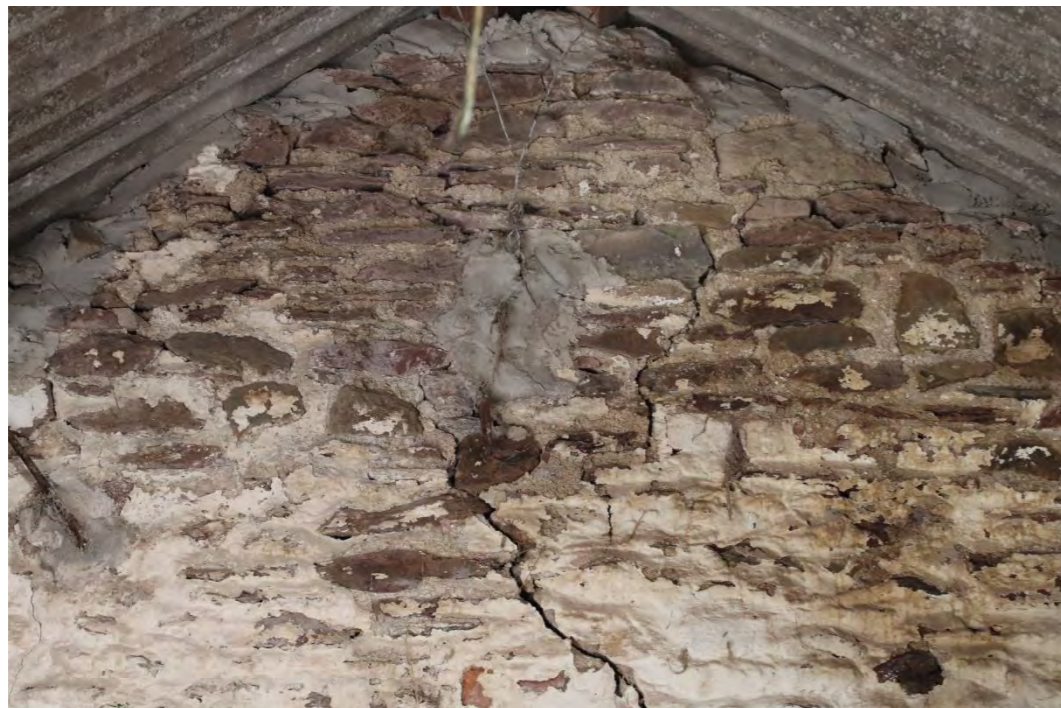
Photo 22: Detail of blocked light in upper part of interior western gable end wall of Building B

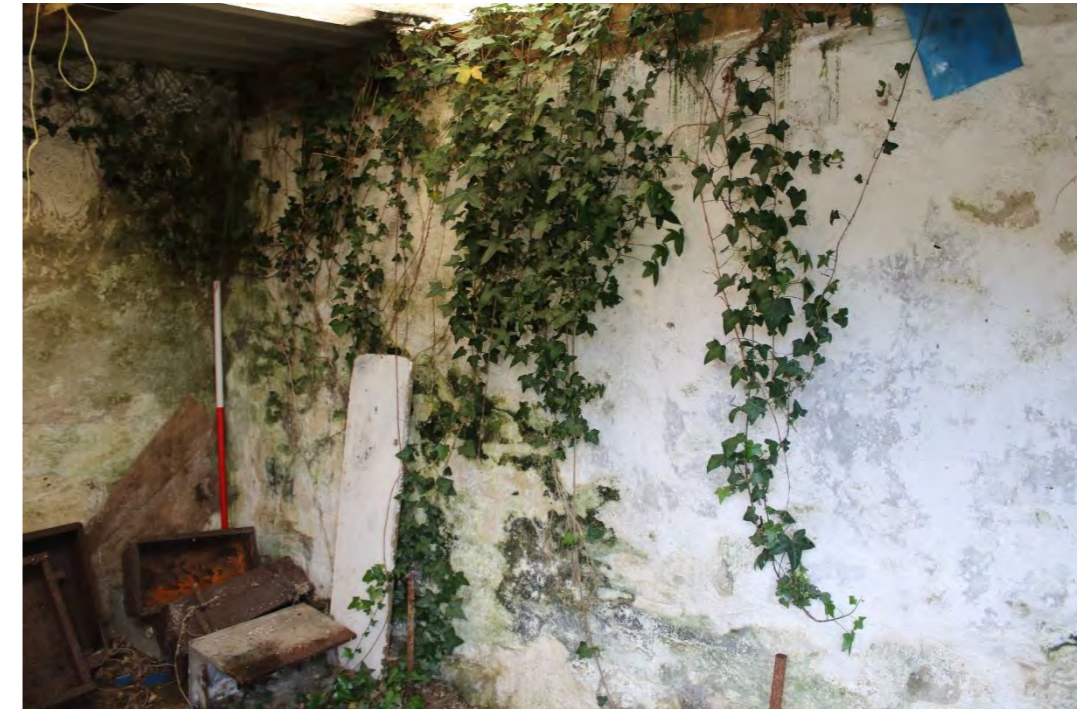
Photo 29: View northeast of eastern interior wall of Building C, which is probably a former revetment wall holding up the bank material to the east

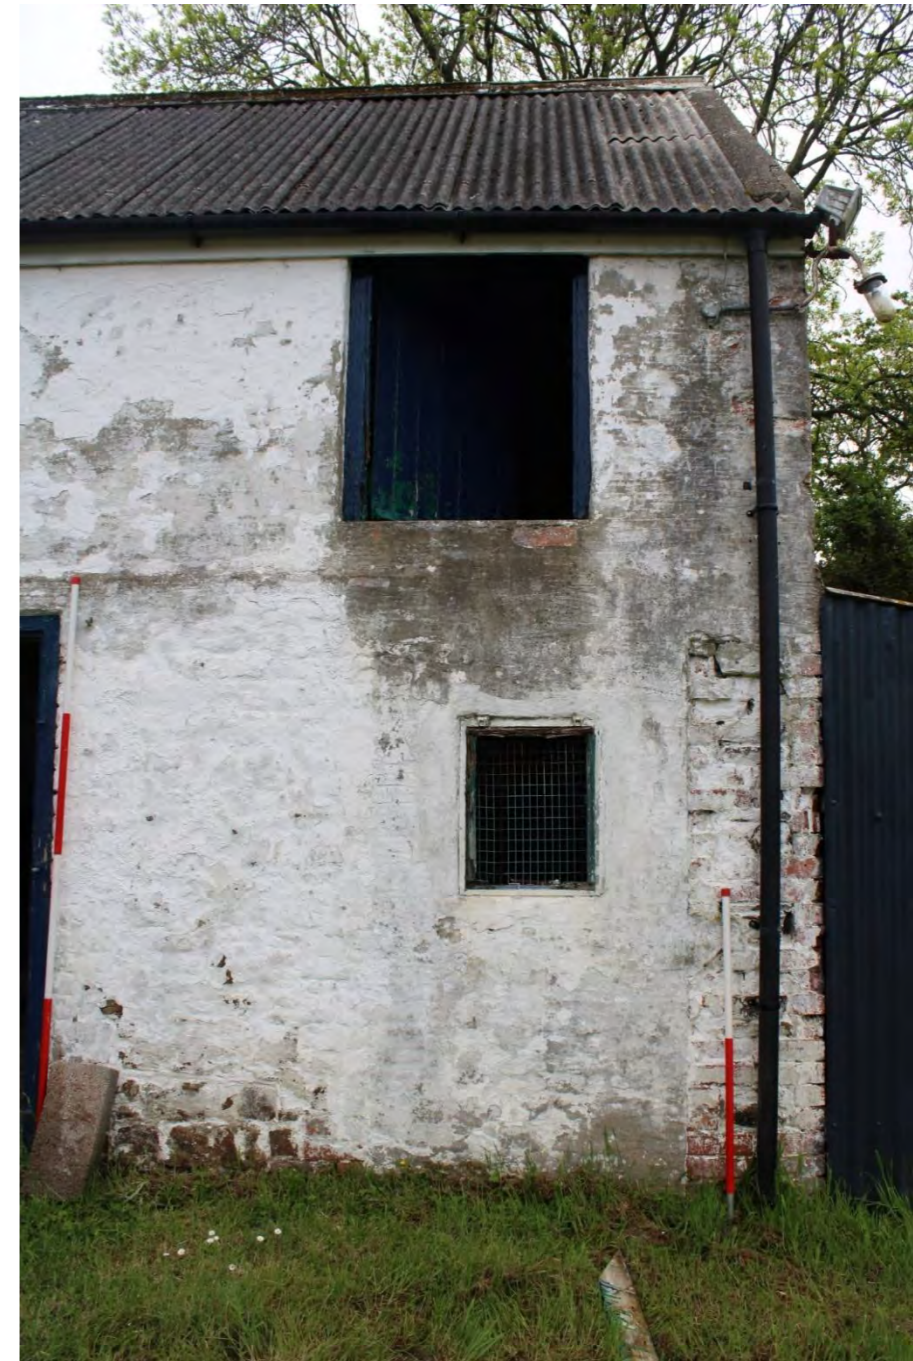
Photo 40: Detail of southern end of western façade of Building D showing the doorway to the first floor, brick repairs on southwestern corner, brick blocked doorway with later window at ground floor

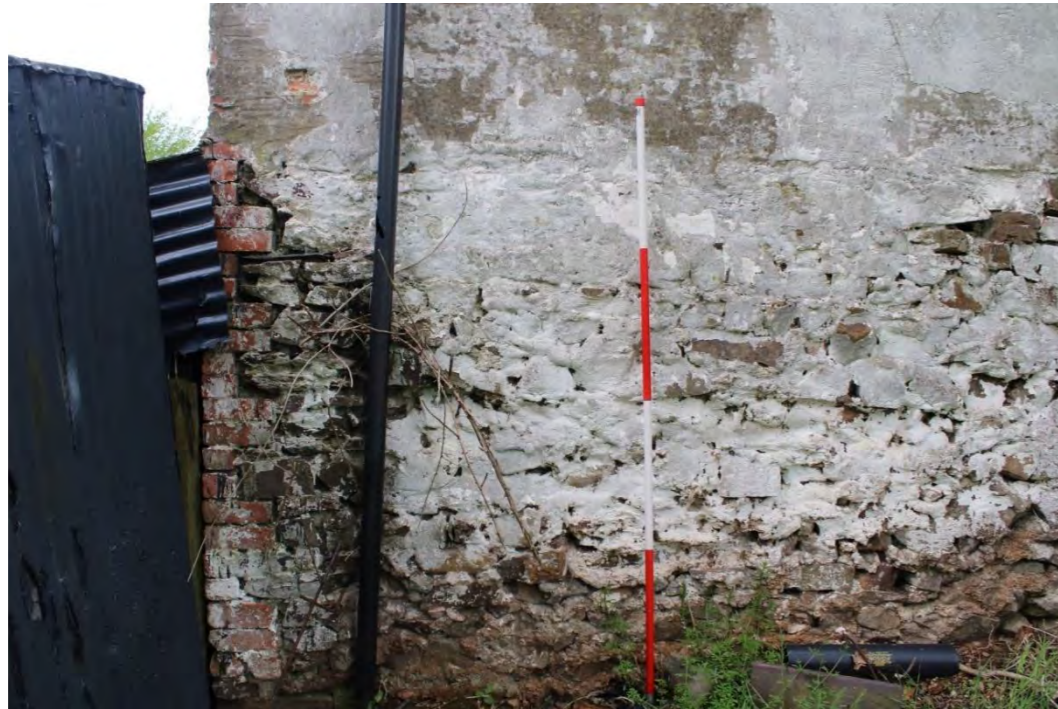
Photo 41: Detail of brick repairs on southeastern corner of Building D

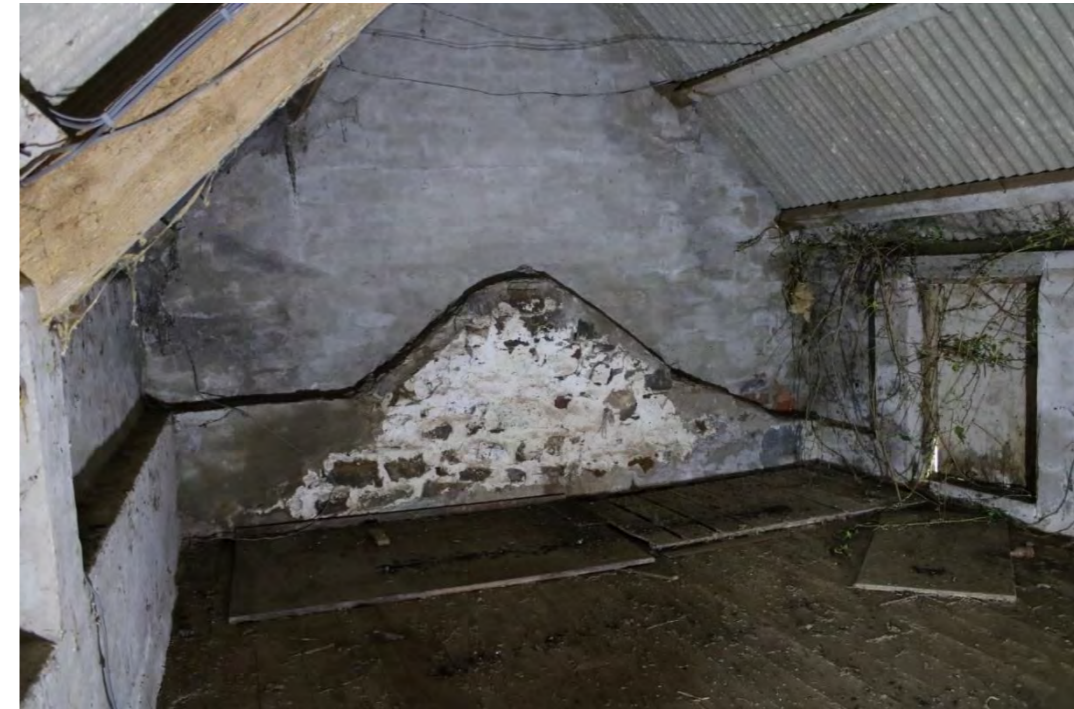
Photo 43: View of interior of southern gable end of Building D at first floor level showing original stone built gable and modern brick rebuild above, with blocked door to right

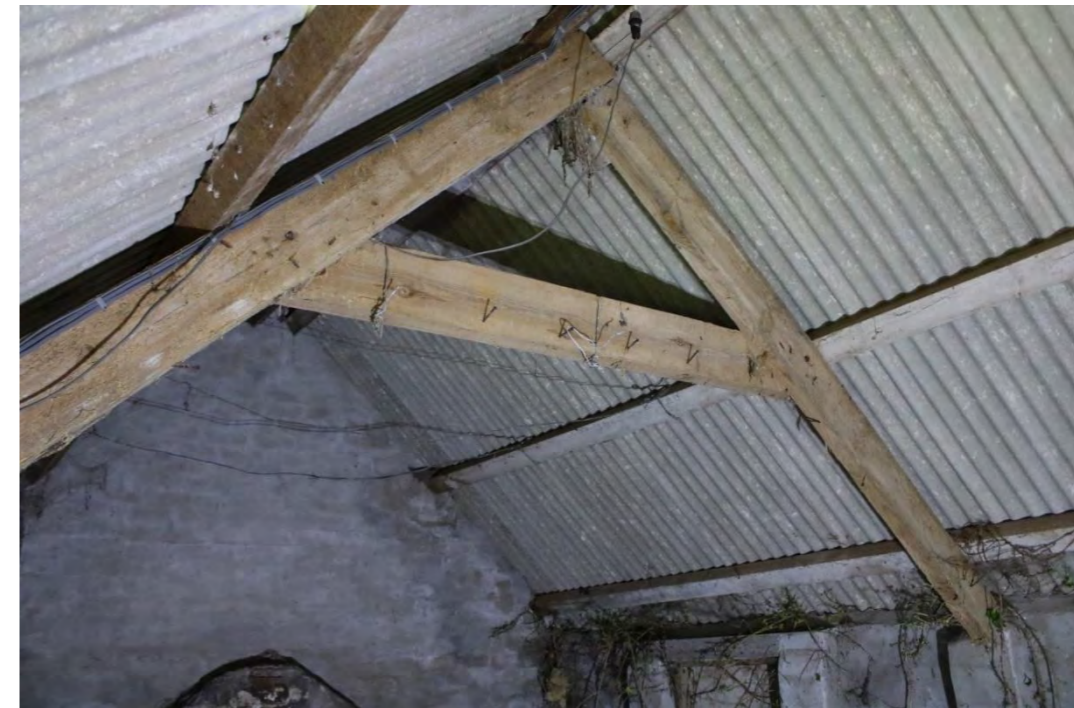
Photo 44: View south of roof structure of Building D comprising of simple A frame supported on later brick heightened walls

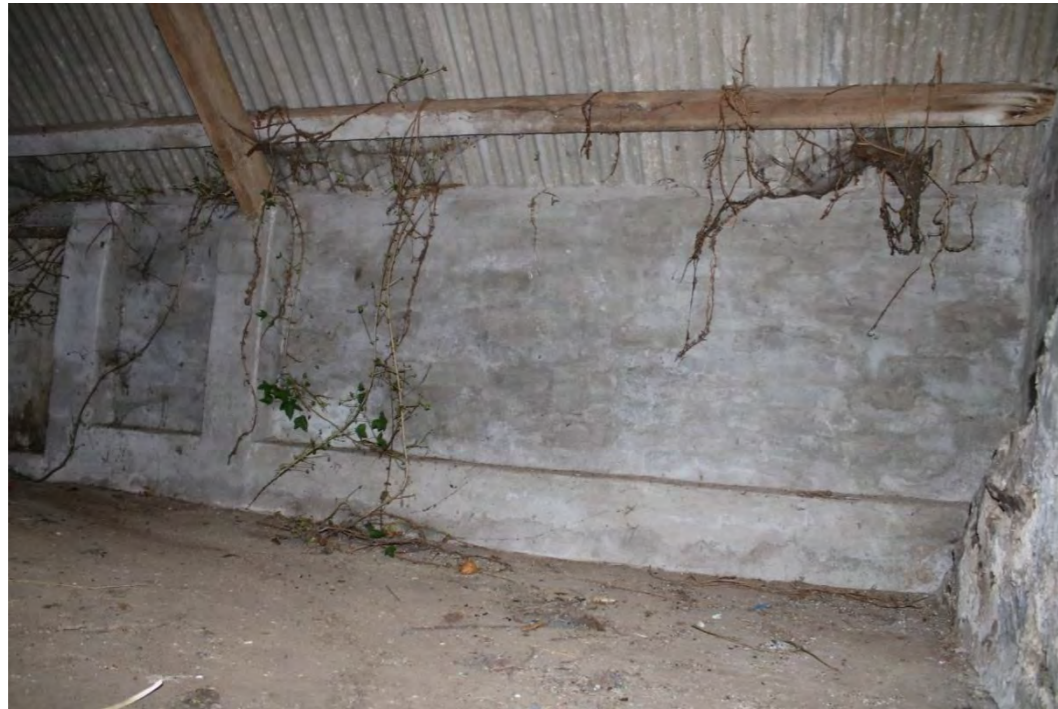
Photo 45: Northern end of western interior wall of Building D showing modern brick wall heightening

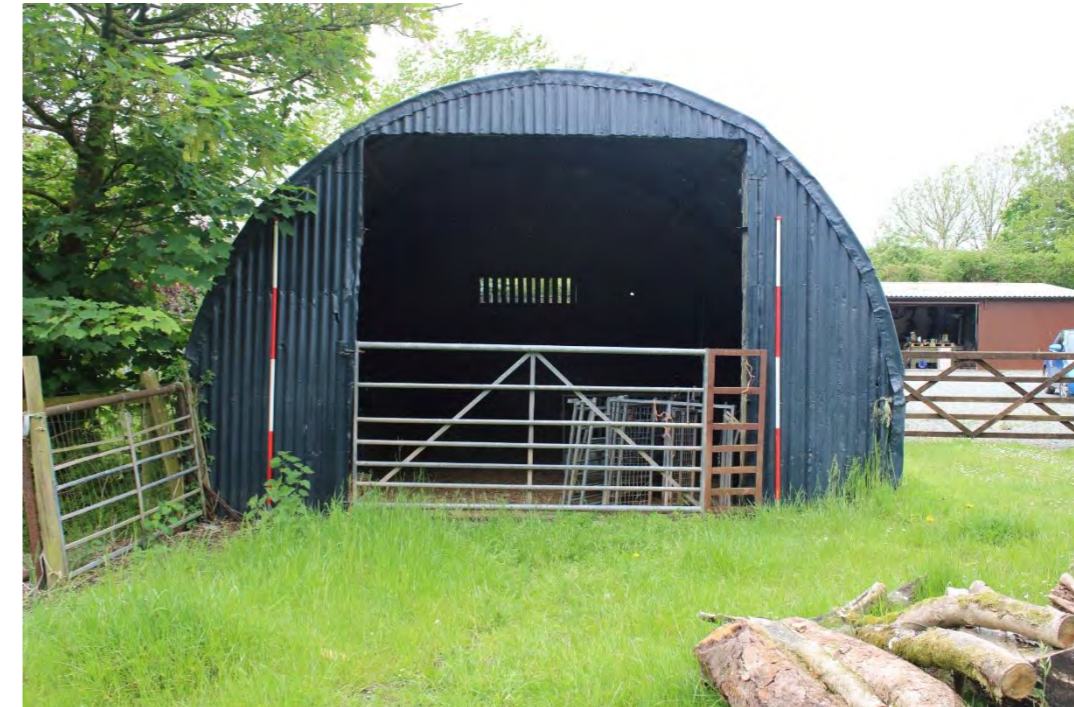
Photo 62: Eastern elevation of Building F, showing entrance and classic Nissen Hut shape

- 5.10 Building F is a relocated Nissen Hut from World War II, possibly originating from RAF Talbenny Airfield to the west and reused for animal housing. It is of the correct width and length for such a structure. The building has been maintained quite well and is in a good state of repair. Some stencilled information was visible on a number of the internal panels but it is not known if this related to the original panelling or later repairs. No information regarding this could be found online.
- 5.11 It is likely that Buildings E, F and the shed are contemporary additions to the farm, possibly all acquired as redundant World War II military equipment.

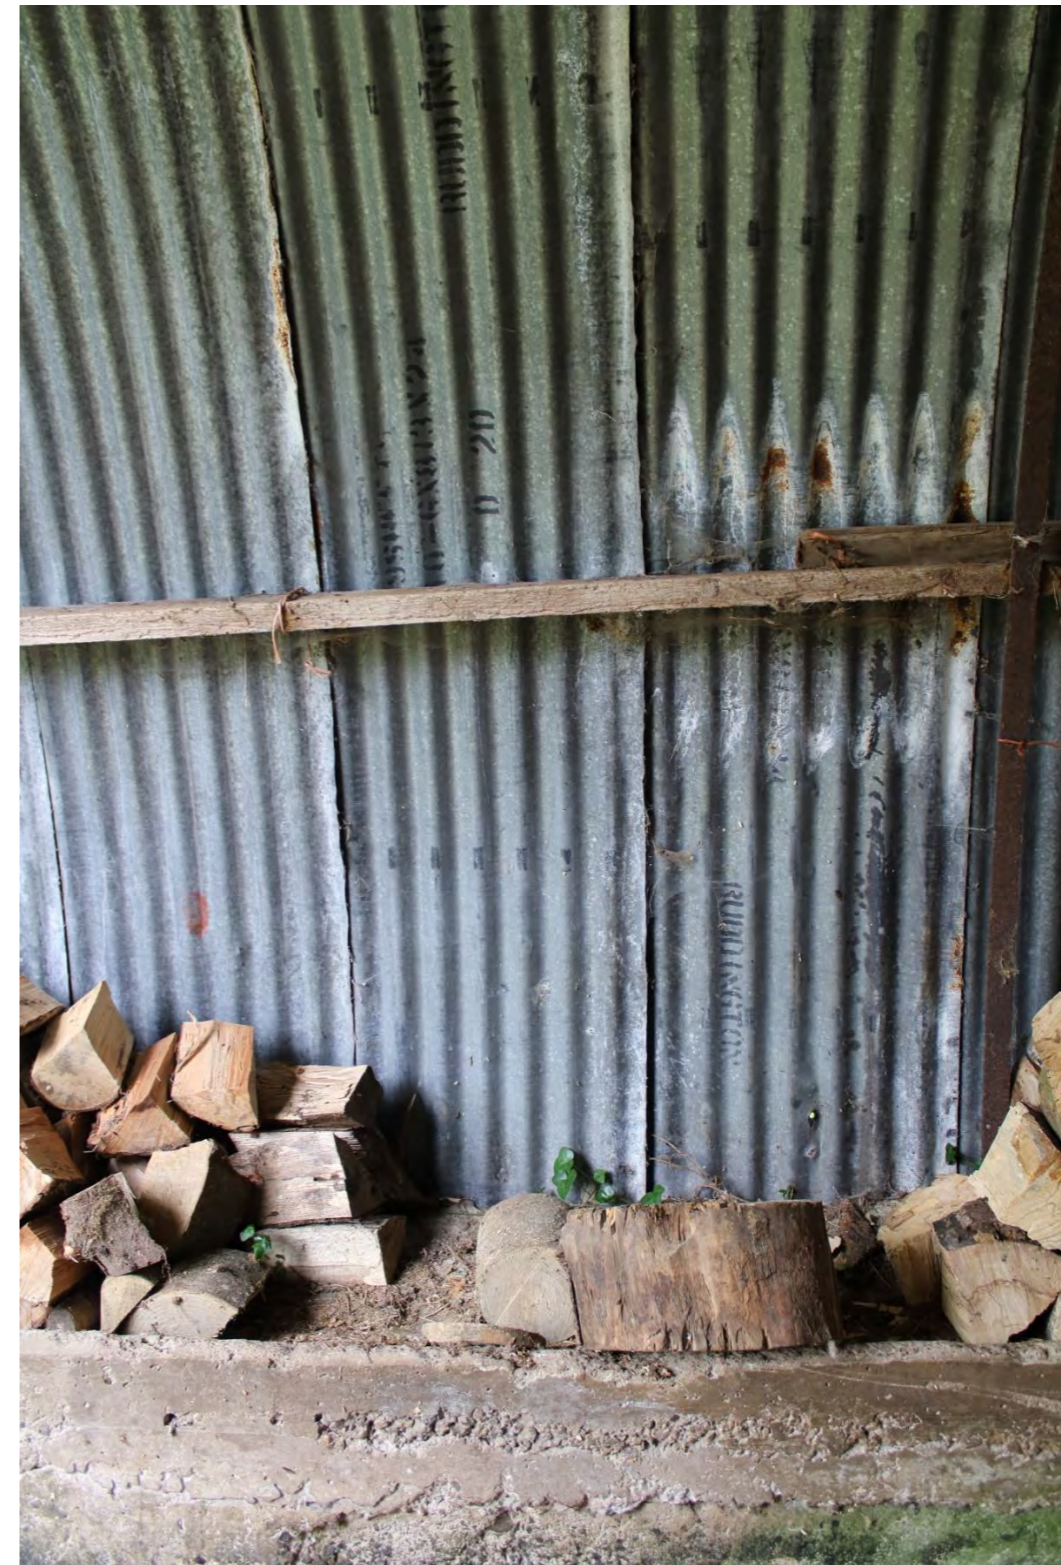
Photo 74: Detail of galvanised corrugated iron panels of Building F with stencilled writing located on southern side at eastern end

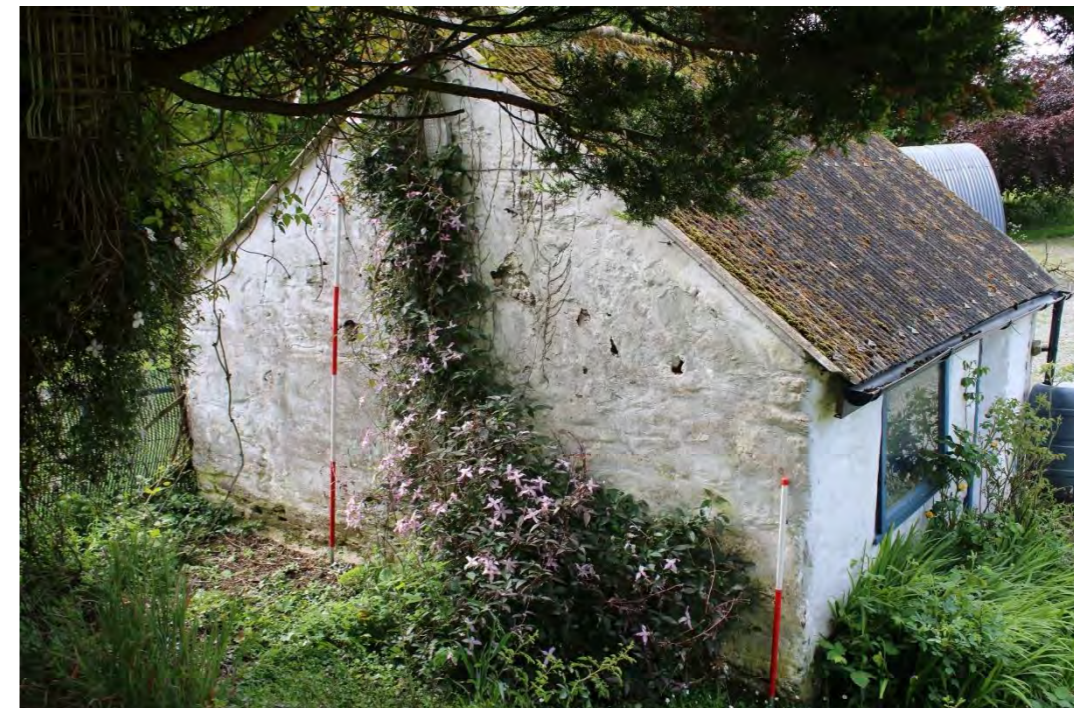
Photo 76: Northern gable end of Building G, with blocked window behind scale bar

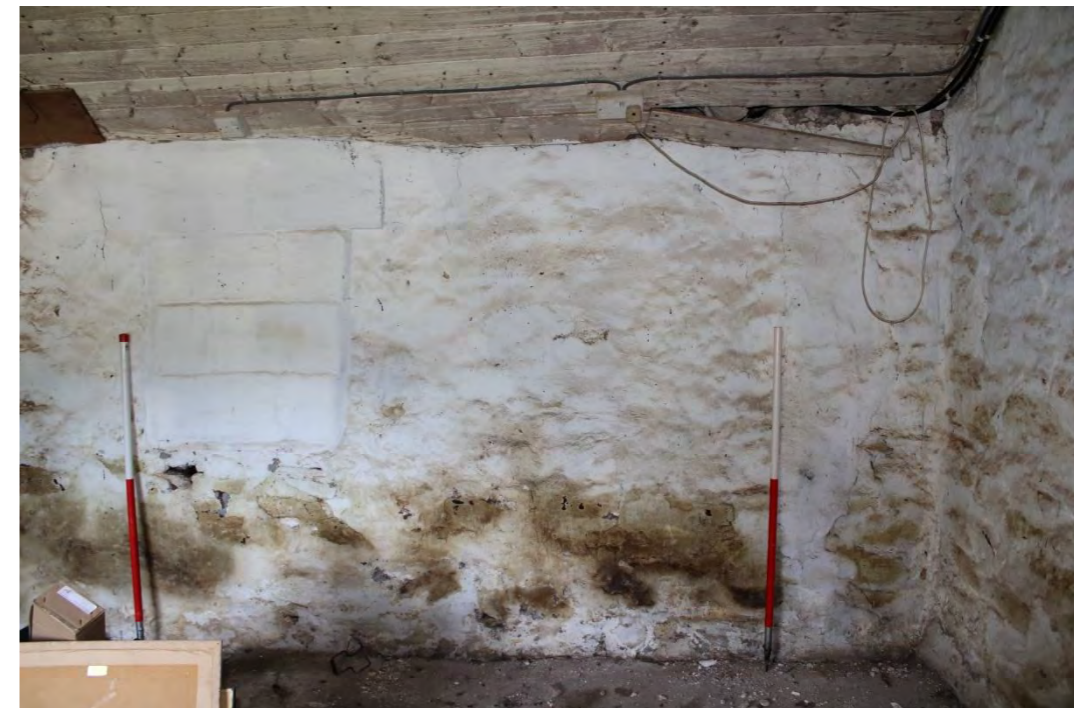
Photo 80: View of eastern interior wall of Building G with blocked window to left
