## **The Old Library, Corporation Street, Aberystwyth.**

### **Pre Start Photographic record of the building.**

Planning Consent Ref A211032

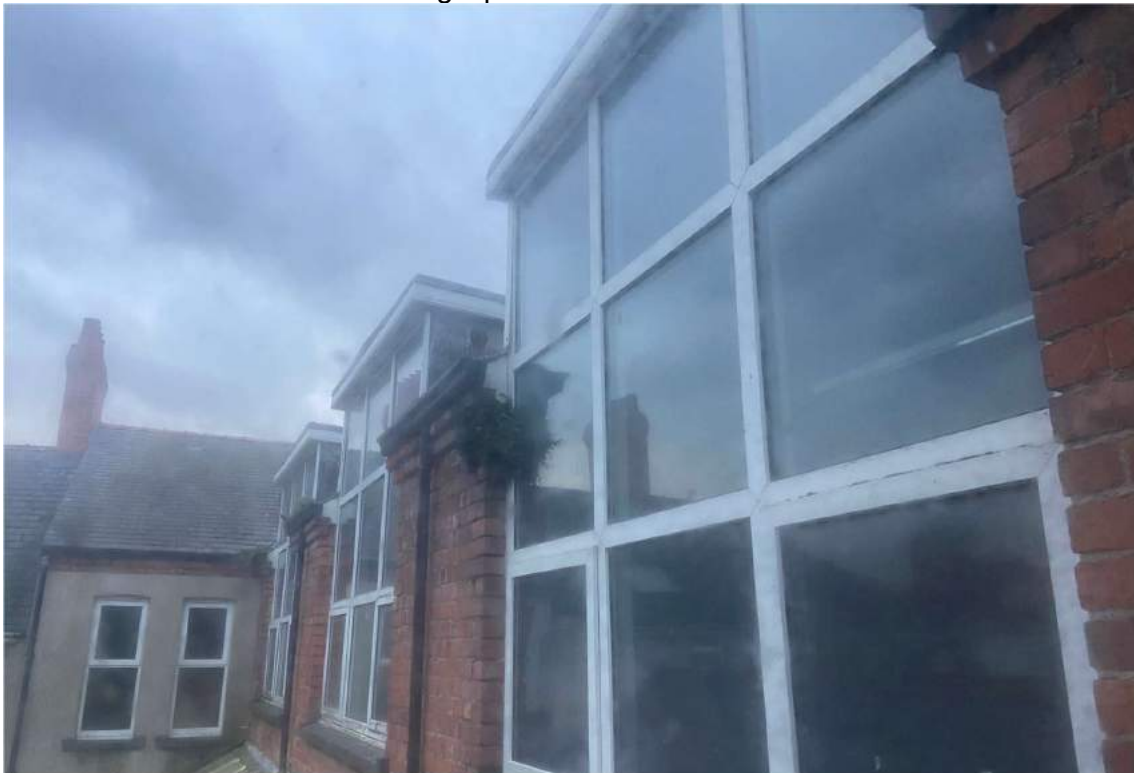
Photo 7 North Elevation Existing Upvc Windows

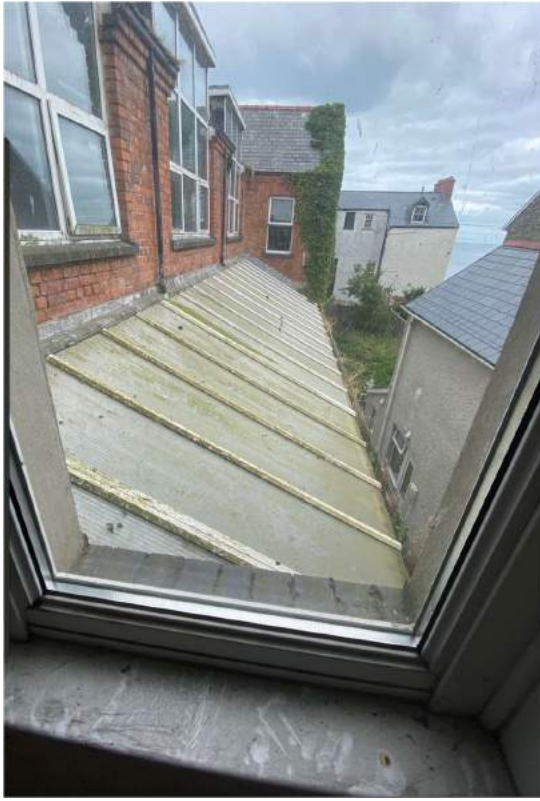
Photo 8 North Elevation Showing Polycarbonate Roofing.

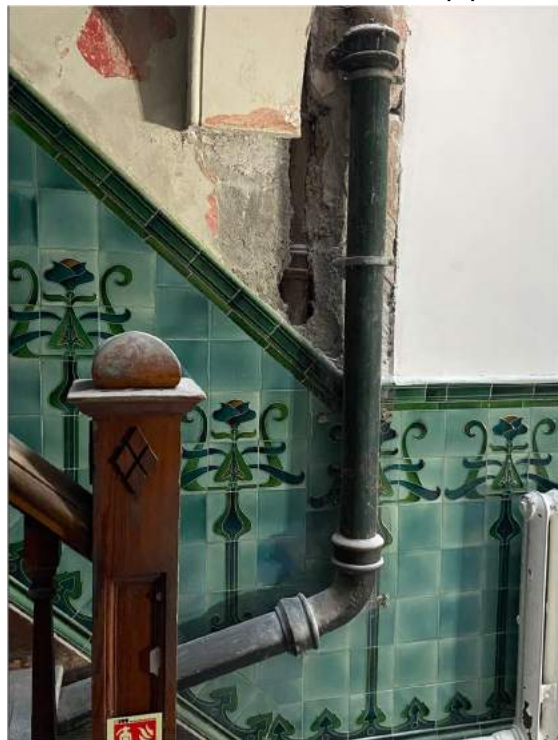
Photo 16 Rear Stair rain water pipe.

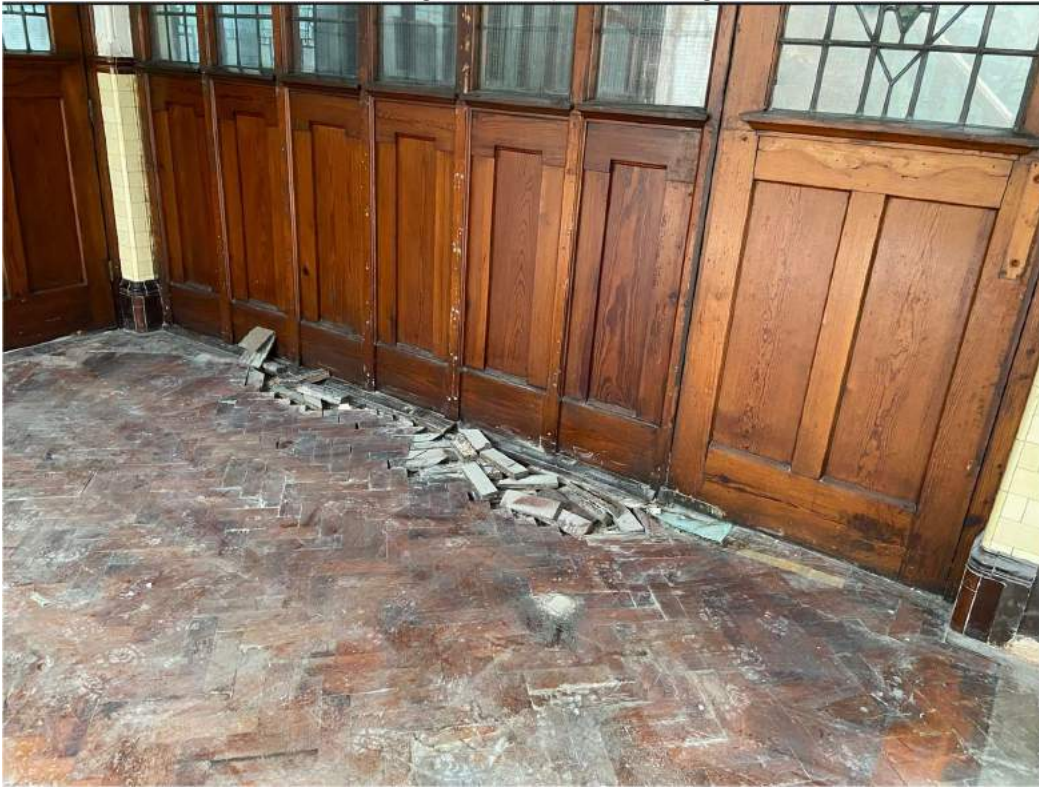
Photo 19 Ground Floor Damage to Parquet Flooring

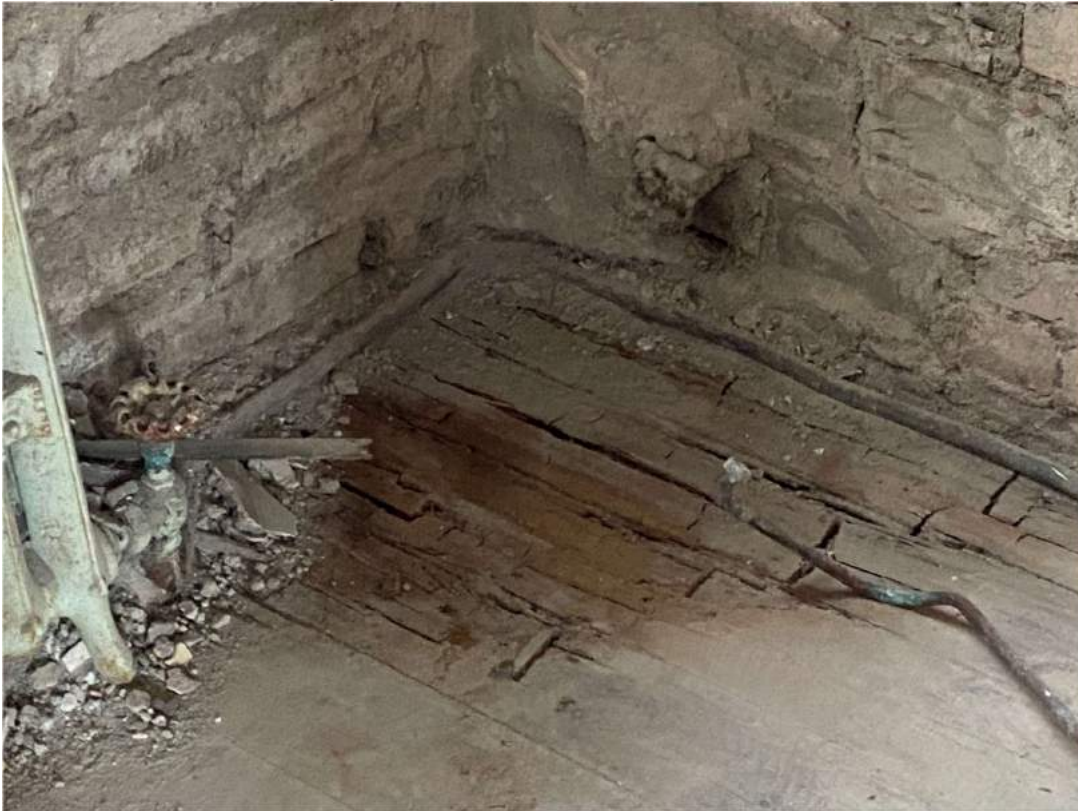
Photo 31 First Floor Dry Rot in Floor Boards
