**Old College and 1 & 2
Marine Villas,
Aberystwyth**

**Historic Building
Recording (Level 2)**

Prepared by:
**The Environmental Dimension
Partnership Ltd**

Report Reference
edp7672_r002a

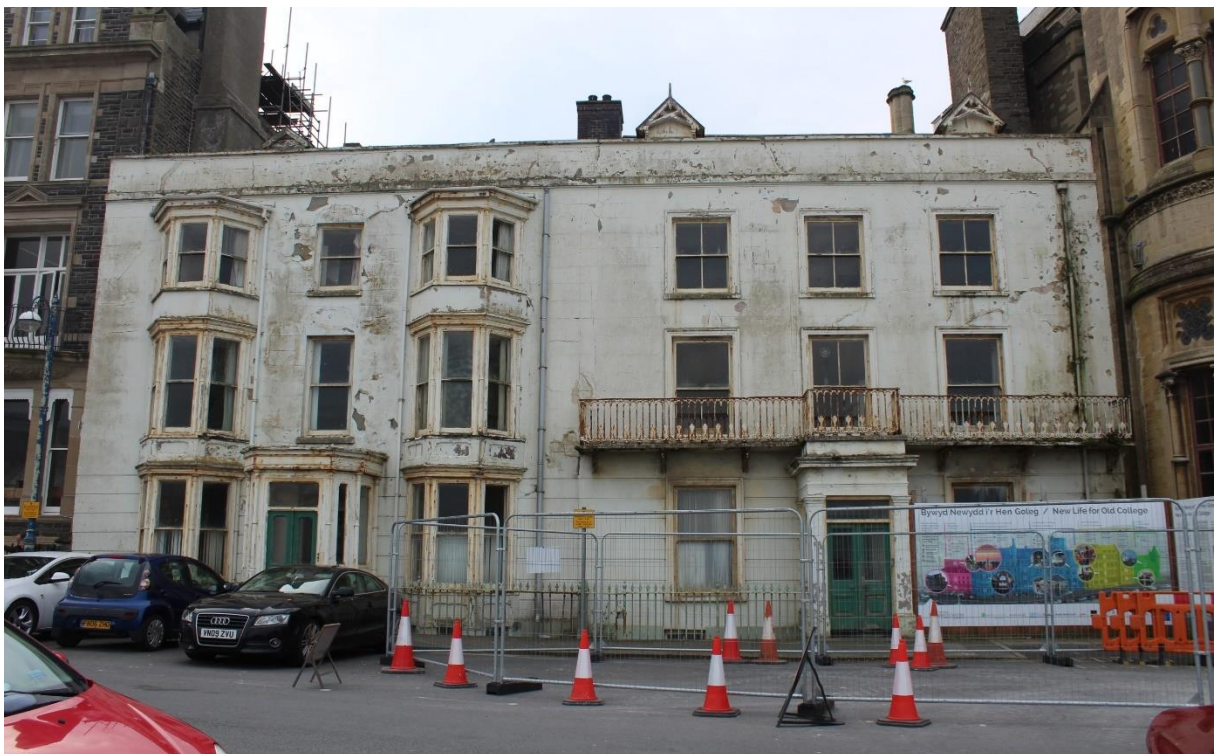
- 3.49 Marine Villas present as two Regency double fronted seaside villas on New Promenade, set back behind a narrow area with iron railings in a state of decay (**Image EDP 9**). Number 2 features projecting timber porch and full height canted timber bay windows. Number 1 is devoid of bay windows but has a projecting stone porch with classical detailing and a cantilevered slate balcony with iron railings at first floor. Both properties are rendered in imitation of rusticated stone at ground floor beneath a flat horizontal architrave, with imitation ashlar above.

Image EDP 9: Nos 1 & 2 Marine Villas present as two Regency double fronted seaside villas on New Promenade. Number 1 is devoid of bay windows while Number 2 features projecting timber porch and full height canted timber bay windows.

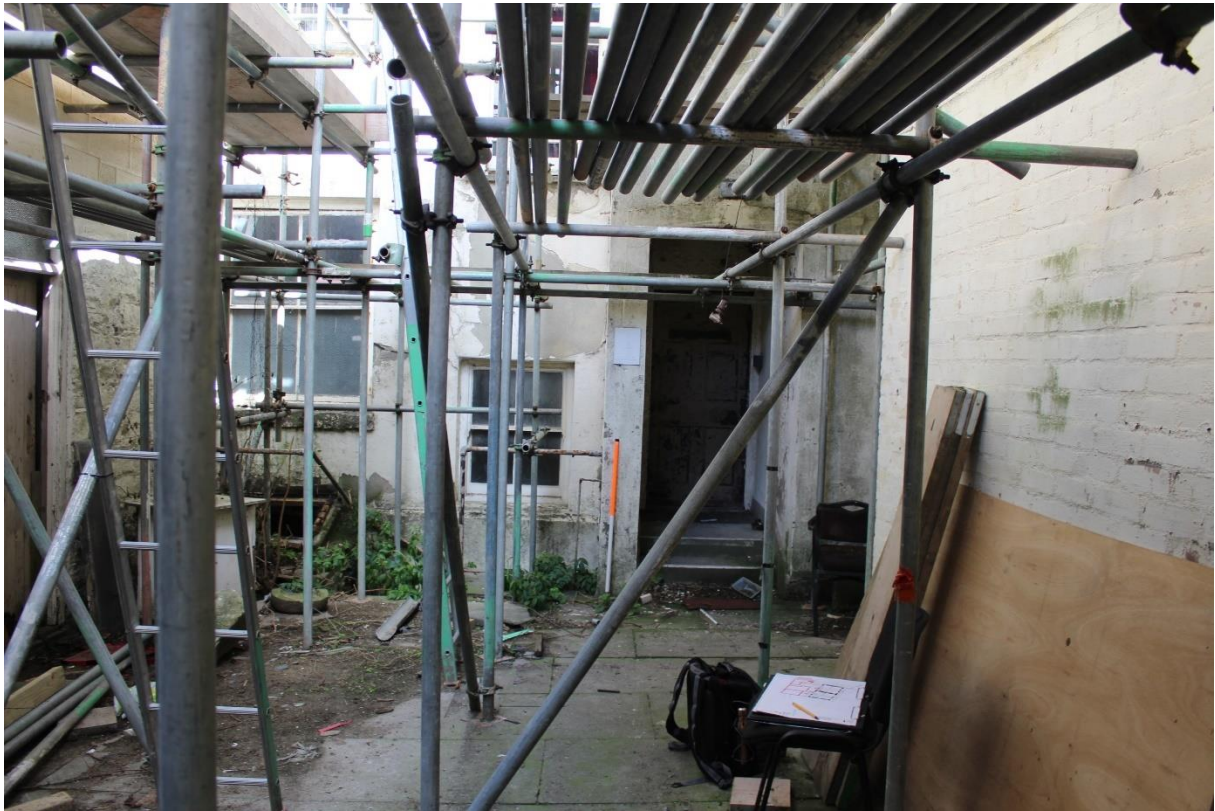
- 3.51 The rear elevation of both properties is utilitarian in nature (**Image EDP 10**). Simply rendered with central outriggers. Number 2 has a glazed sunroom at first floor level with original timber casements with stained glass; this has been modified to accommodate a bridge link to the rear mews properties. Number 1 retains some original sash windows in their original configuration, Number 2 has been modified due to the construction of the sunroom. The properties onto King Street are rendered but have been heavily altered with modern picture windows to the building behind Number 1.

Image EDP 10: The rear of No. 1 Marine Villas is mostly utilitarian in nature (and currently largely obscured by scaffolding). Number 1 retains some original sash windows in their original configuration

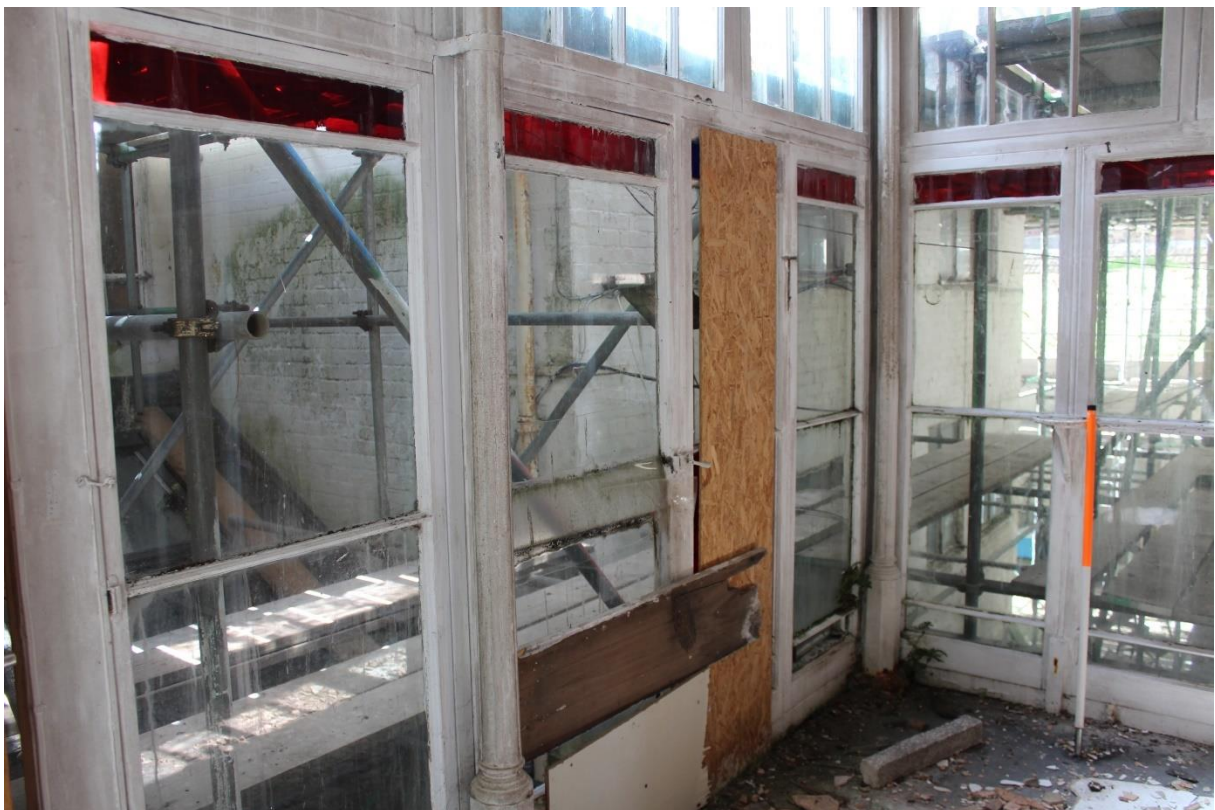
- 3.72 Number 2 Marine Villas features a glazed conservatory at first floor at a small landing off the staircase halfway between the ground and first floor (**Image EDP 19**). This has been modified to provide a bridge link to The Cottage at the rear of the site, however, original timber-framed casements with stained glass are present, with modified panels used within the link.

Image EDP 19: Marine Villa No. 2 features a glazed conservatory at first floor at half landing level which has been modified to link it to the Cottage.
