PE273 PORTH-Y-RHAW CAMP
FOOTPATH DIVERSION WORK
COMPLETION REPORT

Prepared on behalf of the Pembrokeshire Coast National Authority by Tomos Jones, Community Archaeologist.

28 September 2023

The following report provides details of work carried out at PE273 Porth-y-Rhaw Camp scheduled monument in April and May 2023. Specifically, work to remove the footsteps and cut through a post-medieval bank within the scheduled area as part of work to re-divert the coast path away from the scheduled monument area.

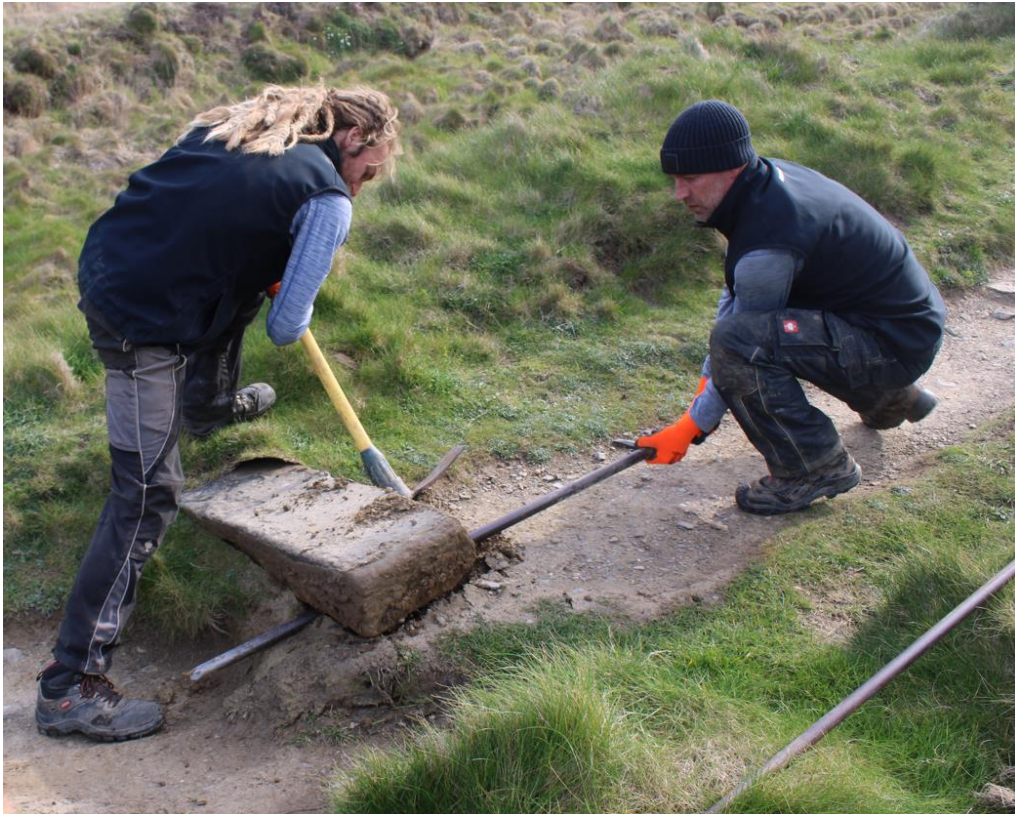
Figure 9. Photo showing approach to remove steps, including pickaxe and then crowbar to help lift steps from the ground.

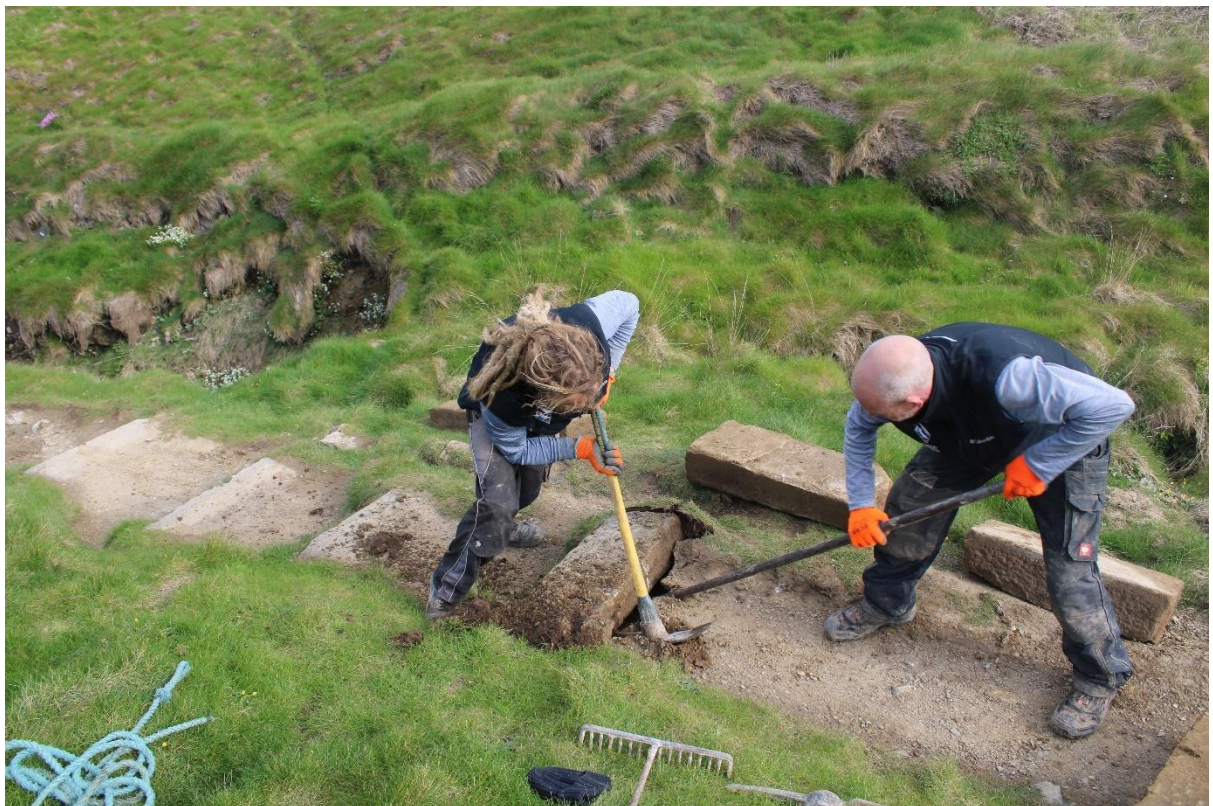
Figure 10. Photo showing removal of steps using hand tools.

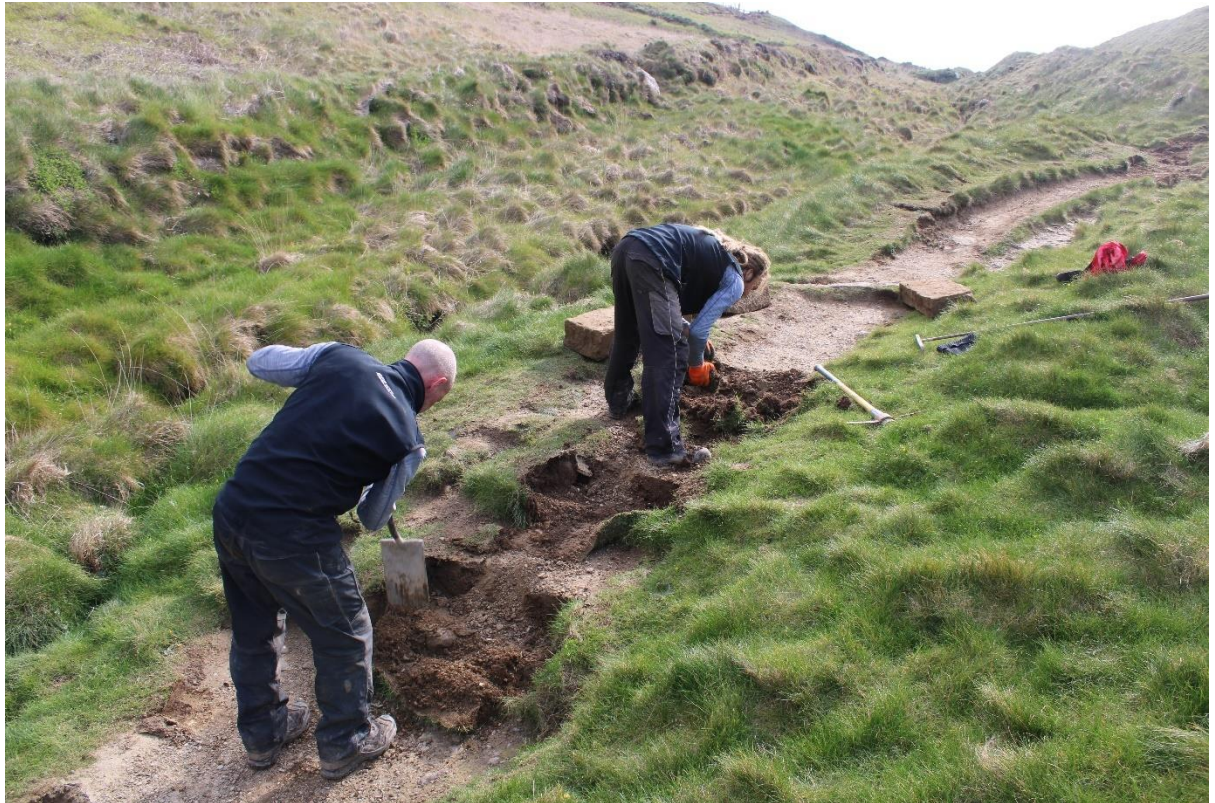
Figure 11. Photo showing use of hand tools to re-profile the surface after removing the steps.

- Following an archaeological check, the wardens reprofiled the area where the steps used to be with hand tools to smooth the surface. This approach meant that the soils were mixed which would help with re-growth of turf. The wardens also walked over the area to help compact the surface.

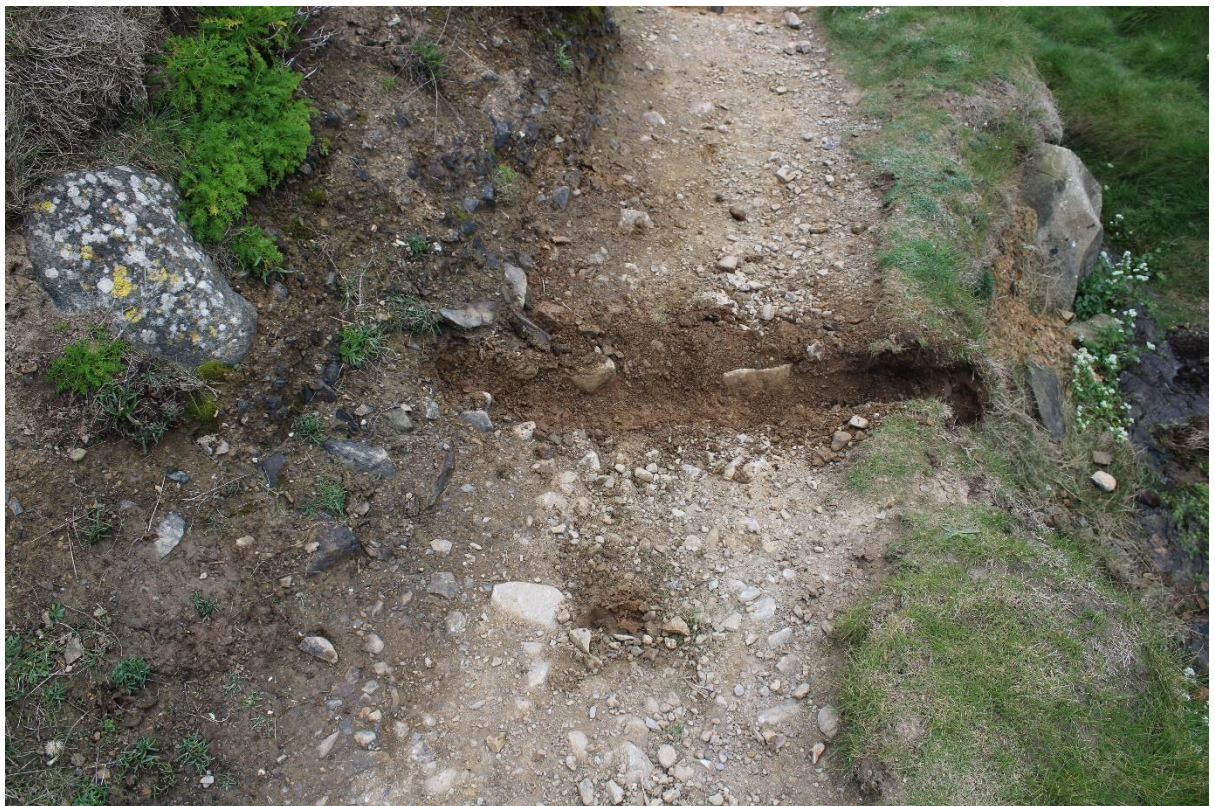
Figure 12. Photo showing shallow drainage ditch created directly above the bottom group of steps that were removed.

- To assist with water management and erosion following the removal of the steps, the wardens cut a shallow drainage ditch above the group of steps directly next to the footbridge. This would help encourage water to runoff directly into the stream rather than running down the surface of the monument.

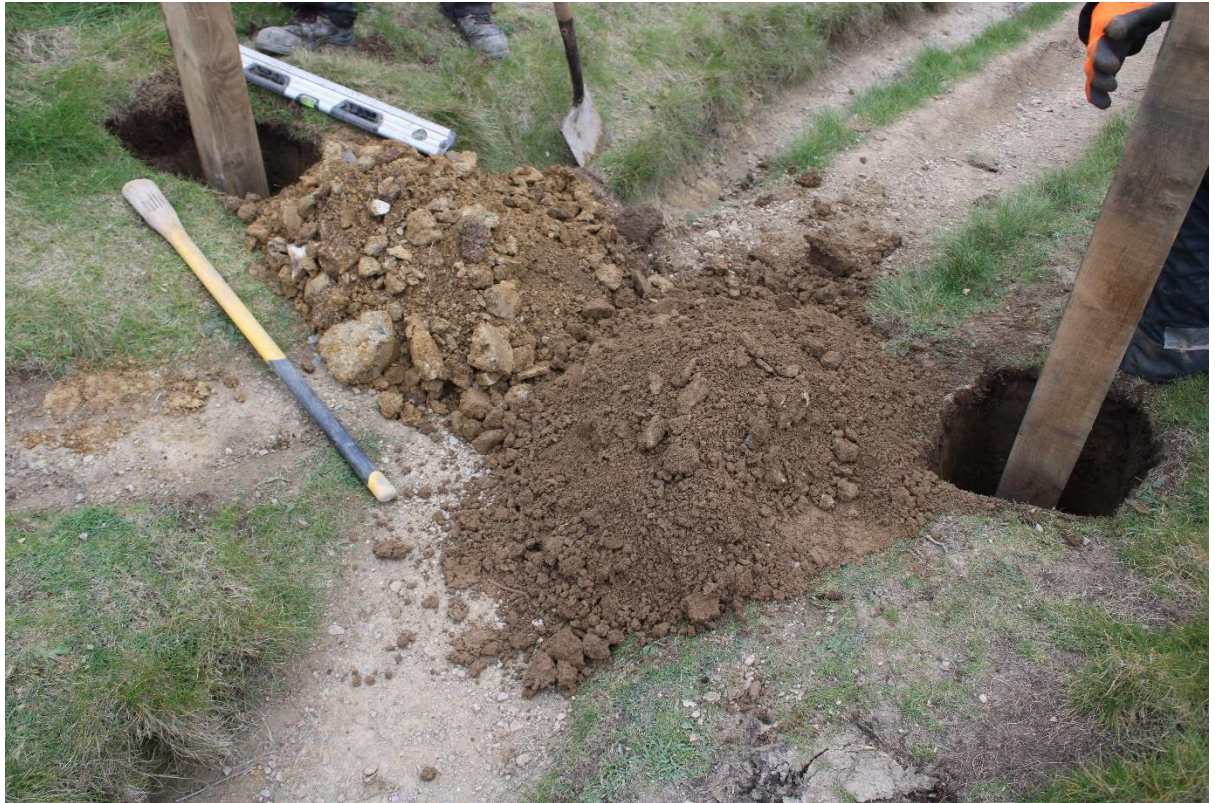
- Once the work on the steps had been completed, the wardens diverted their attention to the installation of the physical barrier. An attempt was made to drive the wooden posts directly into the ground, but this was not possible due to the hardness of the surface. As a result, pits were dug to accommodate the posts. The community archaeologist checked for any anomalies as the pits were created, but no archaeological feature or material was identified. However, there did appear to be a difference in colour and composition between the material removed from the two pits. Due to the small size of the pits, it was not possible to determine if there was any significance to this variation.

Figure 13. Photo showing pits created to house the wooden posts of physical barrier. Note the colour and composition difference between the material from the two different pits.

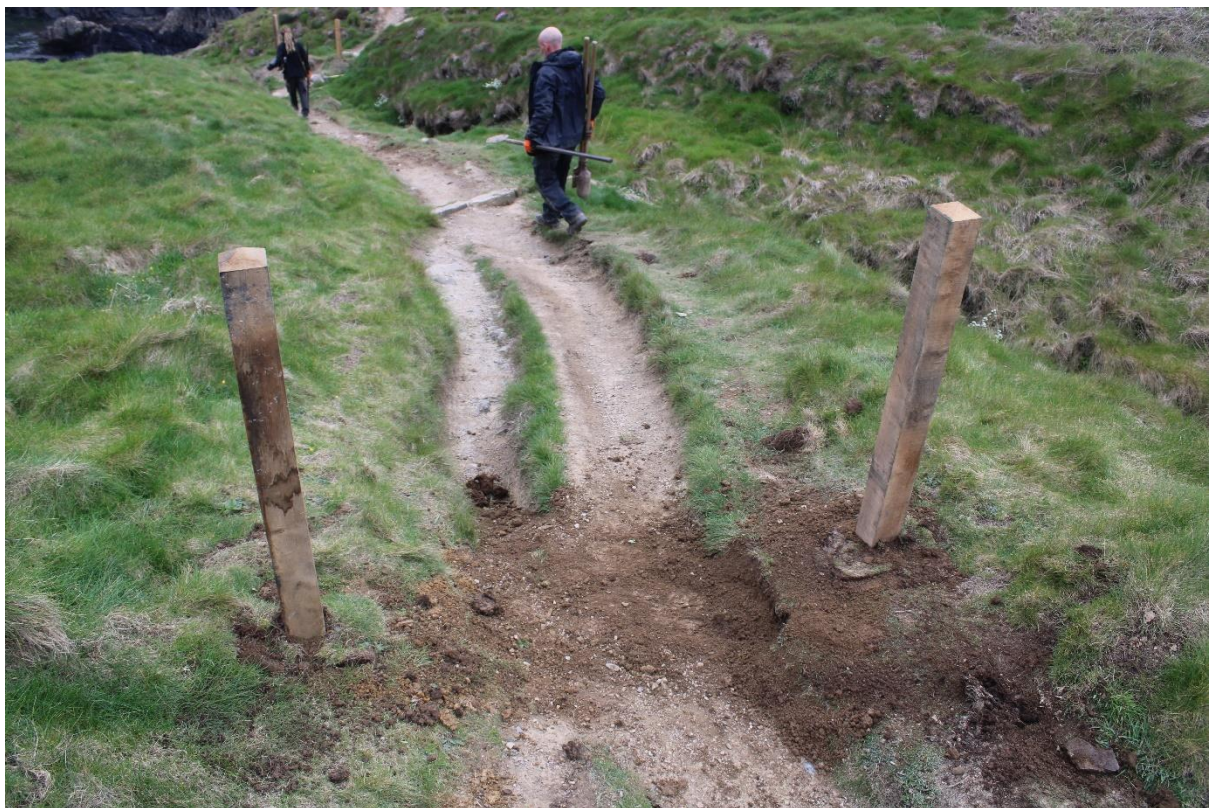
Figure 14. Photo showing posts in place packed with the material dug out to create the pits.

- Once the pits were created, the wooden posts were installed and packed with the material that had been dug out to create the pits. The timber frame connecting the posts was then added to complete the physical barrier.

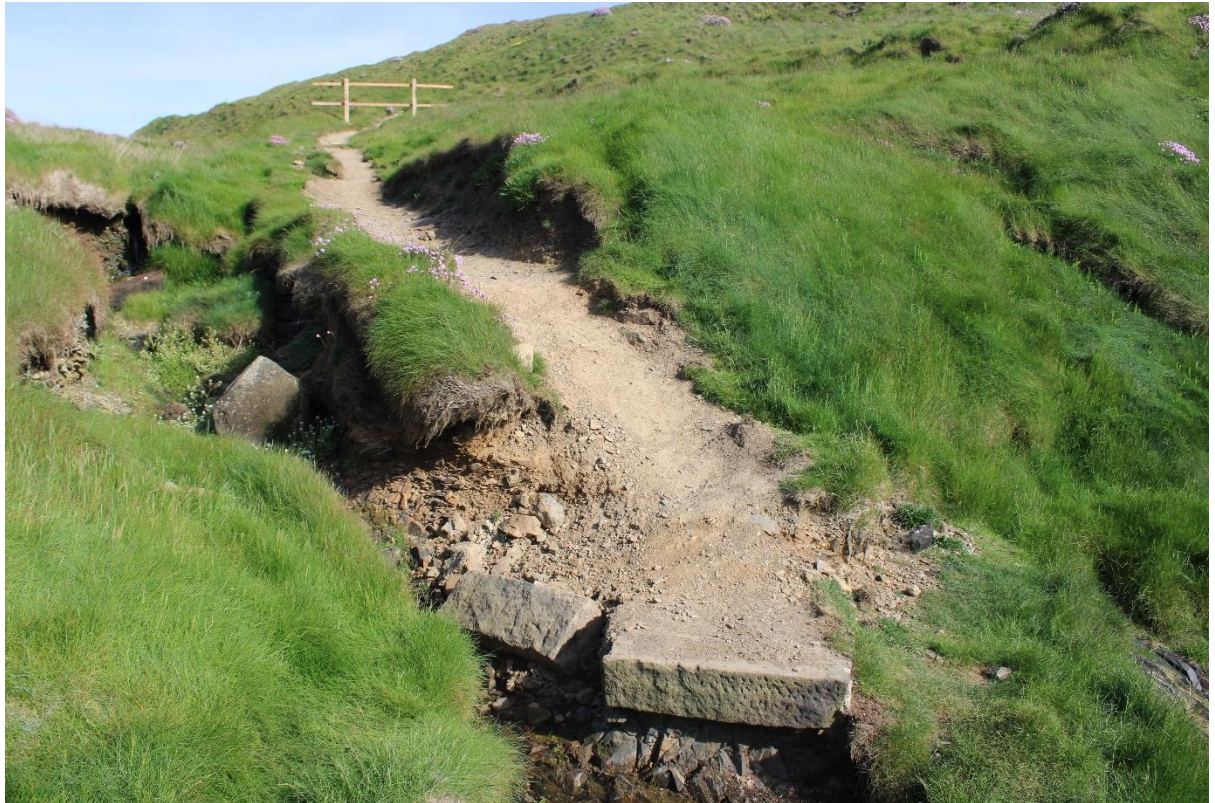
Figure 17. Photo showing condition of surface where bottom group of steps used to be, also physical barrier in background.

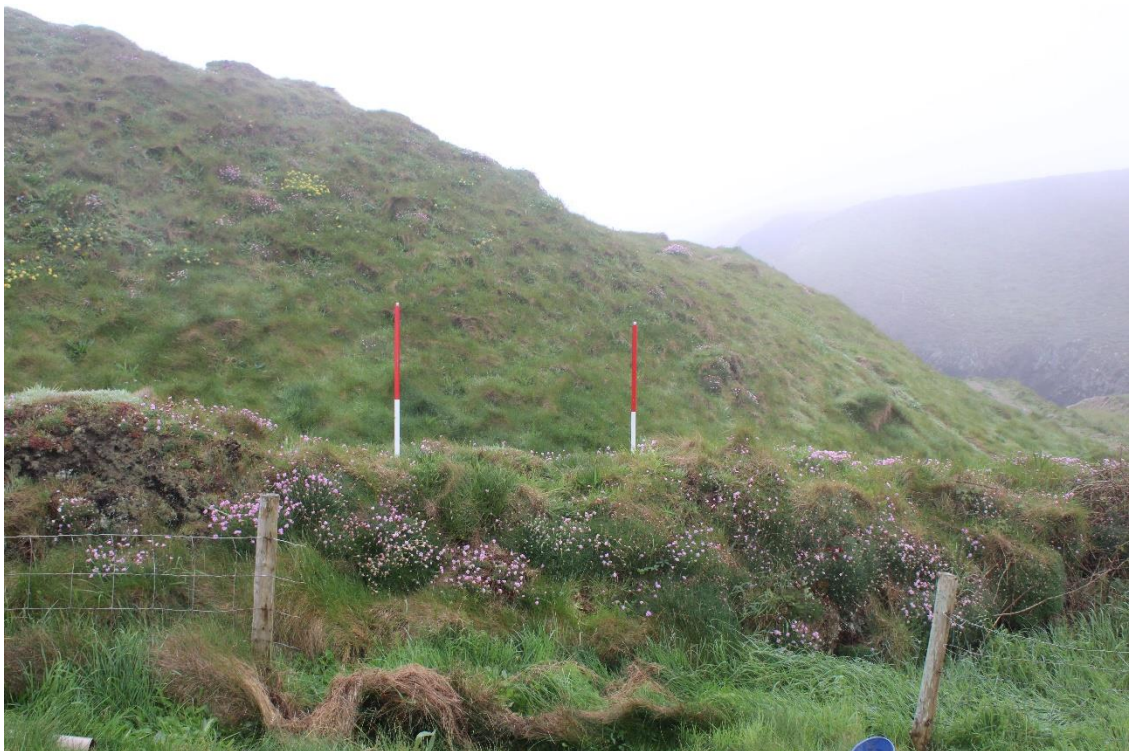
Figure 20. Photo showing cut wire fence and ranging rods marking area to be opened in bank.

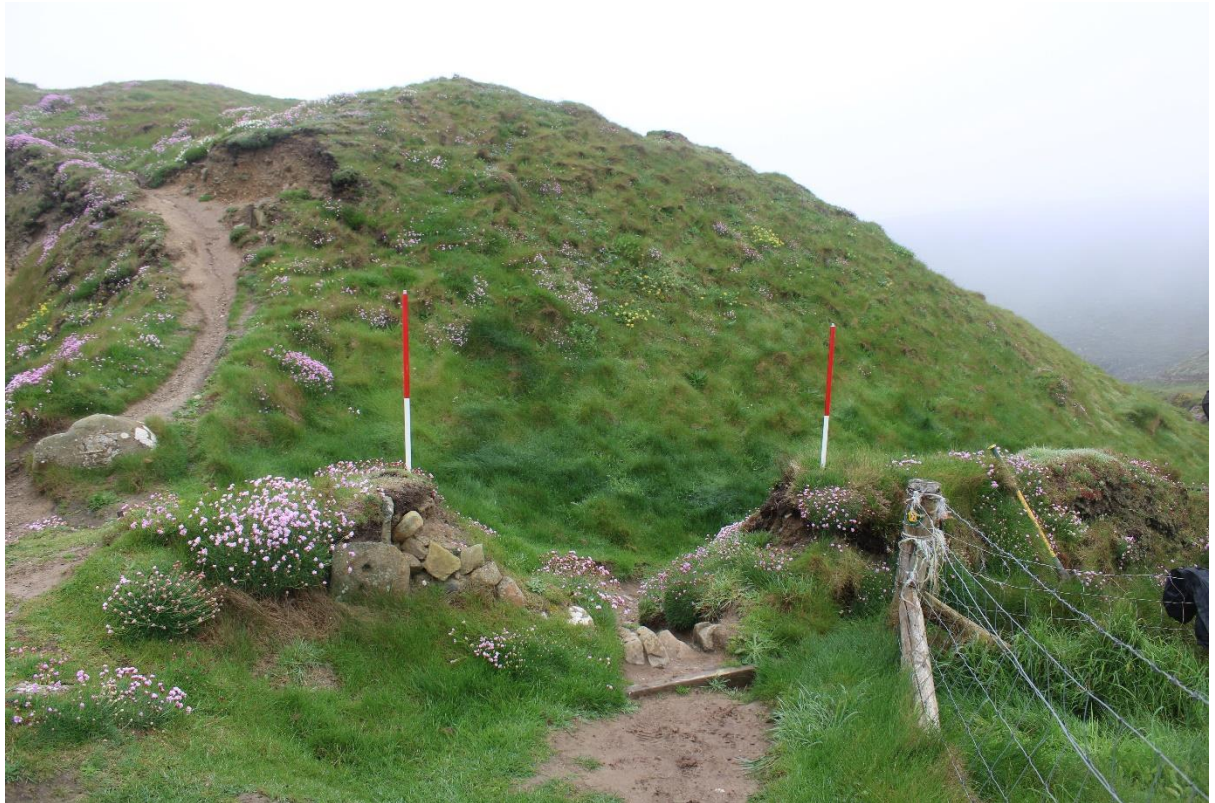
Figure 29. Photo showing access through bank to be infilled to deter use of the old coast path.

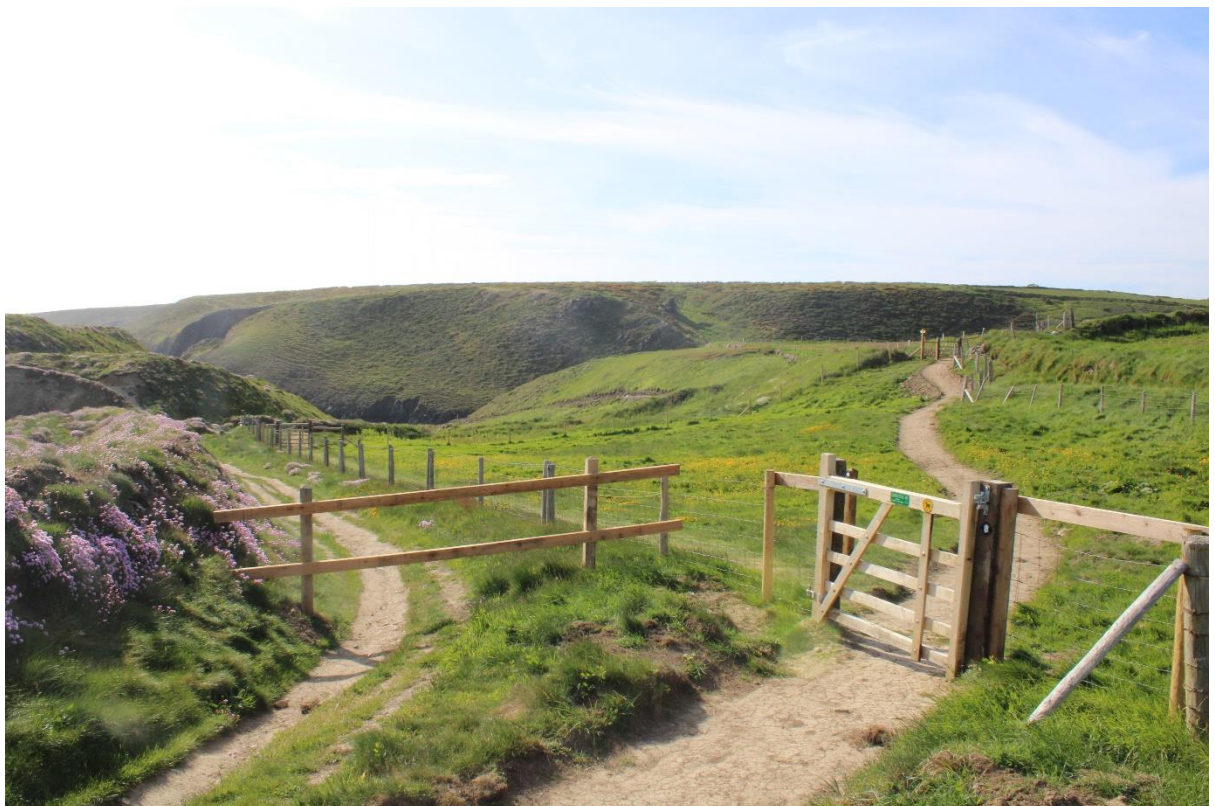
Figure 32. Photo showing physical barrier to access the old path from an east direction, also view of new path heading towards the right in the image.

- The old path leading to the monument from the east was blocked with a physical barrier to deter continued use by visitors. A post and way marker were also installed to indicate direction and access to the scheduled monument.
