Tir Hen, Llanddeusant, Llangadog, SA19 9YU

Photographic Survey

Planning Application No: 19/17322/FUL

Written By Mr A Phillips – 21/10/19

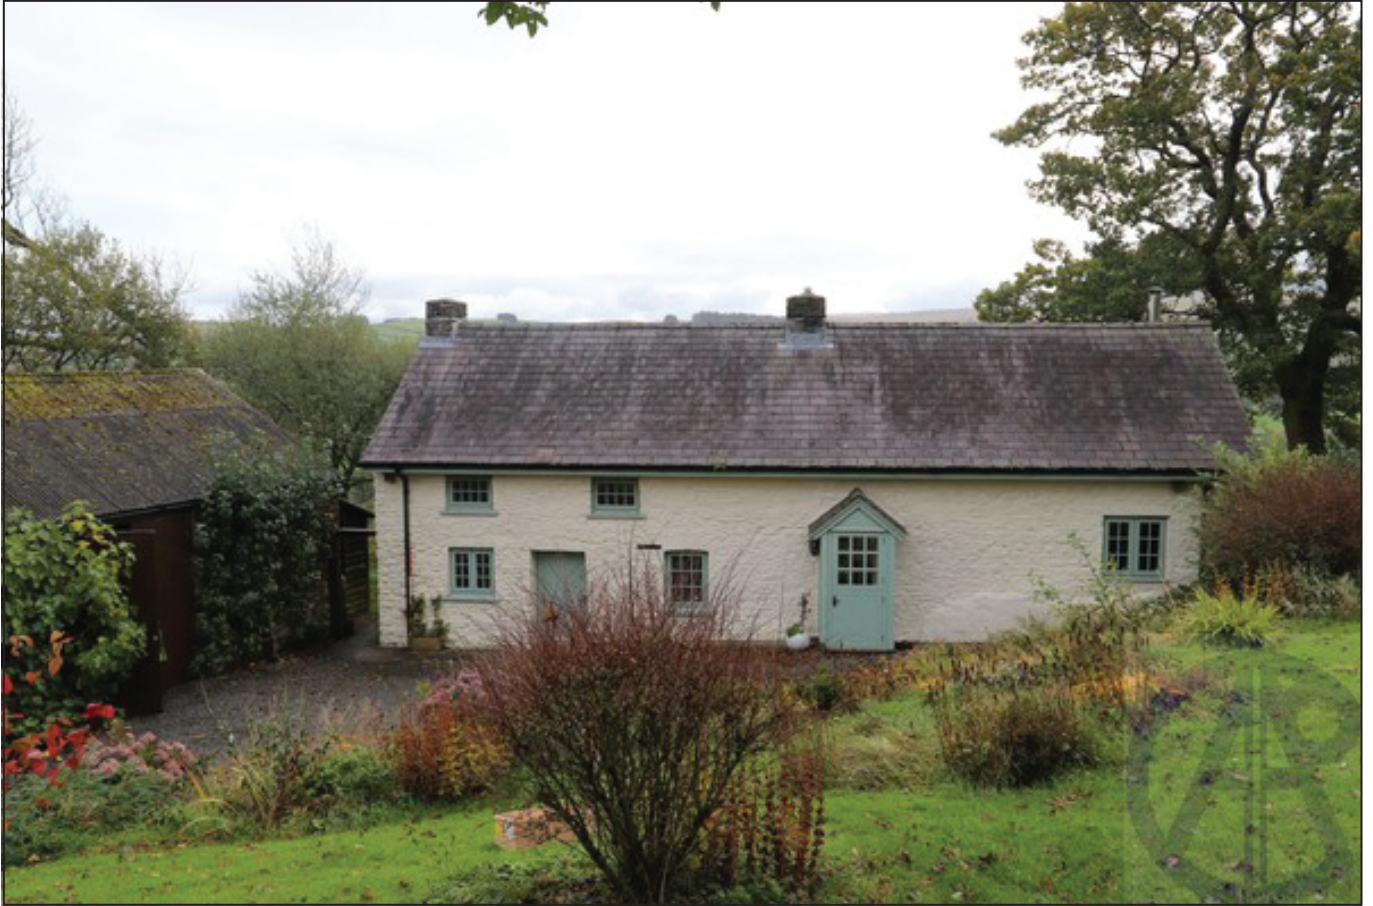
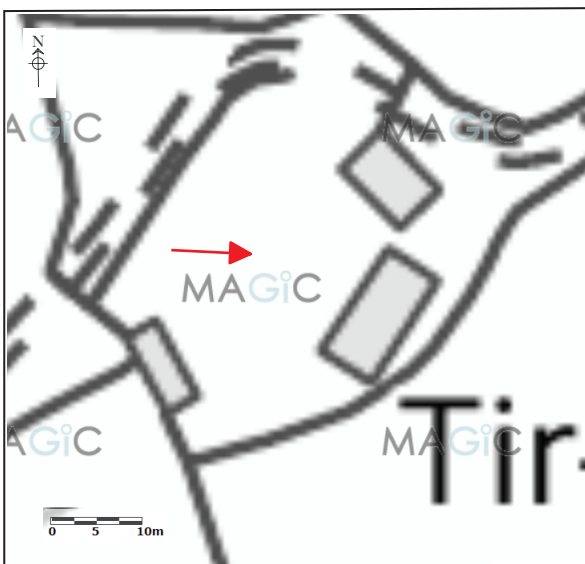
The building is built of coursed stone, rendered white and is roofed with slate, PL01

Western elevation of house. House built of coursed stone with brick repairs/window installations and rendered white. House roofed in slate.

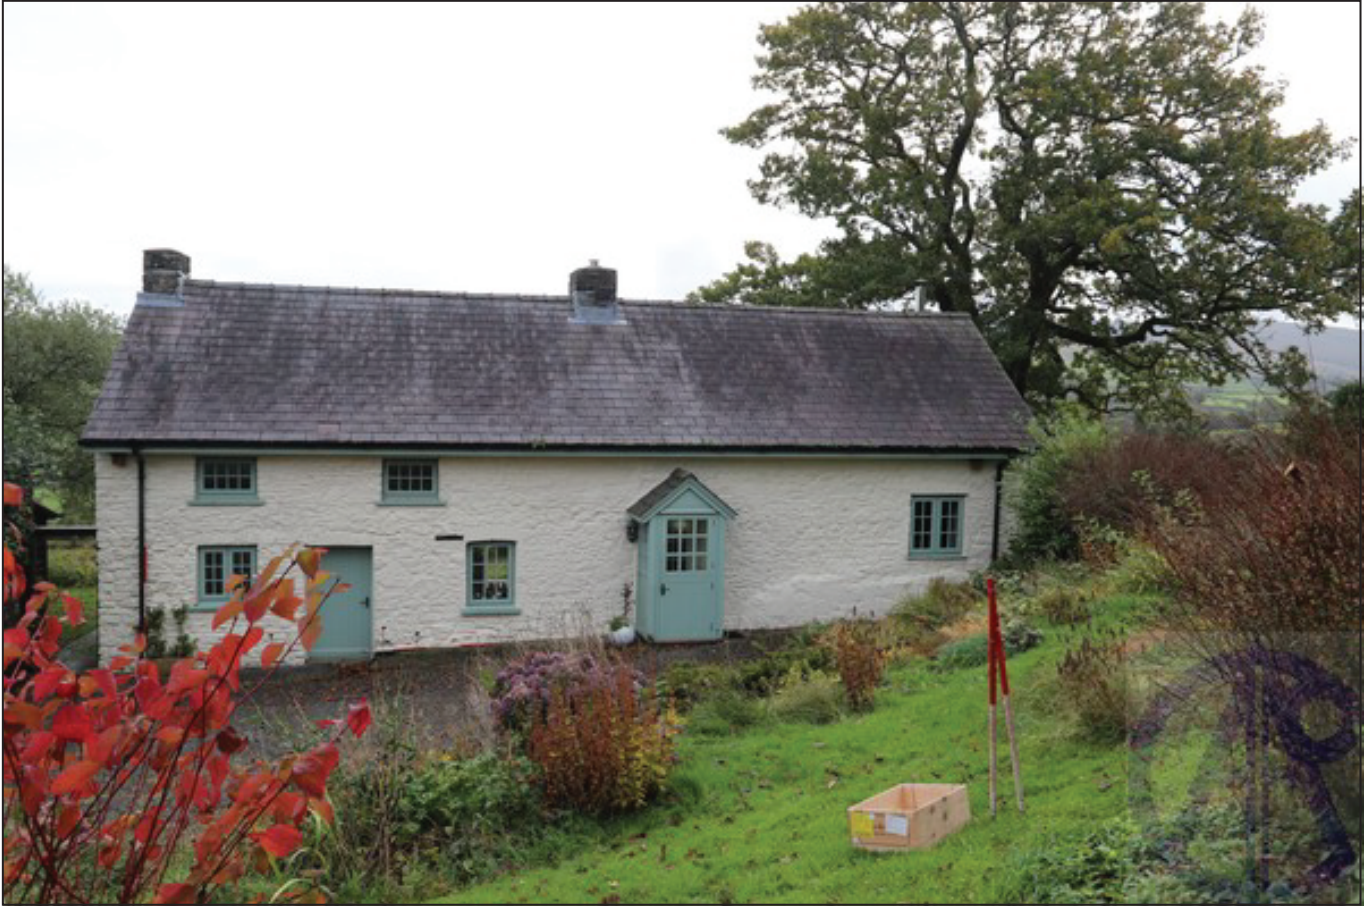
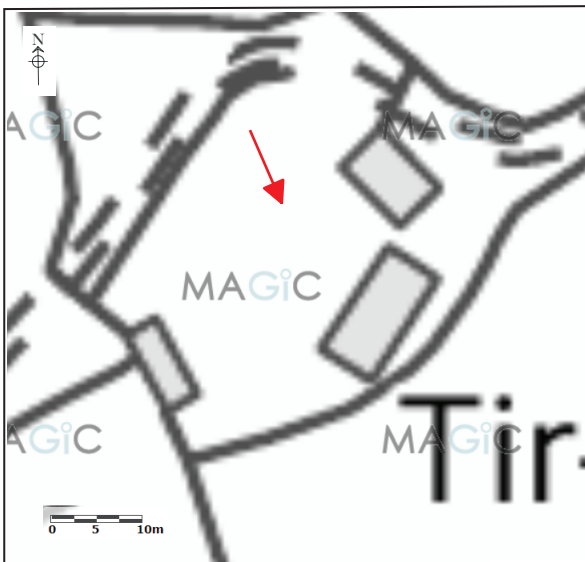
The build features a timber addition porch on its western elevation, PL02 and a modern conservatory on its eastern elevation, PL03.

Western elevation of house. House built of coursed stone with brick repairs/window installations and rendered white. House roofed in slate. Western elevation also features a timber-built porch extension.

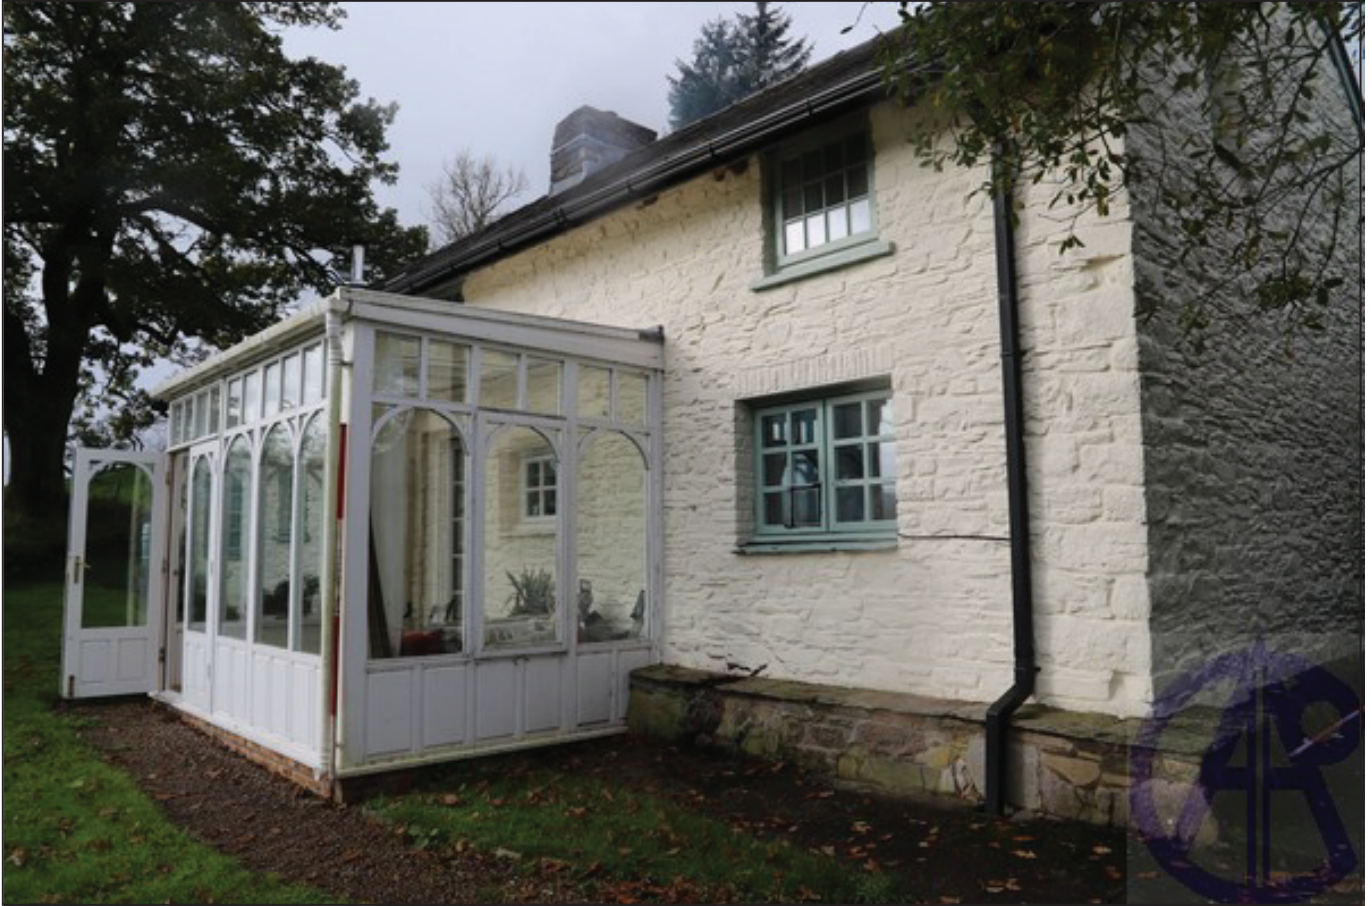
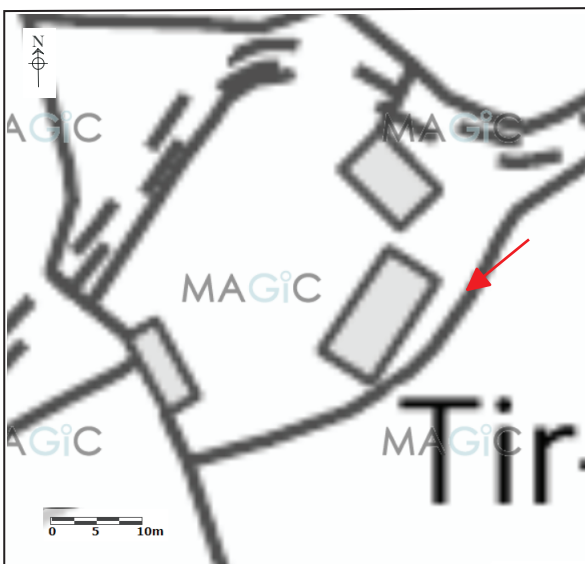
Eastern elevation of house. Fitted with conservatory.

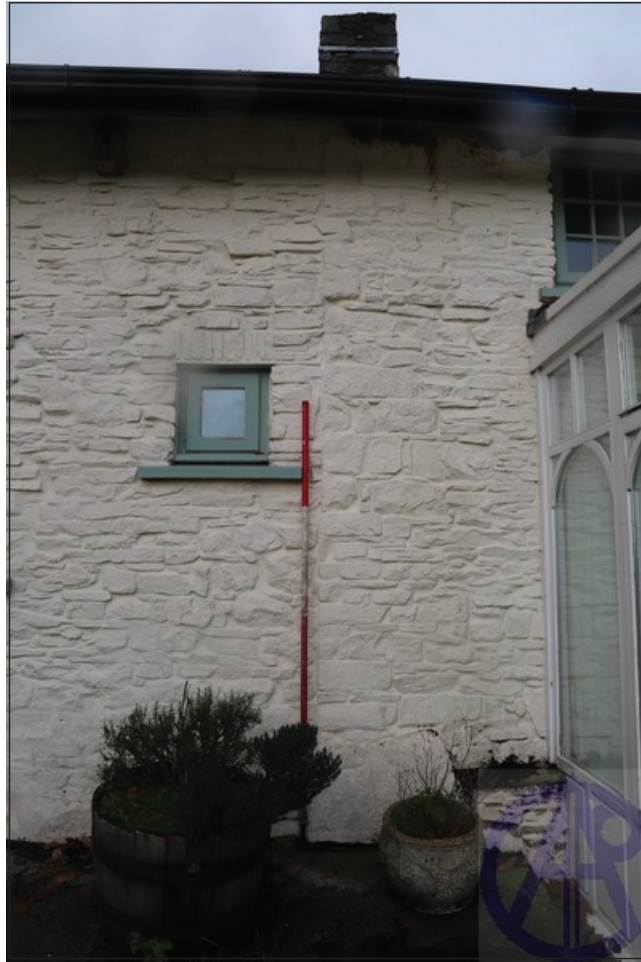
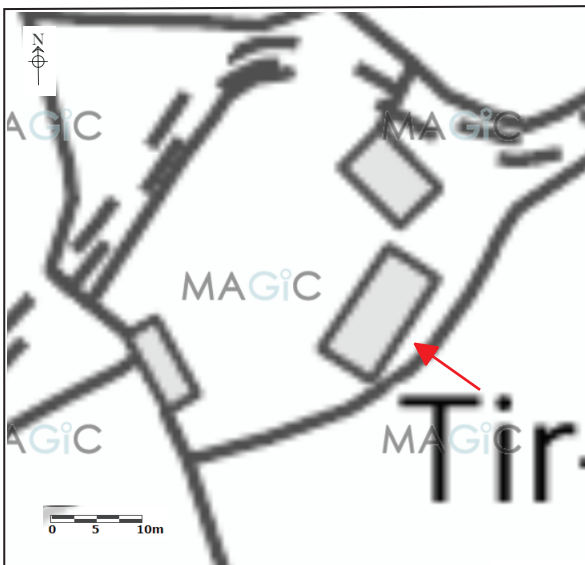
The eastern elevation also shows a prominent wall scar; PL04, which would entertain the possibility that the property was once smaller, being at a later date, extended into a much longer house.

Eastern elevation of house, southern end. Wall scar between southern and northern section of the property suggest two different building phases, (detail)

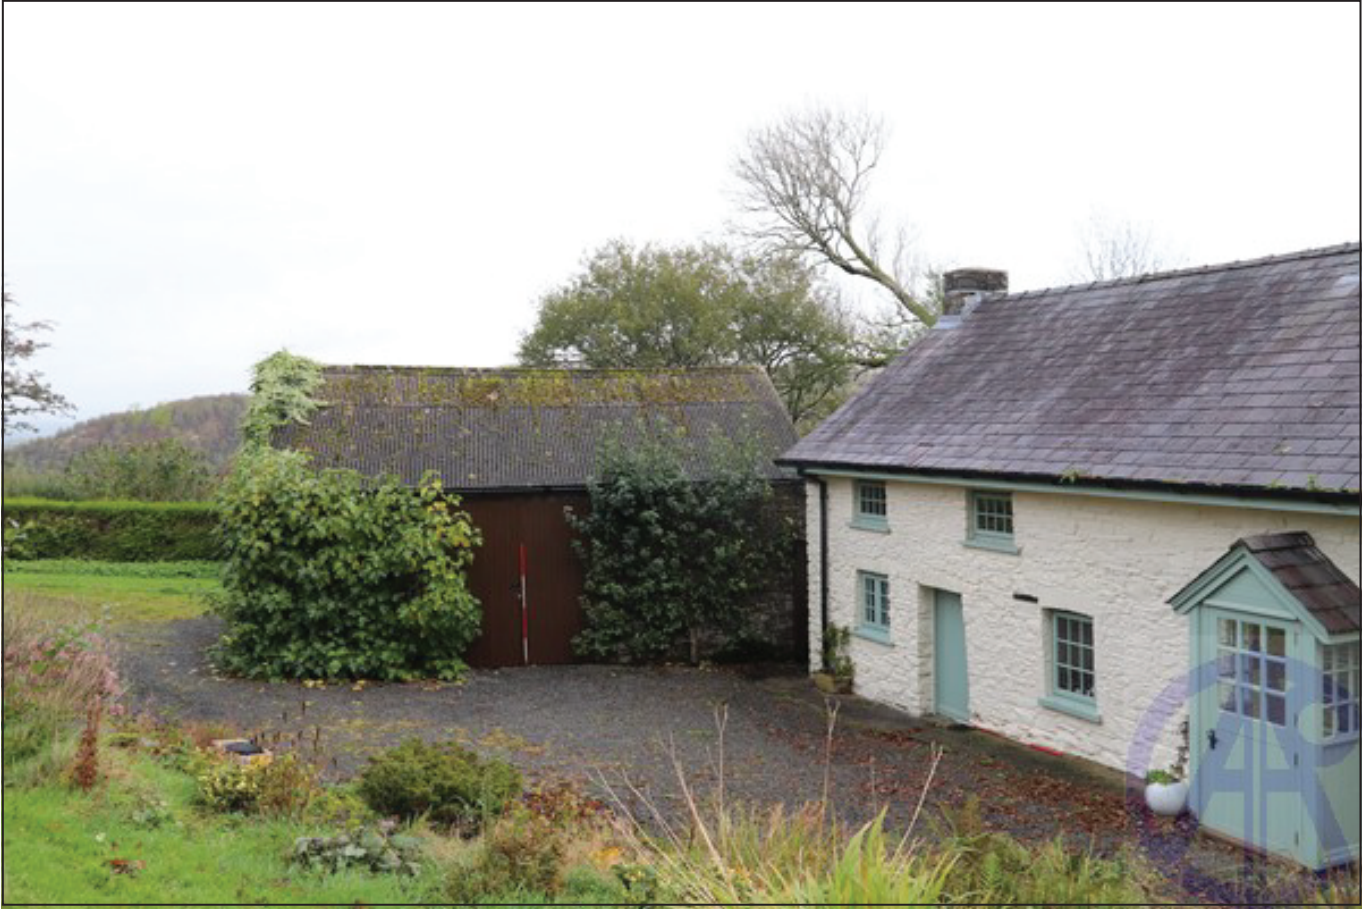
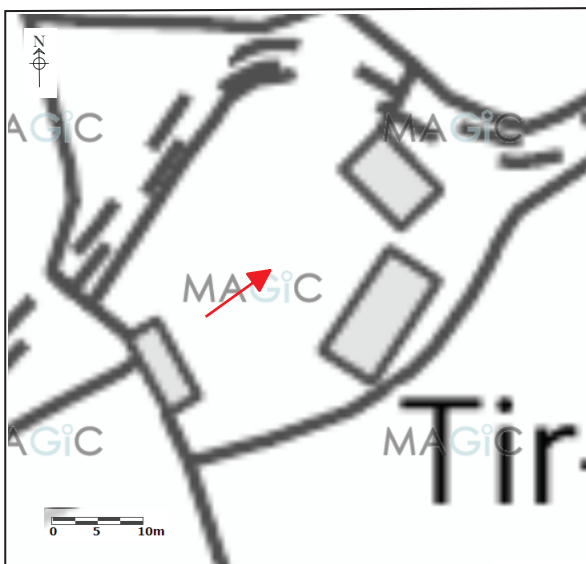
The majority of the southern elevation; PL05, and entirety of the western gable; PL06, walls are currently inaccessible due to dense vegetation.

The southern elevation holds a modern timber double door that extends from ground to roof height, PL05.

Southern elevation of barn. Southern elevation and western gable of barn are obscured by dense vegetation, southern elevation features central double doors, (modern) that extend from roof to ground level. (doors closed)

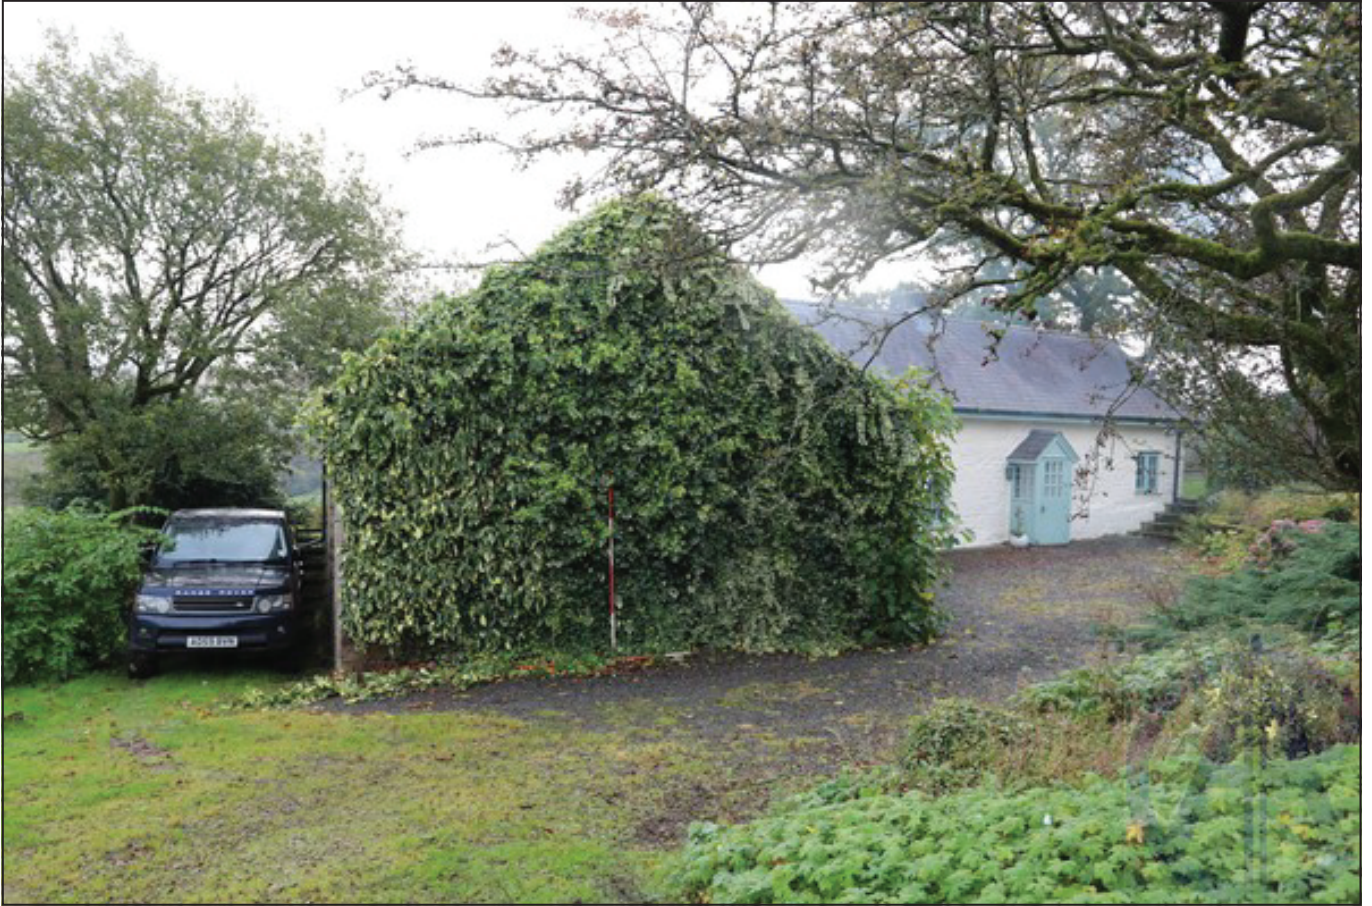
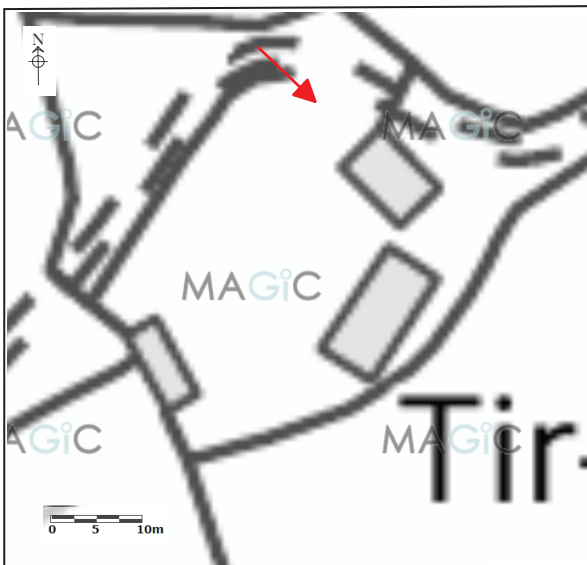
Western gable of barn obscured with dense vegetation.

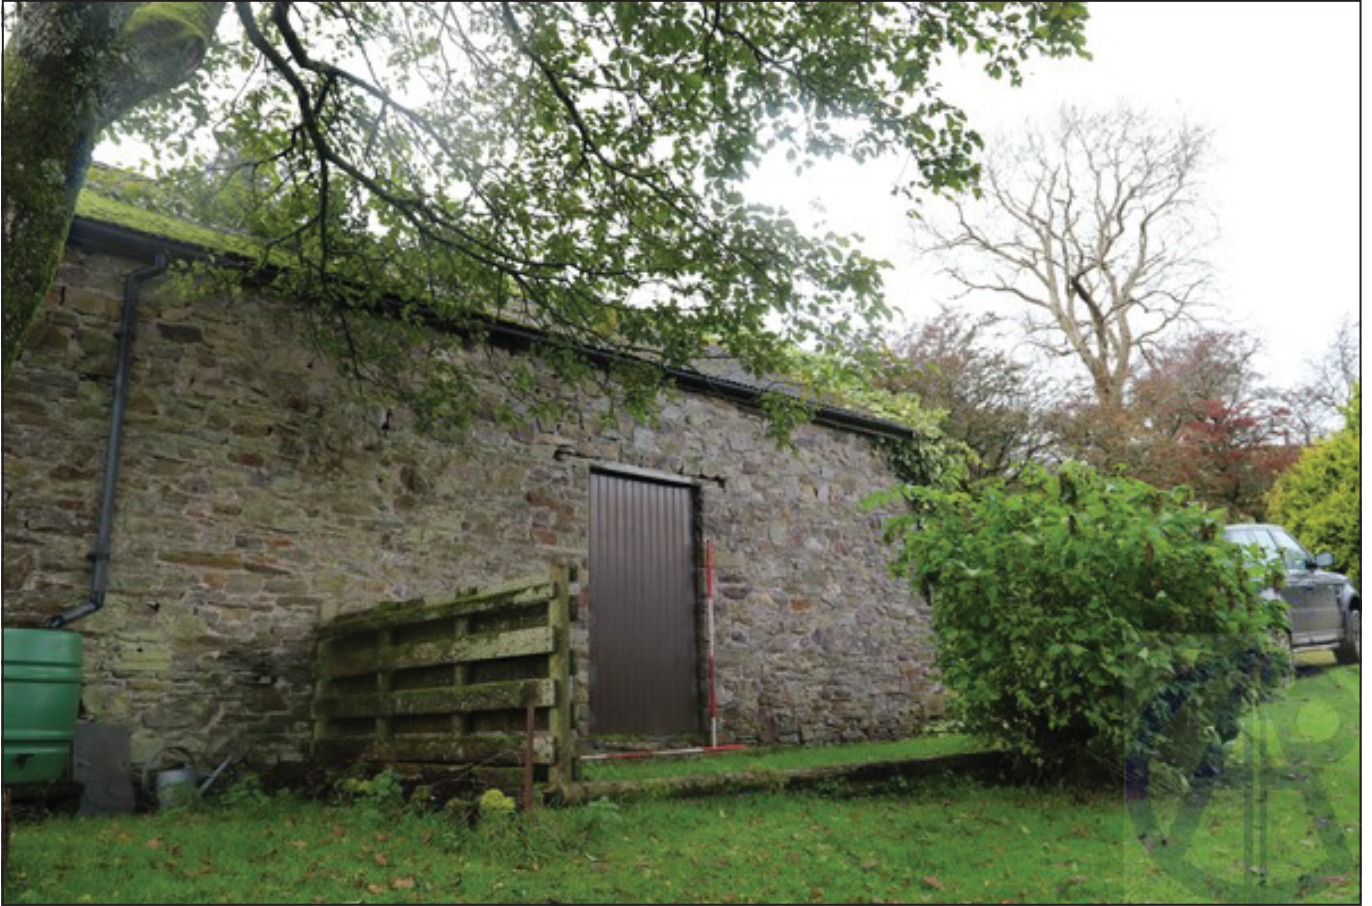
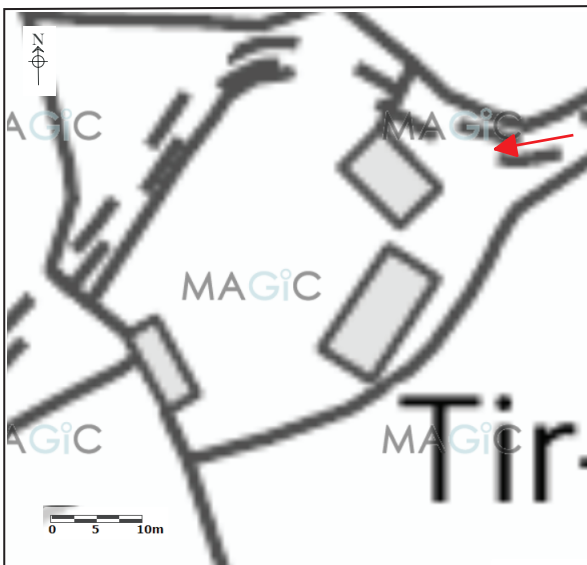
The northern elevation holds a small centralised modern timber door, PL07.

Northern elevation of barn, Random coursed stonework, (repointed) with a timber central door. Roof made of tin sheeting.

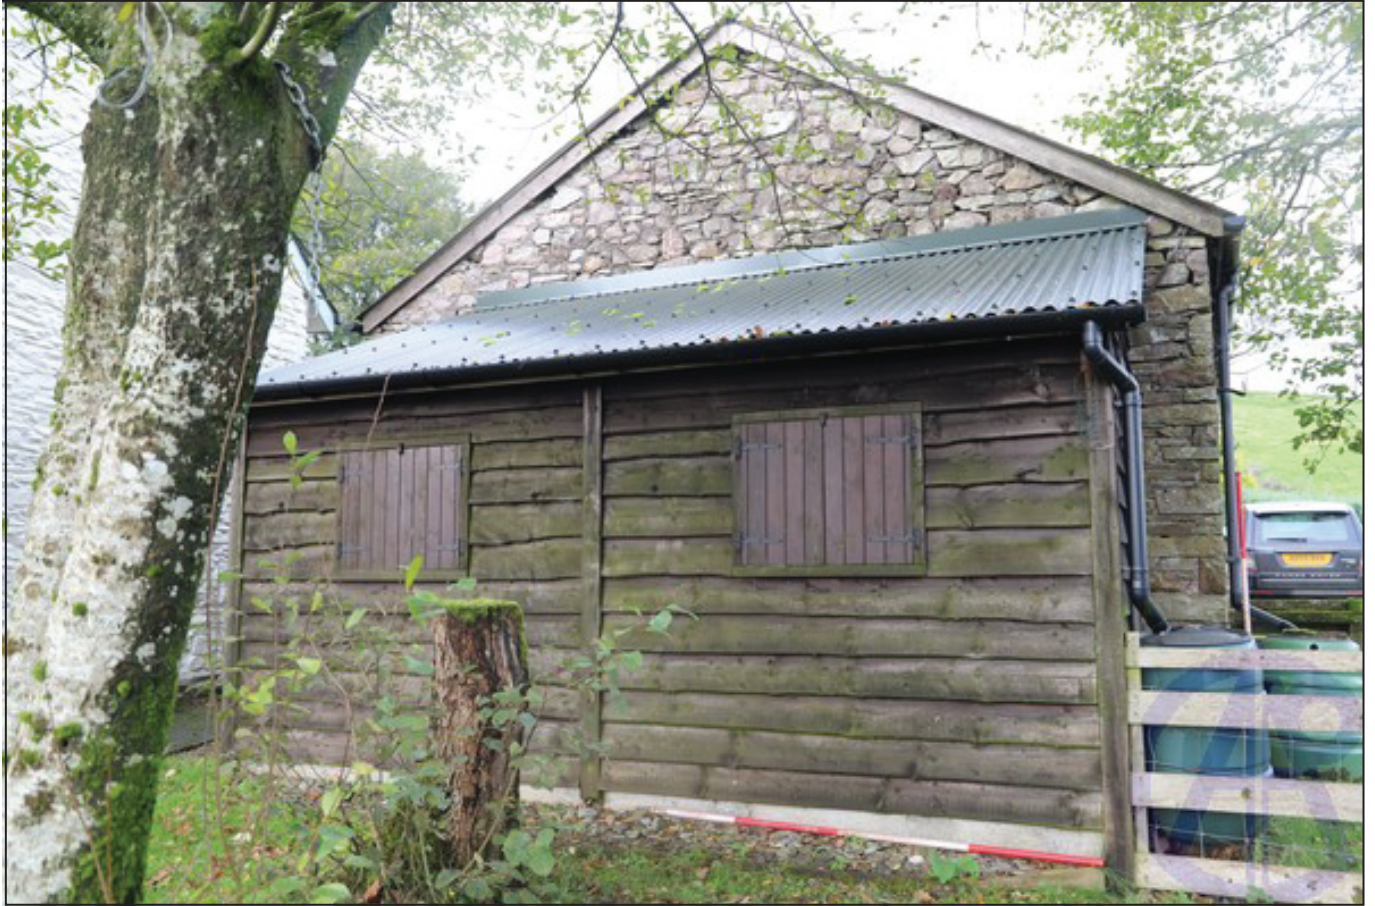
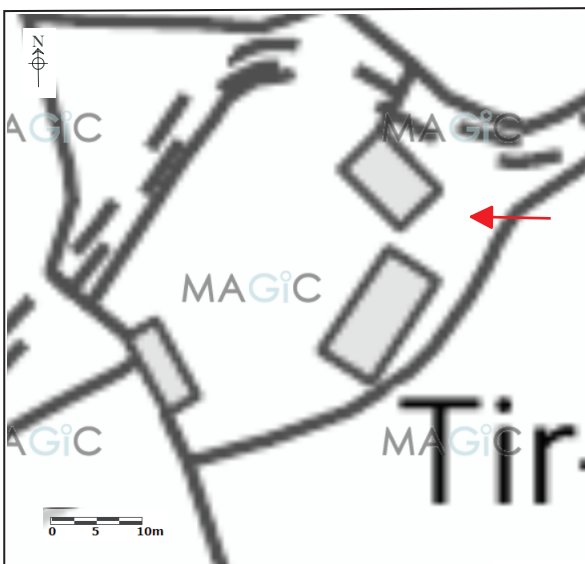
On the eastern gable of the barn, a timber lean too extension has been added, PL08.

Eastern gable of barn with timber lean to extension. Lean to roofed with tin sheeting.

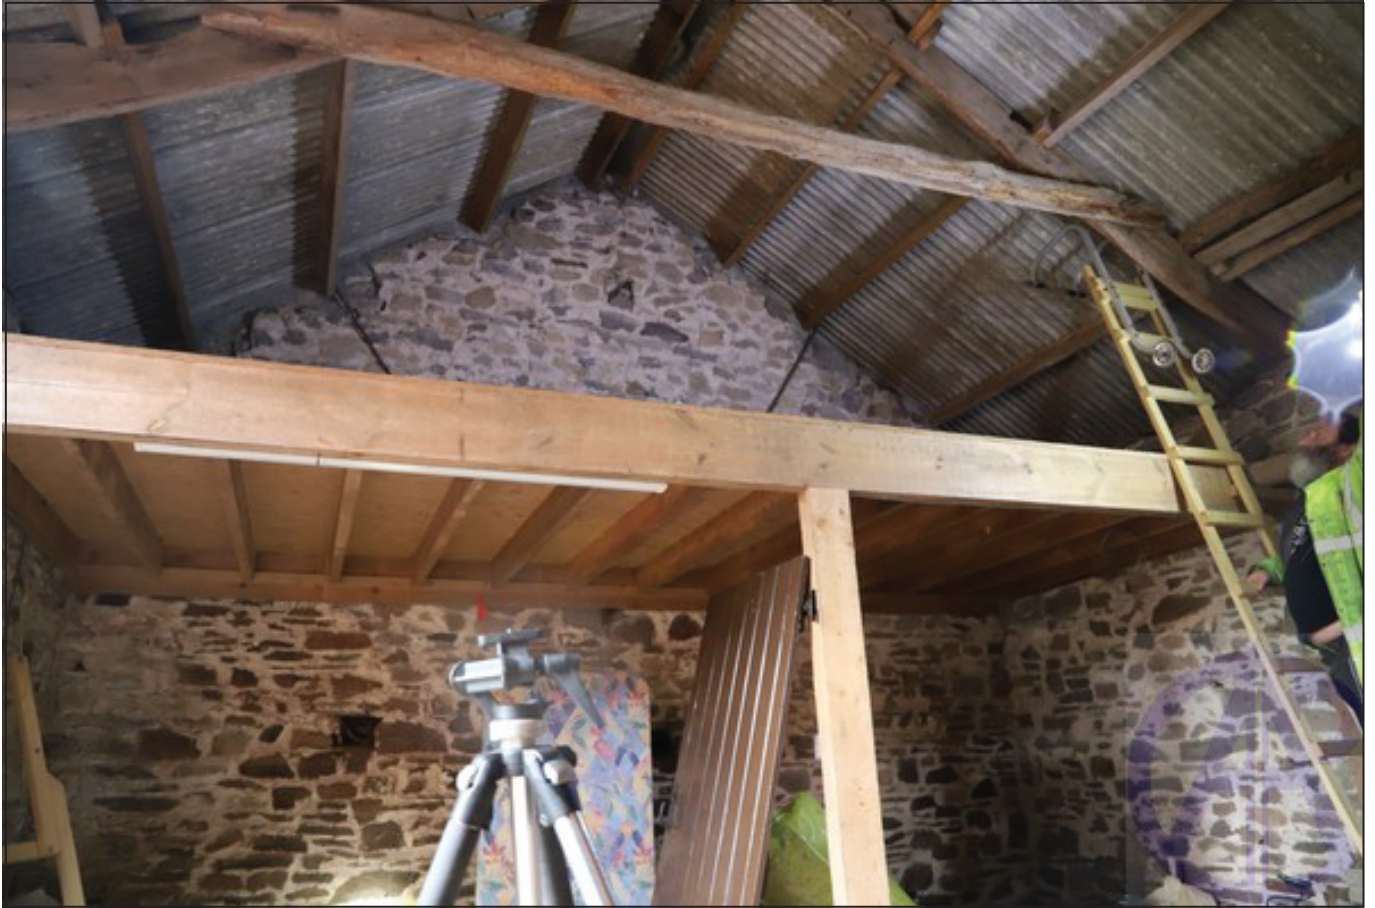
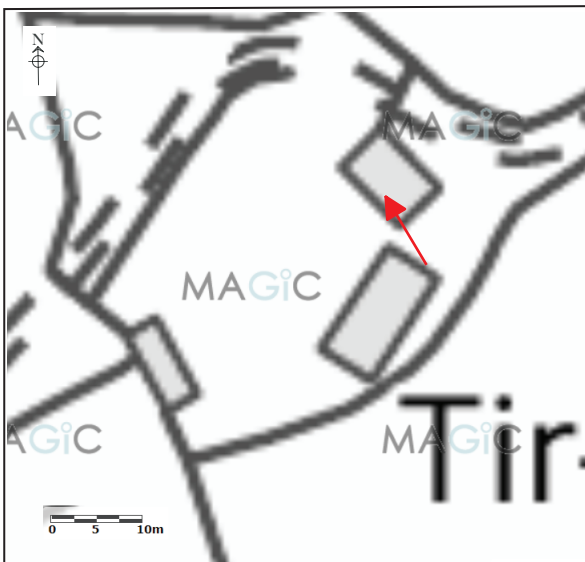
Internally the barn has been fitted to the west with a wooden timber first floor, PL09.

(Internal, barn) – western gable, barn built of random coursed stone, repointed.

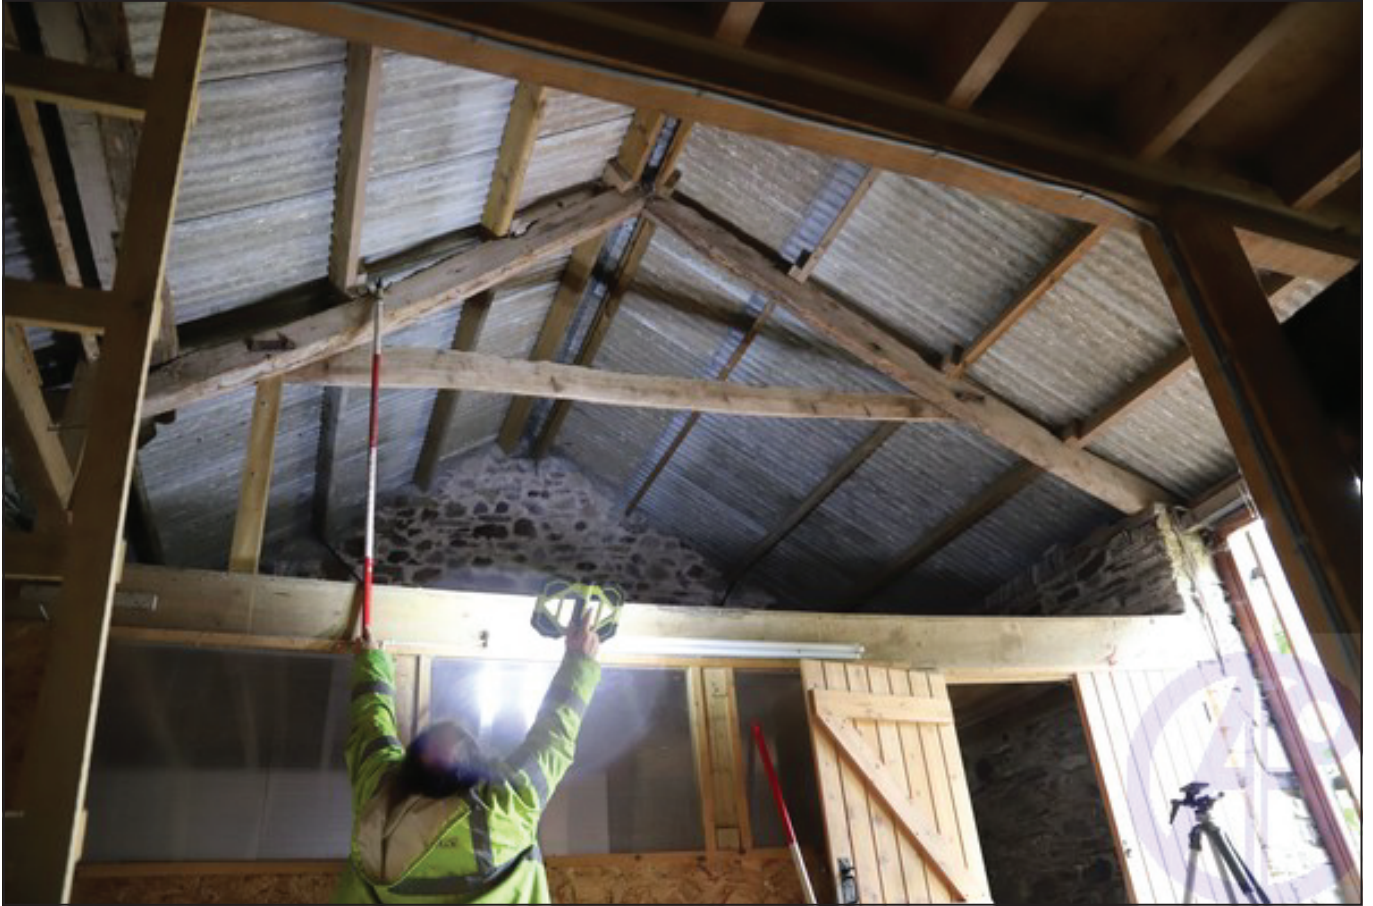
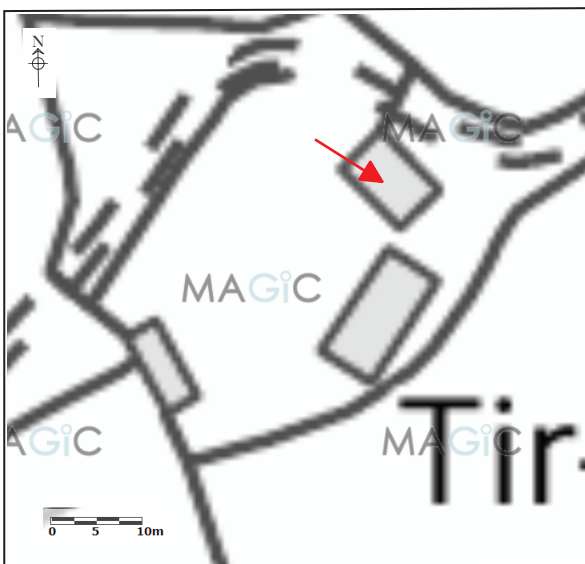
(Internal, barn) – eastern gable fitted with a modern ground floor room, separated with a timber partition, accessed via a timber panel plank and batten door.

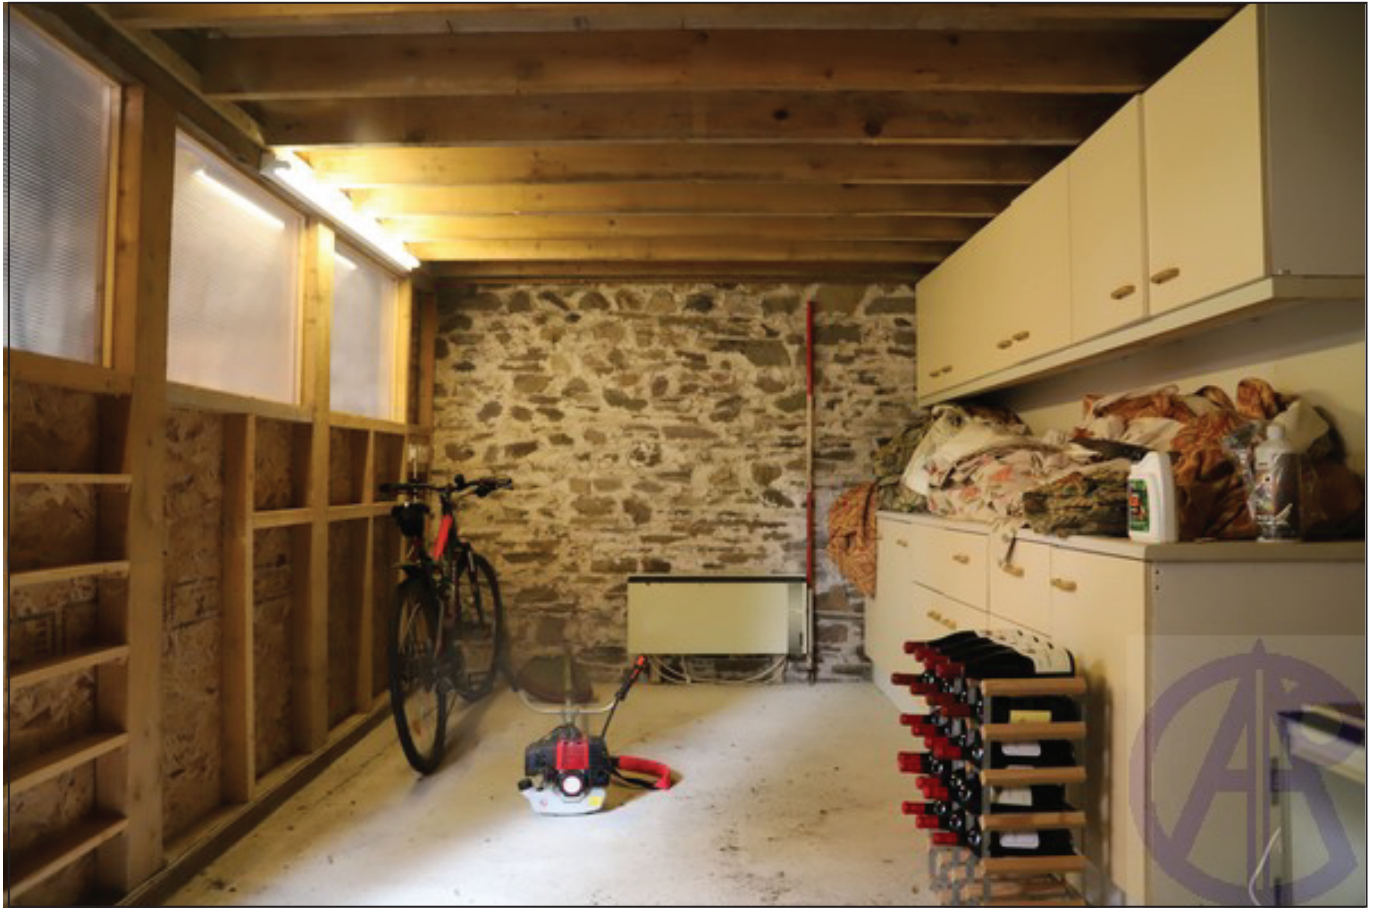
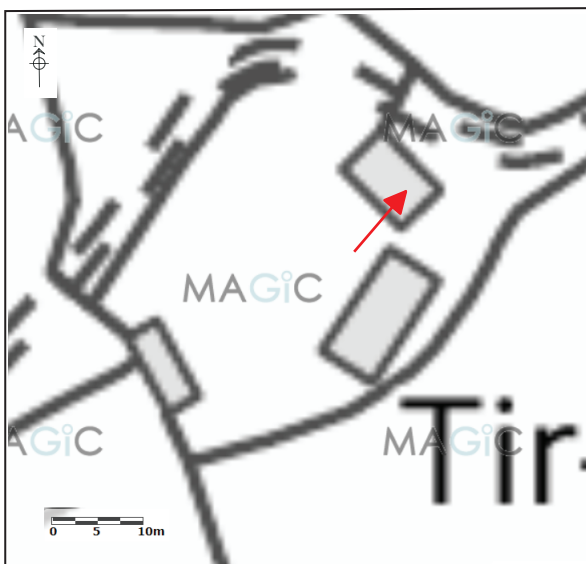
It is also fitted to the east with a timber first floor, with the ground floor underneath this, being partitioned to create a separate room, PL10, PL11.

(Internal, barn) – eastern gable, inside modern ground floor room. Room features modern fixtures and fittings and floor has been concreted.

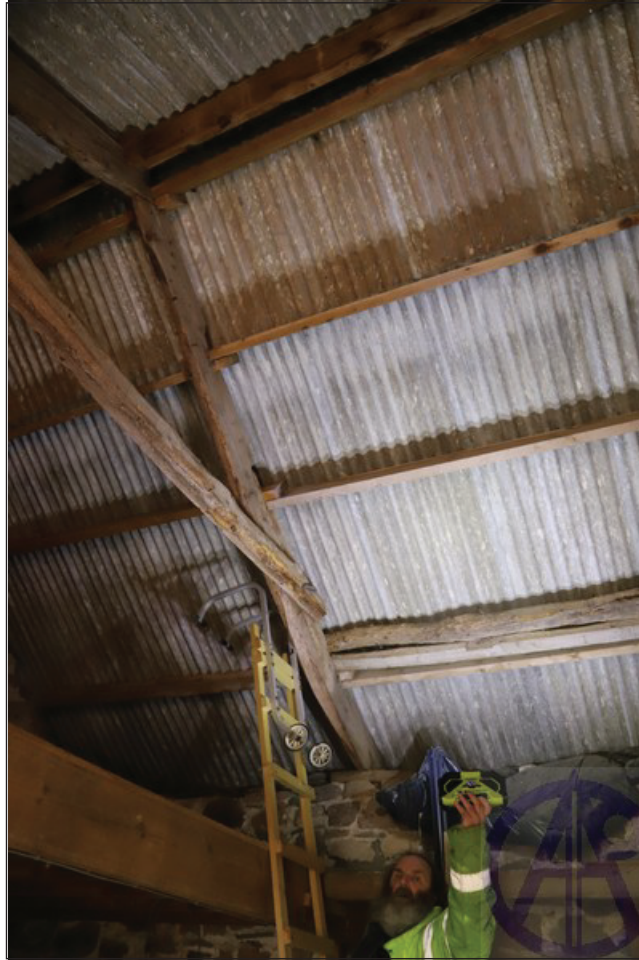
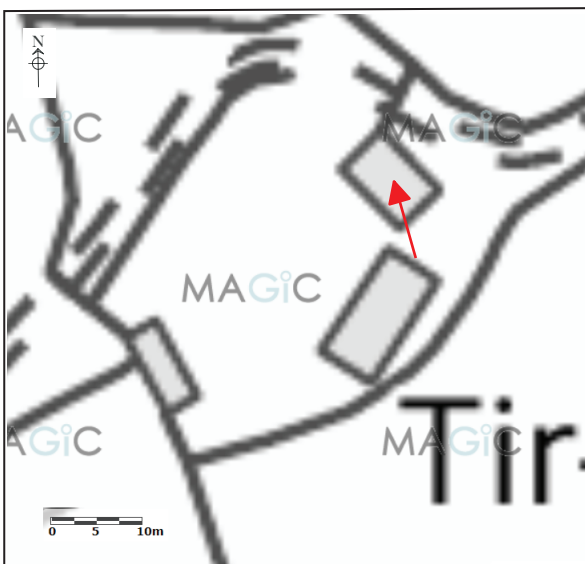
The roof structure of the barn consists of timber trusses made up of hand cut, and modern machine-made timbers. All situated under tin sheeting, PL12.

(Internal, barn) – timber roof structure under tin sheeting.

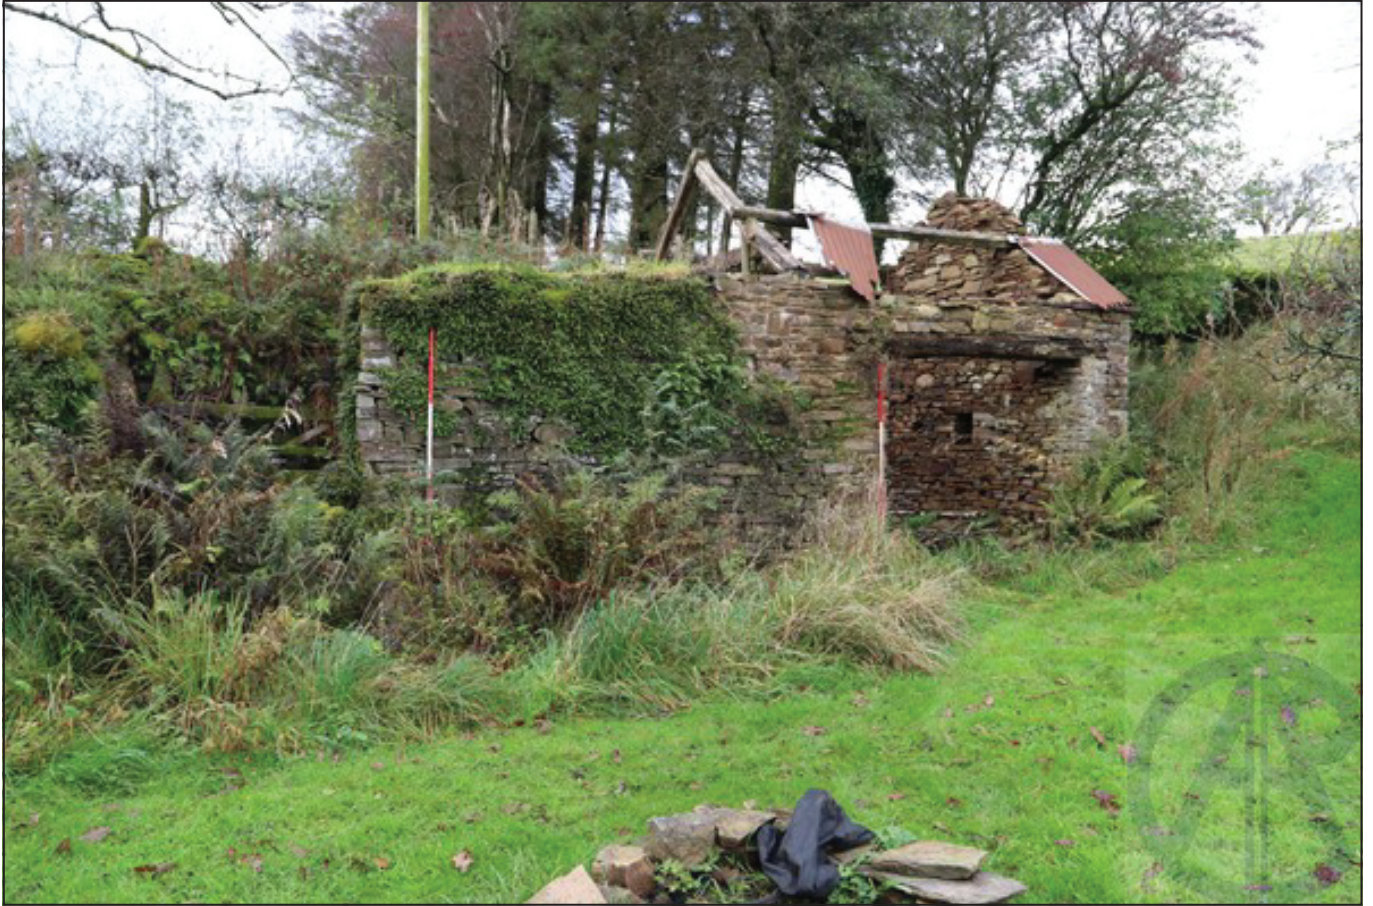
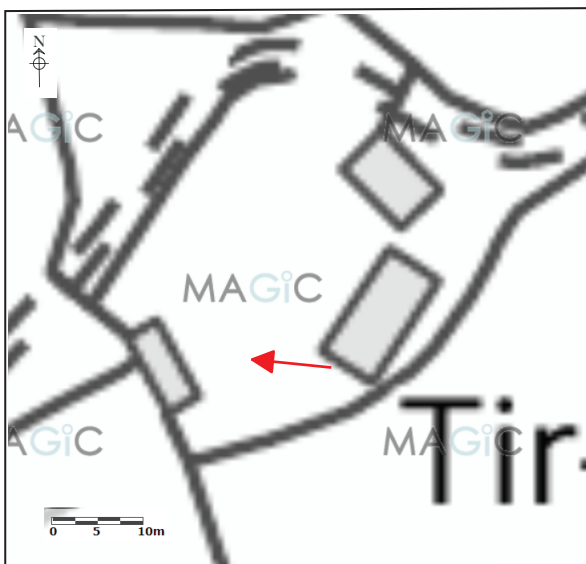
There is also an outbuilding situated to the west of the property; PL13. The building, now in a dilapidated state, was possibly once two buildings joined via a central wall in the middle.

The southernmost part of the building has however now partially fallen away, making this indiscernible.

Dilapidated outbuilding to western boundary of plot. Random coursed stonework with continual repairs. Partial surviving timber truss roof frame under tin roof.

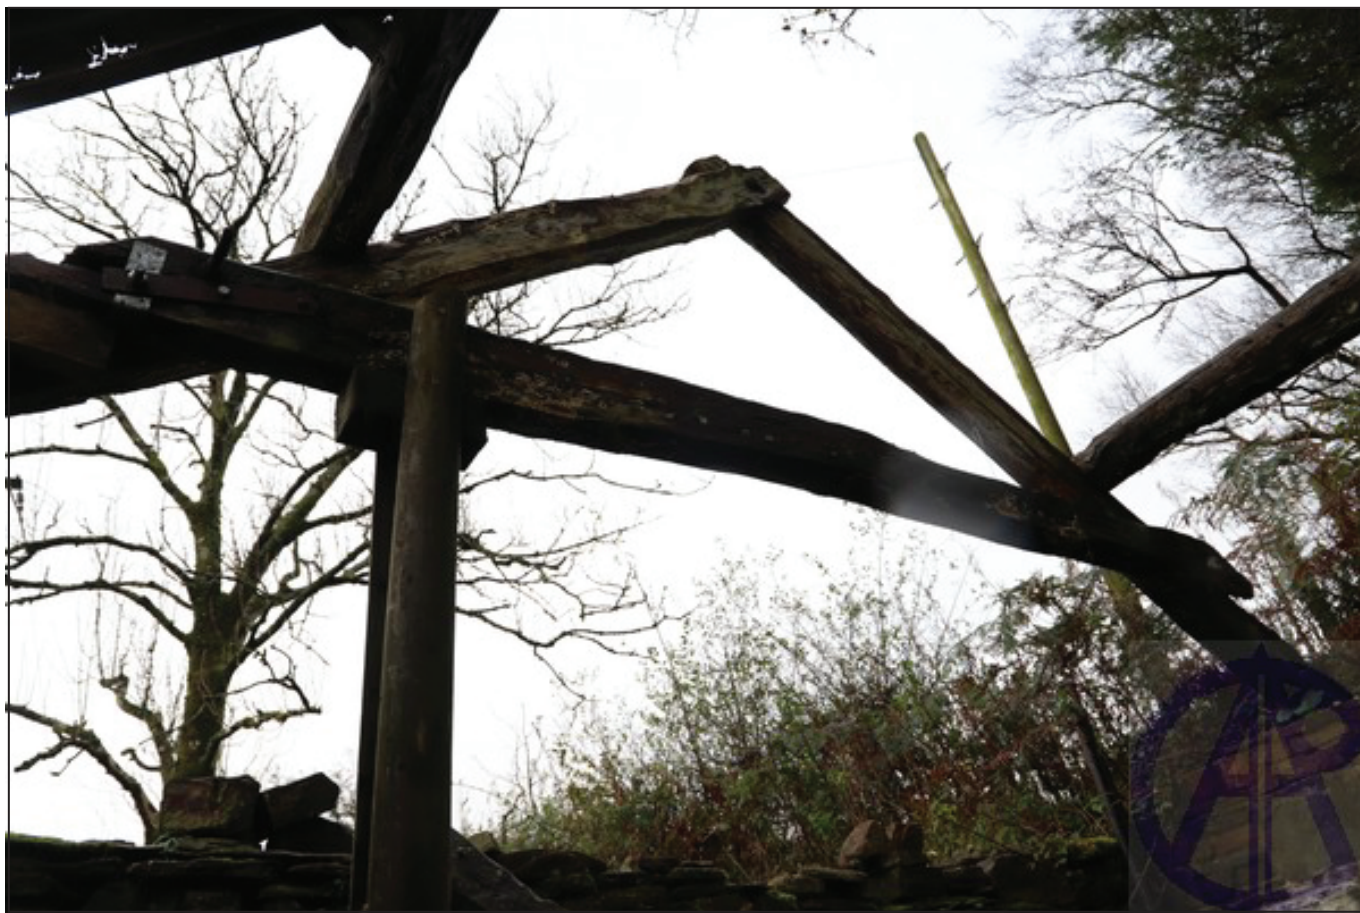
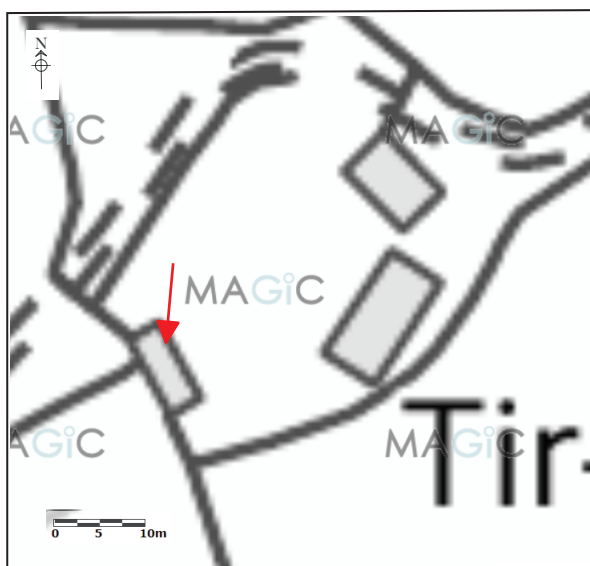
Dilapidated outbuilding, surviving timber roof truss

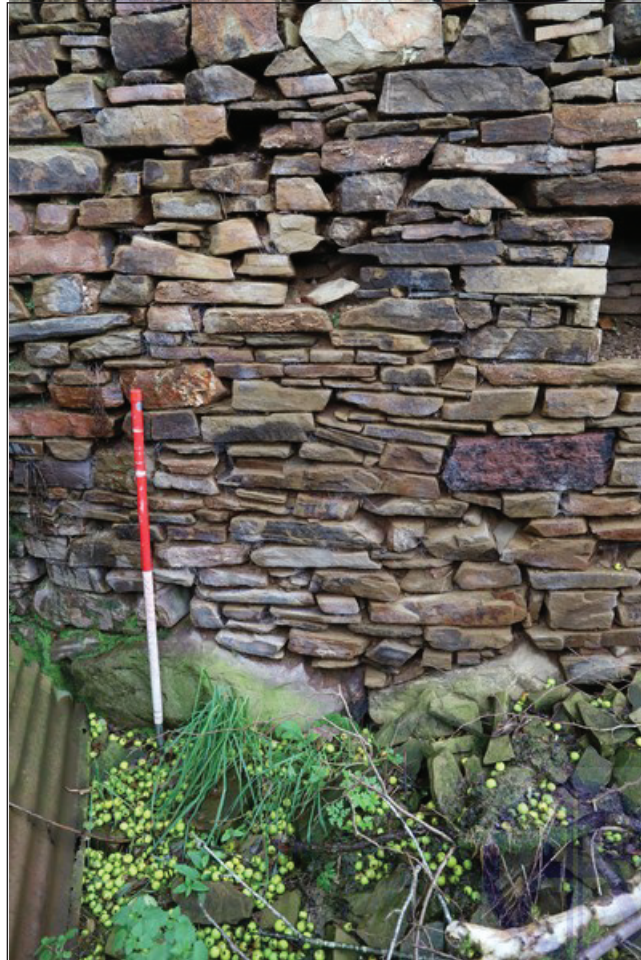
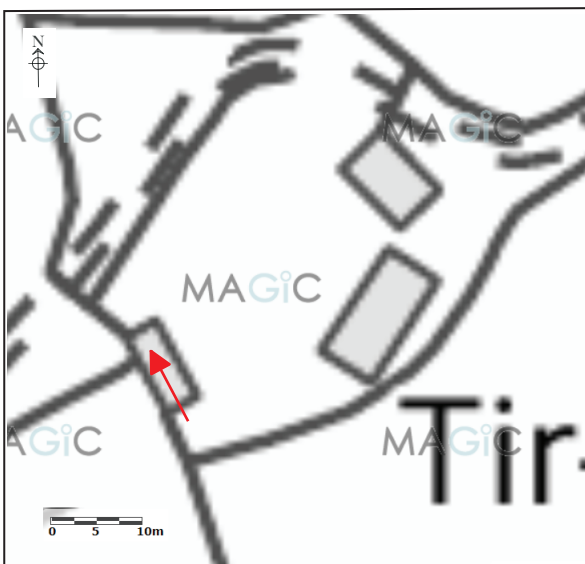
The building is built of coursed stone with sections of rebuilding evident. The lower level of the wall can be seen to have been built upon large foundation stones, PL15.

Dilapidated outbuilding, Northern gable wall of most northern building, coursed stonework over large foundation stones.
