LEVEL 2 HISTORIC BUILDING RECORD

THE BYRE

To support Listed Building consent for proposed alternations/works to be implemented at The Byre, Llawhaden, Narberth. SA67 8HN.

15 June 2023

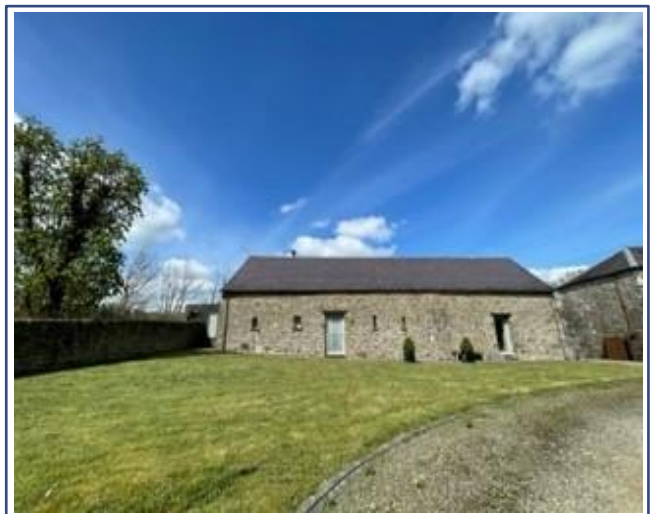
Figure 59: The Byre Front (South Elevation) showing the doors and windows.

- 7.16 The doors have single glazed glass fronts and have exposed oak lintels at the top of each door frame, together with an oak sill and slate steppingstone at the bottom of each door. Each window has a slate windowsill, and the glazing is single glazed. All doors and windows are made of wood and painted. Photographs of the doors and windows are shown in Figures 60 to 63.

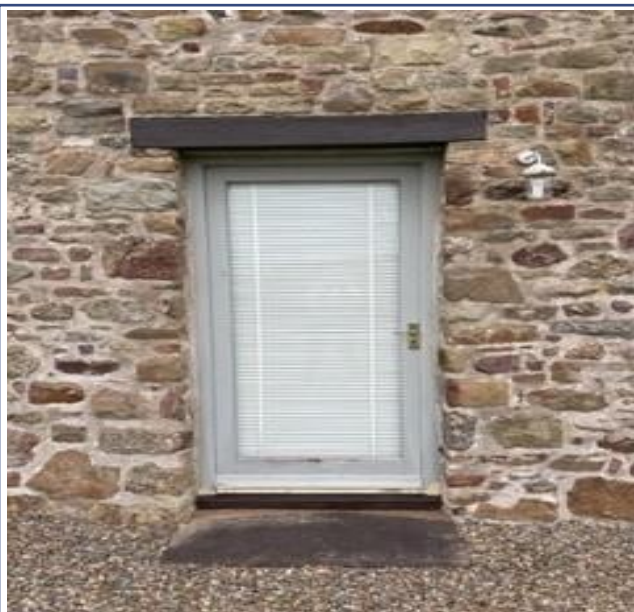
Figure 62: The Byre Front (South Elevation) Lounge door.

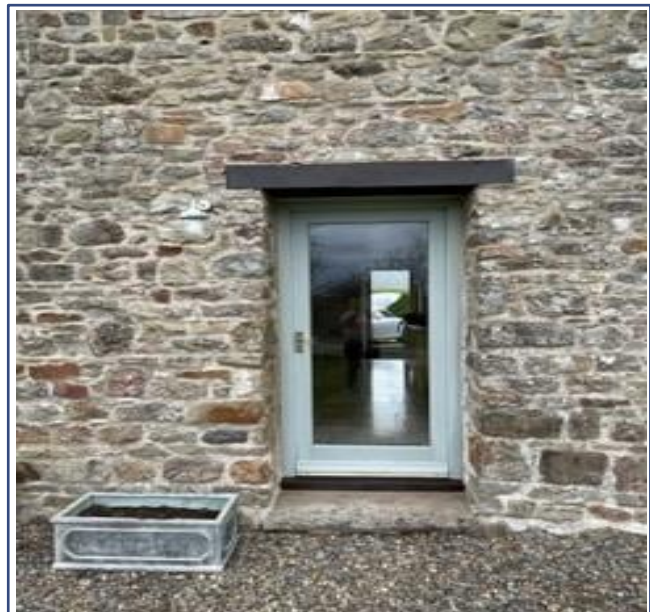
Figure 63: The Byre Front (South Elevation) Kitchen/Dining Area door.

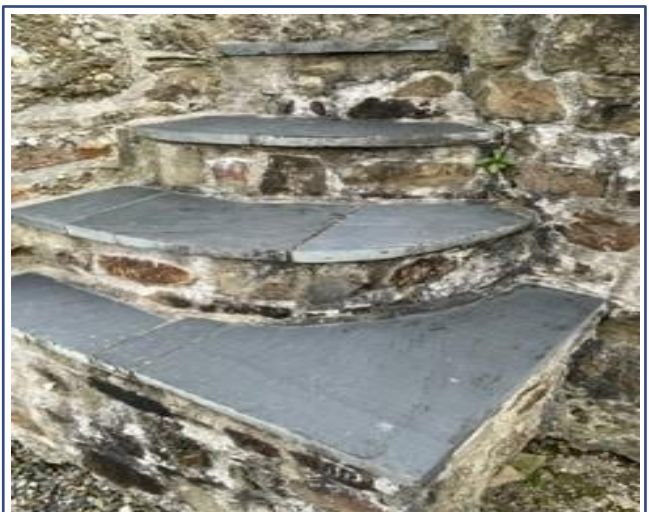
Figure 67: The Byre Front (South Elevation) milking steps showing the Welsh slate.

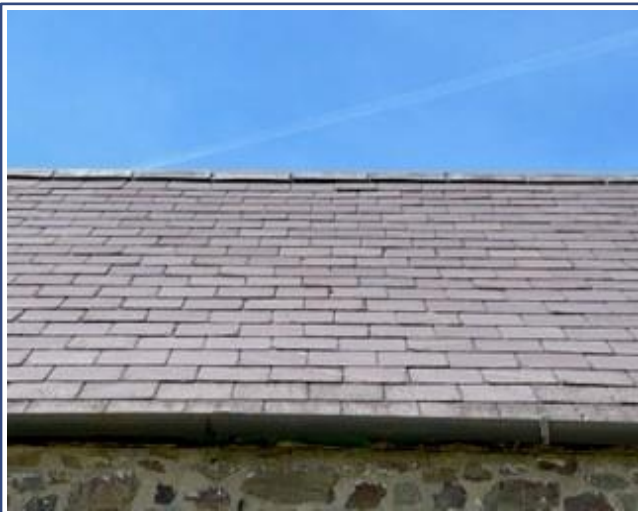
- 7.19 The roof of the **The Byre** is tiled in traditional Welsh slate with concrete ridge tiles and black painted timber fascias/soffits. This is shown in the photographs in Figures 68 and 69. The rainwater goods are painted metal. This is shown in the photographs in Figures 70 and 71. Looking at the roof of **The Byre** from the front (south elevation) to the left you can see the metal wood burner flue painted black which is at the rear of the building (north elevation), and you can see the TV aerial which is attached to the west elevation and which has now been removed in accordance with Condition 3 of Listed Building Consent Application 22/0408/LB. This is shown in the photographs in Figures 72 and 73.

Figure 68: The Byre Front (South Elevation) showing the slate roof tiles.

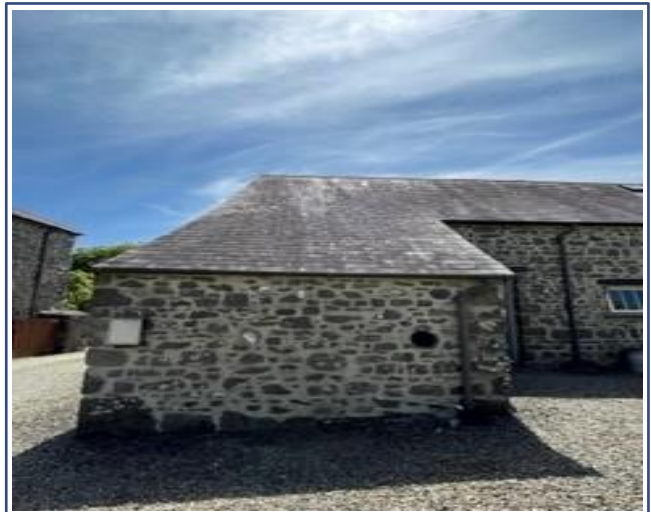
Figure 69: The Byre Rear (North Elevation) showing the slate roof tiles.

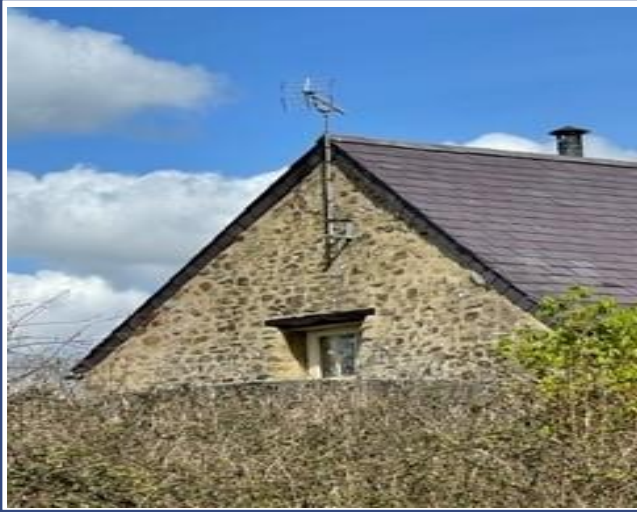
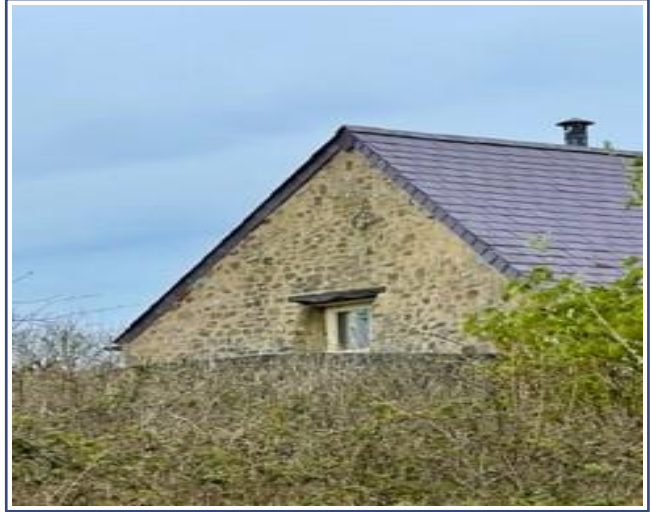
Figure 72: The Byre Side (West Elevation) showing the metal wood burner flue.

Figure 73: The Byre Side (West Elevation) showing the metal wood burner flue and aerial removed.

7.35 Attached to the side (west elevation) is a TV aerial which has been removed in accordance with Condition 3 of Listed Building Consent Application 22/0408/LB. The wood burner flue painted black attached to the rear roof (north elevation) is also visible. This is shown in the photographs in Figures 72 and 73.
