ST DAVIDS CATHEDRAL PORTH Y TWR

ARCHEOLOGICAL REPORT 1999

Caroe & Partners

Porth y Tŵr - The Archaeological Survey 1998

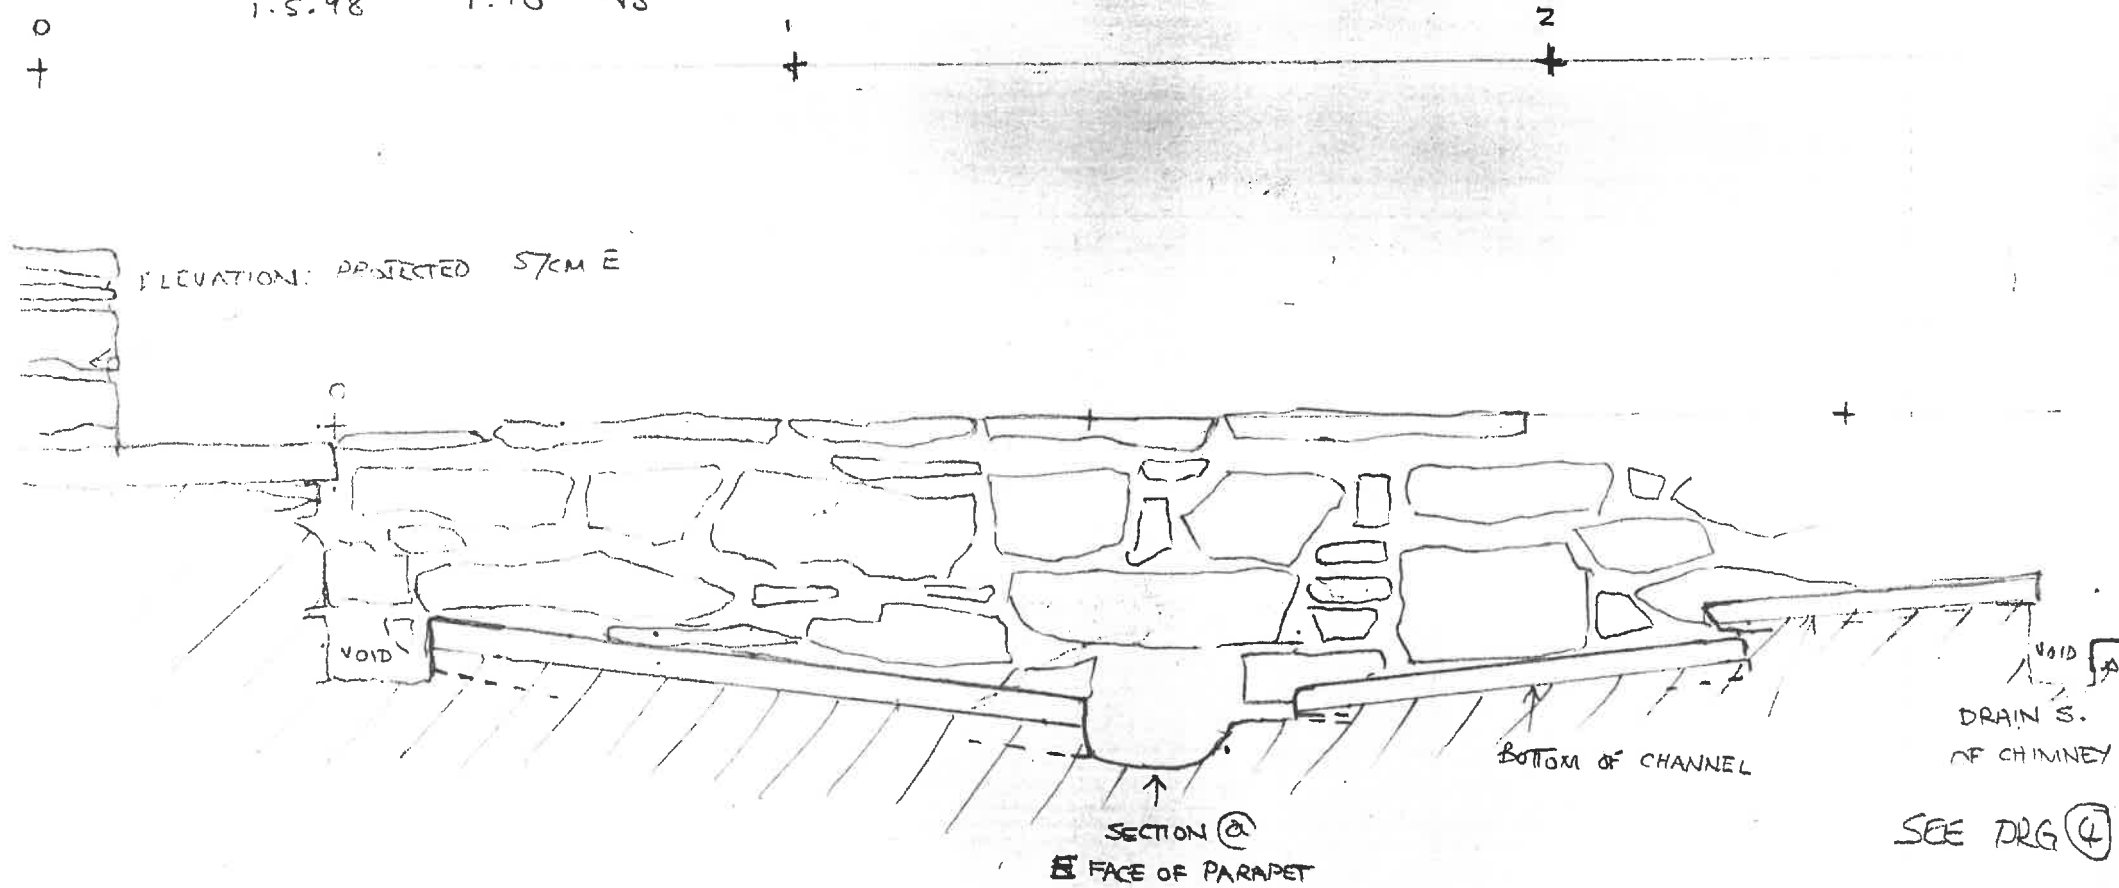
(2)

N-S SECTION OF PARAPET DRAINAGE SYSTEM, S SIDE OF W. ELEVATION
1-5-98 1:10 NS

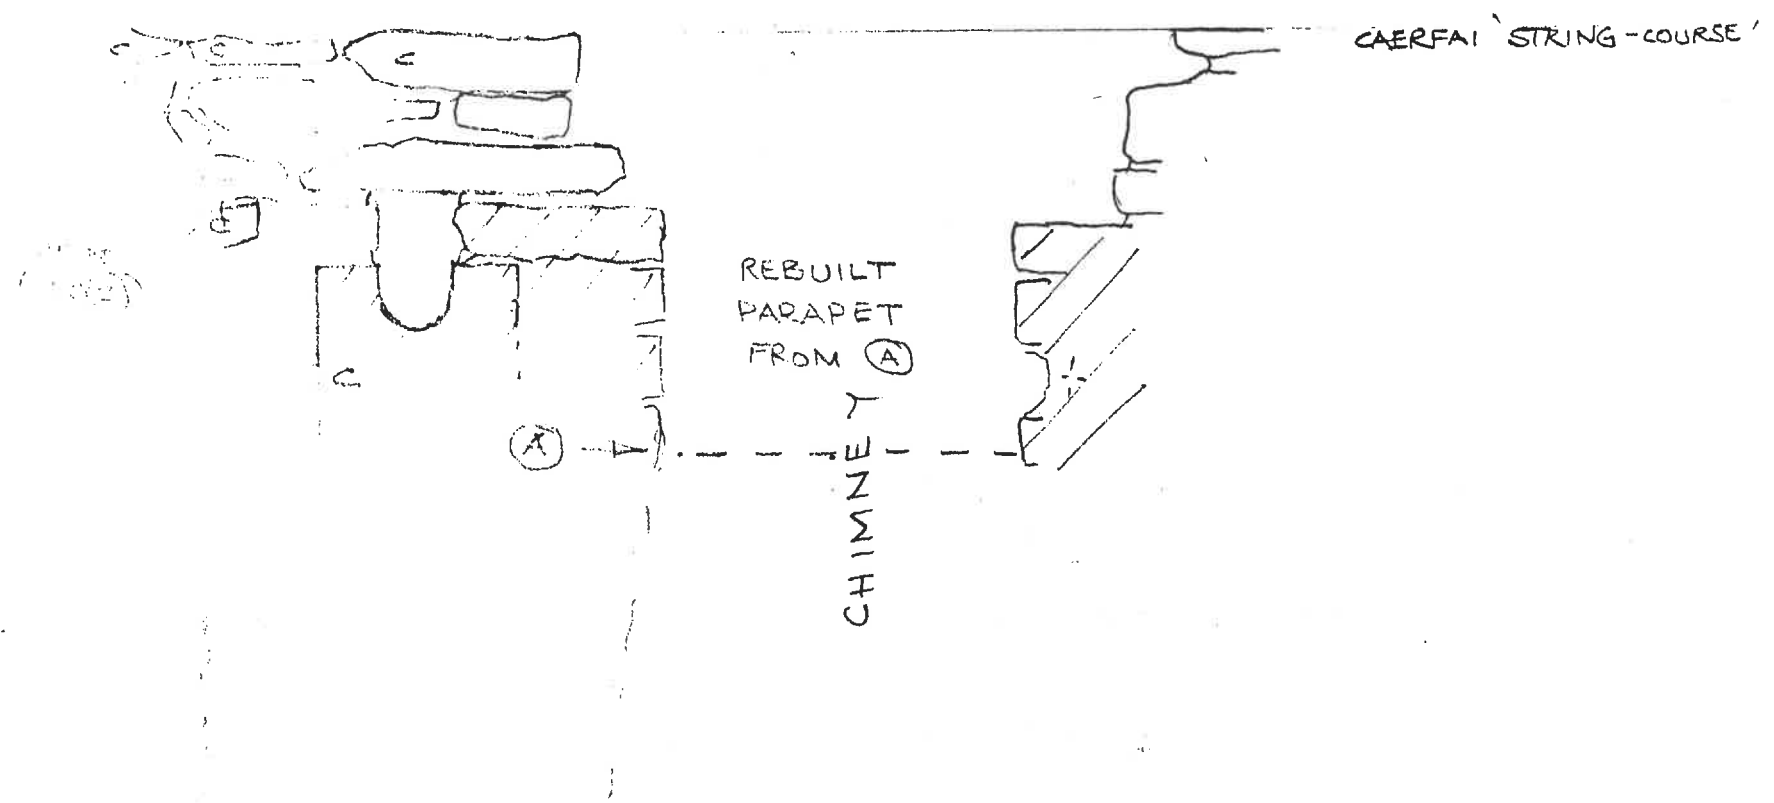
W. ELEVATION, S. END OF PARAPET - DRAINAGE CHANNEL CONTD. FROM DRG. 2)

PARAPET REBUILT 1972

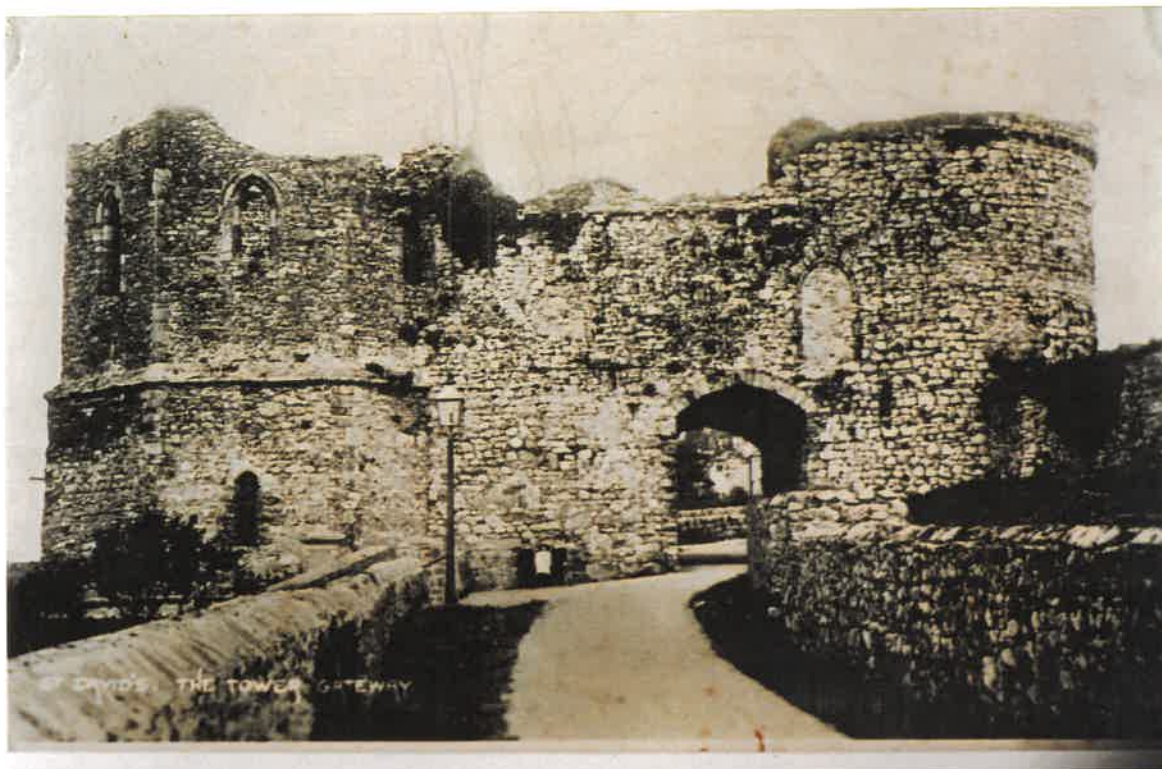
The western elevation of the gate around the turn of the century, showing the first floor openings blocked with masonry, but with considerably more masonry at the top of the north-north-western elevation of the belfry. By c.1925 the western window and first floor doorway had been reopened, but the belfry parapet had been reduced. [postcard from the collection of J.Viles and Sons]

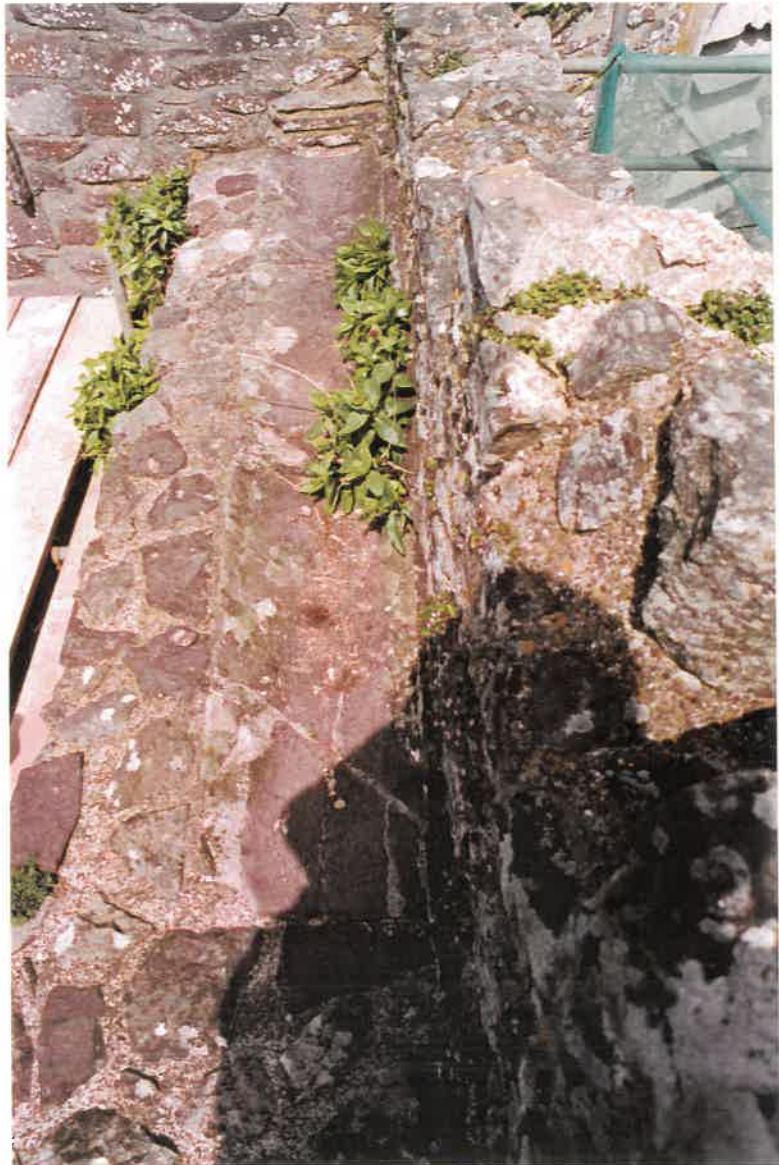
PT98/12/8: The remains of the gutter on the northern end of the east parapet, rebbed when the parapet was repaired under Alban Caroe in 1950-1. At this time the wall top was rebuilt removing any traces which may have survived of the slot along the inner margin of the wall to accommodate the wall plate of the medieval roof.

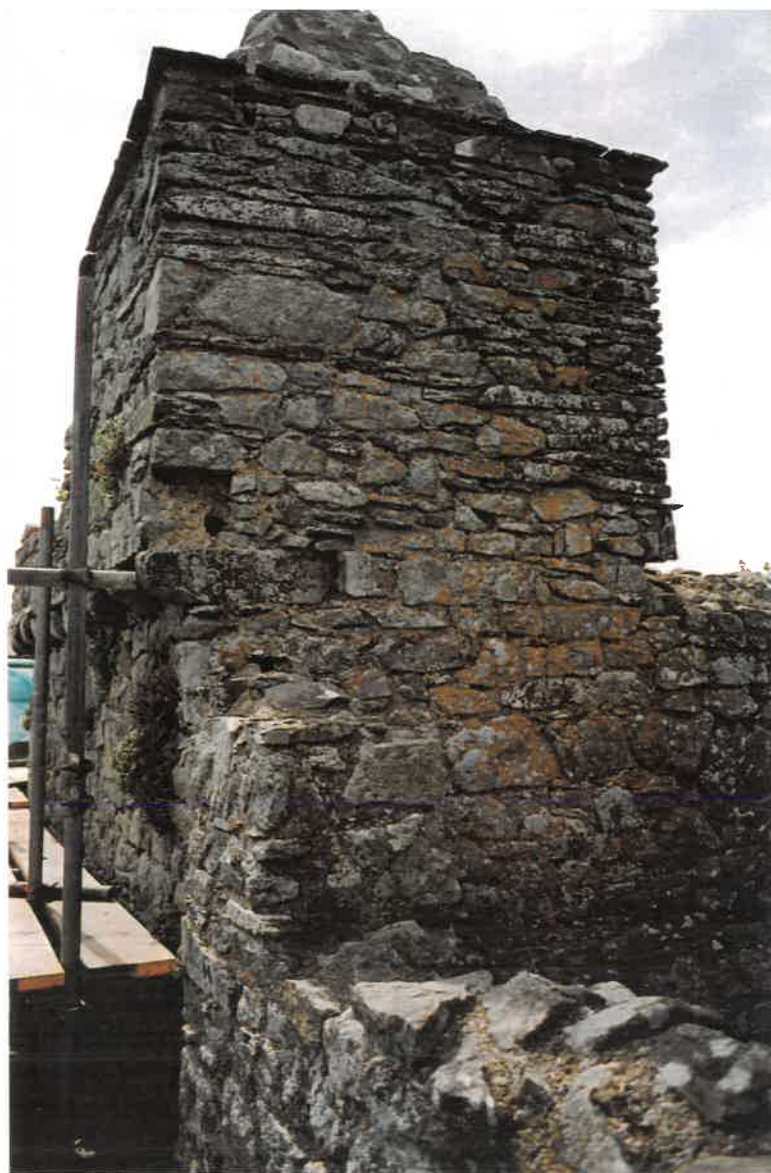
PT98/11/27: The northern elevation of the stair turret at the north-east angle of the south tower, showing the scar of the junction of the parapet occupying the course above the tower string-course. This provides evidence for the original height of the merlons over the gatehouse chamber. The cap of the stair turret was renewed by Caroe in c.1950-1.

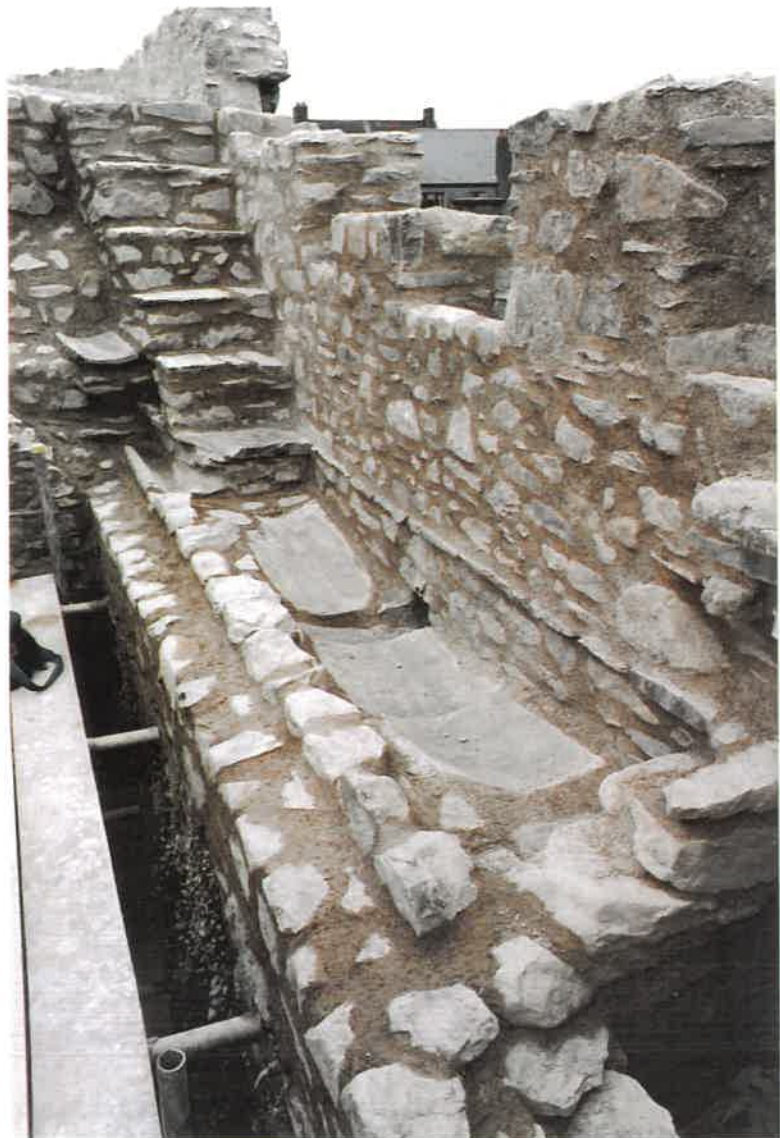
PT98/15/19: The south end of the parapet of the west elevation showing the gutter to carry off water from the chimney and parapet steps emptying through the exterior wall; the two gutter-slabs to the east of the steps which rose to the tower parapets; and the ledge and socket to accommodate the wall plate of the gatehouse chamber roof. [After repair]

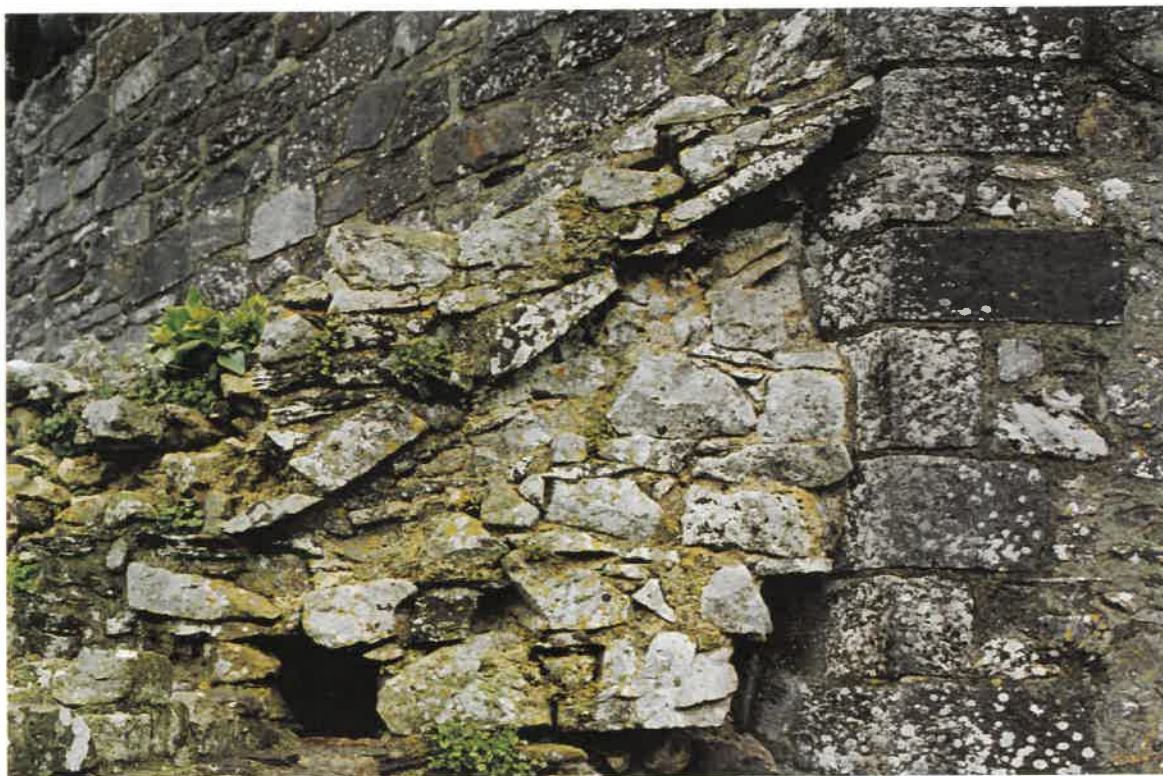
PT98/7/32A: The north-west corner of the gatehouse chamber showing the remains of the original roof-line, with the socket for the wall-plate beneath

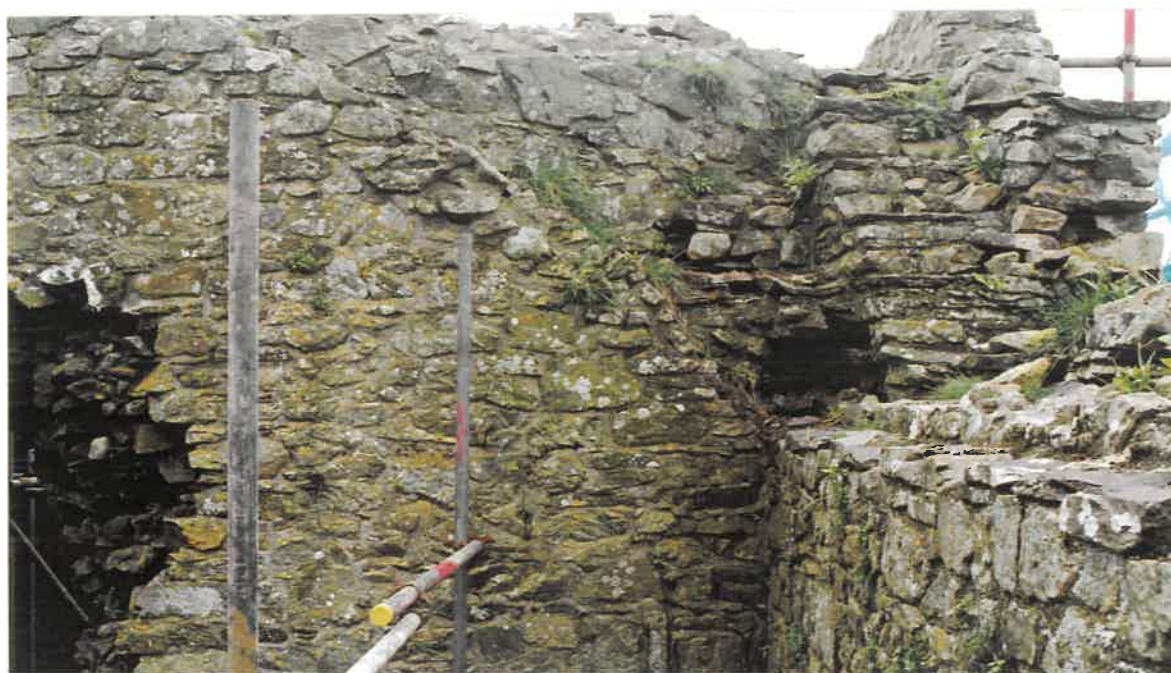
PT98/7/34A: The south-west corner of the gatehouse chamber showing the rebuilt roof-line against the south tower, with the shallow 'trough' and the socket for the wall-plate.
