St Davids Cathedral

The Cloister Project

The Archaeological Implications

17 July 2001

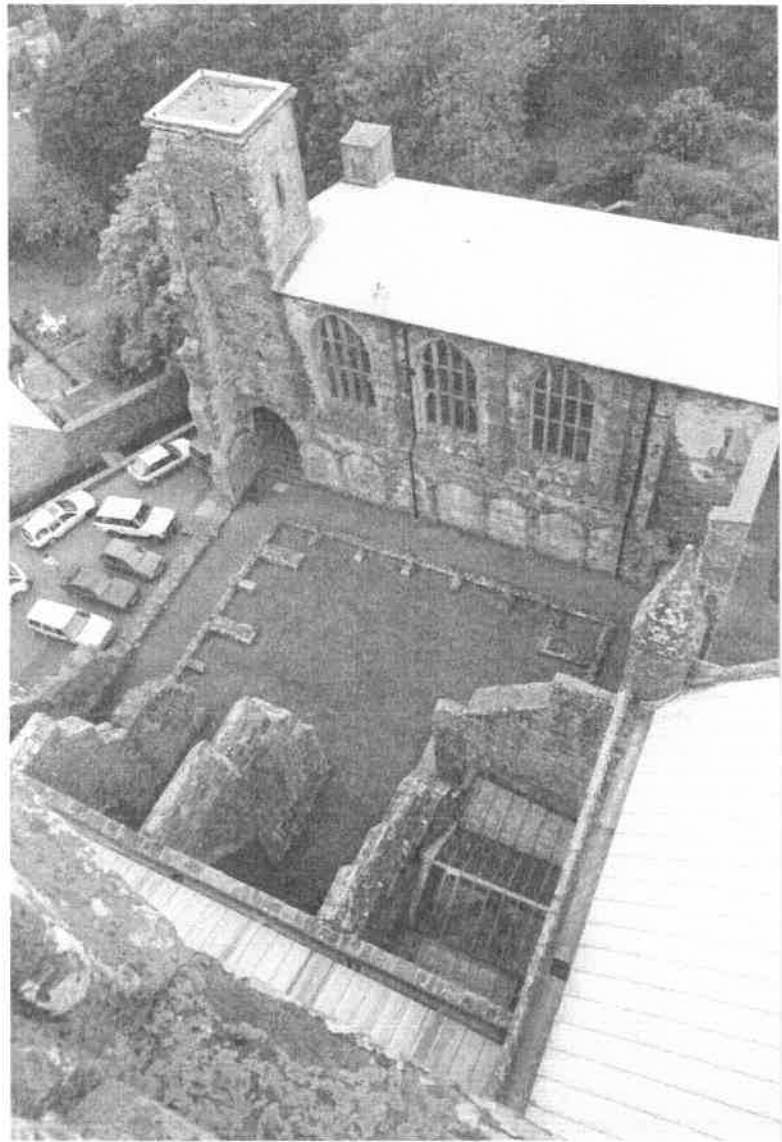
Plate 1. - The cloister and St Mary's Chapel from the central tower, looking slightly west of north. The Choir Room lies between the nearest buttresses. At top right the overgrown ruins of the NW corner of the communal buildings of the college are just visible.

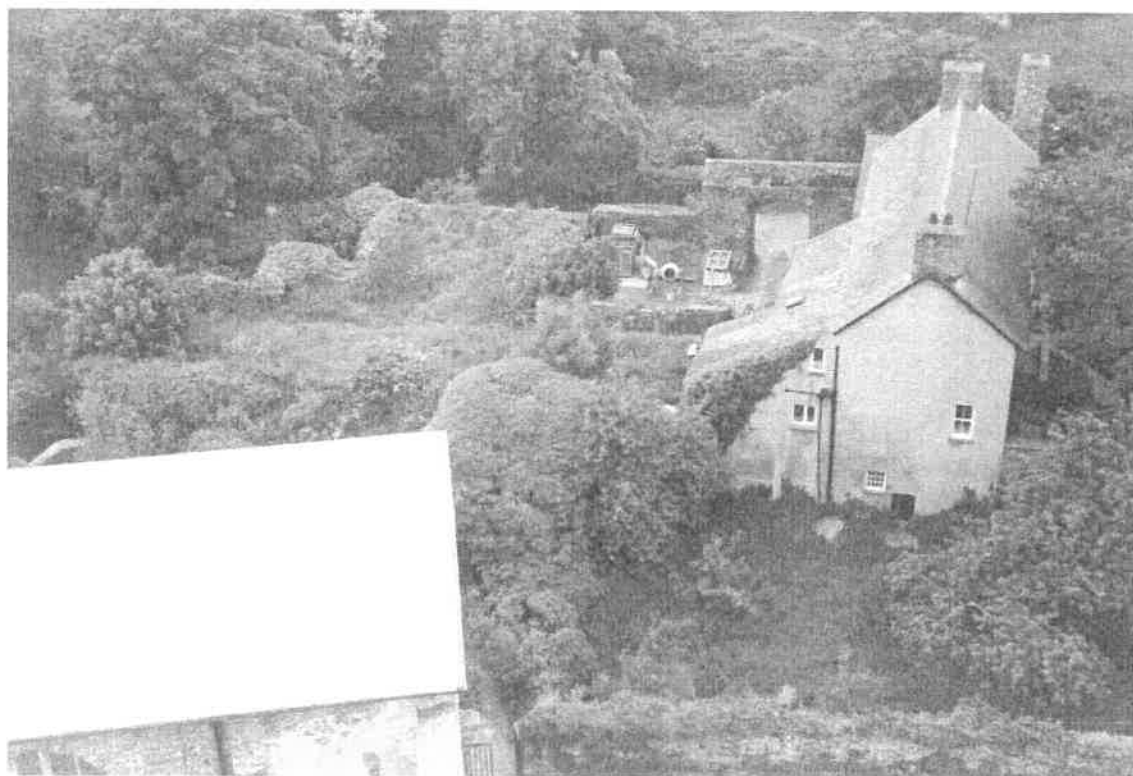
Plate 2.- The ruins of the communal buildings of the College from the central tower. The 18th century house at right, Cloister Hall, incorporates two cellars of the eastern range. The gate to the College is immediately west of the Lime Shed (which forms the northern end of the east range). The overgrown mounds to the west are the remains of the ground-floor cellars of the College buildings, the southern range apparently having been backfilled

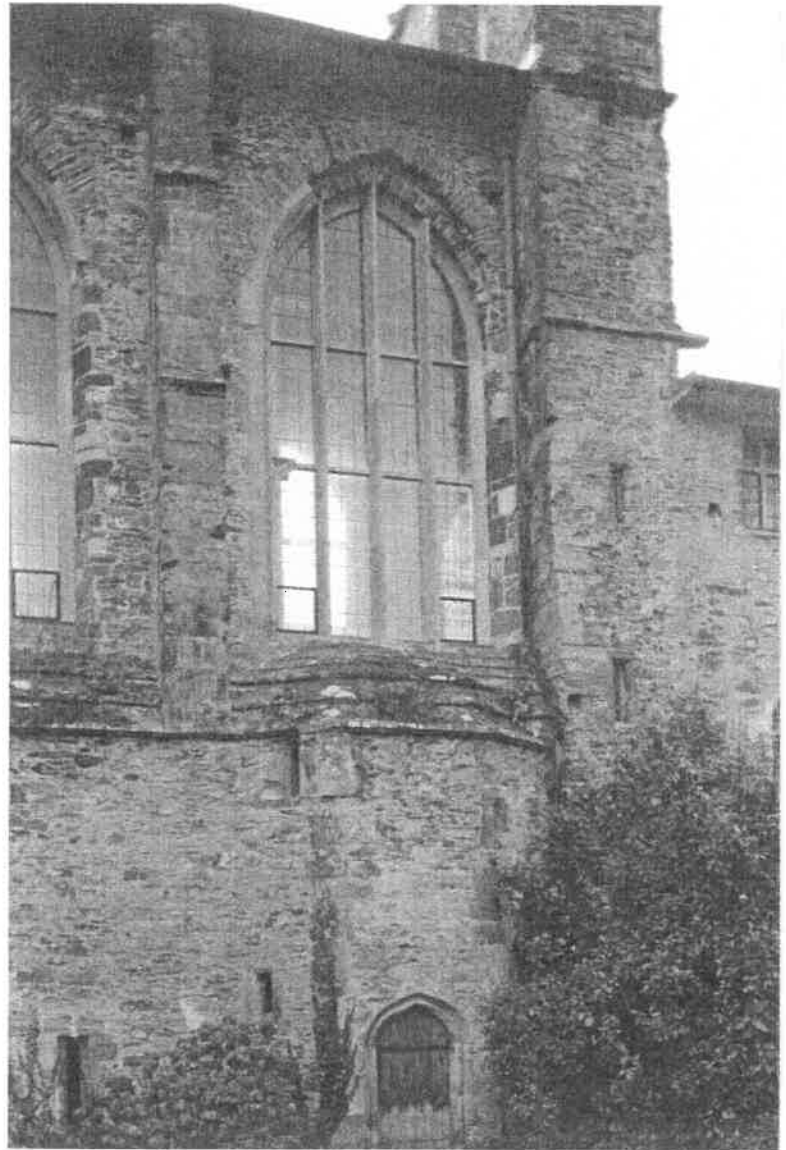
Plate 3. - The western end of the north elevation of the Chapel. Below the renewed chapel window (the eastern transom springer of the tracery remaining) is the projecting demi-hexagonal stair turret which provided direct access from the College buildings to the ante-Chapel. A short passage at the head of this stair gives access to the projecting square vice to the west which communicates with the chambers over the narthex and the roofs of the Chapel.

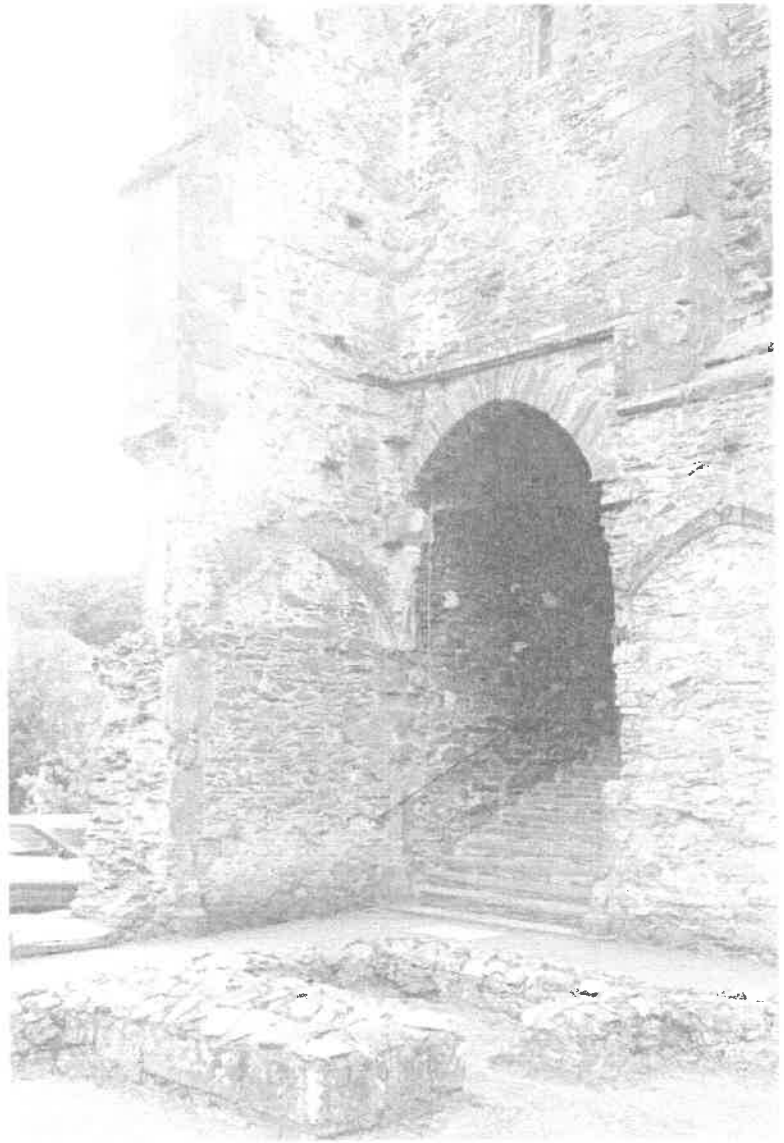
Plate 4. - The NW corner of the cloister with the entry to the narthex stair. The existing arch over the stair was rebuilt or refaced by W.D. Caroe; the medieval arch springer remains at the west. The string-course above the earliest west cloister roof passes above the narthex arch and returns onto the buttress; while the mortar scar of a higher roof can be seen above this, with a pitched line on the wall above the arch. On the west cloister wall the northern jamb of a secondary doorway can be seen in the south elevation; this door appears to have been created after the slighting of the cloister vault.

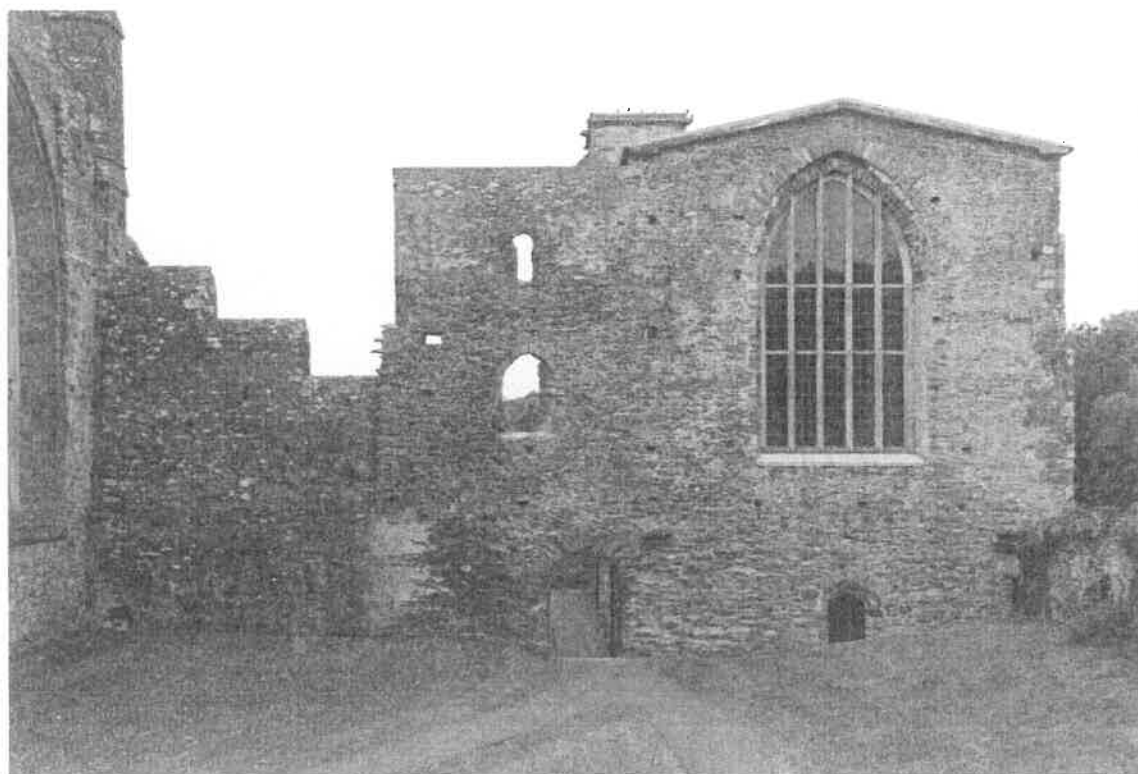
Plate 5. - The east elevation of St Mary's Chapel and cloister. Between the N Transept and the Sacristy tower the upper part of the wall consists of a post-medieval buttress, but the scar of the upper storey of the medieval cloister can be seen against the Sacristy Tower. Two massive corbels set in the east wall of the chapel may have supported a pentice roof or a first floor walkway (or both) providing access from the College to the Cathedral without passing through the Chapel. The arched opening in the east wall of the undercroft (a doorway in the 19th century) was originally a window, so in the fourteenth century there was no direct access to the undercroft from the College, suggesting that this part of the building was related to the cloister and/or cathedral, rather than the functioning of the College, which was already well provided with cellarage. The E window and roof of the Chapel are by A.D.R. Caroe.

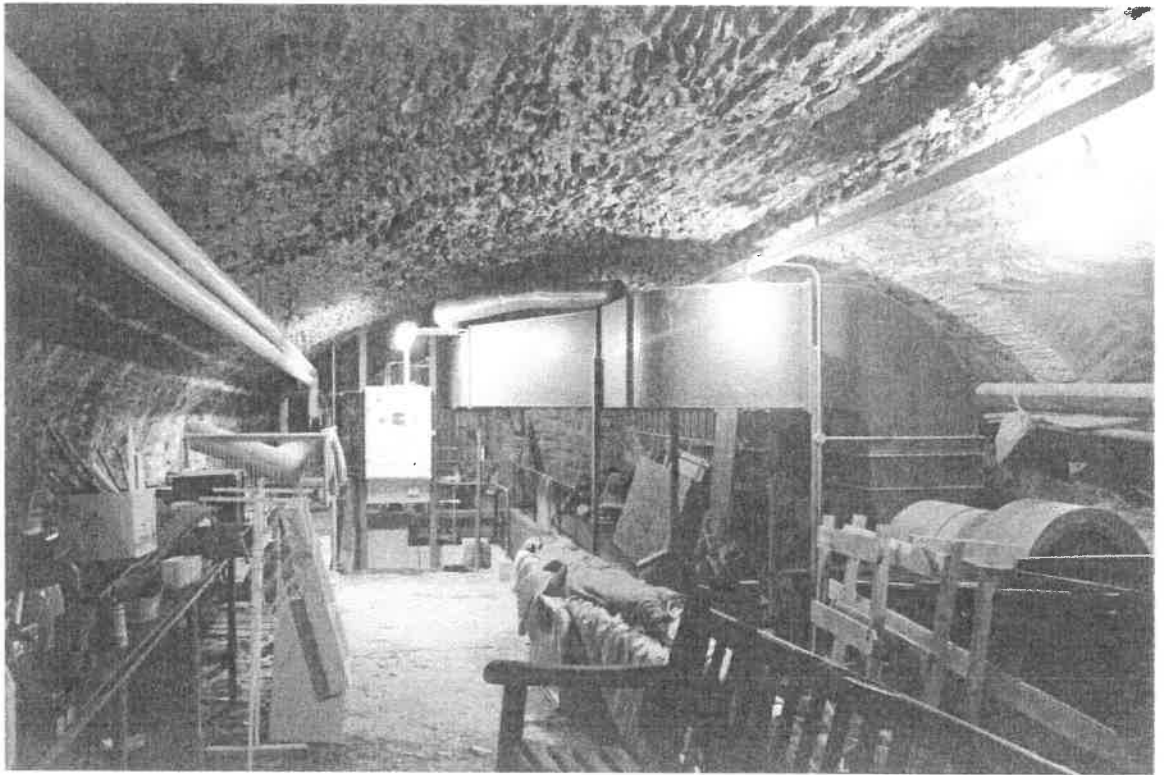
Plate 6. - The western undercroft beneath St Mary's Chapel, now used as a store and housing the heating system and its associated ducting (looking W). Discontinuities in the vaulting probably represent the phases of construction, and the impress of the shuttering of the centreing is visible (as in the Bishops' Palace). The cobbled flooring visible in the foreground appears to run beneath the later cement screed over the western floor.

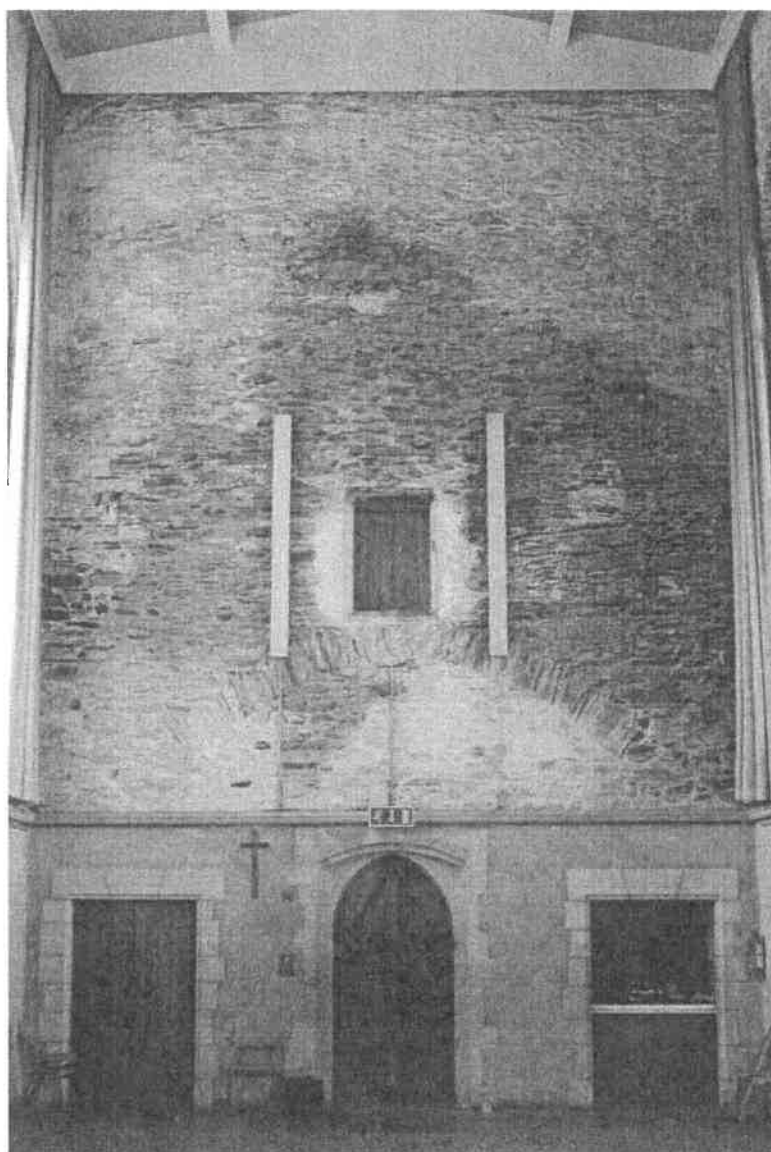
Plate 7. - The interior west end of St Mary's Chapel. The existence of the narthex and the rooms above it prevented the provision of a west window, the square opening being a window into the northern narthex room - perhaps the office of the warden with a secure muniment room in the tower base to the south. The three openings beneath (from the south: to a cupboard, the stair door, and the hatch to the kitchen) all date from A.D.R. Caroe's restoration of the building.

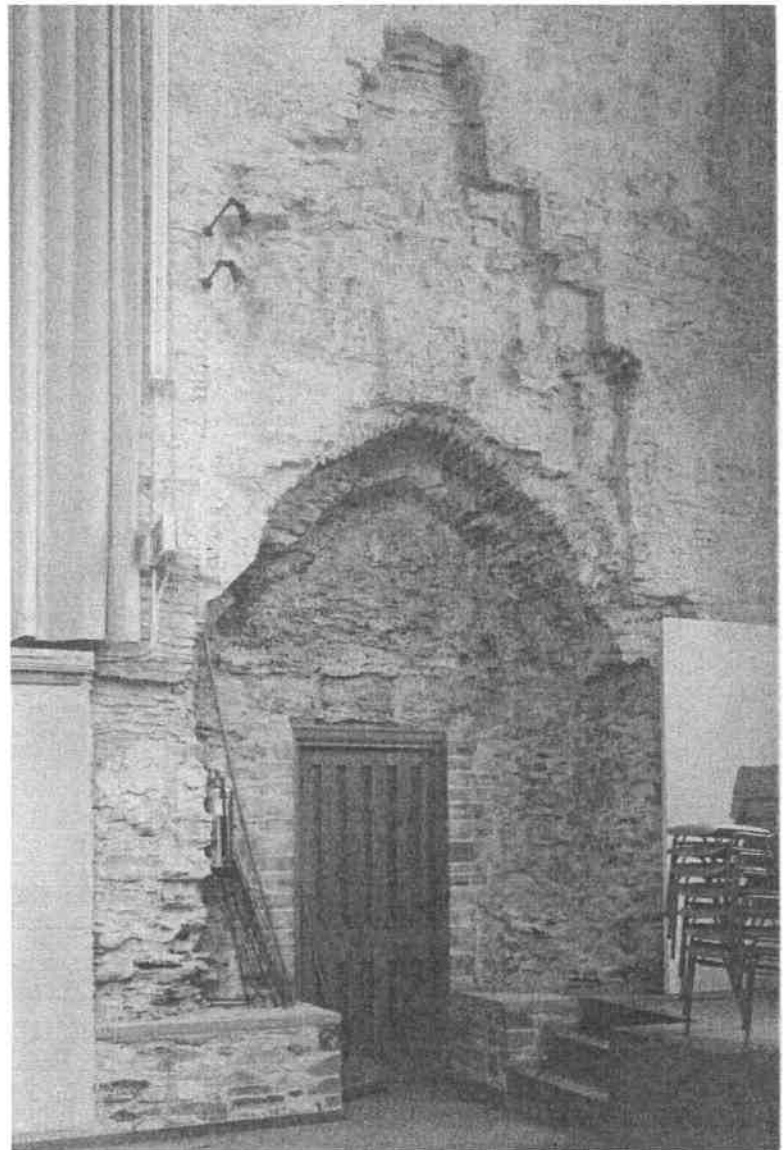
Plate 8. - St Mary's Chapel, north wall of east bay - the scar of the tomb of Bishop Houghton. The medieval floor level was at the height of the existing staging, but even so the tomb was well over 5 metres high with complex canopy work the general form of which can be inferred from the scar left by the removal of the ashlar. In the 1960s a fire escape was cut through the centre of the recess.

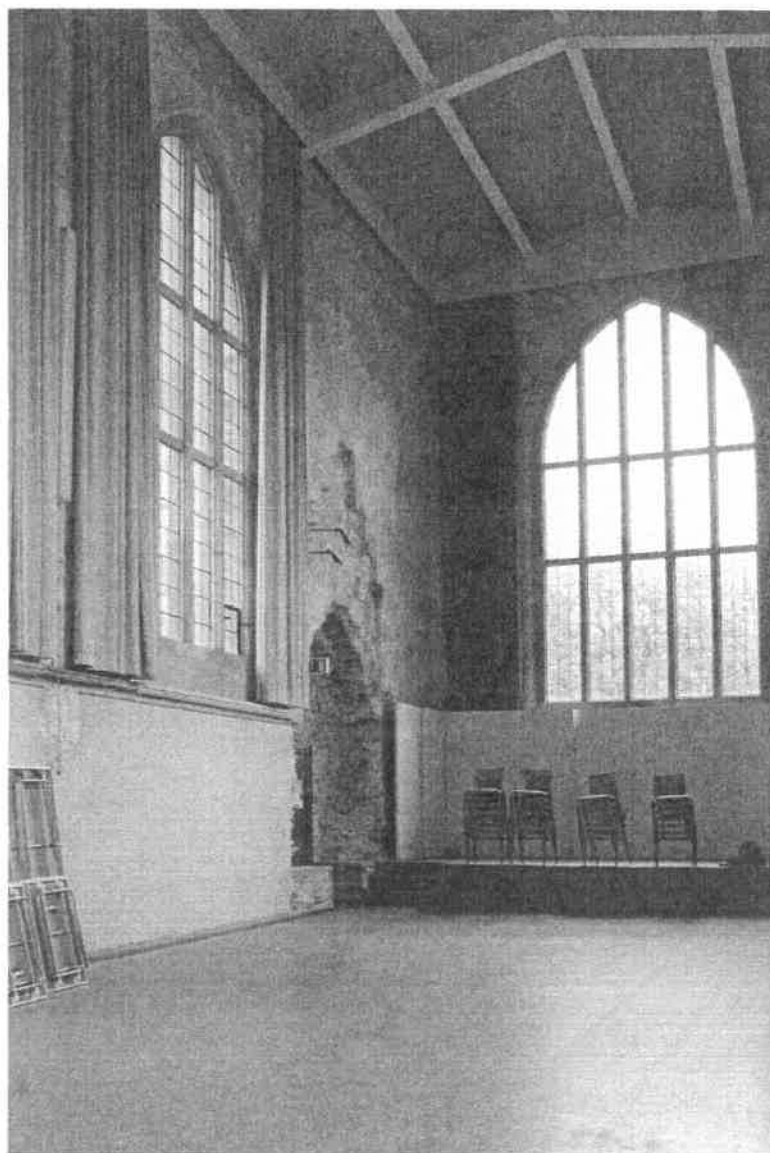
Plate 9. - St Mary's Chapel, looking ENE, with the recess of Bishop Houghton's tomb just left of centre, and the well preserved consecration cross near the left hand edge.

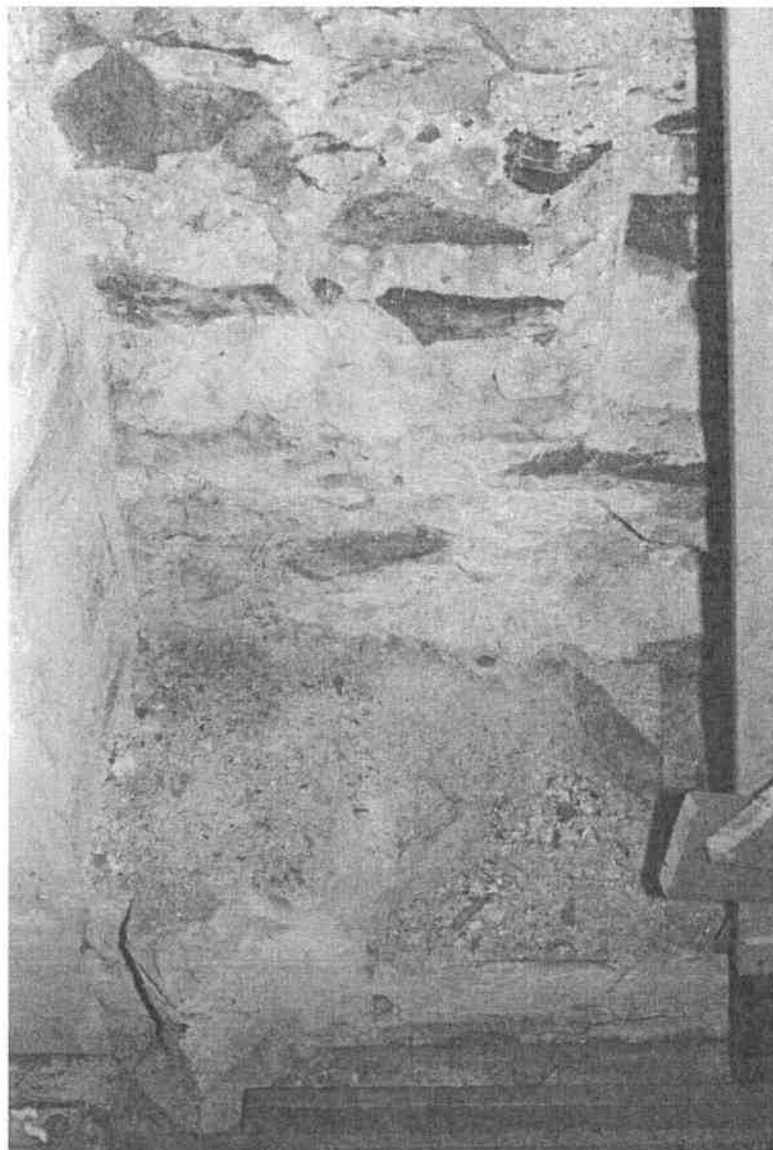
Plate 10. - The south wall of the east bay of the Chapel is unfenestrated, and originally had a doorway to the Sacristy and a lost ashlar feature (probably a piscina) to the east of this. The recess for the latter survives where the ashlars have been robbed out, but at the eastern margin of the base of the recess a fragment of the framing pilaster still remains.

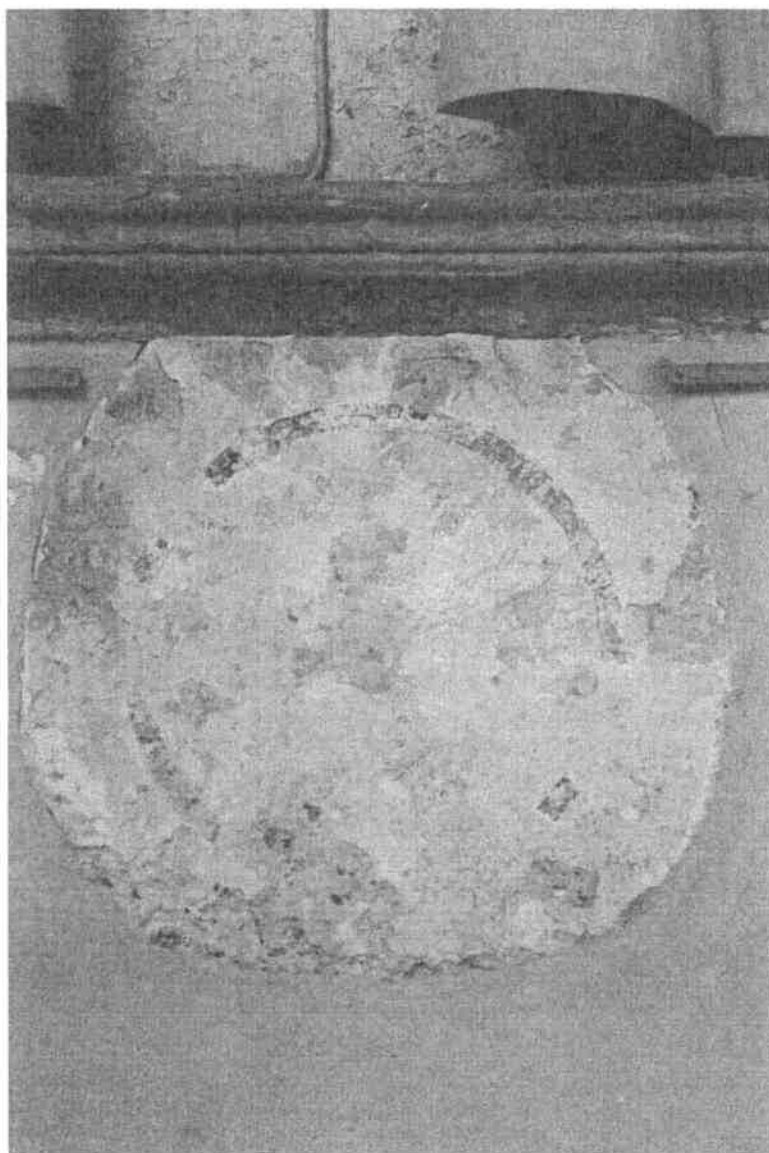
Plate 11. - The best preserved of the fourteenth century consecration crosses on the Chapel block (interior north wall) which retains not only the incised setting-out by which the others can be recognised, but also substantial traces of the painted finish.

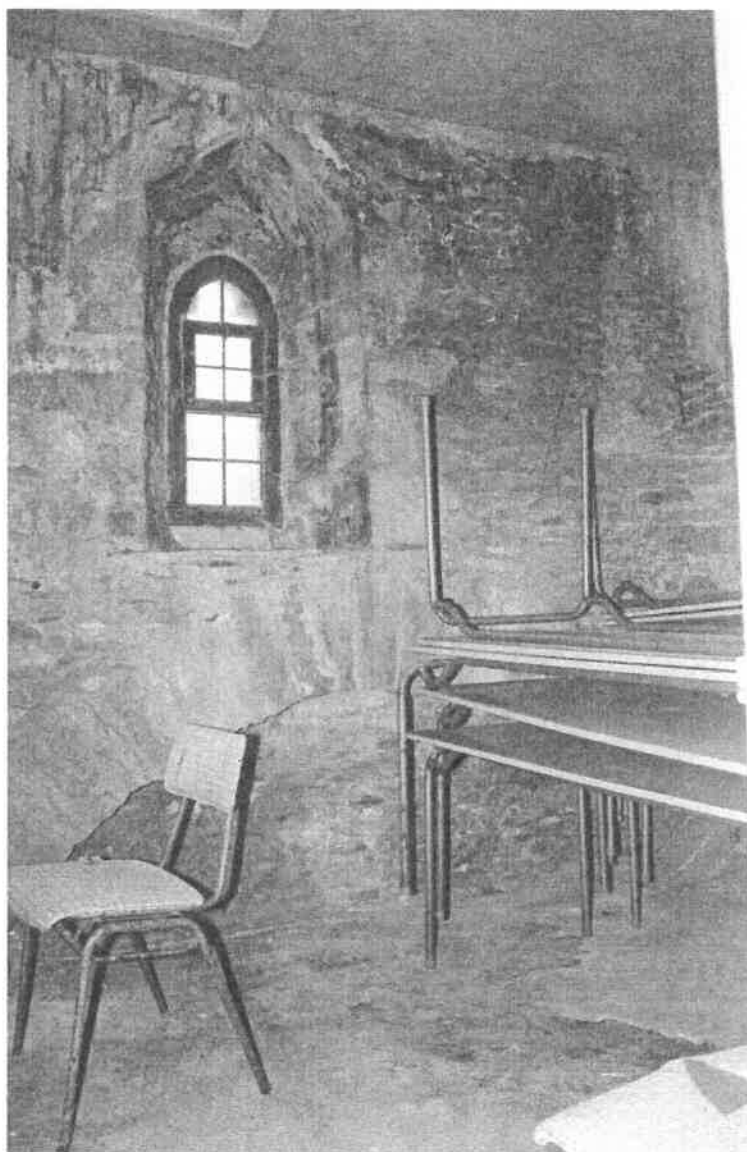
Plate 13. - Southern room above the narthex of St Mary's Chapel, looking SW, with concrete floor and roof by Caroe. One of the original constructional putlog holes can be seen at the western edge.

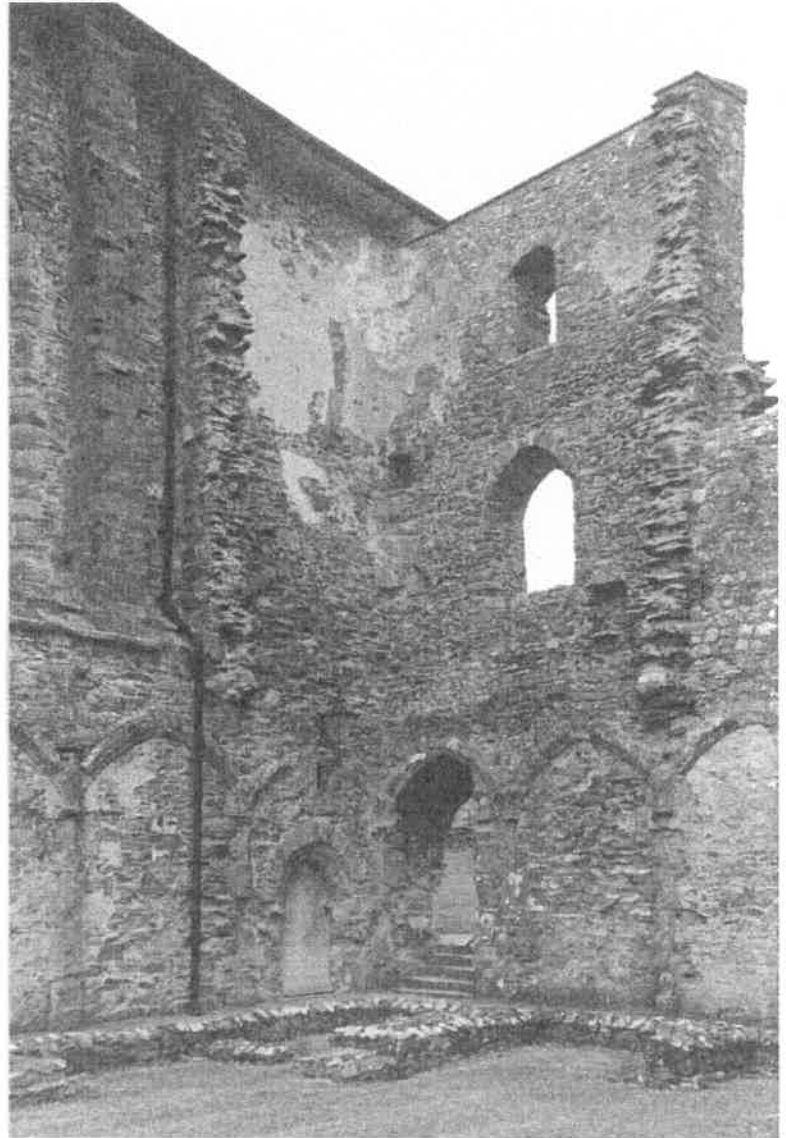
Plate 14. - The 'Sacristy Tower' at the NE corner of the cloister. The vertical scars of the walls over the cloister walks are clearly visible, and must have been carried on relieving arches similar to those carrying the tower over the narthex stair. The southward facing scar at the south end of the east wall indicates that the east cloister was of two storeys to the south of the Sacristy Tower, and may have incorporated a first-floor access into the North Transept, since there are redundant corbels within the latter at this height. The door in the north cloister leads to the undercroft of St Mary's, that in the east walk leads to the NE churchyard and the College.

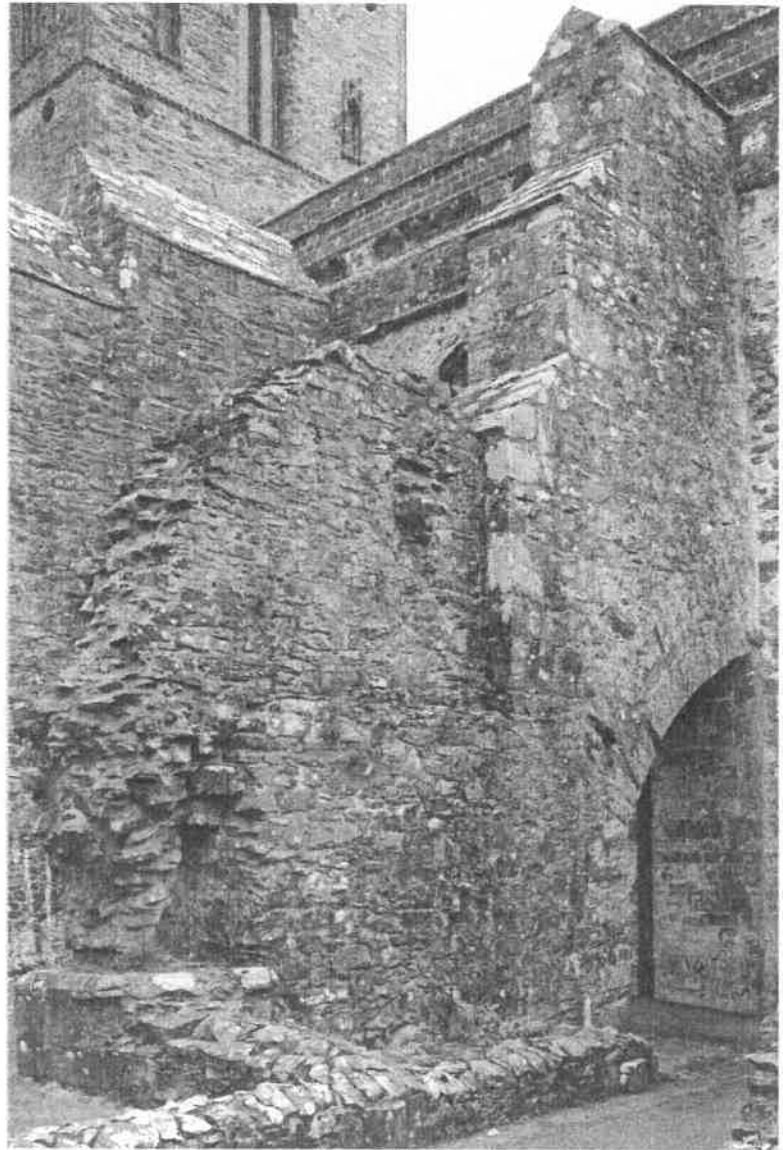
Plate 15. - West cloister, junction of the later rebuilding with the nave buttress, looking SE. The phasing here is difficult to establish, but the lower part of the nave buttress oversails the projecting buttress of the west cloister walk, and a second phase of walling has been superimposed on this, the latter incorporating a wall running E-W at first floor level just north of the face of the nave buttress. The projecting stub of the latter can be seen in this view.

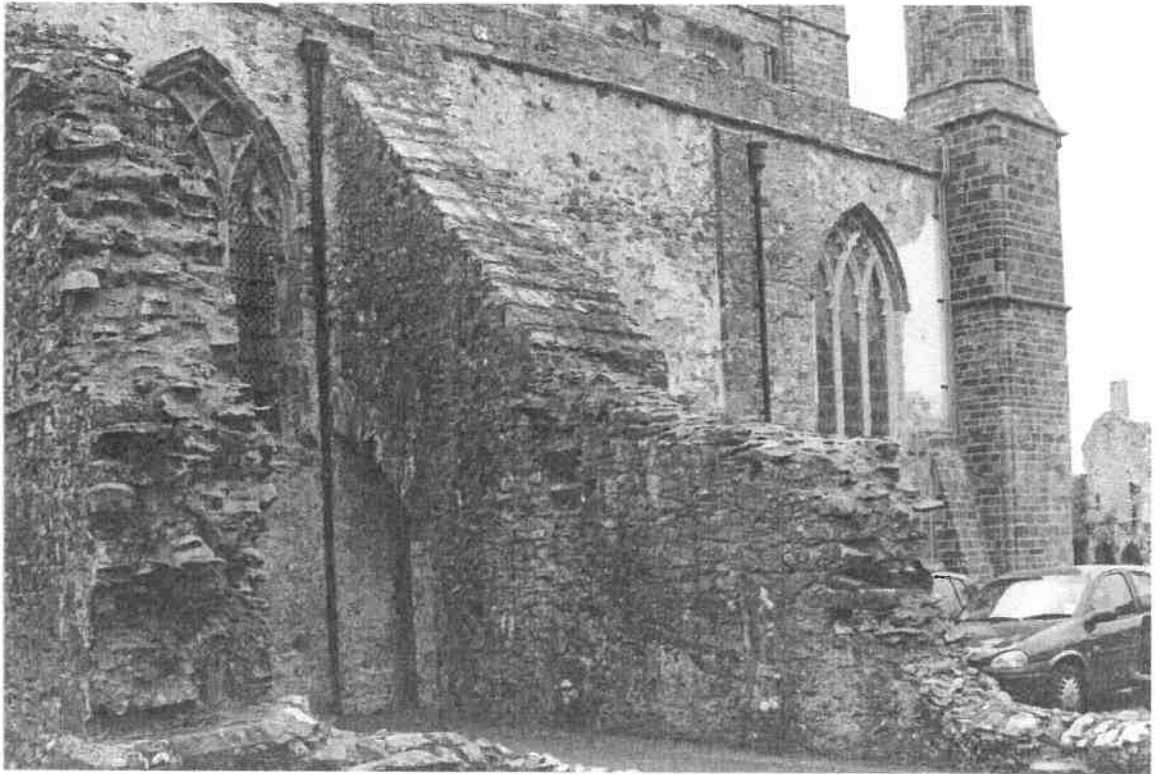
Plate 16. - West cloister, junction with western nave buttress. The remains of two shafts of the wall arcade remain, the southern of these later replaced by the springing of a low arch on the same line as the first floor wall stub on the buttress to the east.

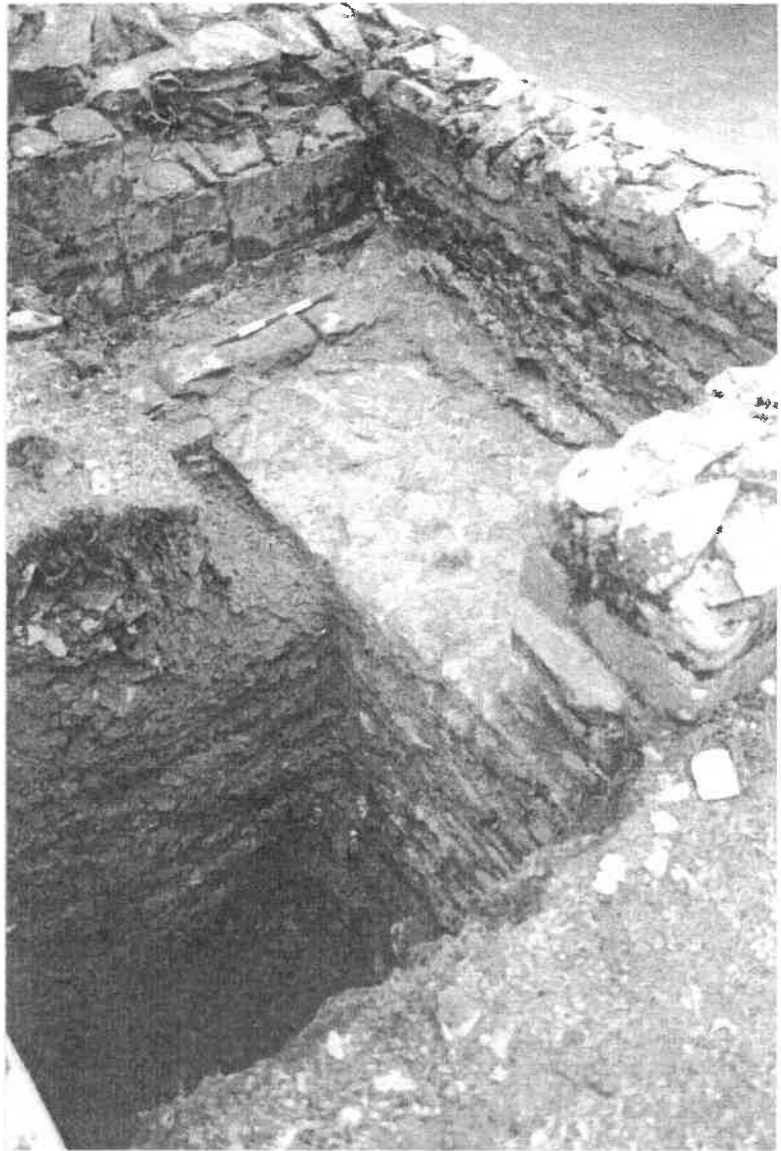
Plate 17. - Test Pit 3 (1998) against the east face of the west cloister pentice wall immediately north of the second nave buttress from the west exposed a massive wall built on dark maroon clay natural.

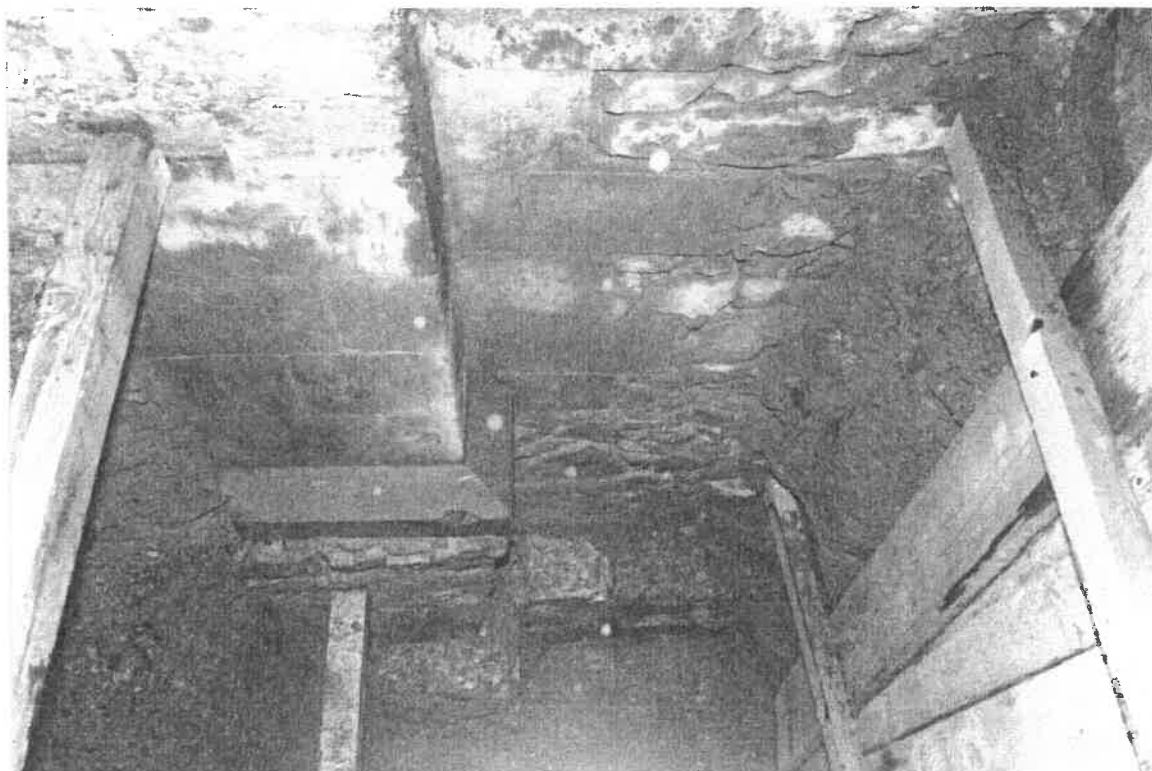
Plate 18. - Test Pit 4 (1998) against the north wall of the cathedral exposed a well finished ashlar wall with a fine plinth well below the level of the nave door immediately to the west. The water-level at the base of the pit is well above the bottom of the foundation, which rests on gravel and loose stone natural.
