Aberglasney Mansion, Llangathen, Carmarthenshire.

Archaeological Watching Brief

CAP Report No. 370

Date: 16th May 2005

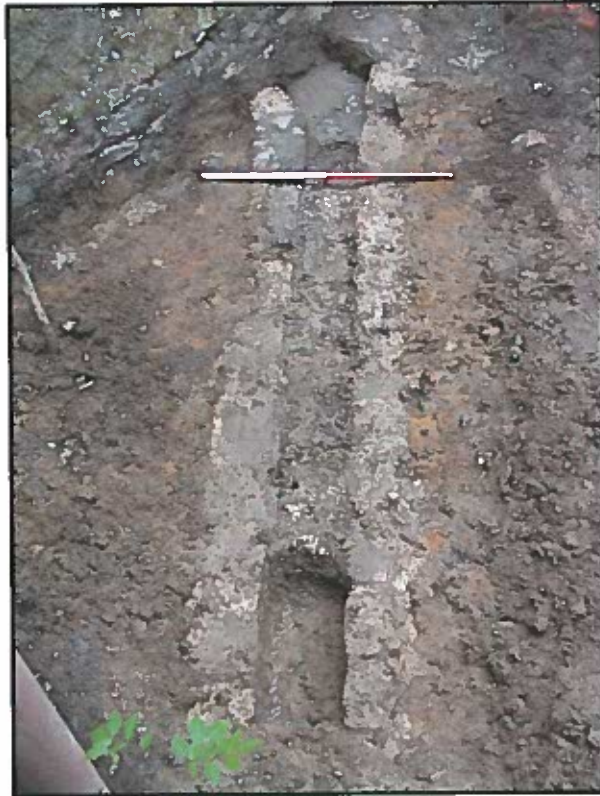
Plate 01: Exposed rain overflow culvert in Area 9 (Looking northward)

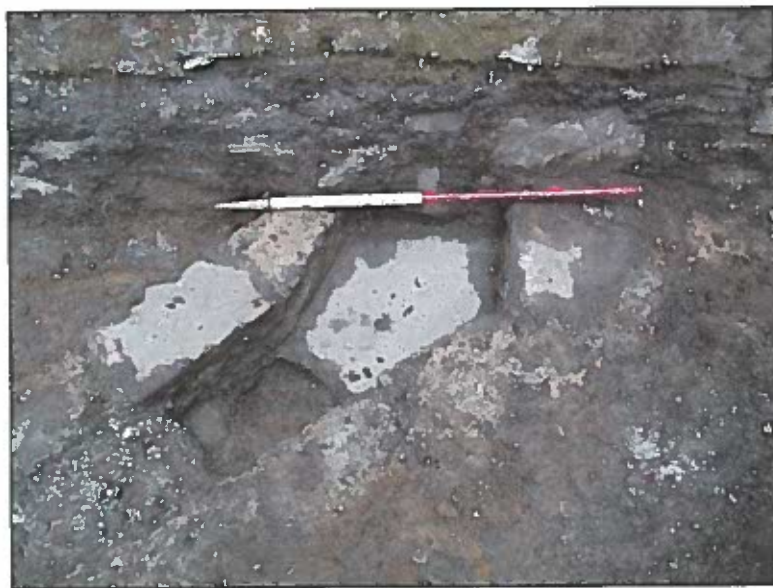
Plate 02: Part of exposed rain overflow culvert in Area 9 (Looking north-west)

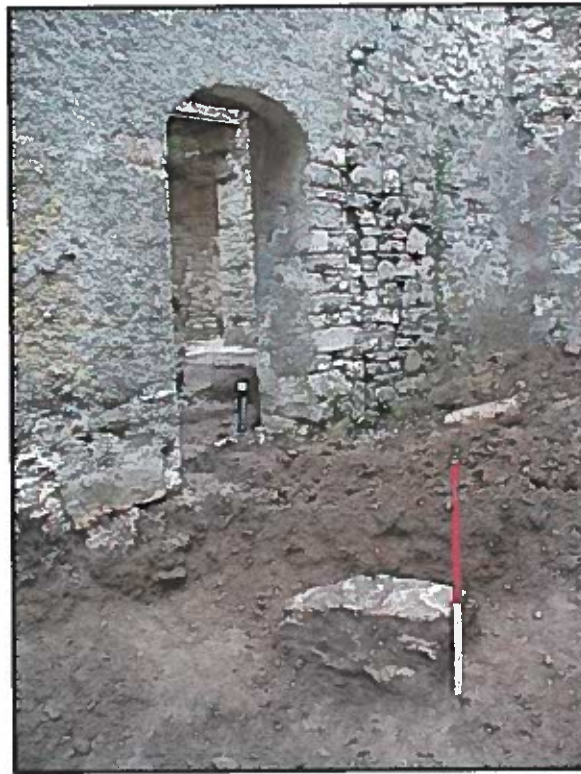
Plate 03: Remains of stone stump fully exposed in Area 9 (looking eastwards)

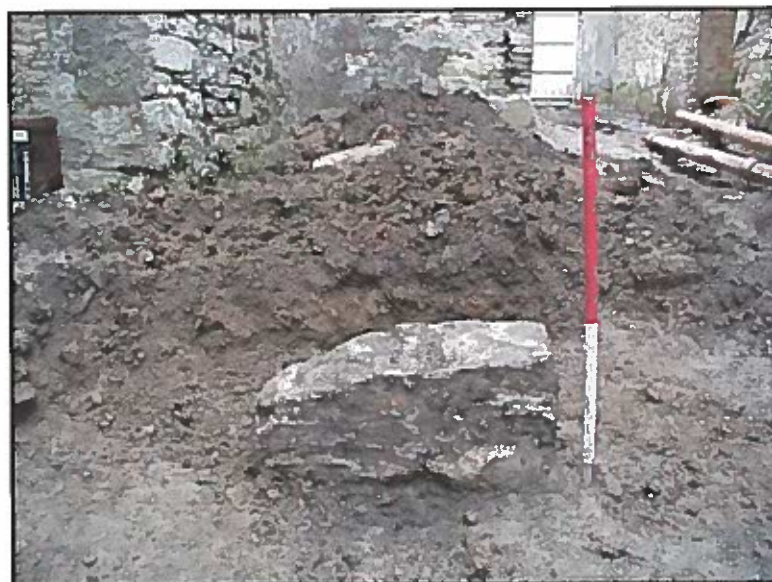
Plate 04: Remains of mortared stone stump exposed in Area 9 (looking south-east)

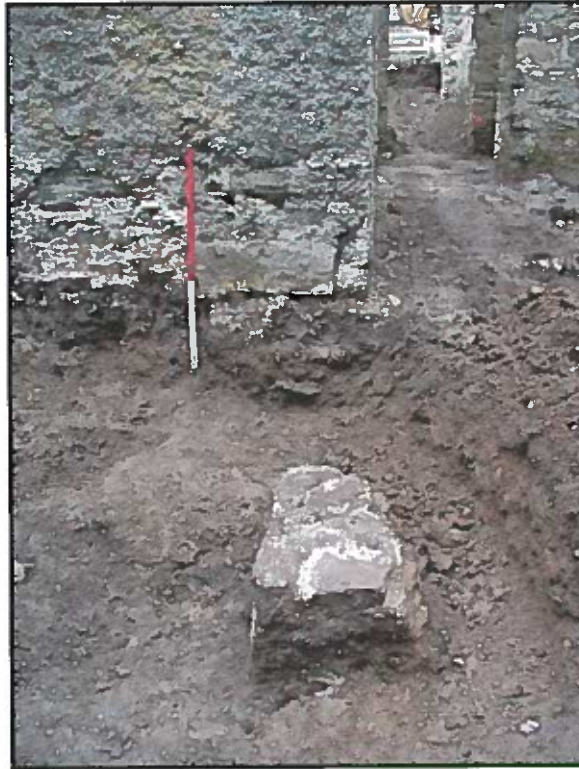
Plate 05: *Remains of stone stump fully exposed and east side wall in Area 9 (looking north-eastwards).*

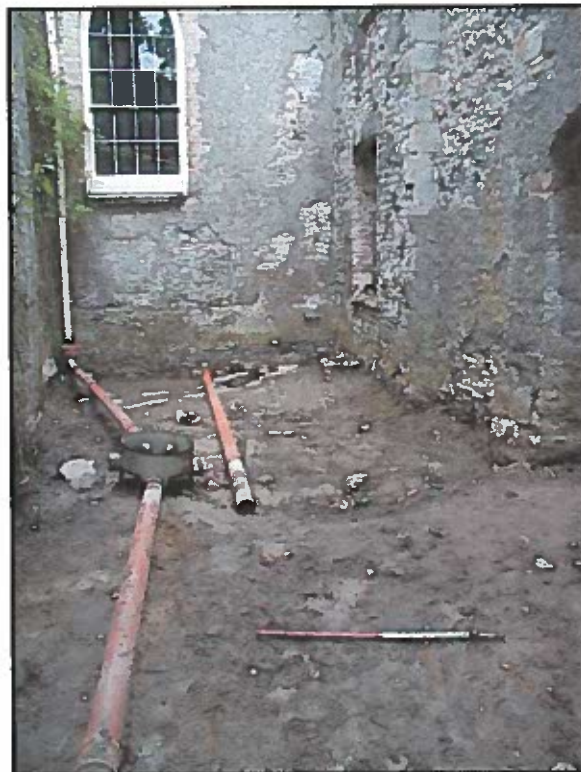
Plate 06: *Area 9 after reduction of ground level (looking northwards).*

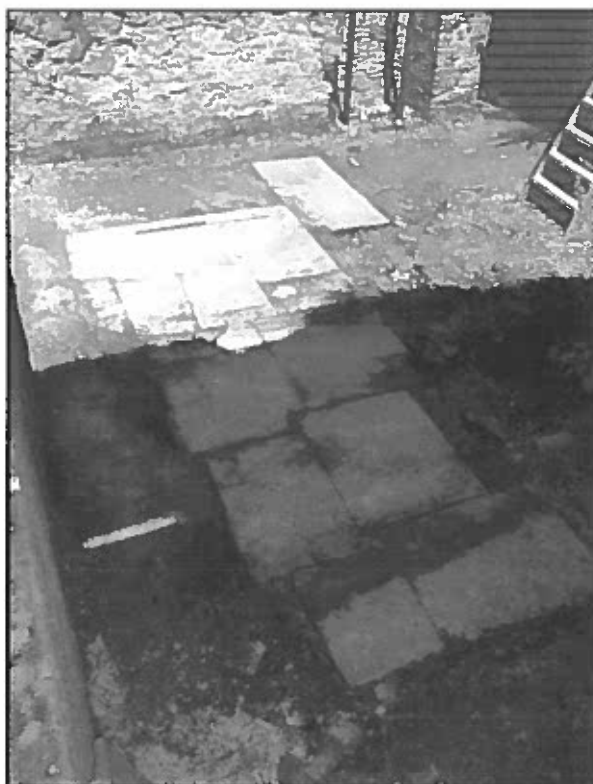
Plate 07: *Remains of exposed sandstone slabbed floor in Room 8 (looking northwards).*

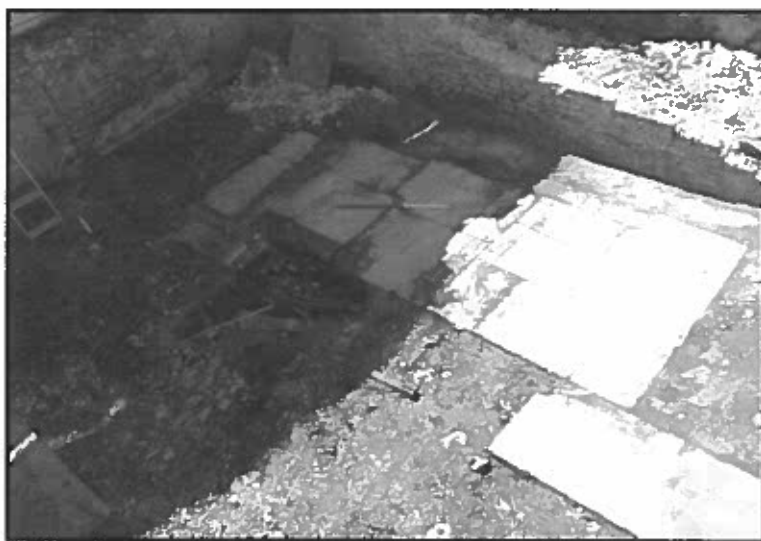
Plate 08: *Remains of exposed sandstone slabbed floor in Room 8 (looking southwards).*

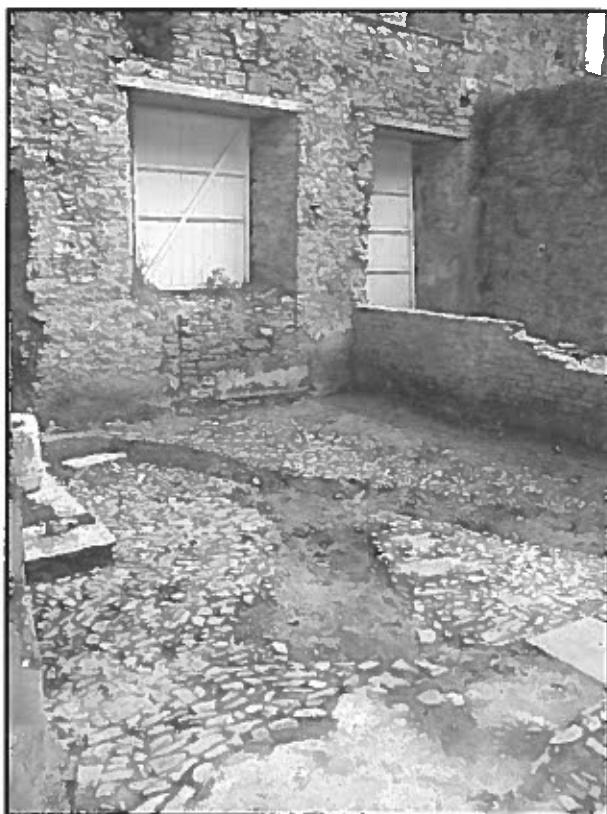
Plate 09: *Exposed cobbled floor in Room 8 (looking southwards).*

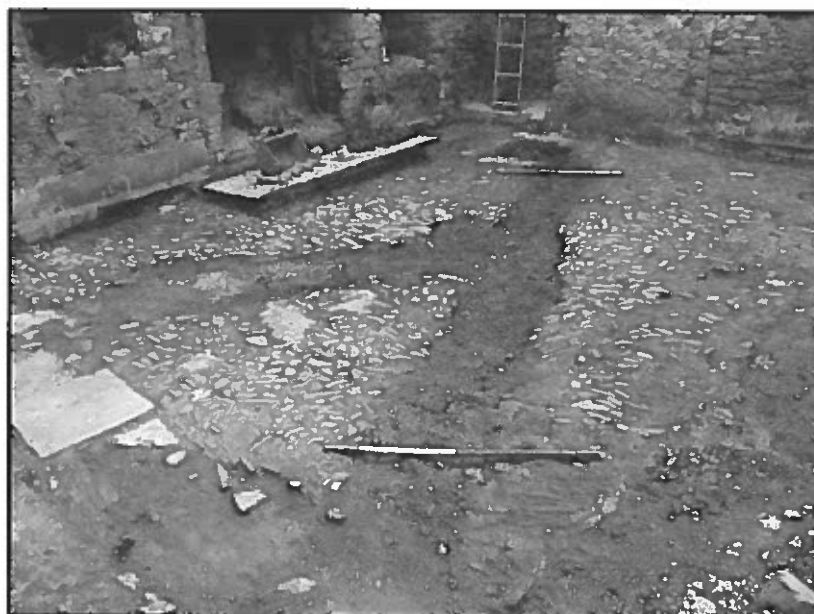
Plate 10: *Remains of exposed cobbled floor in Room 8 (looking eastwards).*

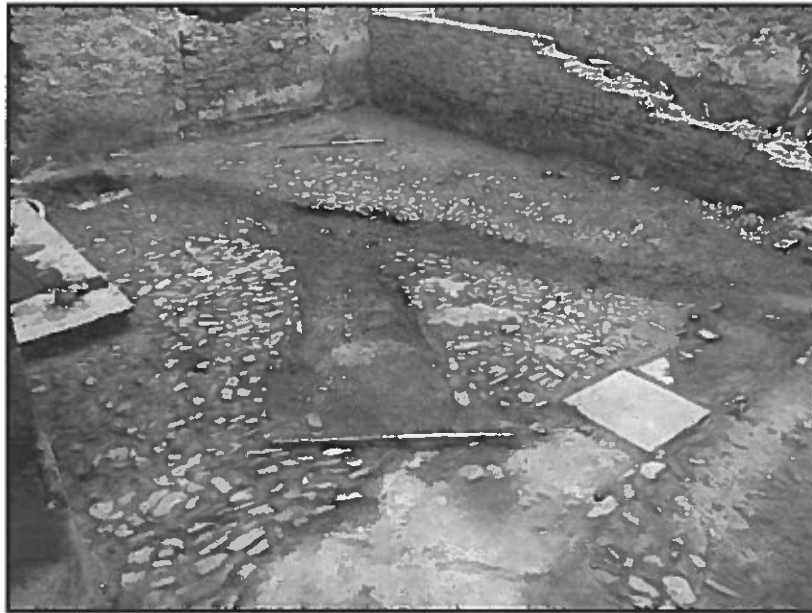
Plate 11: *Exposed cobble floor in Room 8 (looking southwards).*

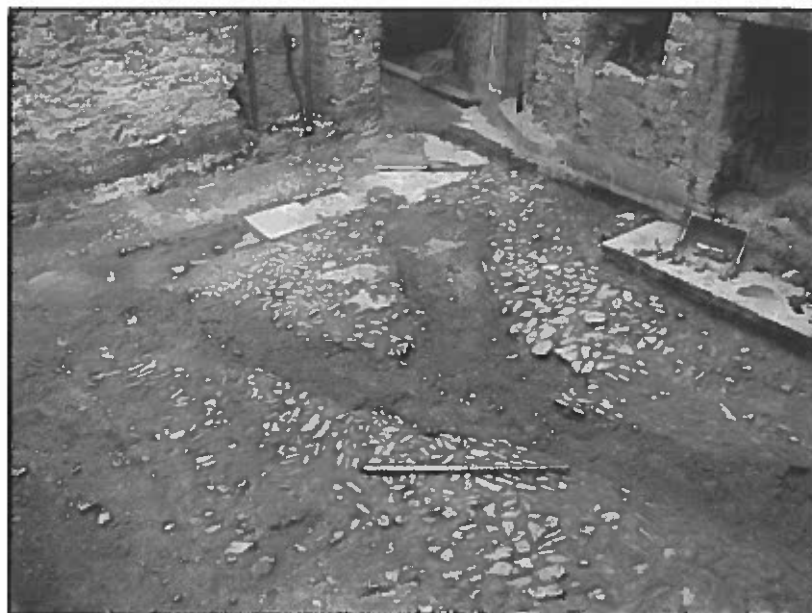
Plate 12: *Remains of exposed cobbled floor in Room 8 (looking northwards).*

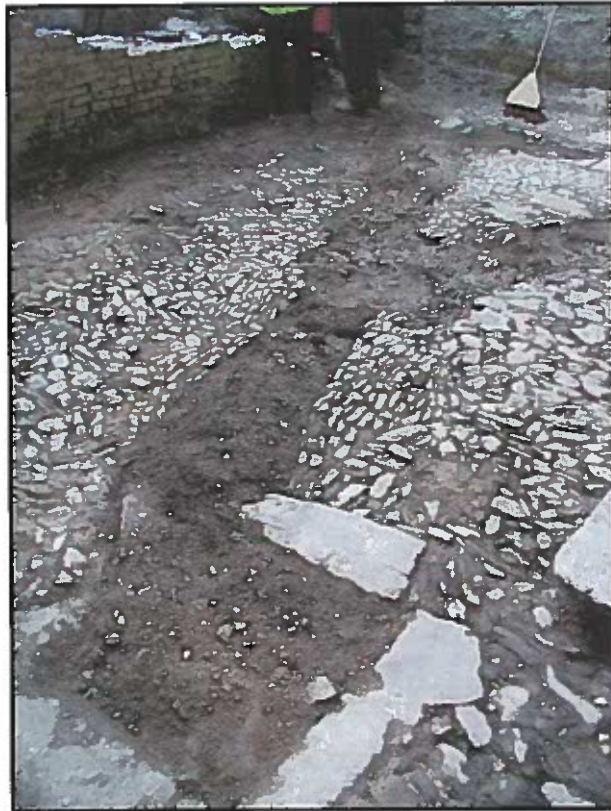
Plate 13: Exposed cobble floor in Room 8 (looking westwards).

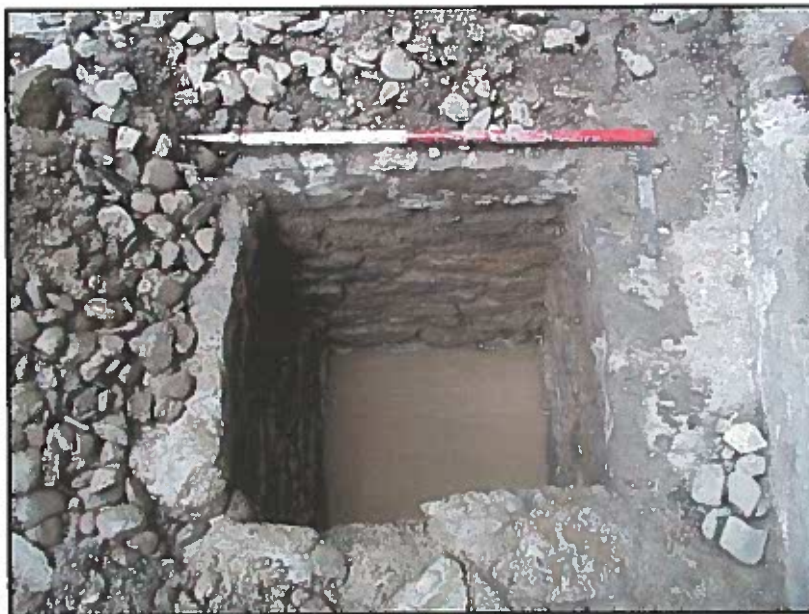
The fill of this well was removed by hand, which caused problems as the well/spring was continuously filling with water. This fill was significant in terms of its character, as its uppermost deposit consisted of river pebbles (3.12), the largest being approx. 0.20m in diameter, and the smallest approx. 0.04m in diameter. This deposit continued for approx. 0.60m, but finally cleared whereupon a thin deposit of fine grit/sand/charcoal/mortar was reached (3.13). Following this a 0.30m thick deposit of rubble was removed (3.14). Below this was a further residual deposit of silty grit and sludge, as would have been expected (3.15). Within this last thin deposit was discovered small fragments of window lead, window glass, a few animal bones (part of a sheep's jaw and bird bones), and two small fragments of blue-white ceramic, one of these marked with the word 'Victory' above the mast of a ship with an English flag. This suggests a portion of an early 1800's Commemorative pot. Although this dateable material doesn't give a precise date for the construction of the well and cobbled floor, it does however give us a potential date for the fill of the well, and as such suggests that the well/spring pre-dates the 1800's. The bedrock base of the well was reached at approx. 0.90m in depth. No deliberately constructed water inlets were exposed at the base of the well. Water seemed to percolate through the base of the side walls and the bedrock itself, mainly from the north-east side.

Plate 14: Exposed sunken well/spring within cobbled floor in Room 8.
Note removed river pebble fill at side

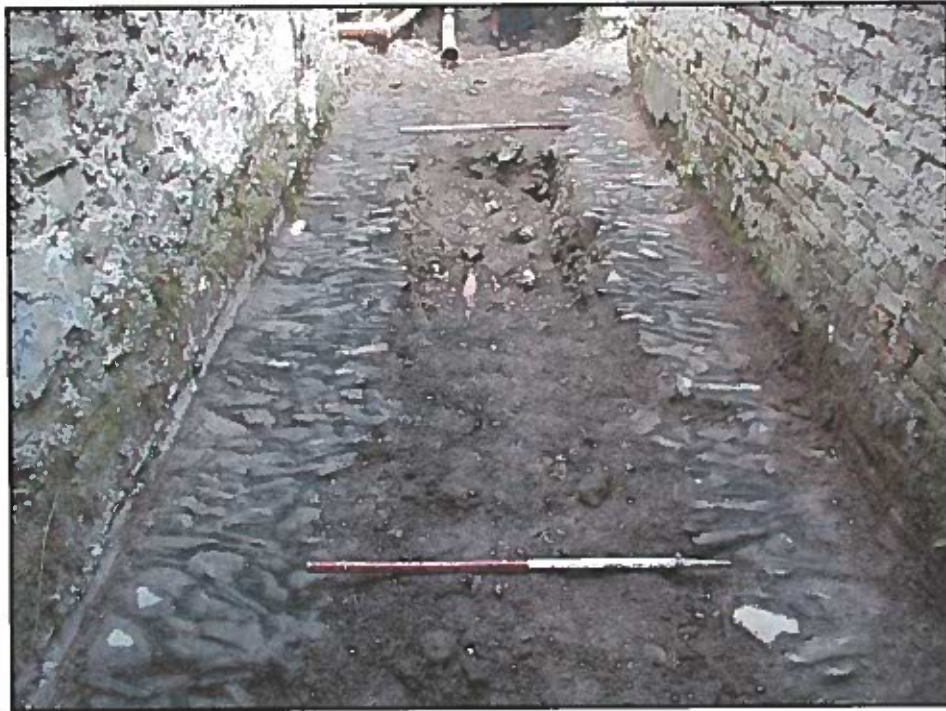
Plate 15: Exposed cobble floor in Area 10 (looking north-west).

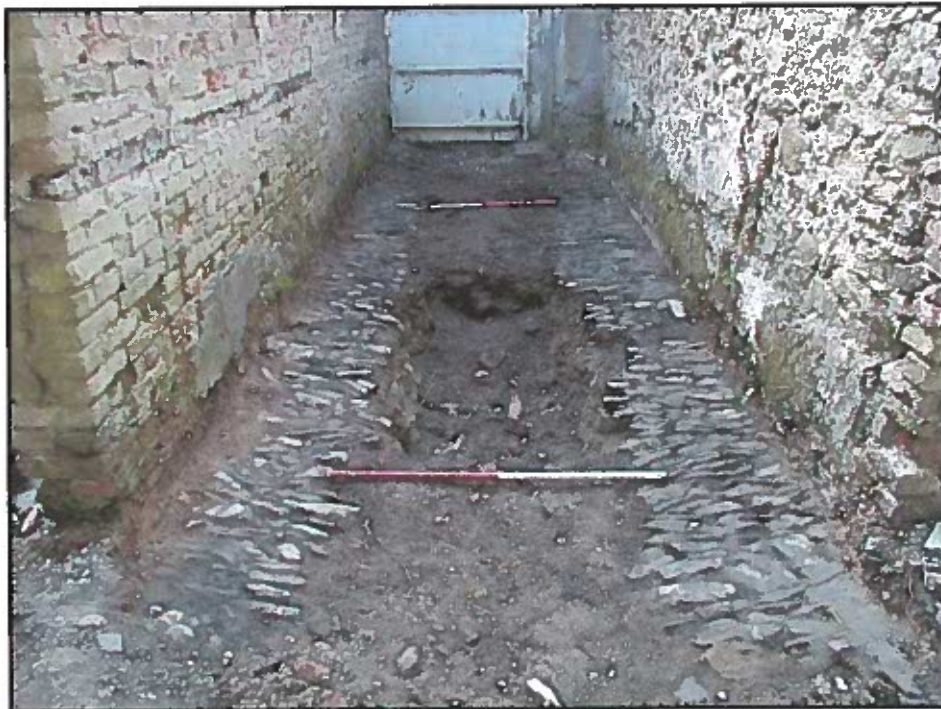
Plate 16: Exposed cobble floor in Area 10 (looking south-east).

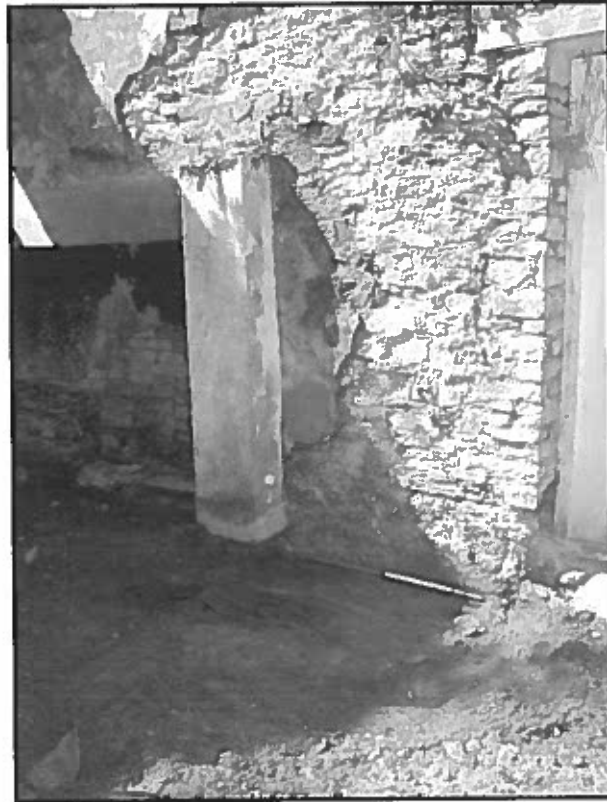
Plate 17: *Remains of patch of cobbled floor in Room 11 (looking south).*

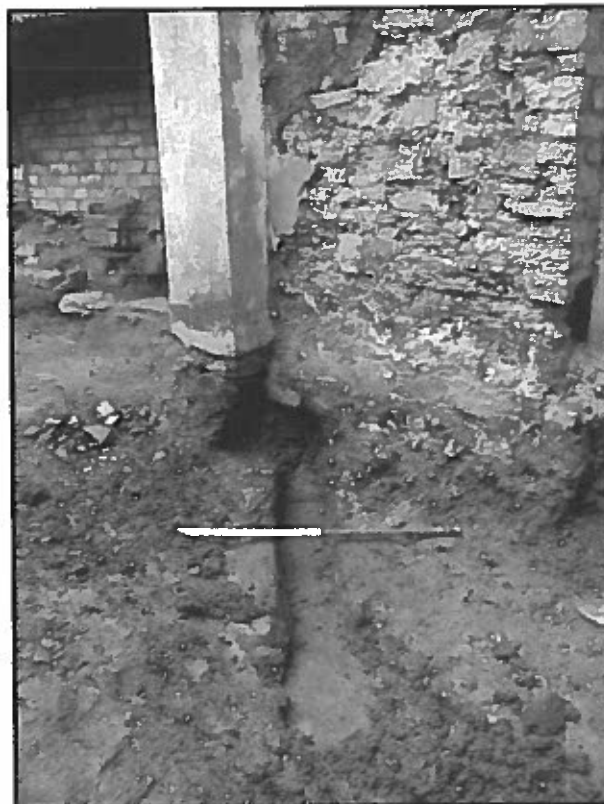
Plate 18: *Remains of culvert channel exposed beneath patch of cobbles (looking south).*

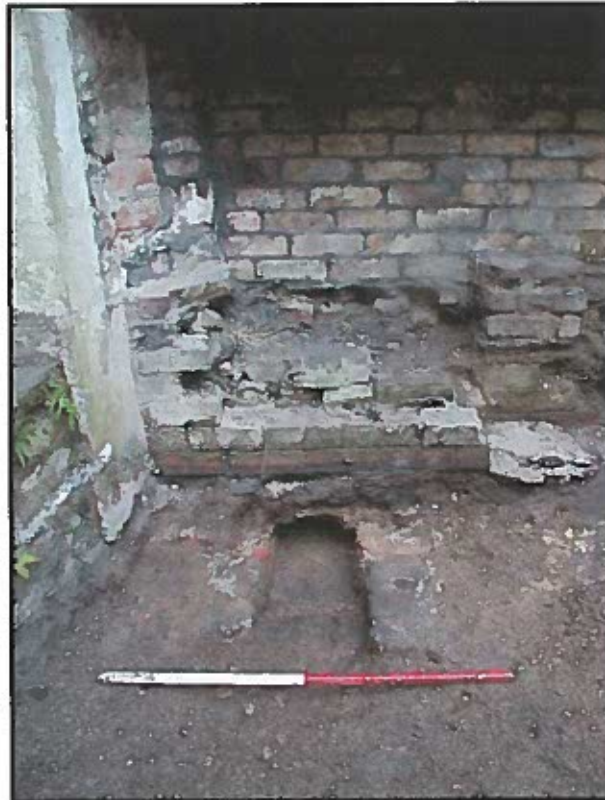
Plate 19: Remains of exposed air duct for brick oven in earlier hearth (looking south-west).

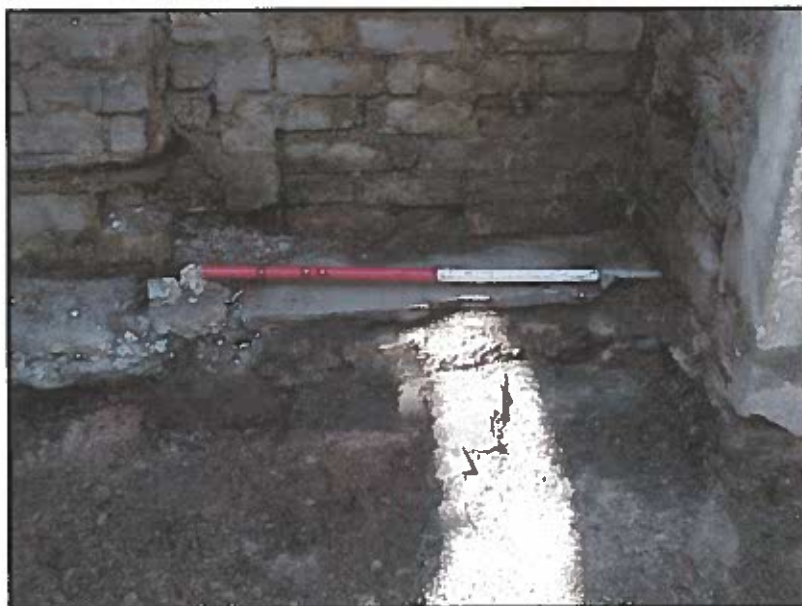
Plate 20: Remains of exposed earlier hearth beneath later hearth in Room 11 (looking south-west)

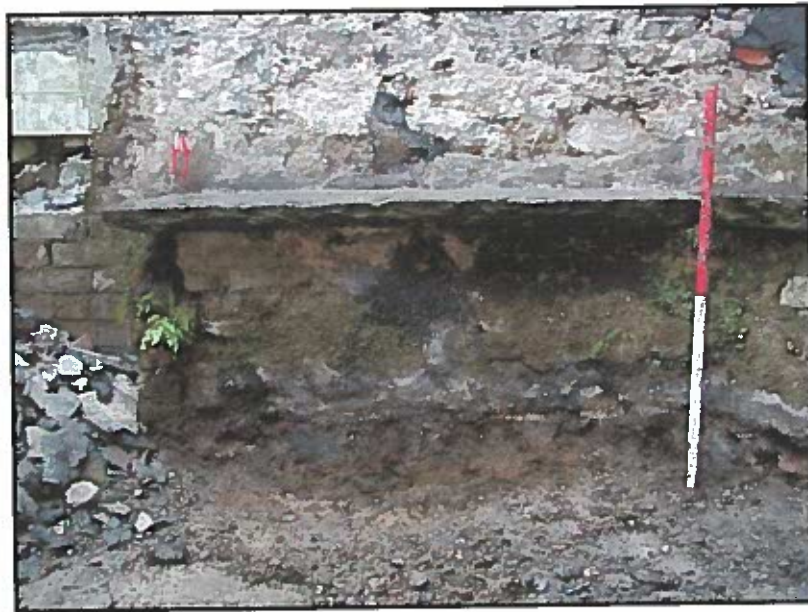
Plate 21: Remains of possible former cobbled floor exposed beneath later stone seat arrangement in Room 11 (looking south-east).

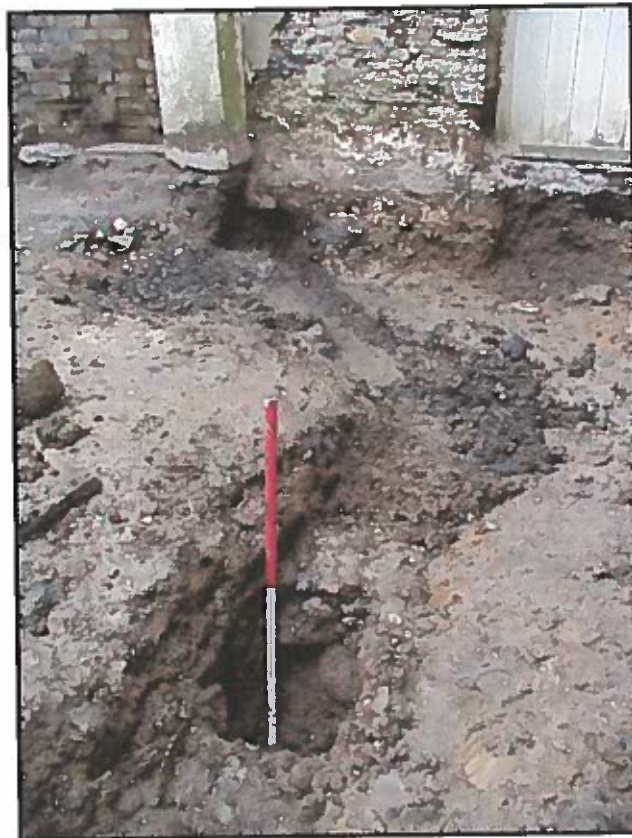
Plate 22: Rubble-fill section removed from cut trench (possible drainage sump). (looking south)

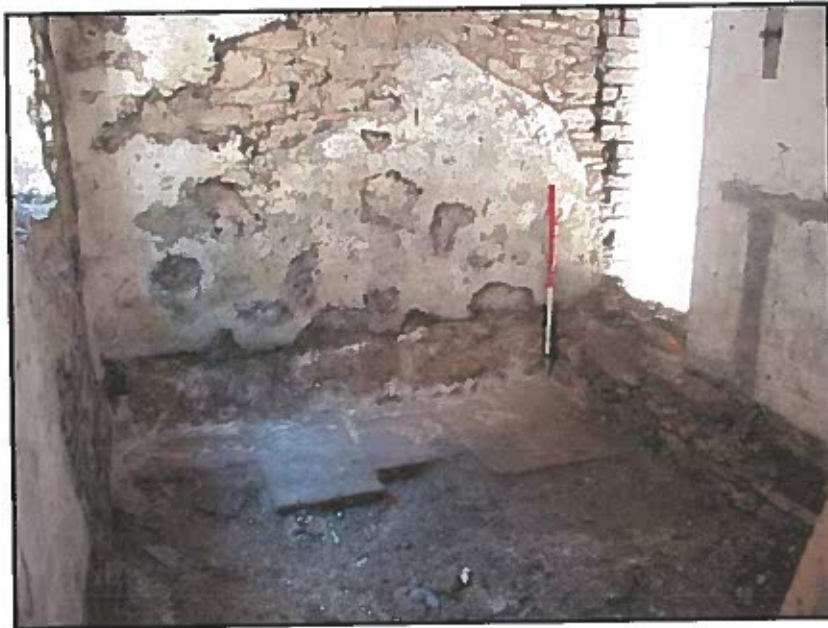
Plate 23: Remains of exposed sandstone slabbed floor in Room 14 (looking south-east).

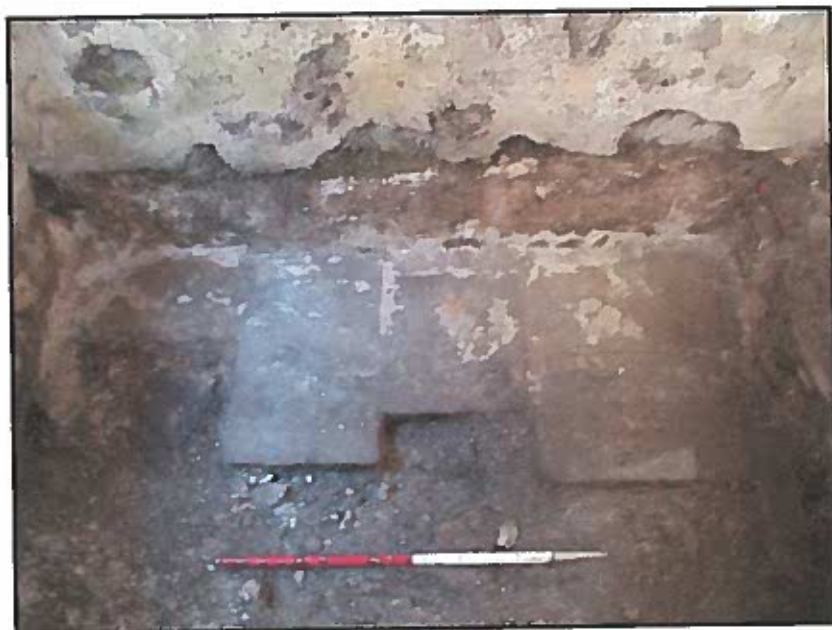
Plate 24: Remains of exposed sandstone slabbed floor in Room 14 (looking south).

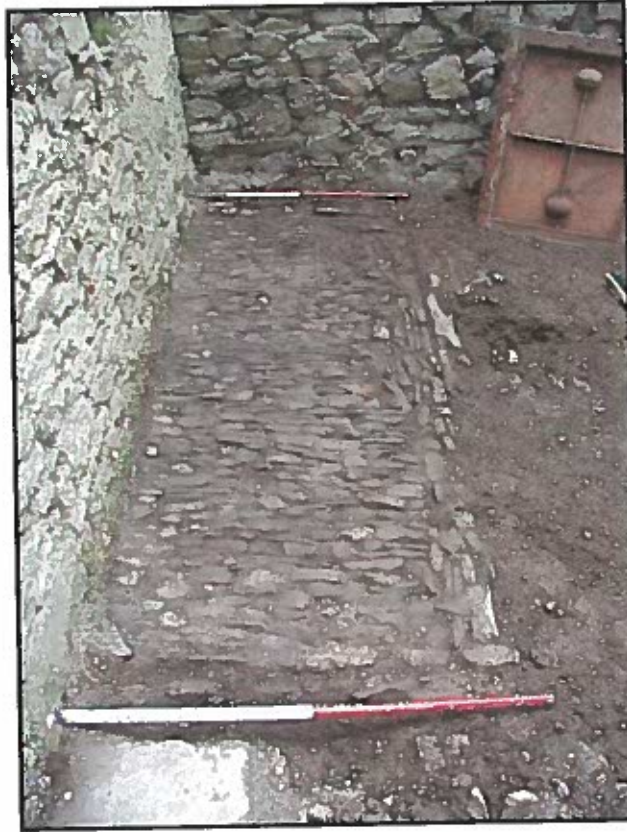
Plate 25: Remains of exposed cobbled floor in Area 6 (looking south-west).

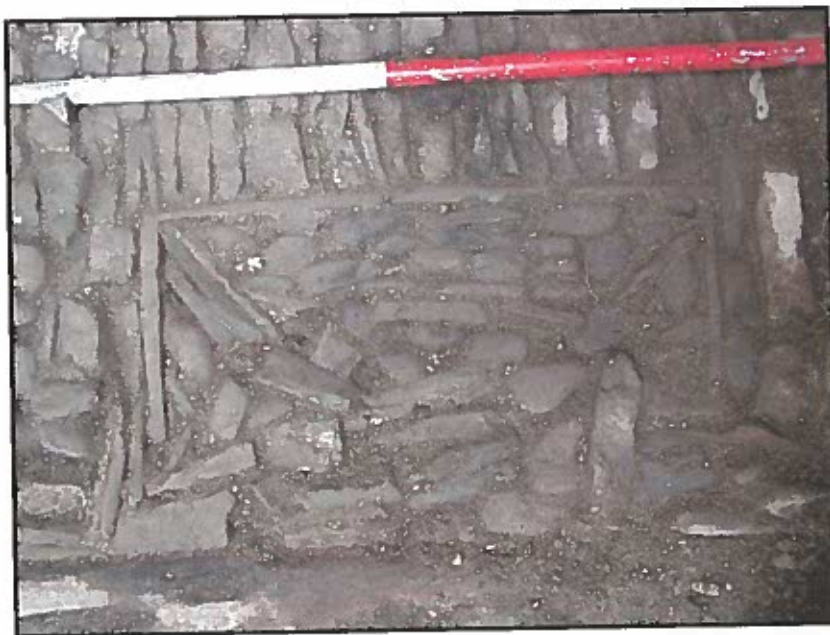
Plate 26: Section of patterned cobbled floor in Area 14 (far south-west end).

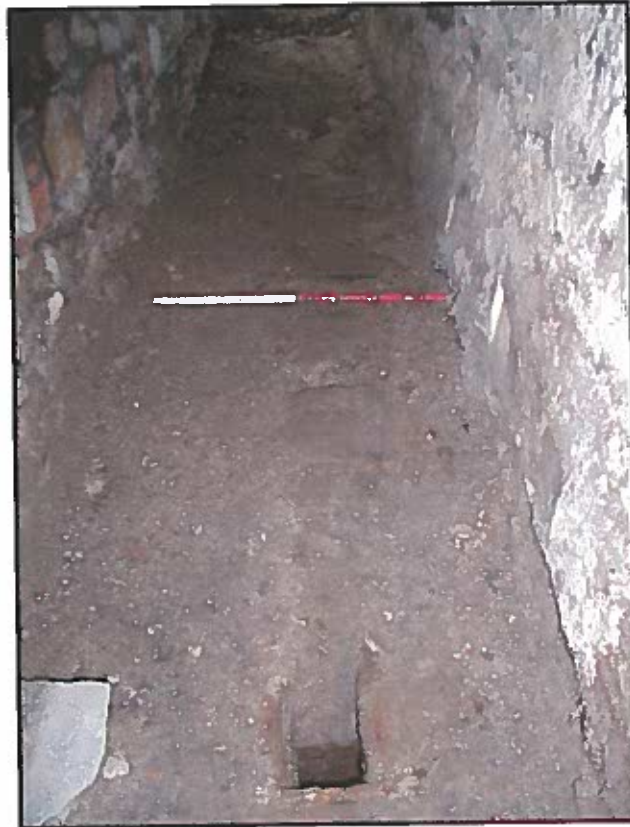
Plate 27: Remains of culvert exposed along corridor outside Room 14 (looking south-east).

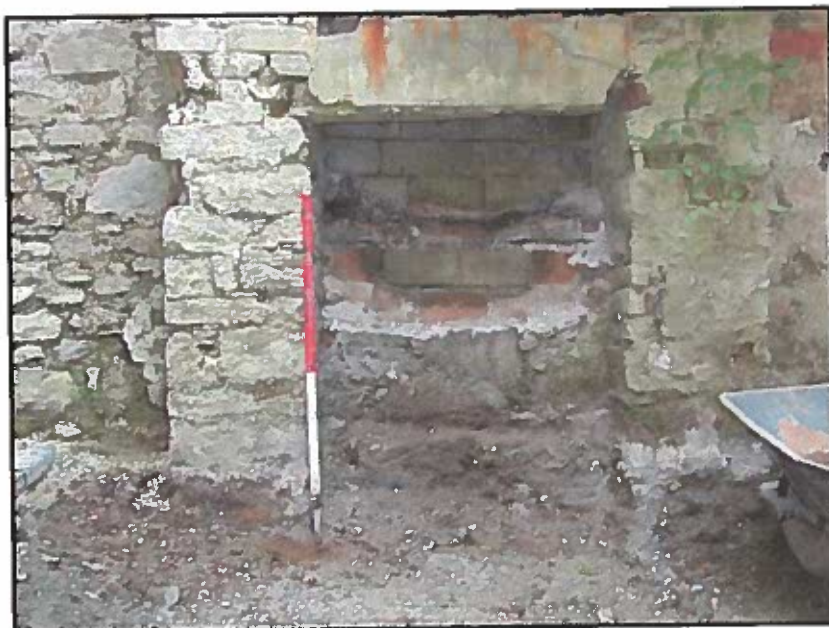
Plate 28: Photo showing shallowness of bedrock beneath fireplace in Room 4 (looking south-east)

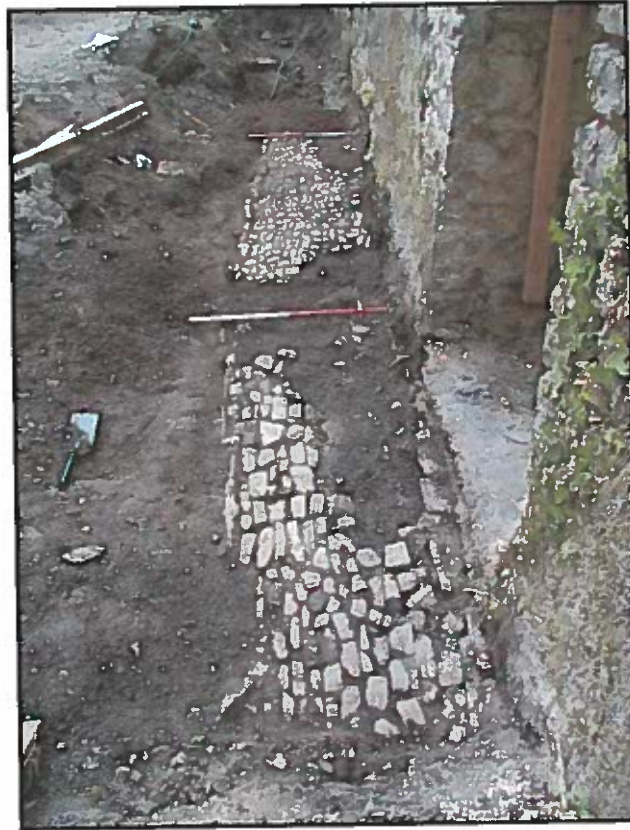
Plate 29: Cobbled floor exposed during ground work at external east side of house.
(looking south-east)

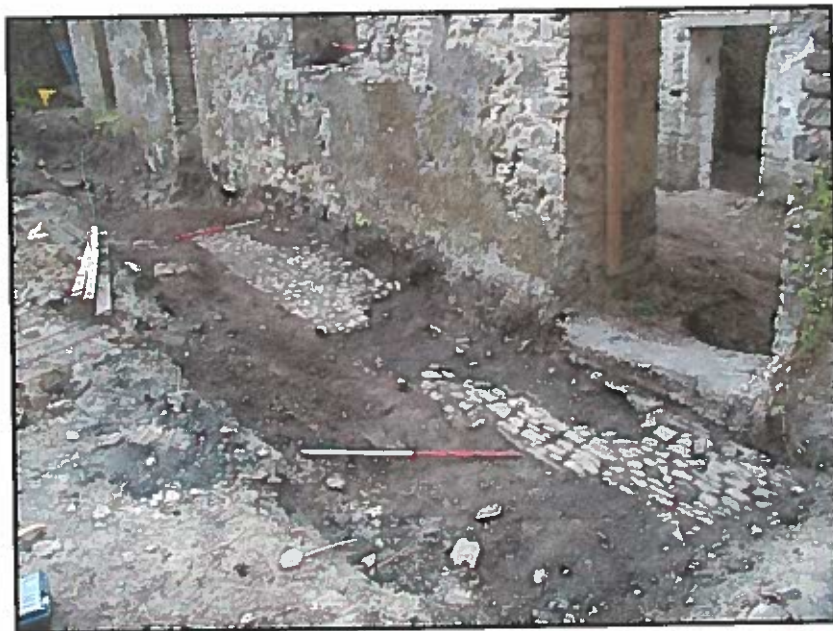
Plate 30: Cobbled floor exposed during ground work at external east side of house.
(looking south)

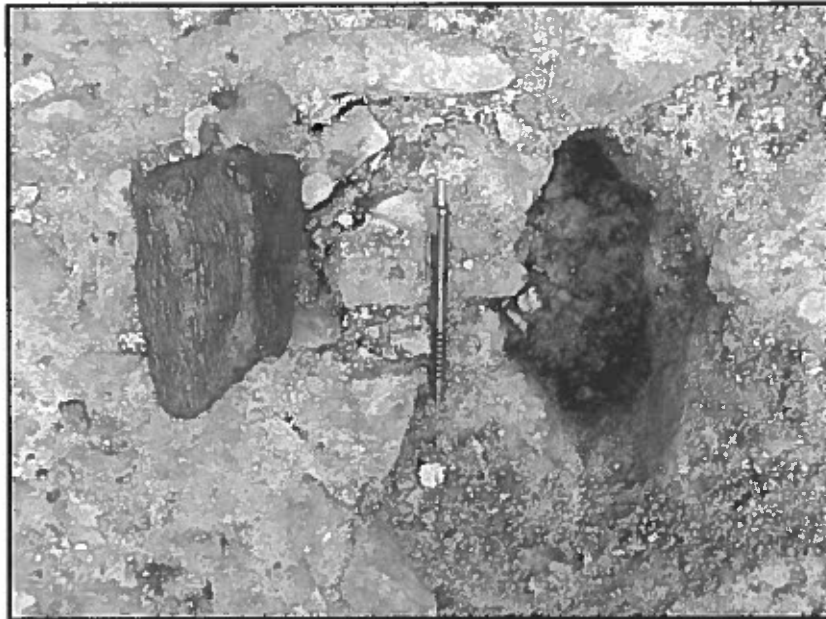
Plate 31: *Post-hole and remains of wooden post stump exposed within cobble floor in Room 8.*

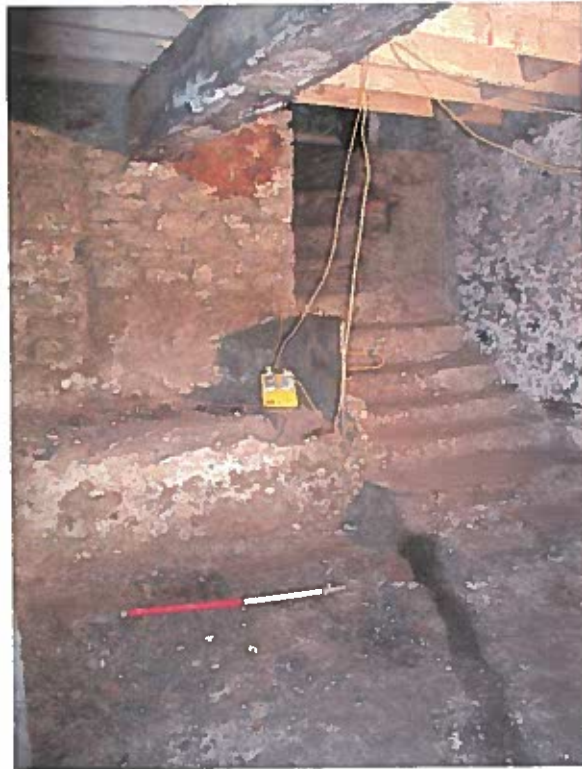
Plate 32; Area of basement at side of entrance steps.
Showing blocked single culvert running west from beneath stone steps
(looking east)

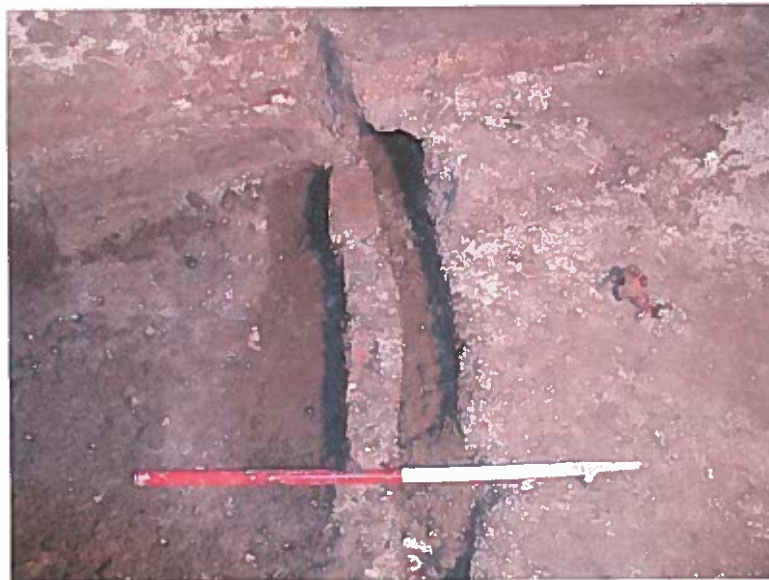
Plate 33: Twin culverts at base of stone steps into basement cellar.
Culvert runs west from beneath steps and other basement room.
(looking east)

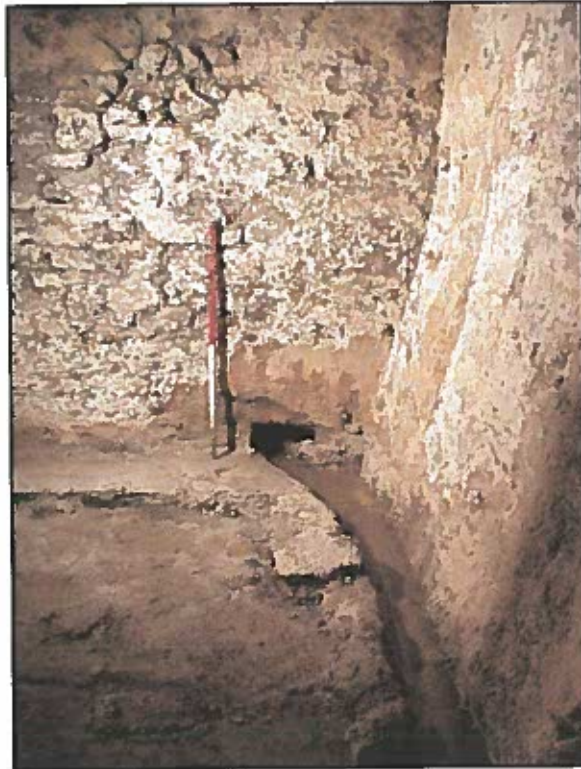
Plate 34: Back room in basement showing culvert running parallel to back wall and continuing beneath wall and stone steps.
(looking north)(looking north)

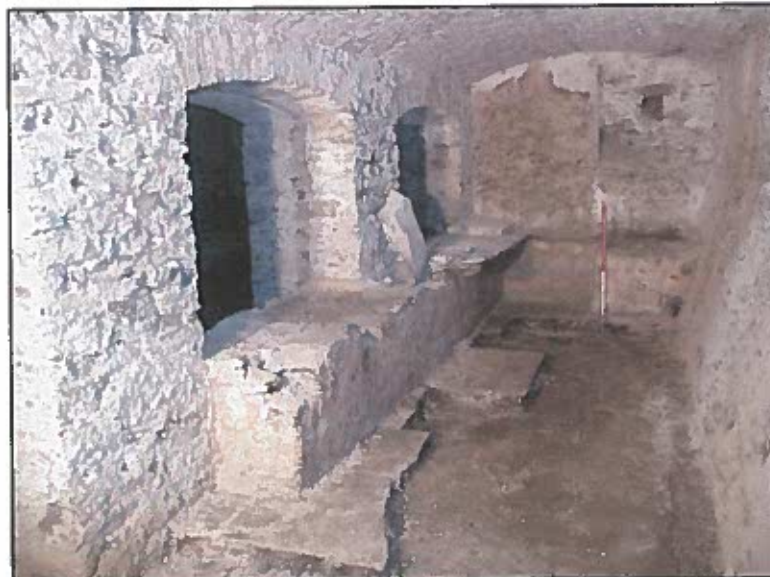
Plate 35: Back room in basement after clearance of floor debris (looking south)
