Llanwenog Church - Llanwenog, Cerdigion.

Watching Brief

Trench for insertion of electric cable

26/07/04

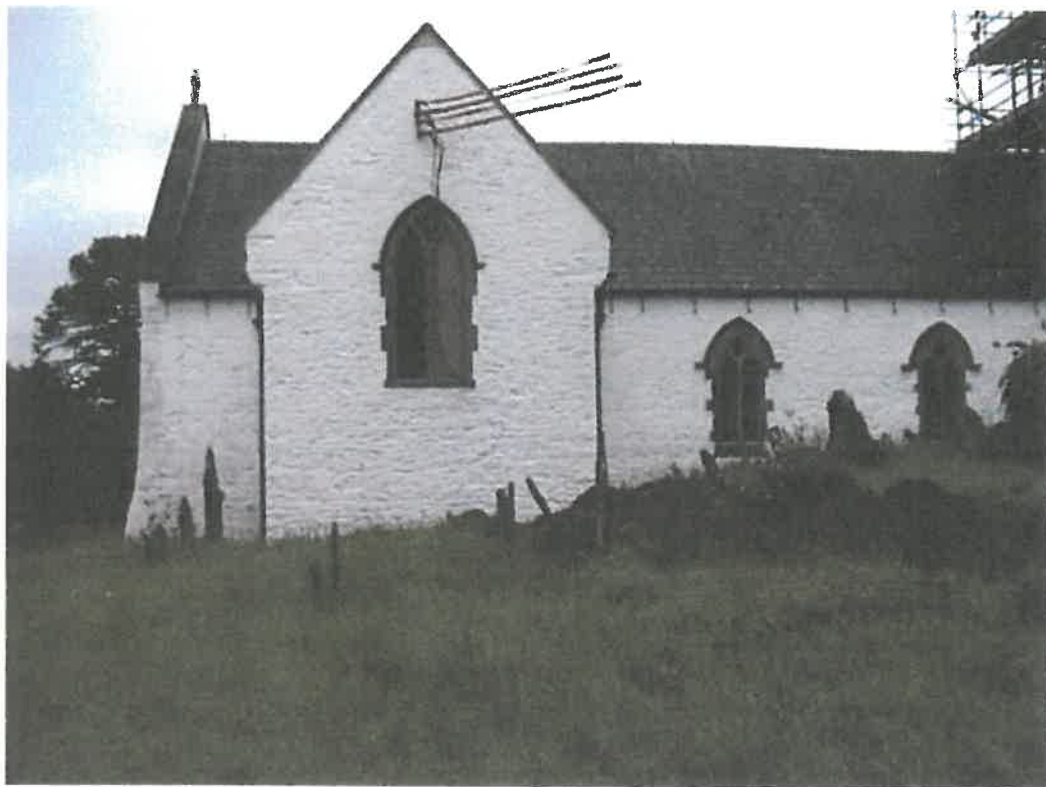
Photograph 2. View of north transept wall – showing old electrical cables and trench spoil.

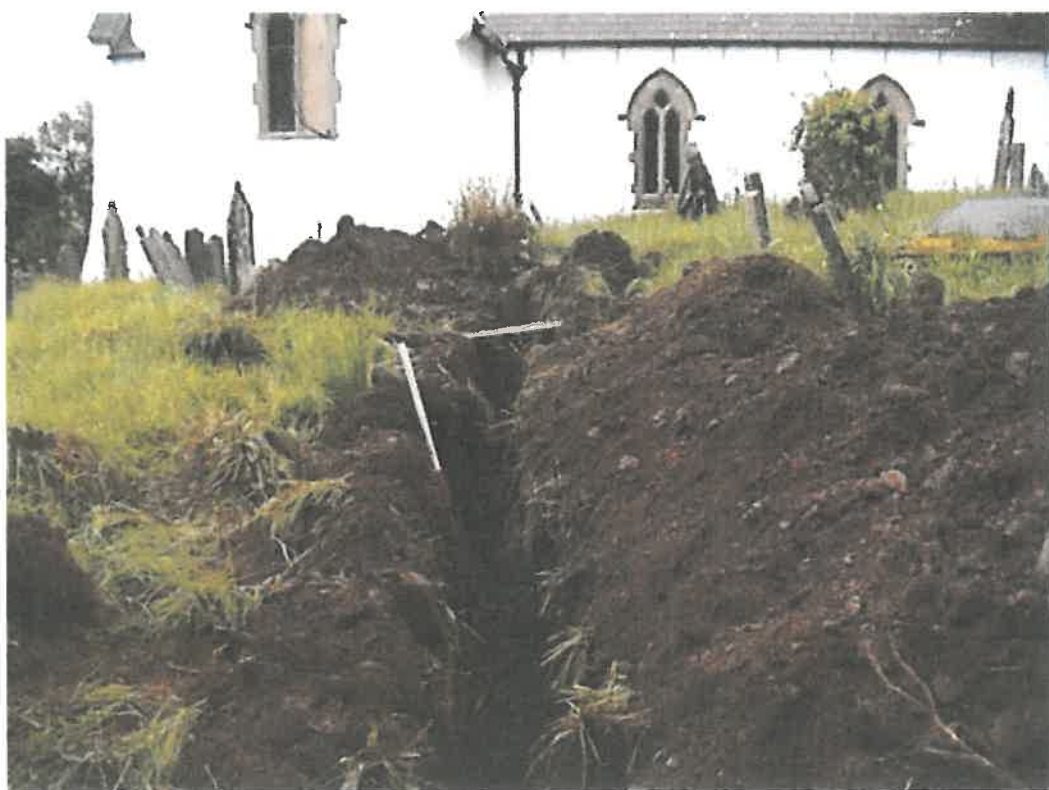
Photograph 3. View of trench - looking south

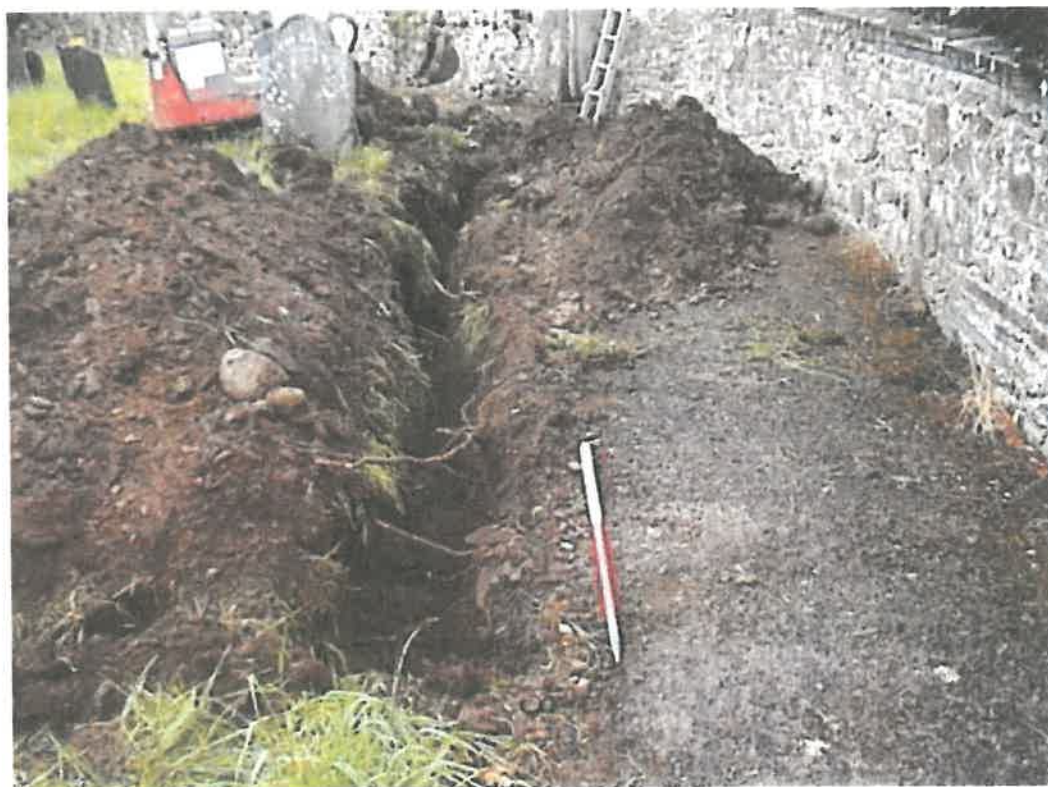
The trench reached the edge of the 1.6m wide tarmac perimeter pathway circumnavigating the church enclosure. For a further 6.1m the trench diverted west to run adjacent to, and parallel with, this path. The trench was slightly wider (50cm) at this point. Some large isolated rocks were encountered towards the end of this section and a lighter, yellowish context was observed some 60cm deep in the southern section of this trench. This may have related to the edge of another nineteenth century grave adjacent to the pathway. A short 2.2m section of trench was then cut through the tarmac and a hole bored through the churchyard wall to enable cable access. No archaeology was encountered during this process.

Photograph 4. Looking west. View of trench running parallel to and cutting through pathway. The churchyard wall is visible on right of photograph.
