# Pricaston Farm, Castlemartin, Pembrokeshire

Archaeological Building Recording

Ref: 53179

July 2003

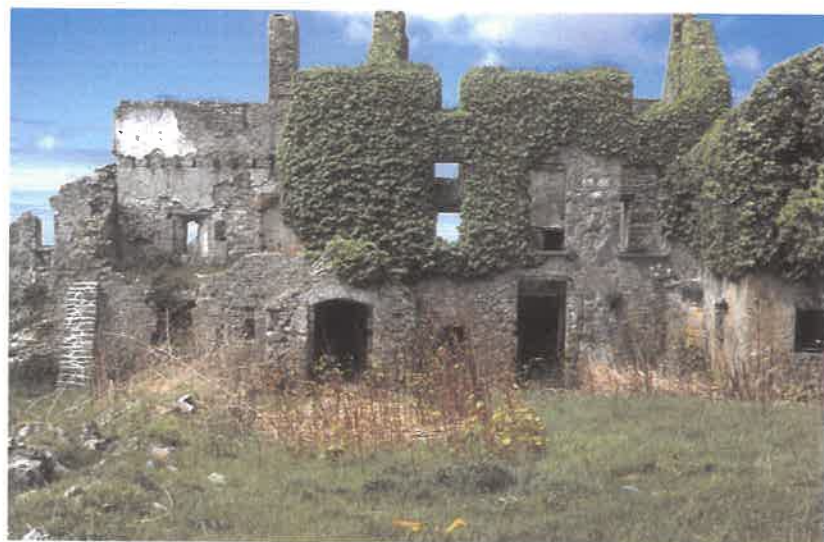
- 3.1.1 The ruins of Pricaston Farmhouse (**Figure 2: Plates 1-5**) lie in a slight hollow and consist of a large stone-built farmhouse with additional stone outbuildings to the north. The main elevation of the Farmhouse faces south-east.
- 3.1.2 The house runs along a north-east/south-west axis with one wing projecting forward (south-east) at the north-east end. Numerous farm buildings lie in a courtyard formation to the north of the main house.
- 3.1.3 In plan (**Figure 3**), Pricaston Farmhouse presents itself as a typical medieval hall-house with later rear additions. It consists of a main entrance (now

Plate 1. South-east elevation

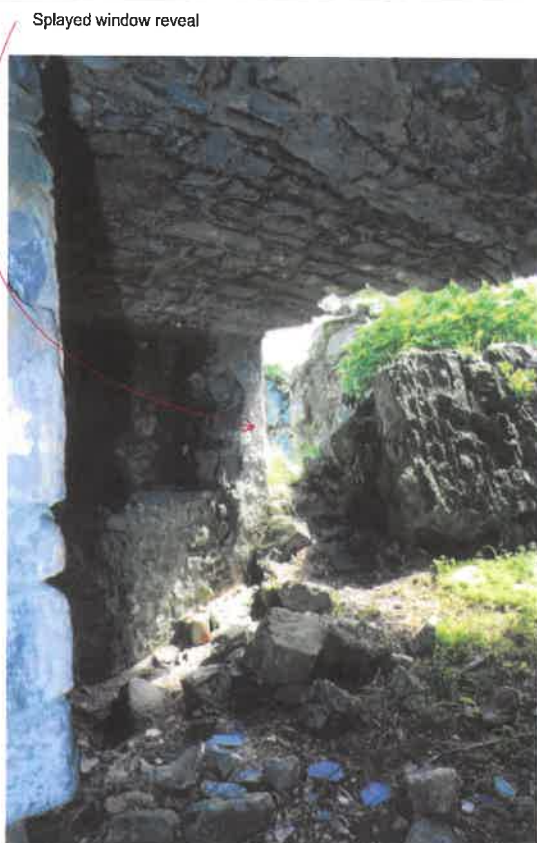
- 3.2.4 Two parallel service rooms to the south-west of the cross passage are stone-vaulted. The vaults have a flattened-semicircular profile. The front (south-east) vault is partly collapsed (**Figure 5: Plate 9**), but that in the rear (north-west) room is very well preserved. The two rooms were probably interconnecting; a blocked doorway is visible in the partition wall between the two rooms immediately next to the central arch (**Figure 5: Plate 10**). Interestingly, the infill here includes a large stone column base or padstone (**Figure 5: Plate 11**). A single square opening remains in the partition wall, probably for the purpose of sharing light between the two rooms (**Figure 5: Plate 12**). Just to the right (south-west) of this opening is possibly another blocked opening, long vertical stones indicating the jambs.

**Plate 9.** Collapsed vaulting in the south-east service room

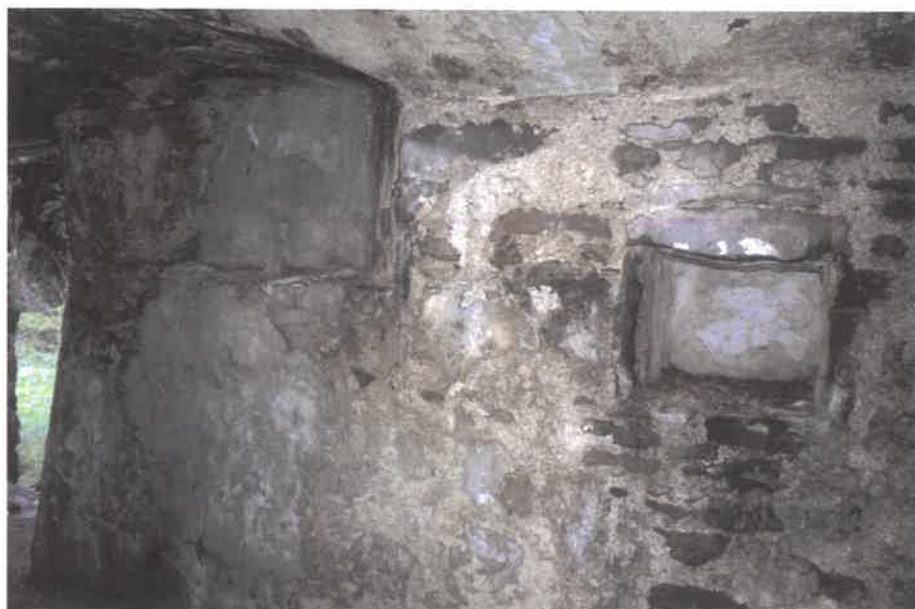
- 3.2.5 The rear (north-west) service room has a blocked external window with a vault which intersects the main vault (**Figure 6: Plate 13**). There is a smaller blocked opening to the right (north-east). In the north corner is a contemporary doorway with stone voussoirs (**Figure 6: Plate 14**). At the west corner is an inserted opening broken diagonally through the external wall, indicating it was made after the range behind was constructed (**Figure 6: Plate 15**). To the left (south) of this opening is a large structure of unknown purpose.

**Plate 13.** The blocked openings in the north-west service room

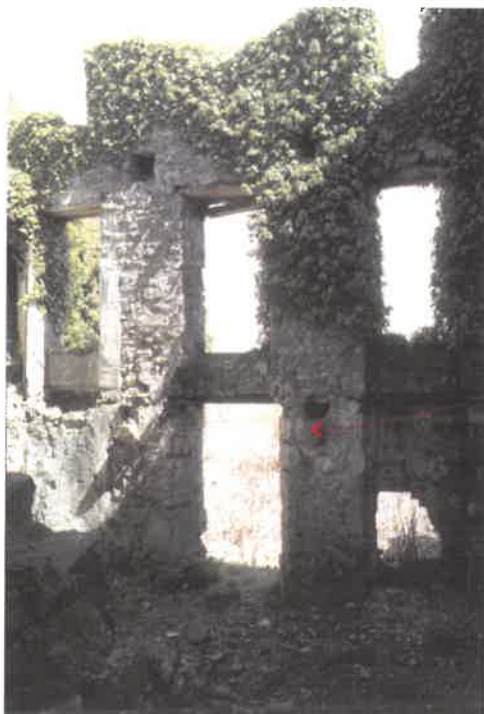
- 3.2.8 The south-east wall (**Figure 7: Plate 17**) contains three openings at ground floor level, three at first floor level and a further two on the second floor. The central ground floor window is now a doorway, and the two flanking windows are blocked but show evidence of originally being square in shape. The south-east wall is considered to have been remodelled in a Georgian style *c.*1783 as a reply to the newly-built Brownslade House approximately 1km distant. It was at this time that a second floor was added to the house

**Plate 17.** Openings in the south-east wall of the hall

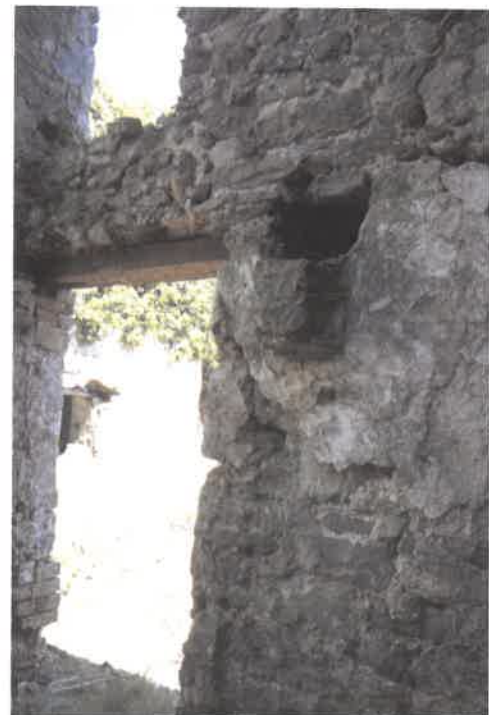
- 3.2.9 It is not clear whether the medieval hall was open or had a first floor. Rough corbels in the south-east wall corresponding with beam-slots in the opposite wall indicate that there was a first floor, possibly accessed by a winding stair in the eastern corner of the room (**Figure 7: Plate 18**).

**Plate 18.** A rough corbel in the south-east wall of the hall

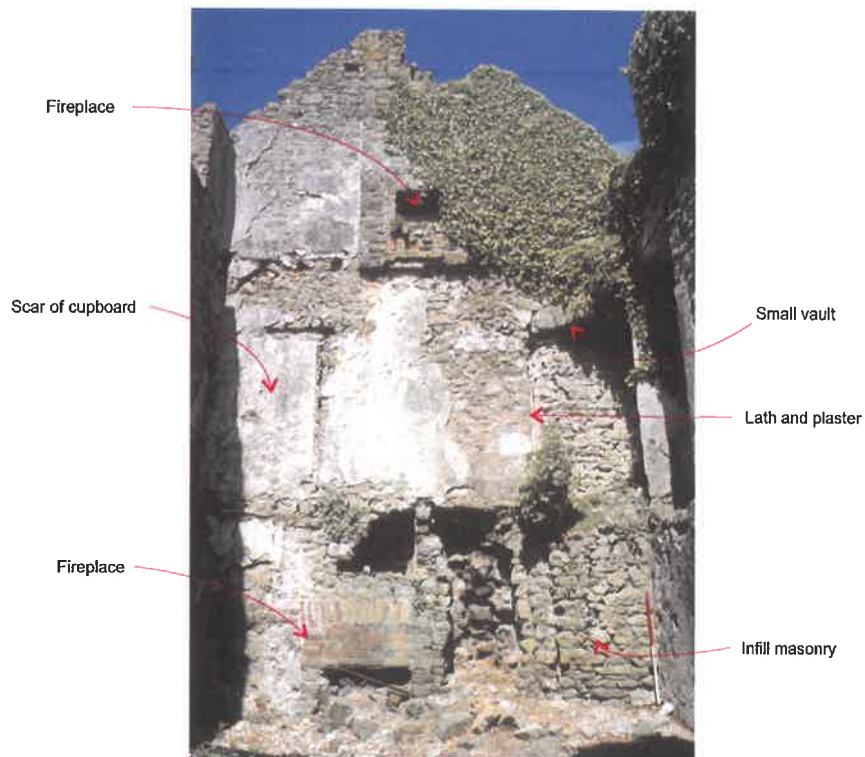
- 3.2.10 The eastern corner is difficult to interpret (**Figure 8: Plate 19**). A large amount of infill material is visible, above which is a small vault of similar construction to that above the service rooms but with additional slate packing. Lath and plaster (probably eighteenth or nineteenth century) is seen to disappear behind the infill material. To the left (north) of the infill is a possible blocked ground floor opening which, when viewed from the other

**Plate 19.** The north-east wall of the hall

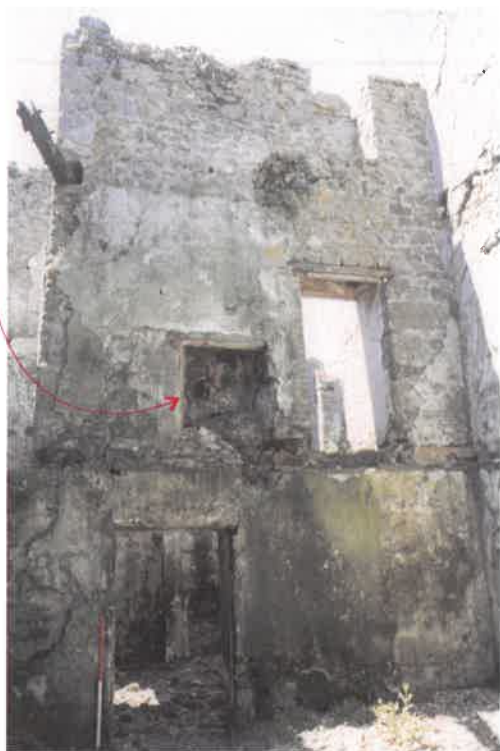
- 3.2.12 At ground floor level the north-west wall (**Figure 9: Plate 21**) has a later opening through to the Dining Room, above which is a small stone fireplace of a style contemporary with the rest of the medieval masonry - further evidence that the hall probably had a first floor. In the west corner is a stair turret (**Figure 9: Plate 22**), the exact layout and development of the stairs within is not fully understood, especially as the stair turret appears to be of one construction and is contemporary with the rest of the medieval part of the farmhouse.

Plate 21. The north-west wall of the hall

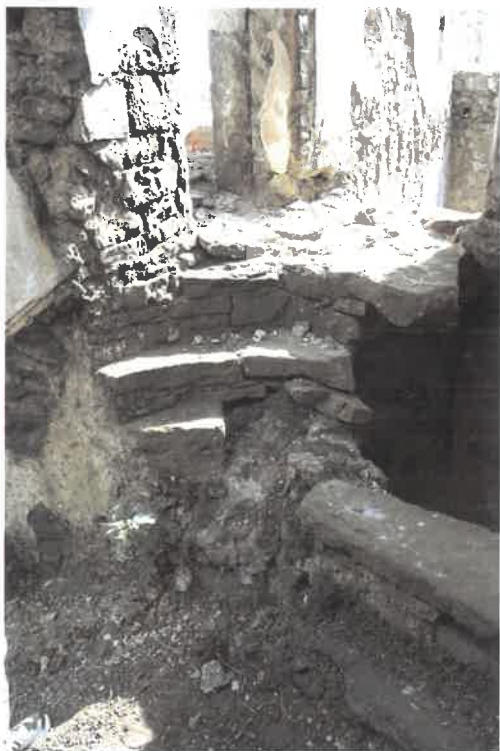
- 3.2.13 The left side of the stair was the original access to the solar, the concave stone steps curving to the left (**Figure 9: Plate 23**) and forming part of the cross passage roof. These steps also later gave access to the first floor of the Kitchen Range.

Plate 23. Concave stair to the solar

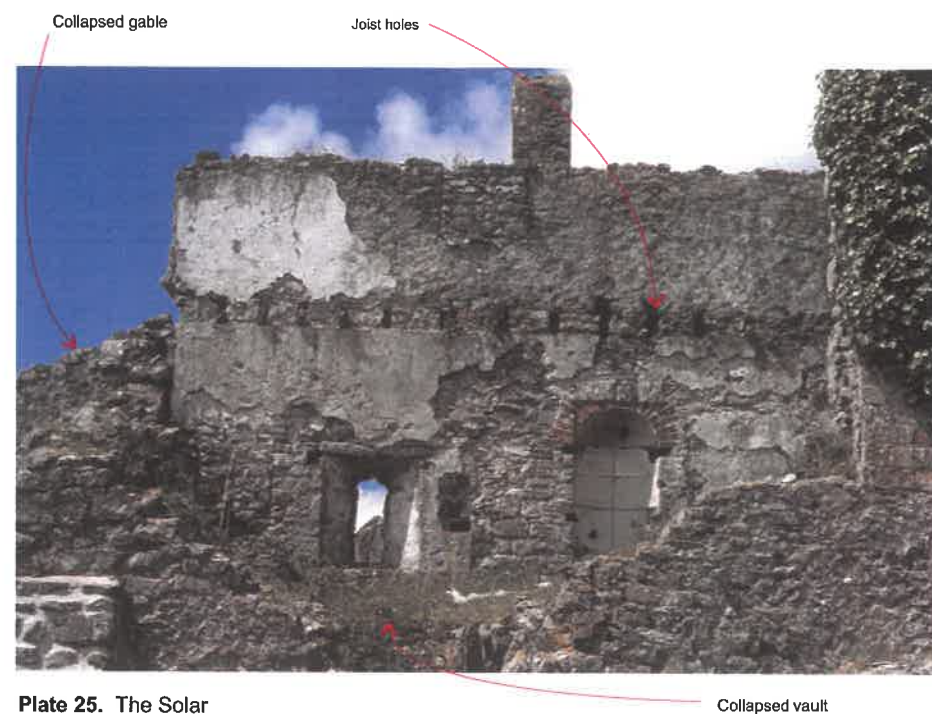
- 3.2.18 Above the vaulted service rooms and extending over the cross passage is the solar, the private chamber of the master of the house. The south-east and

much of the south-west walls have unfortunately collapsed with the vault below (**Figure 10: Plate 25**). Joist holes are visible in the north-west wall.

Plate 25. The Solar

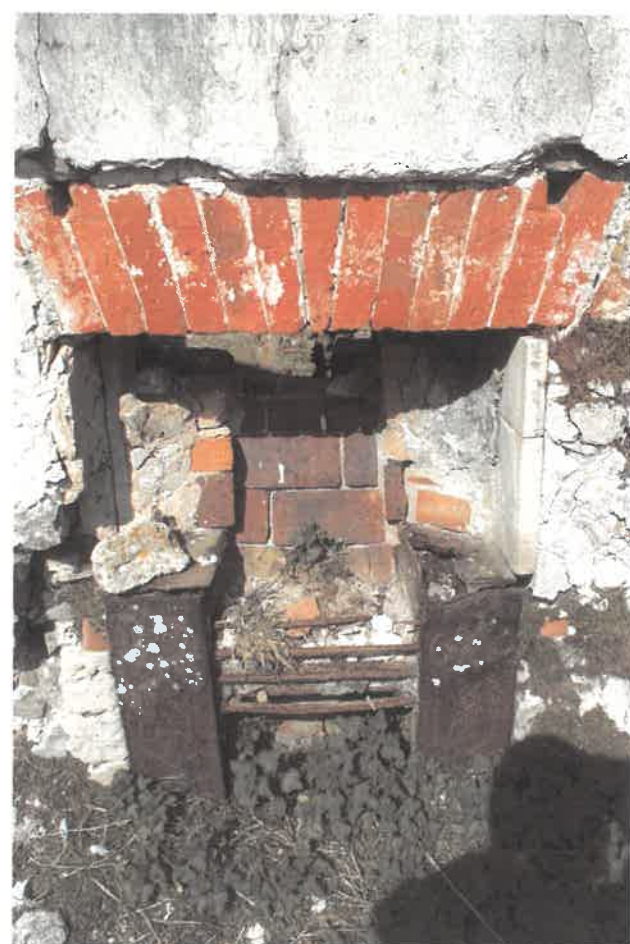
- 3.2.20 In the north-east wall is a small cast iron fireplace (**Figure 10: Plate 28**) with brick surround, which backs on to the fireplace above the main entrance to the hall.

Plate 28. Cast iron fireplace in north-east wall of the Solar

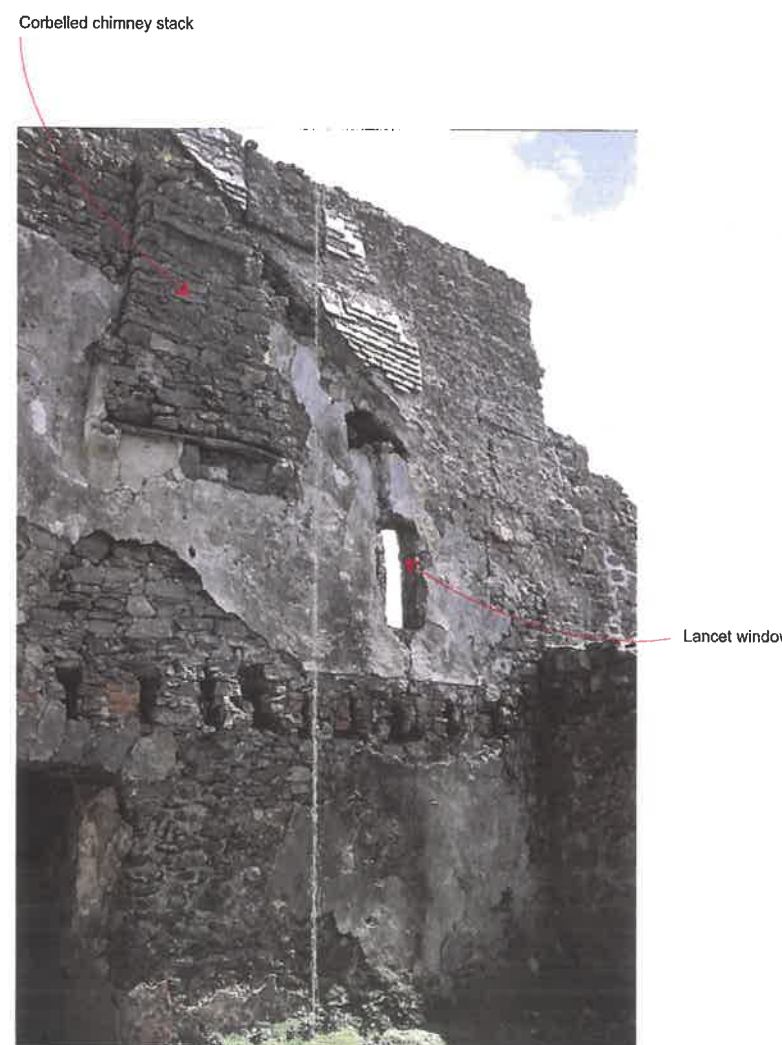
- 3.2.19 The north-west wall contained a fireplace, the corbelled stack for which is visible in the outside wall (**Figure 10: Plate 26**). The fireplace was later blocked, given a semicircular head and used as a china cupboard/niche. To the left (south-west) of the china cupboard is a medieval lancet window with splayed jambs (**Figure 10: Plate 27**).

Plate 26. North-west wall of the Solar - external

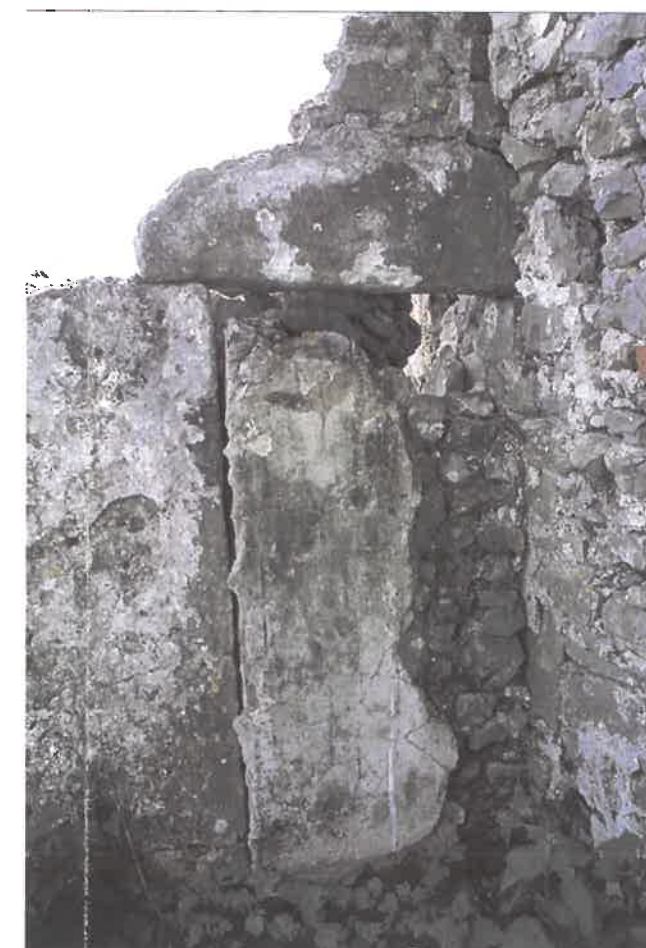
- 3.2.21 In what remains of the south-west wall there is a large stone lintel above a blocked doorway (**Figure 10: Plate 29**). The barley-drying kiln below (now destroyed by the collapse of the gable above) was deemed by RCAHMW to be an eighteenth century addition, and it is possible that this doorway originally led to a privy closet, enlarged to a small room when the kiln was constructed.

Plate 29. Privy closet doorway

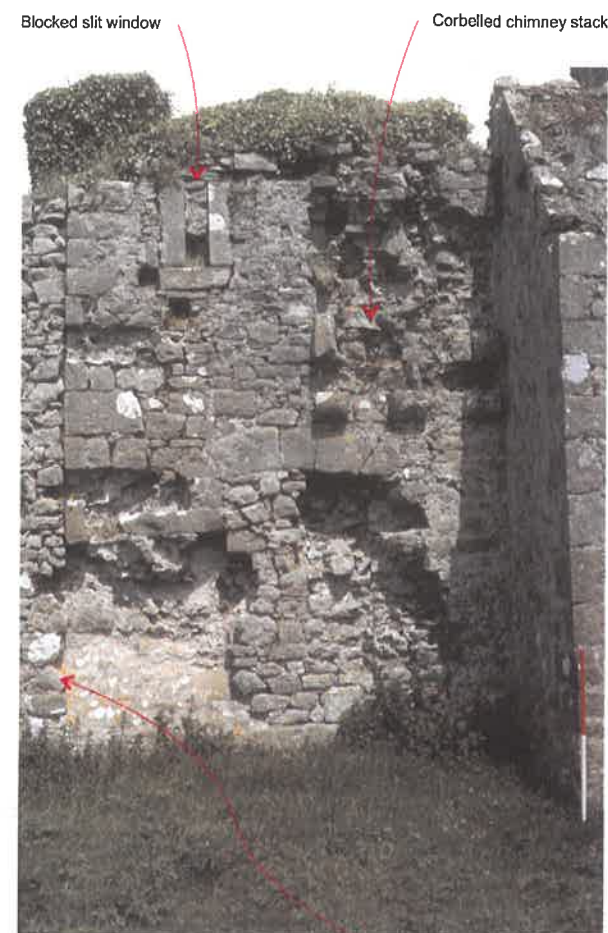
- 3.2.22 Beyond the rear door of the cross passage is further early masonry. This leads to a small, square, two storey building of the same stonework (**Figure 11: Plate 30**). Walker (2002, 556) suggests this was a tower which acted as a temporary retreat from the indefensible farmhouse. An alternative function for this building would be as a kitchen range, detached from the main house to minimise the risk of fire.

Plate 30. The tower

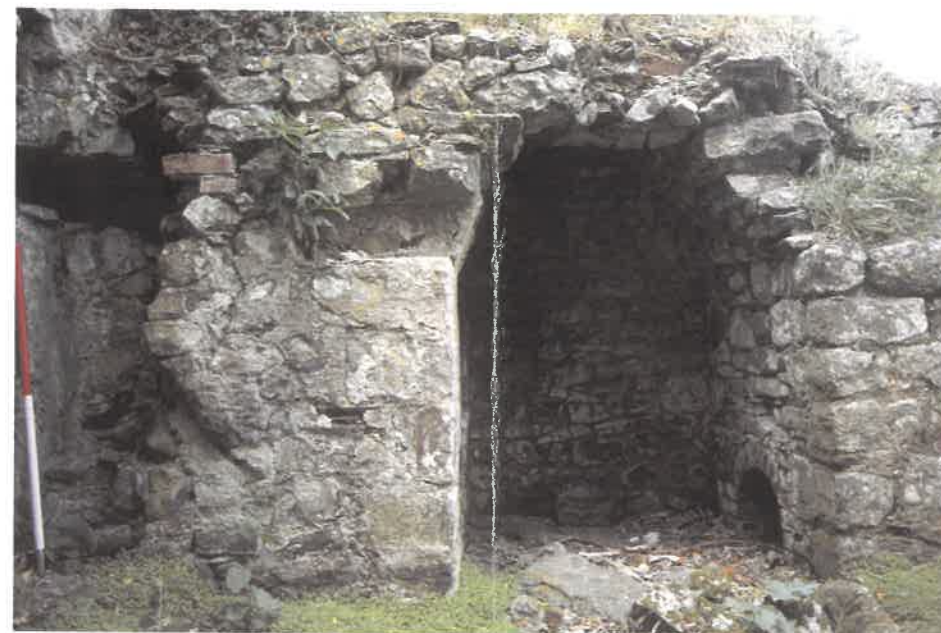
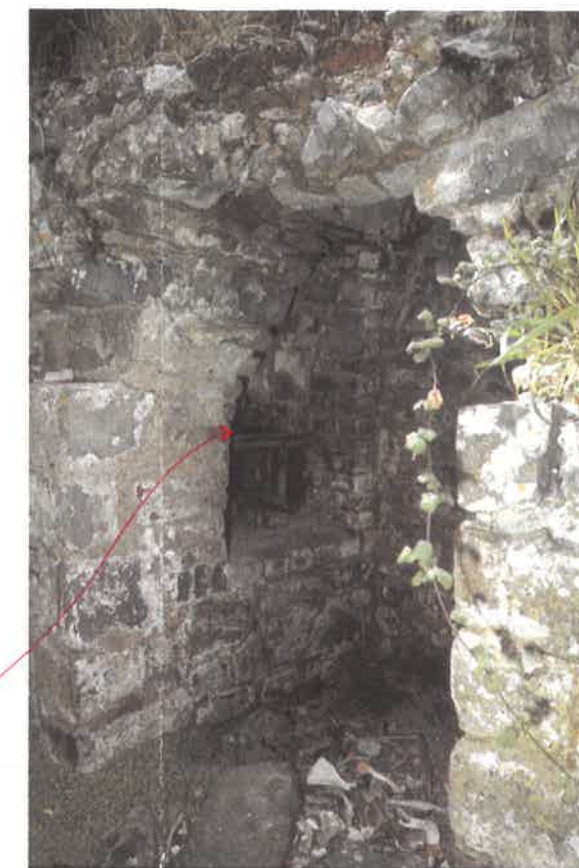
- 3.2.26 The ground floor has a large fireplace with bread oven in the north-west side (**Figure 11: Plates 31-32**). The chimney remains, but perhaps in a truncated form, as it does not project very far above the scar of the pitched roofline (**Figure 11: Plate 33**).

Plate 31. Tower fireplace

Plate 32. Bread oven in tower fireplace

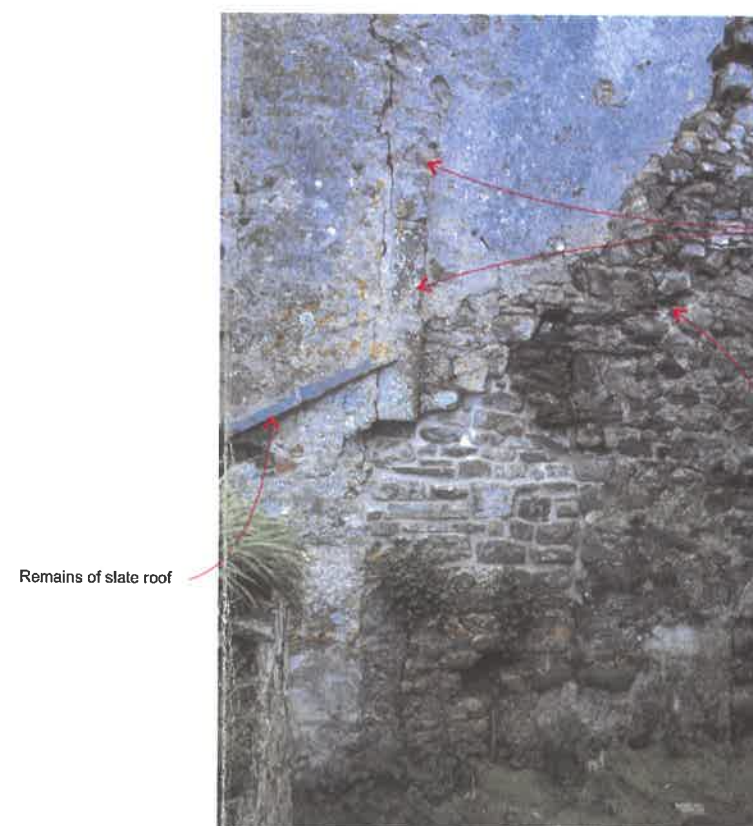
- 3.2.28 To the left (north-east) of the above stack are two (?three) large stones of unknown function (possibly a window- or door-jamb) placed vertically in the wall, alongside the remains of a slate roof (**Figure 11: Plate 34**).

Plate 34. Detail of masonry surrounding inserted chimney

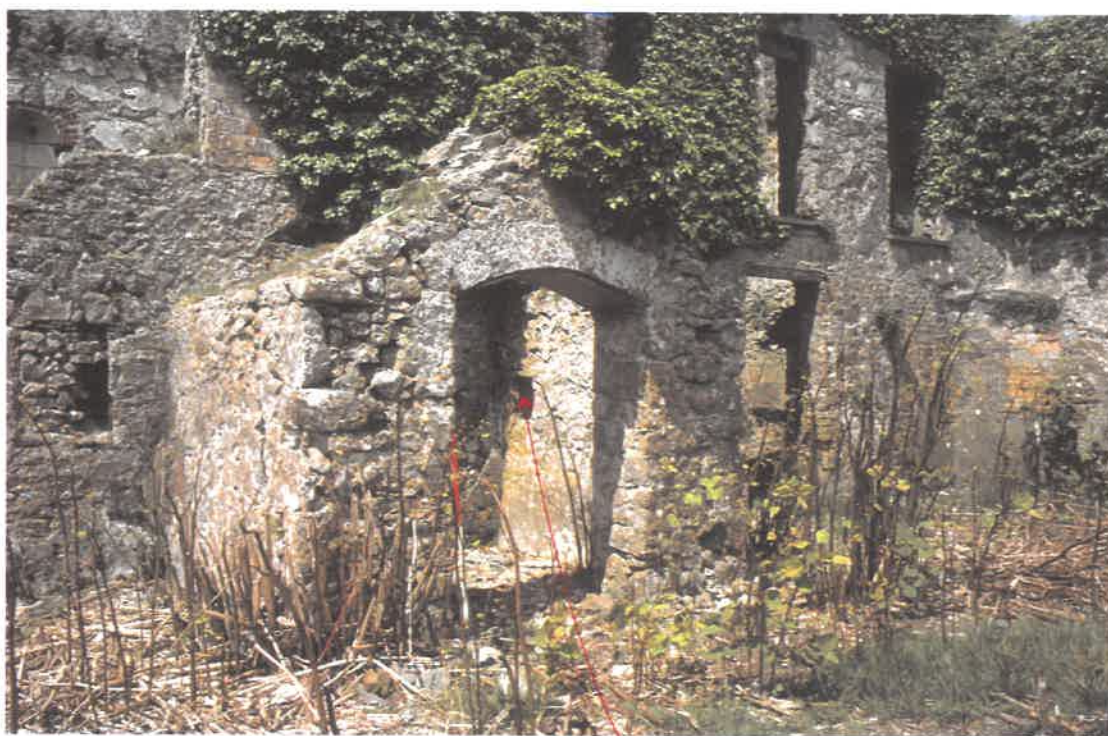
3.3.6 In the nineteenth century a stone porch was added to the front of the house (**Figure 15: Plate 45**). Its addition probably caused the loss of the original arched entrance. The porch is one storey with a pitched roof and flat arched entrance. Inside there are two lamp niches.

**Plate 45.** The entrance porch
