**Penpedwast Farm,
Meline
North Pembrokeshire**

Building Recording Survey

Landsker Archaeology

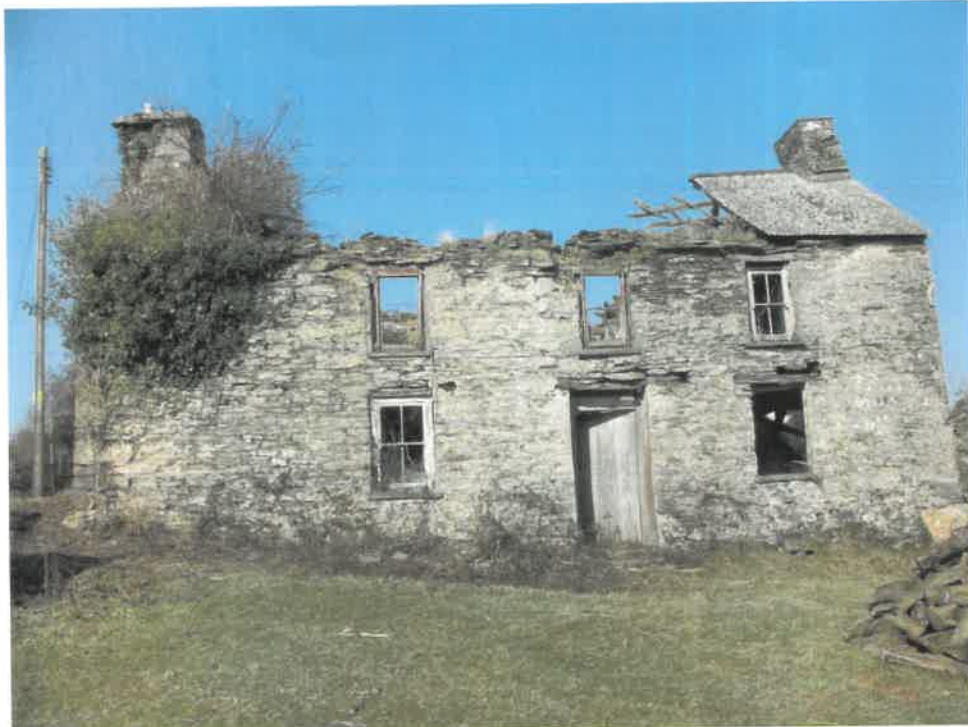
Figure 1 Farmhouse (1) from south

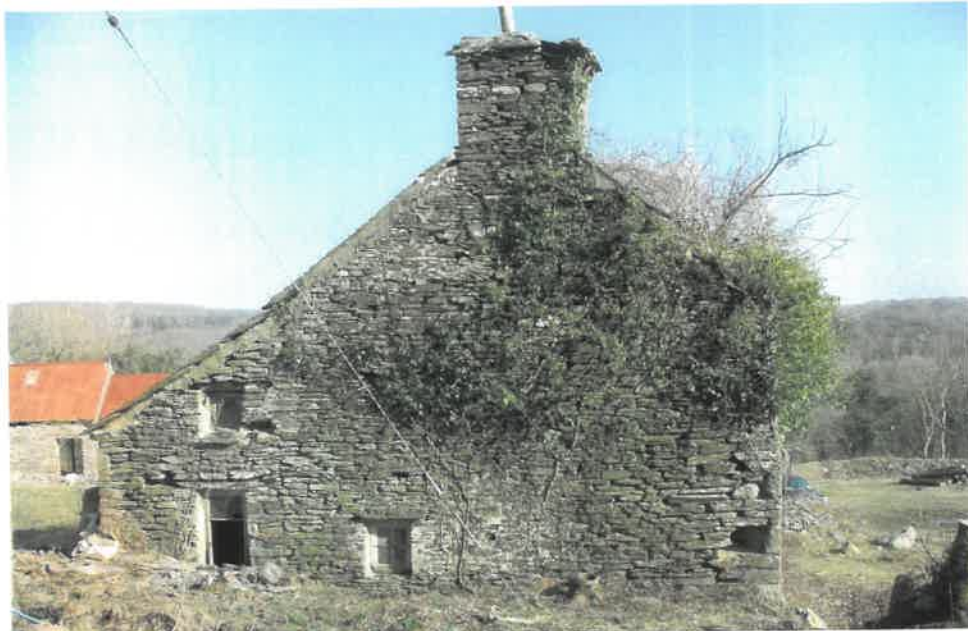
Figure 2 Farmhouse (1) west gable

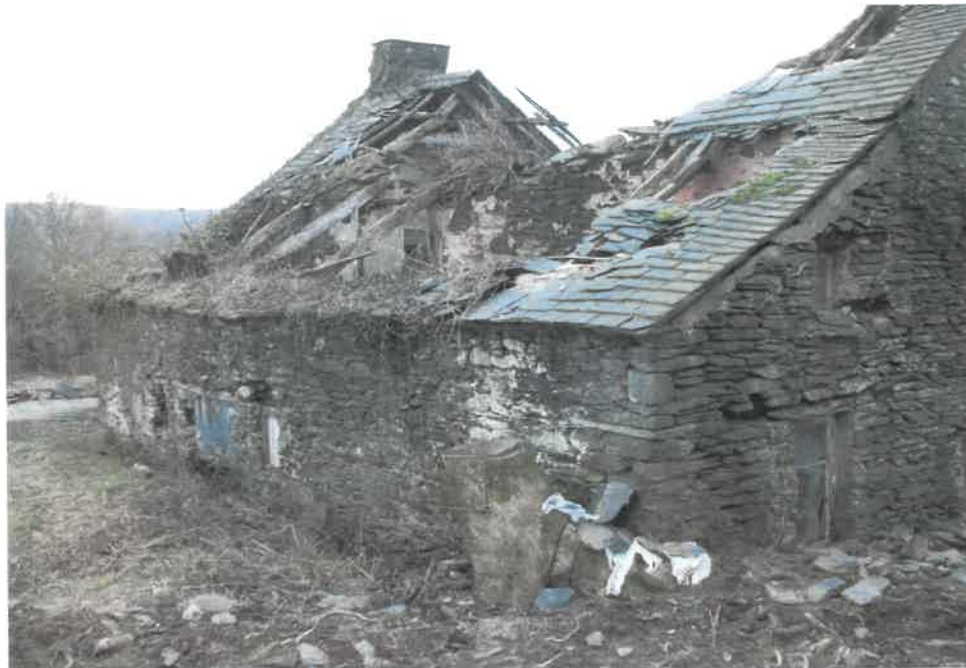
Figure 3 Farmhouse (1) rear of building

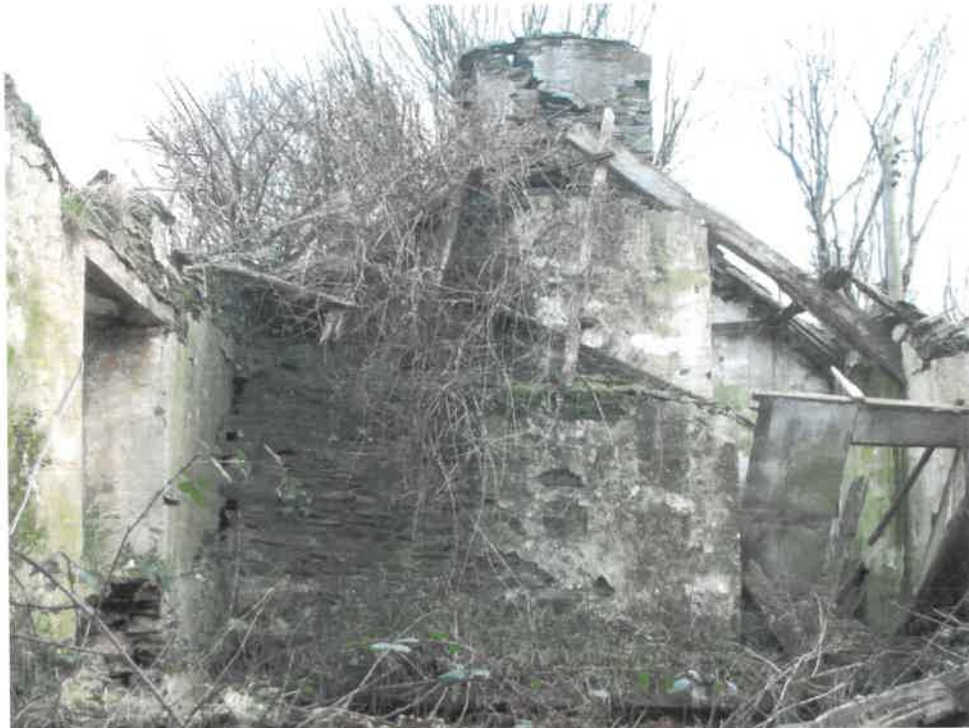
Figure 4 Farmhouse (1) upstairs looking west

Upstairs there are few details as the floor and partitions have collapsed. The main question would be whether the central window opened onto a small box room or whether there were only two rooms to the front of the house. Roof trusses appear to be of roughly dressed pine, but could not be closely examined due to access difficulties.

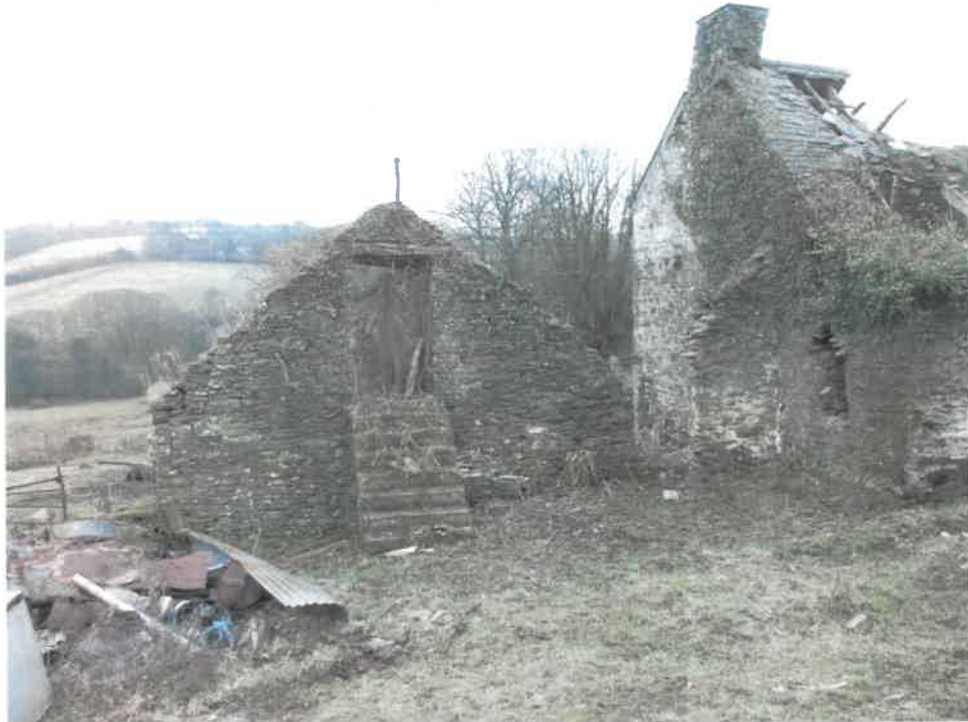
Figure 5 Rear of farmhouse (1) lean-to (10) and barn (11)

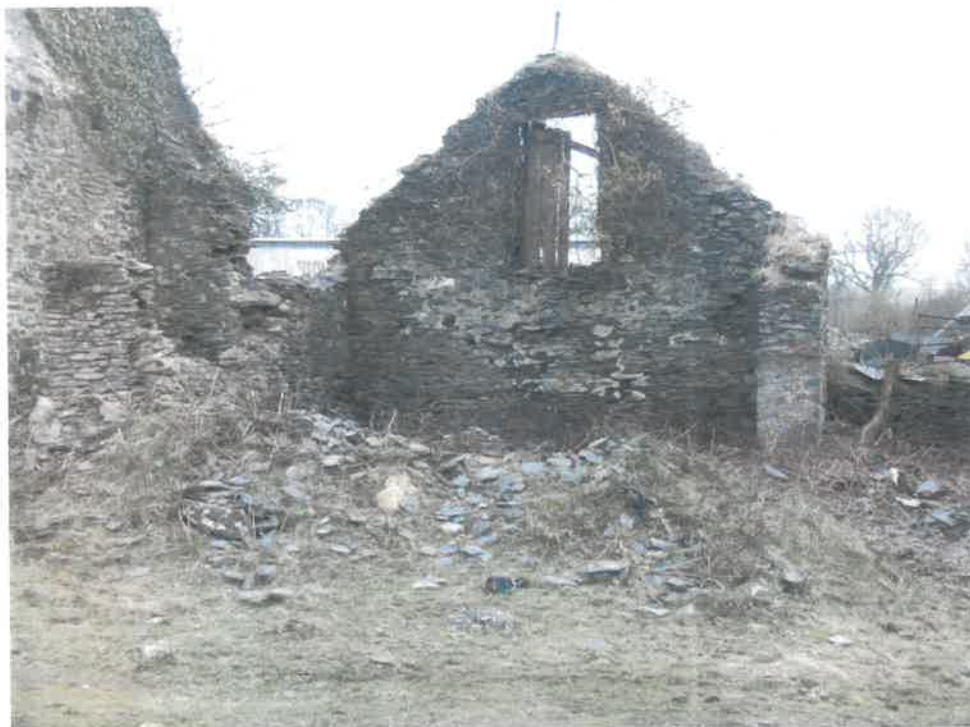
To the east, is a barn structure aligned north to south (11). Only the north gable wall and parts of the east and west walls survive. The remaining parts of the structure probably lie under a pile of grassed over rubble to the south, which allows the approximate dimensions of the structure to be estimated. No part of the roof structure survives. The building was a low two storey barn with access gained to upstairs by an external staircase to the north gable end. The structure is built entirely of slate bonded with lime mortar. There are the edges of a door opening on the east

wall and a wider blocked opening on the west wall. This is possibly a wider doorway, or else a section rebuilt after the erection of the farmhouse.

Figure 6 Barn (11) interior from the south
Penpedwast Farm
P802 Building Recording

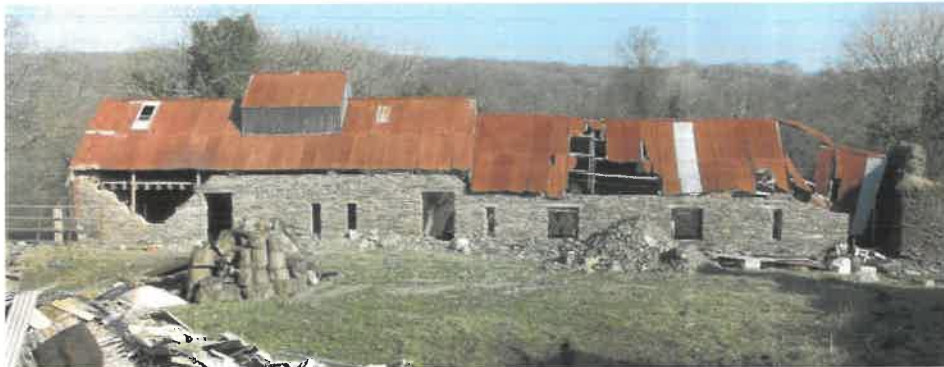
Figure 7 Cowshed (2) from west showing barn (15) and cow byre (14)

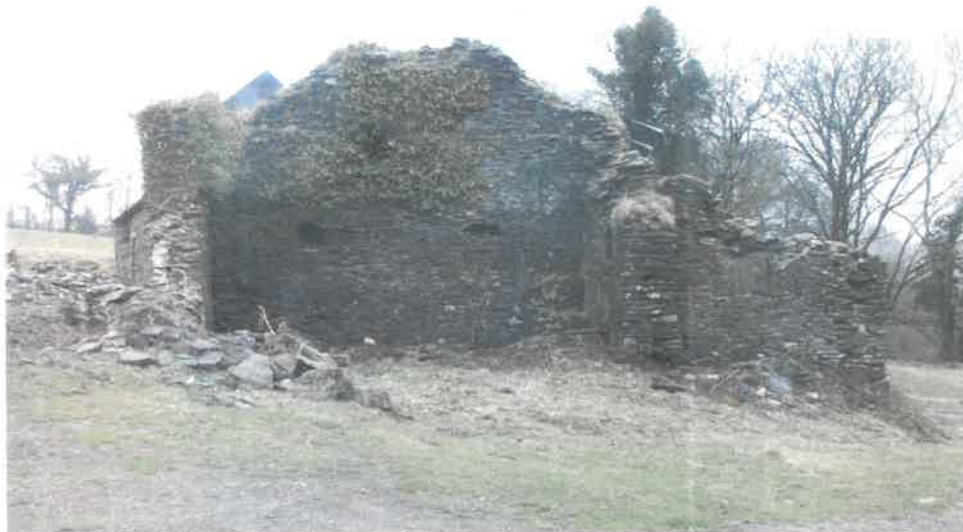
The earliest structure is the two storey barn to the south (12). This is a roofless shell built of rough slate slabs bonded with lime mortar. The southern gable end of the building is missing so it is not possible to determine the original length of the building. The upper storey was entered through a doorway on the west wall, accessed by an external staircase (now removed). This position is odd, in that it would be easier to have entered via the gable wall on the north, as with the barn attached to the farmhouse. Possibly there was a pre-existing structure to the north of this barn.

Figure 8 Cowshed (2) rooms (12) and (13)

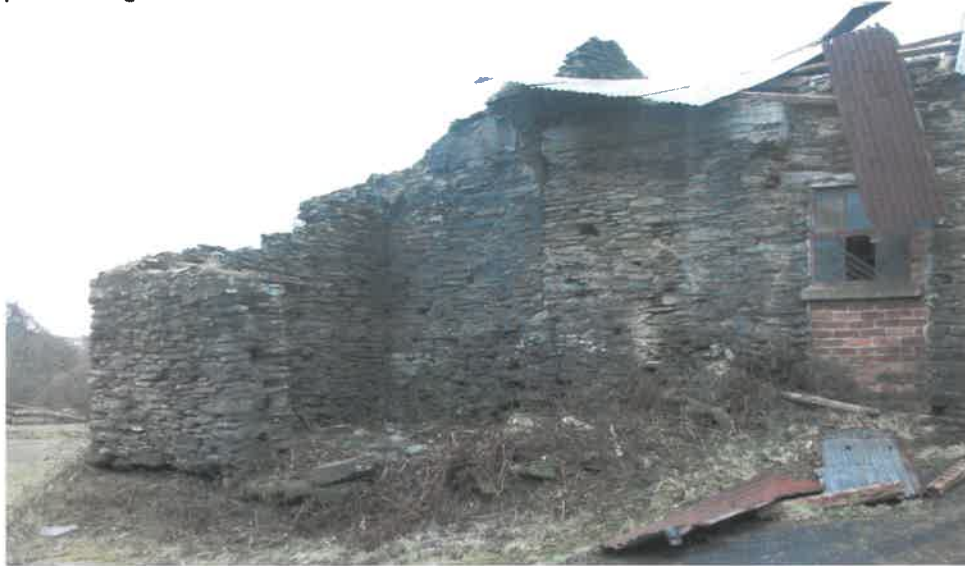
To the east, an additional room was added at a later stage (13). This slate lime mortared structure is now roofless and partly demolished. It originally had a sloping roof draining to the east with a window in the south wall and door to the east. At the time of its construction, it may have abutted the existing cowshed or against some pre-existing structure.

Figure 9 Cowshed (2) junction of (13) and (14)

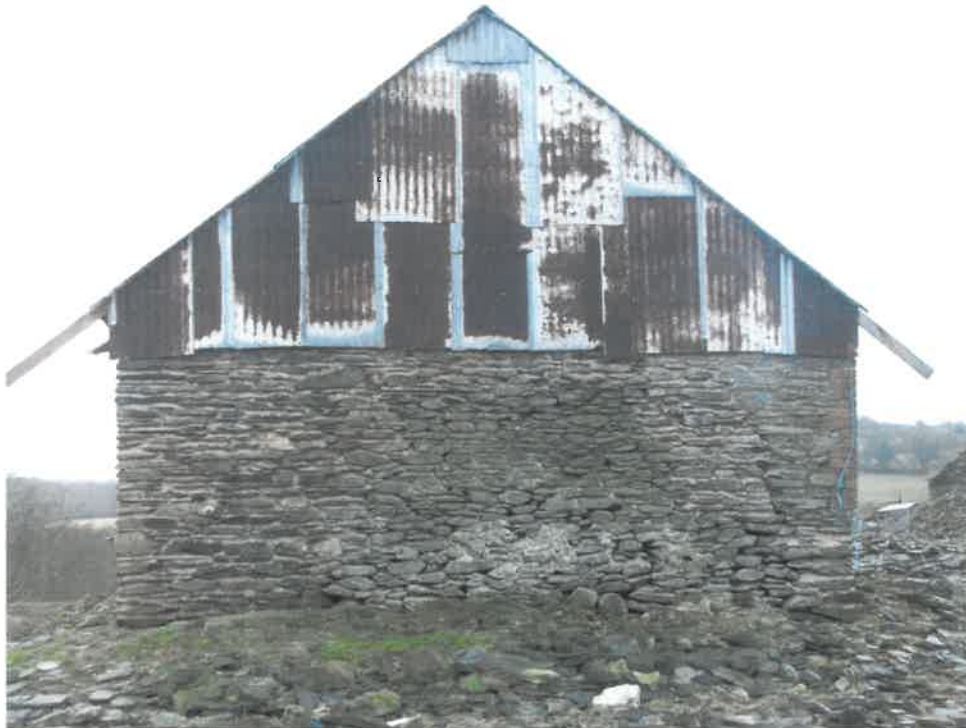
The main cowshed range has been altered so it is not possible to determine if it was built in two phases or as one complete entity. The cow byre to the south is blocked by a transverse wall, while the barn to the north has a higher floor level (caused by rising external ground level) and a different function. There are also bricks built into the gable wall at the north west corner of the of the cowshed, which appear to have been introduced during repairs.

Figure 10 Cowshed (2) North gable of (15) showing repairs

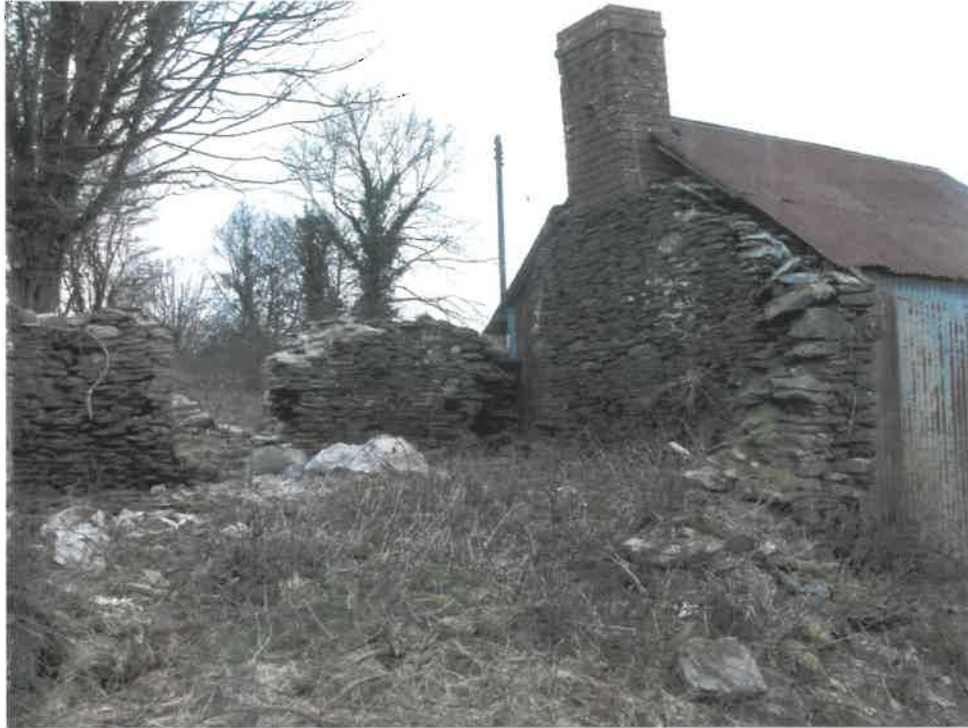
To the west of the farmhouse is the remains of stone built range, roofed on the east end, and surviving as walls only at the west end. The east section is roofed and clad in corrugated iron sheeting and timber, but is formed on a stone foundation and west gable wall. This gable wall contains a large inglenook fireplace and evidence of an incorporated bread oven. It is possible that this structure represents part of a domestic structure earlier than the main farmhouse. The west section is formed of two sections with wide doorways to the south, possibly cartsheds. The building is set back into the rising ground behind and the floors are also heavily worn with the walls standing on raised plinths of shaley mudstone. The walls are built of relatively thin pieces of slate with lime mortar and laid in a distinctive style with horizontal coursing not seen elsewhere in the complex.

Figure 11 Building (3) looking north east

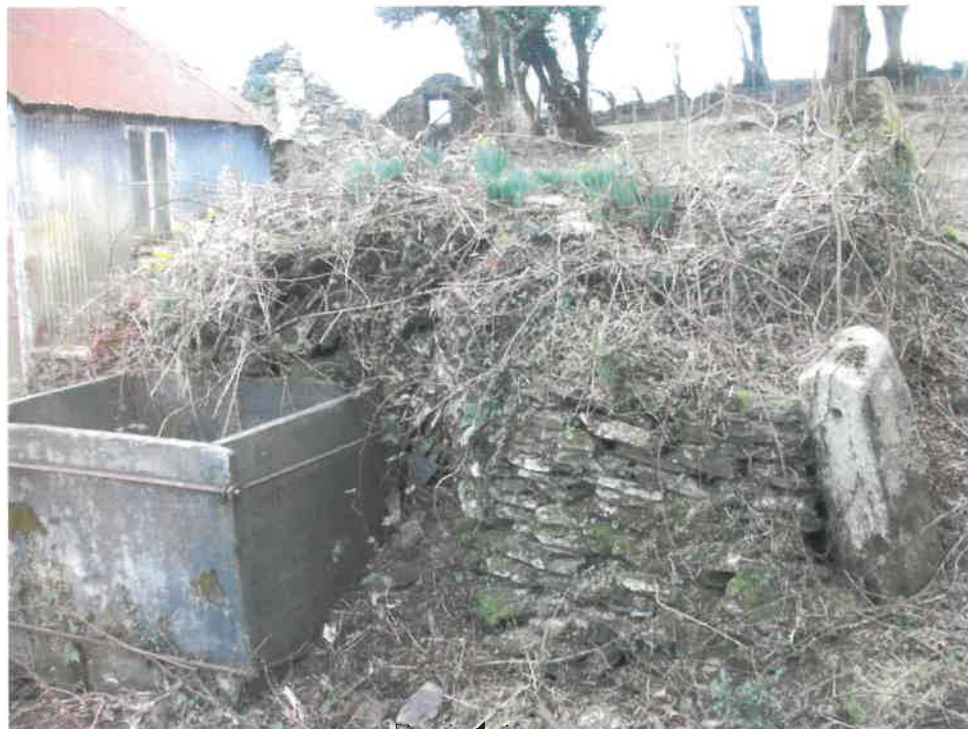
Figure 12 Well head (17) and north of Building (3)

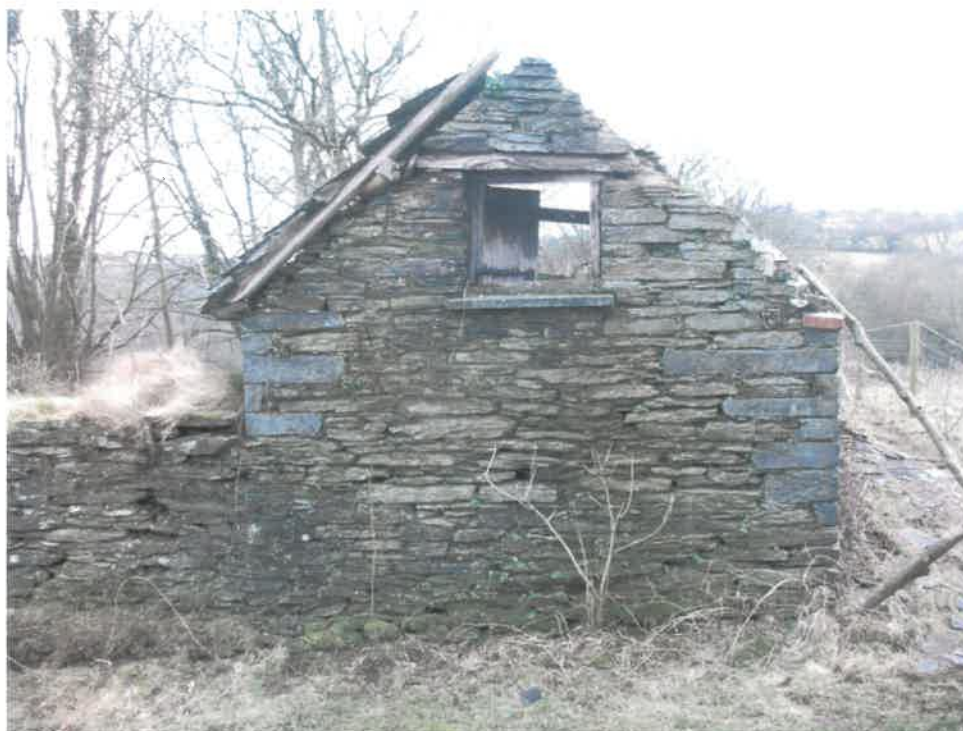
The pigsty is built with rough slate, but with a high proportion of sawn slate, in lime mortared courses. The corners are defined by quoins of sawn slate blocks. This is a different style of construction to the other buildings on site. The whole of this building appears to be of an estate style construction and could date to the 1880's.

Figure 13 Pigsty (4) north wall of sties
