Llechwedd, Lledrod, Ceredigion

Archaeological Buildings Record & Watching Brief Report

Planning #: A120791

12th January 2017

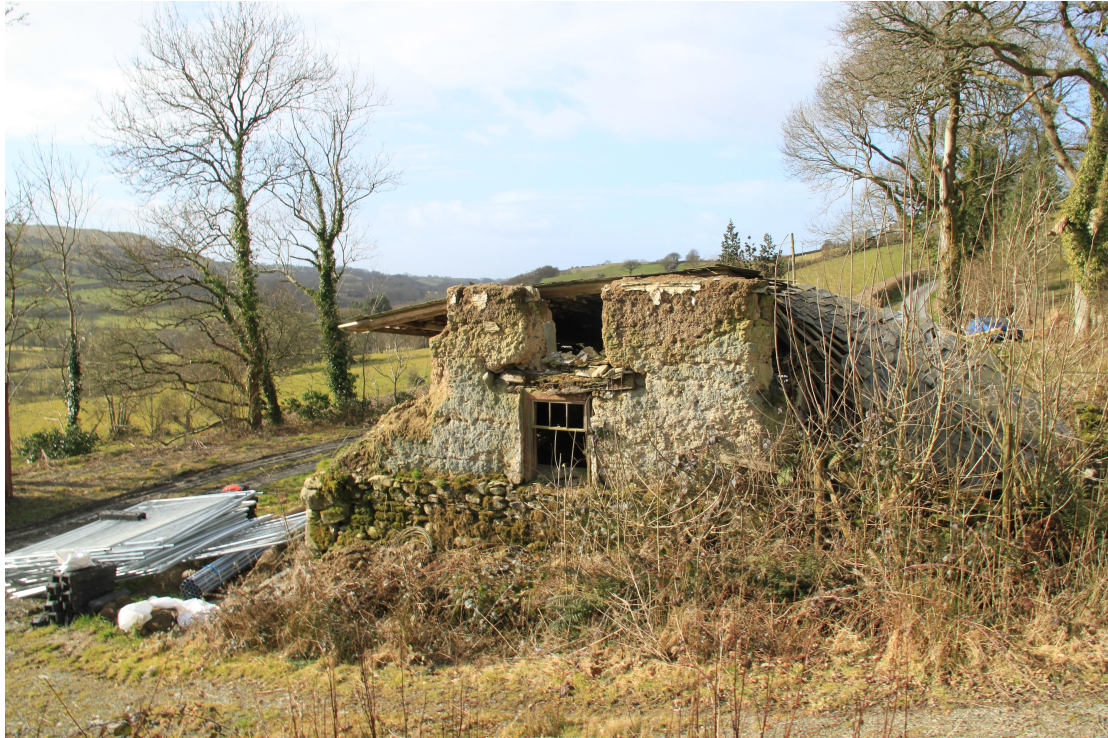
Plate 1 - AD004-BR-001 - View of east elevation, showing remains of ground and first floor windows.

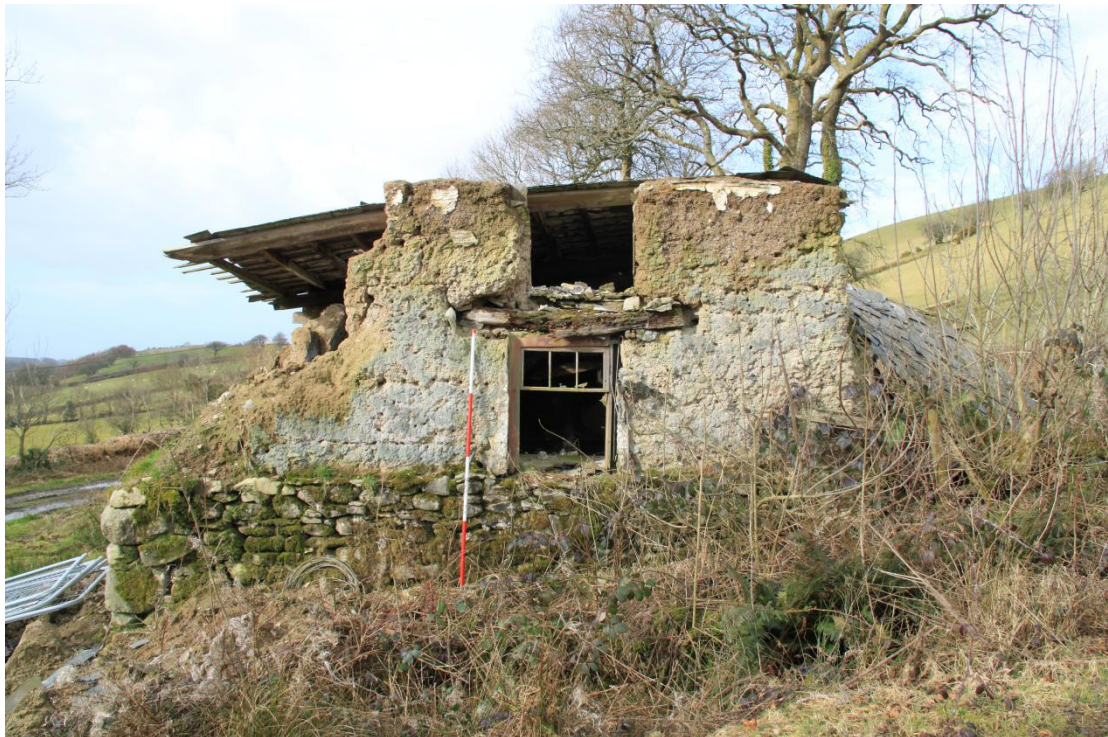
Plate 2 - AD004-BR-002 - View of east elevation. N.B. the change in clom colour to top of wall.

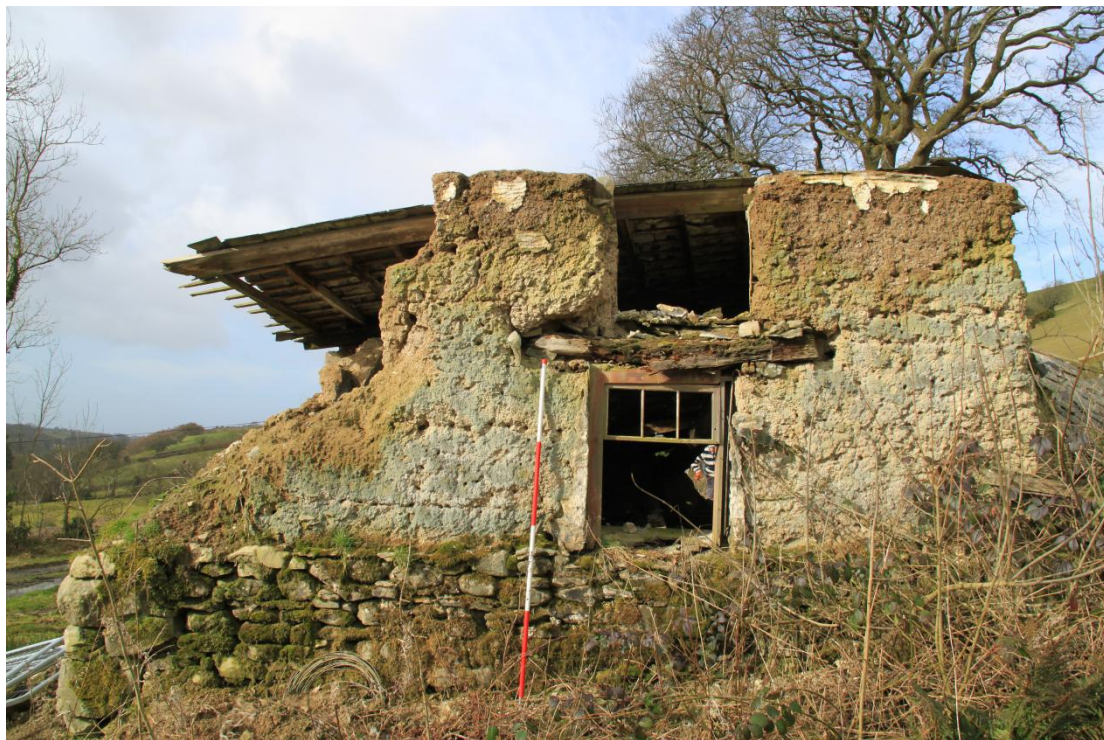
Plate 3 - AD004-BR-003 - View of west elevation. N.B. the change in clom colour to top of wall.

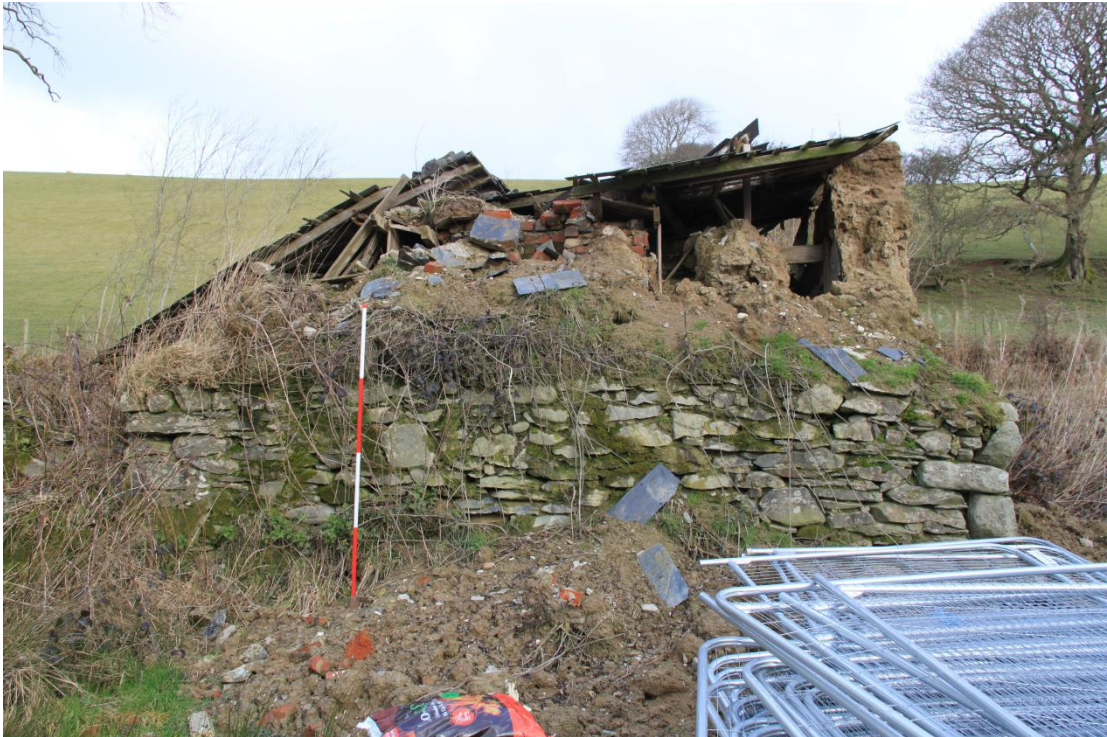
Plate 10 - AD004-BR-010 - South elevation, showing stone platform and decayed clom gable.

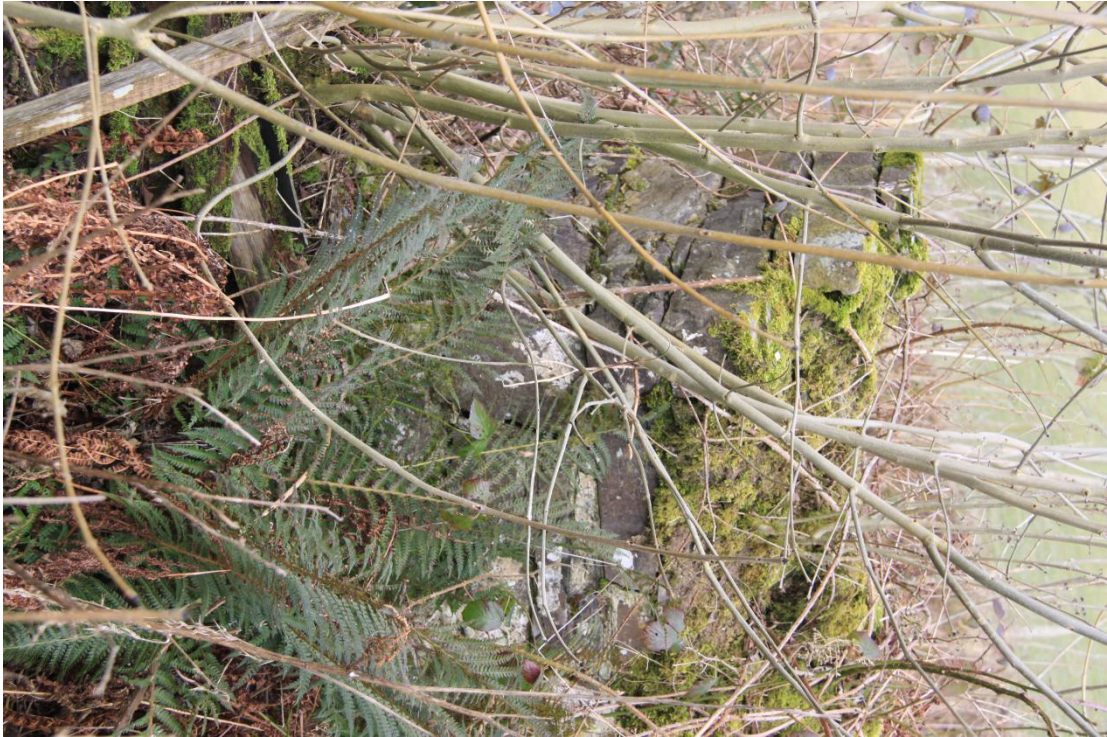
Plate 11 - AD004-BR-011 - Remaining stone wall to north-east corner.

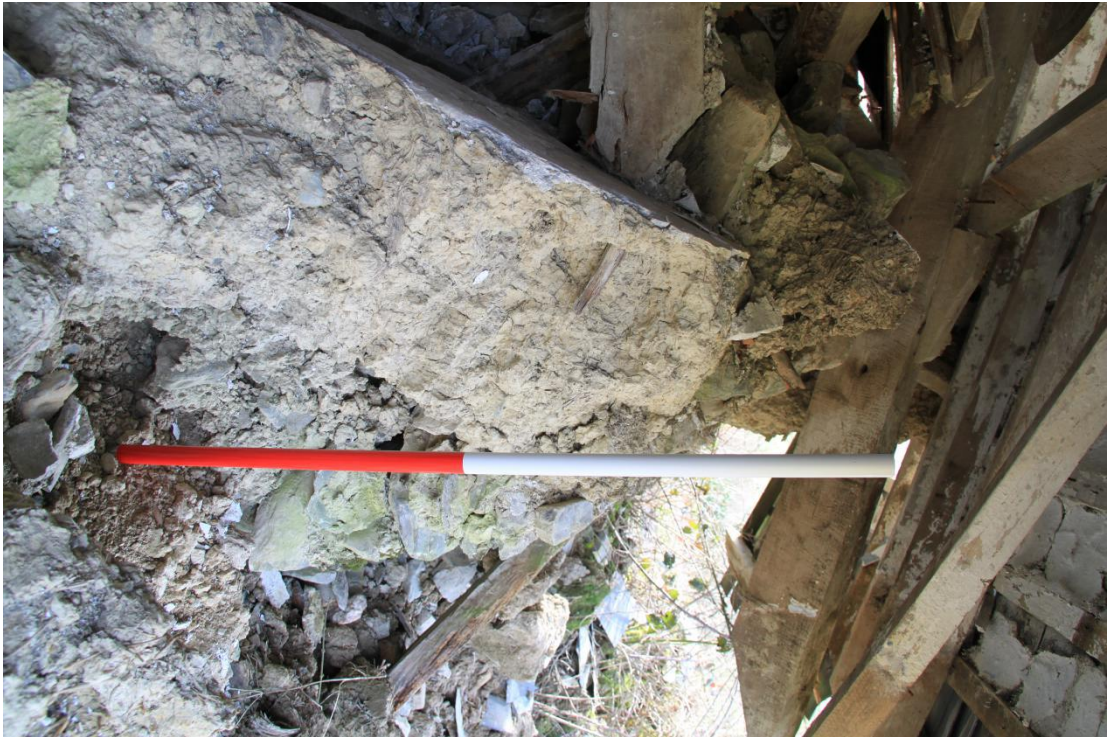
Plate 12 - AD004-BR-012 - Clom wall in section, west lateral wall. N.B. the 'break' where the later layer of clom was added.

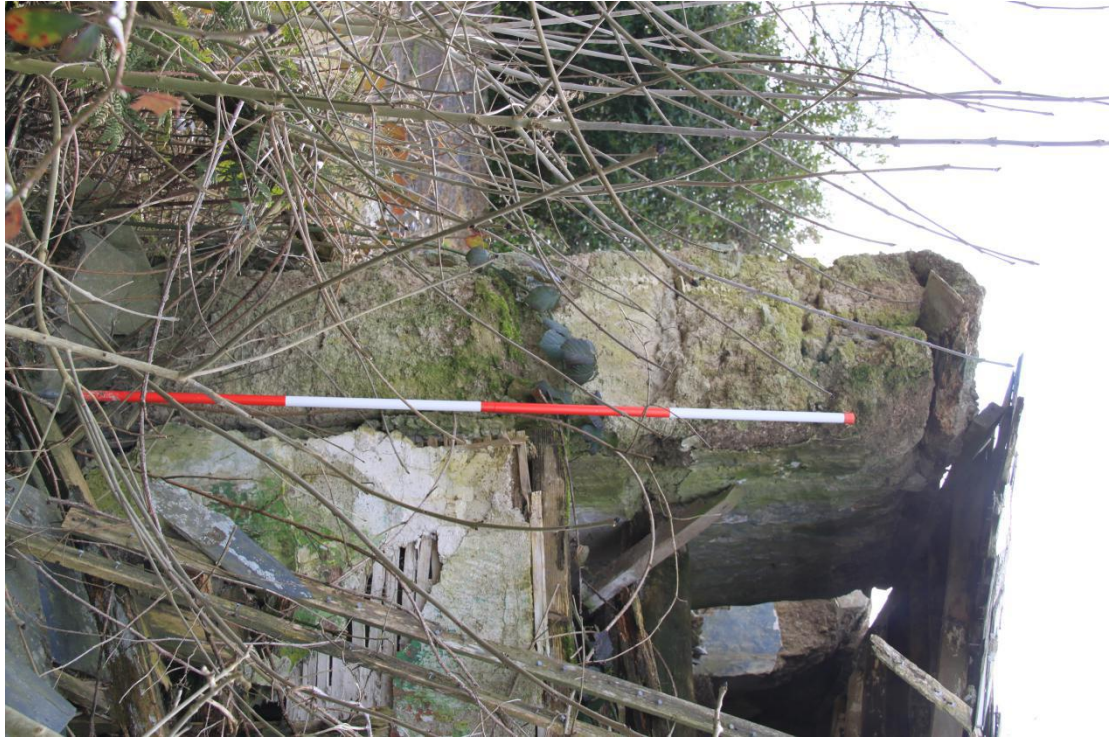
Plate 13 - AD004-BR-013 - Section of east lateral clom wall. N.B. the change in colour and texture to top *circa* 70cm of the wall.

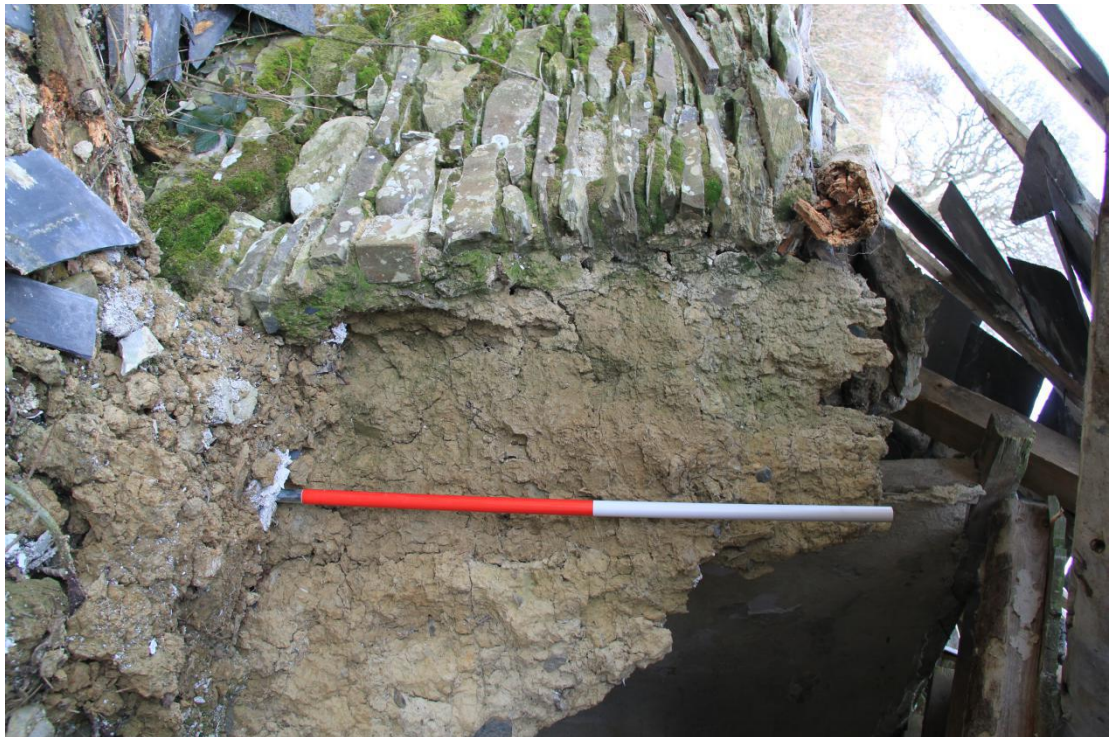
Plate 14 - AD004-BR-014 - Joint between stone and clom in west lateral wall.

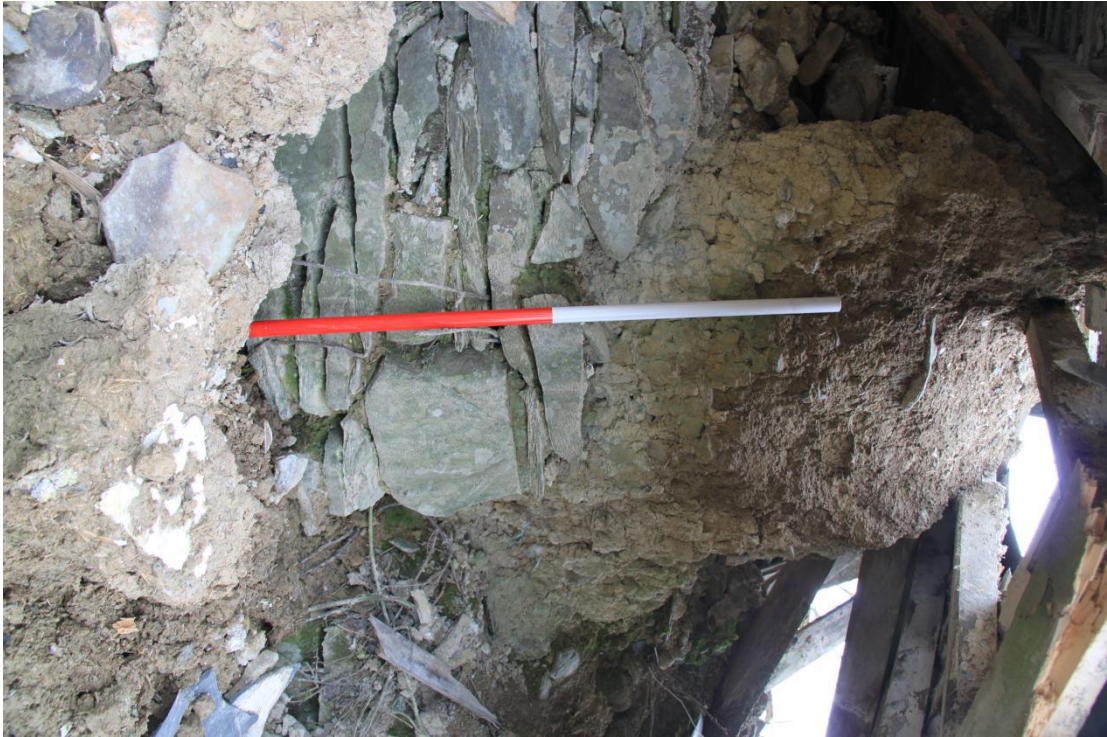
Plate 15 - AD004-BR-015 - Joint between later stone infill and clom wall to former kitchen doorway.

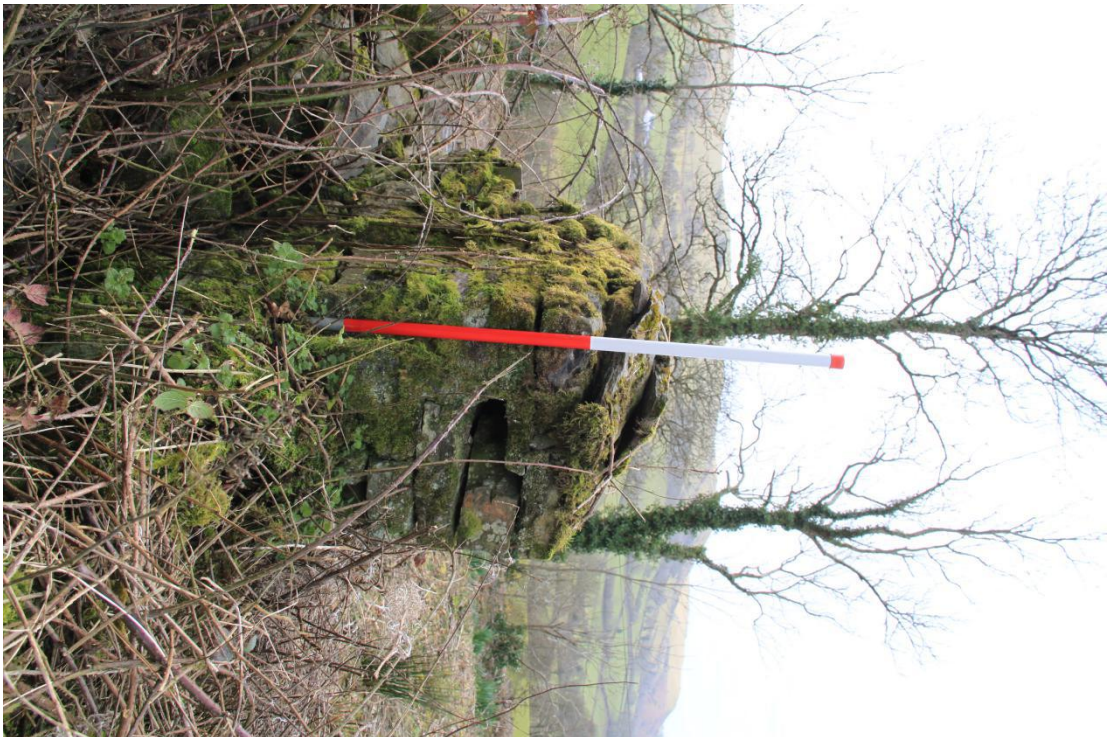
Plate 16 - AD004-BR-016 - Remaining window splay to rear extension, west elevation.

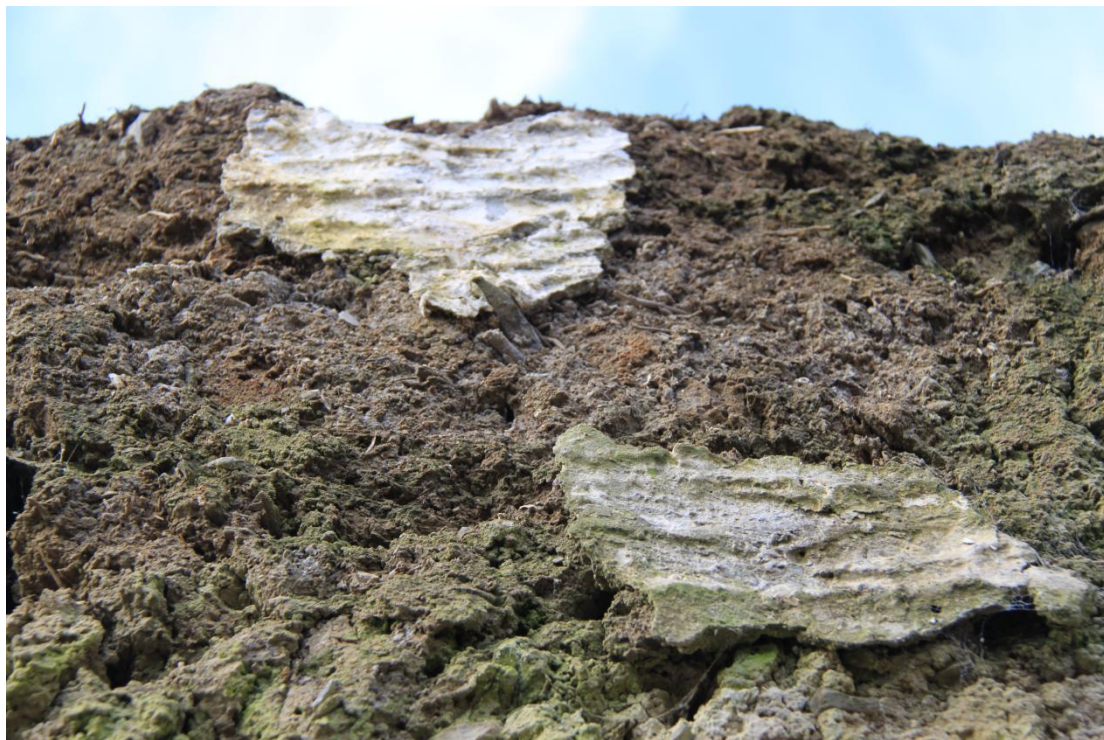
Plate 25 - AD004-BR-025 - Remains of thin lime render.

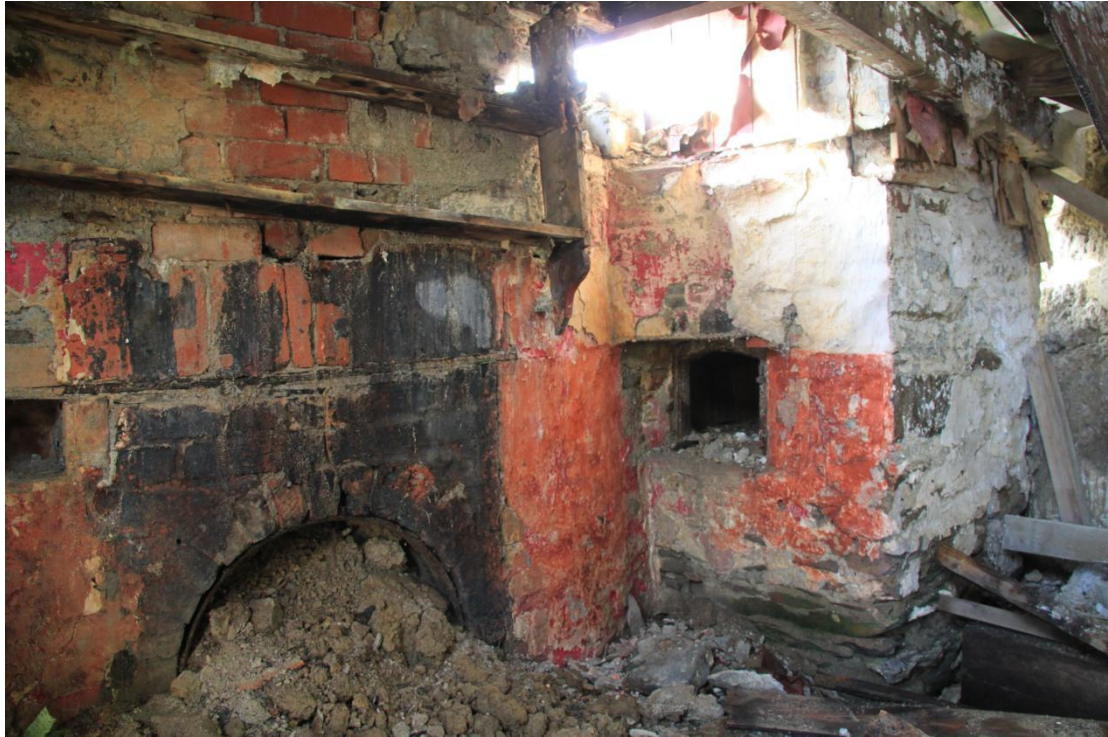
Plate 31 - AD004-BR-031 - Brick fireplace and bread oven. N.B. the later brick infill to fireplace.

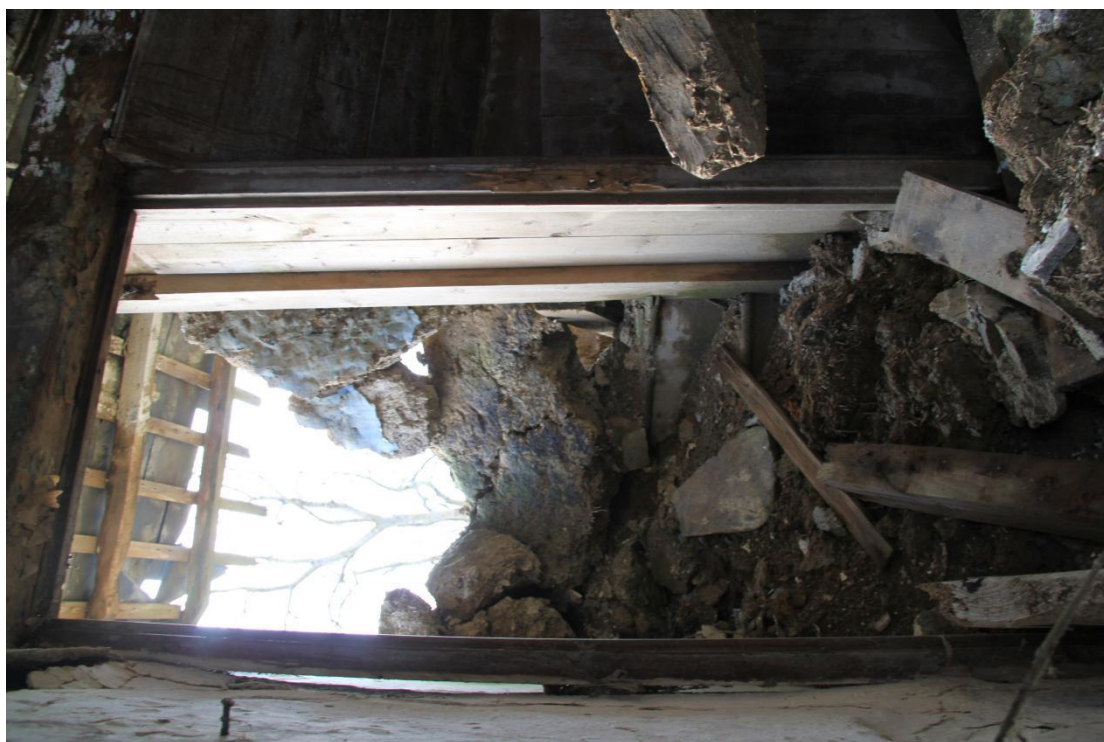
Plate 34 - AD004-BR-034 - Remains of front doorway, east elevation.

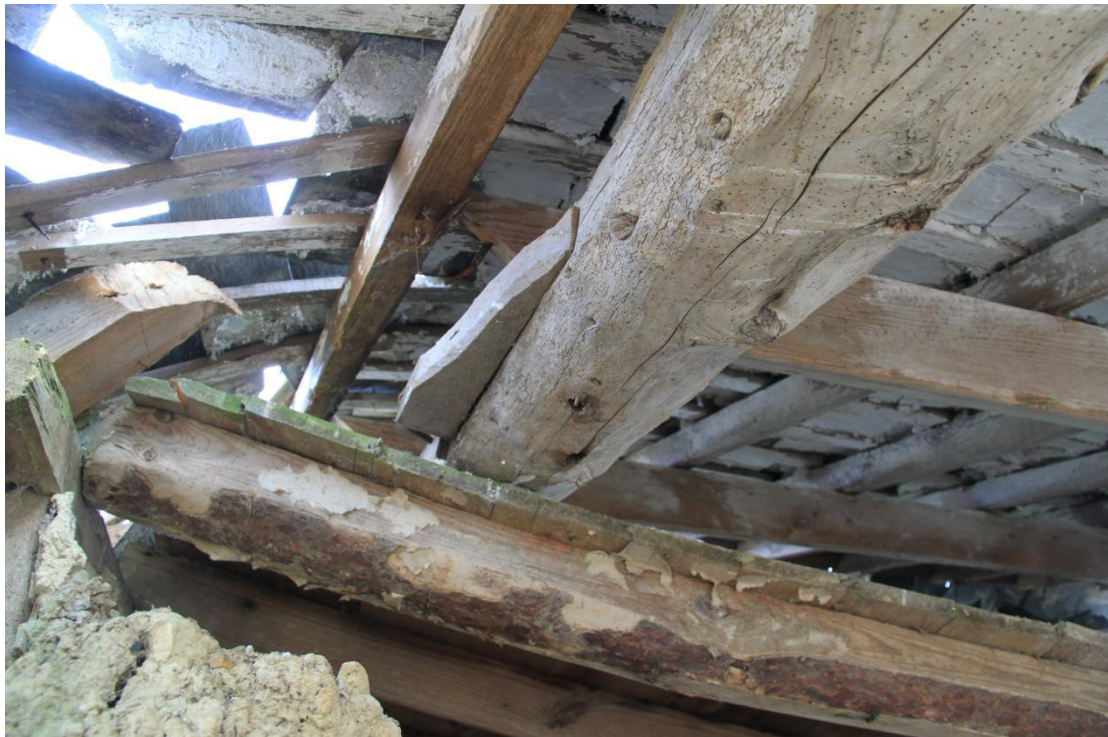
Plate 38 - AD004-BR-038 - Purlin cleat remaining on principle rafter.

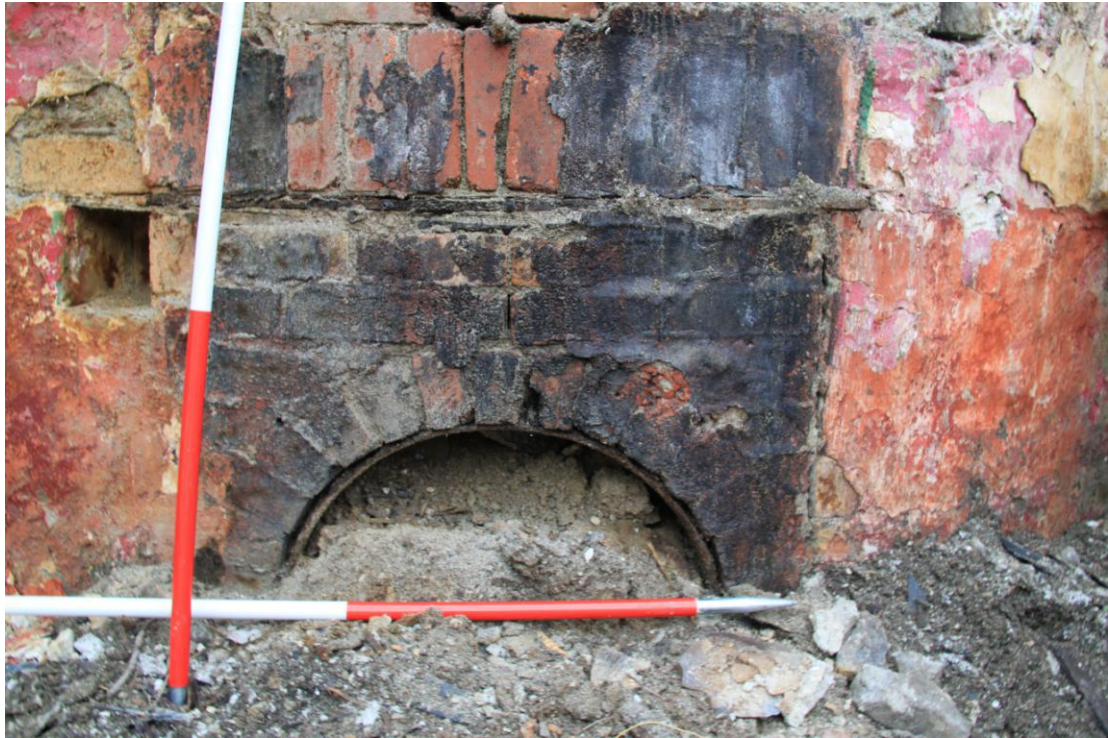
Plate 46 - AD004-D1-046 - Fireplace; black painted bricks a later infill.

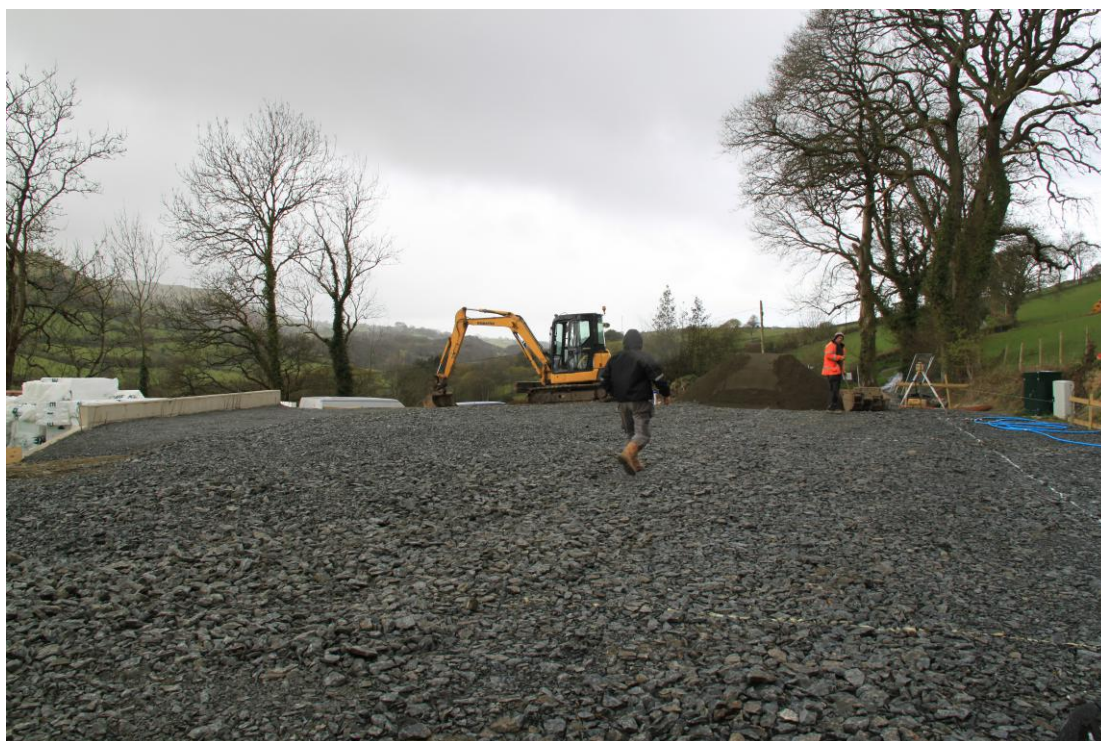
Plate 71 - AD004-D3-071 - View west across levelled site.

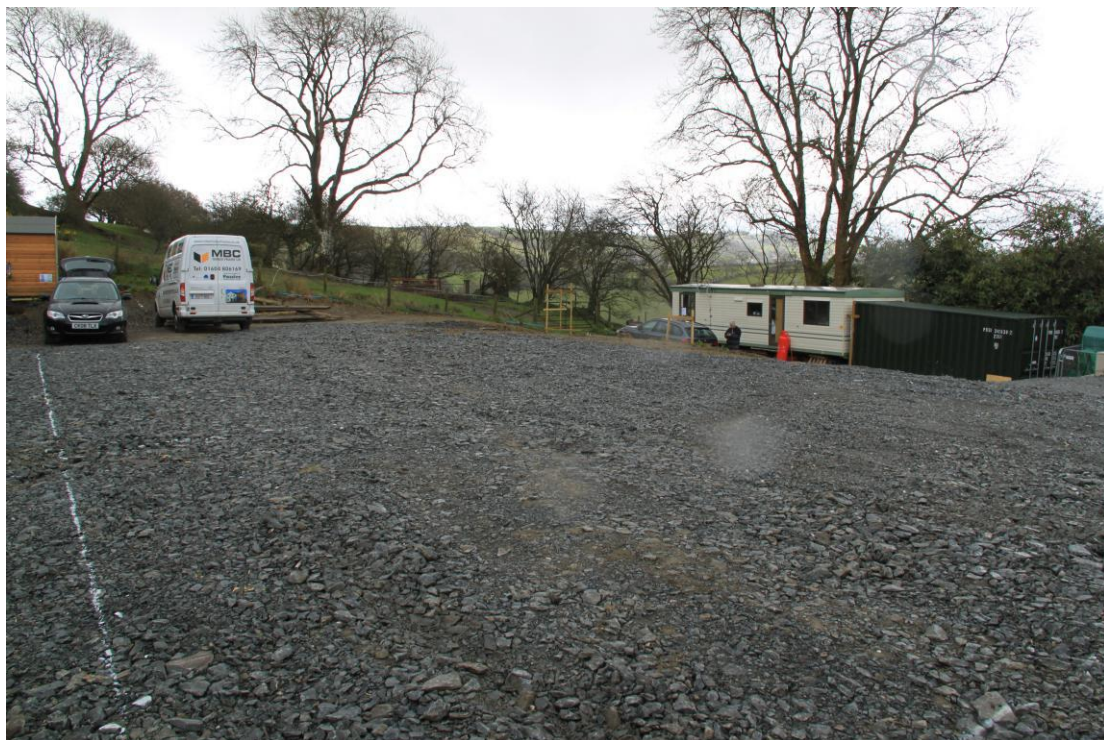
Plate 72 - AD004-D3-072 - View east across levelled site.
