# Glogue, Tegryn Pembrokeshire Archaeological Watching Brief

September 2016

# Glogue, Tegryn, Pembrokeshire Archaeological Watching Brief

Trysor Project No. 2016/519

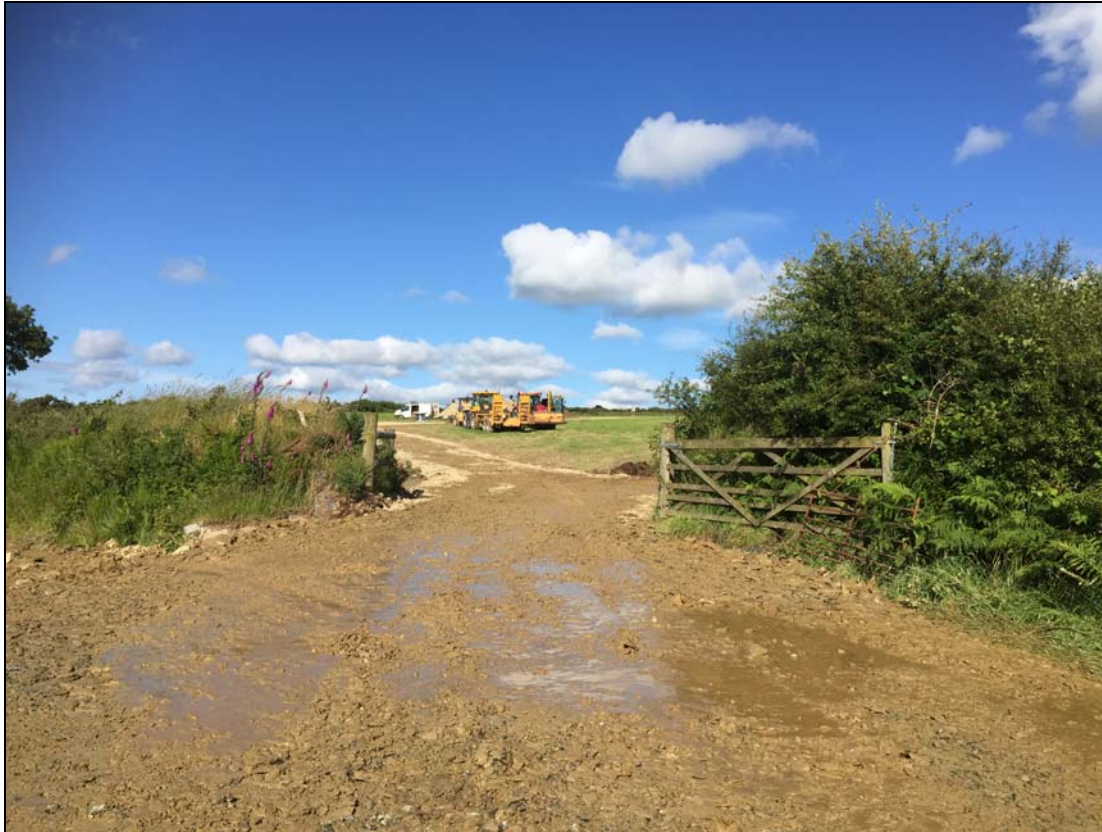
Plate 1: GLG2016\_101, a view towards the development site, looking east (5/7/2016).

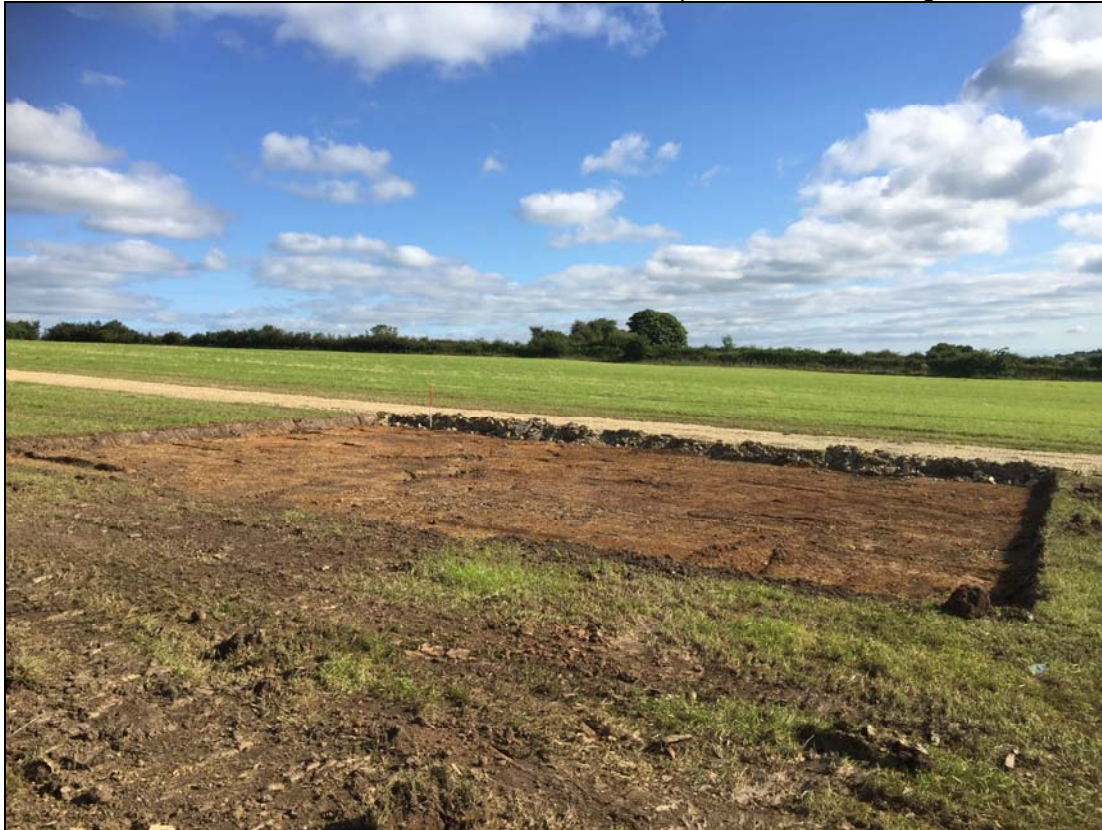
Plate 2: GLG2016\_102, looking south across the hardstanding area adjacent to Turbine 1 (5/7/2016).

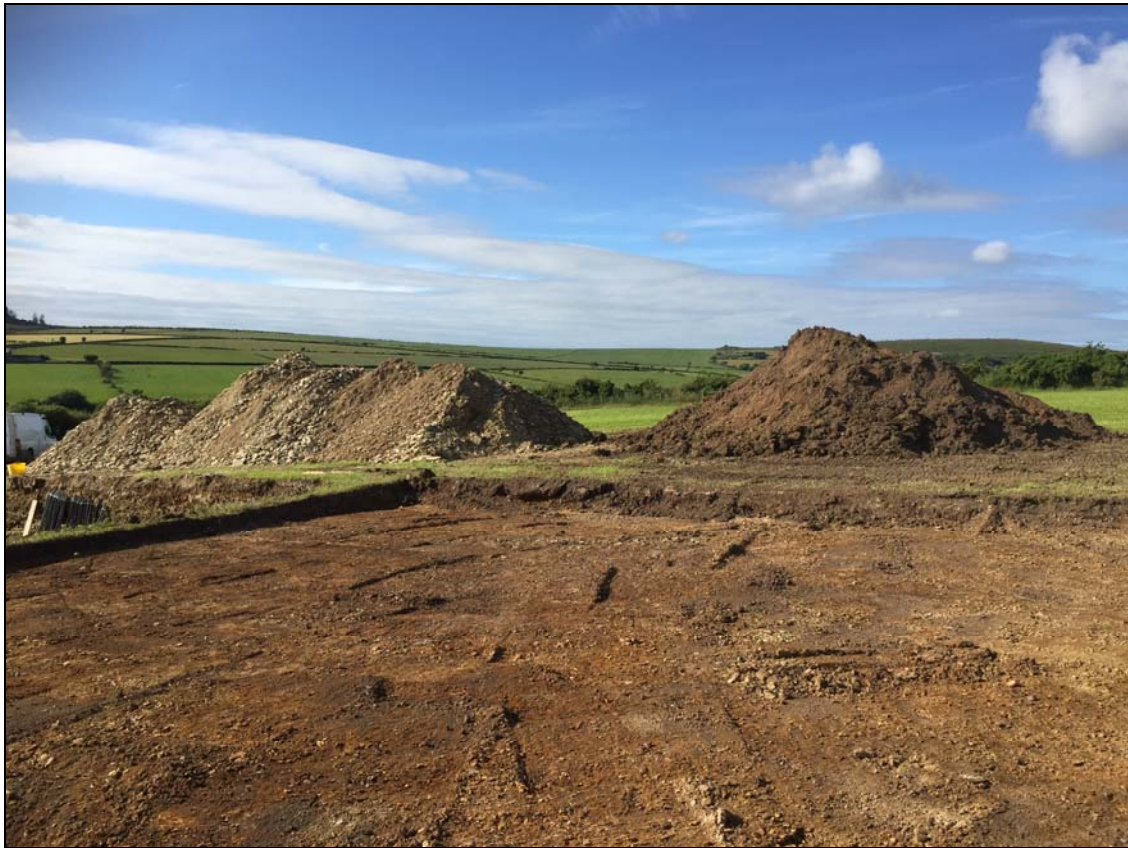
*Plate 3: GLG2016\_103, a view looking northwards towards the spoil tips of Turbine 1 (5/7/2016). The hardstandings and spoil tips were easily accessed.*

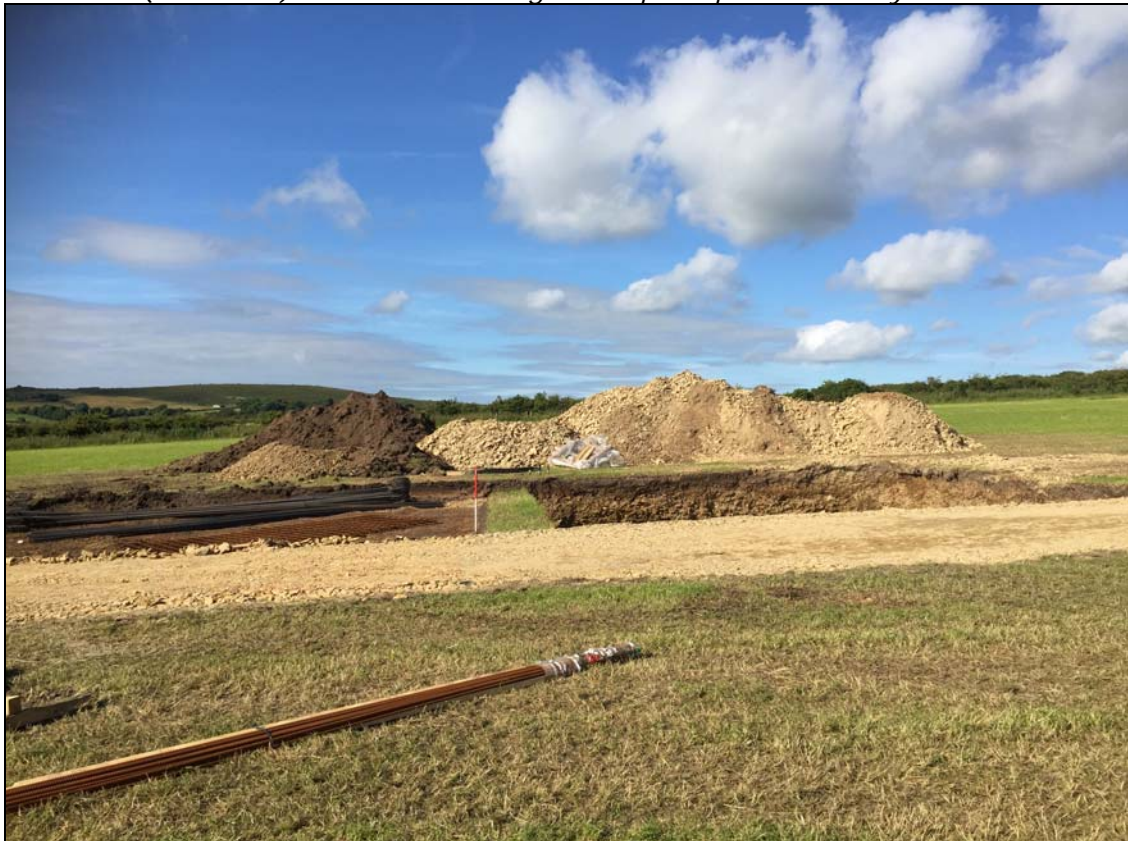
*Plate 4: GLG2016\_104, a view looking northwards at the site of Turbine 2 (5/7/2016).*

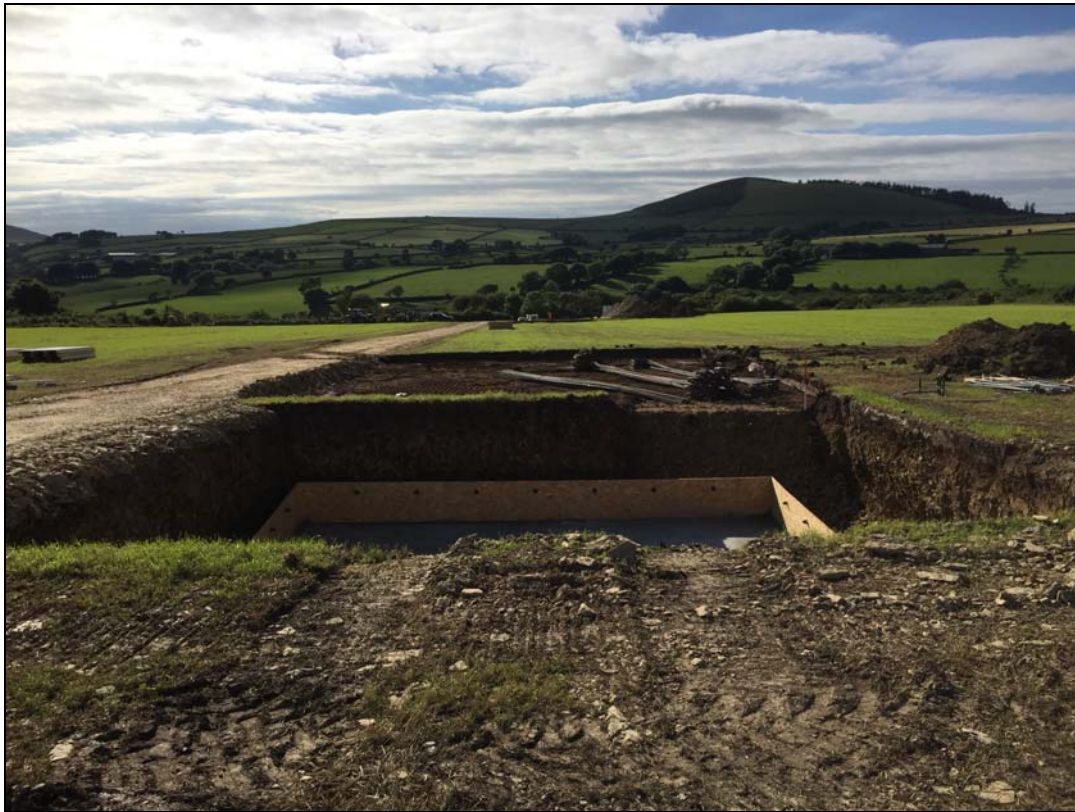
*Plate 5: GLG2016\_105, a view northwest across the development site (5/7/2016).*

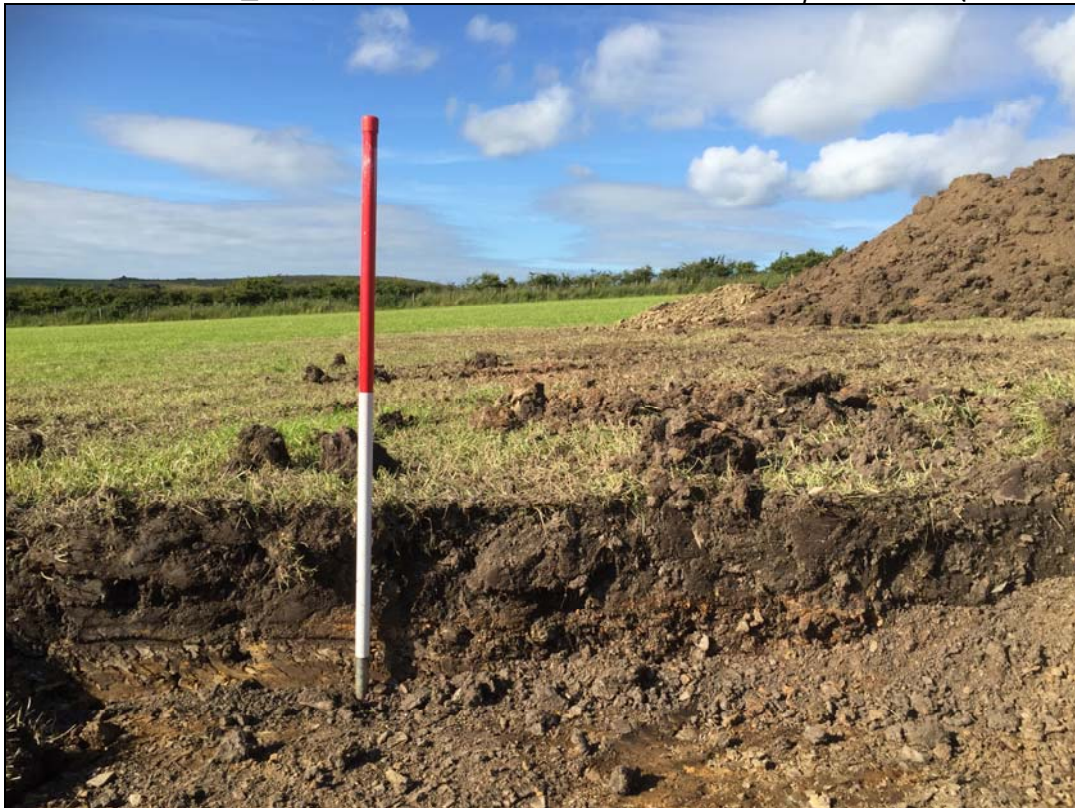
Context Number	Depth	Description	Interpretation
001	0.10m	10YR 3/1 friable silt loam with slate gravel	Ploughsoil
002	0.18m	10YR 4/4 clay gravel mix	Subsoil

*Plate 6: GLG2016\_106, a section of the topsoil and the upper subsoil at the edge of the hardstanding of Turbine 2, looking north (5/7/2016).*

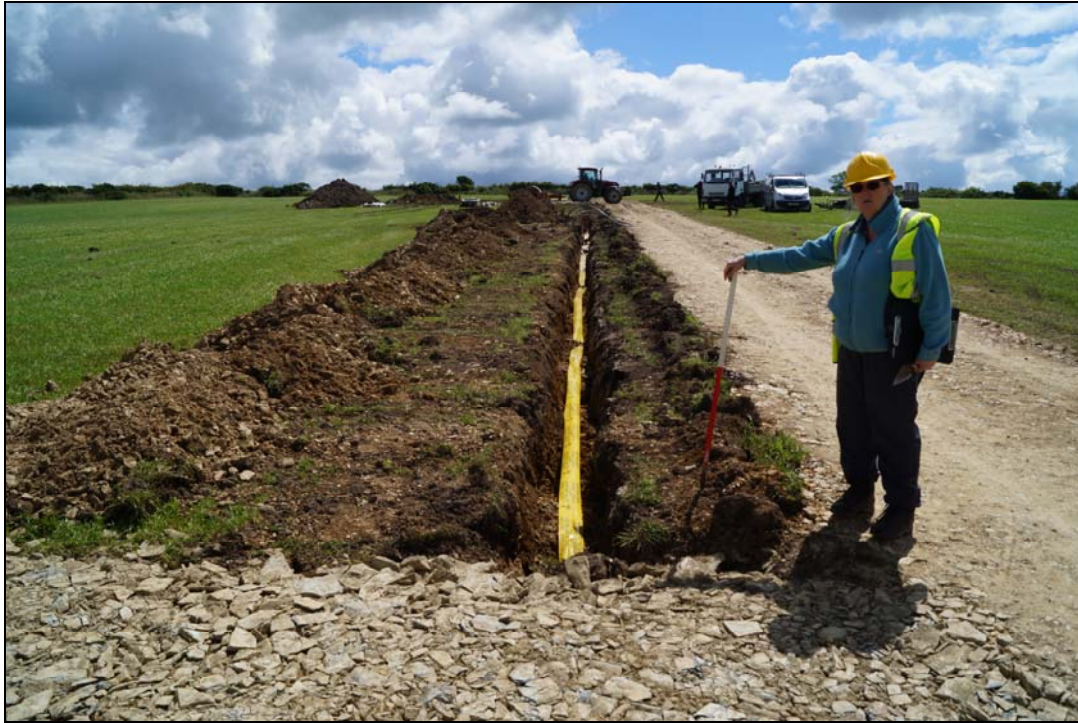
9.2 Sections exposed in the foundation holes for both turbines, as well as the newly opened cable trench were examined. The stratigraphy was found to be consistent at each location and therefore the contexts freshly exposed in the cable trench were recorded.

Plate 7: GLG2016\_107, the cable trench opened alongside the access trackway to Turbine 2, looking southeast (13/7/2016).

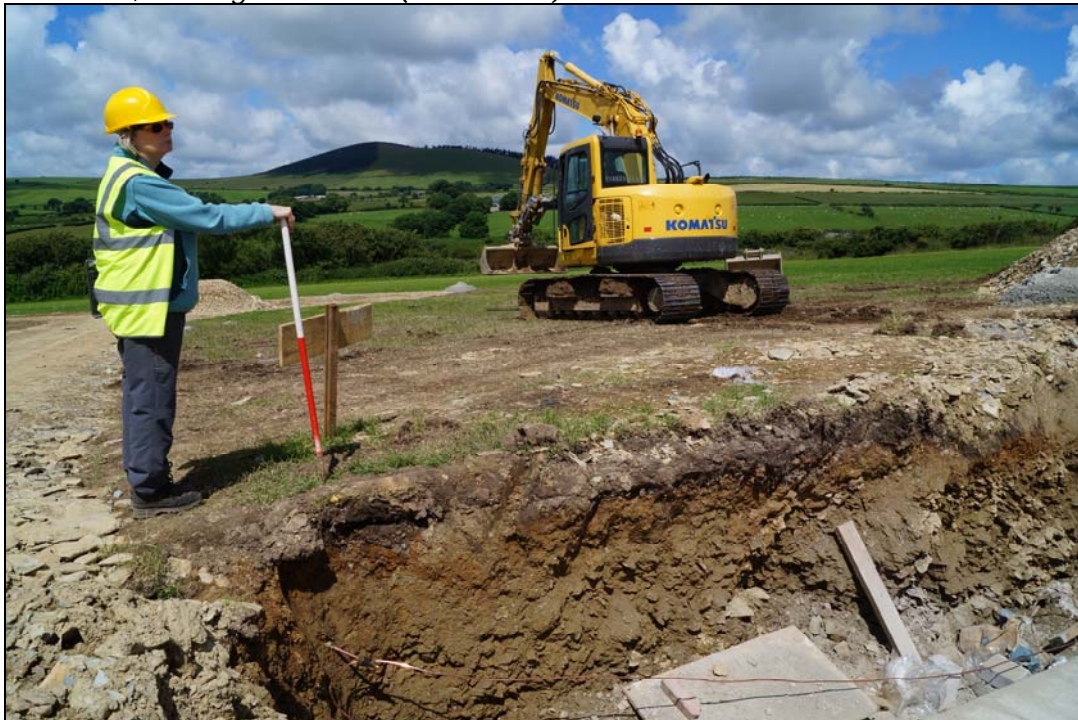
Plate 8: GLG2016\_108, a view of the section exposed in the foundation hole of Turbine 1, looking northwest (13/7/2016). These sections gave a clear and consistent view of the stratigraphy of the development site.

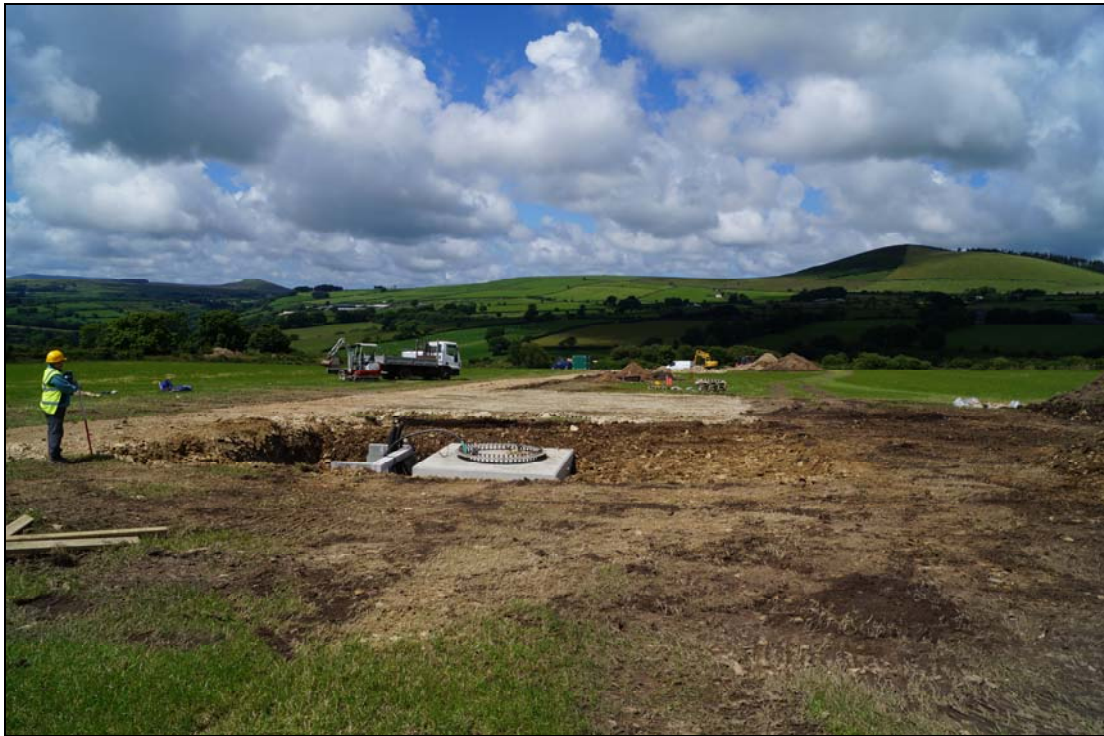
*Plate 9: GLG2016\_109, a view across the development side looking west (13/7/2016).*
