# GLASTIR ADVANCED POST VISIT ASSESSMENT

**DAT 105839**

**Site Name: St Clears, ruined brickworks**

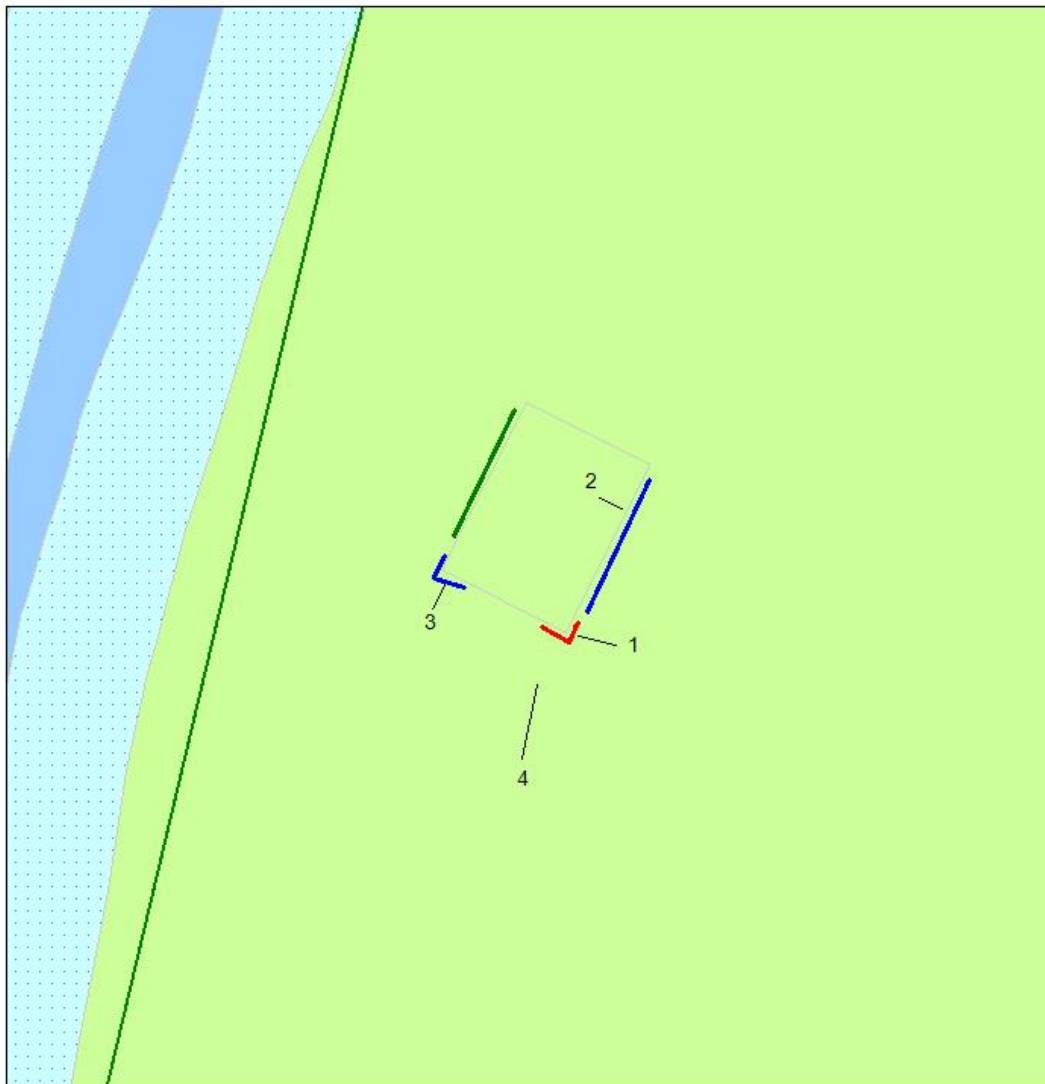
## MAP OF MANAGEMENT AREAS

Corner to be rebuilt

Wall tops to be re-set

Wall survives as rubble bank

- 1) Clear all the scrub vegetation on the footprint of the building as shown on the attached map.
- 2) Cut down all the trees growing on the site. Avoid damaging the exposed walls during this operation. All cuttings and brash to be cleared from the site and disposed of accordingly.
- 3) Spot treat all remaining stumps with appropriate herbicide.

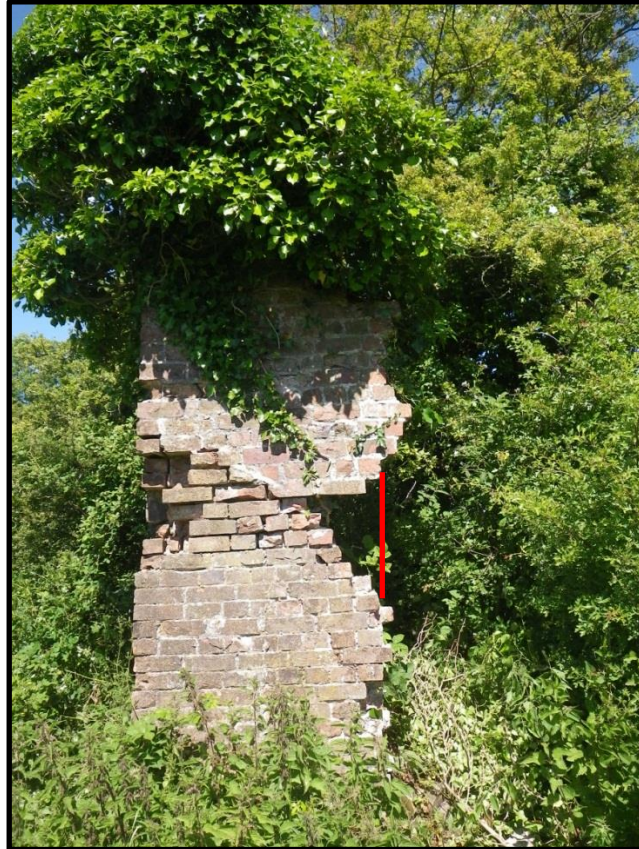
The surviving corner pillar is in a poor condition. The upper part is covered with thick ivy which is destabilising the structure through the invasive nature of the roots and the weight of vegetation bearing down. The eastern wall return narrows into a thinner waist half way down the structure leaving a stepped overhang. At this point the brick work is loose and in poor condition. This leaves it vulnerable to over balance as the damaged area acts as a potential tipping point. The corner of the pillar has missing bricks and poor pointing. The remaining wall lengths are in fair condition although the tops are loose and have been heavily disturbed by root action.

Photo 1. SE corner of Building A. Red line shows edge of area to be re-built.

The SE corner was assessed on site and it was agreed that the preferred option of full repair should be undertaken. Technical note 677 Historic-Repair of Masonry needs to be followed. Also the following specific recommendations need to be included the specification.

- 1) When erecting scaffolding around the structure only move the minimum of fallen material within the structure to set the scaffolding securely.
- 2) Remove ivy from the upper part of the structure carefully by hand. Leave roots in position and spot treat to prevent re-growth.
- 3) Re-point all jointing exposed under the ivy.
- 4) Rebuild the narrow section to the point indicated on the attached photo
- 5) Rebuild the external corner
- 6) Use reinforcement bars if required.
- 7) Where possible use bricks re-claimed from the top of the rubble piles on the interior. Do not dig into the piles to find bricks.
- 8) Repoint the whole of the wall return to the west

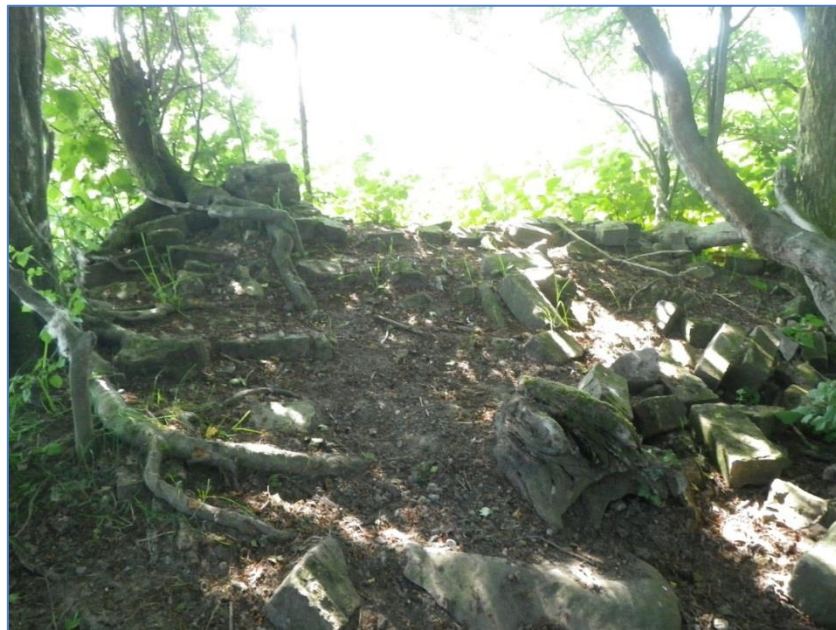
Photo 2 Inner face of NW Corner

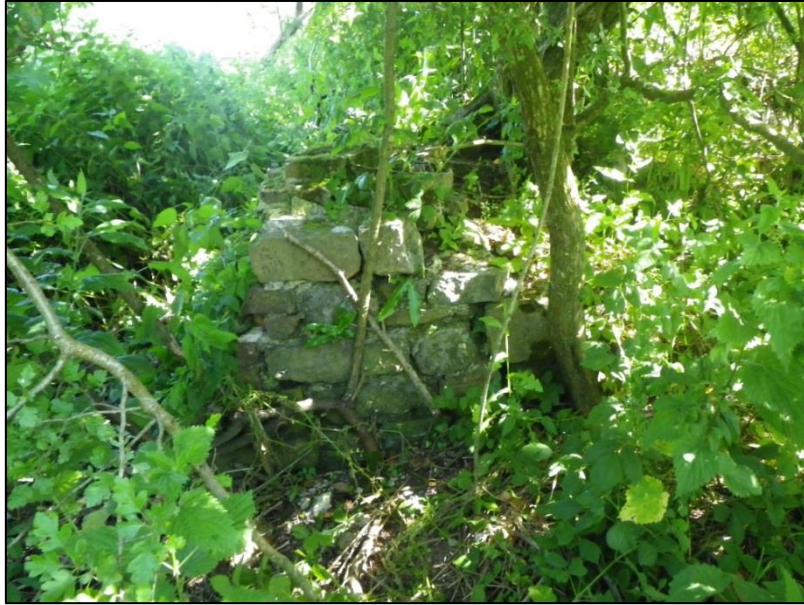
Photo 3 outer face of SW corner
