# GLASTIR ADVANCED POST VISIT ASSESSMENT

**DAT 105844**

**Site Name: Glandulais**

## **Introduction and historic background**

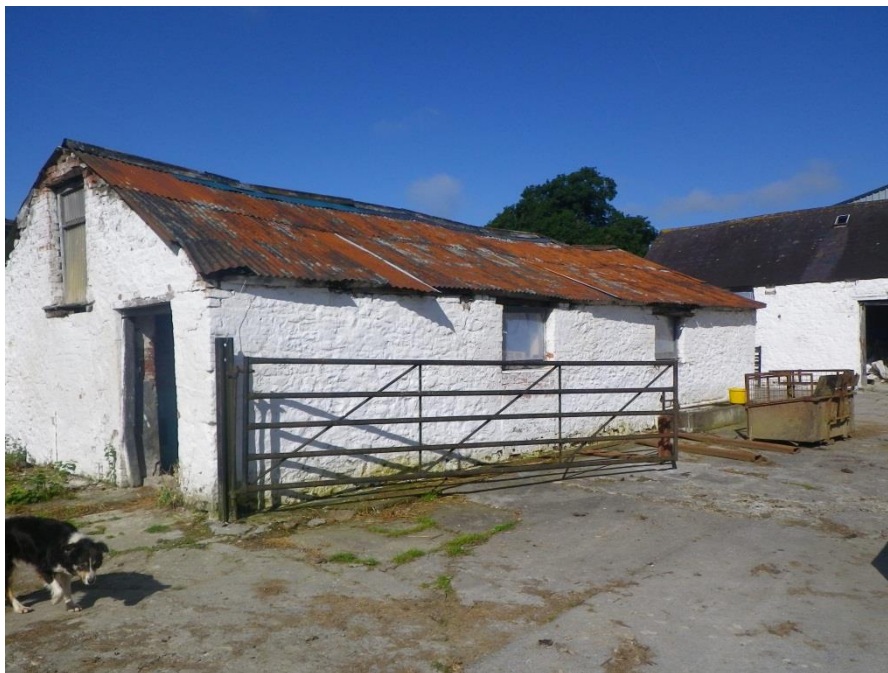
The current condition is fair but the structure is clearly failing in some areas and remedial works are required to arrest any further decline. Particular areas of concern are;

- 1) The roof rafters are in a poor state and the current covering of corrugated metal has holes in it and some sheets are coming loose.
- 2) The wall heads are loose and need re-setting and some fabric replaced
- 3) The SE corner needs some replacement bricks and the rear wall needs re-pointing.

Building subject to proposals

These works are essential for the long term survival of the building and DAT fully supports this work being done.

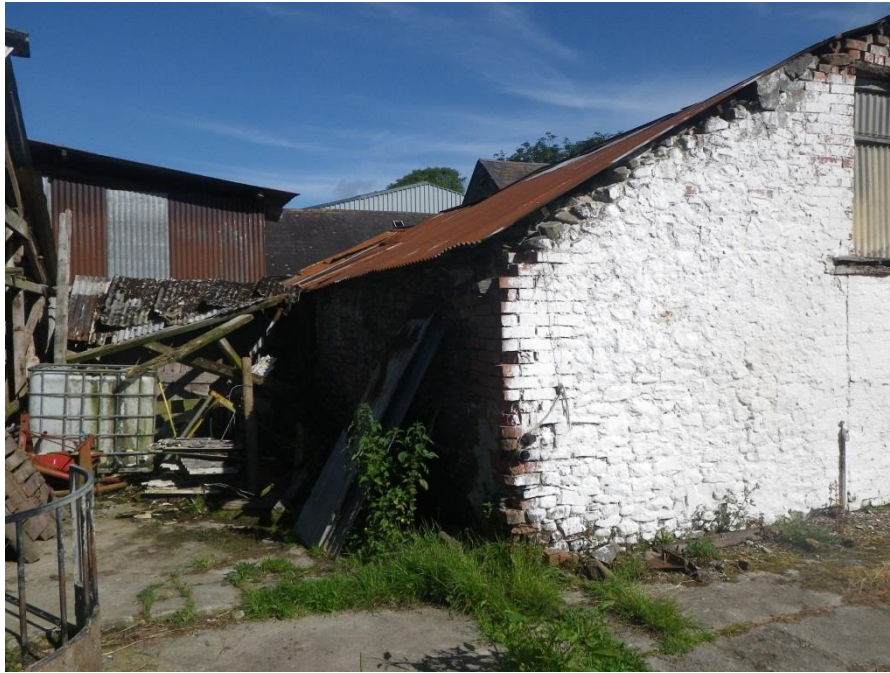
SE corner of building

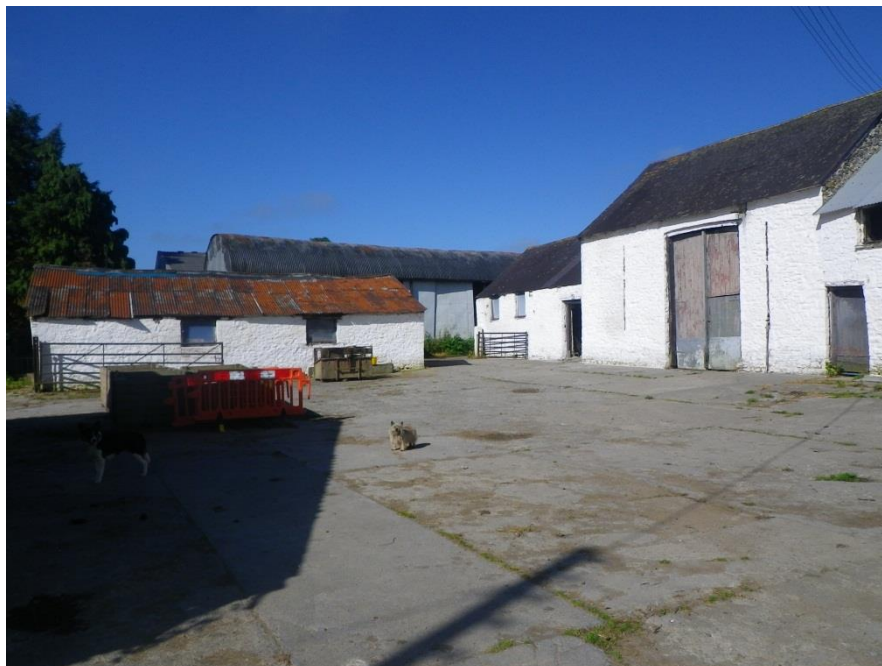
Building in context. Listed barn to right.
