HAROLDSTON HOUSE HAVERFORDWEST

A MANAGEMENT PLAN FOR THE CONSERVATION OF THE REMAINS FOR THE GILD OF FREEMEN OF HAVERFORDWEST

**MANAGEMENT PLAN FOR THE CONSERVATION OF THE MASONRY REMAINS OF
HAROLDSTONE HOUSE. HAVERFORDWEST, PEMBROKESHIRE.**

PART 1 – SURVEY WORK AND DRAFT CONSERVATION STRATEGY

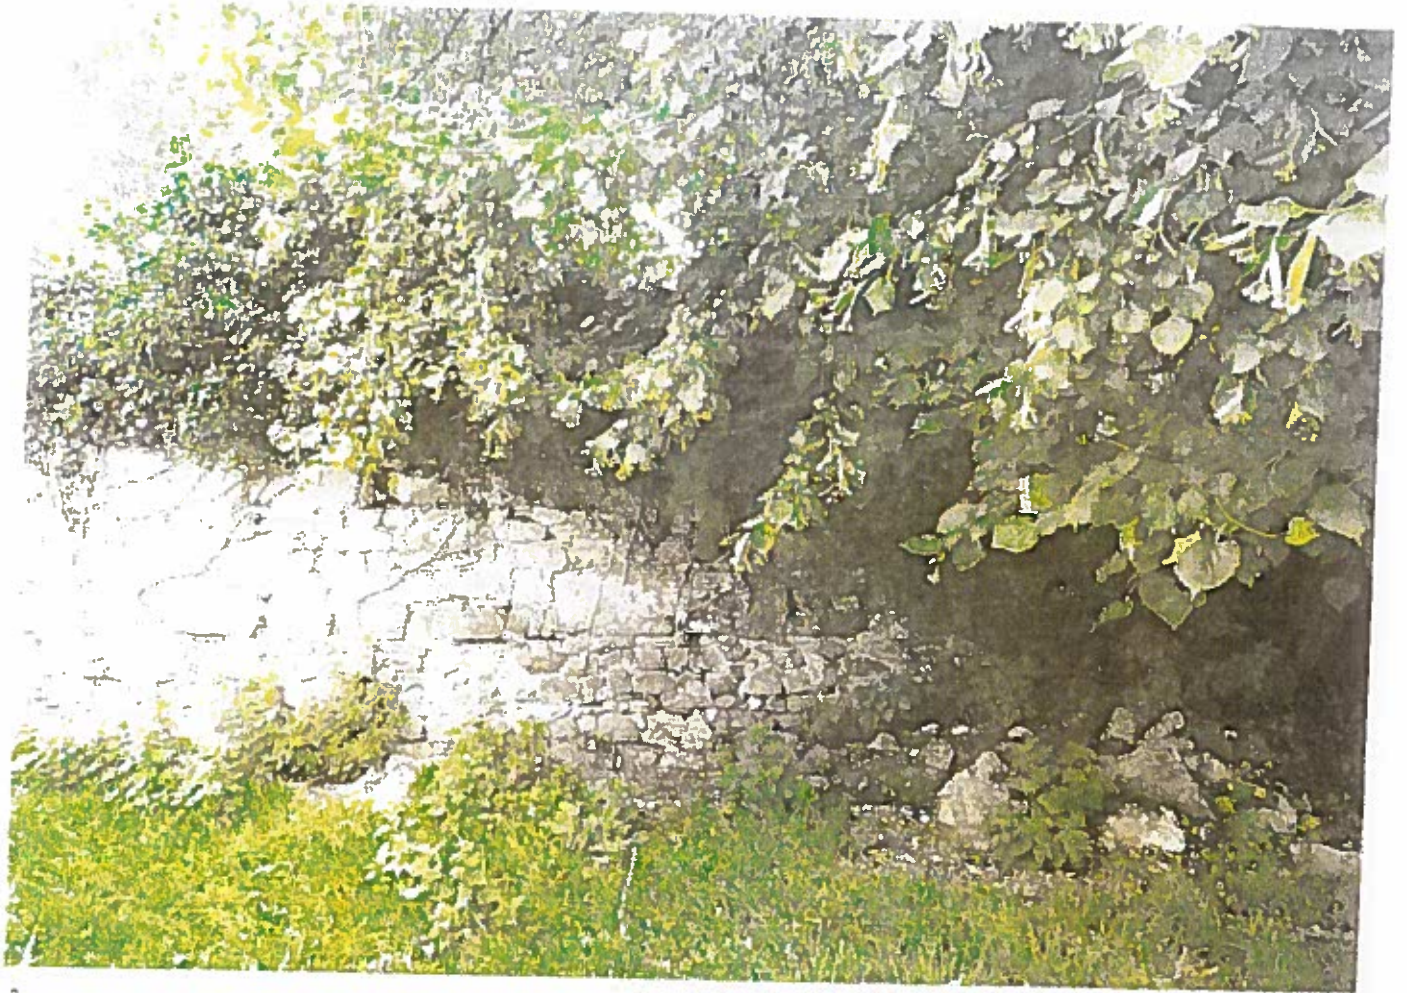
3

- 4.3.2 The west face (photos 3,4,5 & 6) has numerous open joints and some loss of face in isolated locations. Stone is loose around the blocked doorway where ivy is rooted in the wall. The alignment of the wall is good. The walltop is obscured by ivy.
- 4.3.3 The east face (photos 10,11, & 12) has been disrupted by the tree at the south end. There are open joints and holes at low level but the alignment of this is not as good due to ivy roots opening up the joints of the upper masonry and disrupting the wall top.

Ivy and saplings in the wall should be killed. Along the top of the east face masonry should be recorded numbered and dismantled to remove large roots. Open joints should be pointed, loose masonry rebbed and wallcap rebuilt to its original profile following removal of dead vegetation.

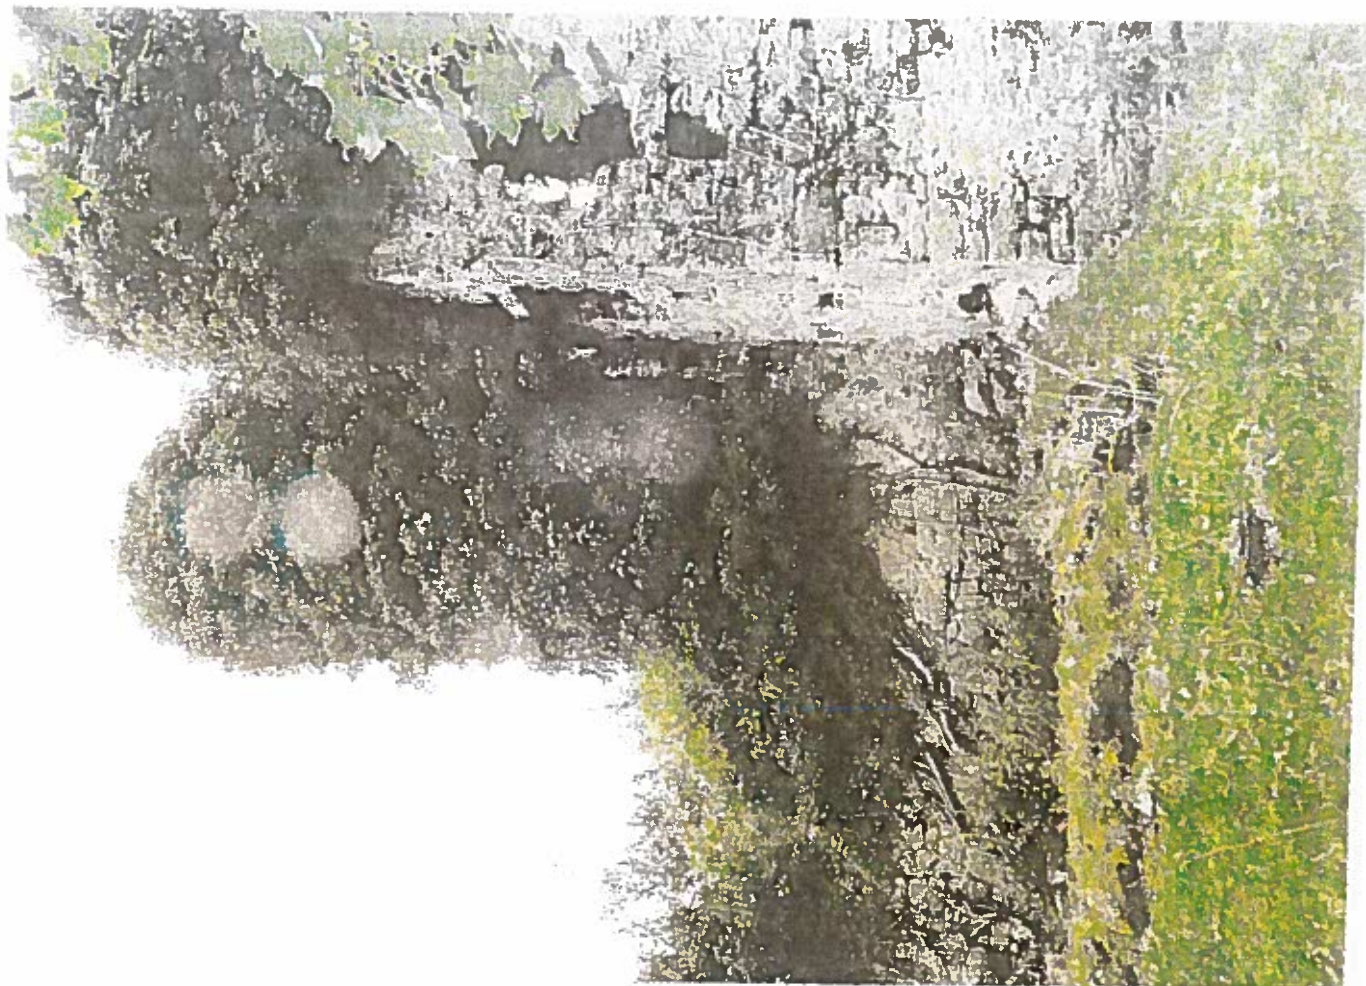
13

The ground floor masonry that can be seen is in relatively good condition with a small number of open joints. Above first floor level there has been a collapse of masonry leaving a gap at the junction of the stair tower and garderobe tower. Above this ivy obscures the rest of the wall with its windows and corbelling.

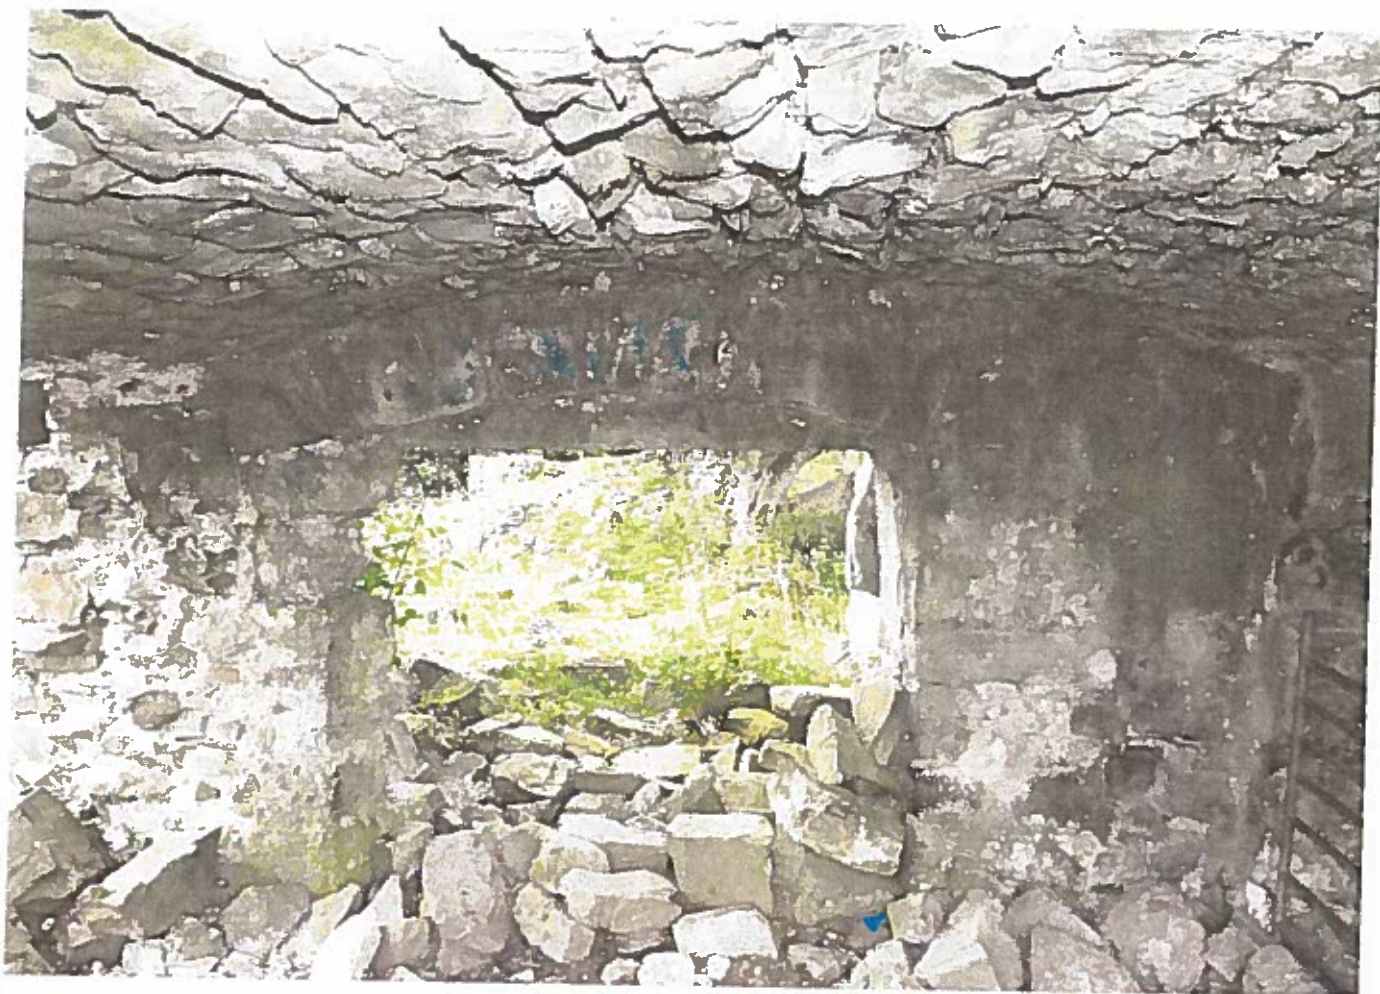
35

The east wall (photo 35) contains the remains of the original outer doorway of the gatehouse with the drawbar slot apparent in the reveals. The opening is partially filled with collapsed masonry and the dressings are missing. The north wall (photos 36 & 37) is in square rubble masonry with a door opening the east end. The dressings and lintel to the opening are missing. The vault (photos 38 – 41) is a flat arch formed of stones about 450 mm deep of various lengths with faces not exceeding 150 mm. The south wall (photos 42 & 43) is in square rubble with a shallow pointed arched opening to the stair well. The west elevation is open.

The north bearing of the east opening lintel is only 40 mm x 50mm and stones of the north reveal are missing. The lack of a lintel on the north door opening has resulted in collapse of stonework above, prejudicing support for the vault. There are signs of recent collapse. On the south wall the keystone of the arch and the steps have been removed undermining the reveals of the staircase opening. Facework has been removed to the west of the door reveal causing collapse of the stairs above.

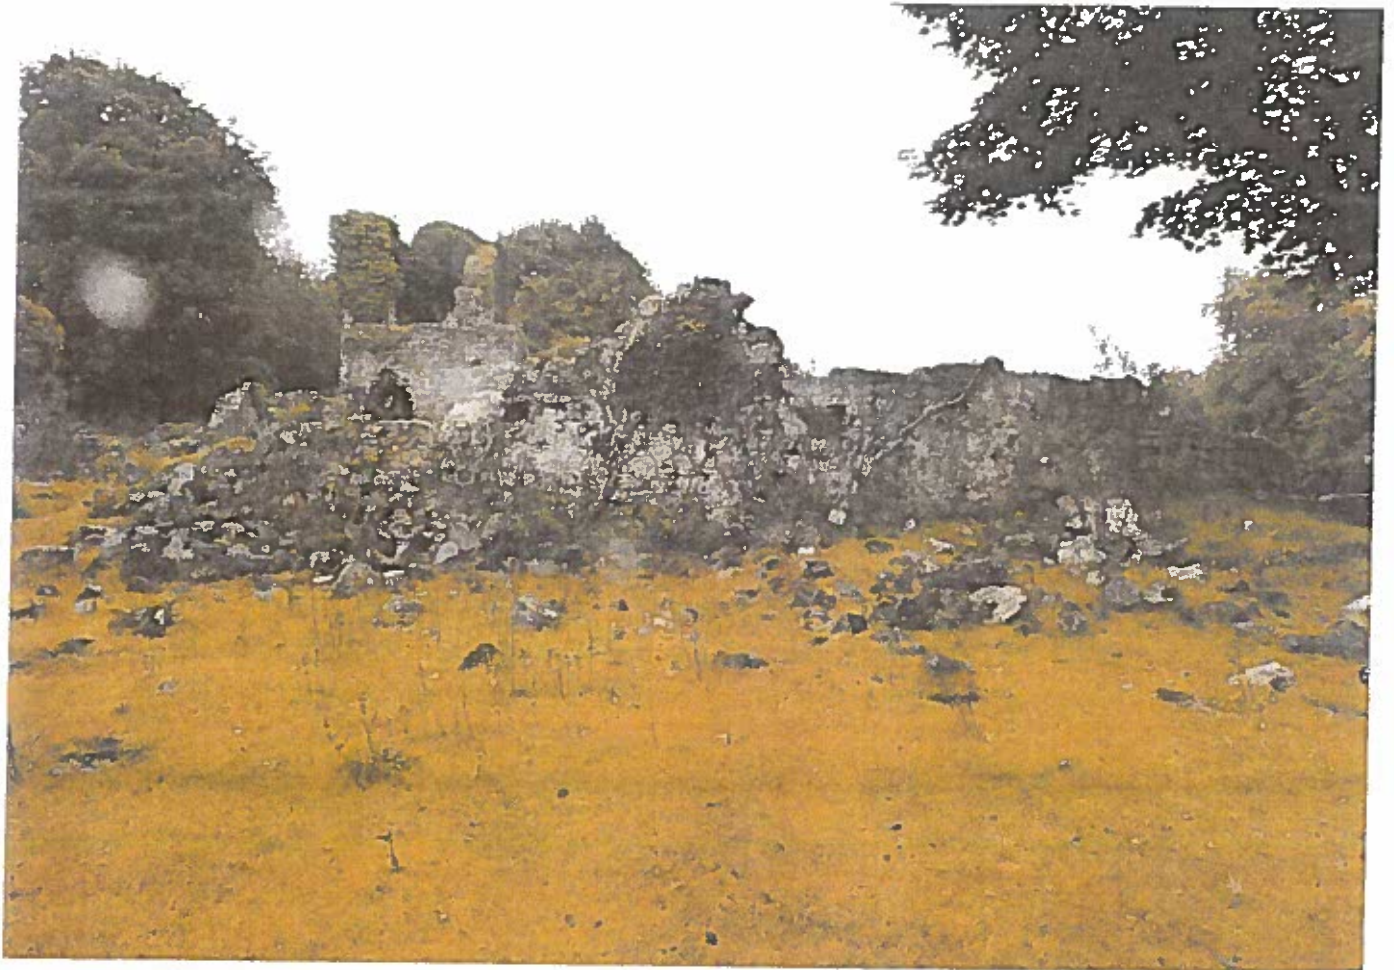
75

The north face is in good condition except for a hole at low level open joints and ivy growth on the south face and ivy on the top. There is recent dislodging of stones on the top of the wall.

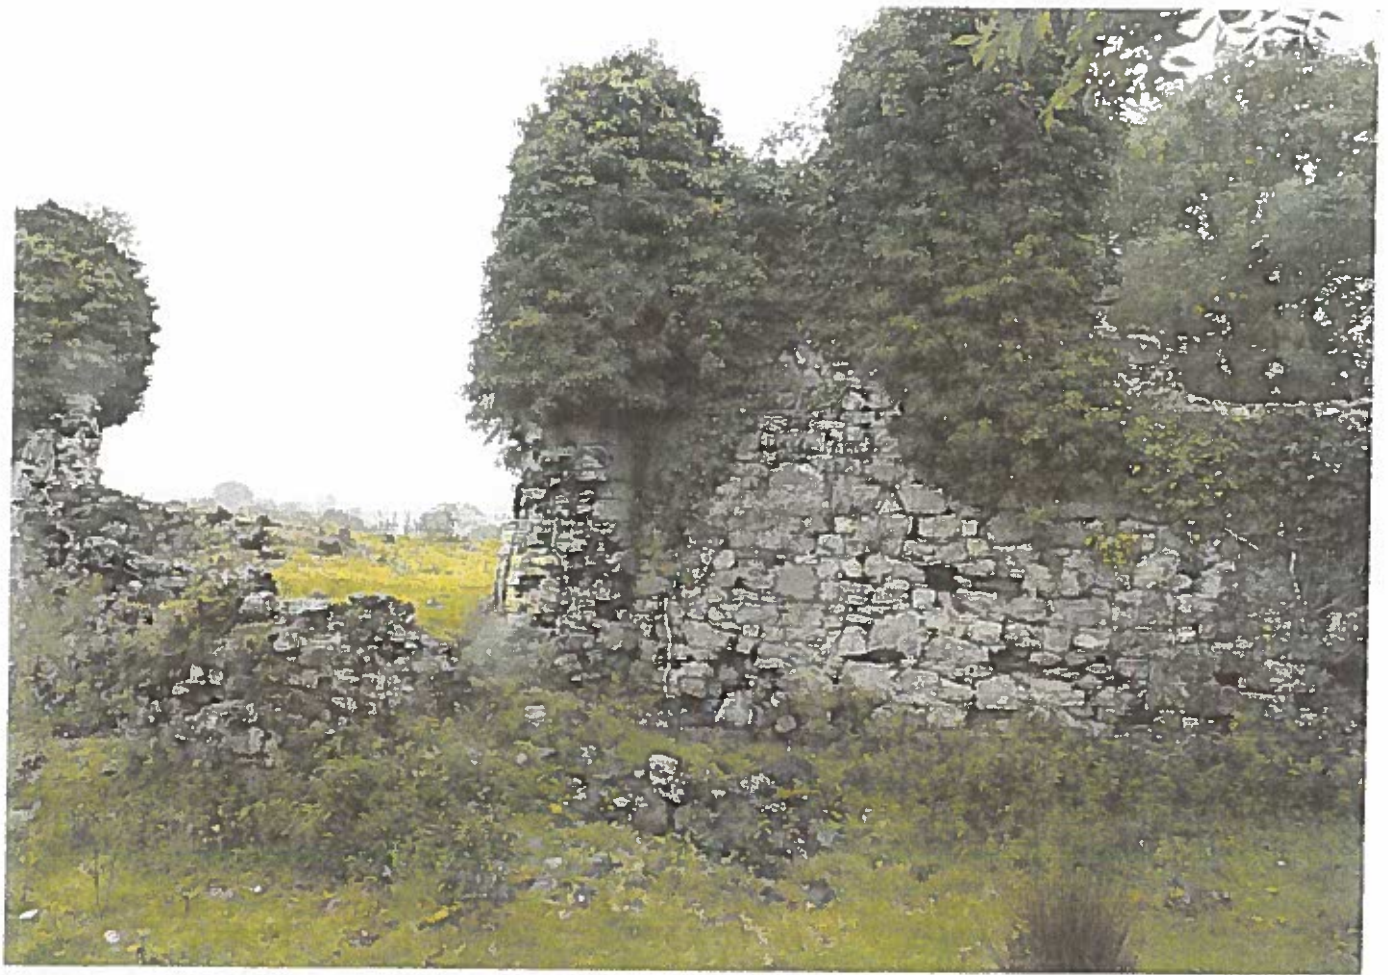
67

The south end of the west wall is open jointed and has a number of collapses on both its east and west faces, together with heavy ivy growth at high level where it is leaning to the east. The south return wall of the west protection is in poor condition with open jointed and unsupported corework on east and west edges, and heavy ivy growth at the top. It is leaning to the north. The rest of the south and west walls of this projection have lost much of their facework and are covered in vegetation. The north wall of this protection and adjoining north section of west wall is lost in rubble.

The west face of the north west corner is in good condition below first floor level, but there has been loss of facework at the corner, and stones are open jointed and unsupported above the losses. The upper face is concealed behind ivy. The base of the north face is open jointed with numerous holes above which ivy conceals the wall. The internal corner has numerous holes and the south and east edge corework is tied together by ivy stems. The ivy clads and conceals all the upper masonry.

The south end of the west wall east face needs extensive filling of holes, introduction of corework to support overhanging face stones, killing and removal of vegetation and pointing. The west face needs holes filling, pointing, lost facework reinstated in corework and killing of ivy. The top of the wall should be recorded, stones numbered, ivy roots removed and rebuilt in capping mortar to its original profile.

The south return wall of the west projection needs the same treatment as the adjoining west wall and on completion should be tied to the west wall using cintec anchors @ 700 mm vertical centres. The other surviving remains of the west projection need the same treatment as described in Clause 4.26.3. The north west corner should be scaffolded and ivy leaves cut back to establish if it is rooted in masonry. If not, it should be killed and vegetation peeled back and discarded. Reinstall missing face stones on NW corner, point walls and fill holes. On internal face, fill holes in corework. Dismantle and rebuild wall top as described previously.
