## Gilfach-y-berthog, Abergwilli, Carmarthenshire.

### Archaeological Watching Brief

HRSWales  
Report No: 131

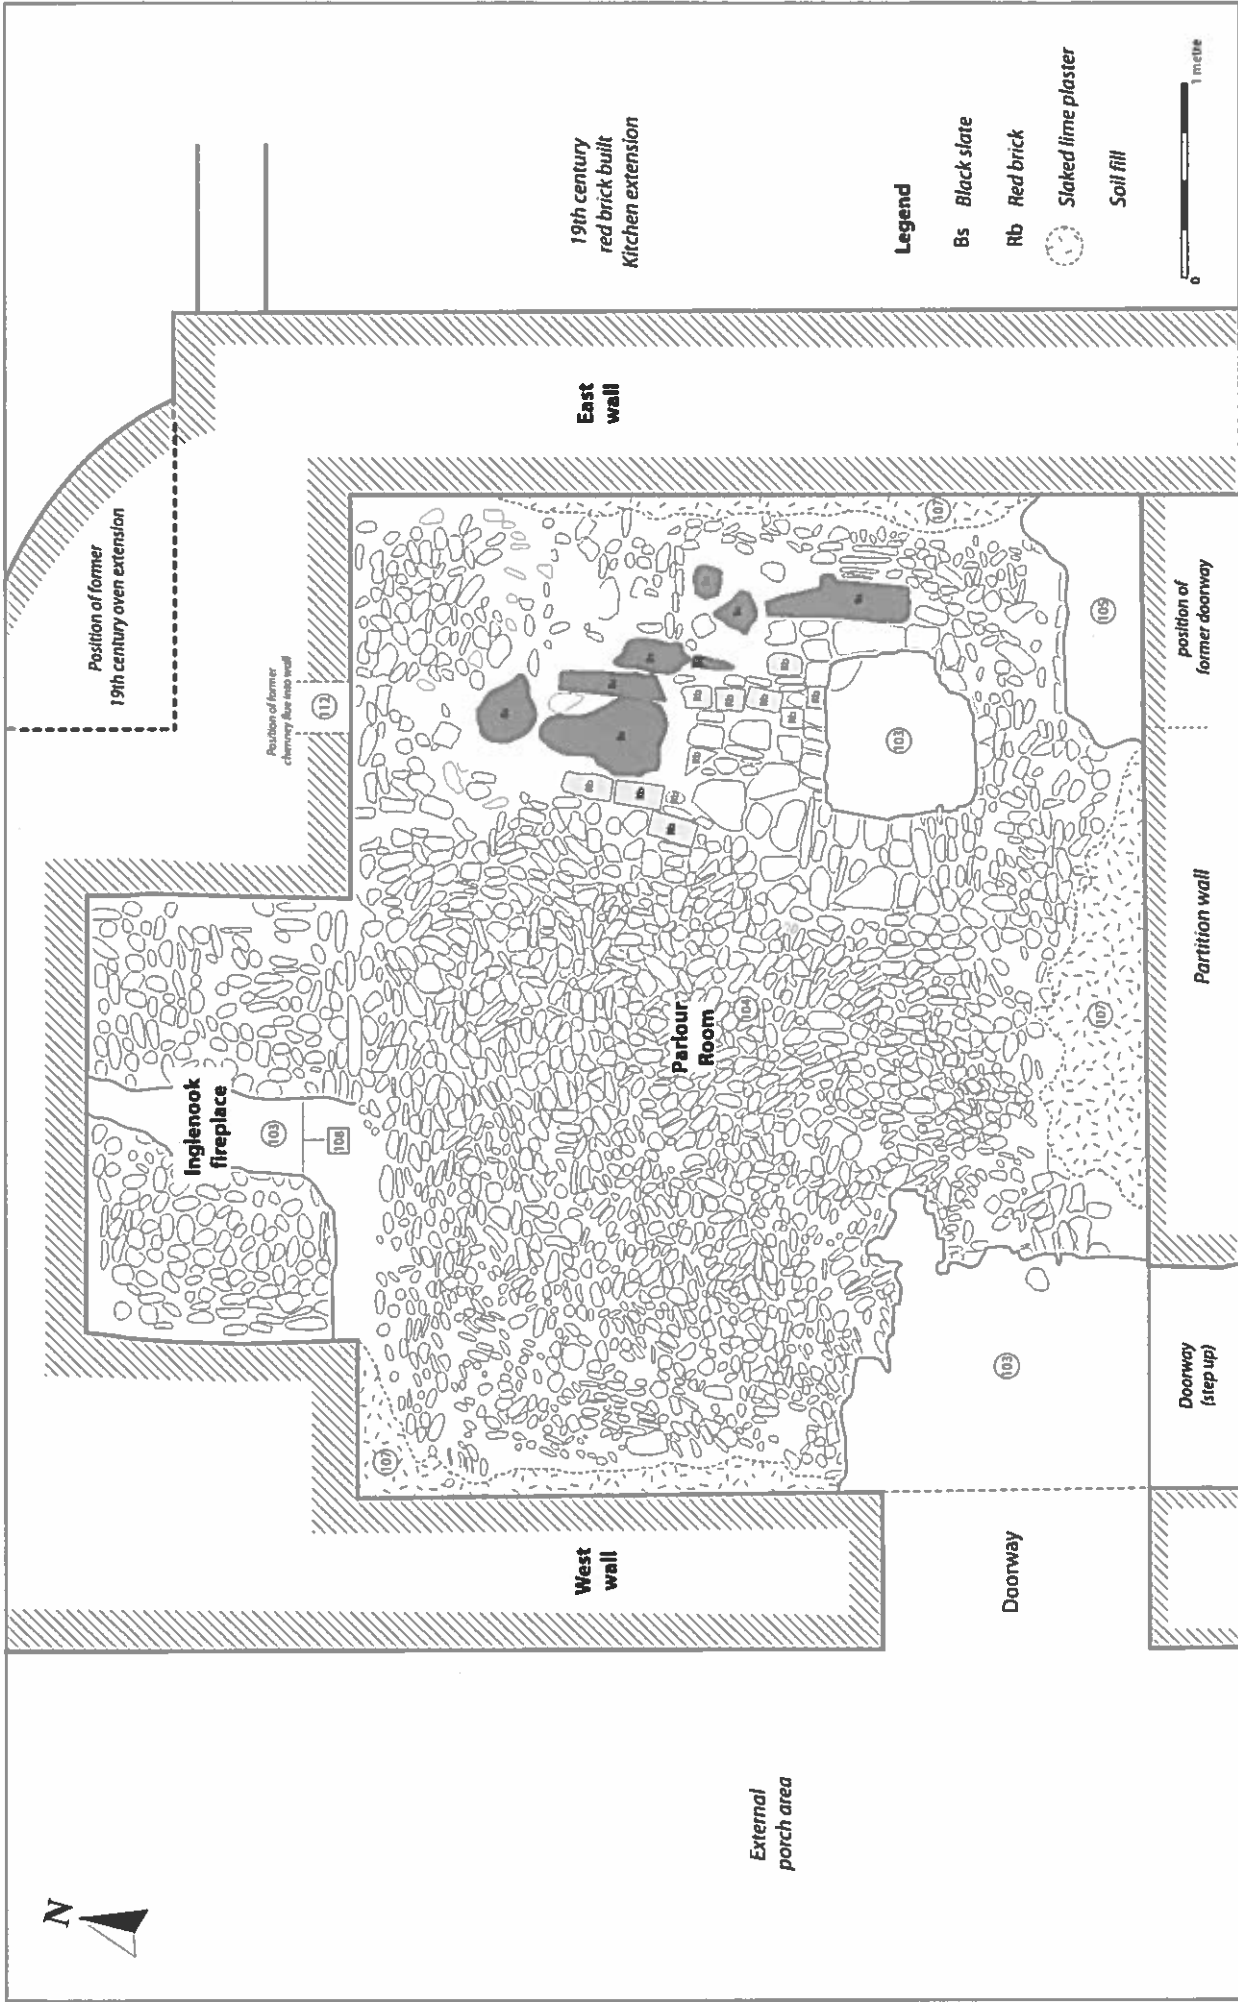
**Figure 10.**

Main House - Lower Parlour Room - Ground Plan showing early 17th century cobbled floor (104), with 18th century repair at east end covering former 18th century slaked lime processing pit (106)

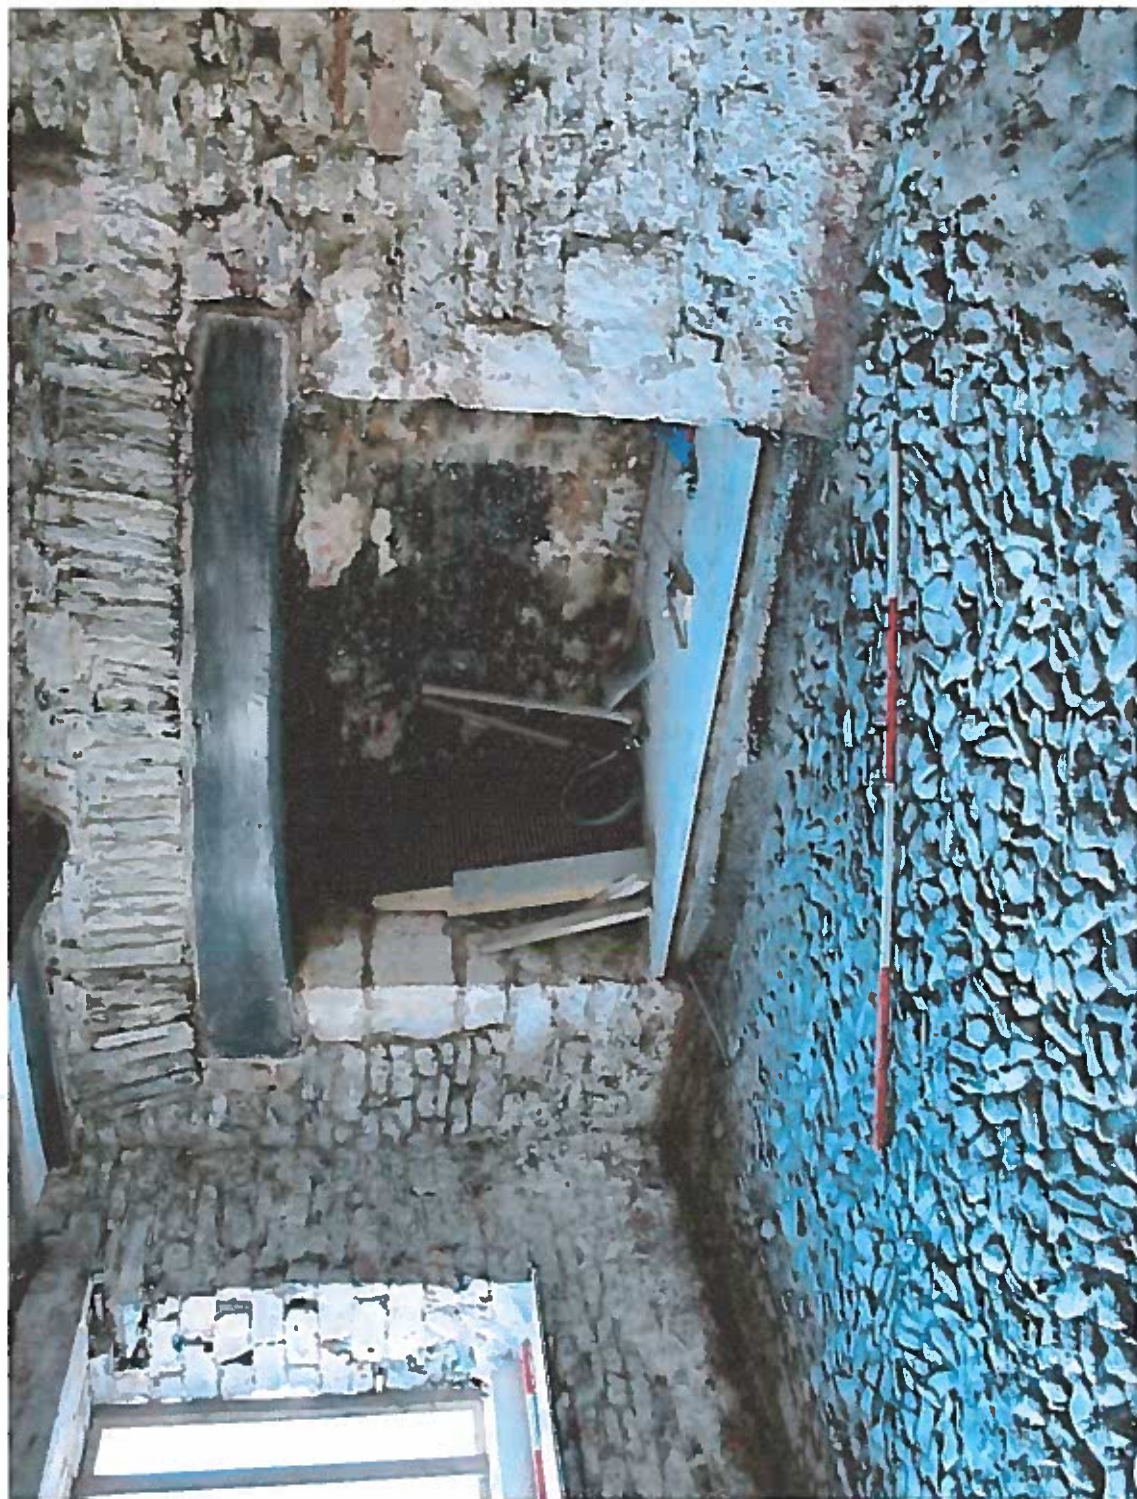
**Photo Plates No.** 55

Plate 55. Remains of early 17th century cobbled floor beneath modern stone floor tiles in Lower Parlour Room. Looking northwest.

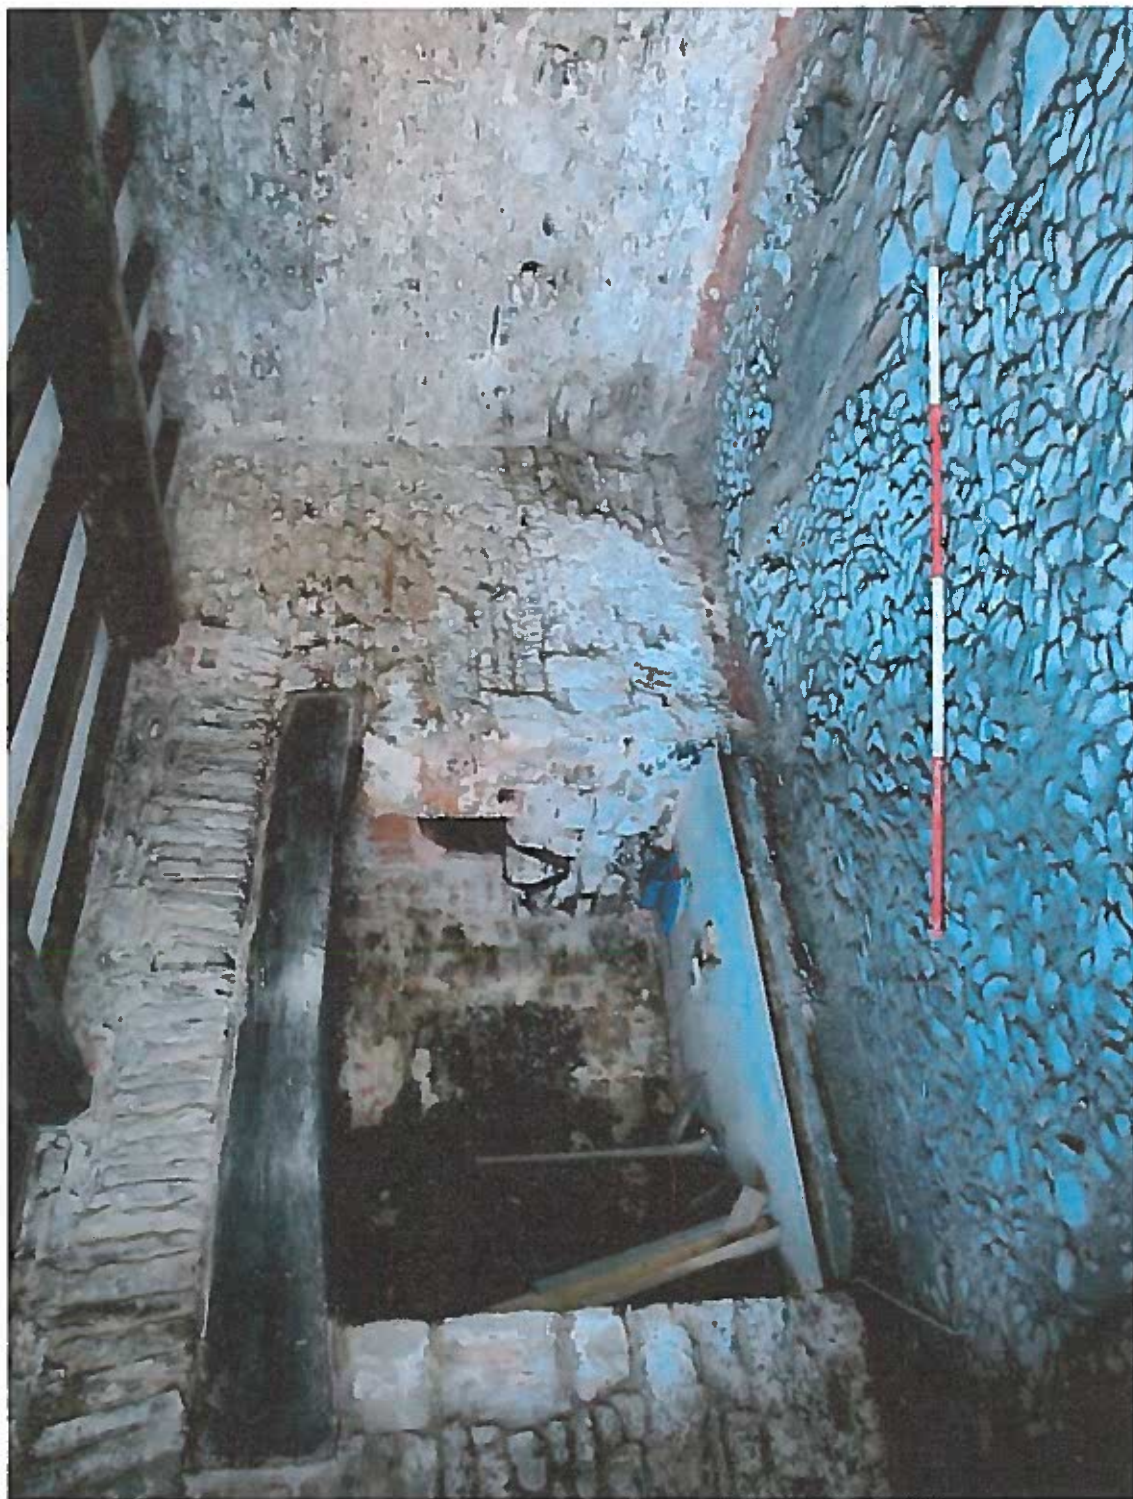
**Photo Plates No.** 56

Plate 56. Remains of early 17th century cobbled floor beneath modern stone floor tiles in Lower Parlour Room. Looking north.

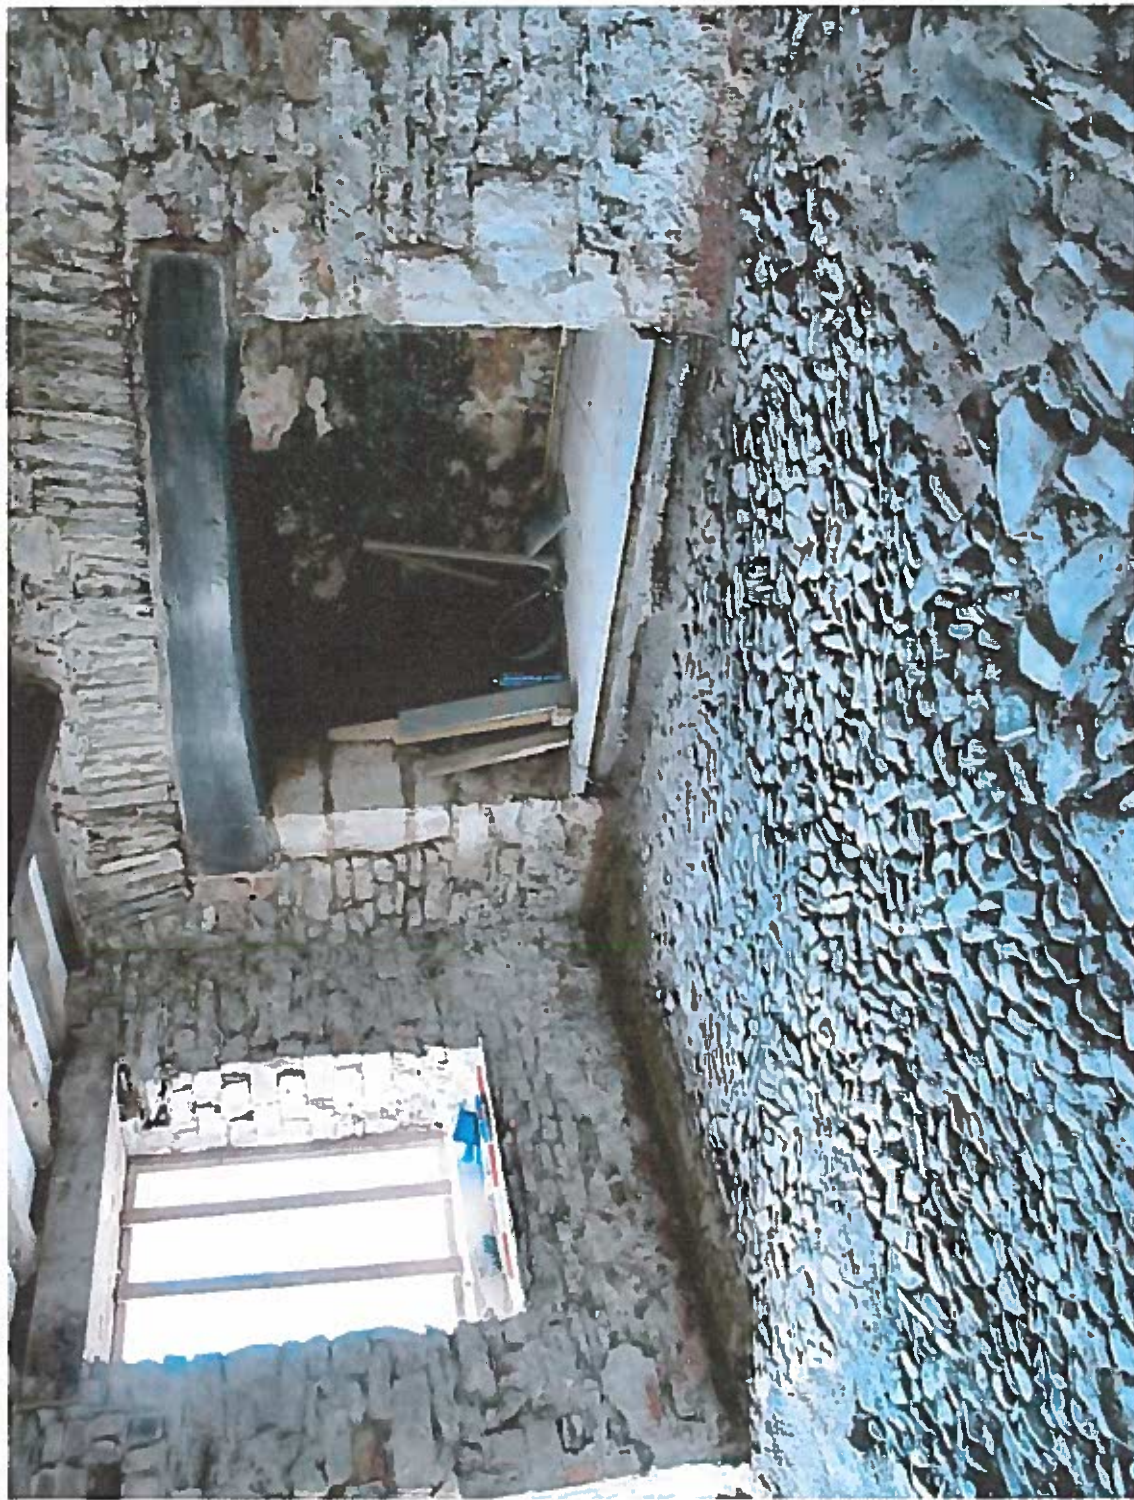
**Photo Plates No.** 57

Plate 57. Remains of early 17th century cobbled floor beneath modern stone floor tiles in Lower Parlour Room. Looking northwest.

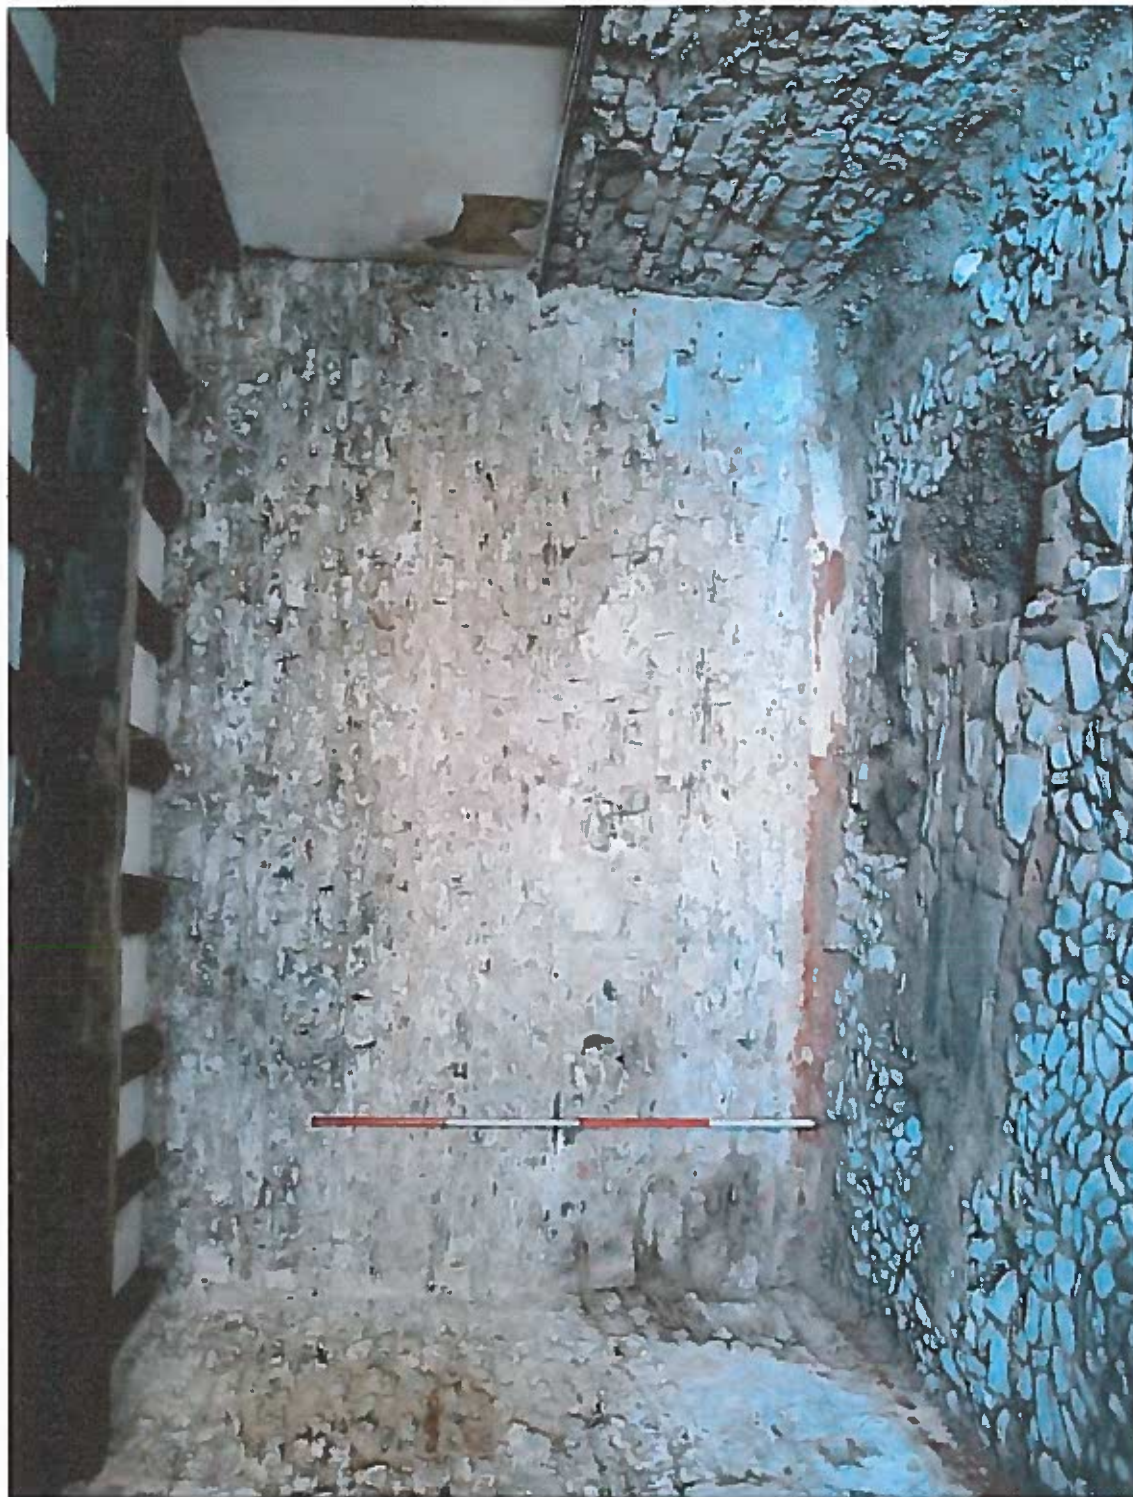
**Photo Plates No.** 58

Plate 58. Remains of early 17th century cobbled floor beneath modern stone floor tiles in Lower Parlour Room. Slaked Lime pit in foreground covered by cobble repair. Looking northeast

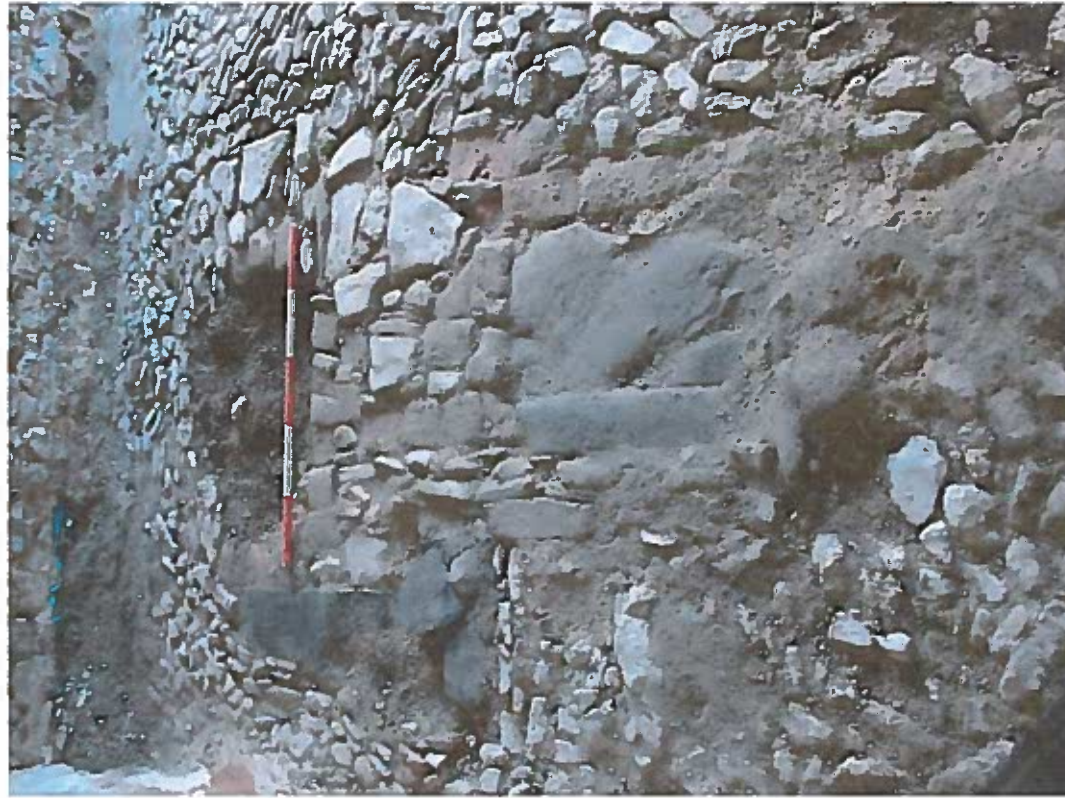
- 4.21 Also, the manner in which the pit was covered over again with only a hap-hazard repair of the cobbles using black slate and red brick suggests that there was little concern about the appearance of the repaired cobbled floor in this room at this time.

Plate 59. View of area of repaired cobbled floor covering slaked lime pit. Looking south.

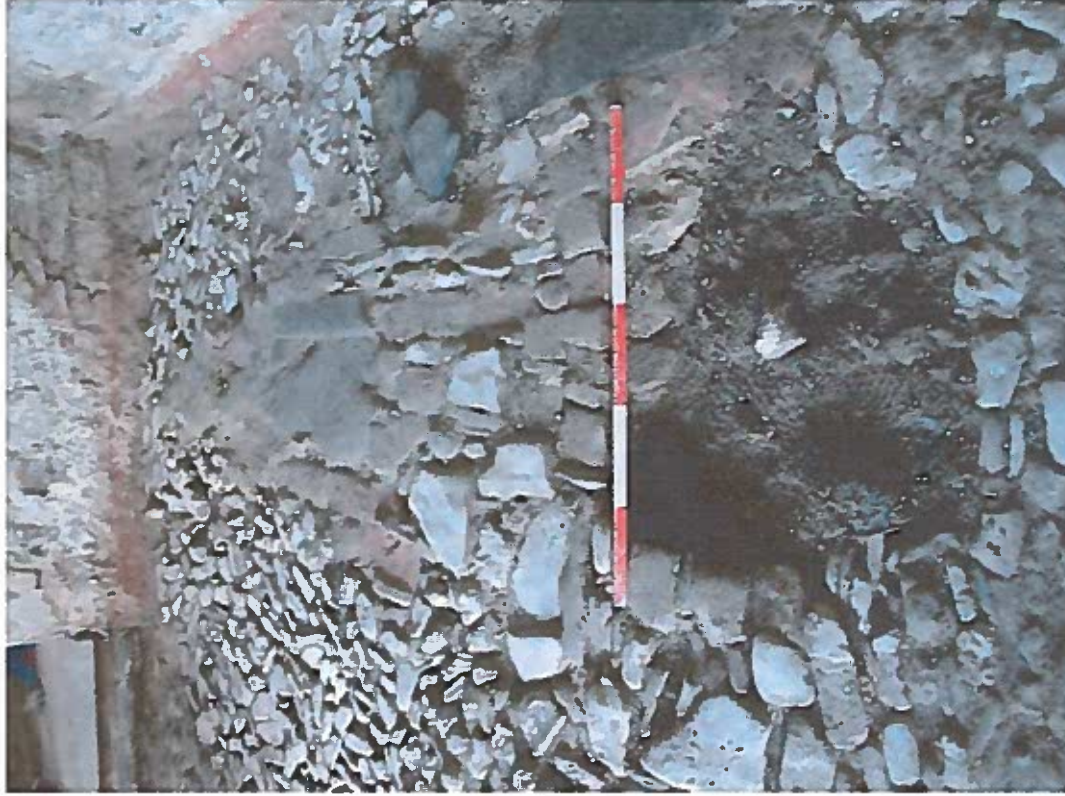
Plate 60. View of area of repaired cobbled floor covering slaked lime pit. Looking north.

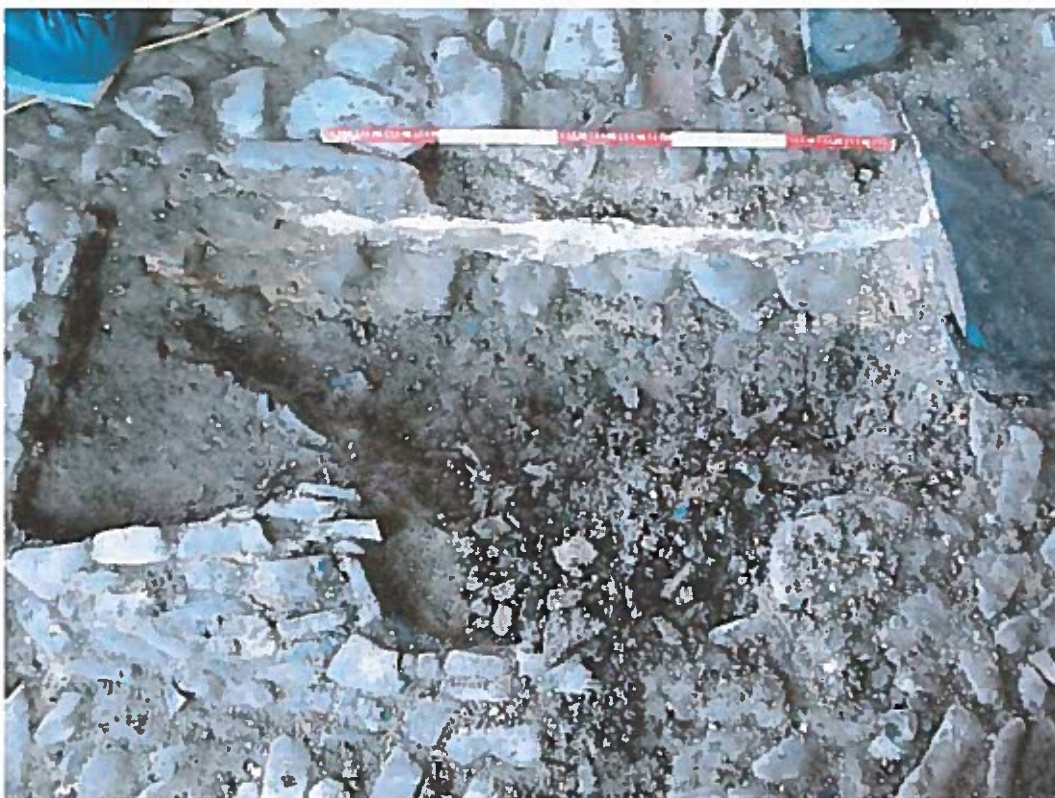
Plate 61. Gylfach-y-berthog - Southern edge of repaired area of cobbled floor covering lime pit. Looking north.

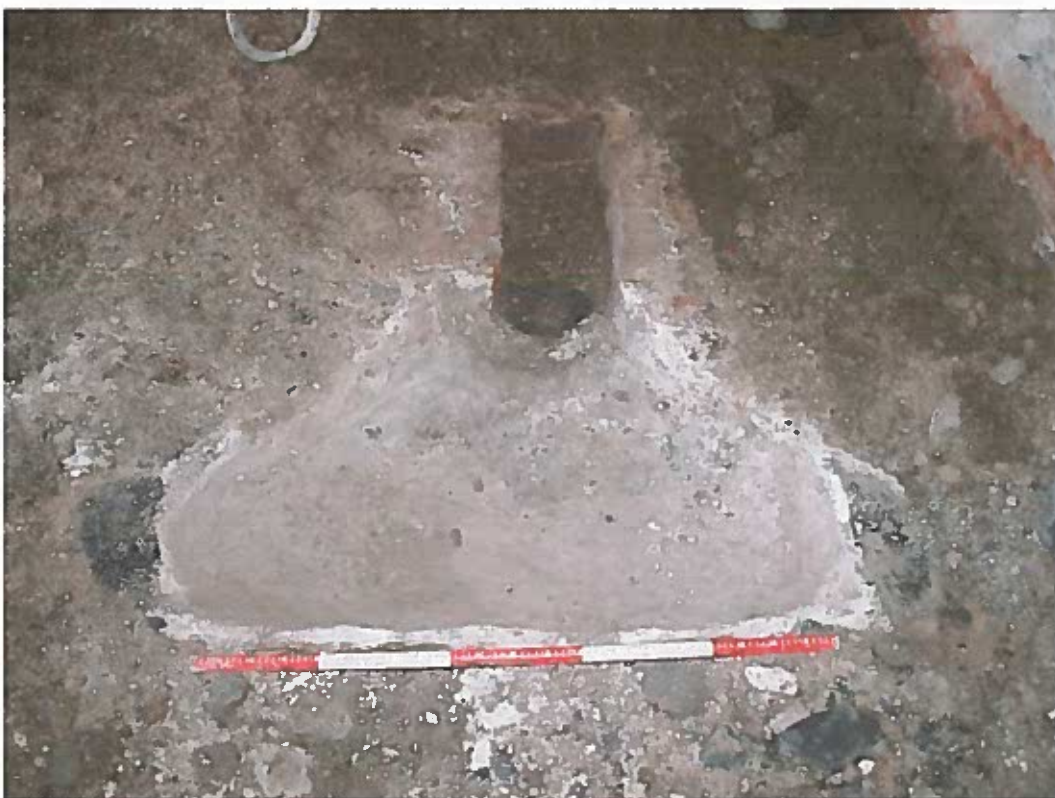
- 4.9 Careful excavation of the lime pit revealed that it had been constructed by digging a shallow 'kidney' shaped hole through the cobbled surface, with a small rectangular structure of red brickwork, only one course high remaining, forming an apparent hearth and flue at its northern end. These remaining bricks had no makers stamps on them and had been mortared together with lime mortar. Their character and fabric suggested that they were either 18<sup>th</sup> century or early 19<sup>th</sup> century in date.

Plate 62. Gylfach-y-berthog - Exposed slaked lime pit following removal of cobbled floor. Looking north.

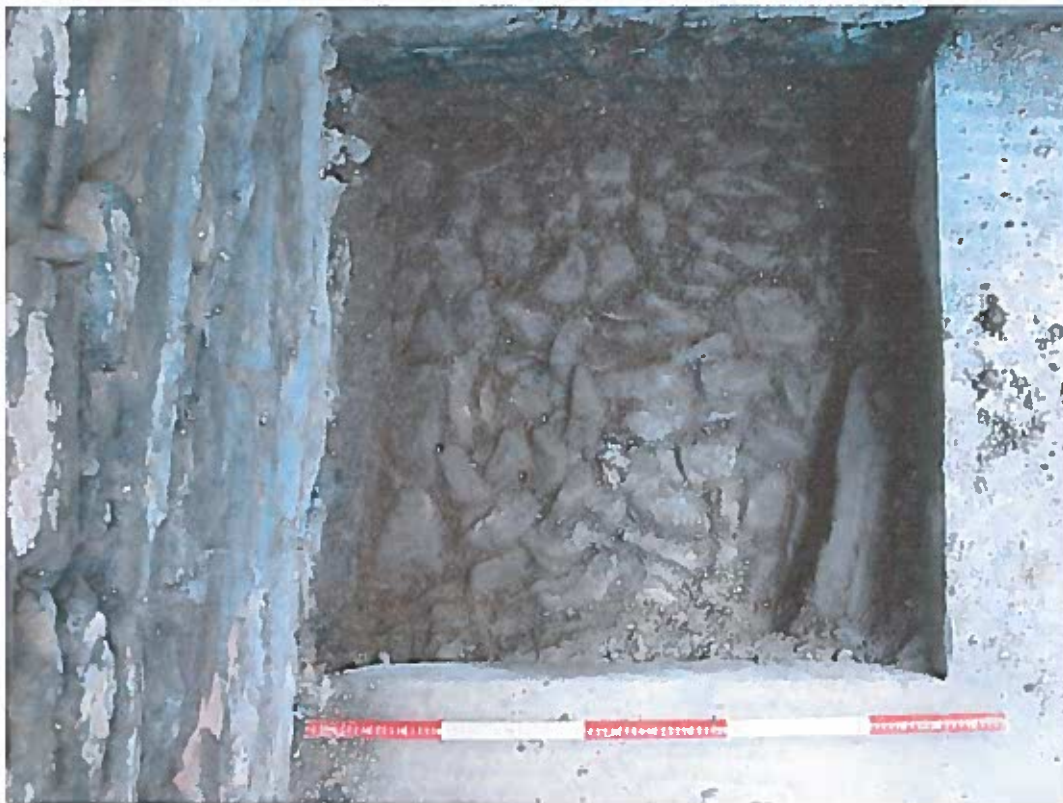
*Plate 74. Gylfach-y-berthog - TR2 - Exposed cobbled floor in area of stone barn during concrete pier support trenches.*

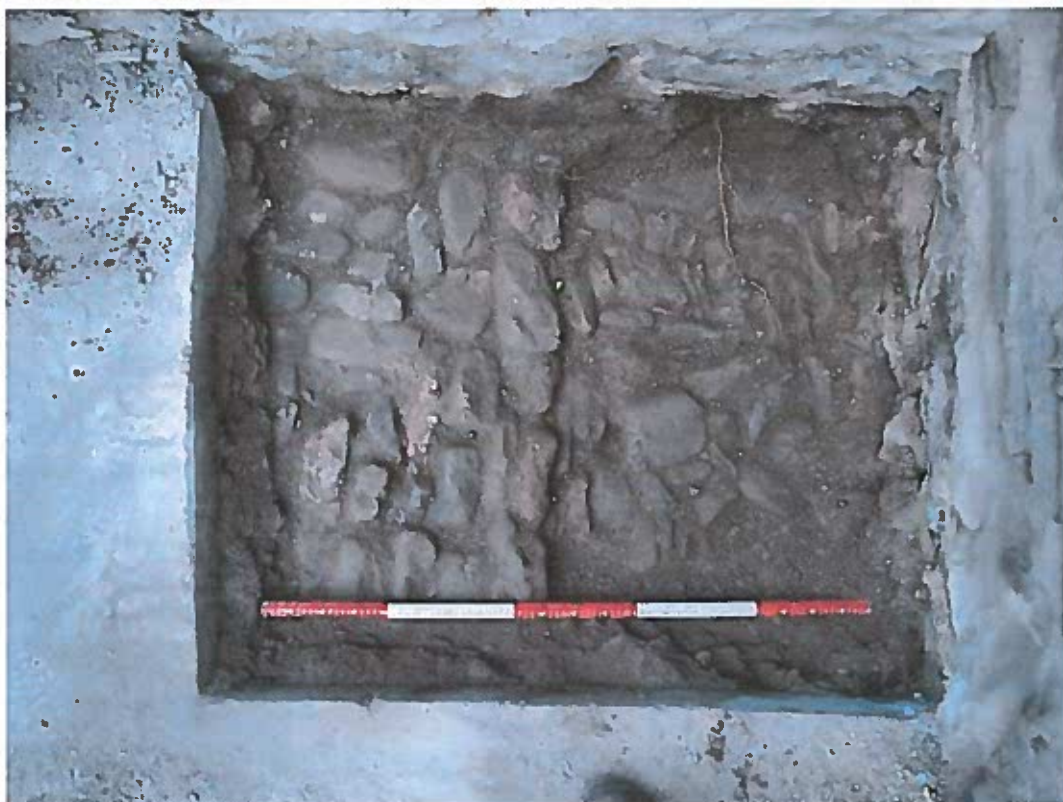
*Plate 75. Gylfach-y-berthog - TR3 - Exposed cobbled floor in area of stone barn during concrete pier support trenches.*
