Talhardd Farm, Llandeilo Rural, Carmathernshire

Building Recording, Archaeological Observation and
Limited Evaluation

Report No. 2002 - 08 - 13

**Standing Building Recording, Archaeological Observation and Limited
Evaluation at Talhardd Farm, Llandeilo Rural, Carmarthenshire**

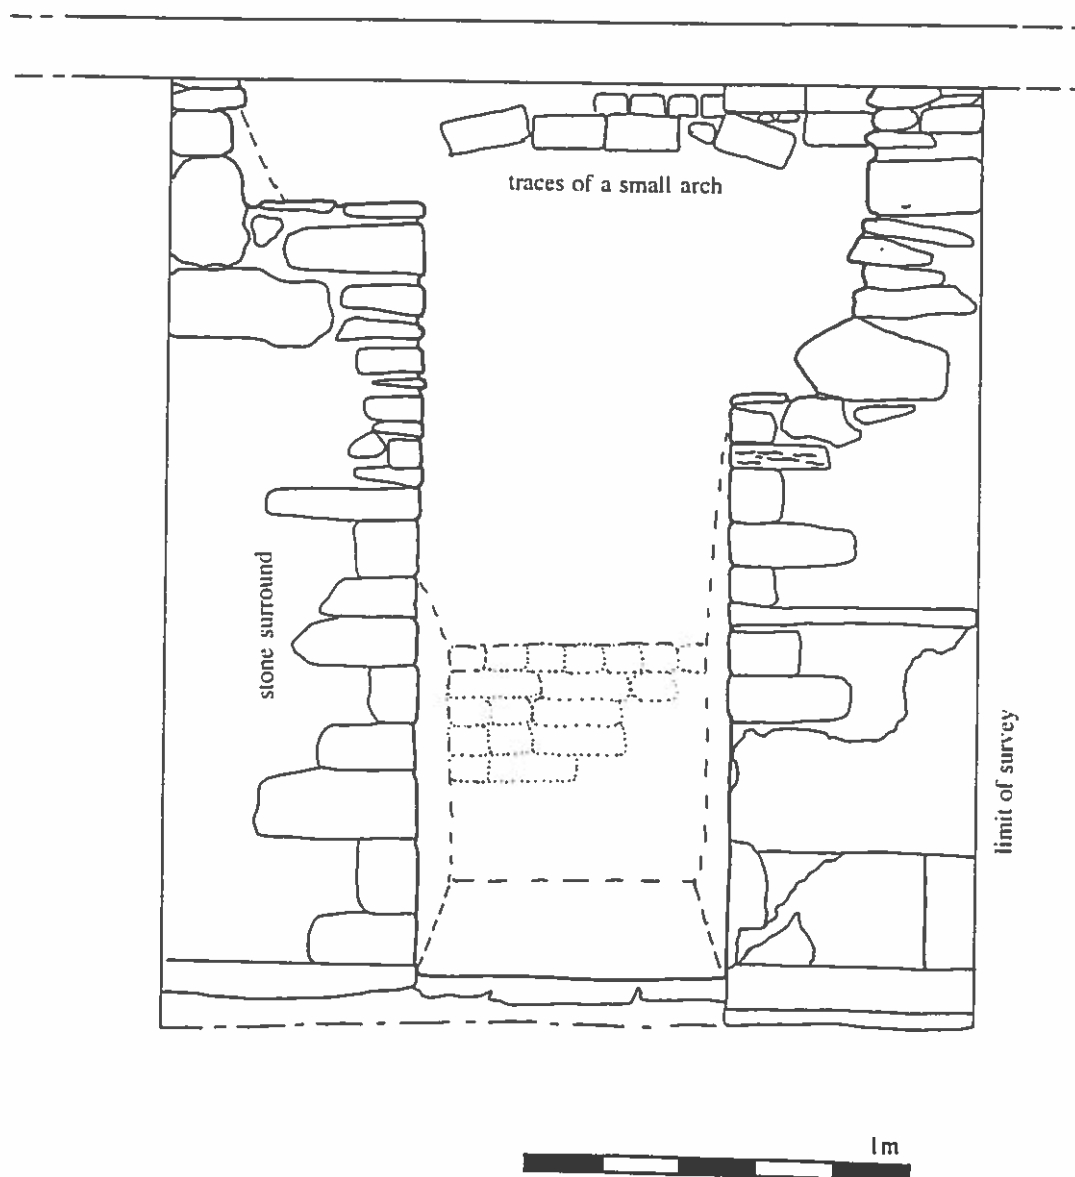
FIGURE 3. AREA C SOUTH-FACING INTERNAL ELEVATION FEATURE

- 5.4 Area C - south-facing interior door opening, located in the southern area of the building (**Figure 3**). The infill of this feature has its base constructed of brick. Above this, the infill is of slate blocking. The infill surface is uneven. Surrounding the opening, the elevation has several Post-Medieval bricks embedded, suggesting repair. The opening surround consisted of roughly-hewn quoins. A concrete lintel spans the top of the blocked opening.

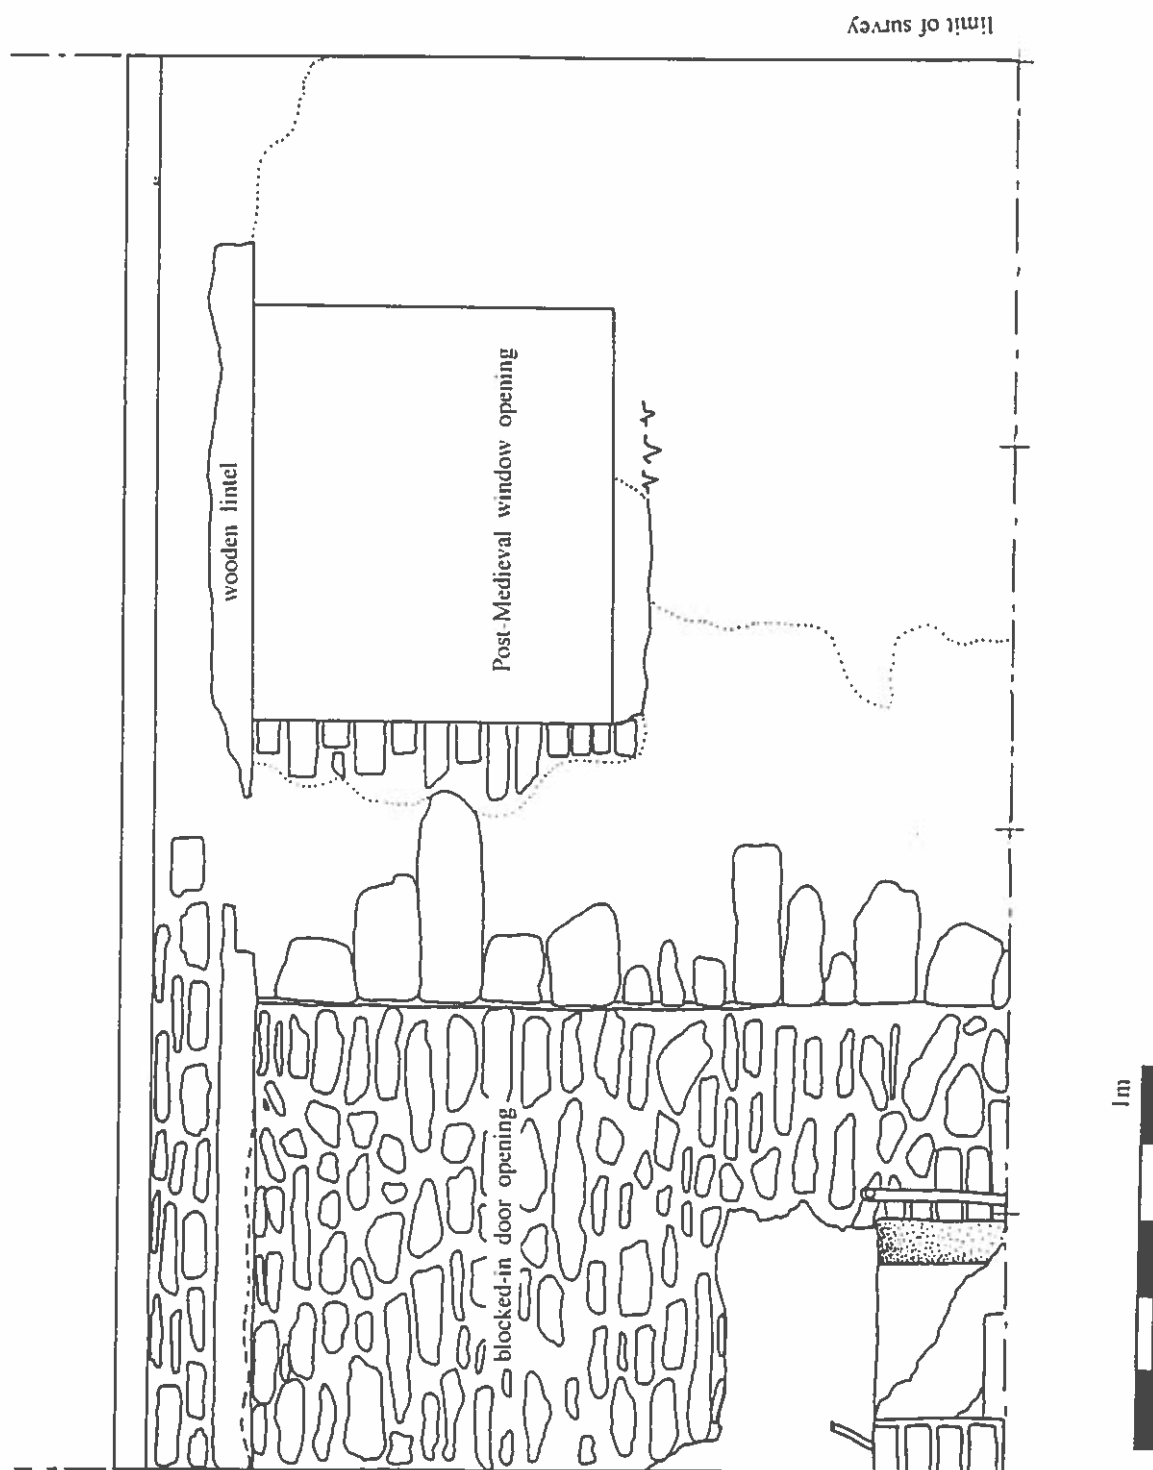
FIGURE 4. AREA C: WEST-FACING INTERNAL ELEVATION, BLOCKED-UP DOOR AND WINDOW OPENINGS

- 5.5 Area C - west-facing interior elevation - blocked-in door-opening and window-opening, located in the southern area of the building (**Figure 4**). In the north corner of the door-opening is a concrete/brick feature that appears to be associated with modern activity within the dairy/utility. To the south of this feature is a recess 0.13m deep. Adjacent to this recess is a small lead pipe. The window opening has a concrete lintel, suggesting that the wooden lintel has decayed and been replaced. This section of the elevation also shows evidence of repointing - hydrated lime overlies an earlier pink-creamy lime mortar. The window-opening is probably Post-Medieval and replaces an earlier opening. The surrounds are of red unfrogged brick rather than stone. The blocked-in door-opening, supported by a wooden lintel, has recent 'float-and-skim' plaster over the blocked-in stone.

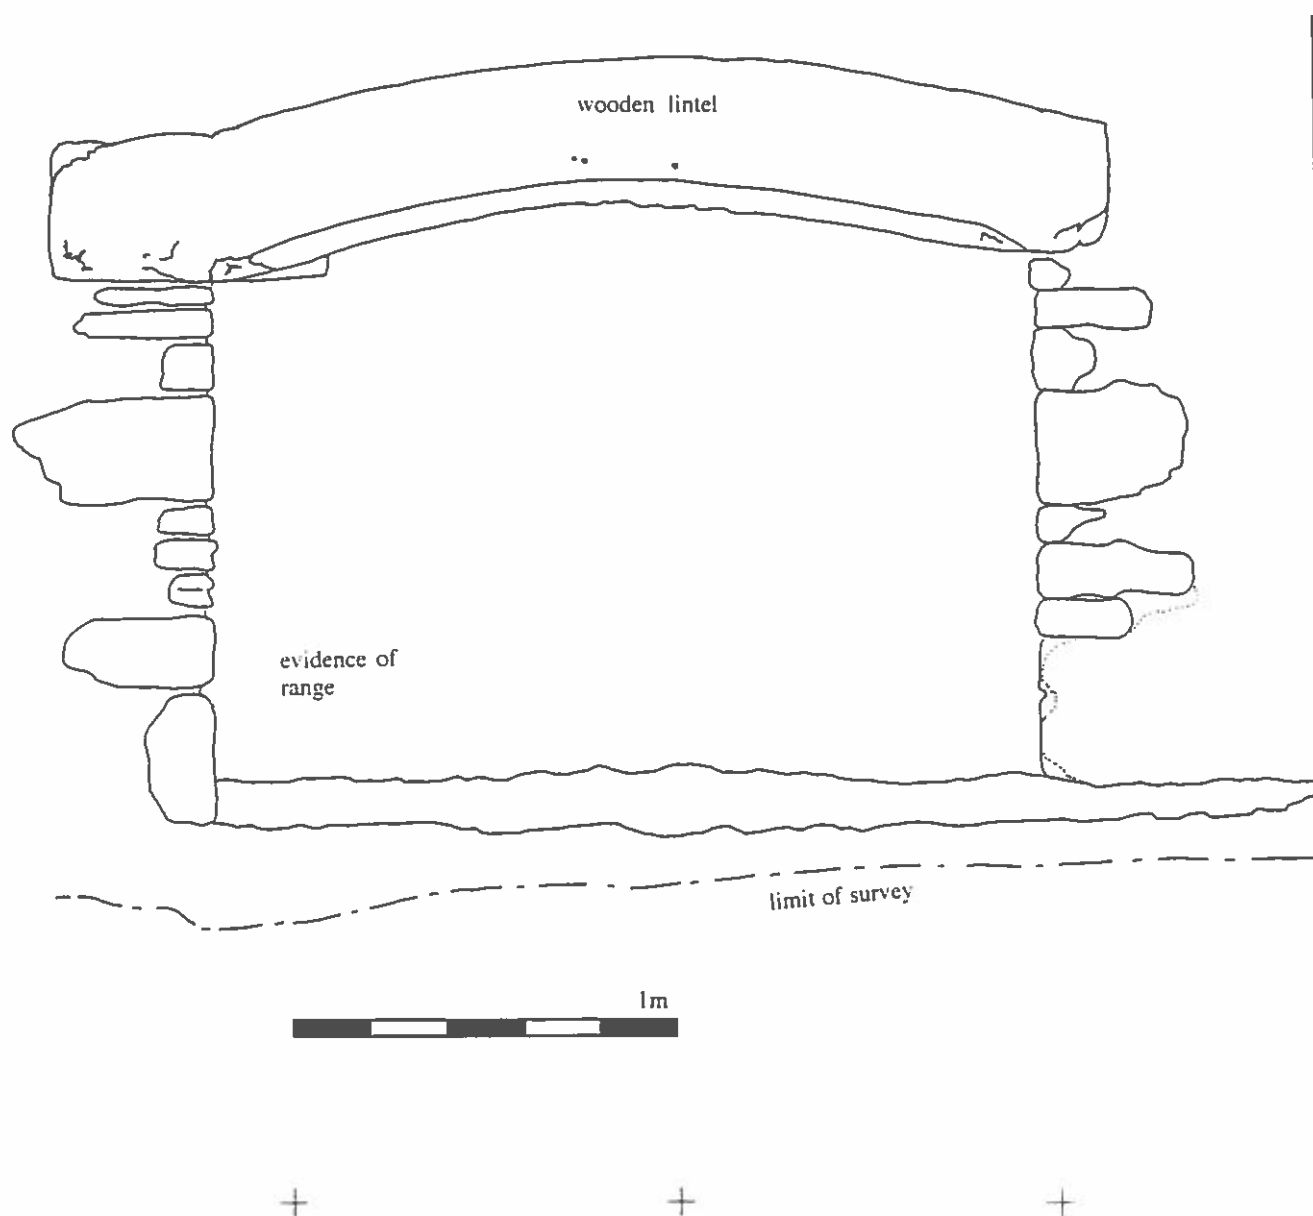
FIGURE 5. AREA C: NORTH-FACING INTERNAL ELEVATION AND FIREPLACE

- 5.6 Area C - within the south gable of the dairy(?) is an impressive open fireplace, located in the southern area of the building (**Figure 5**). A large chamfered timber lintel spans the top of the fireplace. The timber shows some scorch marks on the western side. The stonework surround also shows fire damage on the western side. There are two ovens which are directly associated with the chimney. The east-facing oven is 0.94m from the base of the fireplace and the west-facing oven is 0.73m from the base of the fireplace. There is also a corner shelf on the east inner side constructed of stone. An iron bar is present, being positioned at a right angle to the large timber lintel. This was fitted with a four-

pronged meat hook and chain, which are still attached. Traces of red/pink paint remain on the stonework on each side of the fireplace. This impressive feature probably dates to the later Medieval period.

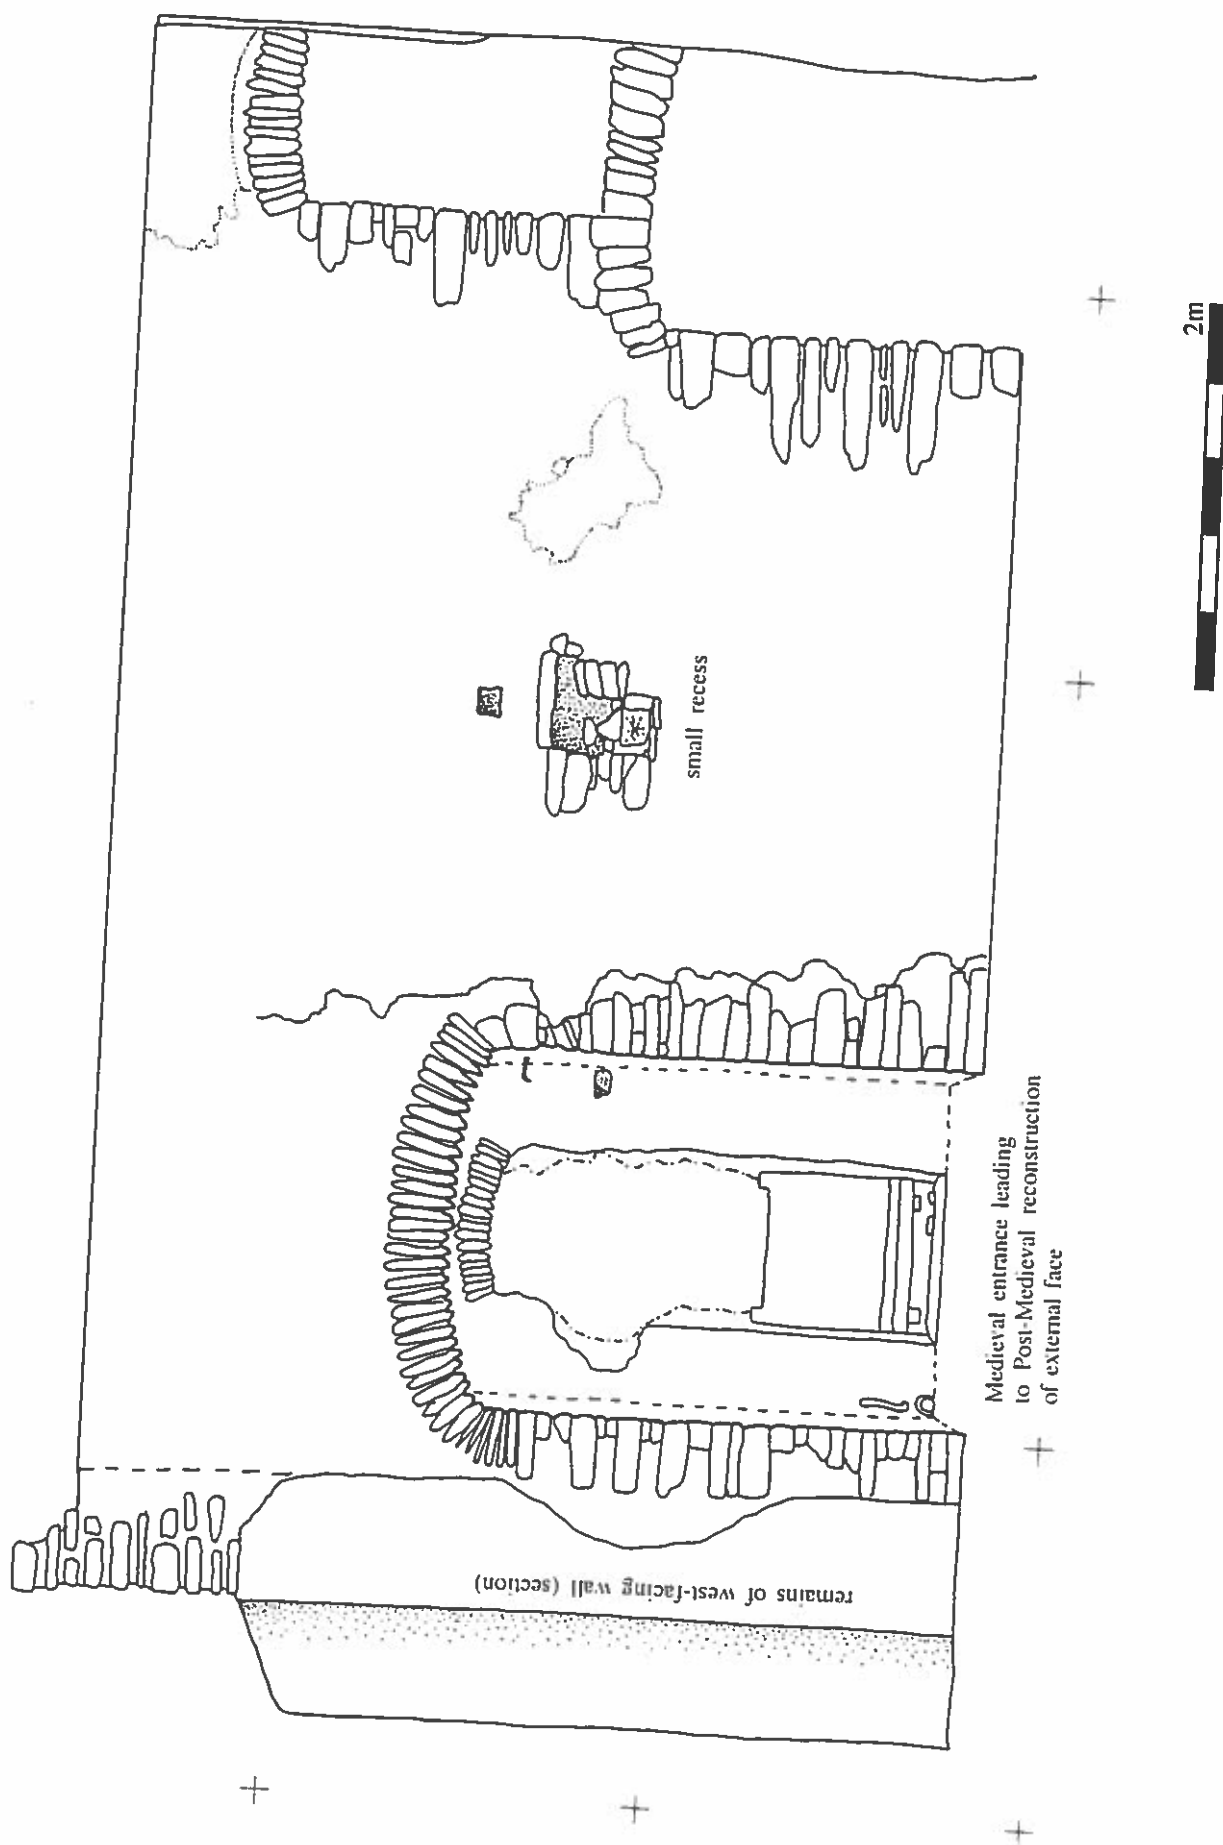
FIGURE 6. AREA B: NORTH-FACING INTERNAL ELEVATION

- 5.7 Area B - north-facing interior elevation (**Figure 6**). Located within the surviving Medieval fabric of the building, and within the open hall, on a north-facing wall, are a number of features, among them several door- and window-openings, including a recently-exposed entrance (**Plates 7 and 10**). The fireplace can be considered later than the surrounding fabric. The door- and window-openings show signs of successive alteration to this Medieval elevation. Present on this elevation are occasional sections of Post-Medieval [horse-hair] plaster. Within the centre of the elevation are two small recesses of unknown use. All openings have stone surrounds, including the large and impressive entrance (**Plate 1**).

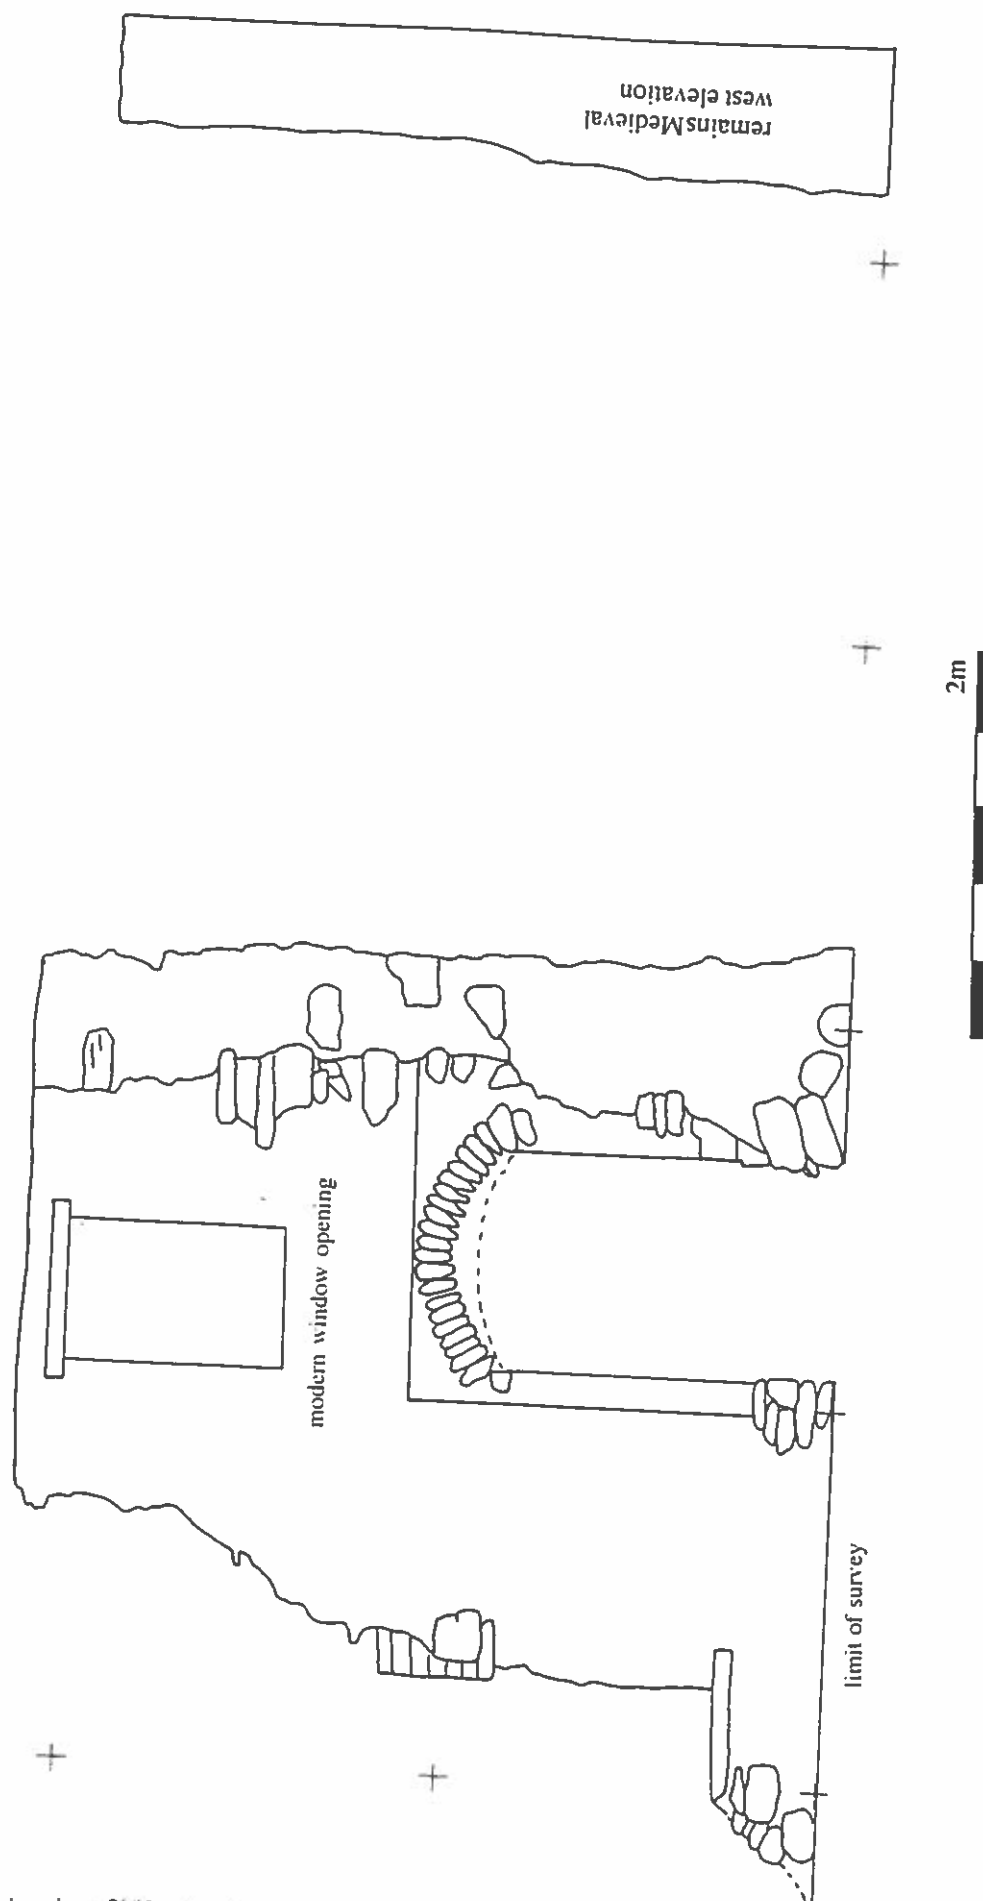
FIGURE 7. NORTH-FACING EXTERNAL ELEVATION

- 5.8 Area C - north-facing exterior gable (**Figure 7**). This elevation comprises a door- and window-opening. The window opening is a recent replacement and has a wooden lintel. The door-opening surrounds and arch are constructed of local stone. Both features are set within the Post-Medieval fabric of the building.

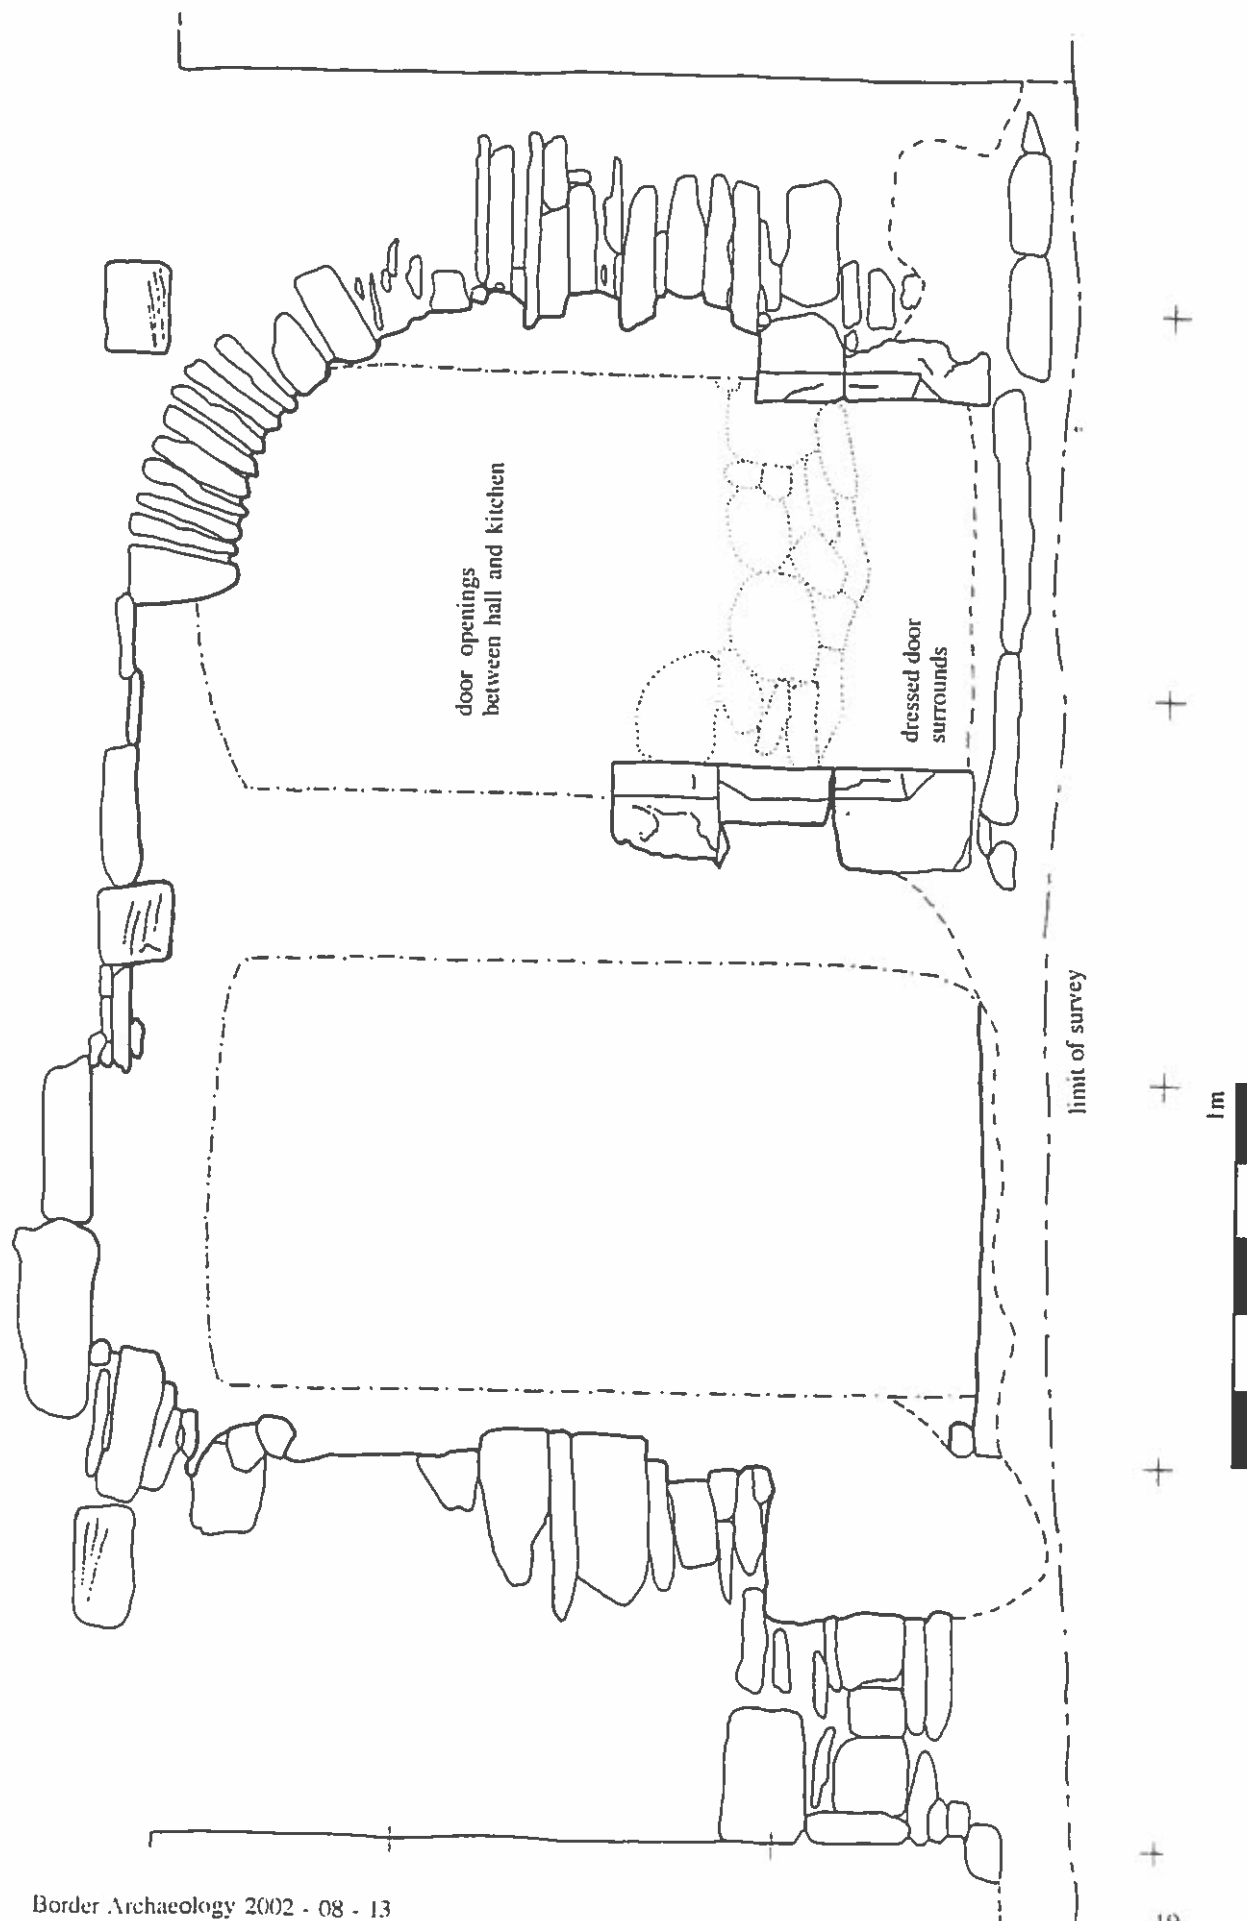
FIGURE 8. AREA B: EAST-FACING INTERIOR ELEVATION AND DOOR OPENINGS

- 5.9 Area B - east-facing interior elevation (**Figure 8**). Within this internal elevation are two door-openings retaining much of their original stonework (**Plate 9**). The best preserved of these is the northern door-opening, which still has some of the decorative slate archway. Located at the base of this opening are the remains of the door surround, in the form of five cut-and-dressed stones. The base is similar to other door-openings within the building, especially those in the east- and west-facing sections of area B. These features date to the Medieval period and form part of the earliest phase of construction. The inner cavity of the elevation, either side of both openings, consists of cemented rough stone and slate. At the base of the southern door opening was a heavily burnt timber, possibly forming a threshold. This timber measured 0.70m in length and 0.10m in width. From the kitchen area, the threshold continues (**Plate 3**). The northern door opening was in-filled with soil and stone, a result of recent deposition.

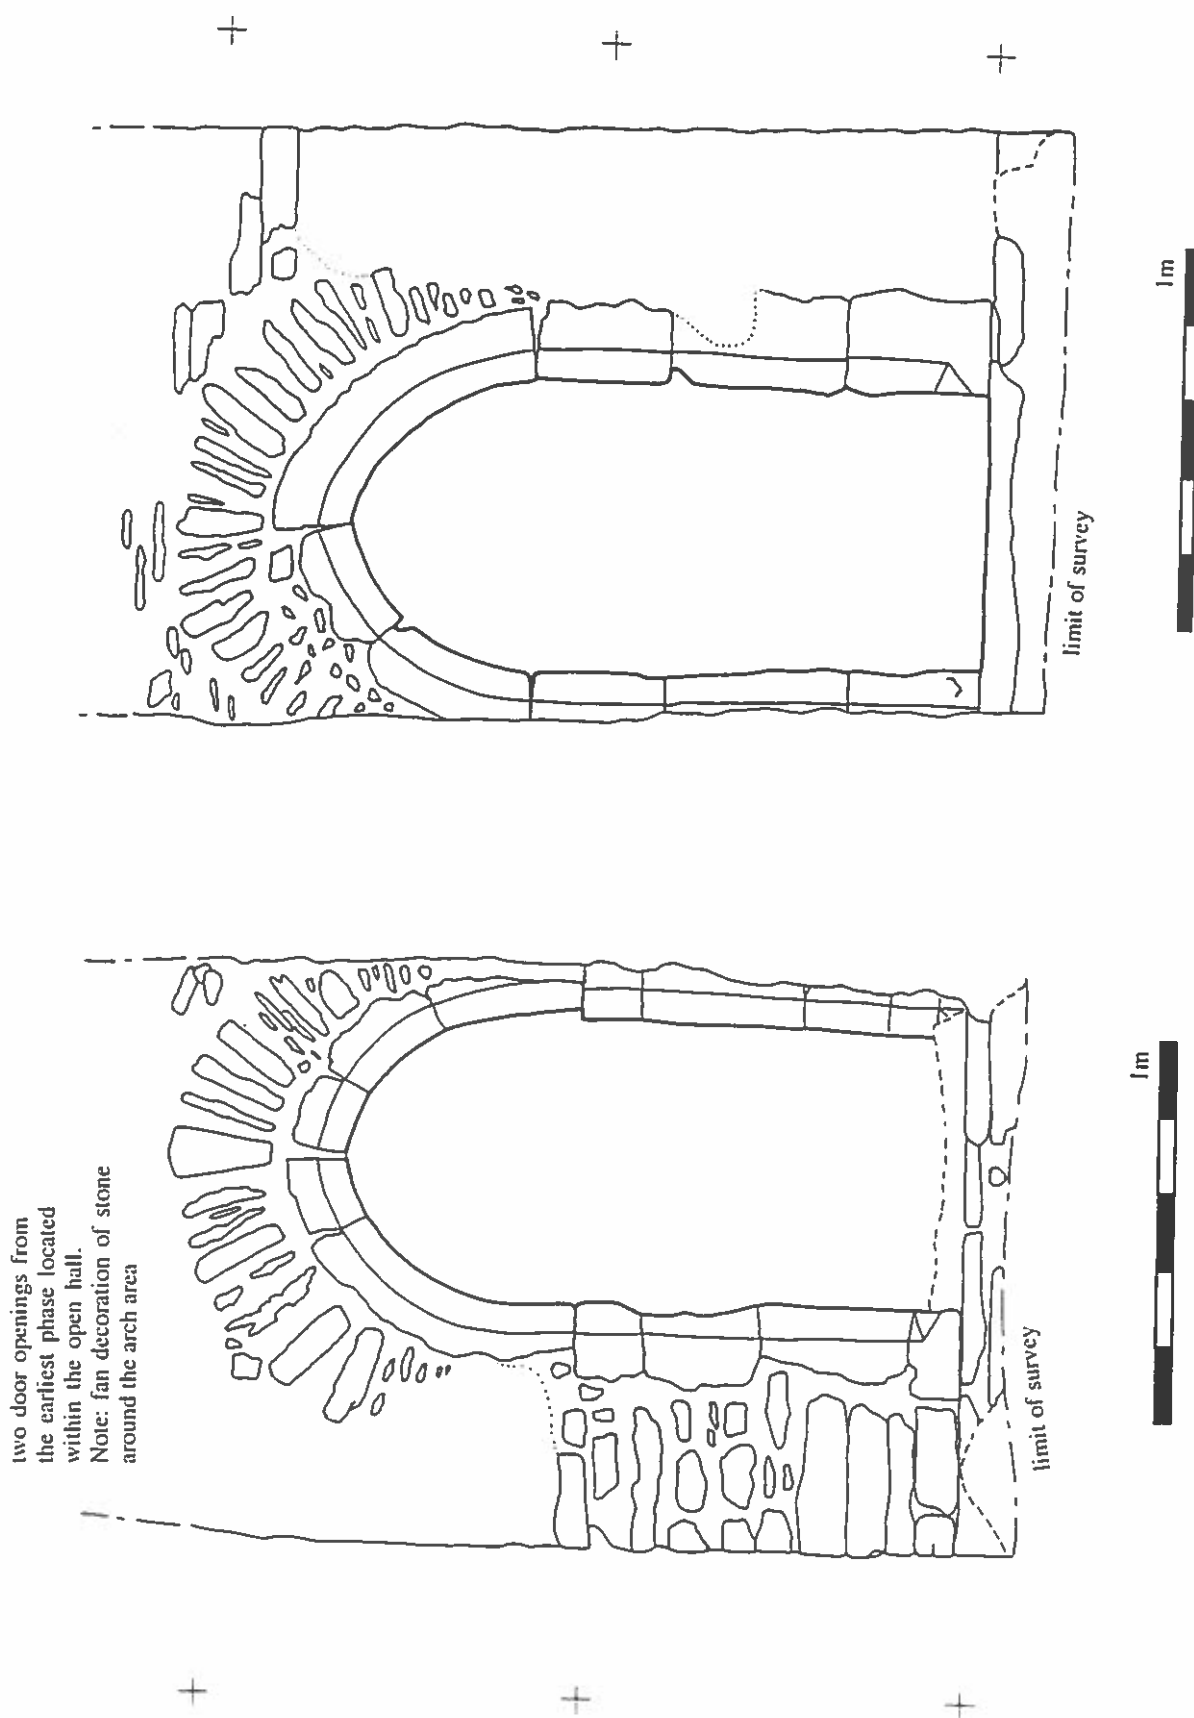
FIGURE 9. AREA B: WEST-FACING ELEVATION

- 5.10 Area B - west-facing elevation (**Figure 9**). Forming part of the earliest phase of building activity and located within the open hall is a recessed stone-arched door-opening. The arch of this opening is constructed of dressed stone. At the base of the door, underlying building debris, was a broken slate slab, possibly forming a threshold. The stonework is pointed with modern hydrated lime plaster. This door-opening, together with **Figure-10**, are typical of ecclesiastical architecture of the 13th and 14th centuries.

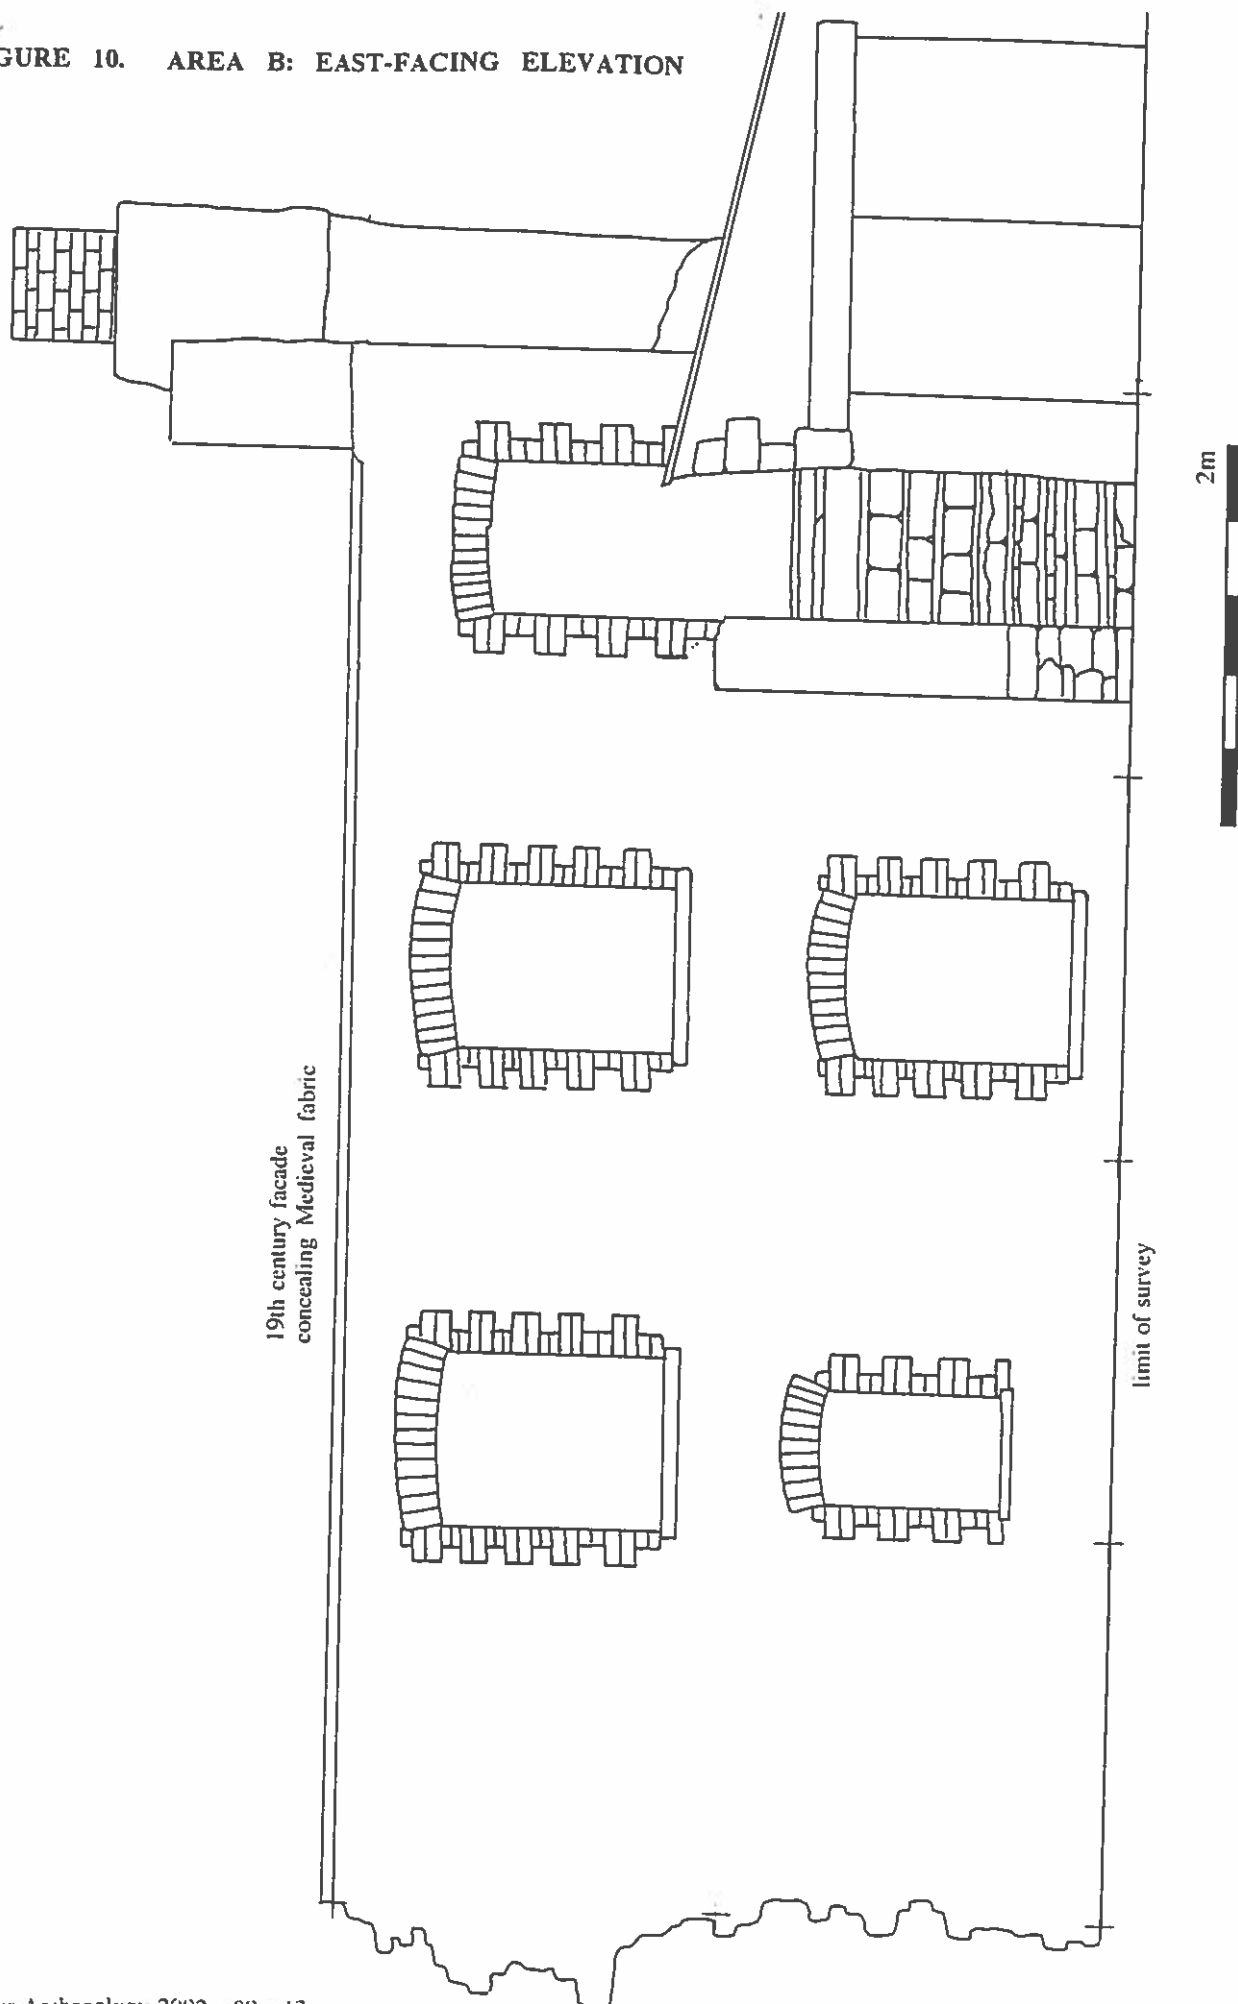
FIGURE 10. AREA B: EAST-FACING ELEVATION

- 5.11 Area B - east-facing elevation (**Figure 10**). Located on the east-facing elevation and forming part of the earliest phase of building activity is a recessed stone-arched door-opening. The arch and surrounds of this opening were of worked stone. At the base of this doorway, was a slate slab stone surface, possibly forming a threshold. Above the arch, the stonework was arranged into a fan which surrounded the upper section of the door-opening. The stonework to the north of the arch was pointed with modern lime mortar (**Plate 8**).

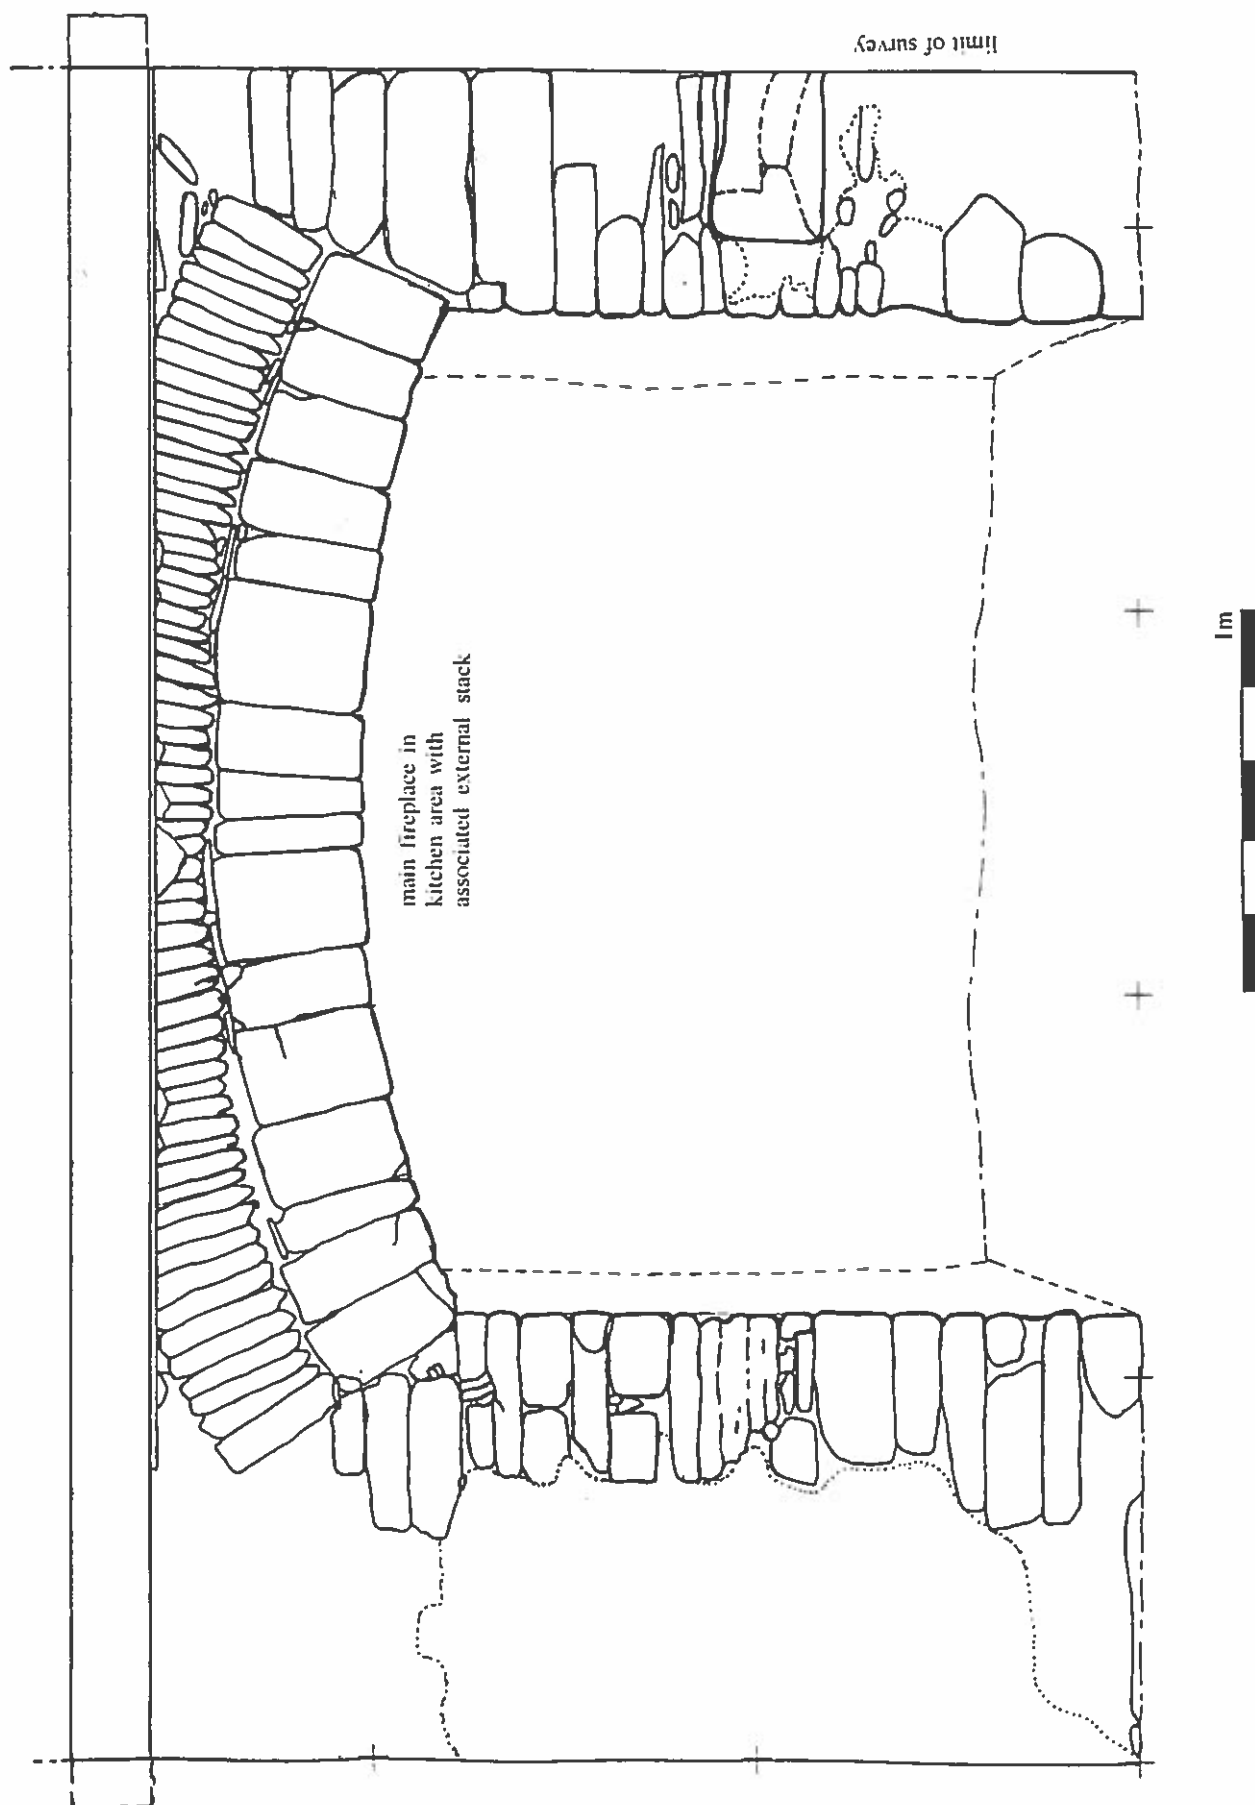
FIGURE 11. AREA A: NORTH-FACING INTERNAL ELEVATION AND FIREPLACE

- 5.12 Area A - north-facing interior elevation and fireplace (**Figure 11**). Located within the kitchen and cut into the southern gable was a large open fireplace which would once have housed a range (**Plate 2**). Above the fireplace was a large wooden lintel, which was fire-damaged, especially in the central area. The walls above the beam retain modern plaster, some of which had fallen and become lodged behind the timber lintel. There was a recess in the stonework to the west of the fireplace, which retained two layers of lead-based paint. The stonework to the east of the fireplace had been heavily skimmed and pointed with modern lime plaster. The stonework at the base of the fireplace retained

modern plaster and a pinkish-red paint topcoat. The fireplace itself was constructed mainly of cut stone [slate/shale]. Externally, this feature, along with the chimney formed an external stack and was recessed from the main building (**Plate 6**). The RCHAM[W] report suggest that it is late Medieval in date.

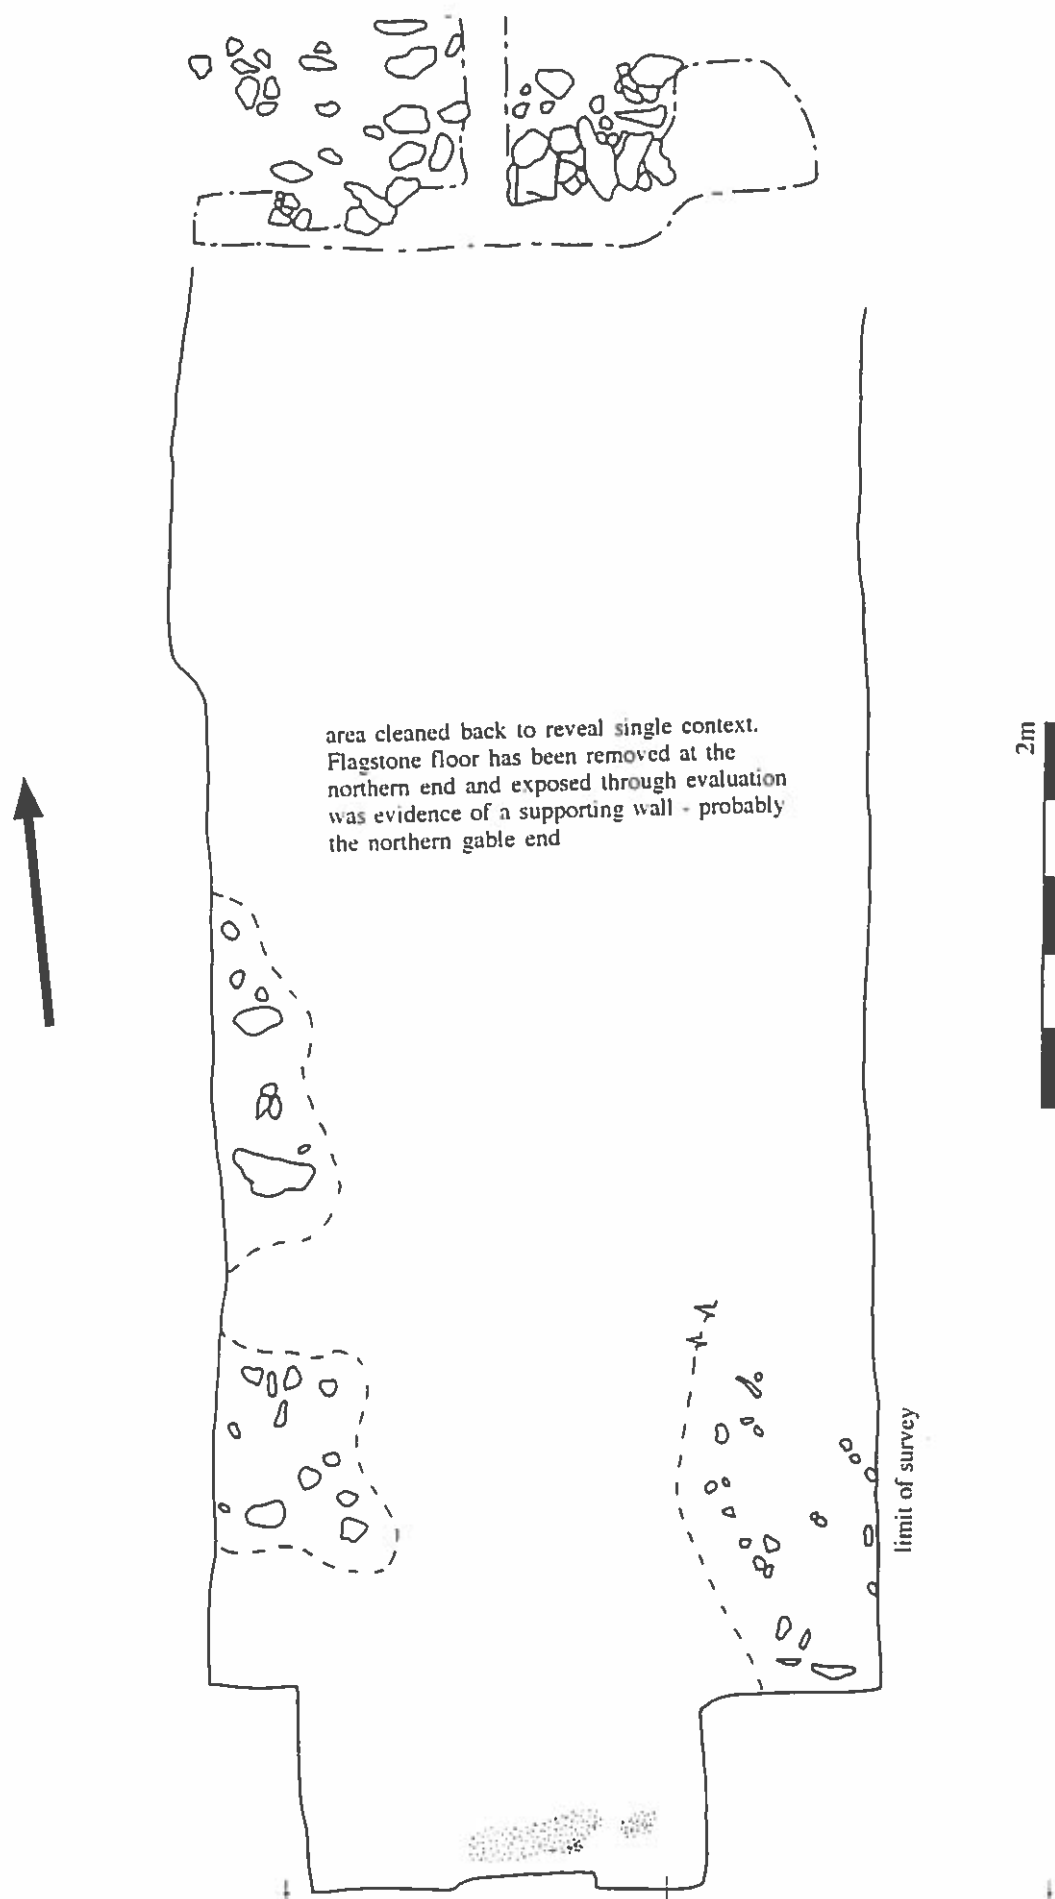
FIGURE 12. PLAN OF AREA A - KITCHEN AND SERVICE ROOM

- 6.3 The clean-back in area A (the kitchen) revealed no archaeological features. The moderately compacted, orange-brown sandy loam (002) revealed was considered to be a natural soil. No evidence of the flooring described in the 1995 Dyfed Archaeological Trust evaluation was found. At the northern end of this part of the building the contractors excavated a foundation trench. This trench was excavated to a depth of 0.92m below existing ground level. Three contexts were observed. A loosely compacted, orange-brown sandy loam (001), the present topsoil/ rubble layer (0–0.10m below existing ground level), overlay a moderately compacted, orange-brown sandy loam (002) (0.10–0.52m below existing ground level). Two fragments of Post-Medieval pottery were found on the surface of this context. Context (002) overlay a tightly compacted, stony, orange-brown sandy loam (003) with frequent large shale stones. This context was present between 0.52m and 0.92m below existing ground level. Both (002) and (003) were considered natural deposits. No foundations were found for the original wall that had stood above this trench and it appears that the house was built directly above the underlying natural geology. A thin scattering of fragmented shale was noted in the western end of this area, along the path of the old foundations. These were interpreted as part of the lowest layers of the demolished/ collapsed northern wall of the house. Within the large fireplace in the southern wall some ash and burnt organic deposits were observed. However, these probably represent the remains of the recent fire that partially destroyed the building, rather than evidence of earlier activity.
