Talhardd Farm, Llandeilo Rural, Carmathernshire

Building Recording, Archaeological Observation and
Limited Evaluation

Report No. 2002 - 08 - 13

**Standing Building Recording, Archaeological Observation and Limited
Evaluation at Talhardd Farm, Llandeilo Rural, Carmarthenshire**

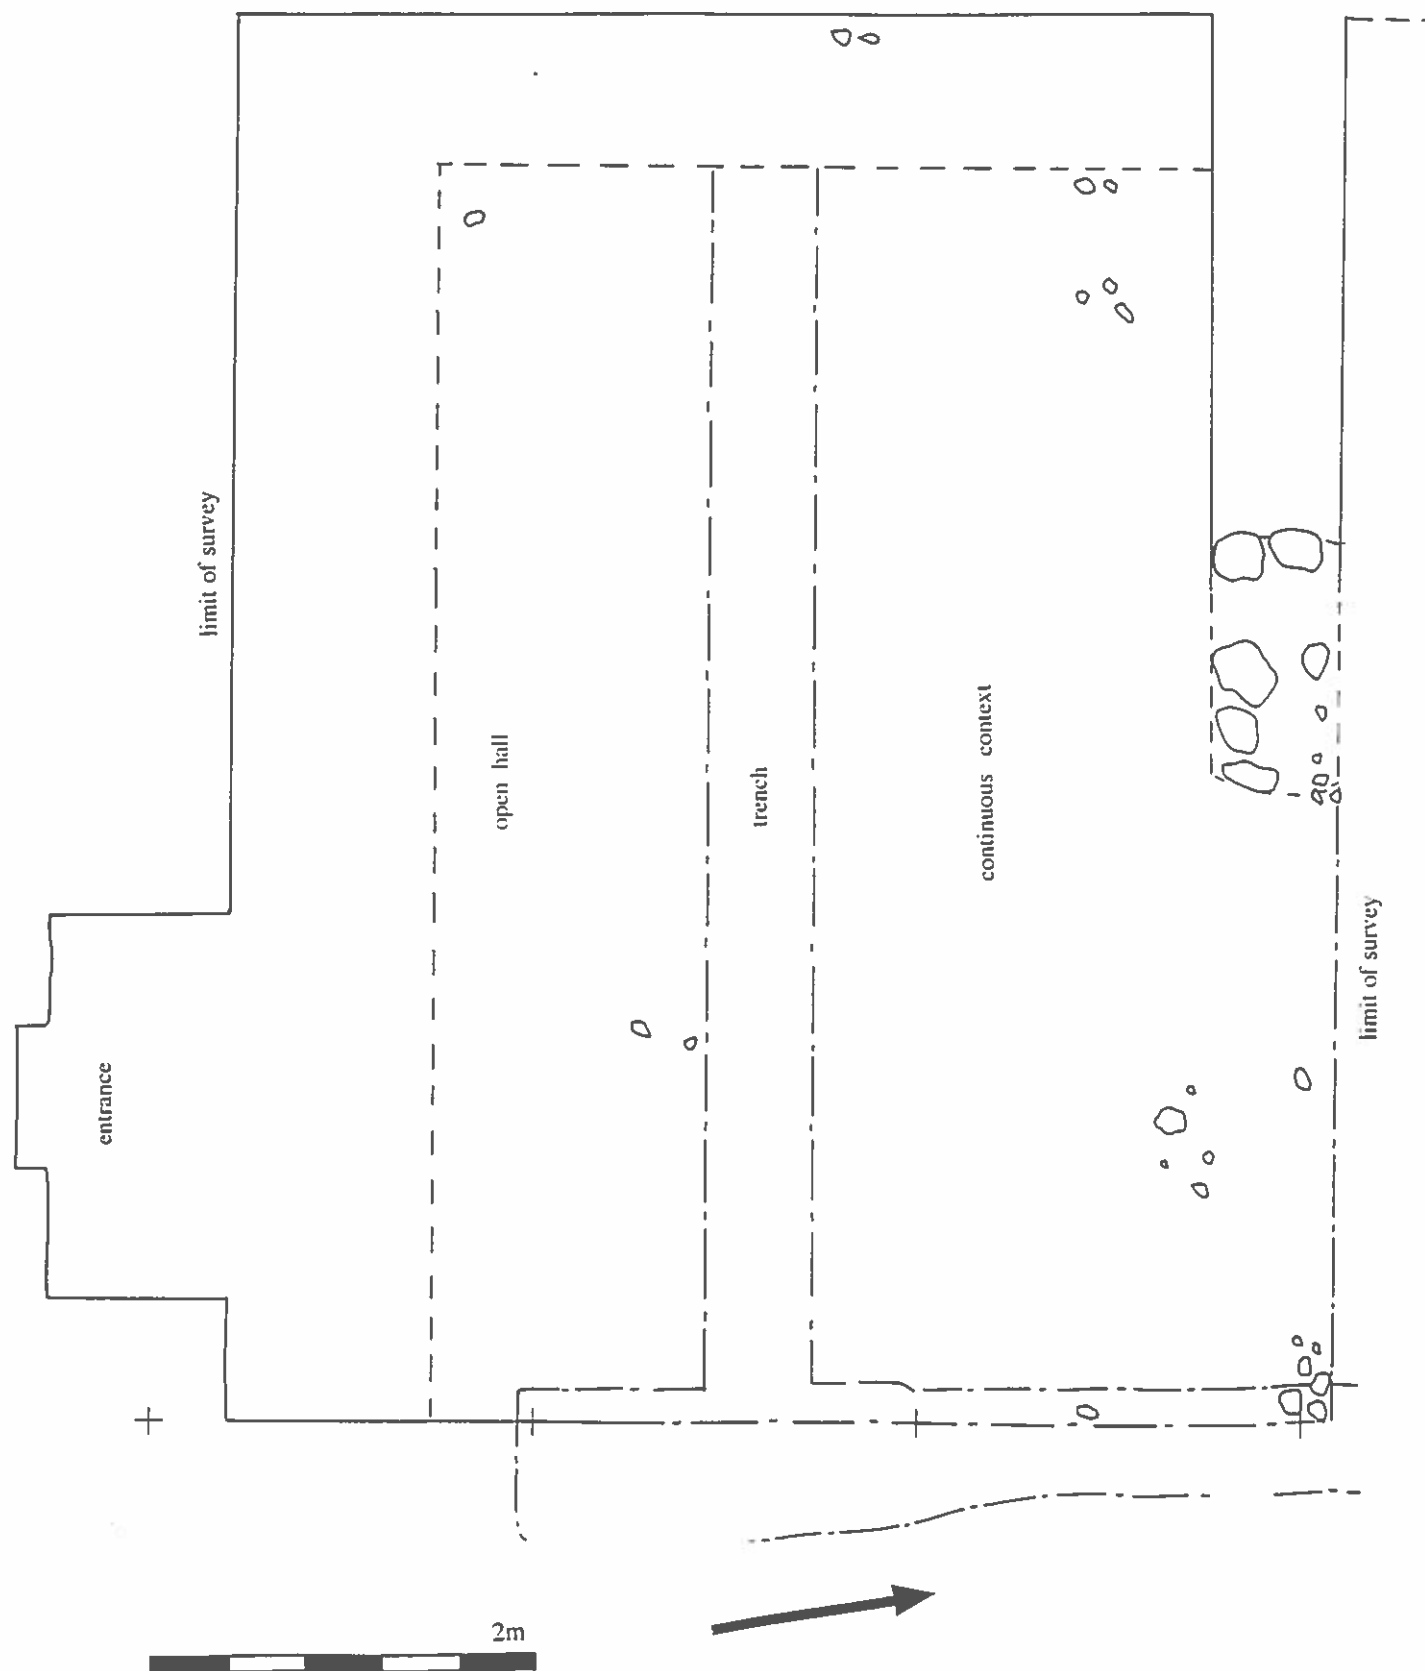
FIGURE 13. TRENCH LOCATION IN AREA B

- 6.5 The clean-back in area B (the main hall) revealed a single context across most of the area, with possibly a second, poorly-defined, deposit along the southern and western walls (**Plate 5**). The clearly visible context was a moderately compacted, orange-brown, sandy loam soil with occasional fragments of stone, plaster, charcoal flecking and animal bone on the surface (102). These fragments had been compressed into the soil, as had a fragment of floor tile, an iron (Fe) nail and a copper belt buckle. The contractor excavated a foundation trench, to 0.80m below existing ground level, across the centre of the area, confirming that this context was a natural deposit and the same as (002). Context (102) extended up to 0.40m below existing ground level. Underlying (102), between 0.40m and 0.80m below existing ground level, was (104) a tightly compacted, orange-brown soil with frequent stone inclusions (same as (003)).

- 6.6 The second, poorly-defined context - a moderately compacted, orange-brown sandy loam with occasional stone inclusions - was tentatively labelled (103). Context (103) was present up to 1.20m from the southern and western walls adjacent to area B. The context was distinguished from (102) by a very subtle colour change and the foundation trench across this area revealed no clearly defined feature.

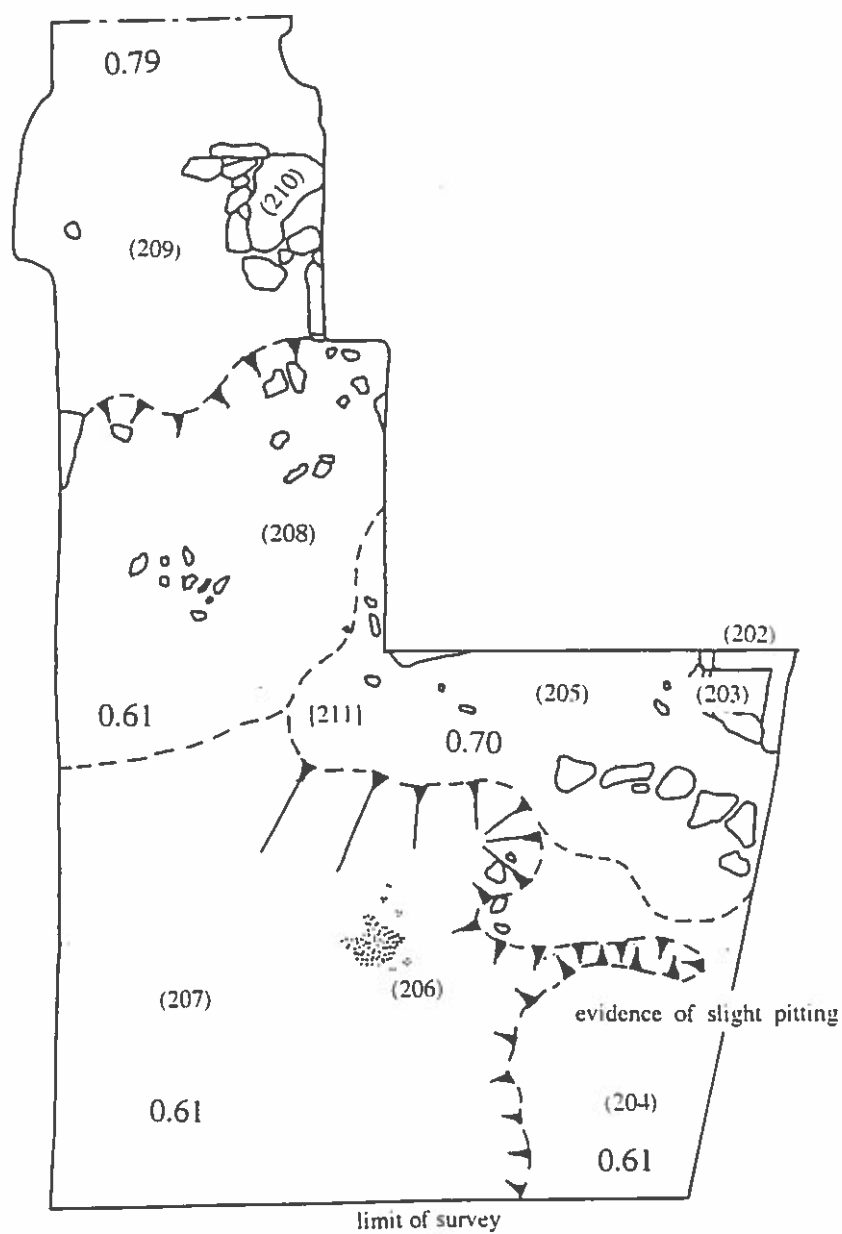
FIGURE 14. EXPOSED AND RECORDED SECTION IN AREA C

- 6.9 The clean-back within area C (southern wing) revealed nine contexts. In the north-eastern corner of the main room was a small brick structure (202) abutting the eastern wall of the house (201). The bricks showed evidence of being exposed to burning and, in places, were coated with a greenish-blue (turquoise) paint. Underlying (202) was a layer of concrete measuring 0.40m x 0.40m (203). Contexts (202) and (203) were considered to comprise part of the internal wall. Context (203) overlay a shallow pit within [211]. This pit was filled with a loosely compacted, dark brown gritty silty soil with a high proportion of burnt organic material and occasional medium-sized shale inclusions (205). Also included within this deposit were a fragment of domestic cow tibia and one river-washed stone. The pit was extremely shallow to the west (0.05m in depth) before deepening to 0.15m (below existing floor level) near the eastern wall of the house, around (203).

- 6.10 On the surface of this area, and cut by [211], was a deposit of moderately-to-loosely compacted, orange-brown sandy clay soil (204) and a tightly compacted, orange-brown clay deposit. These were present in the south-eastern and south-western areas of the room respectively. Compacted into the centre of (204), and overlying it, was a loosely compacted, creamy-white mortar deposit (206).

- 6.11 Context [211] also cut into a moderately-to-loosely compacted, medium brown mixture of silty soil and clay with frequent mortar flecking (208) at the southern end of the corridor between areas B and C. Adjacent to (208), at the northern end of this corridor, was a moderately compacted, greyish-brown silty soil (209) that overlay a layer of rounded stones measuring 0.80m x 0.60m (210). These stones were bonded using a lime mortar and were interpreted as part of the original flooring of the building.

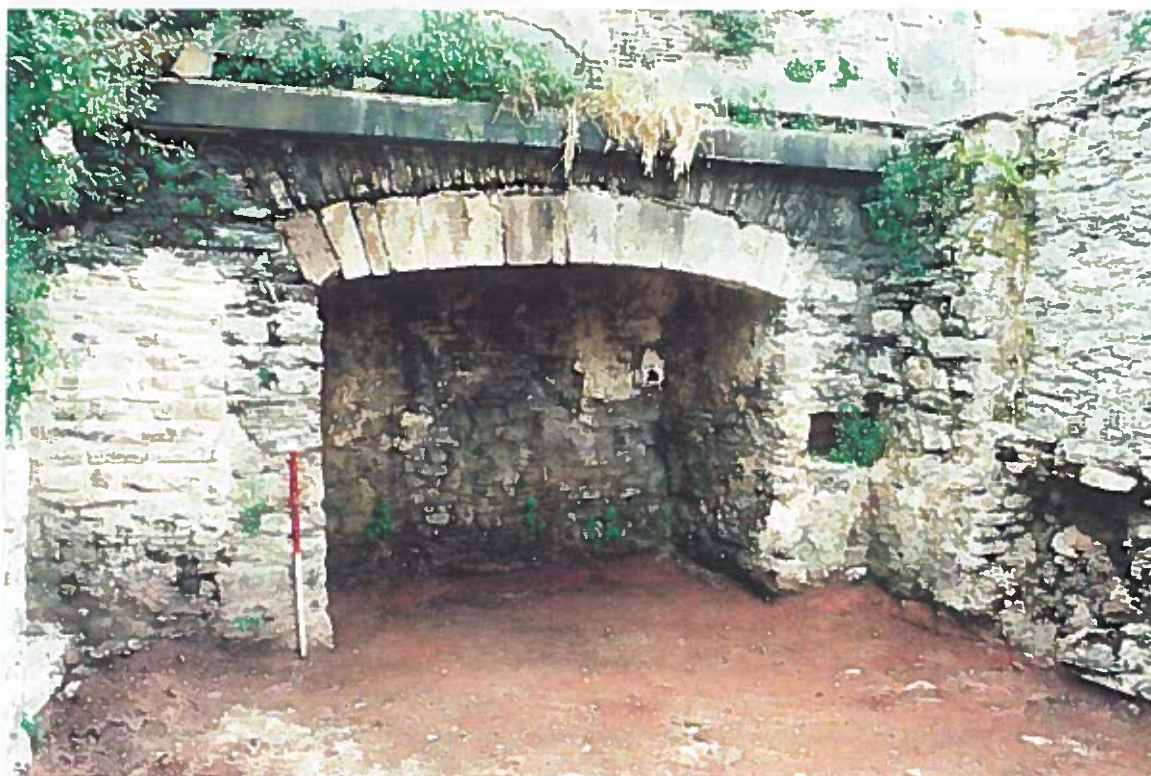
PLATE 2 CHIMNEY CUT INTO SOUTHERN GABLE FORMING THE LOWER SECTION OF AN EXTERNAL STACK

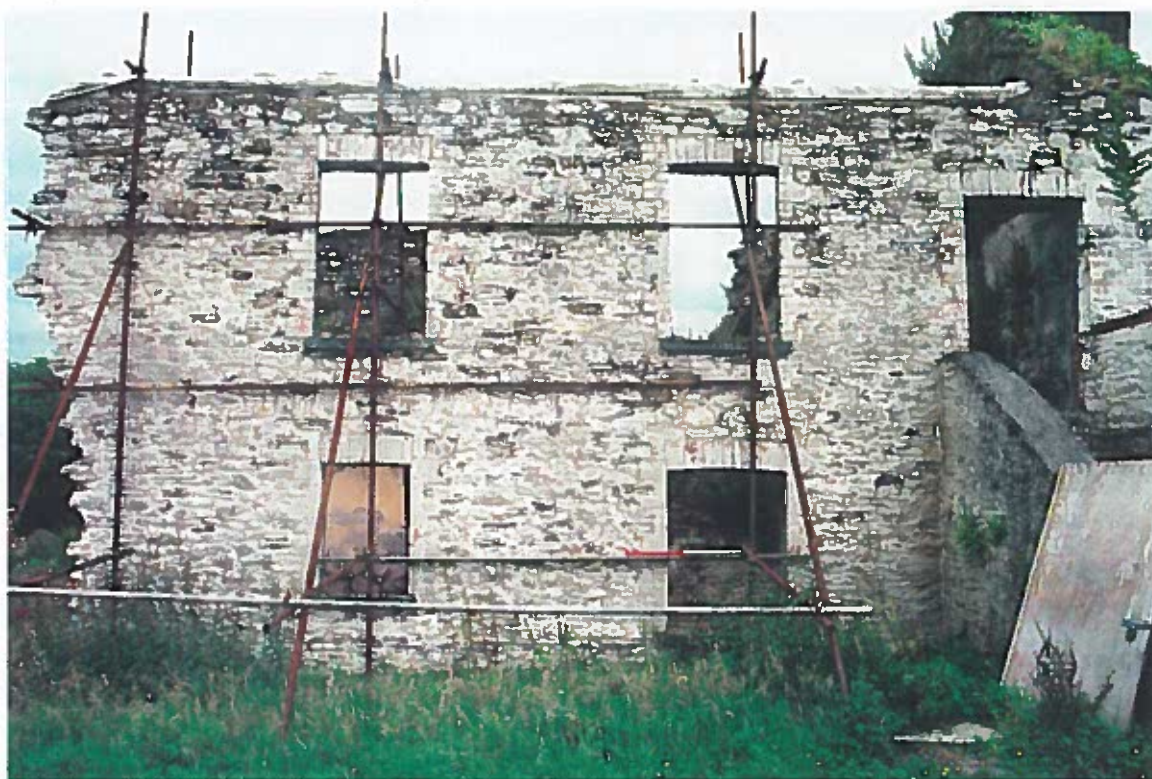
- 5.3 The exterior elevations are complex and consist of a number of chronological phases of construction. The western elevation, which faces an open farmyard, is 19th century (**Plate 4**). This elevation may replace an earlier wall. A late 19th century red-brick chimney stack is located on the eastern gable.

PLATE 4 19th CENTURY FARMHOUSE FACADE

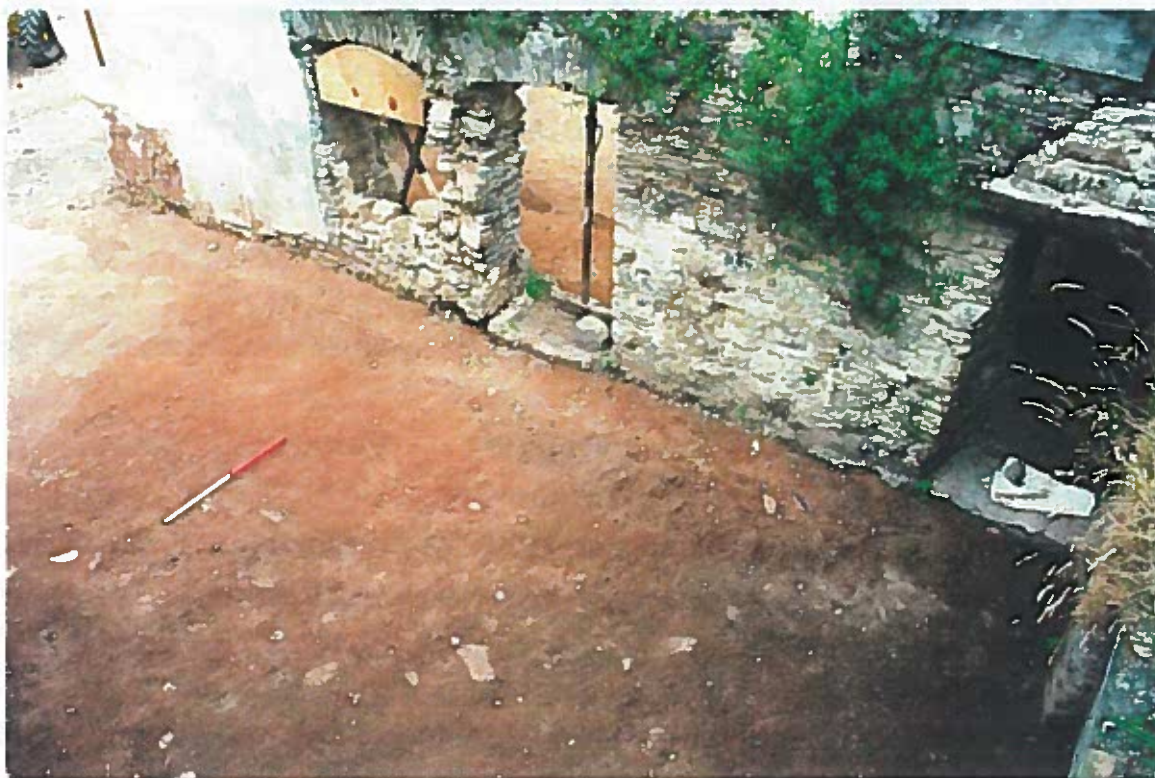
PLATE 5 KITCHEN AREA SHOWING FLOOR - FLAGSTONES ARE REMOVED

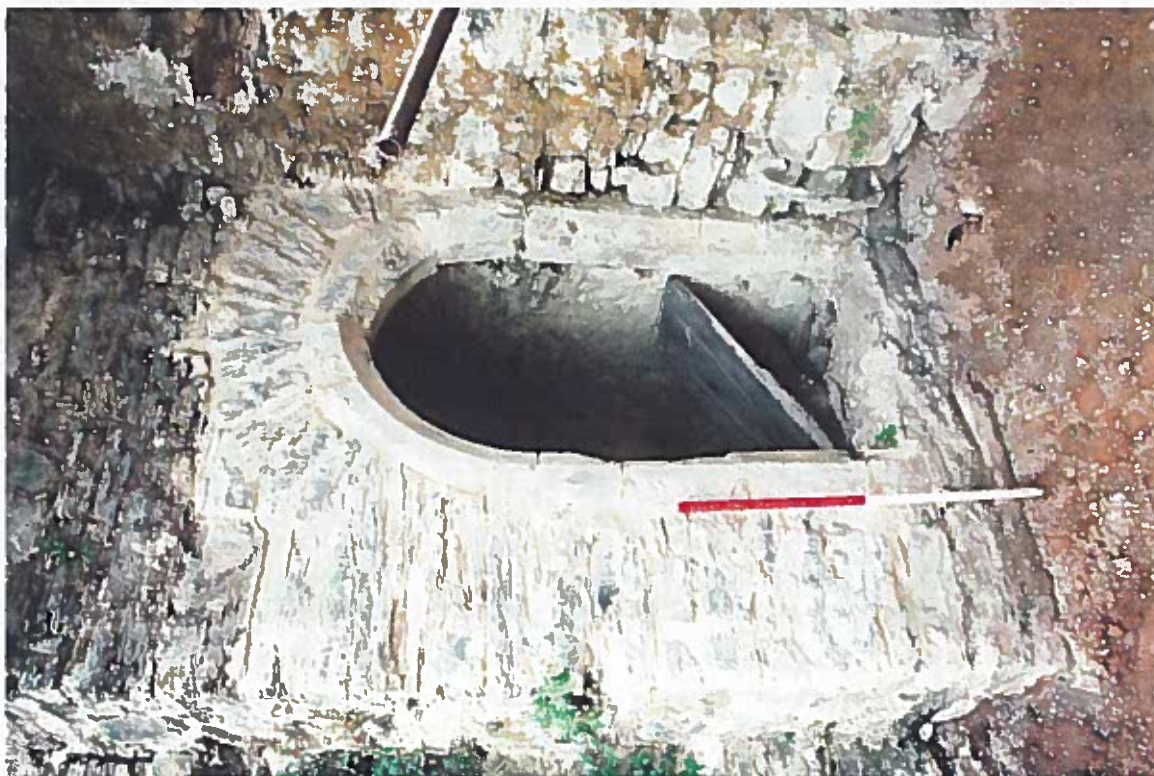
PLATE 8 DETAIL OF DOOR OPENING LEADING TO A STONE STAIRWAY

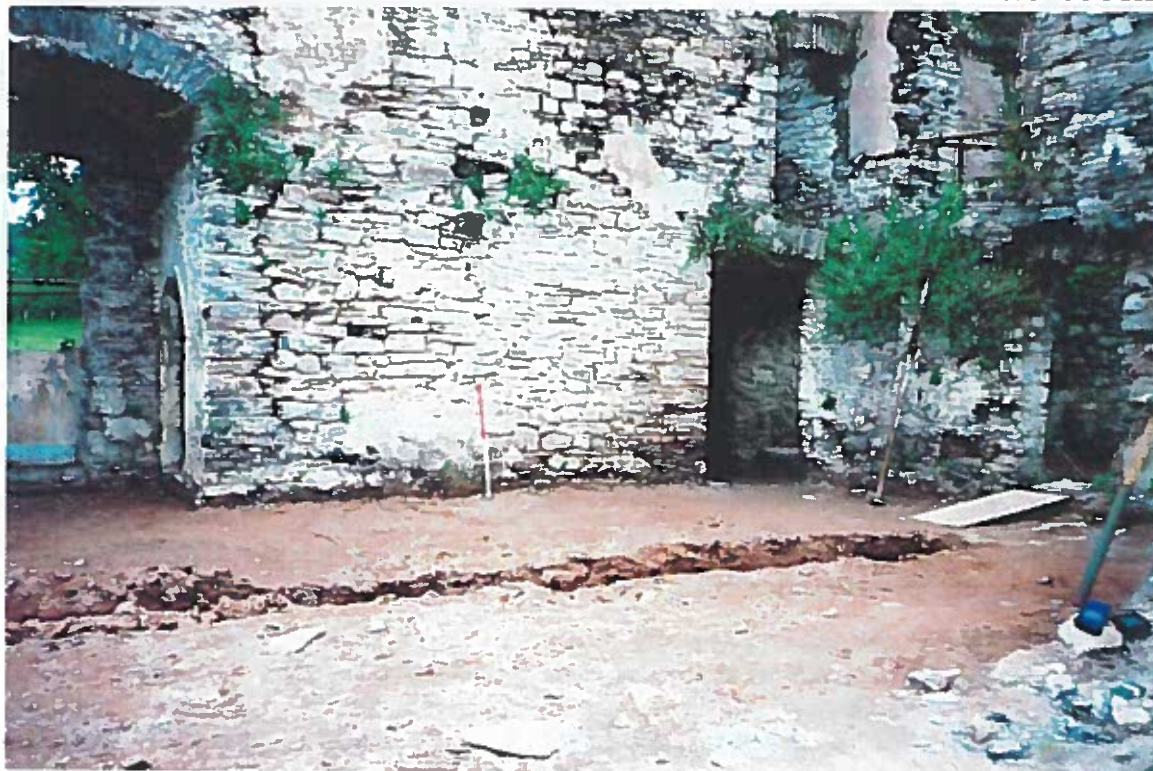
PLATE 10 CLEANED-BACK AREA WITH FOOTING TRENCH - LOOKING SOUTH
