Genwen Quarry, Bynea Carmarthernshire

Archaeological Watching Brief

CAP Report No.251

Date: April 2003

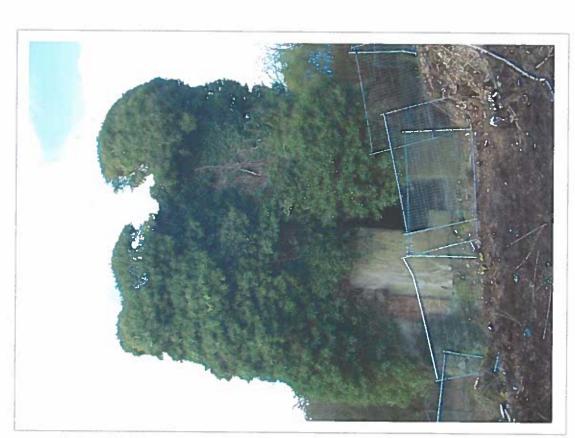
Plate 1: East Facing Side

- 4.3.7 The removal of vegetation exposed the true condition of the surviving structure; it was noted that the eastern side had suffered significant damage around a stone blocked southern window and around the northern robbed window and door apertures. Situated at the central-top eastern side, a brick blocked window was also uncovered. Two further windows were exposed on the southern facing side. A stone blocked window situated to the eastern end probably relating to the earliest phase of the engine house construction. A further brick blocked window was exposed within the central portion of the southern gable of the south side. Both the brick blocked windows on the east and south-facing sides may relate to the later phase of the engine house development. No further features were revealed under the dense cover of vegetation.

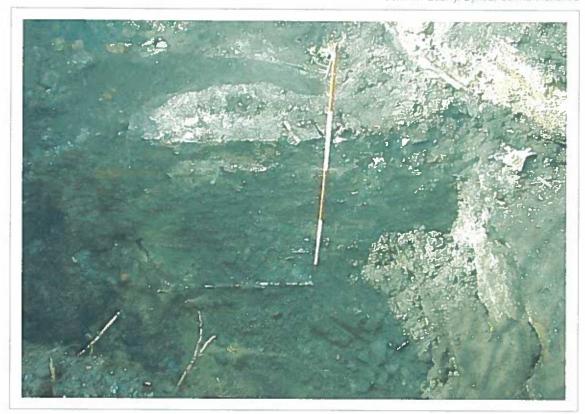
4.3.1 The topsoil (101) was removed revealing a stone edged wall enclosing a brick arch (blocked) and brick built vault (102) situated at the western end of the trench. The top of five stone walls were recorded on the alignment, north south (103), east west (104) & (105). A further east west stone wall (106) was situated to the north end of this trench. Two stone walls (105) and (106) abutted the robbed-out eastern dressed stone wall (107) of a structure that lies part standing to the west of the excavated area. The deposits encountered between structure (102) and (103) consisted of a series of thick infill deposits of shale and clay. Deposit (109) consisted of a black friable shale. This overlay a decayed coal and shale deposit (110) that in turn sealed a yellow mottled sandy clay (111). At the level of a concrete offset a thick layer of re-deposited yellow clay was recorded. The deposits recorded to the east of wall (103) consisted of three dumped clay in-fills, Deposit (113) consisted of a mottled yellow and light blue clay that sealed a yellow sandy clay that contained fragmented shale, this in turn sealed a yellow clay that contained brick fragments. The section recorded to the north of wall (104) consisted of a rotational dump or tipping deposits of yellow clay (113) and shale (114). This subsequent section was capped with mottled yellow clay.

- 6.1.3 The siting of Trench 1 exposed a brick built vault and stone blocked entrance; this was associated with a series of walls that may have two functions. The 1891-1939 maps display the terminal ending of railway lines in this area. It is possible that these walls are associated with the railway or ground stabilisation to allow access to the mineshaft that could lie under the blocked brick vault structure.

Plate 9: Trench 1 detailing brick valt [102], scale 1m, looking west

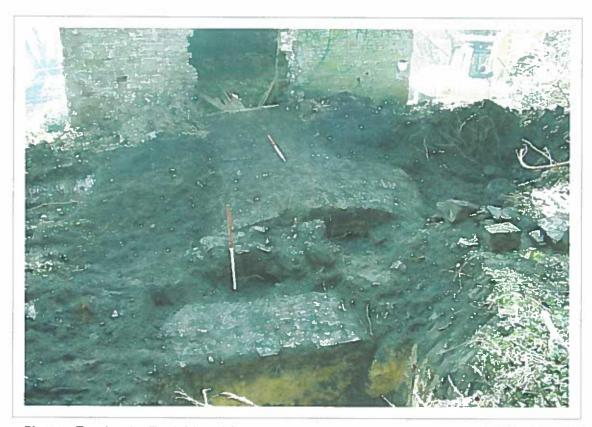
4.3.3 The removal of the topsoil (201) in this 'T' shaped trench revealed a substantial brick vault (202). This vault abutted the north side of the engine house (where a concrete blocking pad was in evidence) and extended northward (4.50m) towards a stone wall (203). This wall was clearly constructed to block the northern end of the brick vault (202). A small trench was excavated to the west of the vault to establish if wall (103) terminated, it was discovered that the angle of the western portion of the brick vault may relate to a blocked door situated to the west of the engine house (402). The final feature to be uncovered within Trench 2 was an east west aligned stone constructed wall (204) that abutted wall (203), it was not possible to ascertain the function of this feature.

- 6.1.2 The overall findings of the watching brief excavation revealed a series of stone and brick built features associated with the operational workings of the colliery and its subsequent abandonment. The excavation to the north of the engine house (Trench 2) was implemented to locate the site of a mineshaft. The discovery of a substantial brick constructed vault situated under the site of the wooden beam would suggest that the vault conceal the exact workings associated with the mineshaft entrance. The stone wall blocking the northern entrance suggests that this may relate with the southern concrete area and sealing of the western door to the phase of activity when the mine was abandoned.

Plate 10: Trench 2 detailing brick vault [202] and wall [204], scale 1m, looking south. CAP Report No. 251

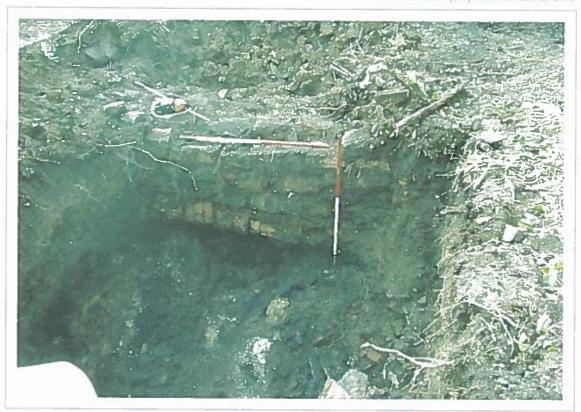
4.3.4 This trench was located to the south of the engine house to identify an entrance to a mineshaft. The removal of topsoil (301) revealed the stone and brick constructed wall that concealed a brick built arch (302). A deposit of dark sandy clay containing concrete and bricks (303) was encountered in the eastern part of the trench. This overlaid a thick deposit of shale and coal (304) that in turn sealed a thin layer of ash (305). Below this a yellow clay (306) encompassed a series of stone constructed walls aligned north south

(308) & (309). Wall (308) abutted a concrete constructed gully (310) that was capped with stone, this gully was observed continuing westwards under (302). To the north of this feature a further east west aligned stone wall was partly exposed (311), the western end of this wall abutted the northern brick arch springer of (302).

- 6.1.4 Trench 3 was also excavated to locate a mine entrance, this excavation revealed a series of robbed walls and a crude built brick arch aligned east west. No mine entrance was located in this trench, other than structures relating to the phase of the colliery workings.

Plate 11: Trench 3 detailing brick arch [302], scale 1m, looking west.

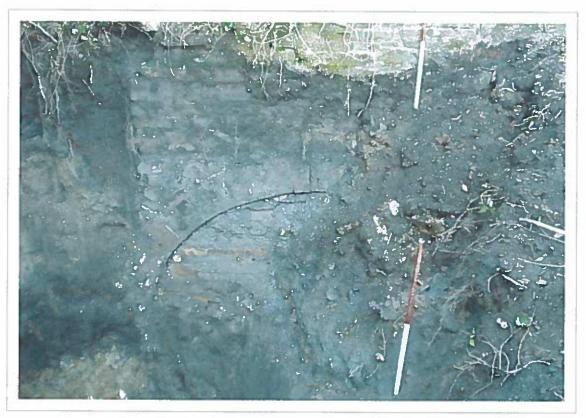
4.3.5 Trench 4 was located in the north west part of the site abutting the Western Wall (401) that was keyed into the Western Wall of the engine house. The exposed wall constructed of stone displayed a blocked arched door measuring 1m wide and 1.20m from the base to apex of the arch (402), as mentioned before this door may have lead into the brick vault of (202). At a depth of 1m below the lower door sill the top of a dressed stone arch was uncovered (403) the excavation of this feature revealed it was the probable entrance to the adit. The base of the blocked entrance was recorded at 3.20m below present ground level; it was at this level that the two fragments of iron railway line were recovered. The infill deposits abutting the blocked adit entrance consisted of a topsoil (407) that sealed a blue sticky clay (404) that in turns sealed a yellow clay (405). At the base of these deposits a black shale and coal deposit was recorded (406).

- 6.1.5 Trench 4 exposed two levels of colliery workings. The door to the northern brick vault and the entrance to the adit. It was not possible to extend the trench to ascertain the relationship between these features and the standing engine house. If the base of the adit was ground level then the engine house could have two buried stories! At some point after 1924 there was a huge movement of ground levelling and landscaping in and around the engine house.

Plate 12: Trench 4 detailing the blocked mine adit [406], scale 1m, looking North.
