# Penally Training Area, ATE Pembroke, Pembrokeshire

## Archaeological Desk-Based Assessment and Condition Survey

Reference: 53268.02

January 2004

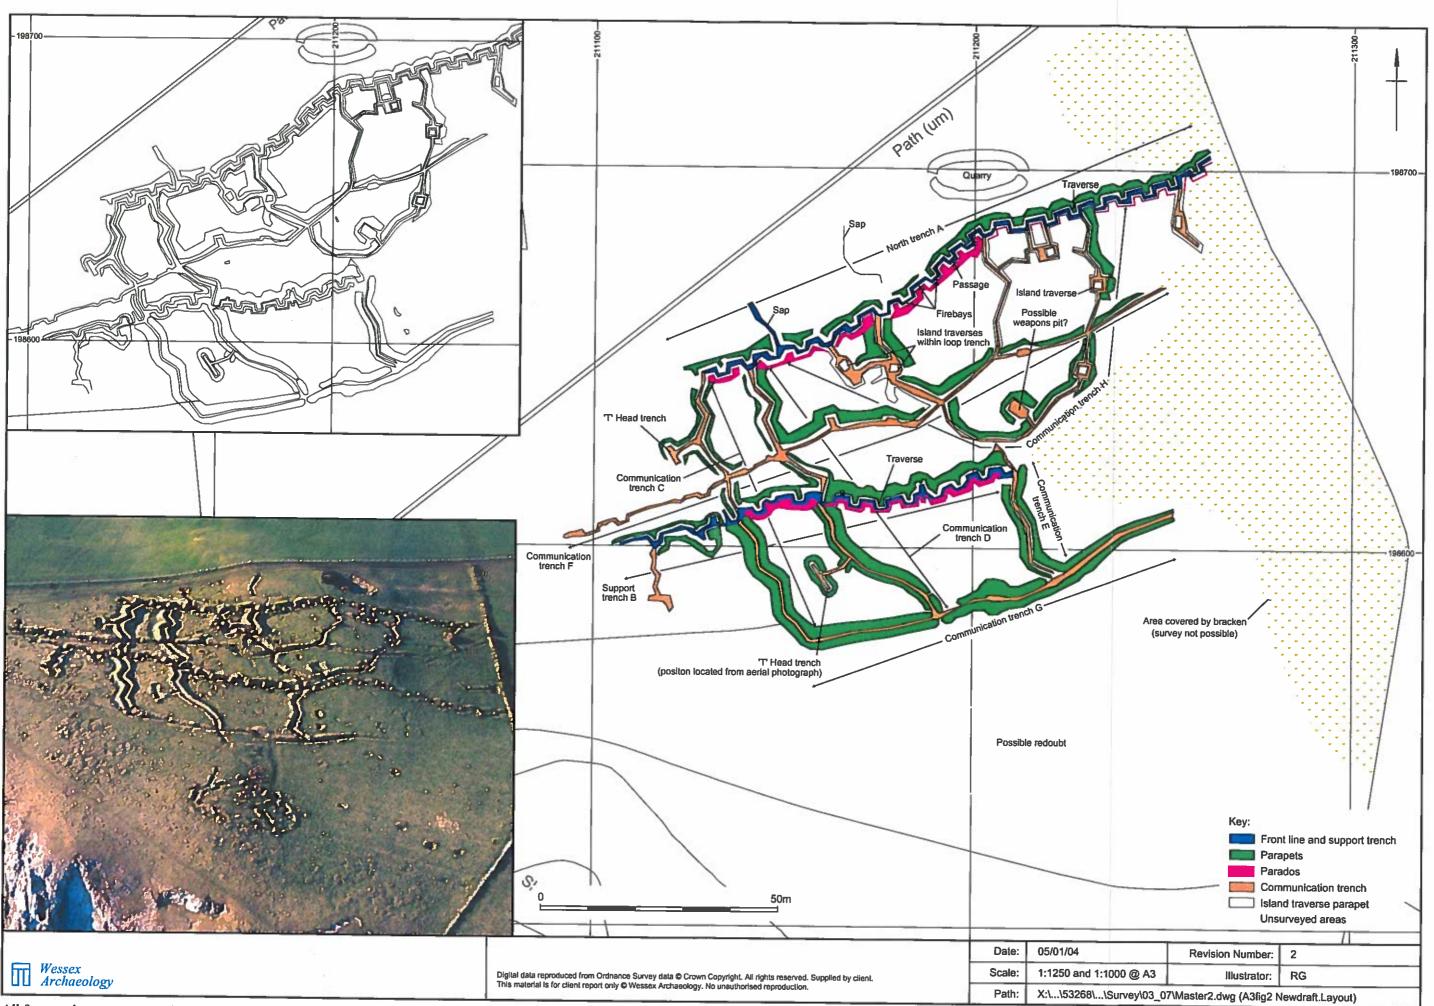
FIGURE 3: Significant Areas of erosion/damage.

- 6.1.14 Significant areas of damage were surveyed and are presented in Figure 3. Encroaching scrub vegetation was predominantly found in the east and north of the site and has principally taken hold within the base of trenches. Erosion and slumping can also be identified in key areas such as the steep sides of the trenches where some parapets are gradually slipping back into the trench. Other areas of bad erosion are located where trenches interconnect and form exposed corners open to the elements. Grazing sheep have exploited these eroded areas forming deep hollows when they shelter from bad weather. Rabbit damage to the monument also appears to be in specific areas. Most of the surveyed burrows are to be found in the west half of the site and several groups can be isolated and probably form warrens, which have been partially exploited for ferreting.

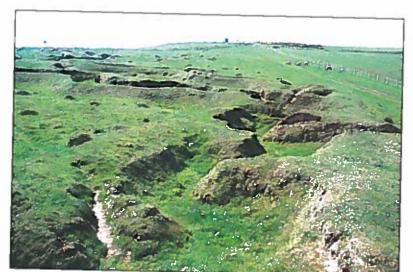
- 6.1.4 The preservation of the north trench (A) varies. The west and centre sections are well preserved and in places are between 1.5m and 2m deep (Plate 1) but further east they are shallower and in places are less than 0.5m deep. General

condition is good but very little evidence survives to indicate the position of the fire step. Both parapet and parados are very rounded in profile. Sheep sheltering has caused some erosion and there are rabbit burrows in some areas (Plate 2).

Plate 1: Trench A viewed from the east

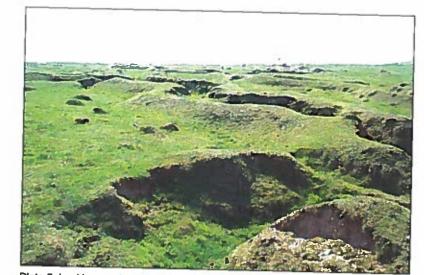
Plate 2: Looking south toward communication trenches C and D from trench A

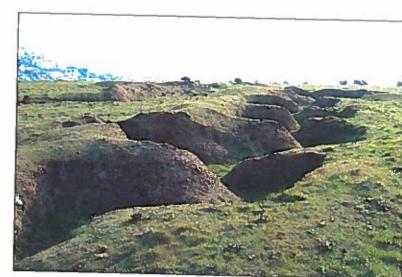
Plate 3: Looking east along trench B

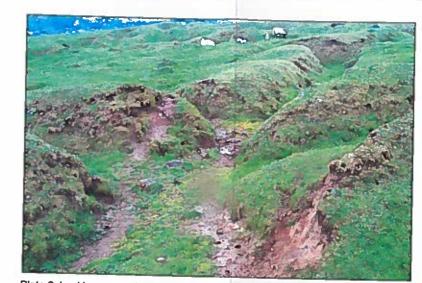
- 6.1.12 The preservation and condition of all the communication trenches varies. In general they are well defined and their general condition is good. Some

- erosion is apparent due to weathering and slipping of bank material. In places rabbit burrows have exploited the banks and sheep have caused damage to some areas where they shelter from the weather and create paths (**Plate 6**).

Plate 6: Looking east at junction of trenches D and F showing erosion and sheep paths

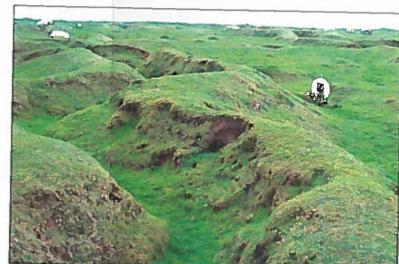
- 6.1.7 The condition of trenches **C** and **D** is good. There are well-preserved parapets on either side of both ditches designed to defend against shell blast or enfilade fire. Evidence of soil erosion and rabbit burrows into the parapets was recorded (**Plates 4-5**).

Plate 5: Looking south along communication trench D showing erosion

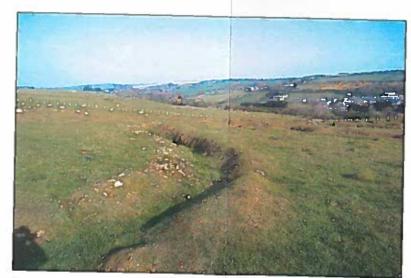
Plate 4: Looking north along communication trench C
