Crowback Tumulus Castlemartin Pembrokeshire

Archaeological Survey and Repair

Archaeological Investigation Report

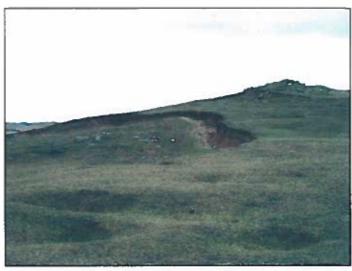
- 1.1.2 The work was prompted by the observation of an erosion scar on the seaward (northwestern) side of the tumulus. An area of disturbance could be seen adjacent to the erosion scar, including old timbers dug into the ground, possibly the result of past military training activity. The brief called for a repair to the barrow, combined with work to record the exposed stratigraphy.

Crowback tumulus and erosion scar, view to the east

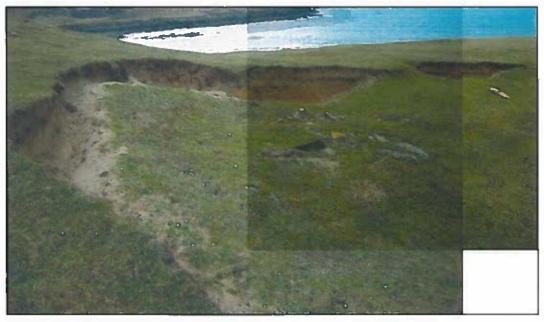
Crowback tumulus and full erosion scar, view to southwest

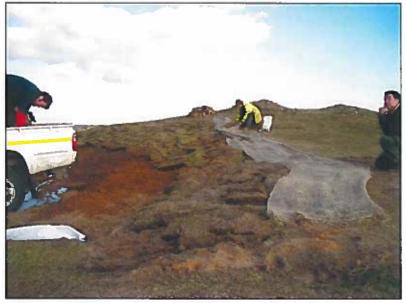
Repairs in progress - view to the east

- 3.2.2 The exposed sand area (including the vertical erosion scar) was then covered with a "Terram" geotextile membrane in order to separate the underlying archaeological horizons from the fill. The geotextile was weighted down (with stones collected from the beach) and pinned in place on the vertical slope so that it finished flush with the slope profile. No textile protruded above ground level. The disturbed sand was then replaced on top of the geotextile.

- 3.2.3 In order to provide additional in-fill material and turf, a small borrow pit was dug 50m to the south-east of the barrow (fig. 2). The turf from this pit was carefully stripped and retained for use. The pit was dug into the sand level, removing the mixed sand which was used to infill the scar in the barrow, smoothing out the profile of the mound.

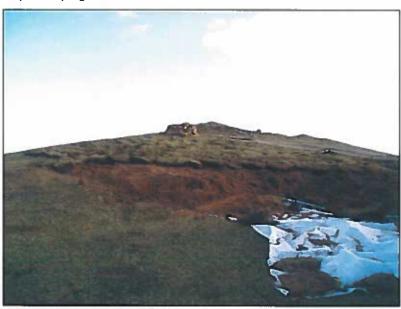
Repairs in progress - view to southeast

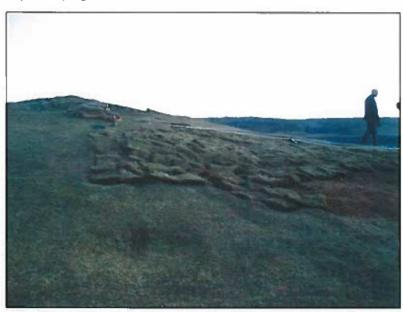
Repair completed - view to south

- 3.2.4 Finally, the turf was re-laid across the repaired area. In order to encourage the vegetation to re-establish, the repaired area was overlaid with a biodegradable layer of Geojute (fig. 5).
