Brownslade Farm, ATE Castlemartin, Pembrokeshire

Archaeological Building Recording

Reference: 53179.2

July 2003

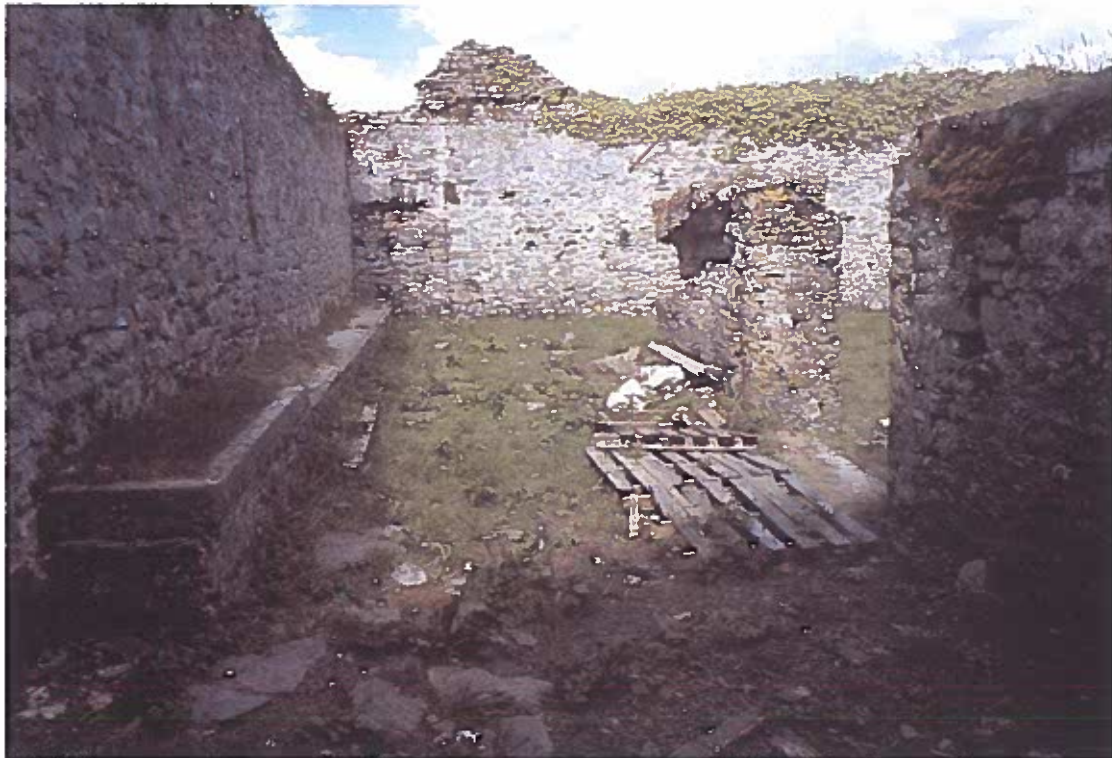
Cattle shed (C)

3.4.1 This building is a single-storey L-shaped byre or cattle shed in the northern corner of the courtyard (**Figure 5**). Built of coursed rubble stone to approximately 1 metre high with random rubble masonry above, the courtyard side of the cattle shed consists of five large drum piers (**Plate 5**). The spaces between some of these piers have been infilled with rubble masonry to give continuous walls.

3.4.2 At the west corner is a doorway with access to the road north-west of the farm buildings. Along the north-west elevation is a stone platform with a cement top, presumably the base for a wooden manger, the holes for which are visible at points along the wall. There is substantial plant growth on top of the platform and this is encroaching into the adjoining wall.

3.4.3 No roof structure survives. The remains of two purlins are visible in the south-west wall, above which is the scar of a lean-to roof; the east wall sloped to accommodate the roof structure. There is some plant growth along the top of the north-west wall, and substantial ivy growth along the north-east and east walls.

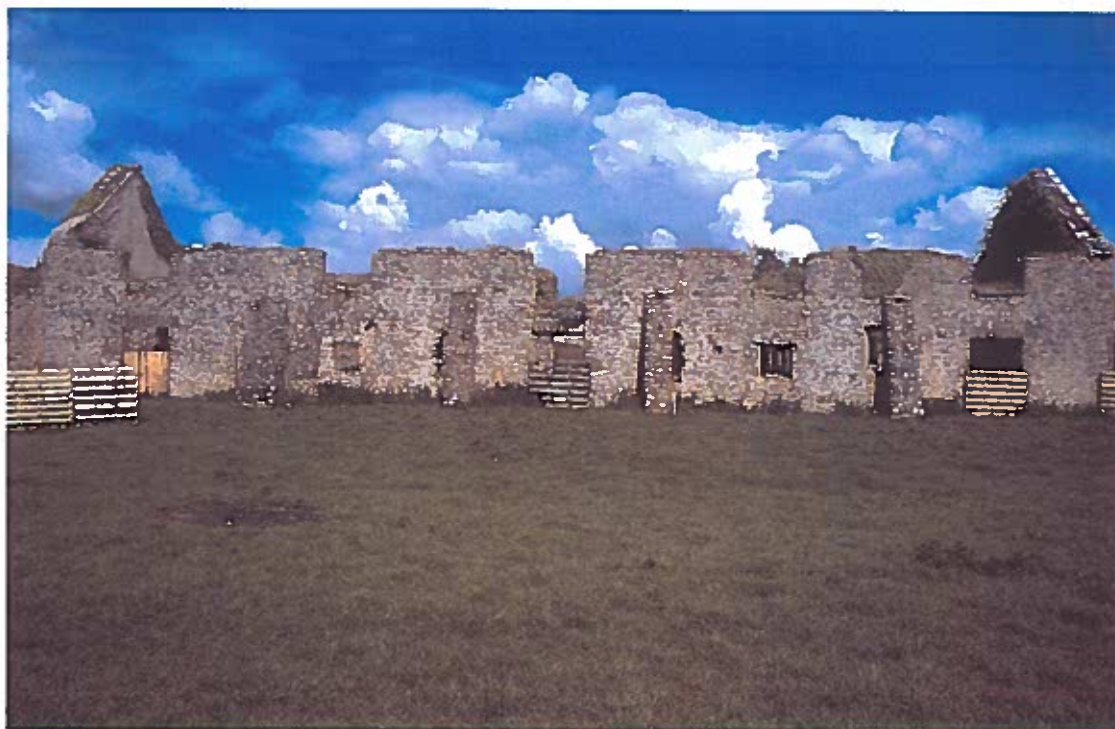
Butressed Barn (D)

- 3.5.2 Again built of coursed rubble stone, this building (**Figure 6**) is 1½ storeys high and has four large buttresses with slate tops (later additions) to its south-west (courtyard) elevation (**Plate 6**). This elevation has three doorways, each with a flat voussoir head; there is also a central doorway to the upper floor. In the north-east wall there is a doorway opposite the middle ground floor entrance, suggesting there was once a central passage through the building. There is a blocked doorway in the north-west wall which led through to the alleyway mentioned above. In the south-east wall is a further doorway which also leads round to the north-east courtyard; this has a replacement oak lintel.

- 3.5.6 There is a structural crack in the south-east end. An additional crack is visible above the blocked doorway in the north-west wall. This wall is covered in substantial ivy growth, which, combined with the cracking, could jeopardise the integrity of the north-west and south-west walls. There is also significant ivy growth on the south-east wall.

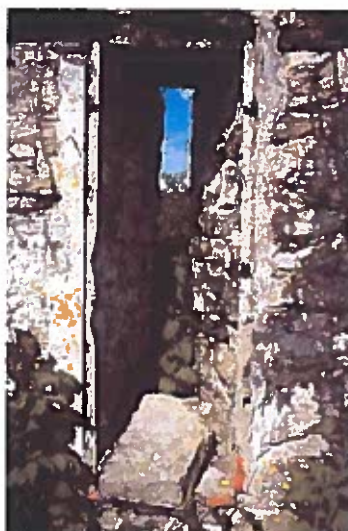
Plate 7. Slit openings

- 3.5.3 Two windows have been inserted into the south-west elevation, these have oak lintels. Original openings are narrow slits with splayed internal reveals and stone lintels (**Plate 7**). These occur in opposing pairs along the south-west and north-east elevations and were probably used for aeration, suggesting that this building was some kind of granary or store. Windows in the upper floor are located directly below the wall-plate, one in the north-east elevation is blocked.

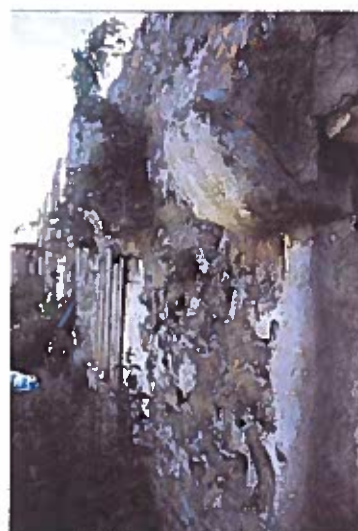
Plate 8. Corbels

- 3.5.4 Internal inspection of the building revealed very large corbels (**Plate 8**) in the south-west and north-east walls, two of which are of dressed stone. Joist holes are located in the north-west and south-east walls. Visible in the gable ends are the holes for double purlins. The building is rendered internally at ground floor level. The 1975 RCAHMW survey recorded a massive roof structure with roughly chamfered beams supported by the corbels. The roof trusses had lapped collars and two purlins per side and the whole structure was covered in slate.

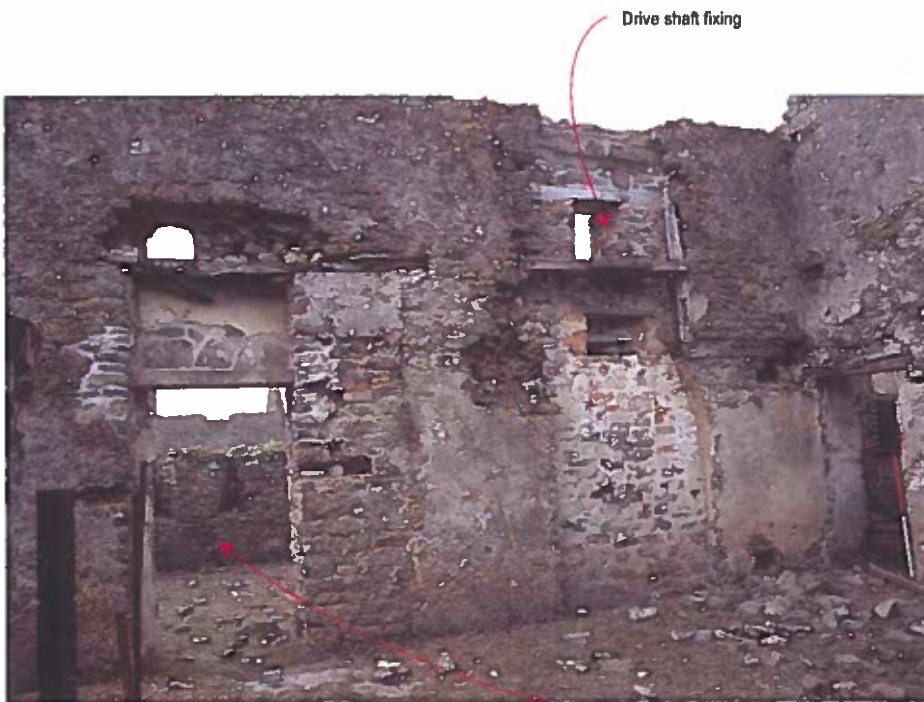
Plate 11. Drive shaft fixing

- 3.6.4 While the south-west end of the barn is largely intact, the north-east end is much altered. Beyond a rubble stone and brick wall dividing the threshing floor from the remainder of the barn, a series of modifications have taken place. In the north-west elevation there is a large opening through to a lean-to building ((G) constructed against the courtyard front of the threshing barn). Above the opening is a replacement timber lintel supporting infill masonry and a (?) failed timber lintel with loose rubble above. To the right (north-east) of this opening is a shaped recess in the wall with two small openings above containing some parts of a timber frame (**Plate 11**). The 1975 survey states these were drive-shaft bearings for a small engine.

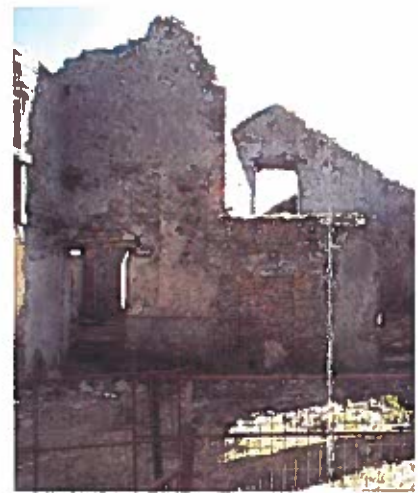
Plate 12. Building F

- 3.6.6 Building (F) (**Plate 12**) is divided in two by a rubble wall. The rear (south-eastern) part has doorways at ground and first floor level in the north-east wall. To the right (south-east) of the ground floor doorway is a rectangular recess with a part brick surround and joist holes above. The front (north-western) part has two wide openings, both with timber lintels and brick surrounds. One is adjacent to the doorway in the north-east wall and the second is in the north-west wall, leading into the courtyard. A doorway leads through to the main barn (E). Two iron beams cross this part of the building between the dividing wall and north-west wall. There is a partially infilled gap between buildings (F) and (G).

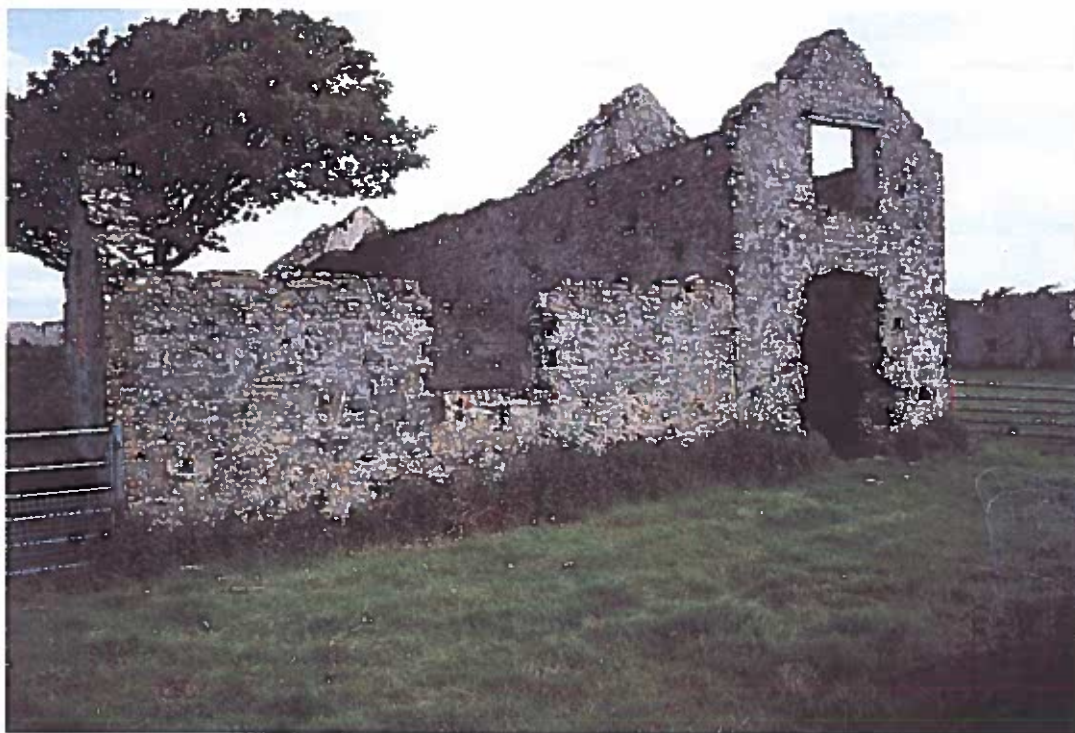
Stables (H)

- 3.7.1 This building (**Figure 8**), again built of rough coursed rubble stone, is of two storeys with a stone external staircase on its north-east side (**Plate 14**) which leads to the first floor of building (I). The building only has two openings, a ground floor doorway with a window above; doorway reveals are in poor condition with many stones missing. The building had a pitched roof, now removed. The 1975 RCAHMW report suggests it was a stable with tack room attached. The possible tack room to the south-west is of similar construction but is only one storey high and has a window in the south-west wall dressed in red brick

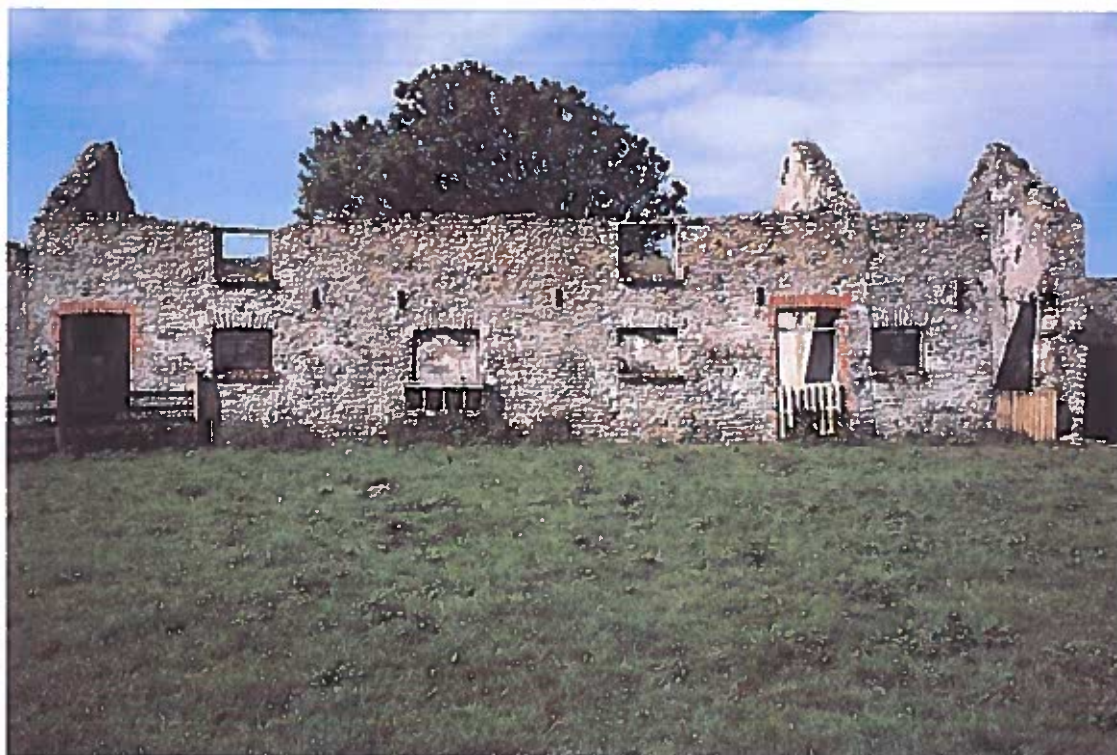
Cow shed (I)

- 3.8.1 Joined with a straight joint to building H and the attached staircase, this is a two-storey, rubble stone building in the southern corner of the courtyard (**Figure 9**). A two-storey extension (possibly a stable) is attached by a straight joint on the north-west wall.

- 3.8.4 At first floor level there is a doorway in the south-east wall (accessed by stone steps), and two doorways in the north-west wall, both now blocked. The pitched roof has been removed and consequently there is some vegetation growing along the eaves line, especially along the south-west wall.

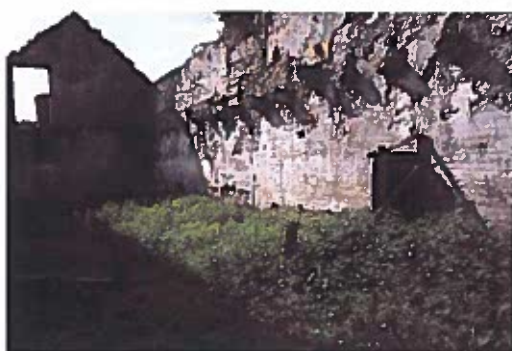
Plate 15. Interior, south-west wall

- 3.8.3 Inside the building is rendered. Rough stone corbels remain in the south-west wall (**Plate 15**), while the north-east wall contains much brickwork (**Plate 16**) and the remains of tie straps (some of which are also visible in the opposite wall). Fixings for mangers (similar to those in building B) are visible in the south-west wall.

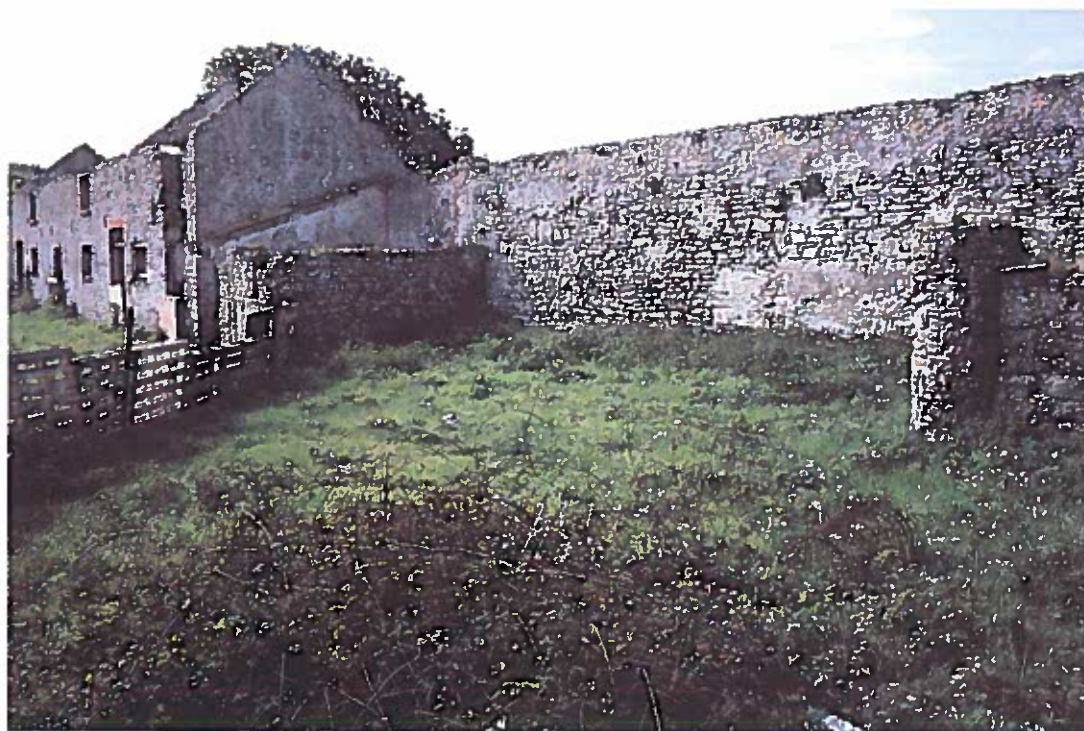
Open fronted byre (J)

- 3.9.1 To the north-west of the cowshed (I) is a long open area, probably open-fronted byres (**Figure 10**). The 1975 RCAHMW survey states that this area also had a beach-pebble floor. A rubble wall approximately 2 metres high projects from the courtyard boundary wall at the point of a blocked opening. Block bonded into the boundary wall here is a column of bricks, possibly a flue for a small smithy-hearth (RCAHMW 1975).

- 3.9.2 The wall has some surviving render. At the west corner is an entrance to the south-west courtyard, which also gives access to the road north-west of the farm buildings. A large timber (**Plate 17**) is set at an angle across the west corner, possibly acting as a tie to the north-west and south-west walls. Adjacent to this is a blocked opening, also visible from outside the courtyard.

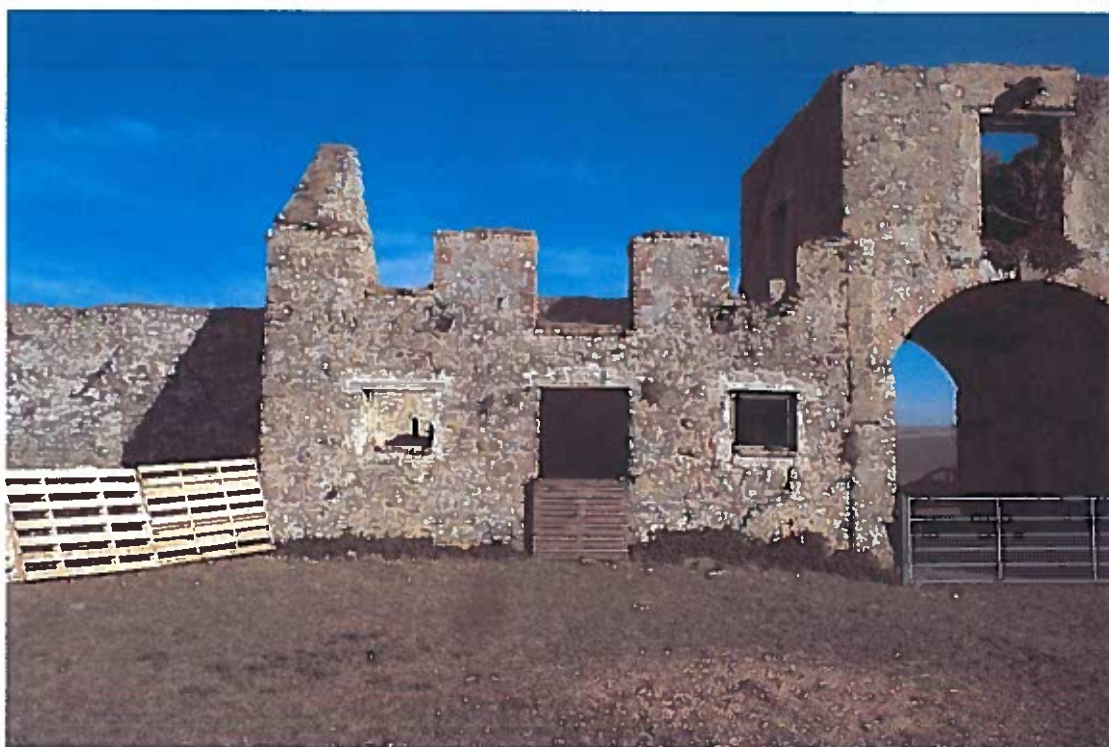
Cottage (K)

- 3.10.1 Similar to building (B), this building was constructed against the gateway (A) and abuts the gateposts with a straight joint (**Figure 11**). Like (A), the building was probably constructed when the gateway was improved, acting as a buttress to the barrel vault. Although it appears to be a domestic building, the absence of a chimney stack might suggest otherwise.

- 3.10.4 No roof structure survives, however holes for double purlins remain, along with a scar demonstrating the building had a pitched roof (**Plate 18**). Some plant growth is visible at eaves level, especially on the gable end (south-west), and notably in cracks in the rubble walls. Some structural cracking is visible in the masonry, the eastern corner of the building in particular.

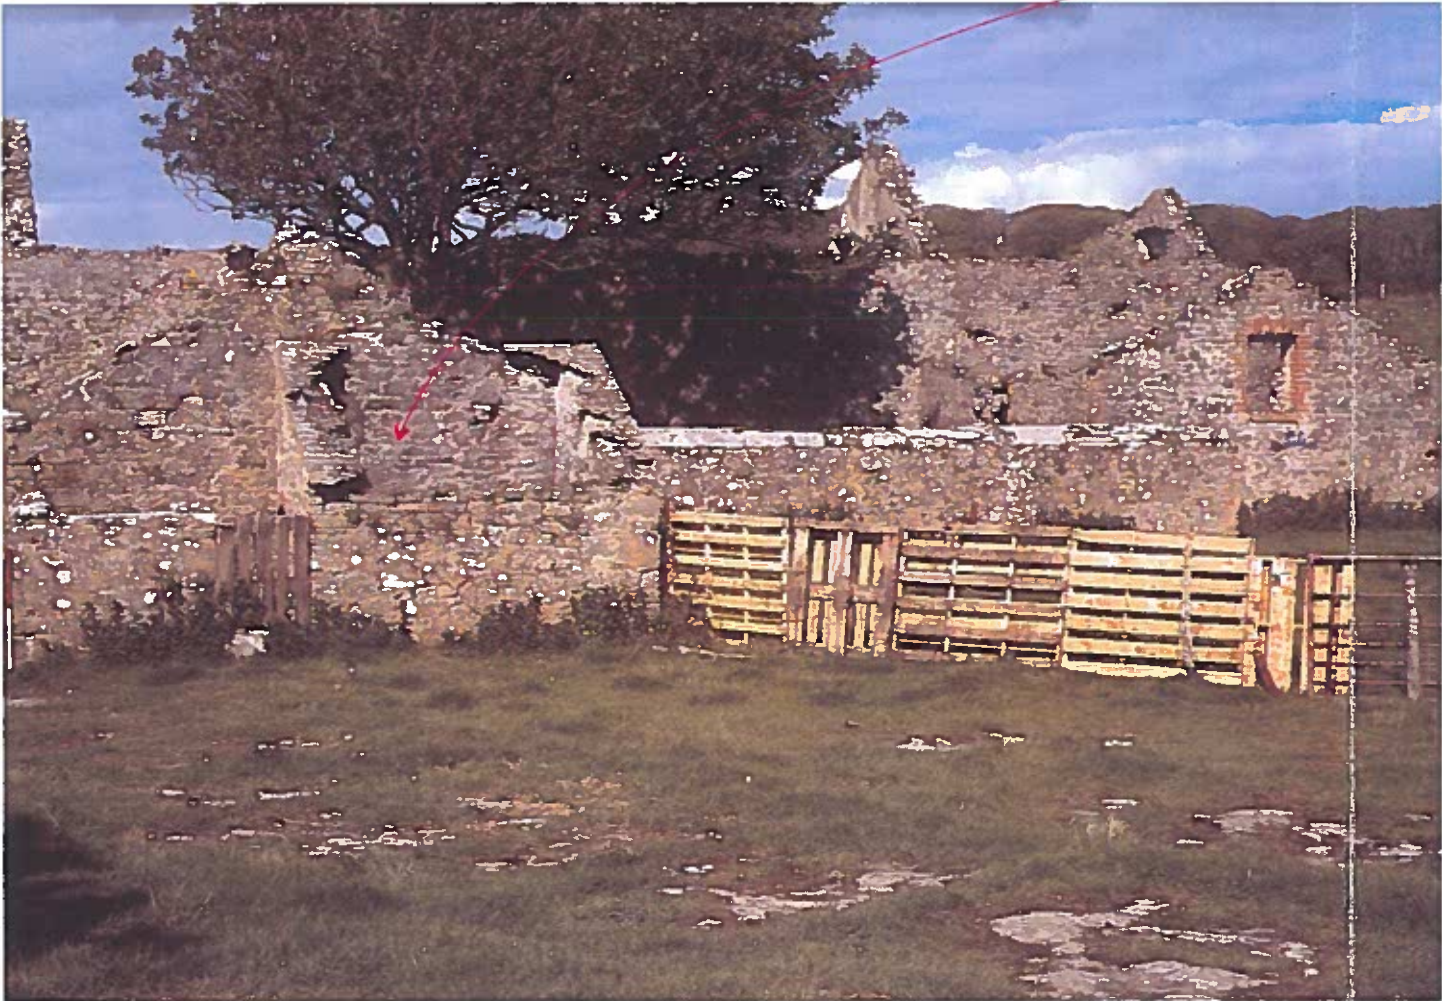
South-west courtyard

- 3.11.1 Bounded by an extension to the front (north-west) wall of the main courtyard and a natural outcrop of rock, this area contains single-storey pens and a derelict concrete building (**Figure 12**). The yard has a natural rock floor.

- 3.11.2 Behind building (I) is an open yard, possibly for poultry. Pens project from the wall behind building (I) (**Plate 19**). Two buildings, each divided into four pens, originally had pitched roofs and were possibly for lambing or - as the 1975 RCAHMW report states - pigsties. An additional pen to the south-west was certainly a pigsty and is only partly roofed. Some of the original decorative stone tiles remain; the 1975 RCAHMW report assumes this sty was separate from the others as it housed the prize boar.
- 3.11.3 The derelict structure at the north-west side of the courtyard is of concrete, dressed to look like rusticated stone (**Plate 20**). The building has almost totally collapsed.
- 3.11.4 From this area of the south-west courtyard it is possible to see coping tiles along the main courtyard wall (**Plate 21**).

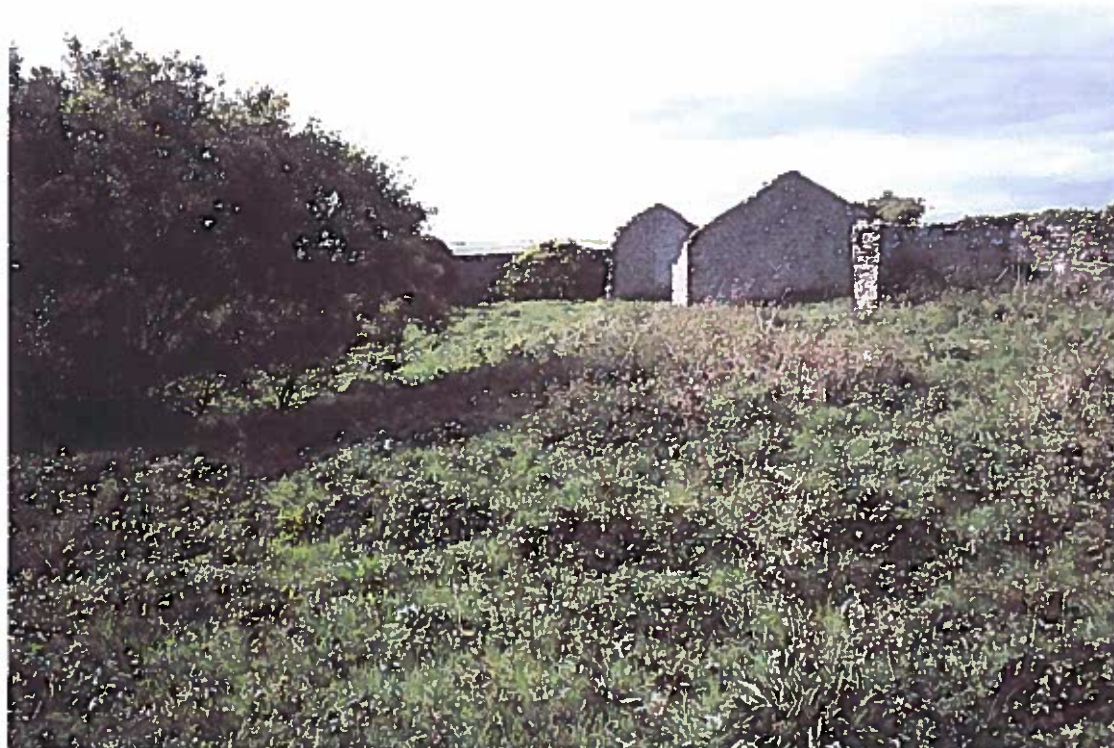
North-east courtyard

- 3.12.1 This area of Brownslade Farm is rather overgrown (**Figure 13**). Three main buildings survive, all of rubble stone construction. Forming the north-east perimeter of the courtyard are the remains of two buildings. The eastern building has a apsidal north-west end and masonry survives to a height of approximately 1.5 metres. The northerly building remains as two gable-ends, the northernmost of which has received some repointing. To the west of this are the remaining walls of a long structure, whose north-west wall forms the boundary of this courtyard.
