Maes y Mynydd (PRN 1209)
St Davids
North Pembrokeshire

Building Recording Survey

Landsker Archaeology Ltd.
Project 904, 5 March 2009

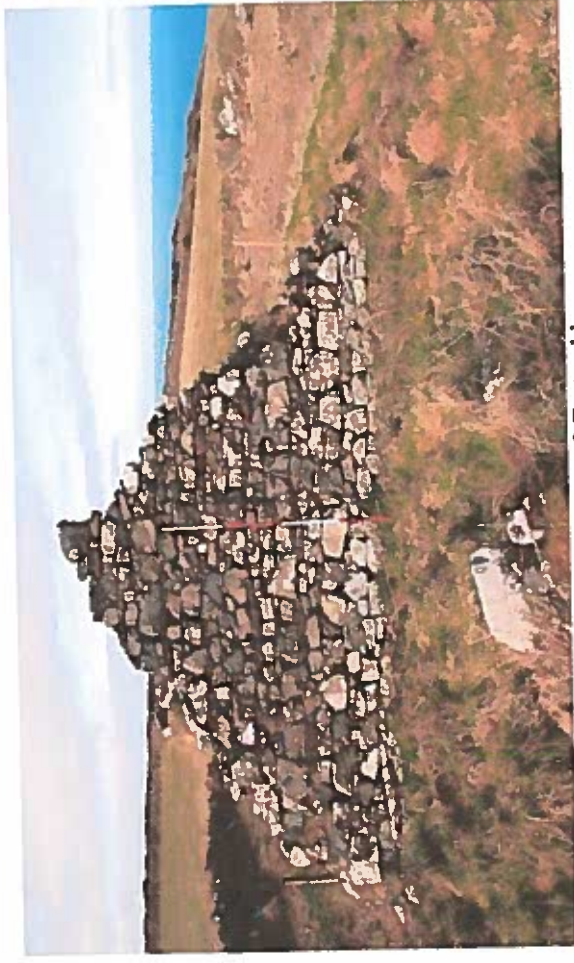
Figure 4 Cottage 2 East gable

This cottage was built onto the east gable of (1). It is also a rectangular structure (9) with a lean-to building(10) to the north. There is an ingle-nook fireplace built into the east gable wall. Nearly all of the chimney has collapsed as has most of the stone corbelling forming the fire hood.

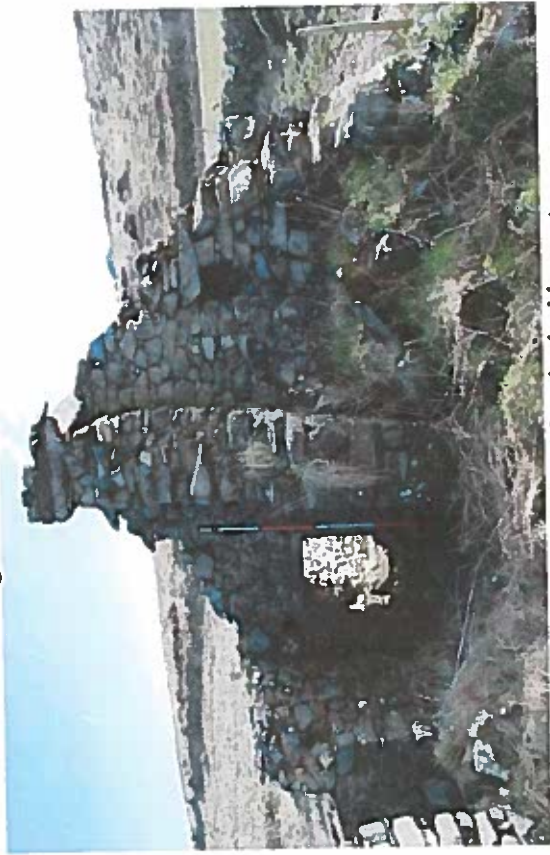
Figure 3 Cottage 1 Interior looking east

The only internal domestic features are two niches (6 & 7), both possibly ovens, set in the south west and south east corners of the building. The south east example lies in the ingle-nook and it is possible that a further one lies in the other corner of the nook, but that it is concealed by the collapsed material.

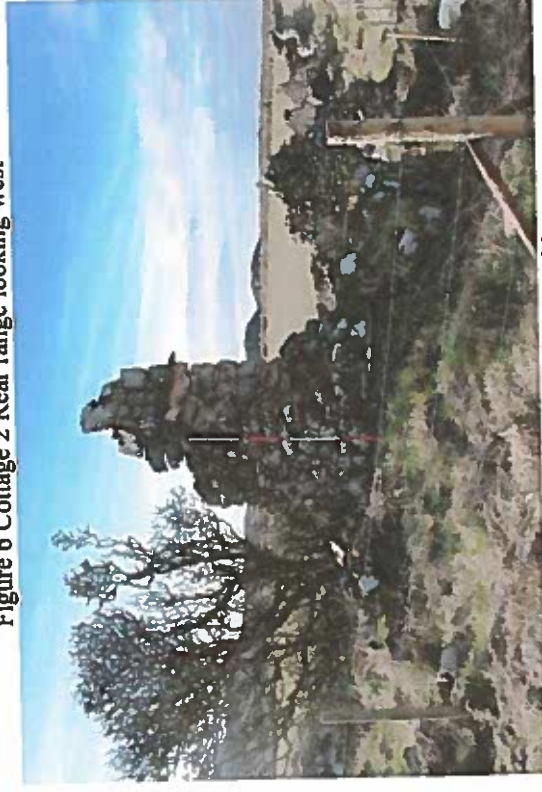
Figure 8 Cottage 3 East gable

The east gable contains the ingle-nook chimney that rises to its full original height on the north side. Slate is set into the north chimney wall to act as a flashing to cast water off the wall/roof junction. The fire hood of the ingle-nook has collapsed bringing down the south side of the chimney. A large pile of stone and slate form the remains of the fire hood which hides any evidence of a niche or oven set into the wall. There is one large piece of wood protruding from the debris which may be the evidence of the supporting beam for the fire hood, although it is rather slender. One curious fact about this is that it is pierced by a series of large circular winding tubes, which may be the result of teredo worms boring through underwater timber. If this is so, then it represents one example of what is claimed to be common in Welsh 18th and 19th century cottages, namely the re-use of timber from ships.

To the north of the ingle-nook wall is a window opening to the east, which has been blocked with stone at a later date. The cause of this blocking must be to do with the rise in the soil level on the gable end of the house. There are many signs of down slope movement of soil against physical barriers on the site, forming lynchets. The floor of the cottage is approximately 1.5m below the present outside ground level, with two cills to the window at 0.80m and 1.23m above this, implying a soil rise of at least 0.3m and probably more since the original construction. There is a trackway running north along a field boundary and by the gable end of the house, with steep ground to the east.

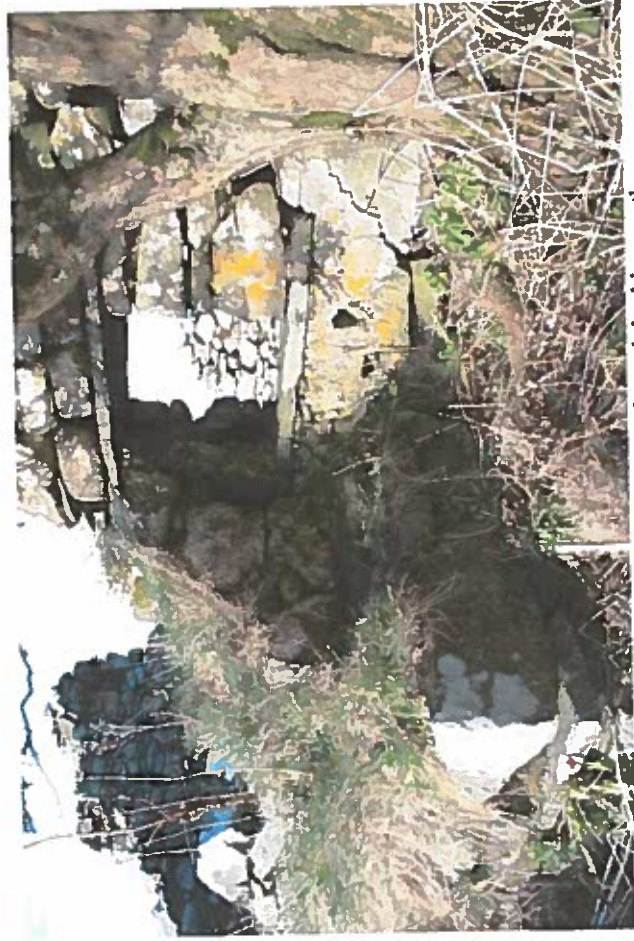
Figure 9 Cottage 3 Window and porch looking north

The south wall contains a central door and two windows to either side. The wall survives to a height of over 1.5m, so the east window retains its cill and lintel and allows details of the splayed window construction to be observed. The window is set in an embrasure with only the upper part open to the outside. The window appears to be intimately connected with the porch structure covering the doorway. The porch (15) contains a plinth around its base that would have acted as a seat around a small sheltered yard onto which the window opened. The porch may have had a sloping roof.

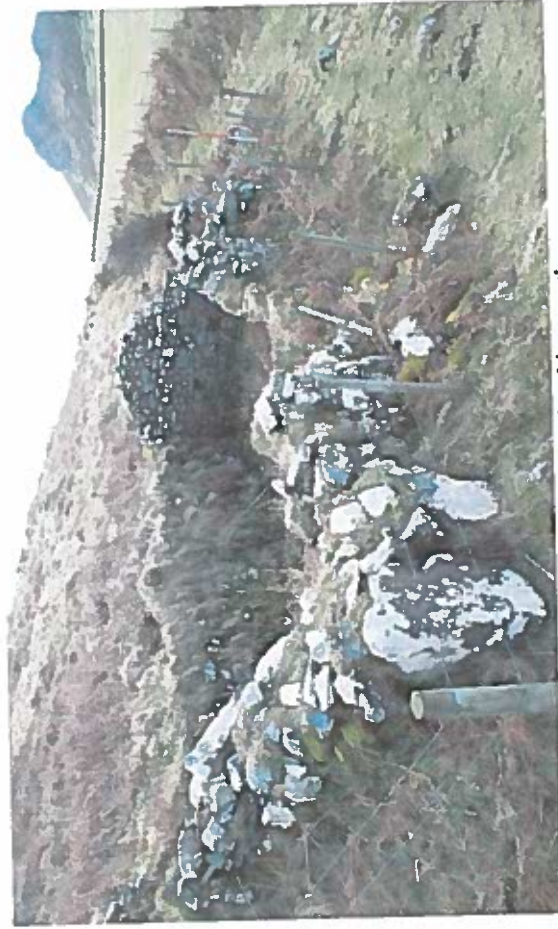
Figure 14 Structure 4 Looking south

The largest structure (4) is a rectangular room set with its axis along the slope, but with the rear wall nearly entirely 1.8m deep into the ground while the front (west) wall is free standing. The west wall contains evidence of a splayed window opening to the north with a possible door opening in the centre, although the wall is very collapsed here. There is also a splayed window opening south of this, with a doorway at the corner of the building.

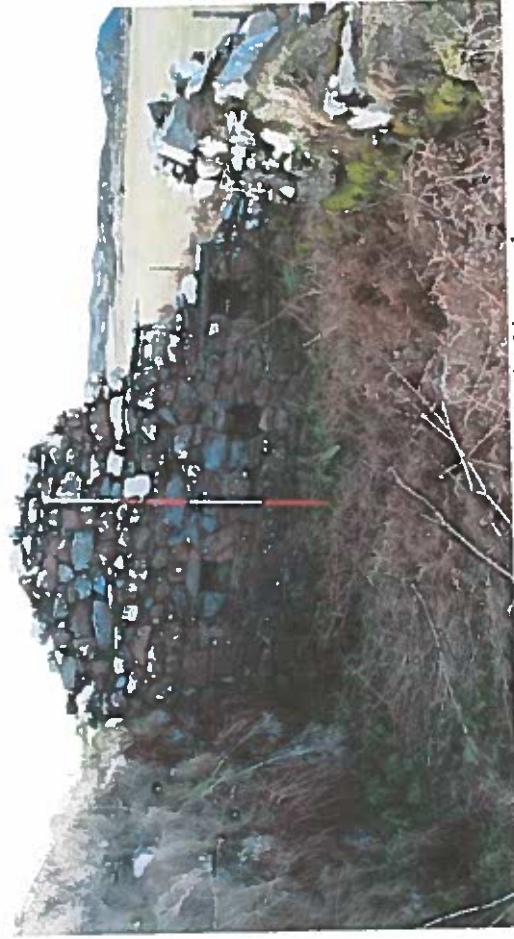
Figure 15 Structure 4 Interior looking south

The interior of the south gable wall contains three niches (19), each approximately 0.25m by 0.3m high and about 0.7m above floor level. The gable above eaves height is set back from the wall by about 0.1m, possibly to support a wooden upper floor, perhaps of crog-loft type.

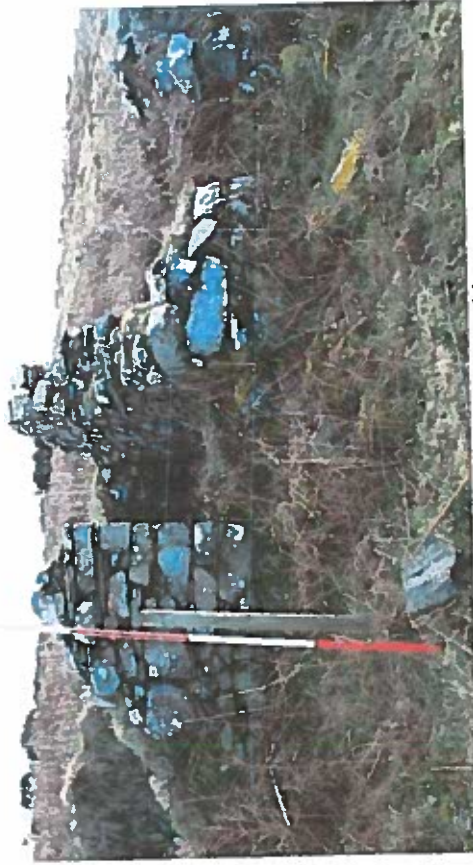
Figure 16 Structure 4 & 20 Looking east

Room (20) is rectangular, but difficult to observe with many tumbled stones and heavy vegetation growth. There is a central door opening to the west.

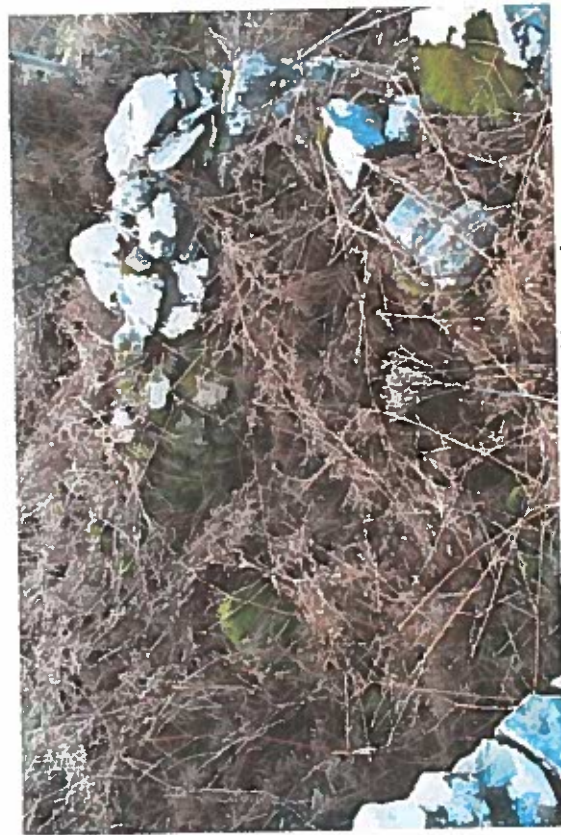
Figure 17 Structure 21 Looking south east

Room (21) is sub-rectangular again with heavy vegetation growth and much disturbance. There is an animal hole in this area, possibly fox or badger. There is an opening to the northwest where the wall opens out around the corner of room (20).

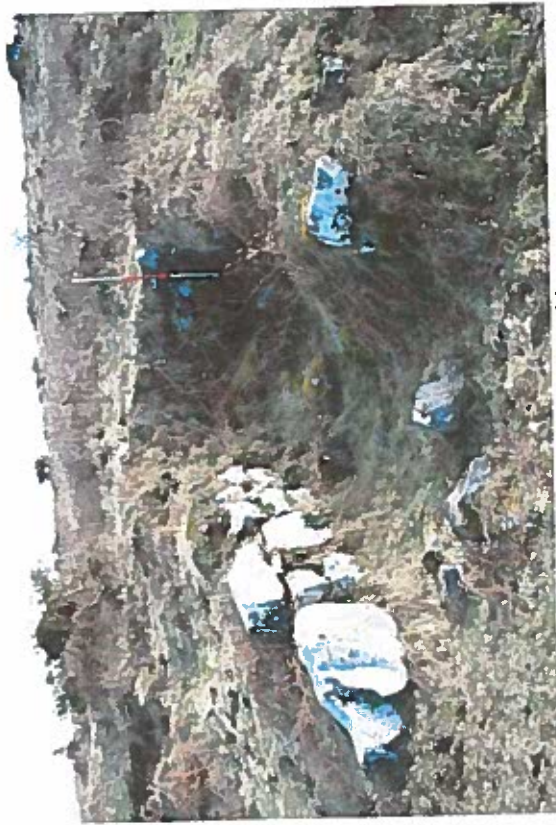
Figure 18 Structure 23 Looking east

Room (23) is a rectangular structure set into the hillside some 10m east of (4). This is sunk into the hillside and appears open ended at the west with walls of large stone and earth. To the north of (3), there is a similar looking area formed of the junction of field boundaries. This has been filled recently with cleared boulders, but it is possible that this is a similar structure.
