Task Description: Bank repair due to erosion Task Code/Plan Reference: FRA19S225/401/PDM Created on date: 08/07/2024 By name: Peter Morgan

FRM System No.: FRA19S225 **Watercourse Name: Llandovery**

NGR: SN 77107 34328 **Location Plan:-Location:** Llandovery Postcode: SA20 0DD

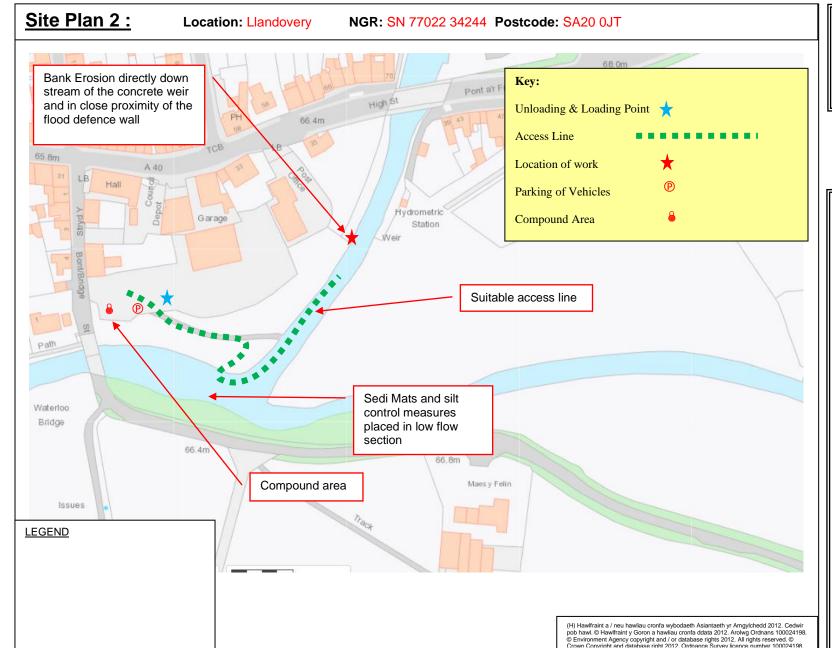
Target condition: Highlighted defect in

AMX

- Prior to entry, Courtesy call to landowners to inform of commencement date
- Unloading & Loading point at Llandovery Bus Depot
- Access for machine via suitable access ramps at confluence.
- 9m eroded section to be repaired with onsite blockstone. 1 to 2 tone block stones
- Terram to be placed behind stones to prevent soil wash out.
- Water levels in the Afon Bran will affect working methods
- This area is subject to flooding
- Parking and compound area to be set up in Bus Depot
- No Machines left in the river overnight
- Sedi Mats and silt control measure placed down stream

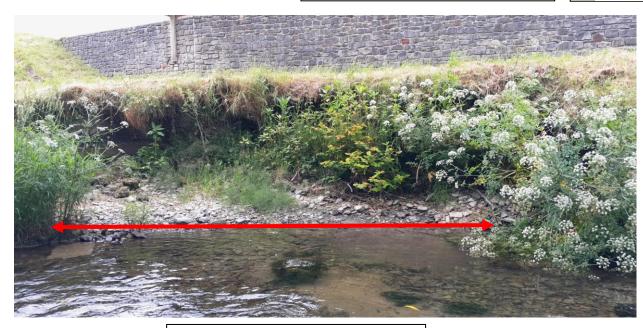
9m long x 1.6m high section eroded

To repair the 9m section with imported block stone material which will prevent further erosion and the threat of undermining of the flood defence wall.

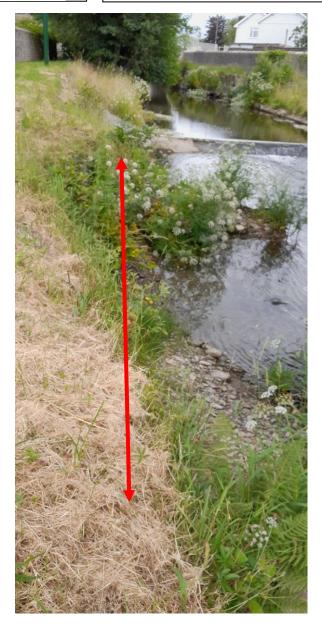
View, looking upstream at the right hand bank, concrete weir and stanchion for the tementry and gauging station on opposite bank.

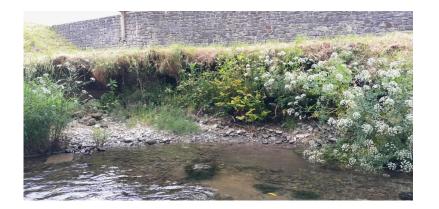
View, looking directly at the eroded pocket. 9m long x 1.6m high.

Natural erosion has taken place following high flows in the past winter months. The bank is not vegetated or protected by imported material and could potentially start to undermine the flood defence wall if not maintained.

The bank is armoured both up stream & down stream.
