## **Tudno Castle Hotel, Vaughan Street, Llandudno**

### Level 2 Building Survey

Report No. 1532

**Prepared For: Tudno Developments Ltd.  
on behalf of Opus Land (North) Ltd.**

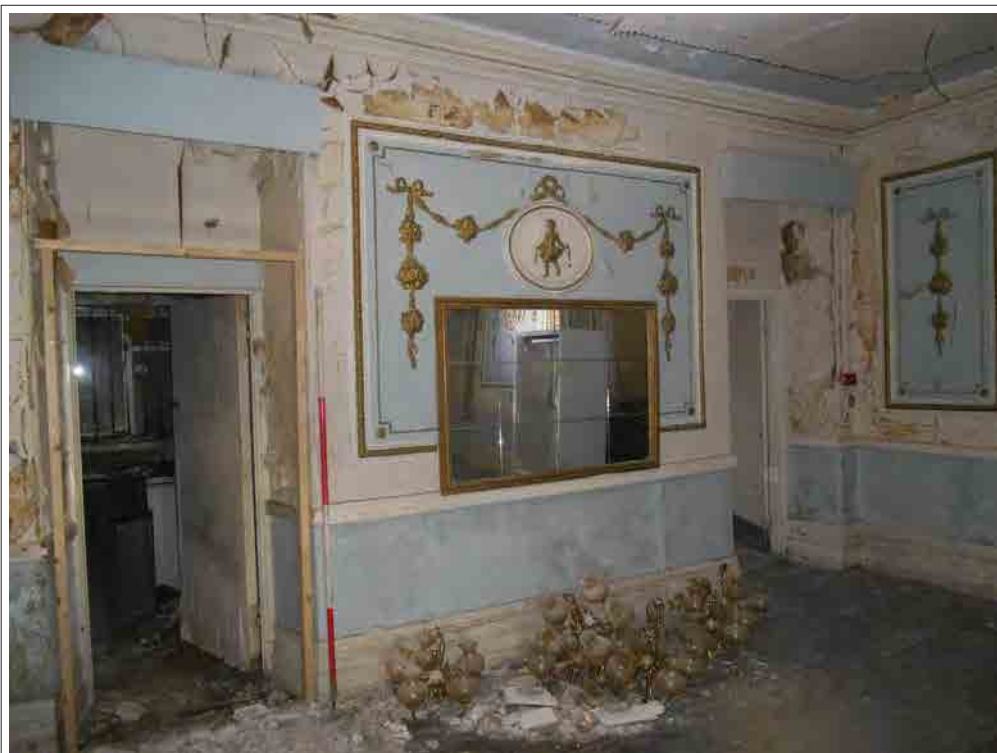
Plate 18. View of altered wall. Fireplace replaced for panelled wall. Looking E.

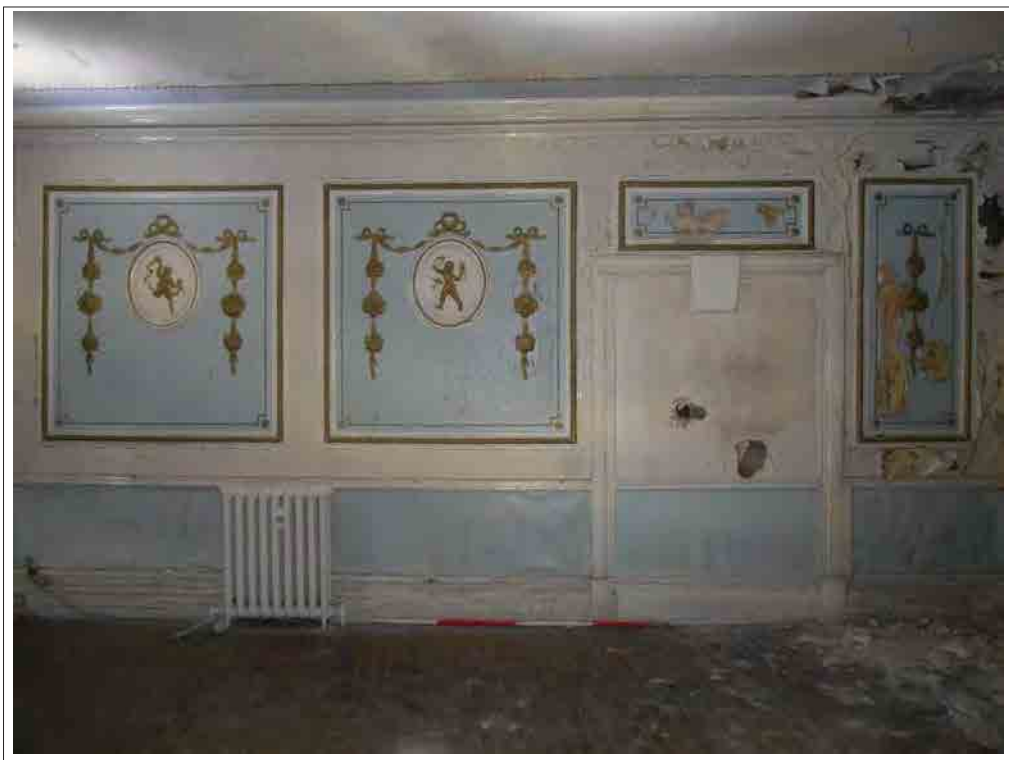
*Plate 19:* This photograph illustrates another even of alteration within the ballroom area. In contrast with the alteration described on Plate 18, this event seems to postdate the decoration found on the wall. On this occasion, a doorway appears to have been blocked and subsequently decorated to follow existing patterns on the wall. This suggestion gains support by noting that the chair railings and skirting boards used in this area are of different style than those used elsewhere.

Plate 19. Blocked door, subsequently decorated, looking N.

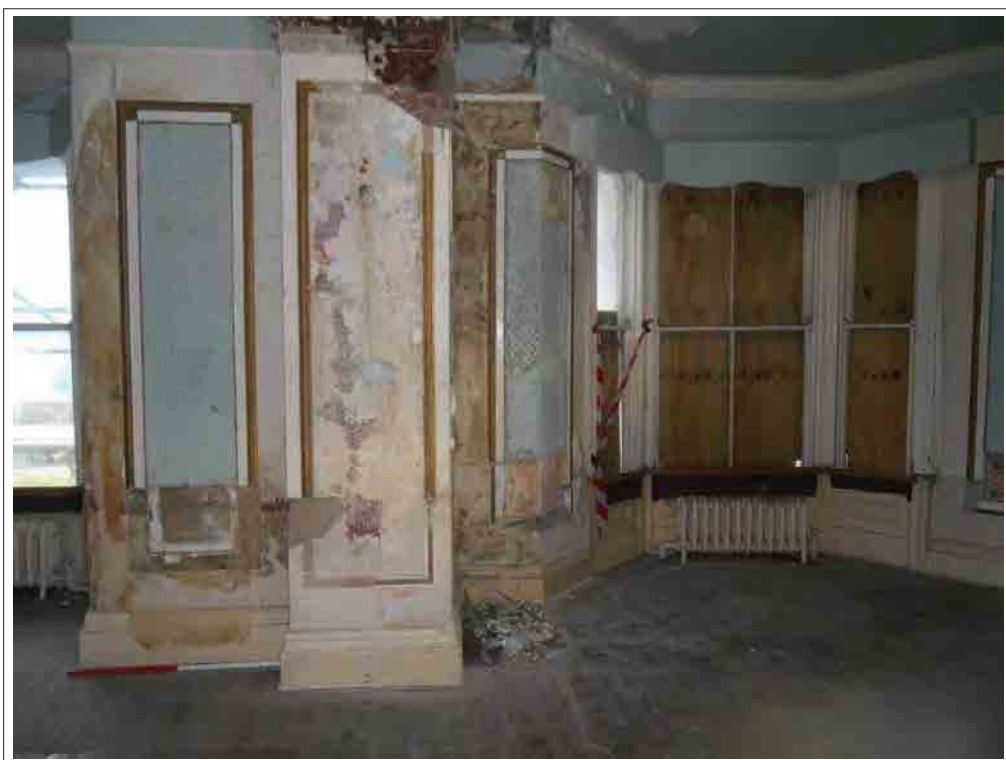
*Plate 31:* The decay of some of the decoration found within the bar area allows documenting earlier decoration events. Before painted following rococo style, the rectangular panels found on walls appear to have been covered with wall paper with floral geometric patterns. Moreover, this image also illustrates the existence of panel mouldings under canted three-light windows and scalloped curtain mouldings. A similar situation is portrayed in Plate 32 and 33.

Plate 31. Projected wall evidencing different layers of decoration. Looking NW.

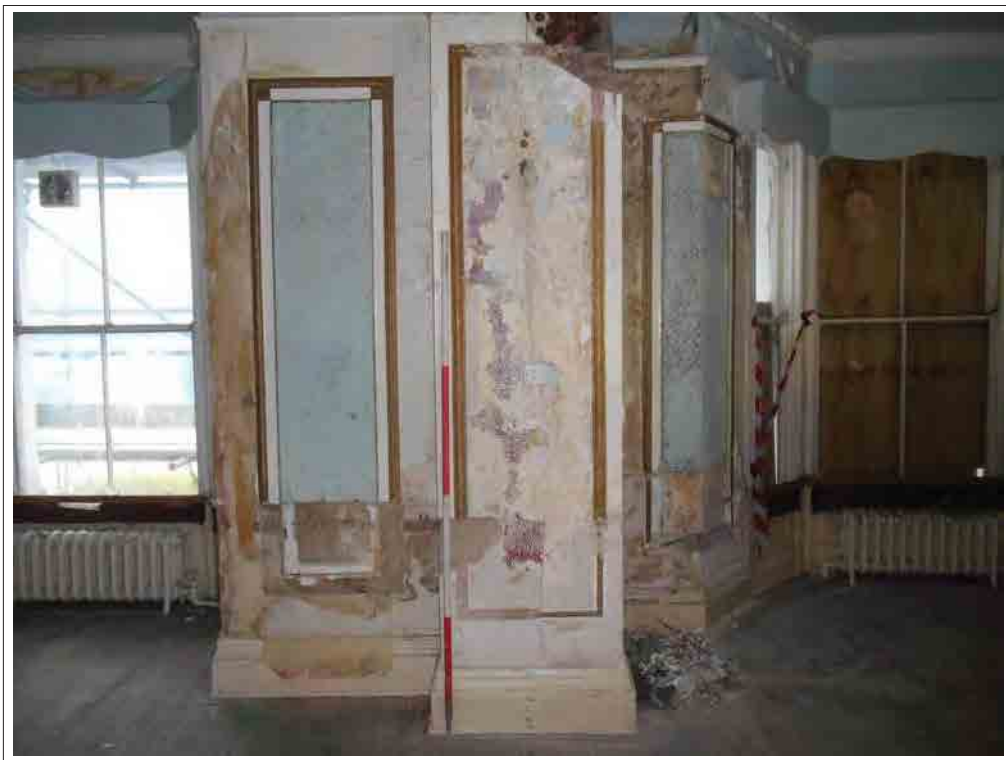
*Area A (Plates 32 and 33):* As already noted, this area appears to respect the general decoration encountered throughout the ground floor. However, it is noted that, in contrast to the ballroom and bar, this area contain the characteristic rectangular panels on the walls without any further decoration within the panels. Moreover, similarly to that stated in Plate 31, resulting from decay, it is possible to observe previous decorative episodes characterised by wall paper floral geometric patterns.

Plate 32. Projected wall evidencing different layers of decoration. Looking NW.

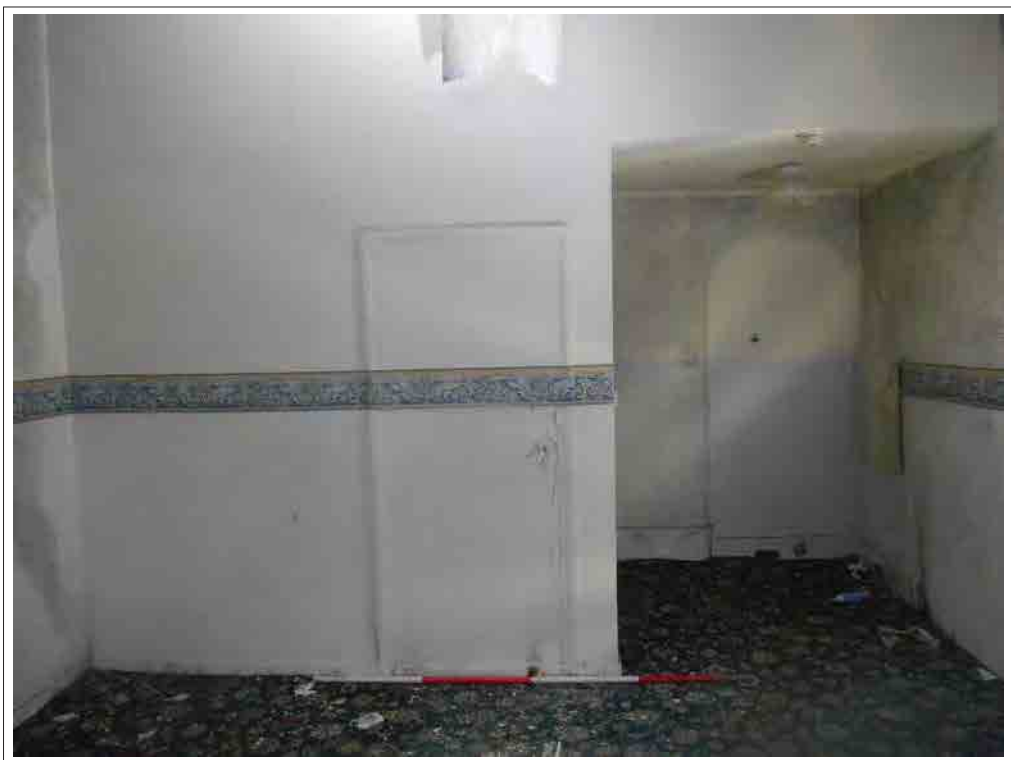
Plate 43. Blocked doors predating current wall decoration, looking SE.

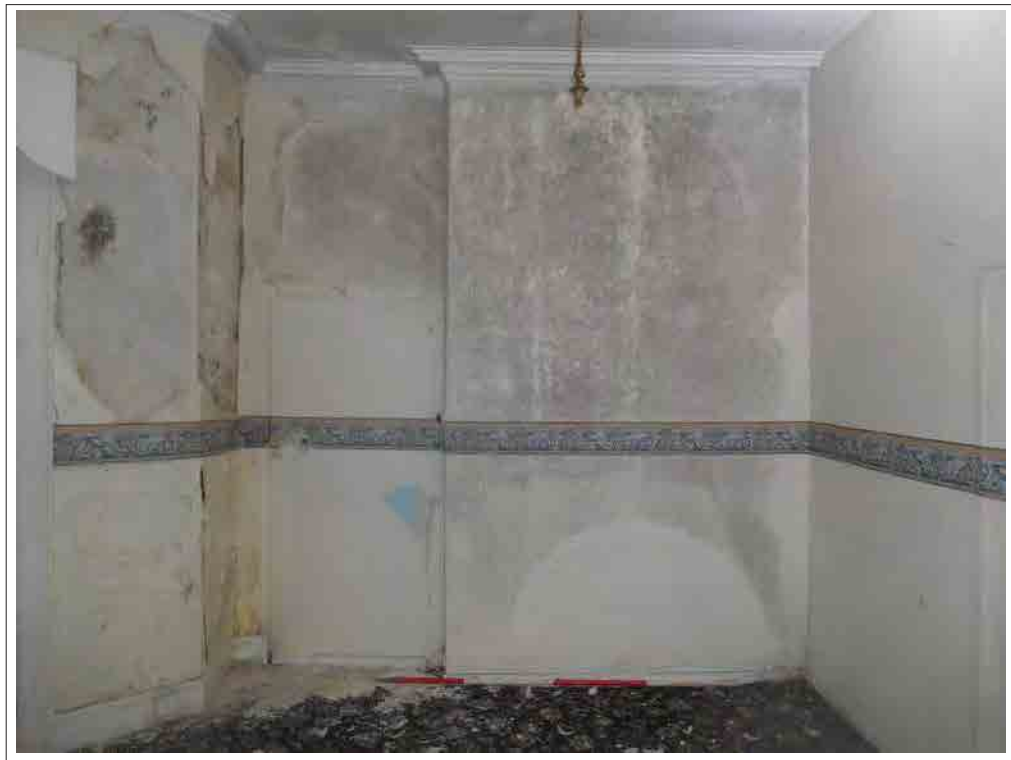
Plate 44. Blocked door predating current wall decoration, looking E.

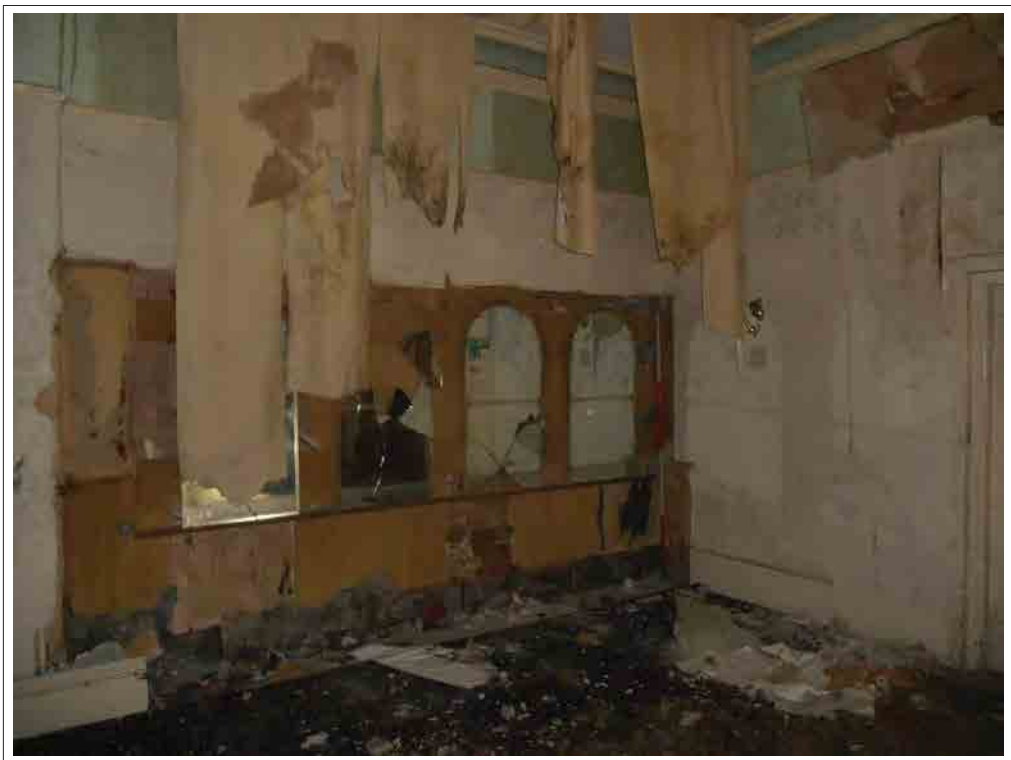
*Plate 50 and 51:* These images depict earlier decoration and original structural components displayed as result of decay. Plate 50 illustrates the existence of earlier floral patterned wall paper and Plate 51 displays the walls original brickwork.

Plate 50. Detail of wall paper and mirror decoration, looking ESE.

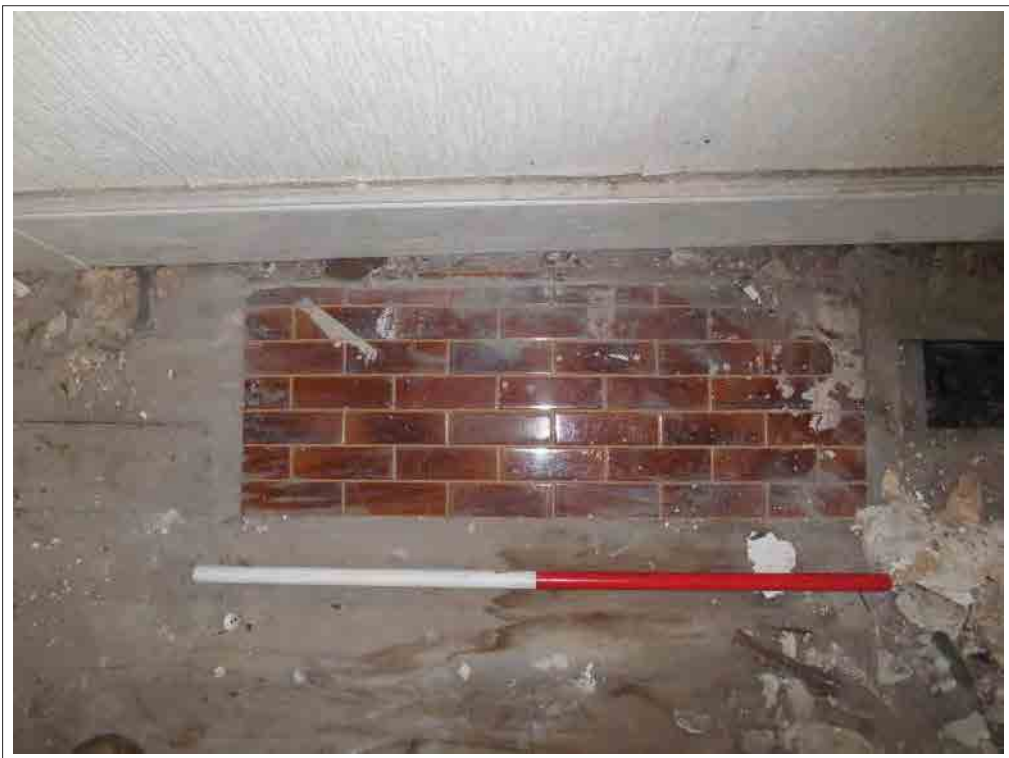
Plate 63. Remaining evidence of original fireplace. Room 5, looking S.

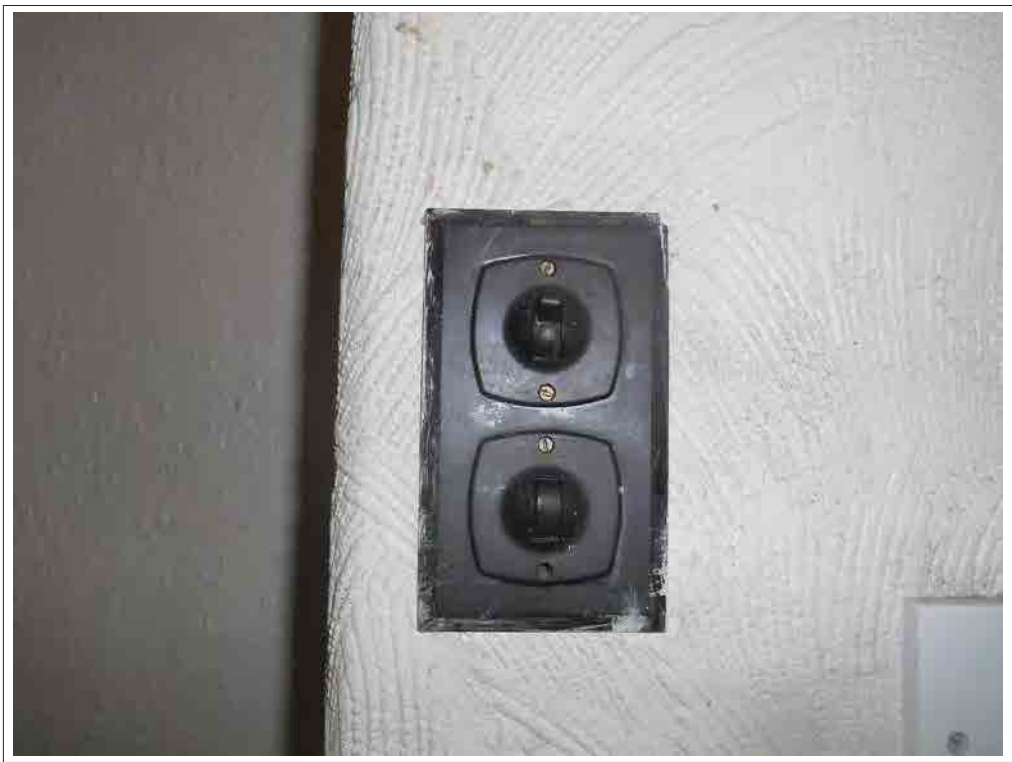
All electrical fittings observed in this floor postdate the 1960s. Nonetheless, a light switch dating to the late 1930s and one dating to the late 1960s were identified in Room 6 (see Plates 93 and 94).

Plate 94. Detail of electrical fitting from Room 6, looking S.

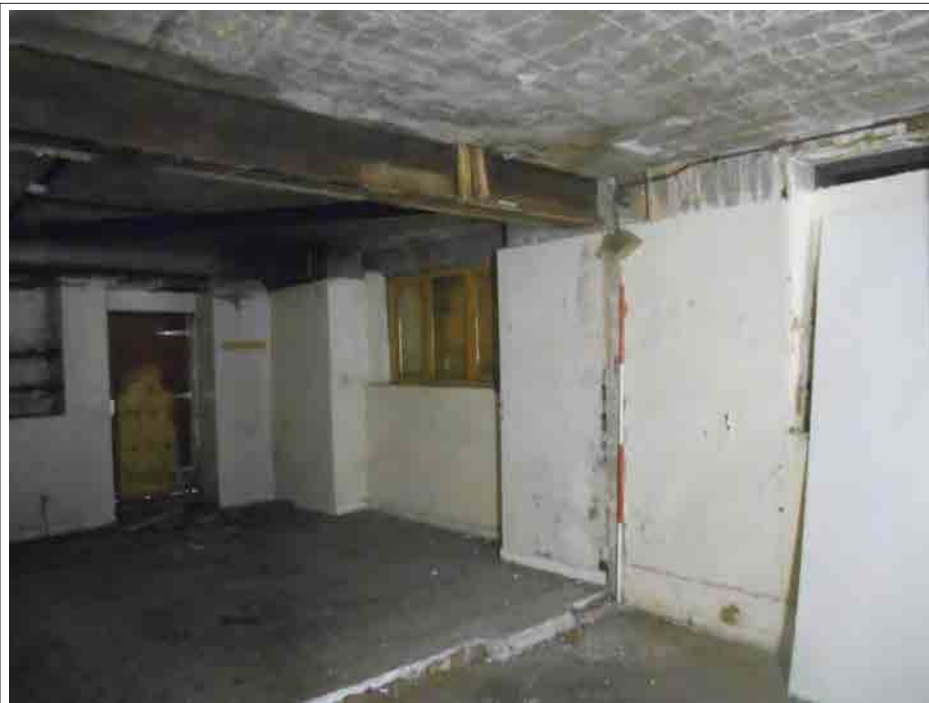
Plate 135. East facing wall. 1960's Window subsequently repaired. North facing wall with back entrance. Not original. Scale 2m

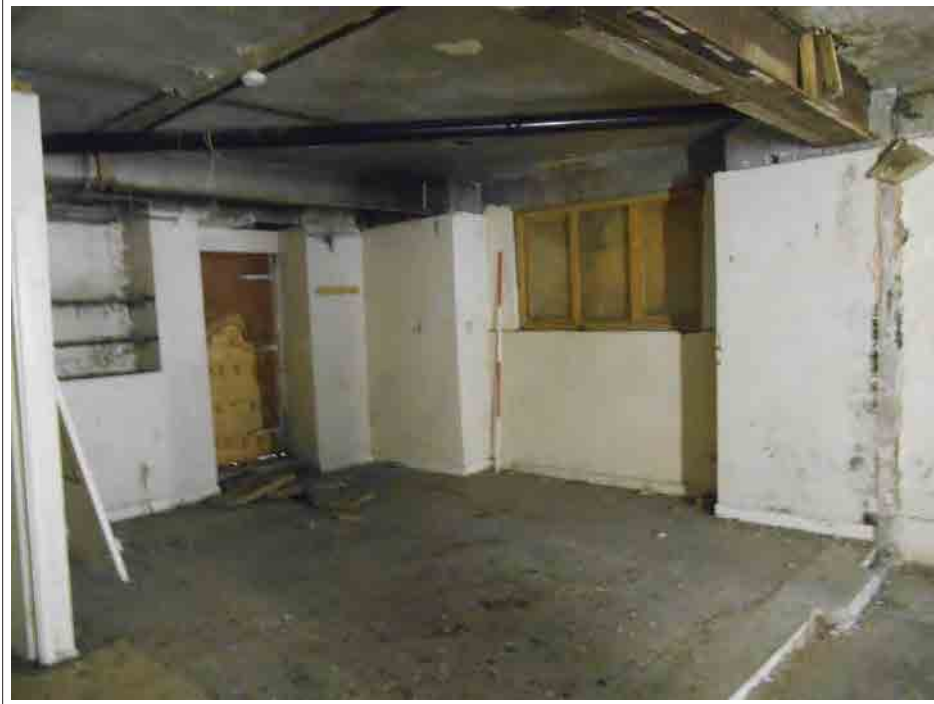
Plate 136. East facing wall. 1960's Window subsequently repaired. North facing wall with back entrance. Not original.

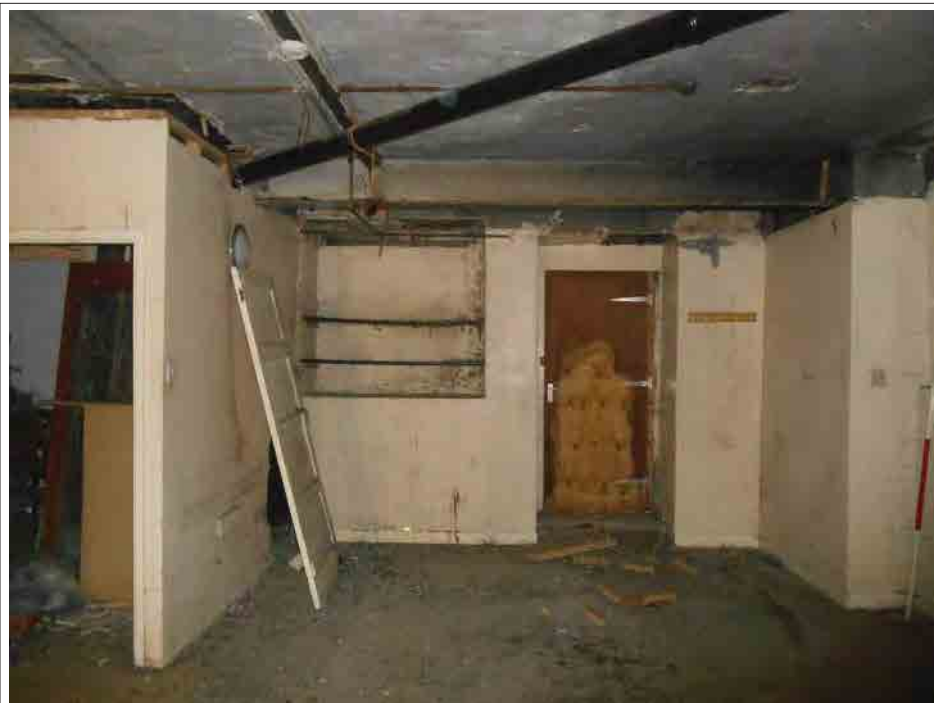
Plate 137. North facing wall. Inset blocked window transformed into shelving.

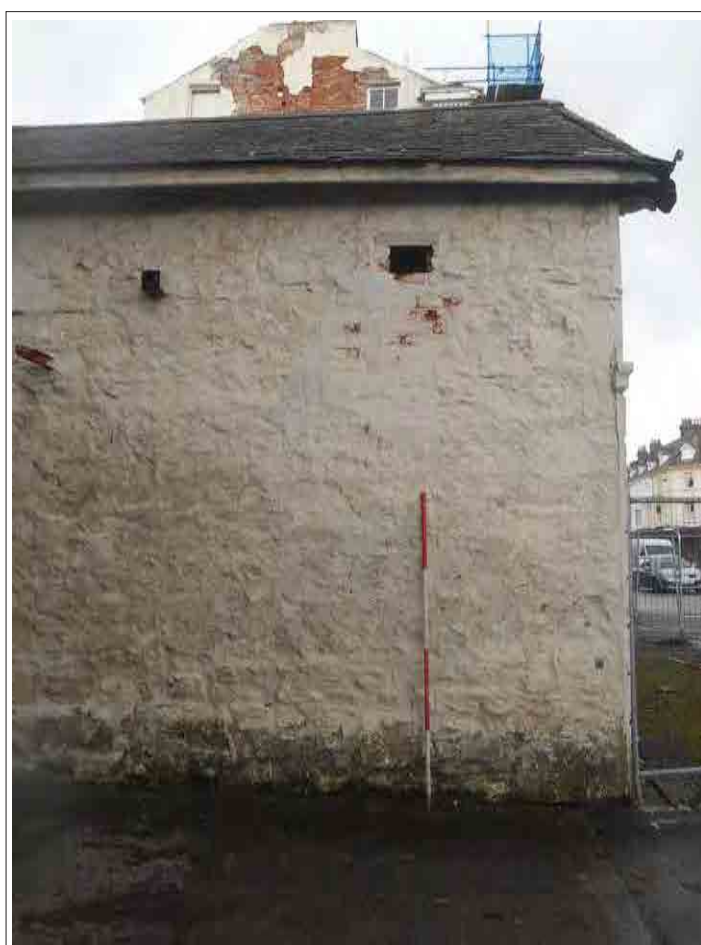
Plate 149. Detail of repair or alteration of possible window or vent.
