TRE'R CEIRI
CONSERVATION PROJECT
1989 - 90
PART 1: TEXT

REPORT ON THE FIRST SEASON OF THE
TRE'R CEIRI CONSERVATION PROJECT
DECEMBER 1989 - MARCH 1990

S.D.BOYLE

GWYNEDD ARCHAEOLOGICAL TRUST LTD.

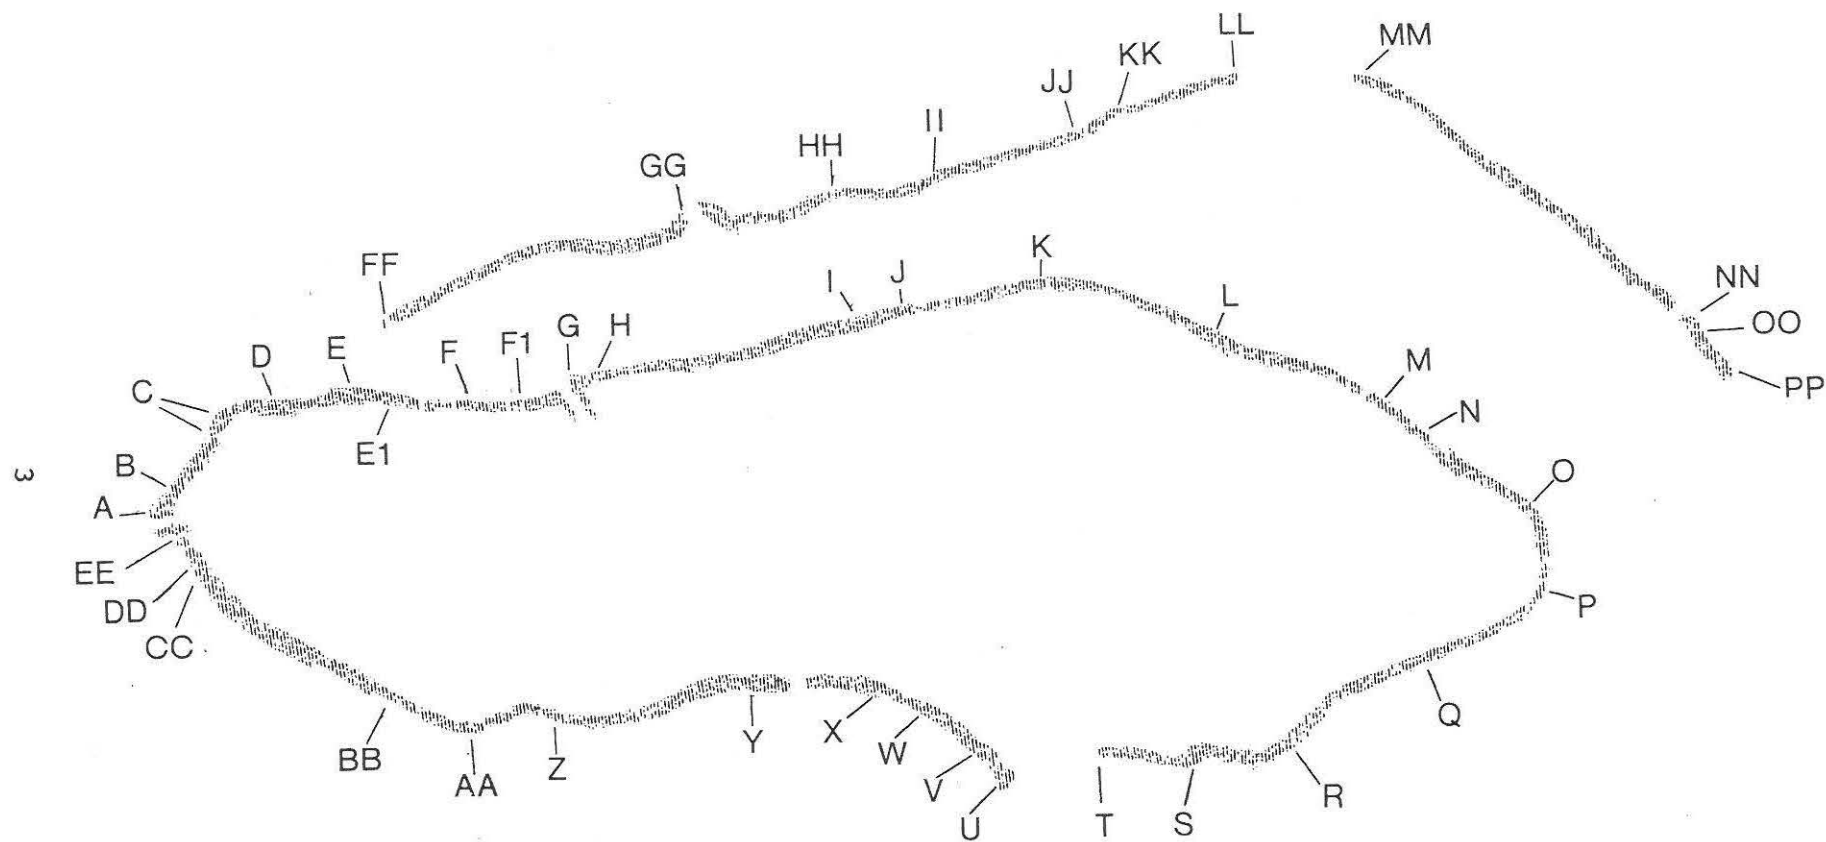
Fig. 2. The Ramparts: points of collapse (after Dallimore 1978).

Dallimore recorded ten points on these stretches of rampart where collapse had occurred. Most of these gaps were readily identifiable, and in general they did not seem to have deteriorated greatly in recent years. However, Dallimore recorded only the outer face of the wall, and made no mention of the inner face, parts of which had also collapsed. Furthermore, at a number of points on the outer face several smaller spills, not recorded by Dallimore, were noted. From the weathered nature of the exposed stones it appeared that at least some of these spills had developed by 1978. For the purposes of the Conservation Project these were identified by adding a suffix to the letters used by Dallimore: thus spill 'F1' was between Collapse 'F' and Collapse 'G', and 'E1' was between 'E' and 'F'.

In the first season, three areas of collapse were repaired ('E1', 'F1' and 'N' on Fig. 2). A start was also made on the north postern (Dallimore's Collapse 'M').

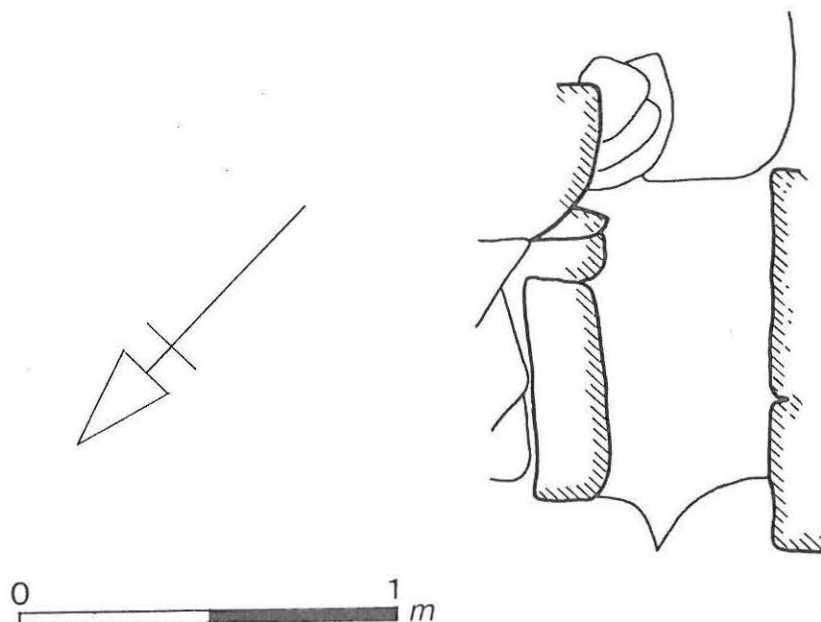
Fig. 7. Hut 86, entrance passage cleared.

The entrance (Fig. 7) was cleared of rubble, and both jambs were uncovered. The E jamb had tilted inwards, and was pushed back. At the inner and outer edges of the entrance flat slabs underlay the walls (the inner one is visible on Plate 5). Between these part of another slab was noted within the passage, 100mm lower down. This was not fully uncovered, but it may be that this hut has a foundation of some depth. Small stones were used to level up the entrance passage (Plate 5).

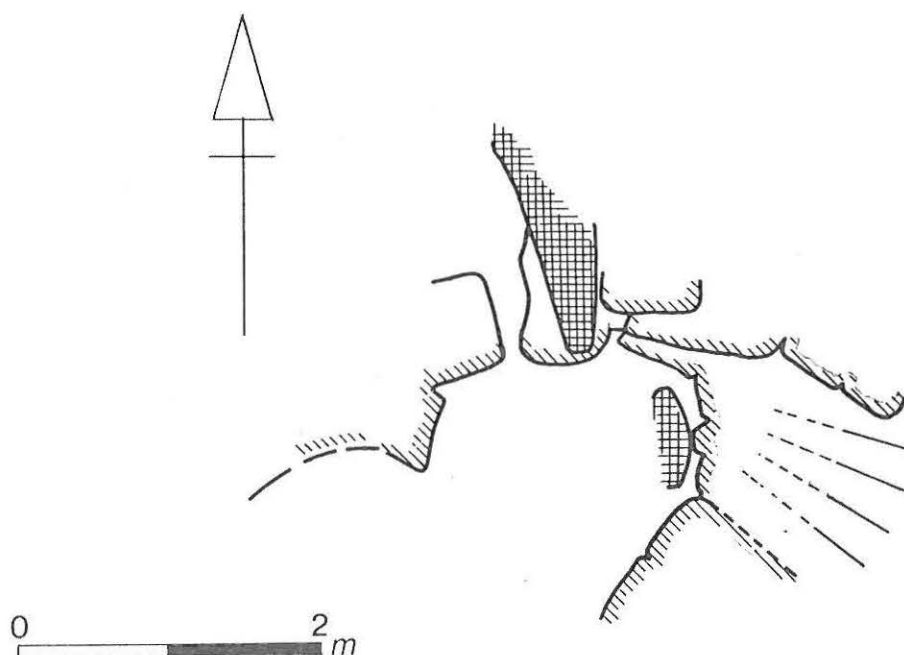
Fig. 12. NE end of hut 92, showing *in situ* facing stones. Cross-hatched stones are edge-set.

It must be emphasised that apart from the possible step at the inner end, there was no evidence that the passageway was originally paved or stepped in any way. Indeed, it is open to question whether the entrance was an original feature of the hut. It is not shown on Hughes' plan (Fig. 3), and clearance of the

debris from the passage produced no evidence of any facing on its S side, in which the core of the SE wall of the hut was clearly visible (Plate 34, bottom right). It would certainly seem that the entrance was at least widened at some point but not refaced. The exposed core in this S wall of the passage seemed to be stable and no attempt was made to build a face, but it will need to be monitored for signs of deterioration during future phases of the Project.

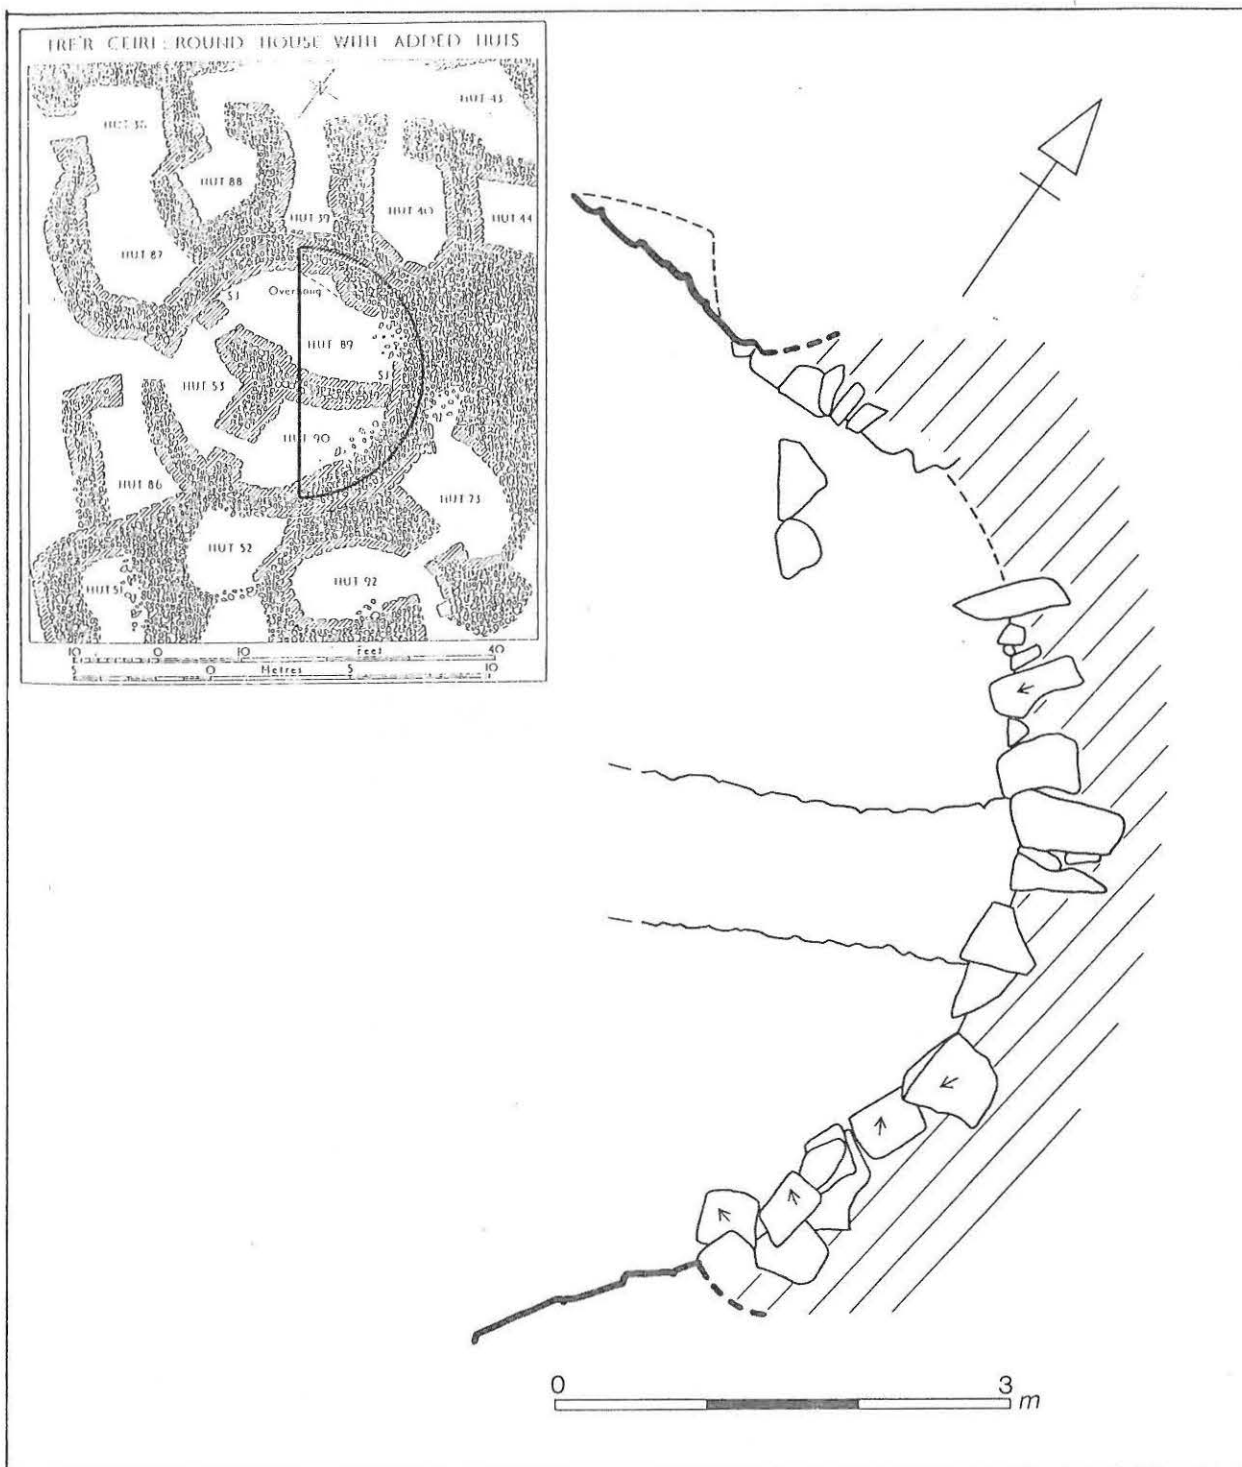
Fig. 17. Rear of roundhouse 53/89/90, showing surviving foundations.
Bold lines indicate standing wall.

The rear of huts 89 and 90 had almost completely collapsed. Only two *in situ* stones, supported by the end of the partition wall remained visible to indicate the original line. The rubble was peeled away in 'spits' so that any buried faces would be recognised in plan. In hut 90, at the very bottom of the rubble a line of large stones, most having roughly flat faces, was uncovered (Plate 83 and Fig. 17). Although these stones do not appear on Hogg's plan, there was no reason to doubt that they were indeed the footings of the roundhouse wall, albeit slightly displaced.

Rather less evidence for the wall was uncovered in hut 89 (see Plate 84 and Fig. 17). Immediately E of the overhang a length of masonry 1.5m long and two courses high was uncovered, as planned in 1956. To the E of this there was a gap of approximately 1.0m, with no hint of a face. One more stone was then found, protruding from the core about 0.5m above the (presumed) floor level, its tip approximately on the supposed wall line, and E of this was a second large stone, lying at an angle. There was thus a gap in the foundations approximately 2.0m wide. Nevertheless rebuilding the wall along a curve projected from the sections which did survive seemed justified. In the first place it is most unlikely that there was originally a gap in the wall here: the ground

behind the hut rises steeply and would not have been a suitable place for an entrance (of which there was in any case no evidence). Secondly, the surviving portions of the hut wall display masonry of a high quality: if it is accepted that the rear of the hut was closed off in some way, it is improbable that the builders would have been satisfied with anything other than a faced wall. Finally, one of the objectives of the Project was to block off the pathway which had been worn across the tumbled stones: building a wall would have the benefit of securing the surviving masonry to either side of the gap.

One final feature uncovered during clearance of the rubble must be mentioned. Close to the N wall of the hut, at a level just below the basal course of that wall, were two large stones, with flat upper faces (Plate 85 and Fig. 17). Mention has already been made of the wall across this hut which was removed during the excavations of 1956. Hogg (1960, 34) assumed that it had been built by the excavators of 1903, pointing out that it 'falsified' the shape of the roundhouse. The stones uncovered in 1989 may have been the foundations for this wall, but if the excavations of 1903 reached this depth, it is curious that they laid out the back wall on such a line, for they can hardly have failed to notice that the N wall continued further to the E (see Plate 85). This raises the possibility that the wall removed by Hogg was in fact a partition contemporary with the occupation of the hut, or at least that the 1903 excavators built their wall on top of the foundations of an earlier one. The temptation to explore further was resisted, however, and the stones have been covered over, undisturbed.

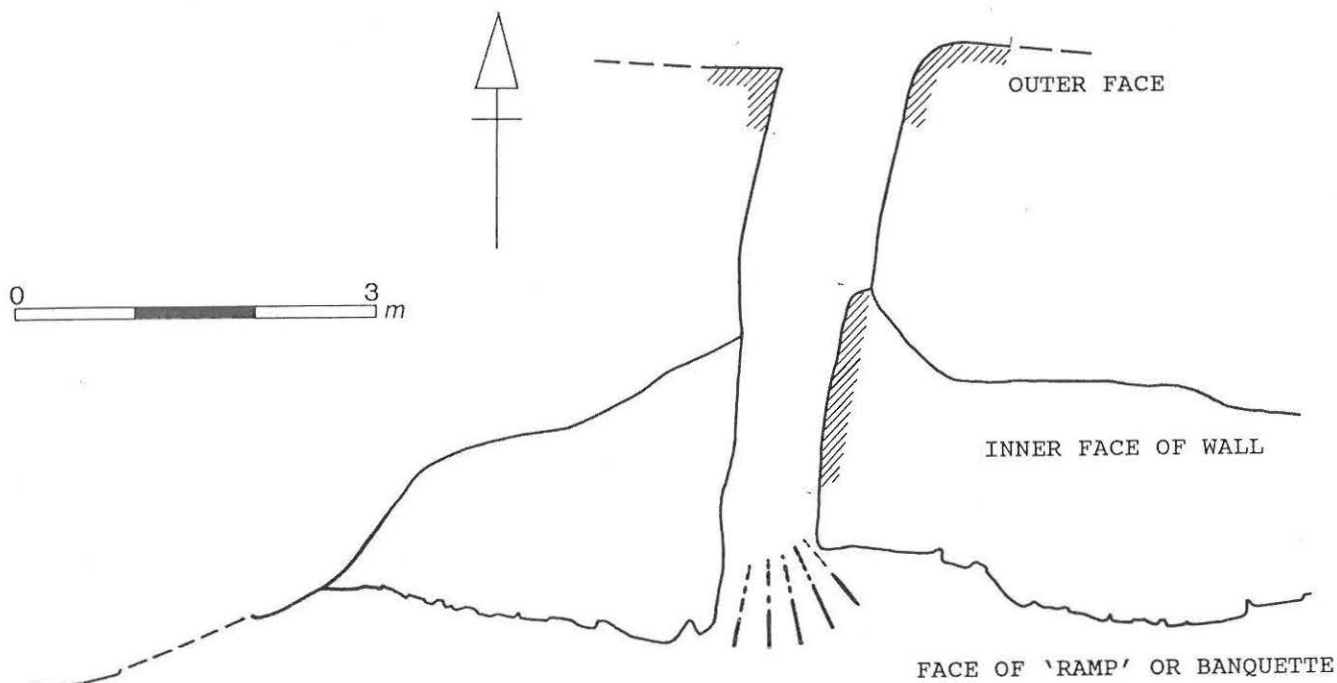
Fig. 19. North Postern, showing wall lines. Areas dismantled and rebuilt are hatched.

It soon became clear that, behind the rubble obscuring the 'ramp', the inner face of the rampart survived, curving in towards the entrance passage (Fig. 19 and Plate 102). As clearance of the passage progressed, this facing became visible in the E side of the passageway (Plate 103, behind the scale) butted by the 'ramp'. No convincing surface was found to indicate the original height of the 'ramp', but rubble was removed to the level of its facing, leaving the inner face standing two courses high on the E side of the passage, but up to 1.0m on the W side (Plate 104).

was holding the sides in place. There was a particular severe bulge towards the inner end of the E side of the passage, where the face of the lower banquette threatened to collapse (Plate 112). It was necessary to dismantle a 1.8m length of this face, from the junction of the inner face with the lower banquette to just short of the inner corner of the passage, as indicated on Fig. 19 (compare Plates 113 and 114). The core material behind this face was also removed in order to provide a sound platform for rebuilding, revealing the original inner face of the rampart (Plate 114, to left of the scale).

As with the outer E corner of the passage, no attempt was made to ensure that the original stones were returned to their original positions, though in the passageway more emphasis was placed on simulating the original style. There has been much discussion of this at site meetings, during which it has emerged that as in the case of the lintel there was a failure in communication between Cadw and those on site. Since then careful attention has been paid to ensuring that stones are replaced in their original position.

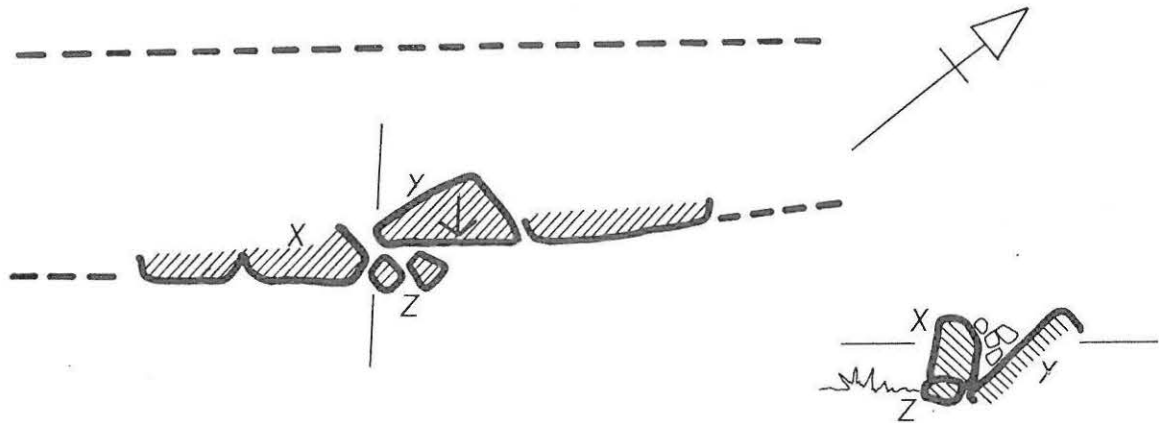
Fig. 21. Collapse 'E1'. Plan and section showing change in wall line.
Sketches only, not to scale.

37m SW of the W gateway, a short length of the inner face had collapsed (Plate 129). As the tumbled stones provided easy access to the wall top, and as the area of collapse seemed likely to widen if this access was not blocked, it was decided to clear away the rubble and rebuild the face.

Once the rubble was removed it was clear that there was a change in the alignment of the wall here (see Fig. 21 and Plates 130 and 131). In Fig. 21 the face of stone 'Y', was set back from the line running NE to stone 'X'. In front of this were two stones ('Z') which appeared to be *in situ*. As stone 'Y' had a sloping face, it seemed likely that these two stones had been placed to provide a foundation for the wall face, and the wall was therefore rebuilt on top of them. The result is shown in Plate 132. Further to the SW enough of the basal course of the wall survived to indicate the original line of the wall, and the loose rubble lying at the foot of the wall was used to build the face up to the height of the masonry to either side (Plate 136).
