TRE'R CEIRI
CONSERVATION PROJECT
1990
PART 1: TEXT

REPORT ON THE SECOND SEASON OF THE
TRE'R CEIRI CONSERVATION PROJECT
JUNE - NOVEMBER 1990

S.D.BOYLE

GWYNEDD ARCHAEOLOGICAL TRUST LTD.

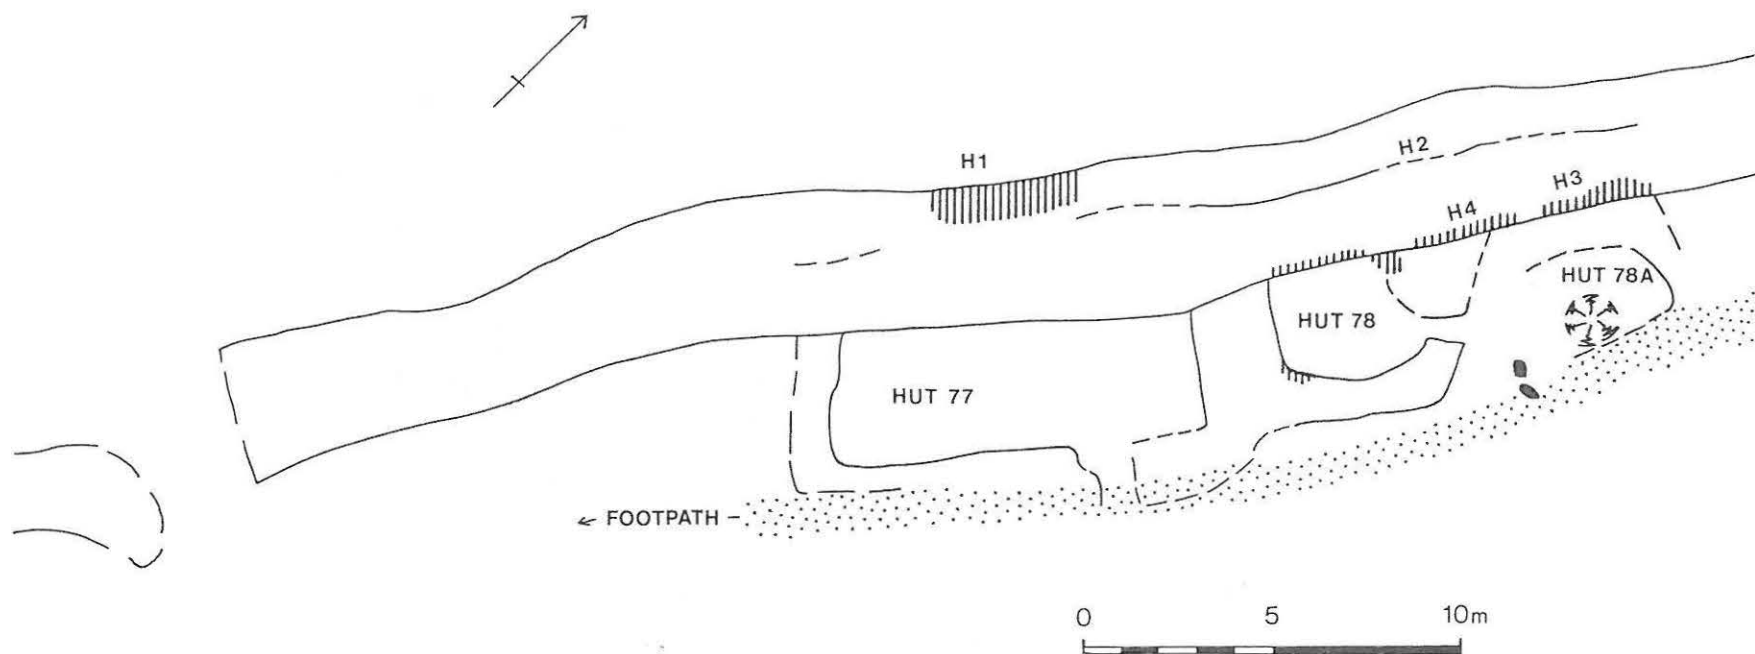
Fig. 4. Huts 78, 78A and adjacent main wall, showing areas conserved.

Conservation work was required at three main points within the hut. The north corner had collapsed totally, and from the unweathered surfaces of the rubble, it would appear that this had happened recently. Dallimore recorded this collapse in 1978, but it was not mentioned in 1946 by Griffiths. Dallimore noted that the south corner had also collapsed, but this had since been rebuilt. The rebuilt masonry, however, was unstable and was dismantled and replaced. The final area requiring major conservation work was the upper part of the north-west wall, which was loose and in need of strengthening. Details of these works are given below. Otherwise the walls appeared to be in good condition. Parts of the outer face on the south-east side had spilled onto the pathway and these were replaced to protect the remaining masonry, although no attempt was made to rebuild a neat face. At the same time occasional large stones lying loose on the top of the hut walls were rearranged to prevent them falling off. Finally, two holes dug in the hut floor, presumably by treasure hunters, were filled in.

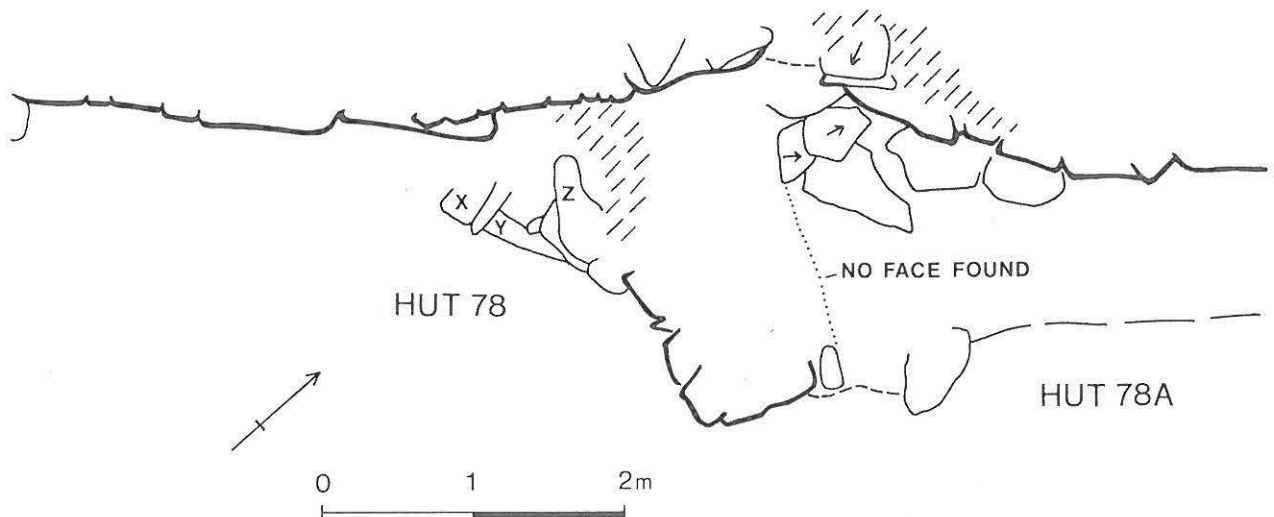
Fig. 5. North corner of Hut 78 and Collapse H4.

This corner had collapsed completely, leaving a pile of loose small core material (Plate 15). Removal of the rubble revealed two possible lines for the wall face (see fig.5 and Plate 16). At ground level a line of three stones (X-Y on fig.5) set firmly into the ground suggested a wall 'smoothing out' the corner of the hut, while 0.5m above stone Y one large slab protruding from the core (stone Z) provided slight evidence for a 'squared' corner. The former appeared slightly more convincing, but the line of stones stopped short of the north-west wall of the hut, the face of which bore no evidence that a wall had once abutted it, and moreover there was not enough rubble within the hut to account for a collapsed wall on this line.

The rubble was cleared away (Plates 126 and 127) and large solidly set stones were uncovered which provided a convincing, if irregular, line for the main wall (shown bold on fig.5). In front of this line was a confused mass of stones, but no trace was found of the facing to the hut wall. The quantity of core

As there was insufficient evidence to determine the shape of this corner an attempt was made to adapt the technique of 'rough-racking', used in the conservation of mortared walls where original masonry has been lost. The aim here was to suggest an exposed core without defining the position of the wall face, while at the same time providing support for the original masonry behind and above. A revetment of small stones was built, starting behind the line X-Y and sloping backwards to meet the standing masonry at the top of the wall. To ensure the stability of this structure stones were angled down into the core. The result is shown in Plate 17.

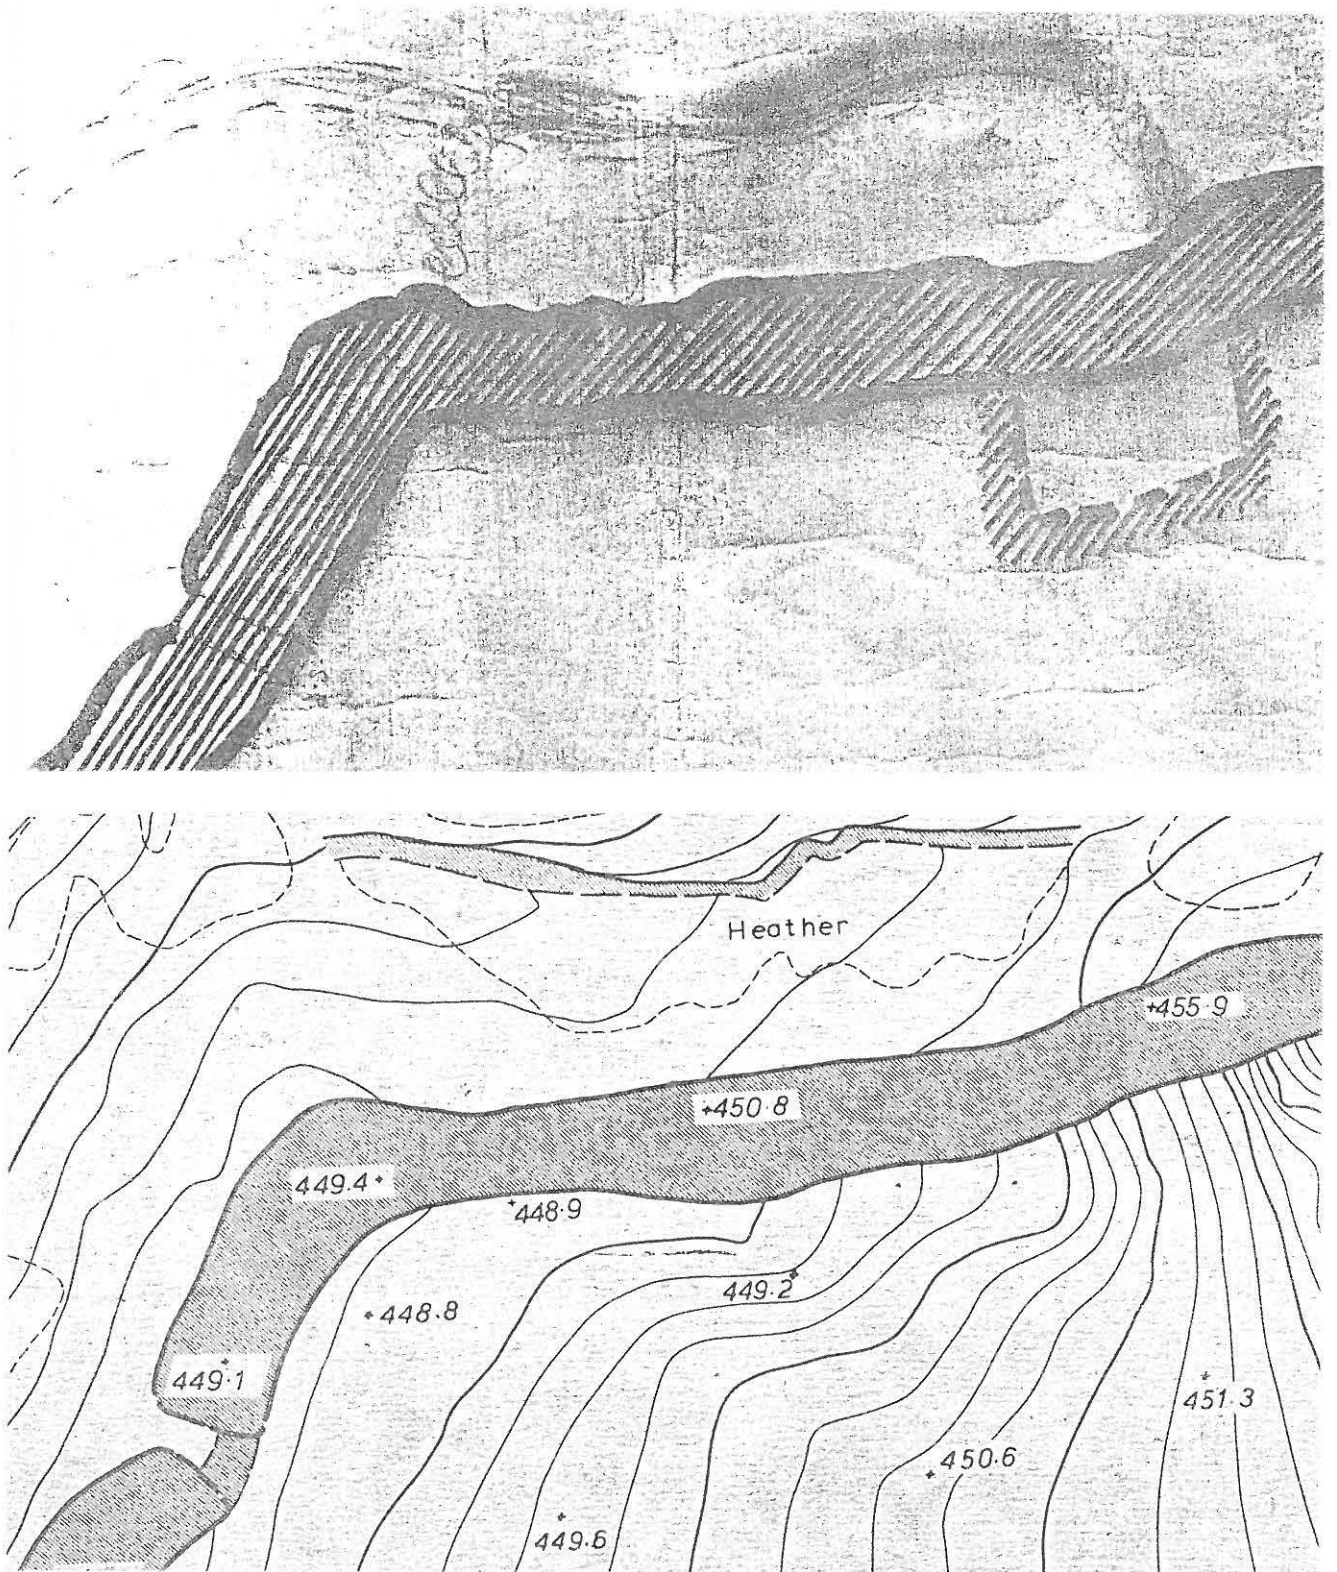
Fig. 6. The west corner of the main wall, surveyed (top) by Hughes ca. 1906, and (bottom) by Plowman Craven in 1980.

At the west corner of the wall the outer face bulged out by some 0.75m, giving the appearance of a corner 'turret'. This bulge is smoothed out on both the RCAHM plan and the Plowman Craven survey, but is clearly shown on Hughes' plan (see fig.6). Griffiths makes no mention of any collapse here, remarking only that 'the wall is thickened to 14 feet (4.27m) at the west corner'. Dallimore makes a brief note of a collapse 3.0m wide.

Before conservation it was clear that the 'turret' appearance was at least partly due to the wall face having slipped forward, opening up a void in the outer face where the 'turret' met the wall to the north-east (Plate 29, left of centre). The wall had not totally collapsed: roughly coursed masonry survived to a height of 0.6m above the scree/tumble at the centre of this stretch, above which was a further 0.6m of displaced and loose stones (Plate 30). At first it was hoped that only this displaced

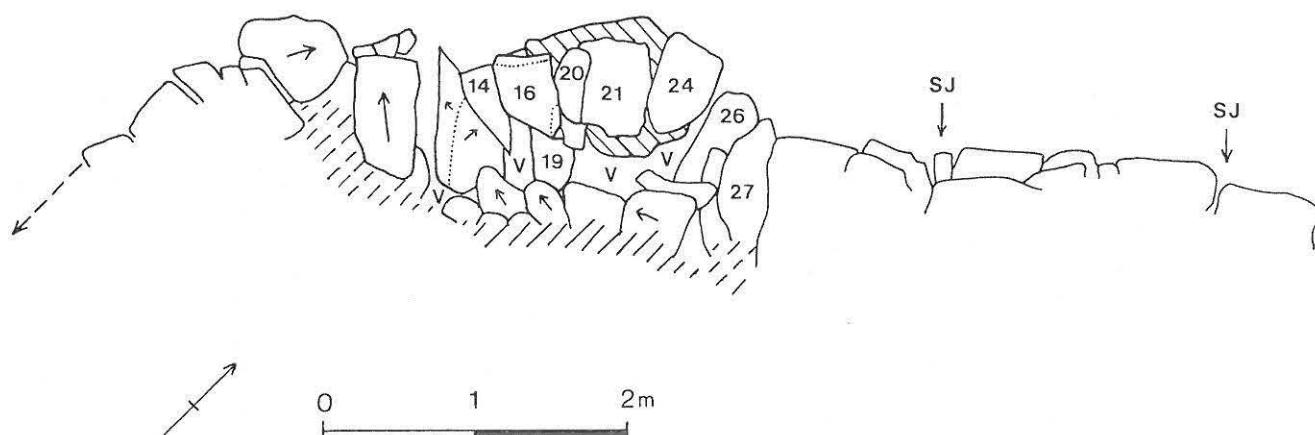
Fig. 7. Collapse D after removal of tumble and unstable masonry. V = void.

Plates 31 and 32, and fig.7 show the basal courses after clearance of loose material; Plate 31 in particular shows that the boulders on which the wall was built had tilted forward: presumably this was the main cause of the slippage. Voids between the back edges of the facing stones and the wall core (fig.7) show that the core had remained in place when the wall slipped, but rather than attempt to rebuild the wall on the original alignment (which could not be re-established for certain), it was decided to rebuild on the line to which it had slipped. To emphasise that this was not the original line the rebuilt stretch was not bonded to the extant wall to the north-east: stone 24 (see fig.7) and those above it were left protruding up to 0.3m from the wall line to the north-east (Plate 33, centre of frame).

The wall was rebuilt to a height of 1.6m above the scree on the north-east and graded evenly down to 1.25m on the south-west, in order to match the height of the extant masonry to either side. The original face here presented more flat-faced stones than are usually found in the wall, and this was reflected in the rebuilding (Plate 34 and compare Plate 30).

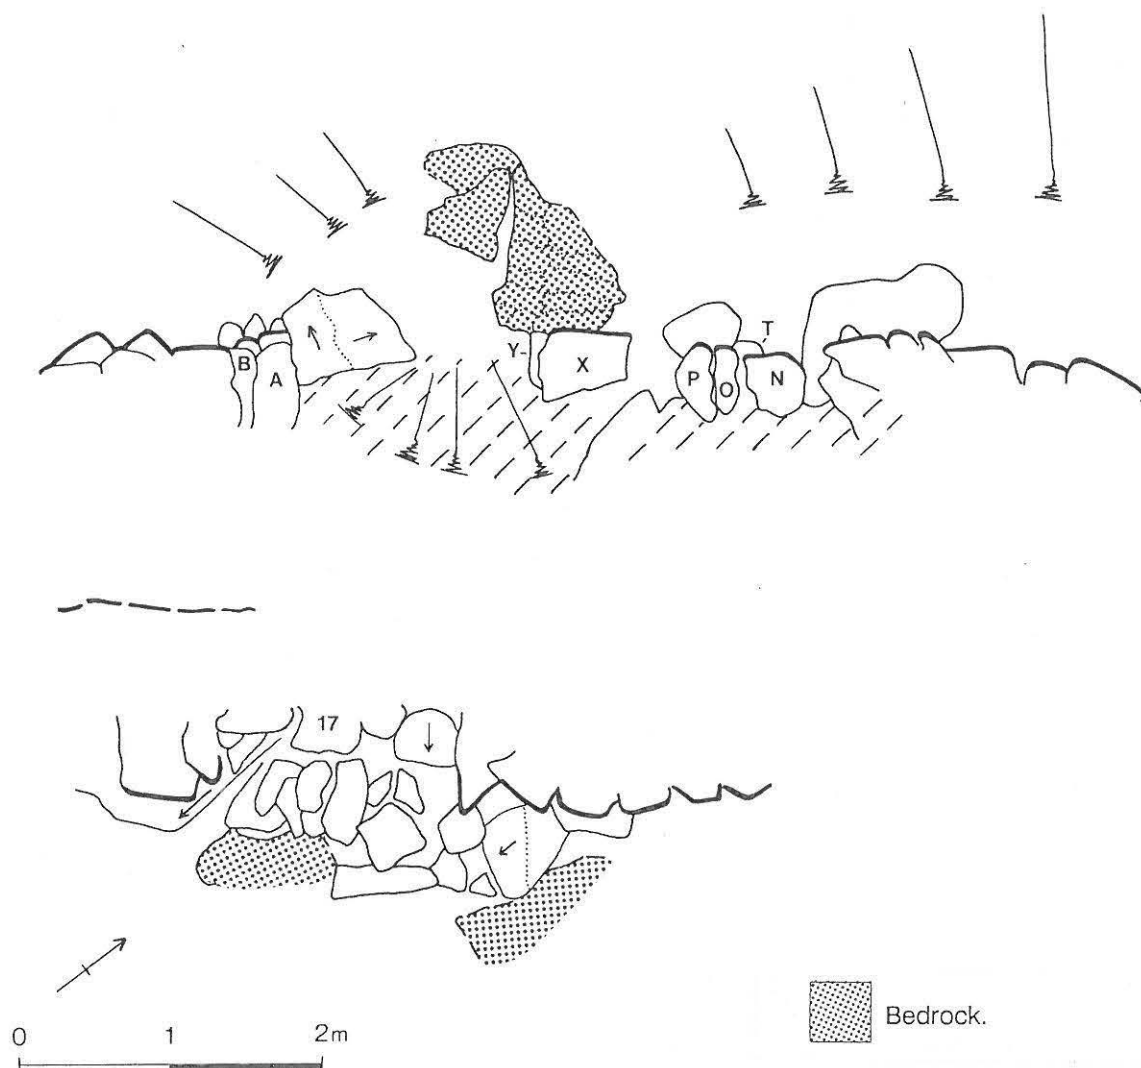
Fig. 8. Collapse E after removal of tumble and unstable masonry.

Before conservation (Plates 64 & 65) 2.5m of the outer face of the wall had collapsed completely. Much of the upper part of the wall to the north-east of this had also collapsed, the wall top rising only gradually for 1.0m-1.5m (above stones P, O, N on fig.8) before levelling out, and much of what remained here was either loose and unstable, or obviously displaced. Those stones

Plates 66, 67 and 68, and fig.8 show the area of the collapse after removal of the fallen rubble. In the stretch between stones A and P on Fig.8 only two stones remained which appeared to be part of the wall face (marked X and Y on the plan and in the plates). The wall had been built across several large boulders, and it was perhaps the irregular surfaces of these which introduced a weakness into the construction, causing the collapse. On one of these boulders presented a difficulty when rebuilding: at the south-west edge of the gap, below stone A, the upper surface of a tall boulder sloped outwards, making it impossible to build headers directly onto it. The problem was solved by 'bridging' the top of this stone with one long slab (see Plate 69).

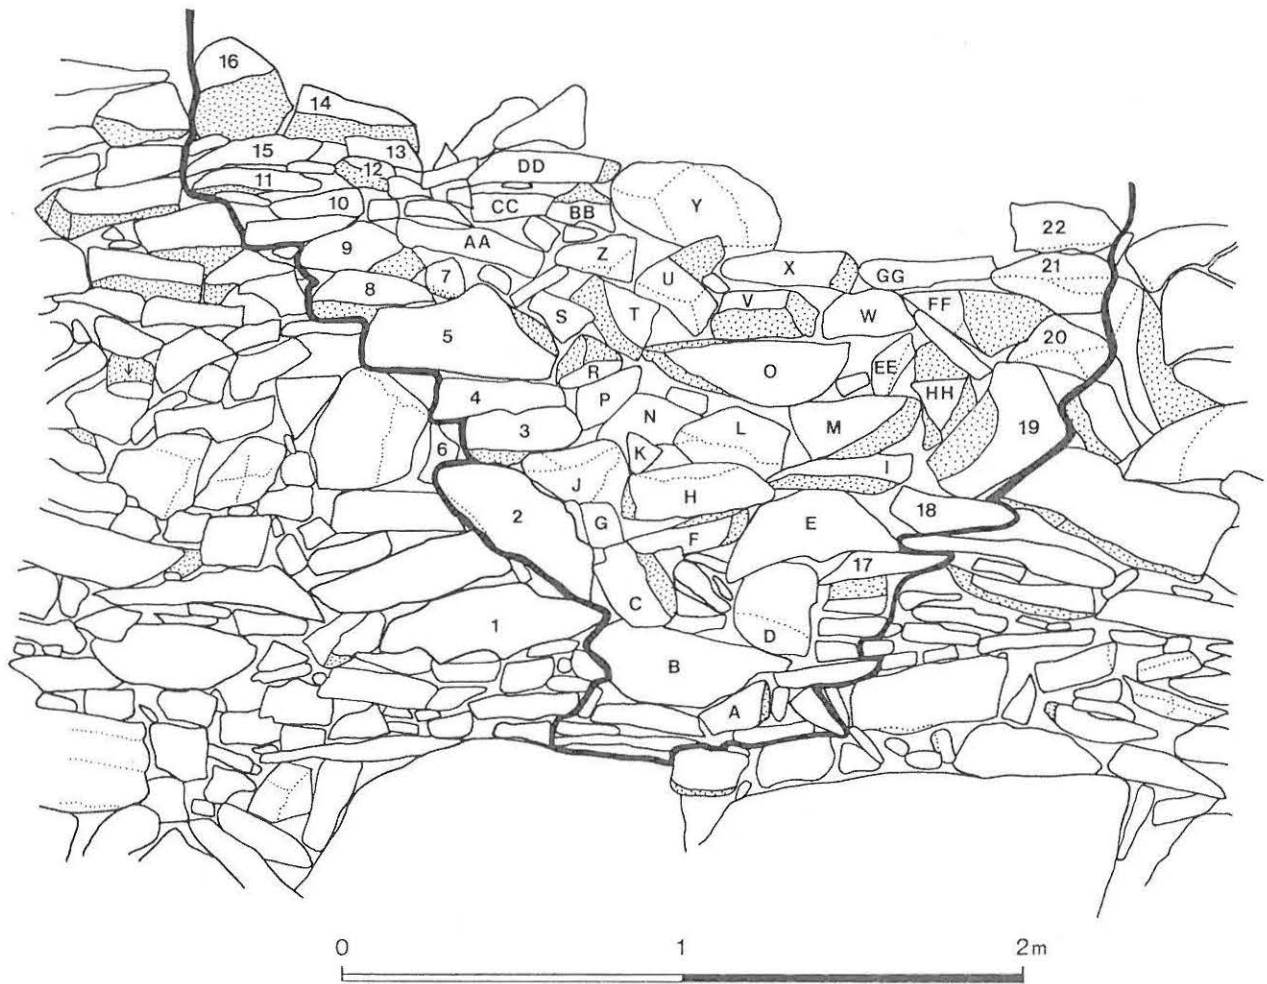
Fig. 9. Elevation of Collapse E3 before dismantling.

The wall here had not collapsed, but was in danger of doing so. A section of wall 2.3m wide at the top, narrowing to 0.6m at the base, was therefore dismantled and rebuilt. Fig.9 and Plate 76 show this stretch before conservation.

The source of the problem was close to the base of the wall, where stone B (fig.9) appeared to have tilted forward, causing the wall to bulge. Stones C, D, H and F were all being squeezed

out (H and F were on the point of falling), and it appeared that only E and J, both very long headers, held the wall in place.

The lettered stones were removed first, in the hope that those marked with numerals could be left *in situ*, but it soon became clear that these were also unstable. On the north-east edge of the gap stone 2, a large slab set on edge (see fig.10 and Plate 77), was being pushed out by pressure from above, and there were similar problems at the south-west edge. The final extent of the dismantled stretch is indicated by the thick line on fig.9.

The wall was rebuilt to a height of about 2.0m, as shown on Plates 78 and 79. As usual the marked stones were replaced as closely as possible to their original positions, but many of these stones were too short to be replaced securely with their weathered side outermost. It is likely that poor quality work in the original construction, with few long headers being used, was the root cause of the wall's instability.

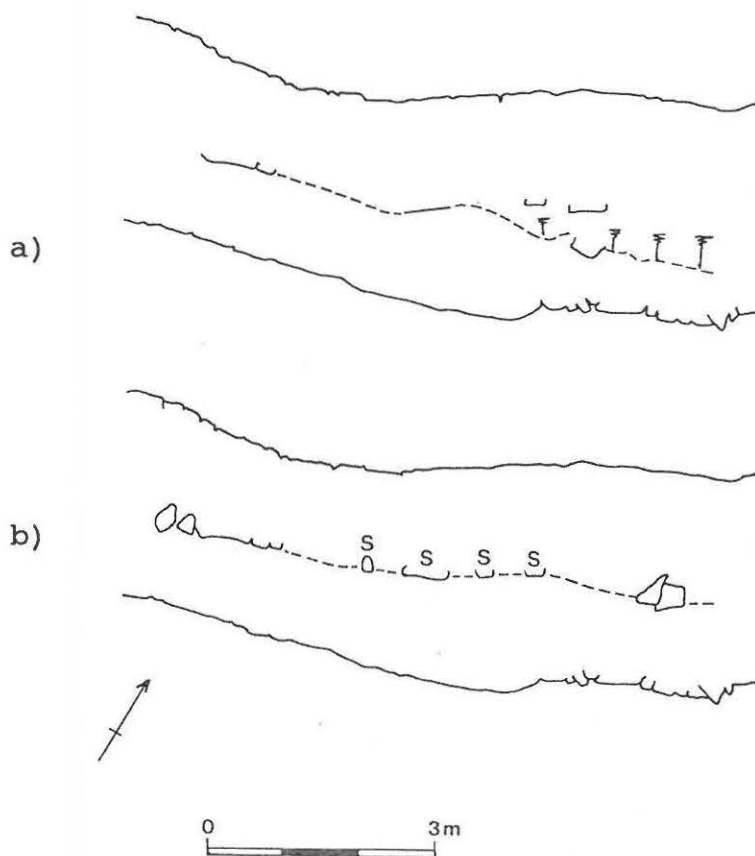
Fig. 11. Collapse E6: a) before conservation;
b) after conservation, S = *in situ* stone used to re-establish parapet line.

Above the repaired stretch of inner face E1 a length of the inner face of the parapet survived, but in poor condition. Before conservation it could be traced for about 7.0m, standing 0.5m high at most, although for most of its length it appeared as little more than a loose pile of stones with no clearly defined facing (fig.11a, Plate 84 - the nearer end of the parapet is behind the left end of the scale - and Plate 85).

A decision was made to peel off the rubble in the hope that at least the lowest course of the facing survived *in situ*. Before this was done, stones at the south-west end which were clearly *in situ*, and other stones at the north-east end which looked to be displaced but were nevertheless secure, were marked to prevent their accidental removal. Between these no unquestionable evidence for the precise line of the parapet emerged. Four large solidly set stones, however, did seem to define a line in the expected position, three of them at the level of the wall walk, the fourth higher up, protruding from the core of the parapet. These are indicated on fig.11b (marked 's') and are also marked on Plate 86. As these stones were the best guides available, the cleared rubble was used to rebuild a parapet face on the line they described, copying the style of surviving stretches of

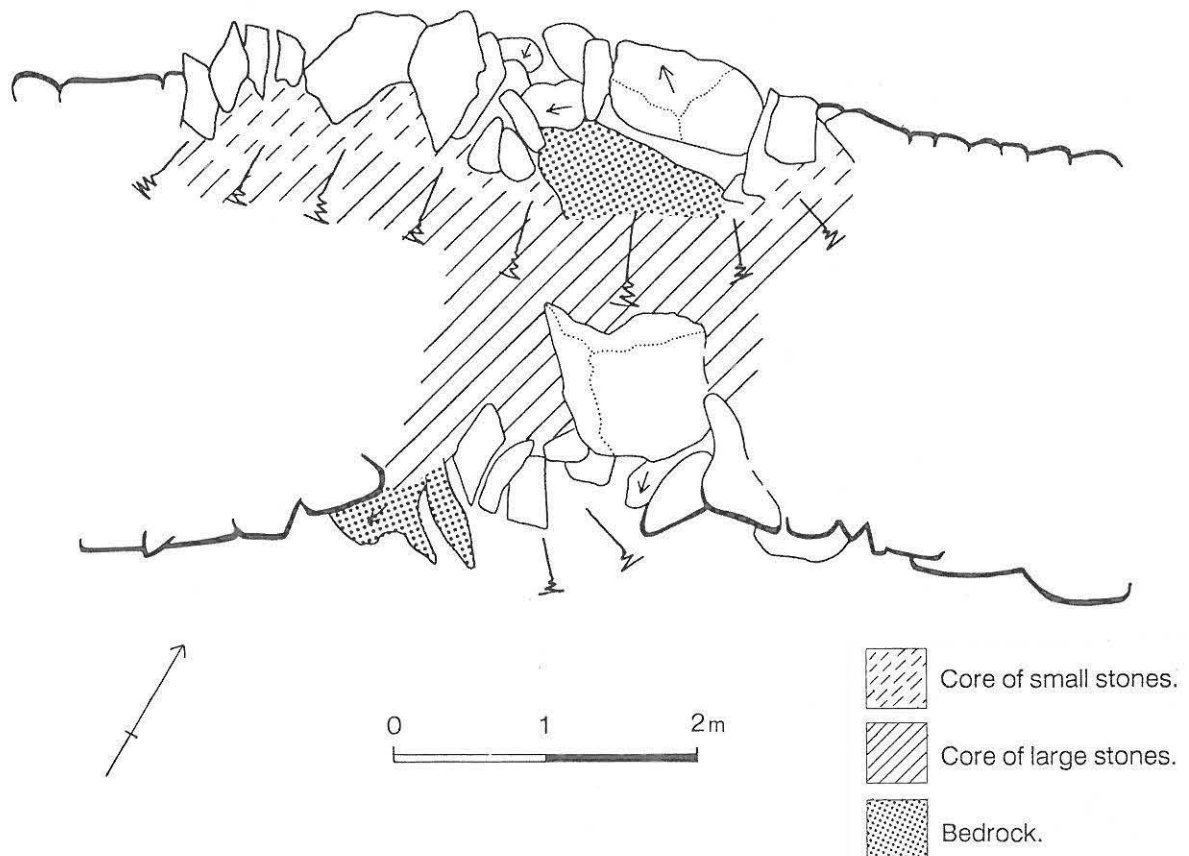
Fig. 12. Collapse F after removal of tumble and unstable masonry.

Before conservation the outer face here had collapsed completely for about 3 metres, as noted by Dallimore (Plates 89 and 90). To either side of this the standing wall had slumped towards the gap, and was supported only by fallen rubble. It was clear that a considerable amount of this extant masonry would have to be dismantled as the rubble was stripped away, and these stones were therefore numbered before clearance began (Plates 91 and 92).

Rebuilding was a straightforward task. Stones were relaid as headers (Plate 97) and regular coursing was avoided. Efforts were made to ensure that the numbered stones were replaced correctly,

but as with the other gaps repaired, large heavy stones were laid along the top edge of the wall. Plates 98 and 99 show the result.

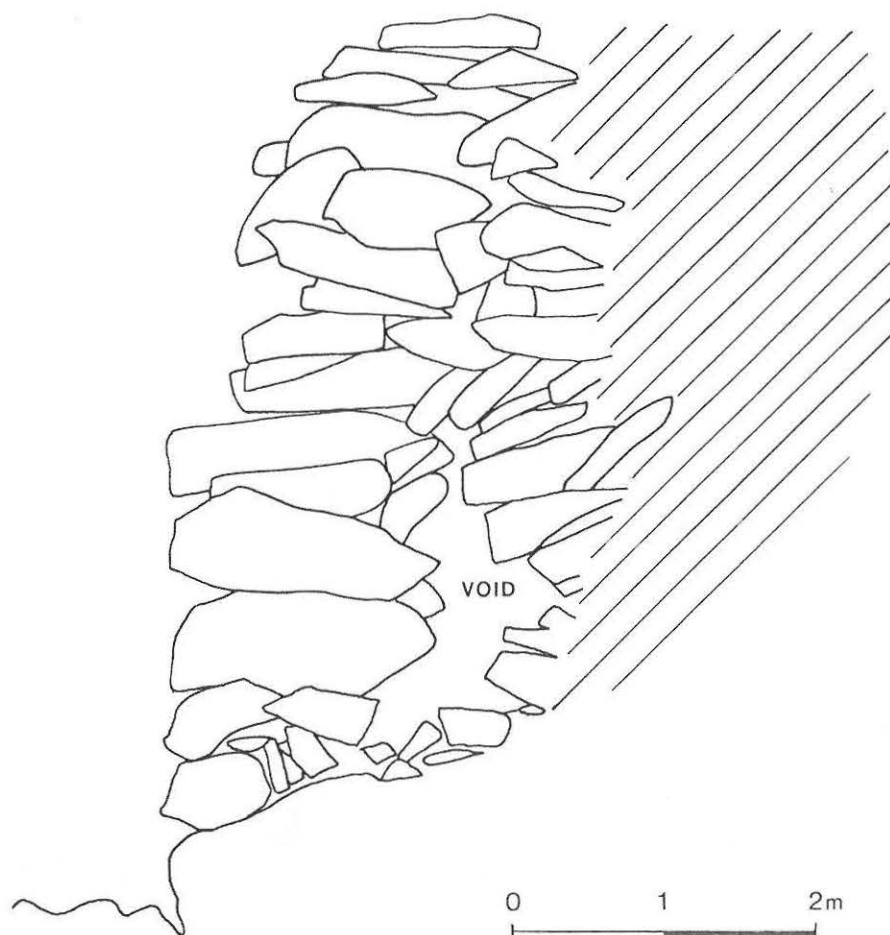
Fig. 13. Collapse F: SW-facing section.

At the north-east edge of the gap it emerged that the face of the wall had slipped forward, leaving a void between the rear of the facing and the core (fig.13 and Plates 93 and 94). One very large stone at the base of the wall here slanted forward (see Plate 94, immediately to the right of the bottom of the scale), and it seemed likely that it had slipped from its original position, taking with it all the masonry above.

In all a 4.2m length was cleared at the base of the wall, widening to 6.2m at the top. The core was removed to about 1.0m from the line of the facing. Only the basal course of the facing remained (fig.12 and Plate 95). Immediately behind this the surface of the bedrock was visible at about the same level. It was noticeable that the core towards the base of the wall was composed of much smaller material than higher up, where large stones (including one massive boulder) were piled loosely on one another leaving large voids in between (Plate 96). Presumably the small core material had filtered down through the voids.
