## North West Wales Dendrochronology Project: Trefadog, Llanfaethlu

Project No. G2113

Report No. 1021

**Trefadog, Llanfaethlu, Anglesey. NGR SH 29288613**

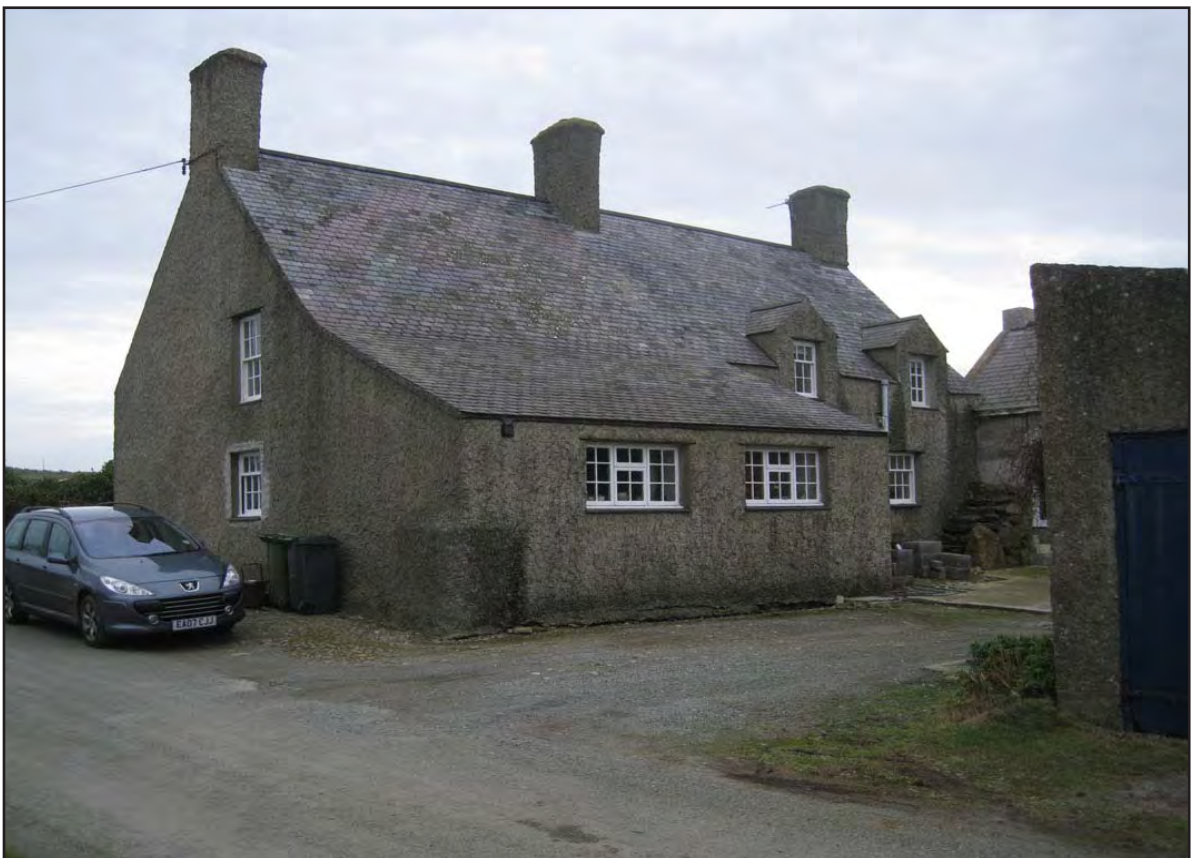
The house is aligned approximately north-south, parallel to the coast edge, and is in a slight hollow 50m from the sea. The house is of two storeys, of rendered stone. The slate roof is modern. There are three rectangular chimney stacks, two at the gables and one to the left (south) of centre. The main front faces east, with an off-centre door to the north, two replaced sash windows to the south and one to the north. Four gabled dormers, all fitted with replaced sash windows, light the first floor. The north side of the house has a catslide addition occupying the north half, of probable 19<sup>th</sup> century date, though with modern horizontal casement windows in the west wall. The south side of the house is lit by a sash window on the ground floor and two gabled dormers on the first floor. A rear door lies in the corner created by the catslide extension (see plate 2).

**Plate 02:** The western elevation of Trefadog; view from the northwest.

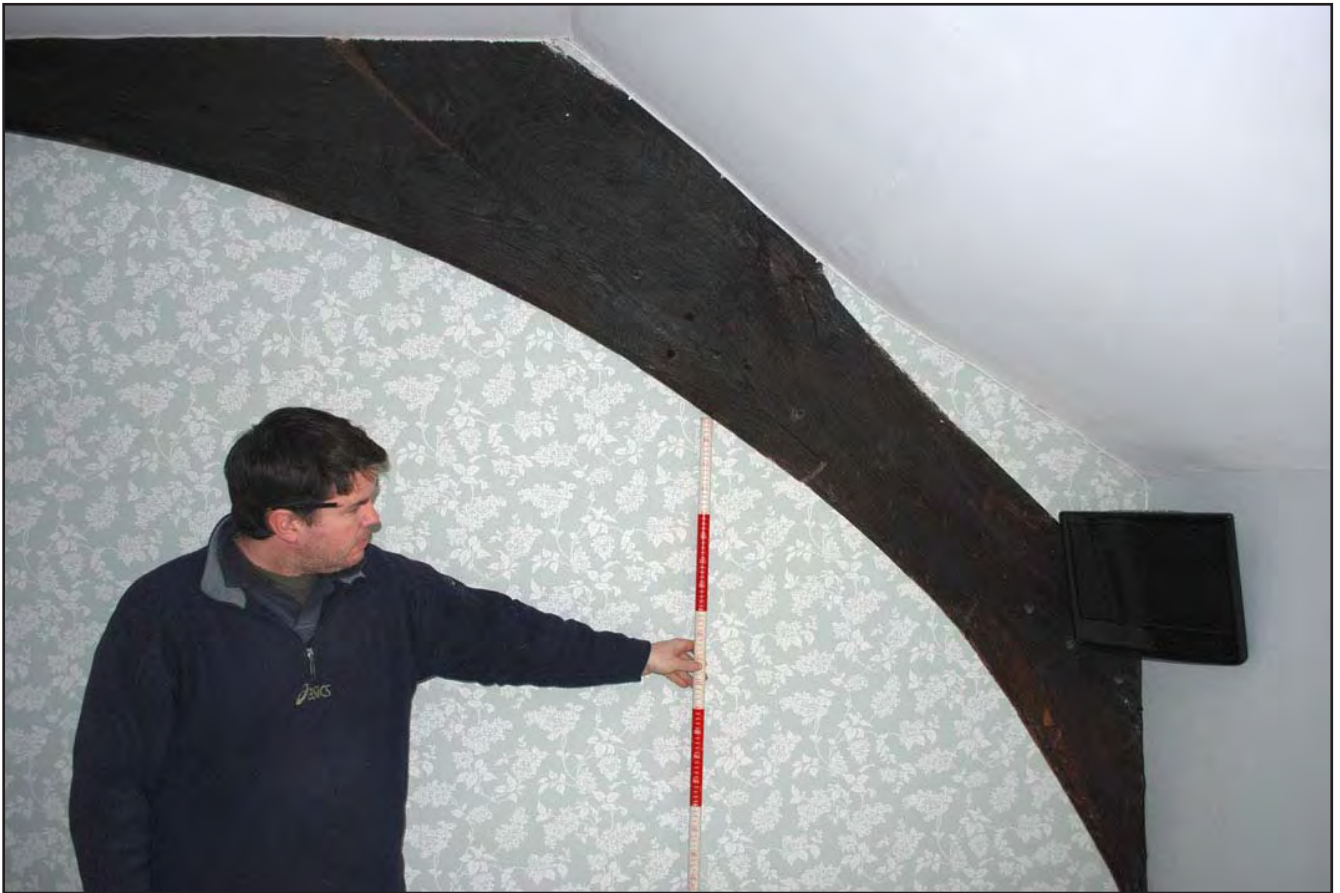
The cruck which divides the hall consists of two principals which disappear into the wall on either side. These have a jointed vertical post which curves onto the principal to form the bend of the cruck. The two are fastened by a wide mortise and tenon joint held with three pegs. It is not possible to see how far the vertical post goes into the wall. None of the vertical posts appear to go below the level of the present first floor, and it is not known if they ever went below that level. An arch-braced collar beam is partly visible below first-floor ceiling level – the remainder hidden by the ceiling. The braces are joined to the collar and principals by mortise and tenon joints (see plates 1 to 6).

**Plate 3:** The eastern side of the southern face of the southern cruck which divides the hall; view from the south.

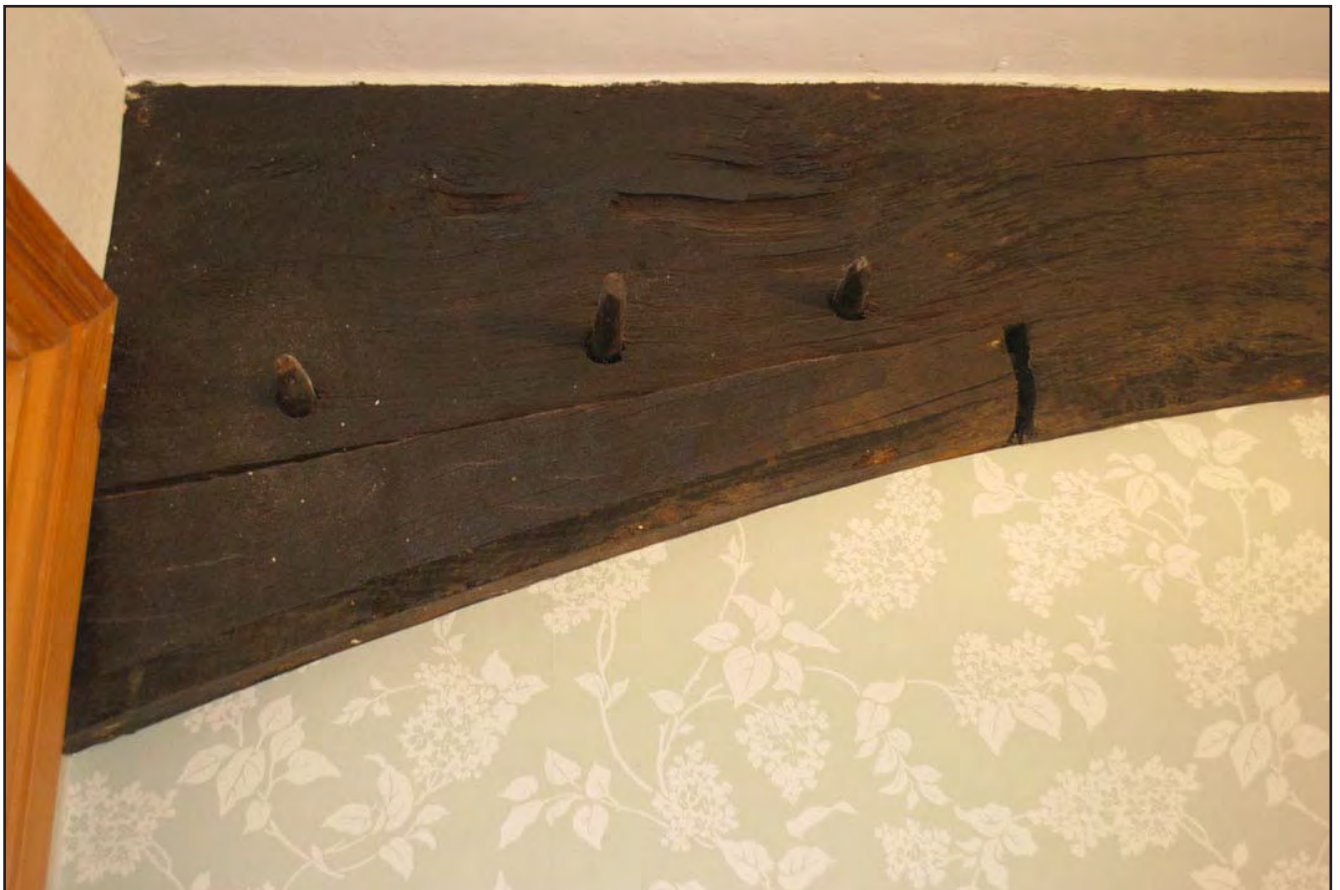
**Plate 4:** Close up of the pegs which join the jointed vertical post with the principal to form the bend of the southern cruck. This is the western side of the southern face; view from the south.

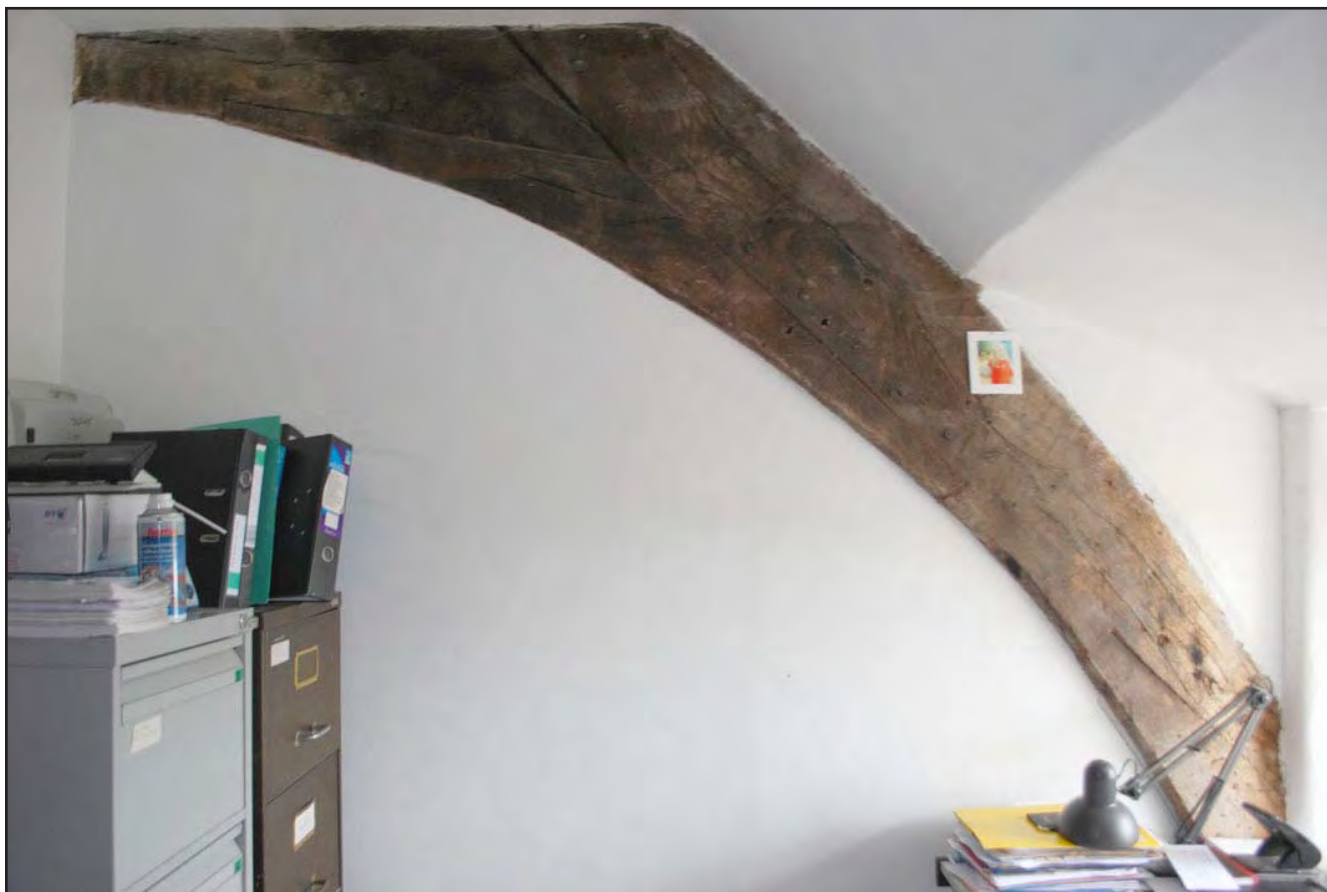
**Plate 5:** The western side of the northern face of the southern cruck which divides the hall; view from the north.

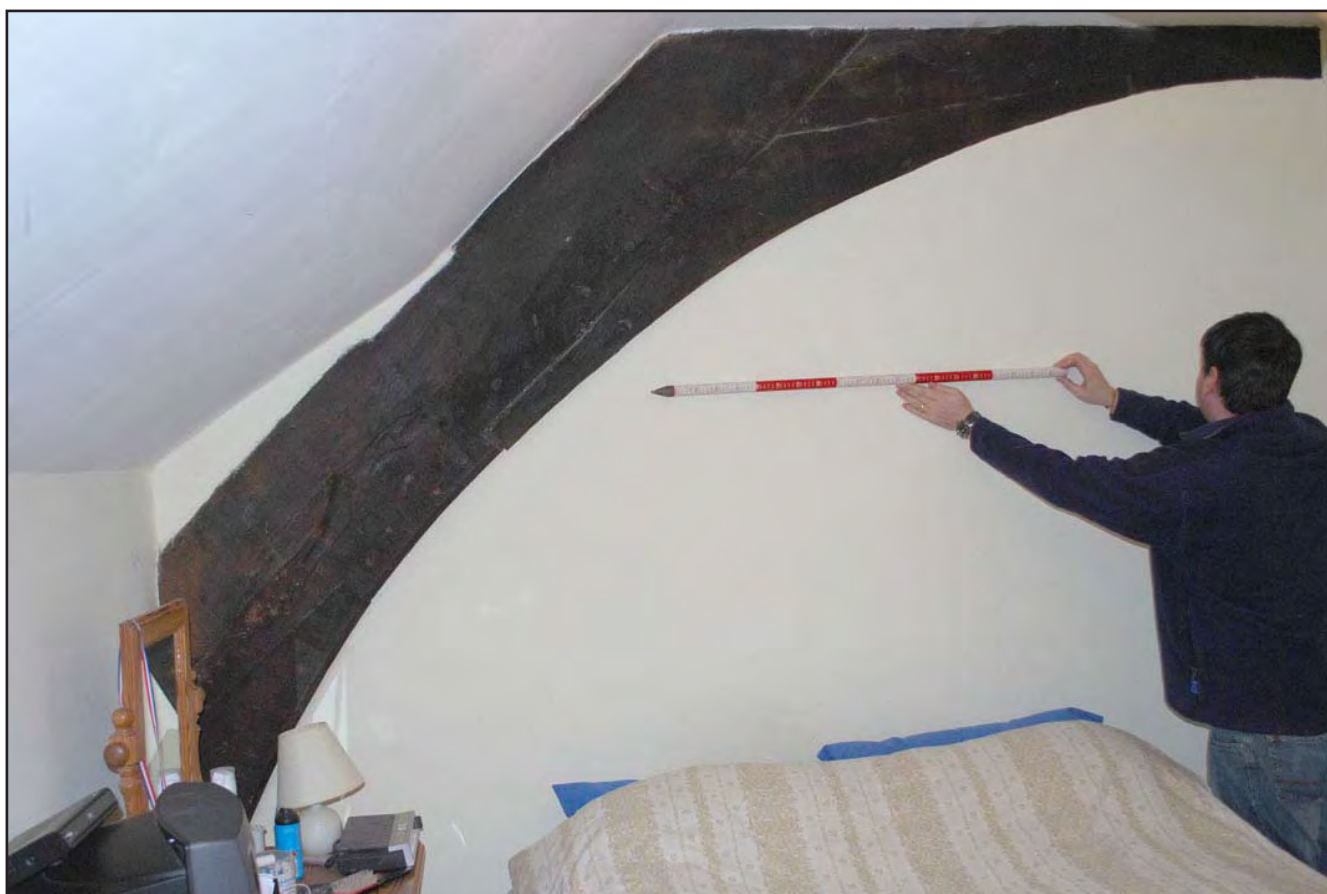
**Plate 6:** The eastern side of the northern face of the southern cruck which divides the hall; view from the north.

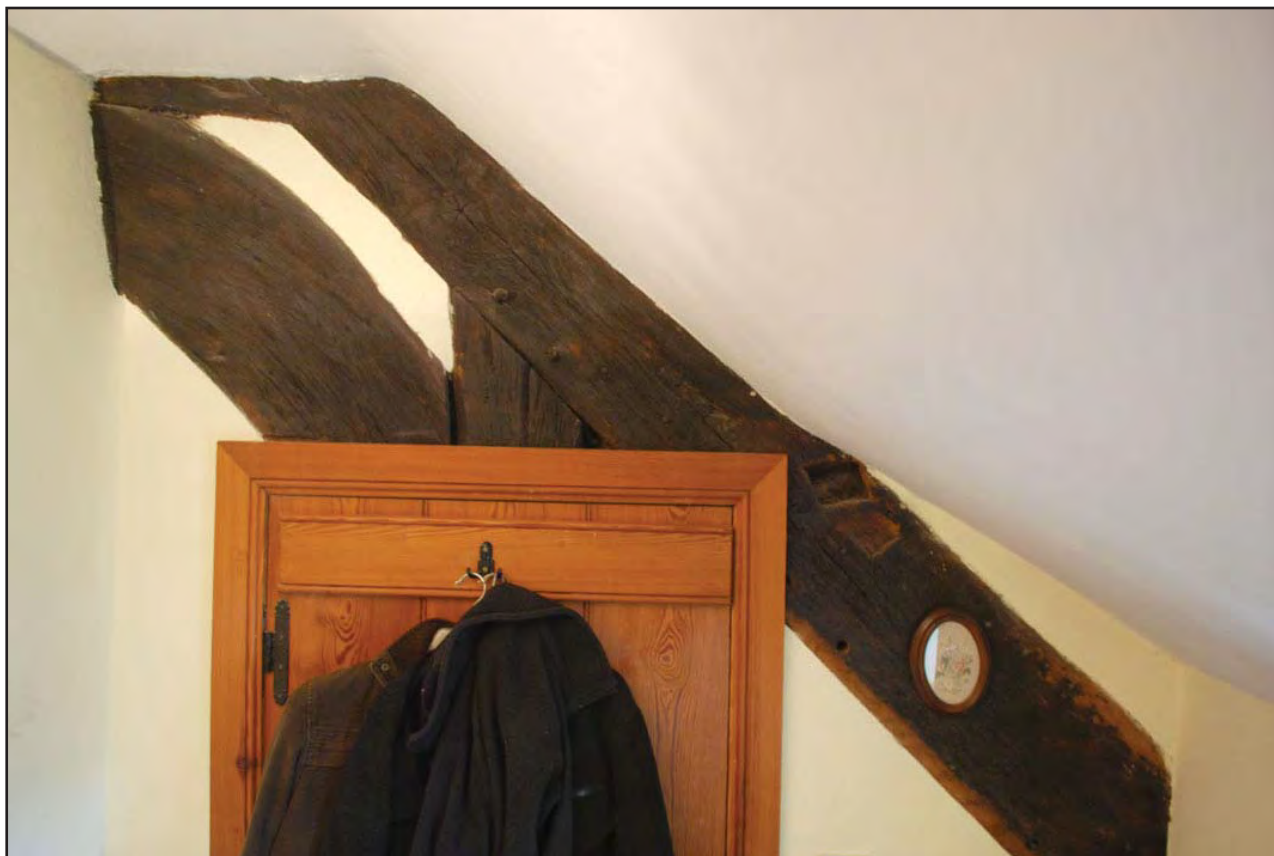
The cruck forming the south side of the screens passage is only partially visible and appears to have been modified on the west side. The arch-bracing to the collar beam on the east side links to a vertical post. There is only a small section left of this, as it has been cut by a door, but it is probable that this vertical post once continued down to ground floor level, and formed part of the screens partition. A vertical wall post, but with less of a curve than on the hall cruck, is linked to the end of the principal, and continues downwards in the lateral wall. This is partly mirrored on the west side, but the vertical post has been replaced with a modern one lower down the principal. Two dowel holes mark the likely location of the original vertical post. There is no evidence for a curving brace to the collar beam, though not enough of the collar beam is visible to confirm if one formerly existed (see plates 7 to 9).

**Plate 7:** The eastern side of the southern face of the central cruck which forms the south side of the screens passage; view from the south.

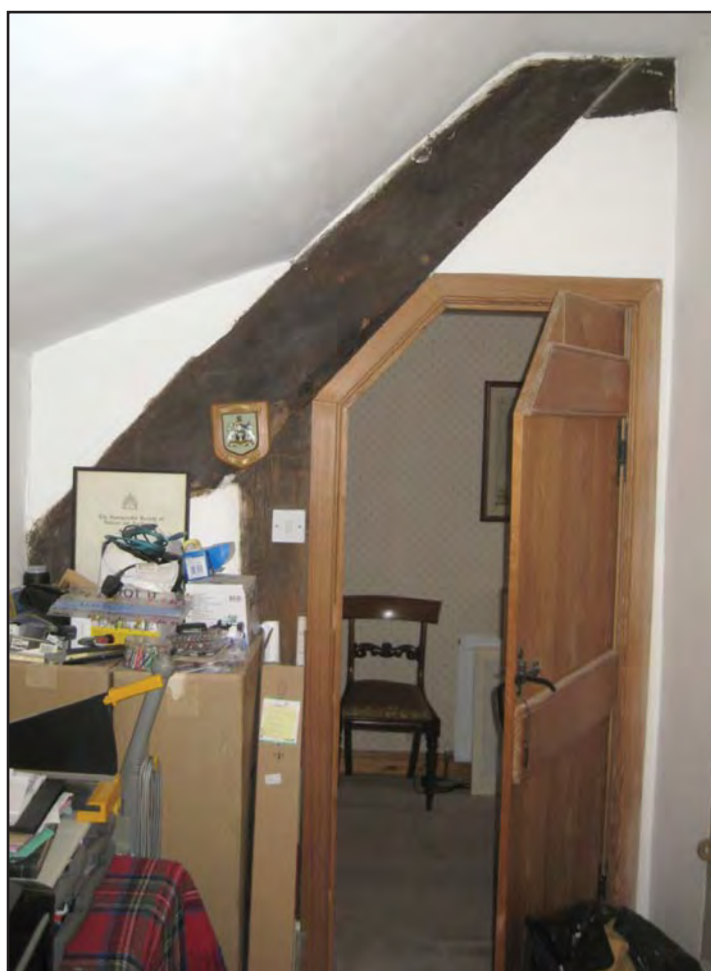
**Plate 08:** The western side of the southern face of the central cruck which forms the south side of the screens passage

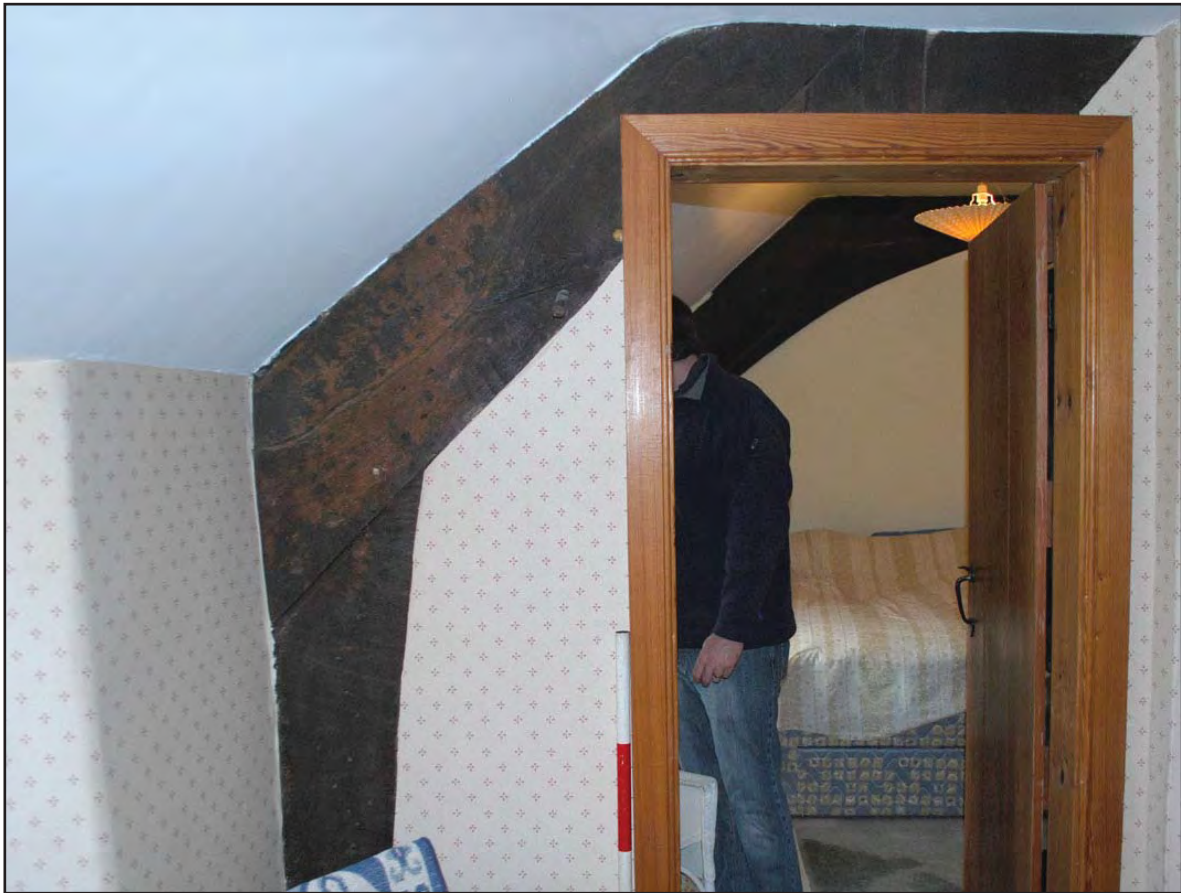
Plate 9: The eastern side of the northern face of the central cruck which forms the southside of the screens passage; view from the north.

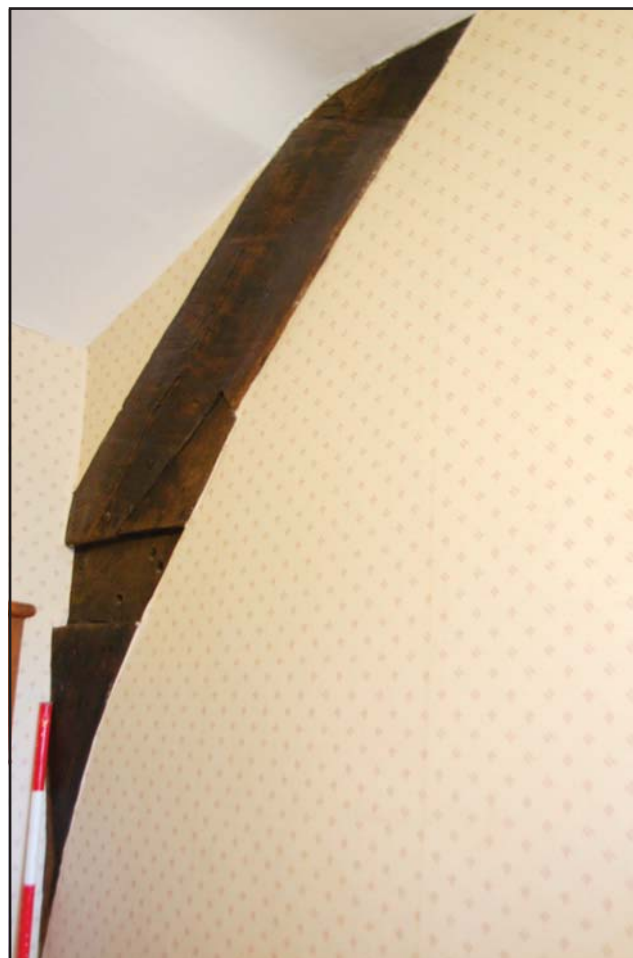
The northern passage cruck is different again. Here the principles are jointed onto vertical wall plates, but there is no collar beam visible, nor any bracing. A housing for a tie beam, however, lies across the cruck joint on the south face – an odd arrangement, but possibly original. The tie beam has been removed, but a housing exists on both east and west sides. The different nature of this truss suggests the outer rooms were two storey (see plates 10 to 12).

Plate 10: The eastern side of the southern face of the northern cruck which forms the southside of the screens passage

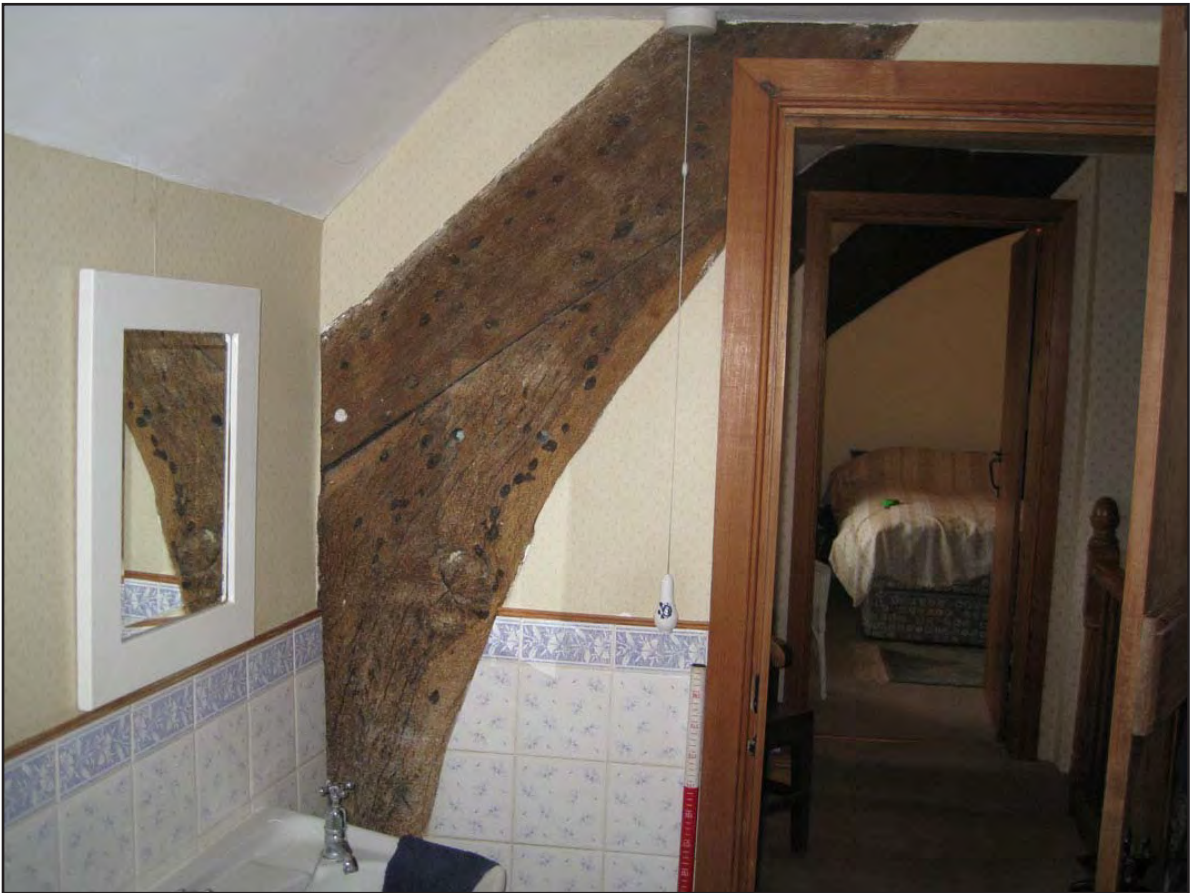
Plate 11: The eastern side of the northern face of the northern cruck which forms the northside of the screens passage; view from the north.

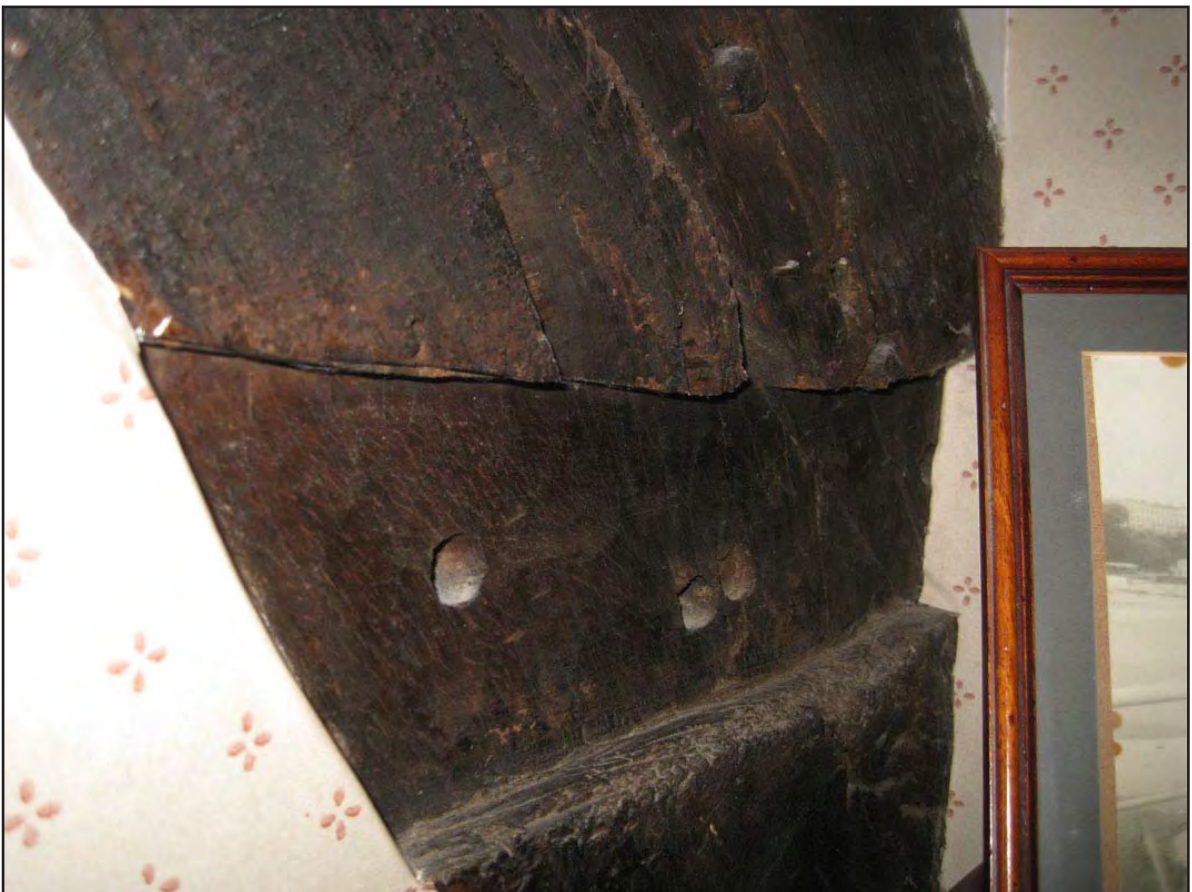
Plate 12: Close up of the housing for a tie beam on the eastern side of the southern face of the northern cruck, which forms the southside of the screens passage; view from the south.
