TAN Y FYNWENT PUBLIC PARK AREA

Bangor

Archaeological Watching Brief

Project No. G2252

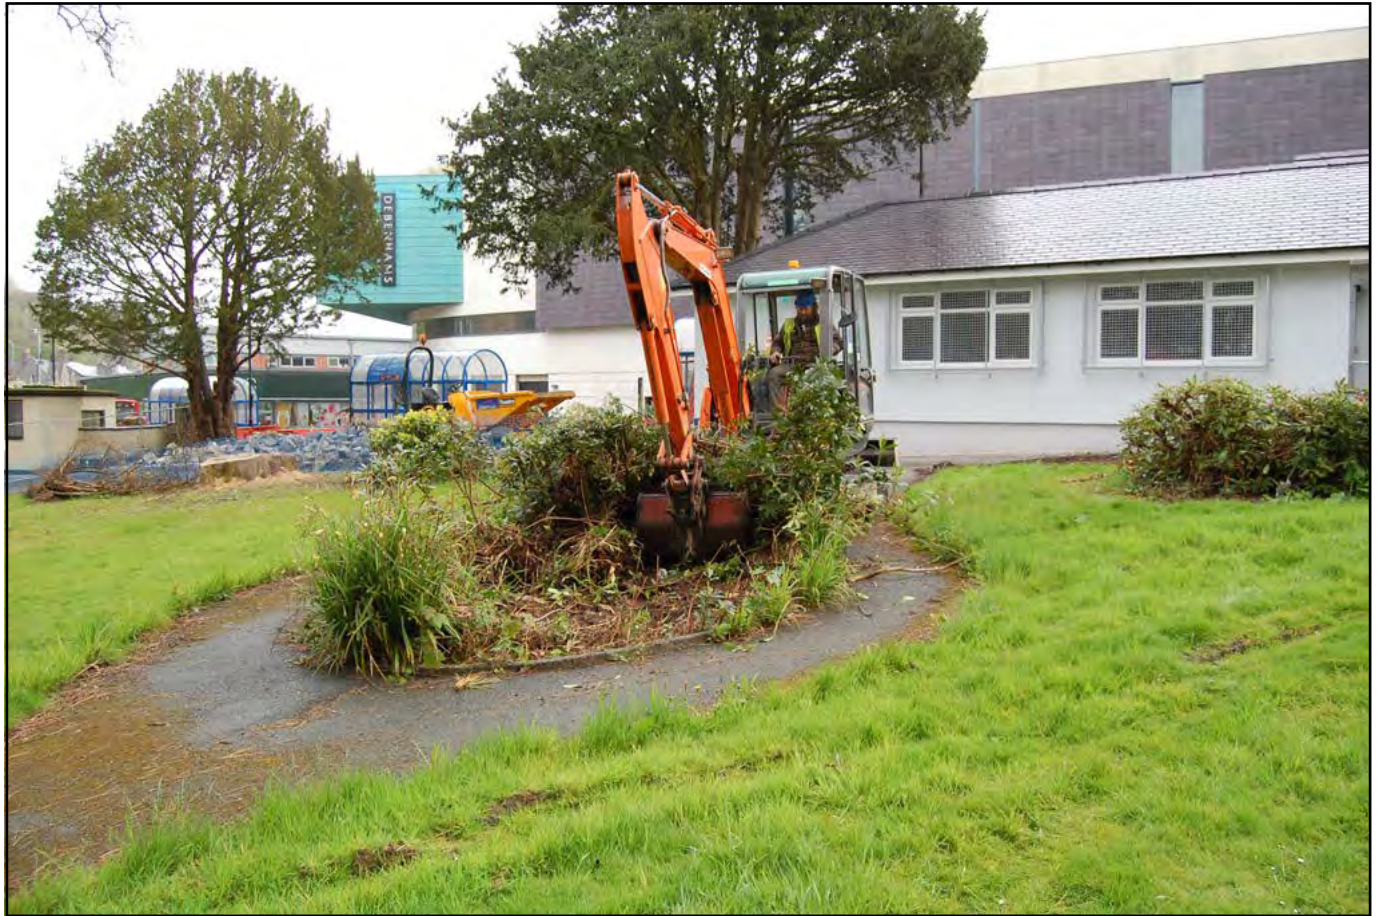
Prior to the removal of the topsoil from the central/southern portion of the park, two shrubby plantations were removed by a tracked excavator: the shrubbery was planted within a bioturbated soil and their removal did not reveal any deposits past that horizon (plates 01 and 02).

Plate 01 - View east of shrub plantation removal ahead of stripping.
This plantation area was located towards the centre of the publicpark area and was replaced both by the new concrete paving as well as a rectangular shaped plantation area

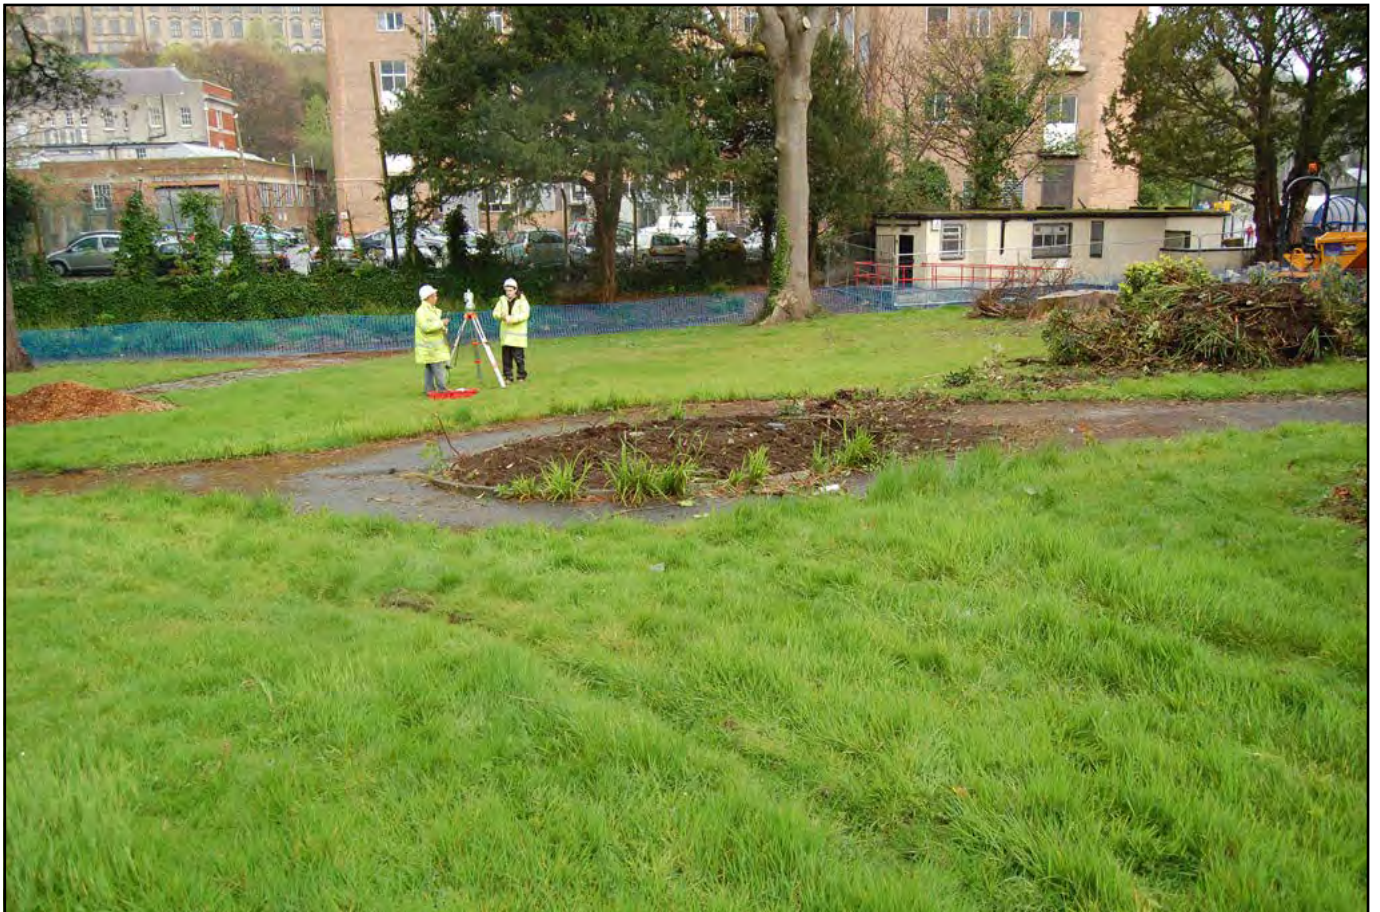
Plate 02 - View north of shrub plantation removal after stripping. This plantation area was located towards the centre of the publicpark area and was replaced both by the new concrete paving as well as a rectangular shaped plantation area. The grassed area in the foreground was also removed to accommodate the new concrete paving

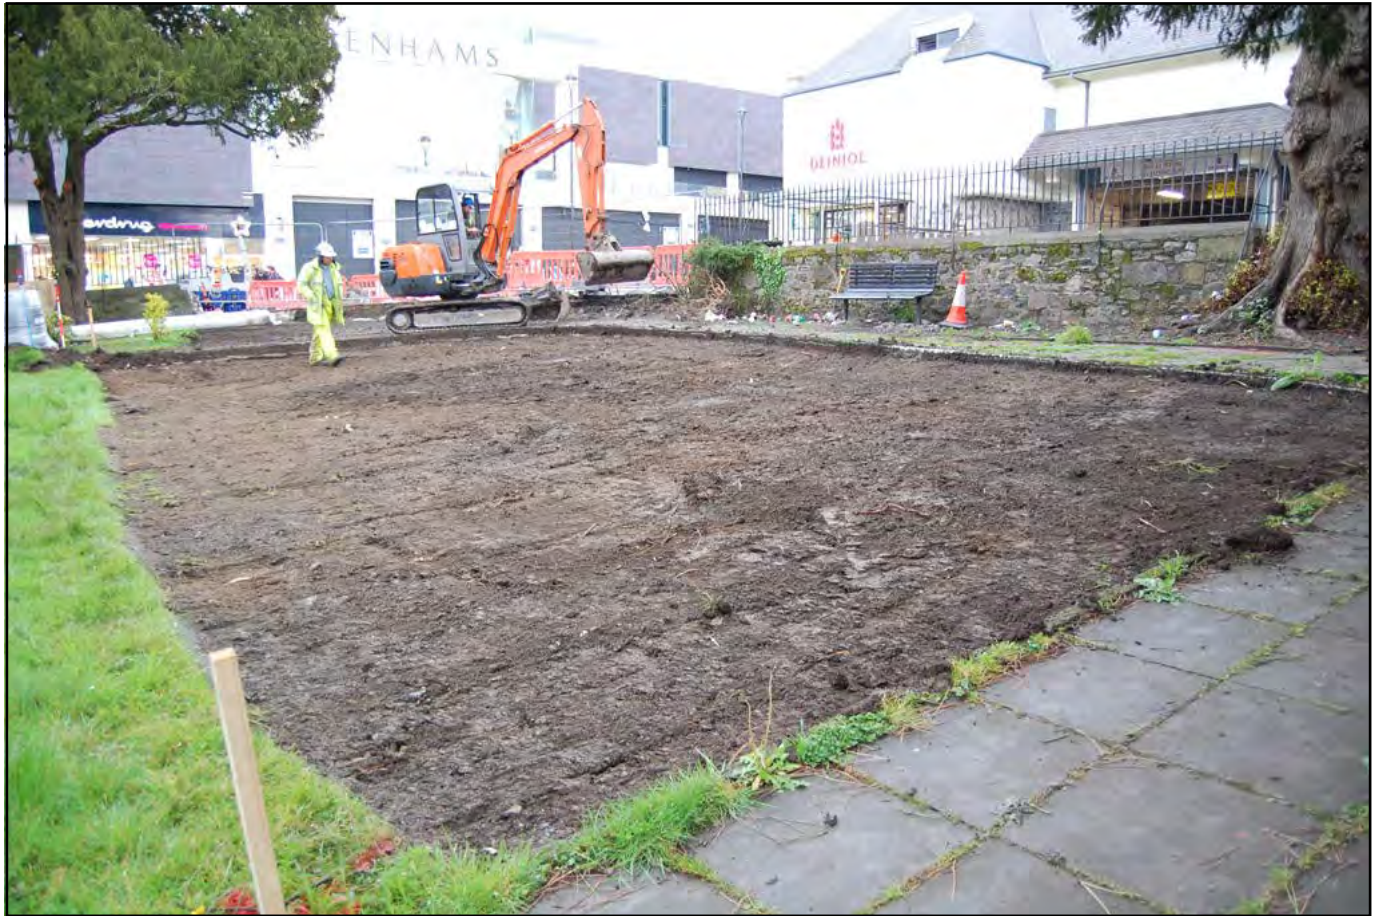
The topsoil was stripped in a sequence starting from the southern end of the park (plate 03) and finishing at the centre of the park (plate 09). The topsoil was stripped to a mean depth of 100mm and did not exceed the topsoil horizon. Where tree roots were encountered at the southeastern and northern portions of the strip, the topsoil strip was reduced to 80mm to avoid root damage. No archaeological activity was identified within the topsoil horizon, nor within the exposed stripped areas.

Plate 03 - General view of southeastern corner of site during stripping; excavation depth is less than 100mm; note that the strip has not exceeded the topsoil horizon; the former location of the plantation in Plates 01 and 02 is visible in the centre as a darkened area

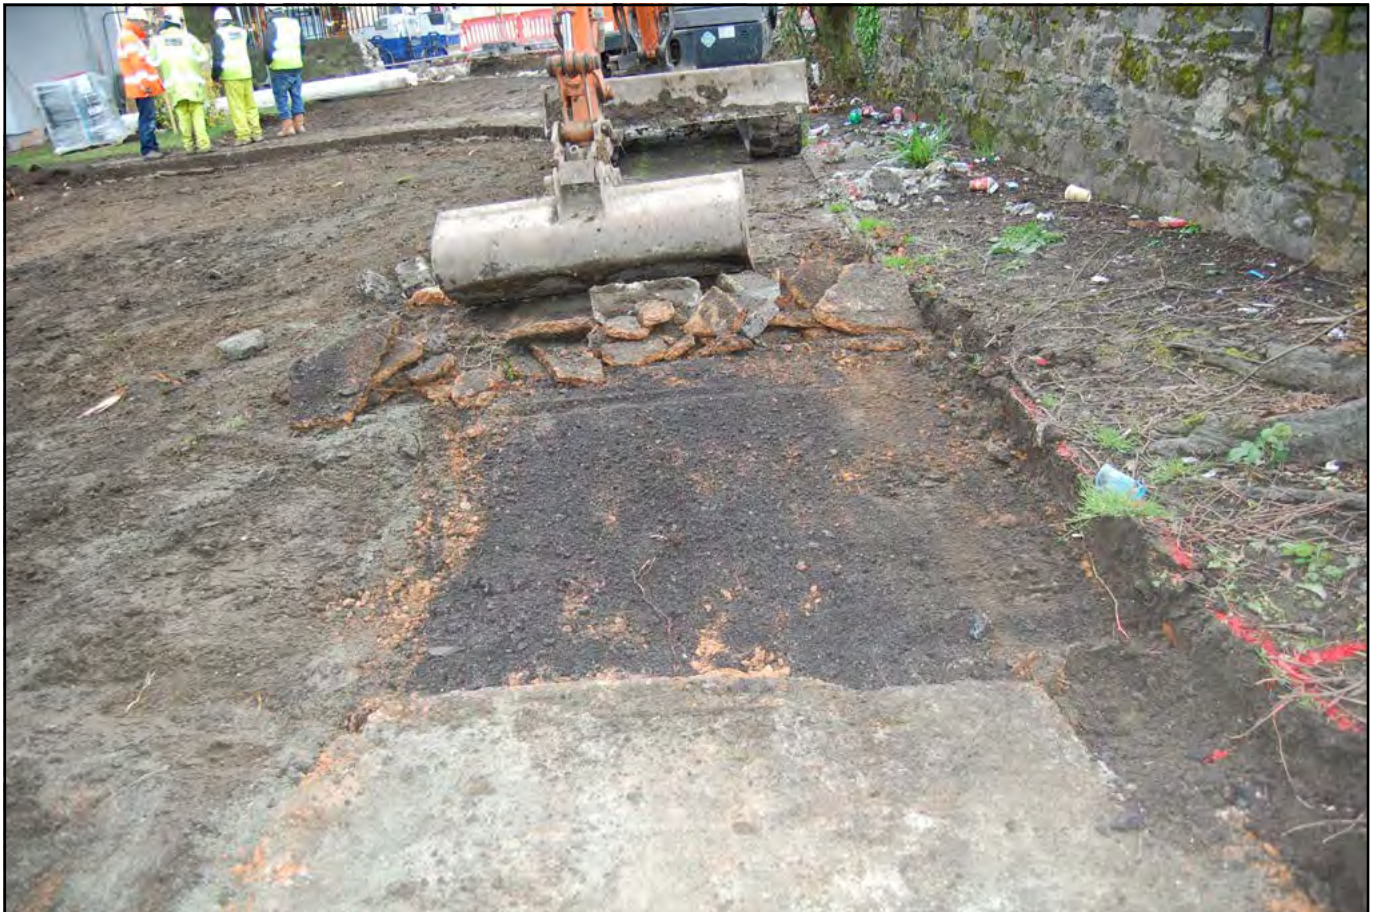
The existing path that ran along the eastern and northeastern boundaries of the park were removed by tracked excavator: the path comprised slabs set onto bedding mortar set onto a concreted sub-base atop a primary layer of clinker type material. The foundations did not exceed the topsoil horizon and had a total depth of 110mm along the eastern portion and 170mm along the northeastern portion next to the refurbished café. The excavation of the path did not exceed the topsoil horizon and no archaeological activity was identified within the topsoil horizon.

Plate 04 - General view of eastern corner of site during removal of existing pathway foundation material (visible in Plate 03). Beneath the pathway slabs were a concreted deposit followed by a thin clinker type deposit that was specifically laid as part of the foundation construction. This area was replaced by a new pathway. Limit of excavation was 100mm

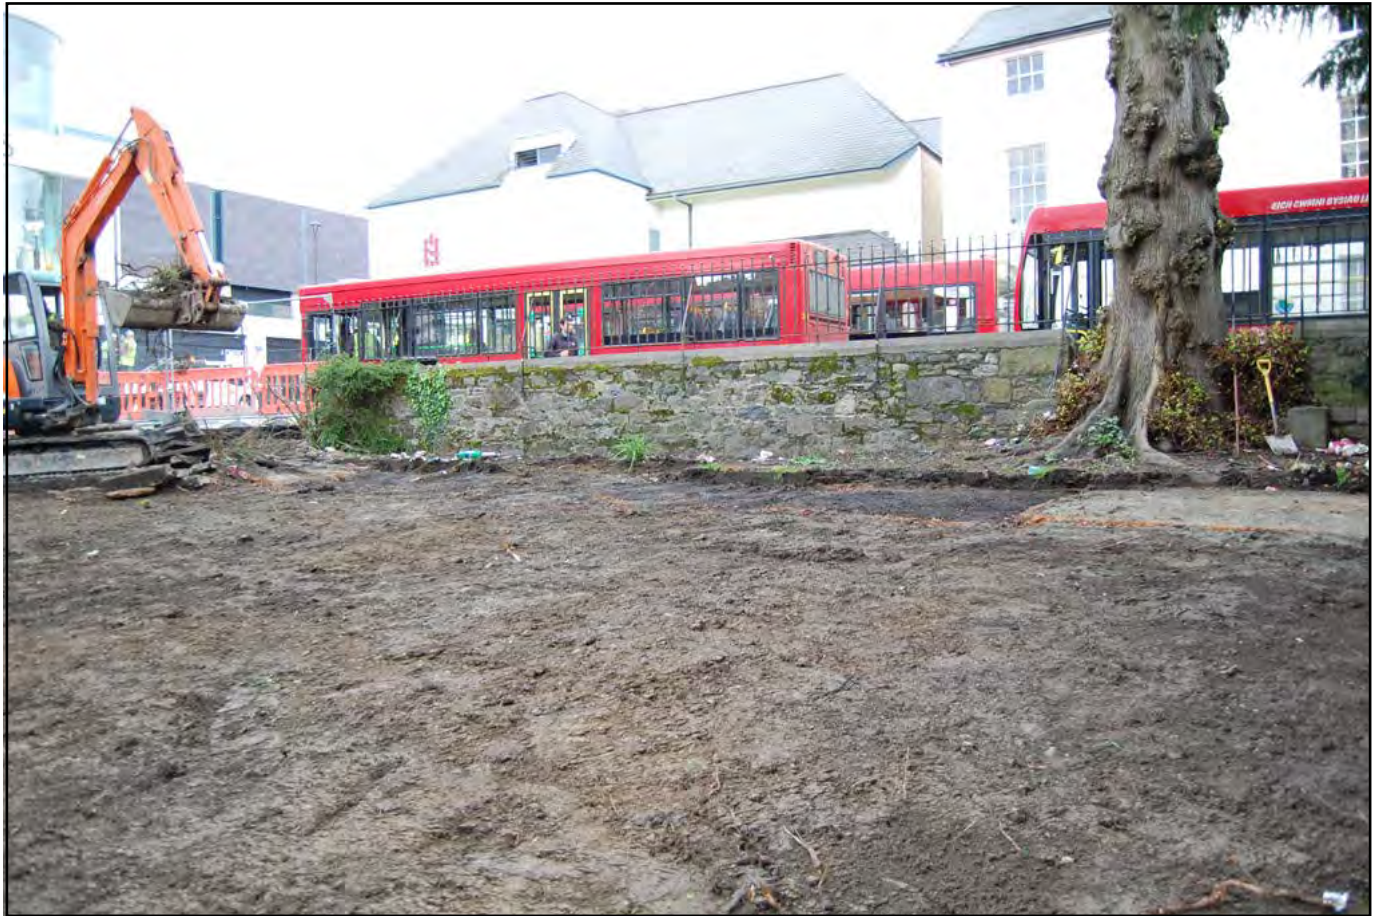
Plate 05 - General view of the eastern corner of site during removal of the pathway foundation material; this included a concreted deposit followed by a thin clinker type deposit that was specifically laid as part of the foundation construction. Note the portion of pathway foundation retained beneath the tree canopy. This area was used for the new pathway that encompassed the southeastern end of the site.

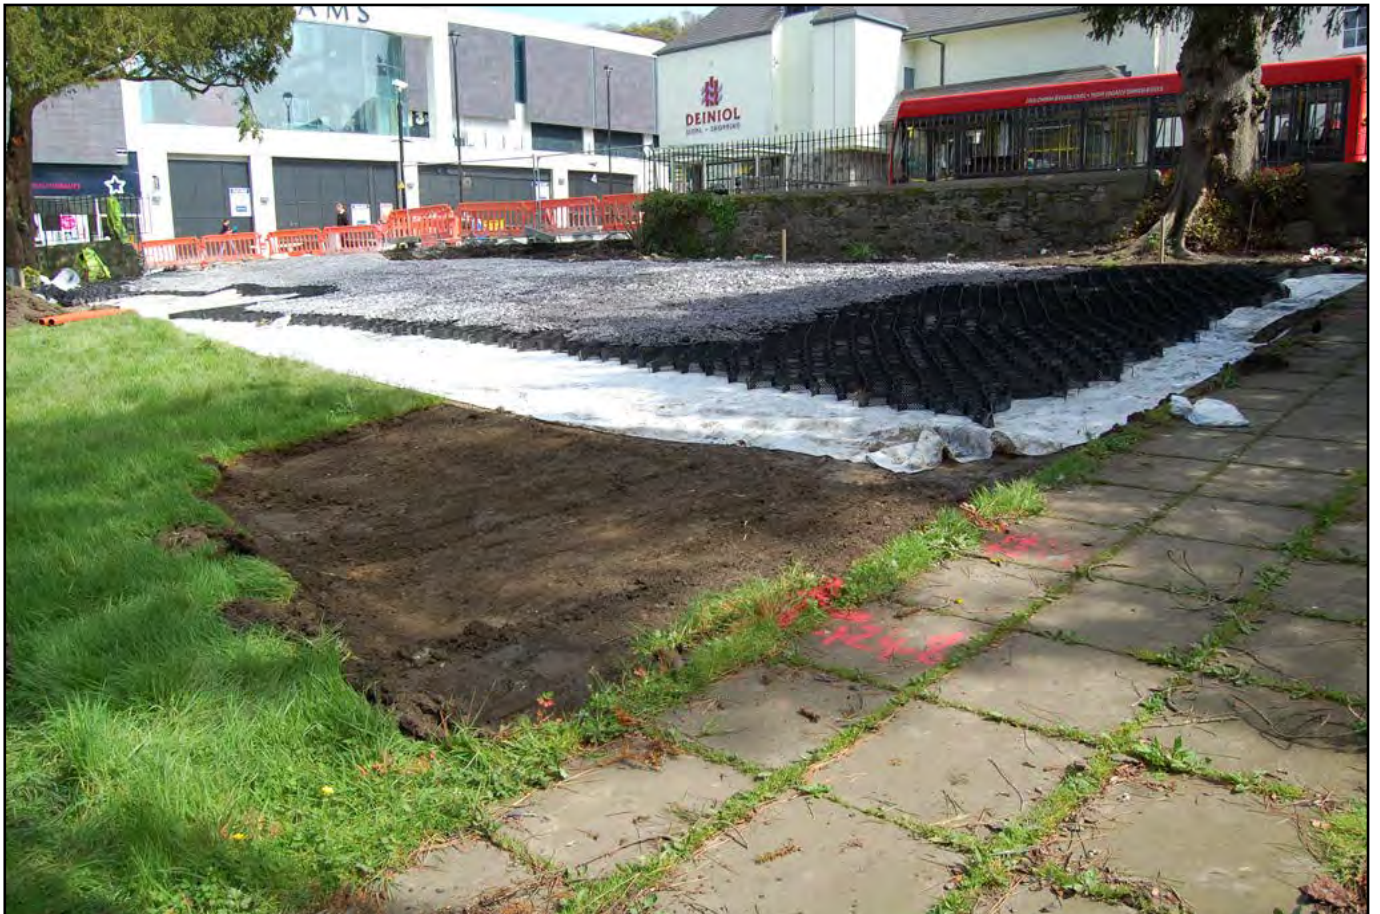
Plate 06 - General view of the eastern corner of site during the foundation groundworks for the new pathway. Note the use of geotextile membrane, followed by a geocell that was sealed by imported slate waste (used as a sub-base). A small portion of stripped ground can be seen in the foreground: the limit of excavation was 100mm or less. the pathway slabs also visible in the foreground were also removed and replaced.

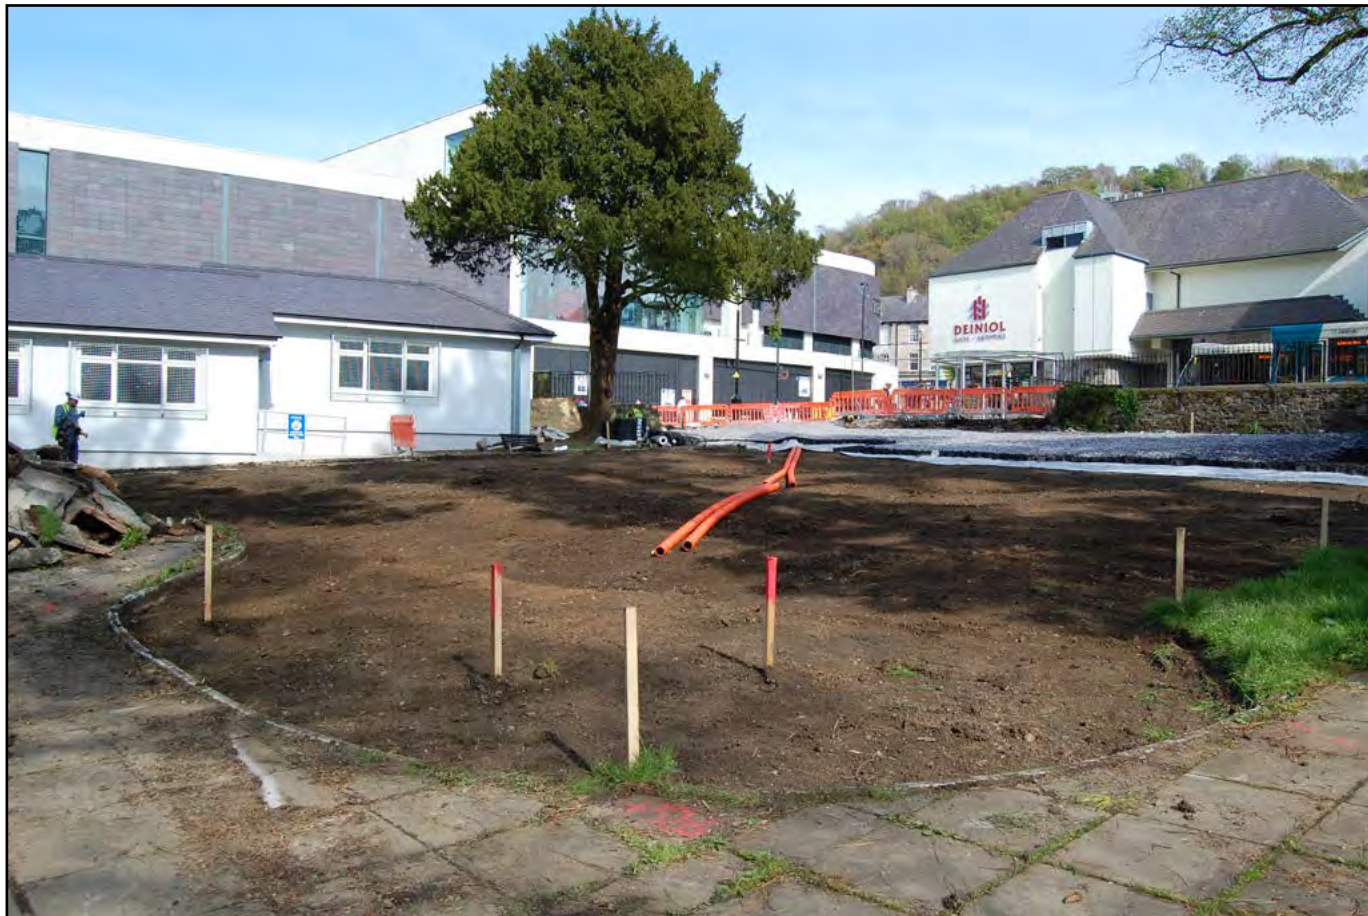
Plate 07 - General view of the centre/eastern corner of the park, after completion of the topsoil strip. Note the shallow excavation depth (less than 100mm) and the orange ducting laid beneath the geotextile membrane: the ducting was used for running cables that powered illuminated bollards; the ducting was not buried into the stripped are, but laid onto the surface.

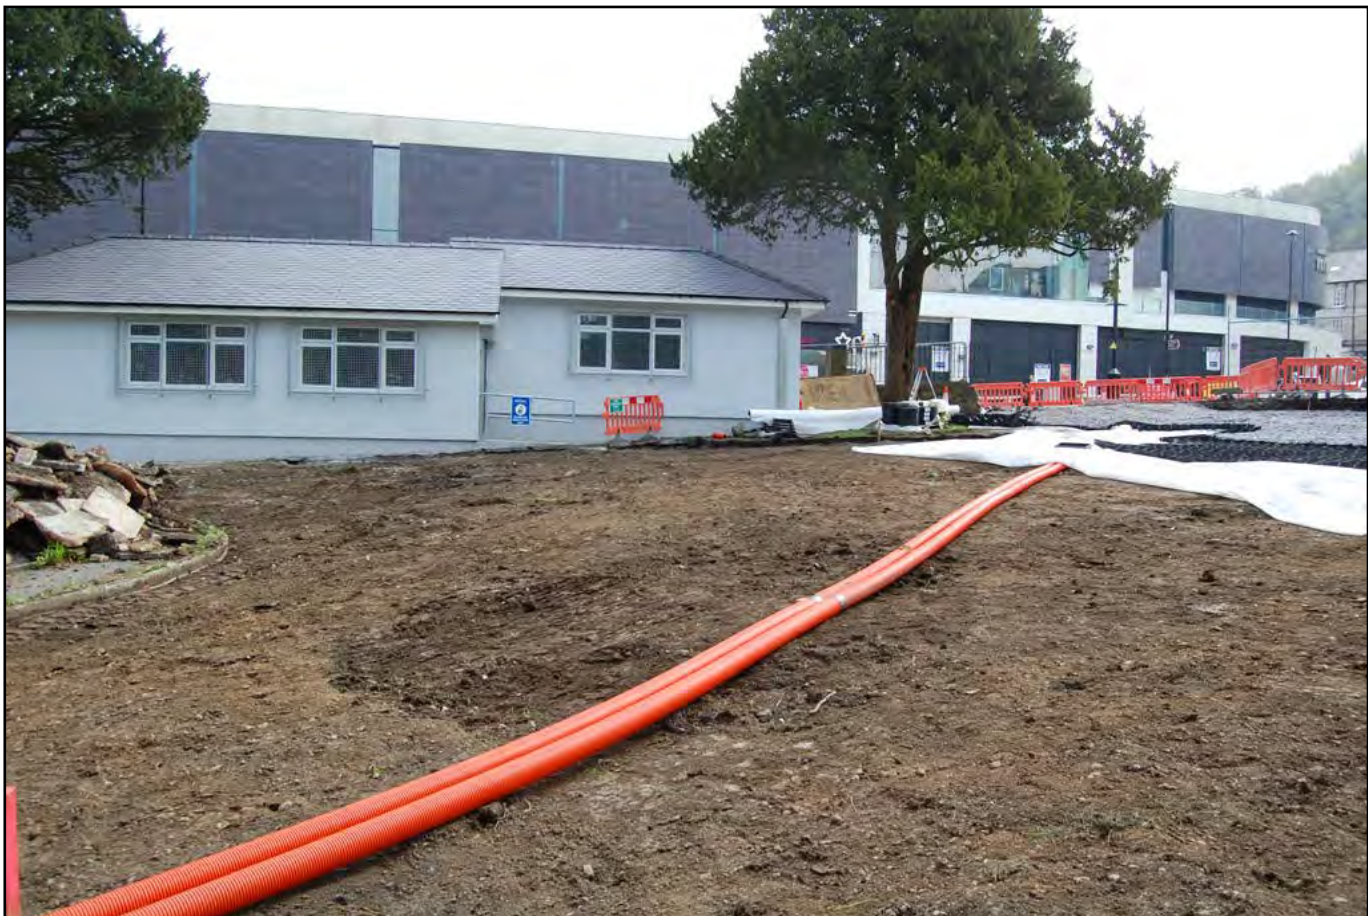
Plate 08 - Detailed view of the centre/eastern corner of the park, after completion of the topsoil strip. Note the shallow excavation depth (less than 100mm) and the orange ducting laid beneath the geotextile membrane: the ducting was used for running cables that powered illuminated bollards; the ducting was not buried into the stripped are, but laid onto the surface. The darkened area is a shrub plantation previously removed (cf. Plates 01 and 02).

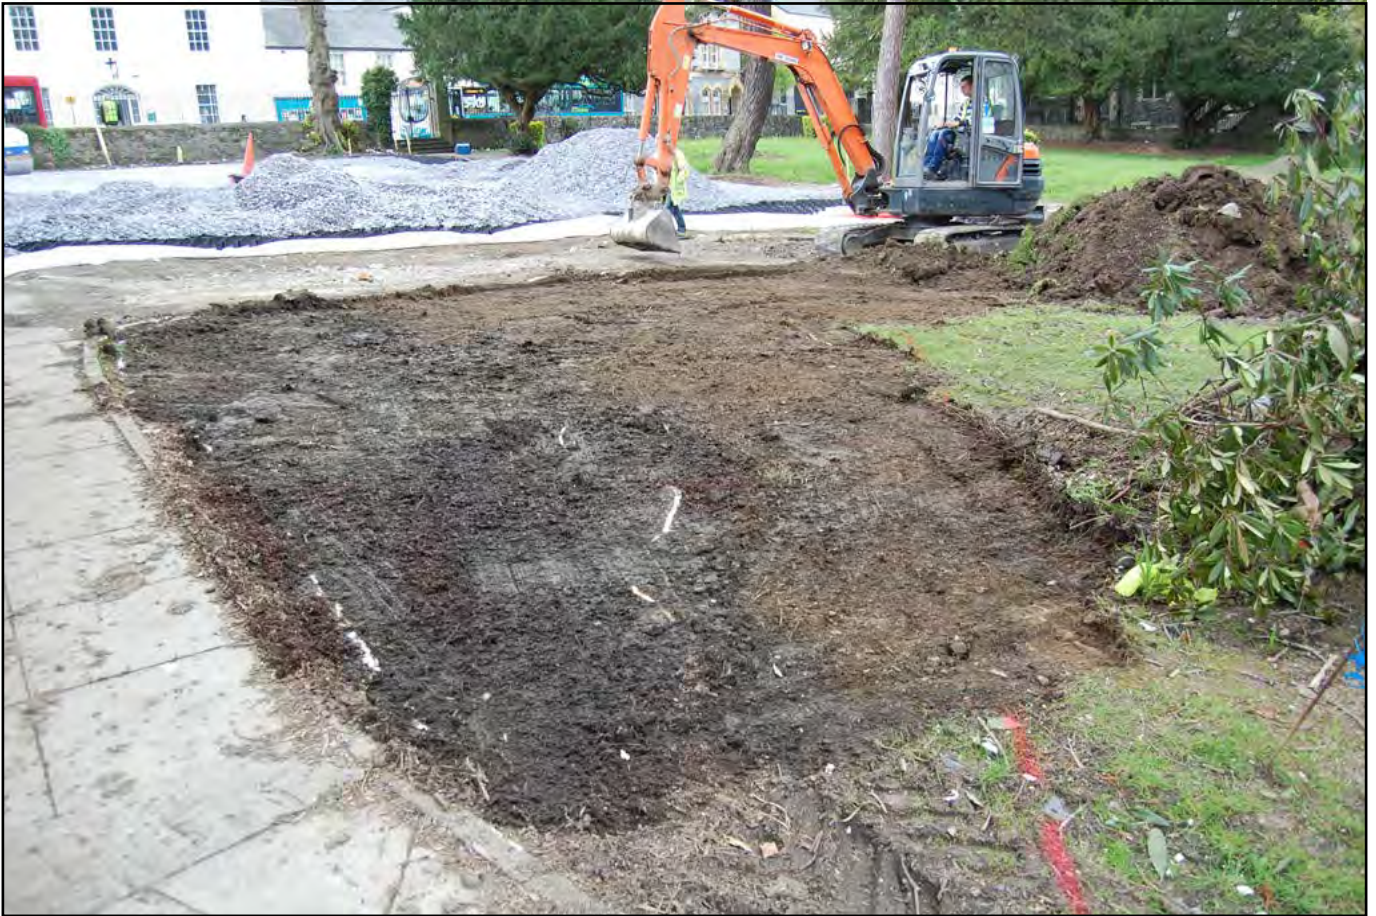
Plate 09 - View southeast of topsoil strip for the new pathway. The spray painted red line on the grass denotes the northern extent of the strip. Note the shallow depth, which is less than 100mm and deliberately kept higher to avoid damage to tree roots. As with the area visible to the top left of the image, the strip deposit was sealed with geotextile membrane, geocell and imported sub-base. The path was also removed.

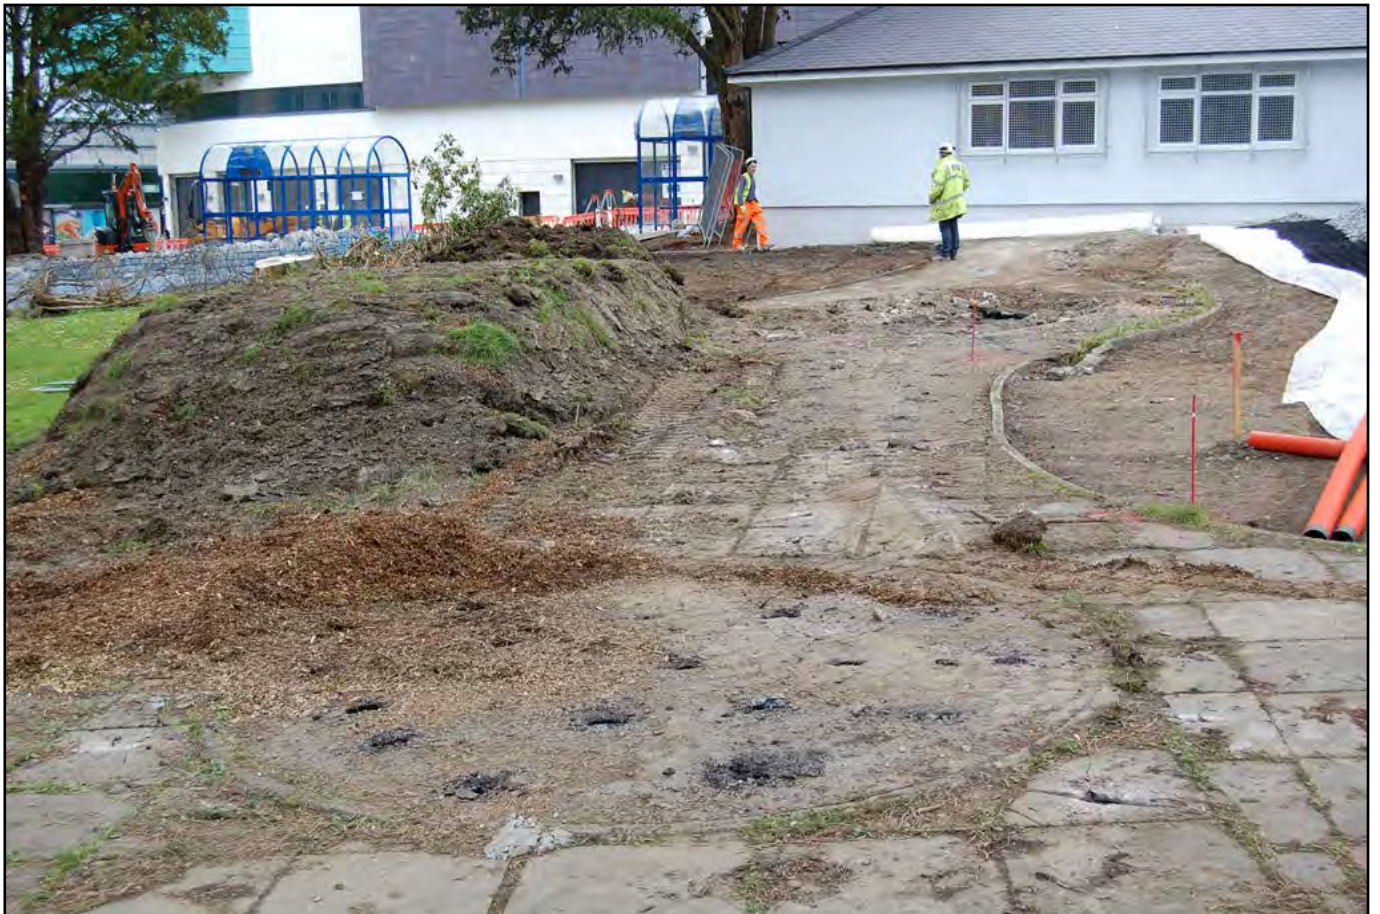
Where the existing path was not removed at the centre of the park, but was sealed by the new surfaces, the existing path was perforated with a pecker attached to the tracked excavator, to allow free drainage once it was sealed (plate 10).

Plate 10 - Alternative view of stripped area detailed in Plate 09; the stripped area can be seen at the top of the image, whilst the original pathway can be seen in the foreground. Note the perforations in the pathway: the geotextile, geocell and sub-base were laid directly on top of the path at this location, rather than the path removed, due to the change in levels; the perforations allowed the original path to drain freely.

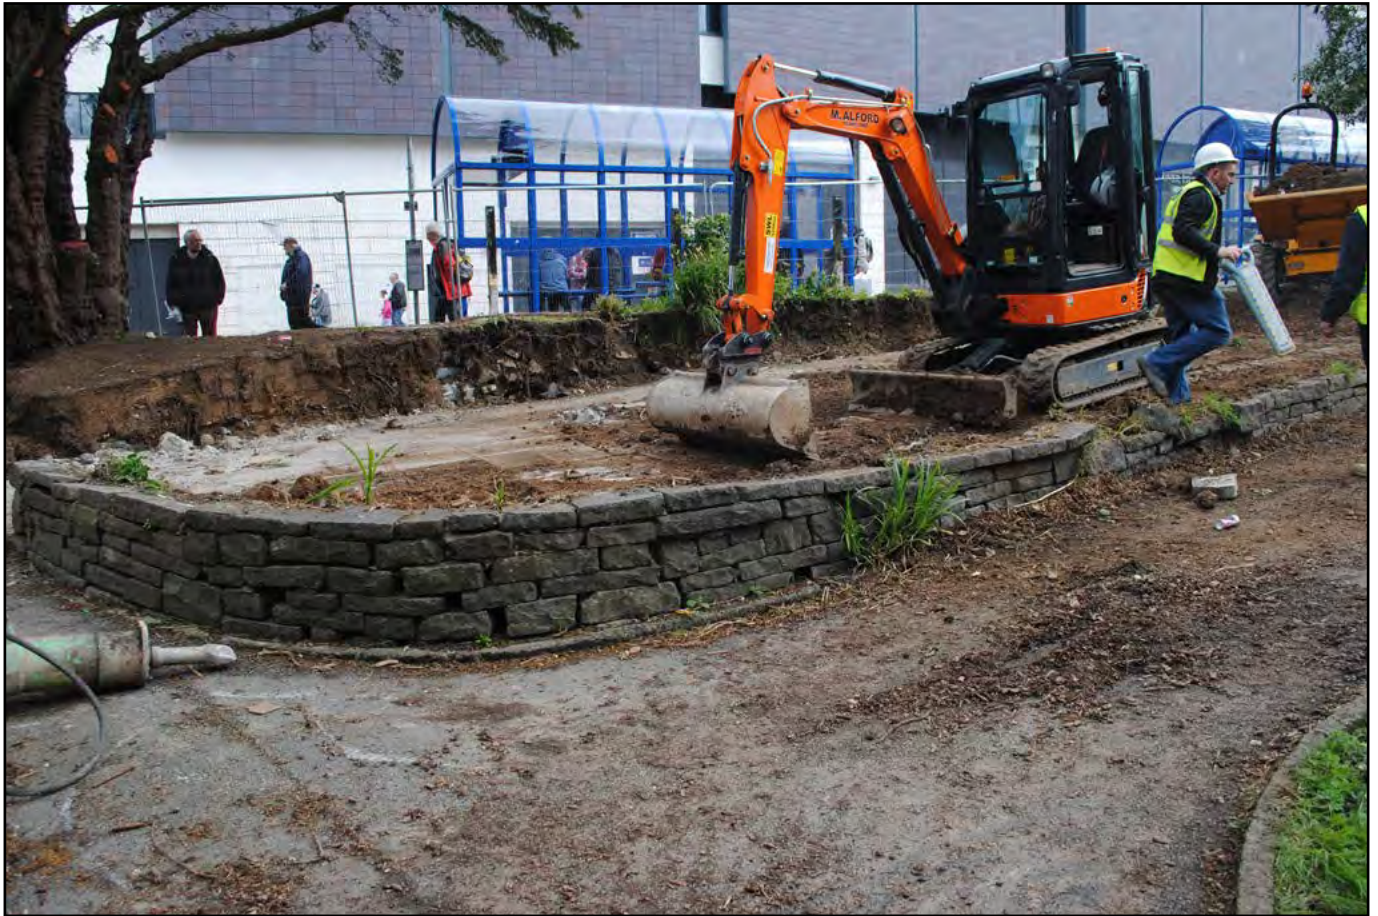
The existing plantation area/tactile garden at the northern end of the site was removed: the wall constructed from drystone dressed slabs, four courses high. The planter wall was removed by a 3 tonne 360° rubber tracked excavator fitted with a toothless ditching bucket. Both the upstanding and foundation portions of the wall were removed: the latter proved to be set within a shallow (<150mm) foundation trench cut into a bioturbated soil. The foundation trench averaged <200mm in width. No evidence of archaeological activity was identified. The replacement plantation area, utilised the same footprint as the existing and was built up from the existing ground level.

Plate 11 - View northeast of removal of an original planter. The planter had been built up from ground level and edged with unbonded stone (four courses high). The depth of the built up material forming the centre of the planter can be seen at the back of image close to the bus shelters. The exposed surface beneath the machine bucket was not breached: the area was subsequently built up and edged with re-dressed stone recovered from the boundary wall demolition zones.

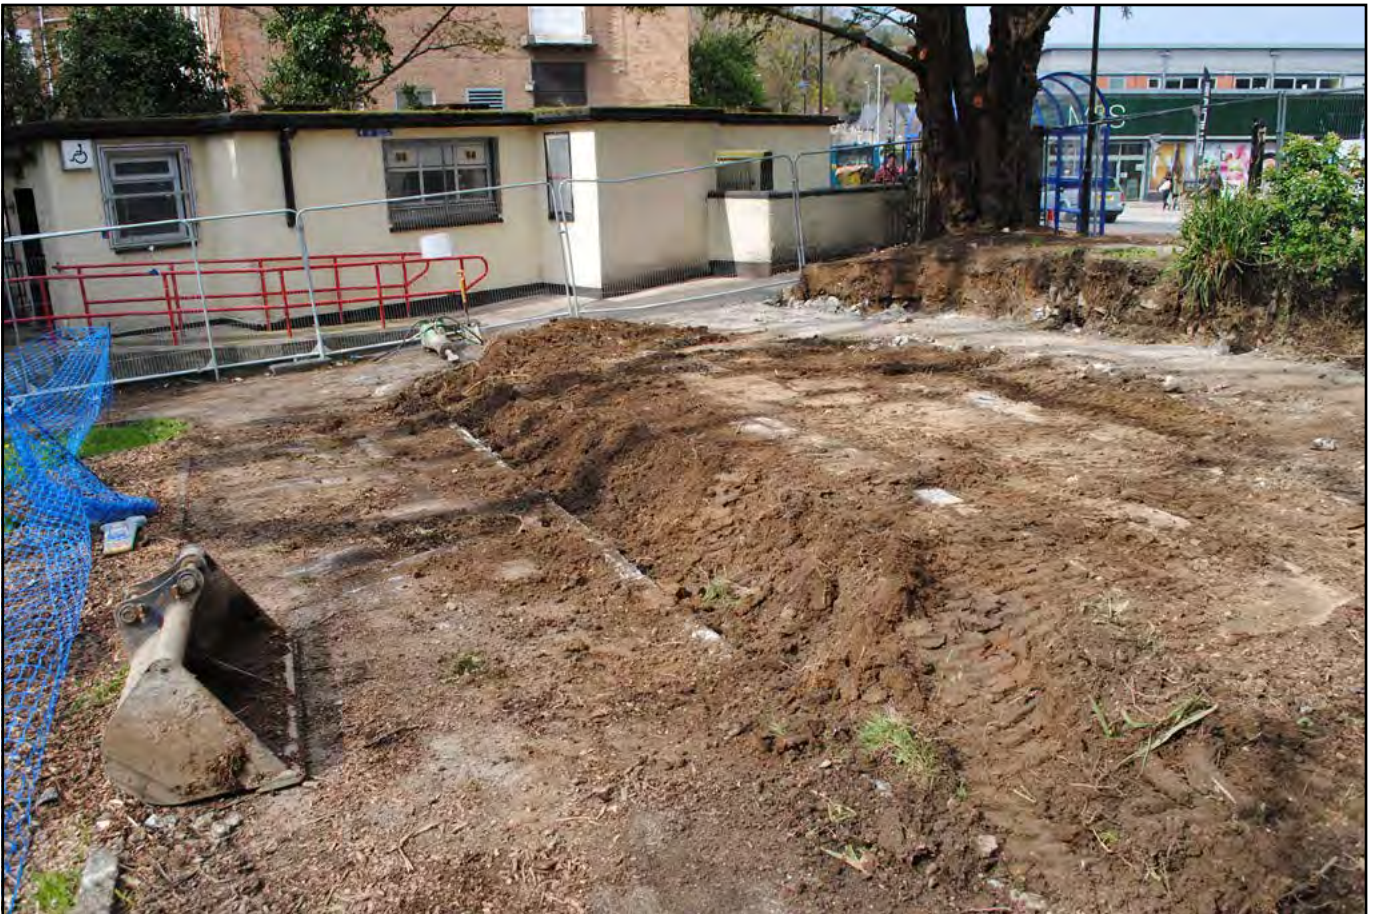
Plate 12 - View north-northwest of the planter area after the removal of the existing wall visible in Plate 11. There was no significant foundation cut or foundation course: the wall was set into a topsoil deposit. The area was subsequently built up and edged with re-dressed stone recovered from the boundary wall demolition zones.
