# Tre'r Ceiri Iron-Age Hillfort Management Plan

Project No. G2245

Report No. 1121

# TRE'R CEIRI IRON-AGE HILLFORT: MANAGEMENT PLAN

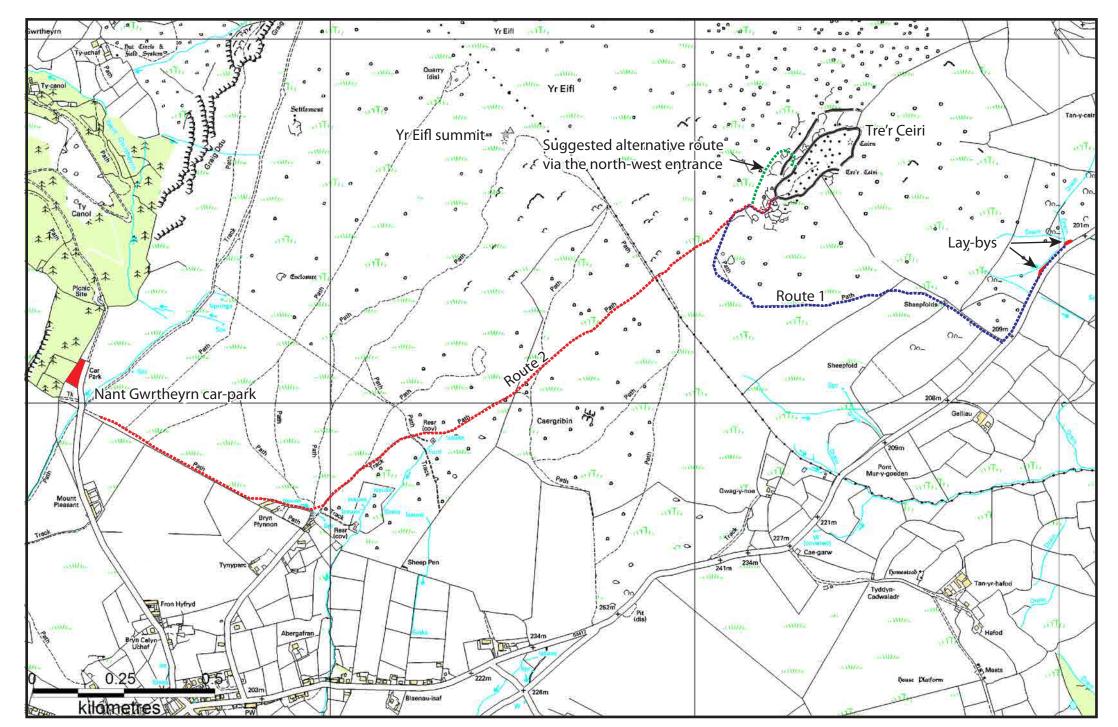
There are three main routes that are used by most visitors to Tre'r Ceiri (Fig. 2).

Fig. 2 Tre'r Ceiri: Main access routes

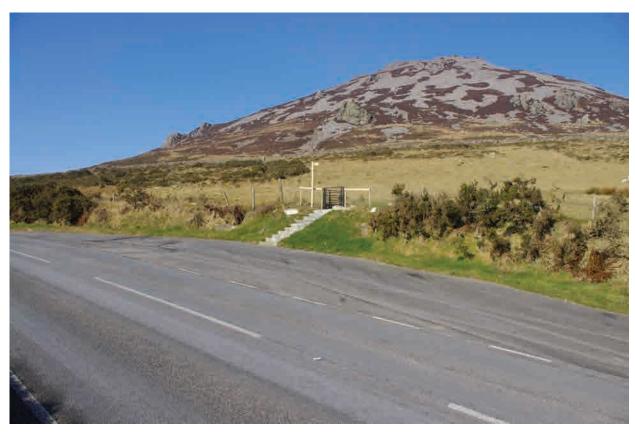
(i) The first starts at two lay-bys on the minor road between Llanaelhaearn and Llithfaen. The largest of the lay-bys is asphalted and there is a gate and a footpath sign, with no marked destination, leading from it (Plate 1). The footpath leads towards the road to Trefor and provides no access to the site. Visitors who are not familiar with the site commonly assume that gate leads to a path up Tre'r Ceiri. There is, in fact, no easy way to the fort from this point. There is no access to the main footpaths to the site, which are further to the south-west because an unbroken dry-stone boundary wall runs from the road to the fort ramparts. The only way get to the site from this direction is over a hazardous scree and boulder slope. There are also no entrances through the ramparts on this side of the fort.

The most urgent problem on this route is a lack of coherent signage. There are no directions from the lay-bys to the start of the footpath that runs from the road (Plate 1). This leads to visitors trying to access the monument from the gate at the main lay-by. This has led to damage to the dry stone boundary wall to the south-west when visitors have tried to climb over it. The most urgent task is therefore to provide signage directing visitors to the footpath and informing them that the gate and right of way in the lay-by do not provide access to Tre'r Ceiri. The route to the footpath involves walking along a fairly busy road for 300m. This is potentially dangerous and consideration should be given to the provision of a footpath, either alongside the road or within the adjacent field, along with the provision of a stile to cross the boundary wall. A second option would be provision of parking closer to the start of the footpath. The verge is sufficiently wide to add a lay-by either immediately to the south-west of the start of the path or a few metres to the north-east (Plate 2). There may however be some issues with line-of-sight for motorists with either of these options. Route 2 (below) is a safer route and information directing visitors from the lay-bys to Nant Gwrtheyrn car-park are also recommended.

Plate 1 The lay-by to the south-east showing gate and sign

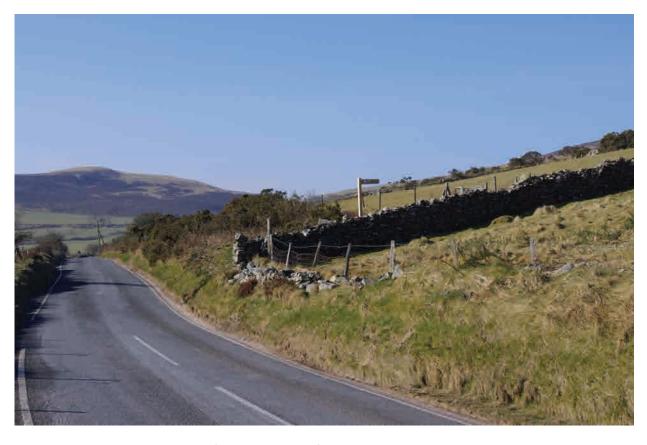
The correct access to the fort is via a footpath which is accessed from the road 300m to the south-west of the main lay-by (Plate 2). There are, however, no signs directing visitors to this footpath from the lay-bys.

Plate 2 The start of route 1 showing footpath sign and boundary wall
