PRINCE'S PIER, MENAI BRIDGE PORTH MENAI DEVELOPMENT

Archaeological Watching Brief Report

Project No. G2352

Report No. 1151

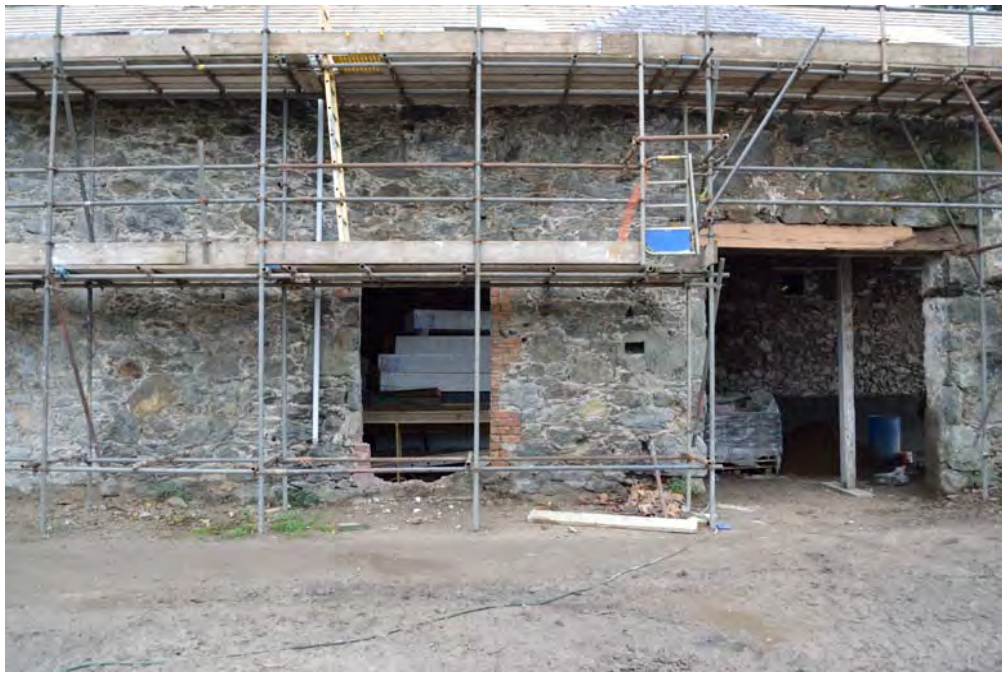
Removal of the render revealed that the southernmost window on the eastern elevation of the warehouse had originally been a doorway (Plate 5). This had at some point been partially bricked up at the base and the northern side so as to create the window. None of the brickwork was disturbed as part of the works.

Plate 05: External eastern elevation showing partially bricked up doorway. View from the east.

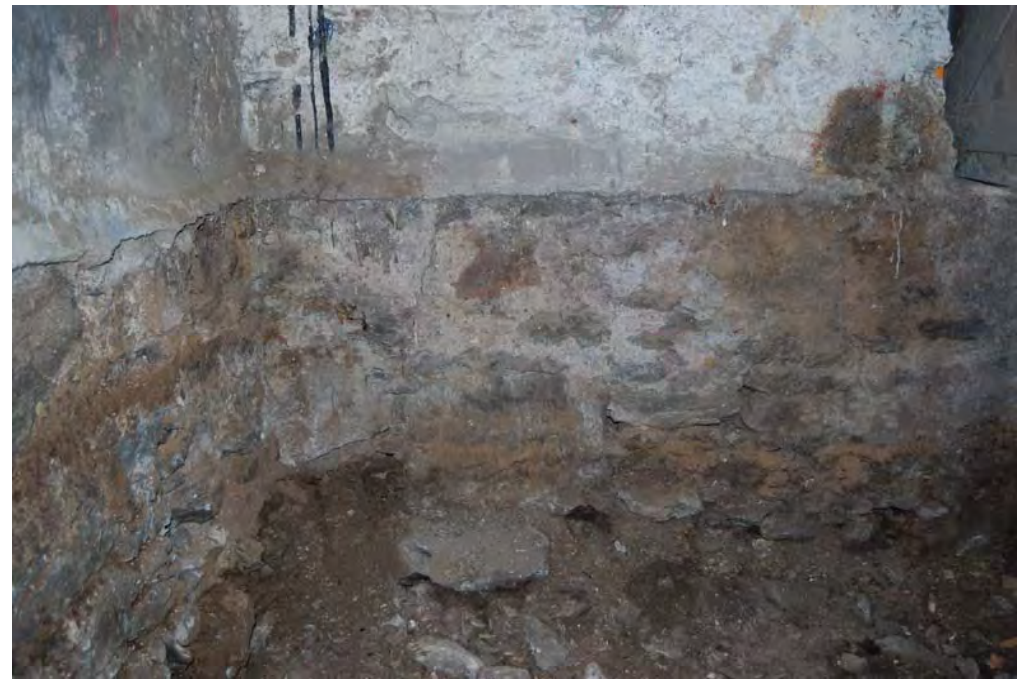
The wooden floorboards were removed revealing a series of eleven stone dwarf walls, approximately 2.15m apart, for the raised floor (Plate 6). The majority of these were in fairly good condition, with the exception of the ones towards the gable end of the building where they had collapsed. Removal of these dwarf walls and excavation of the bedrock below them showed that the walls of the Prince's Pier buildings had been built directly on top of the natural bedrock (Plate 7).

Plate 07: Foundations of northern elevation gable end wall. View from the west.

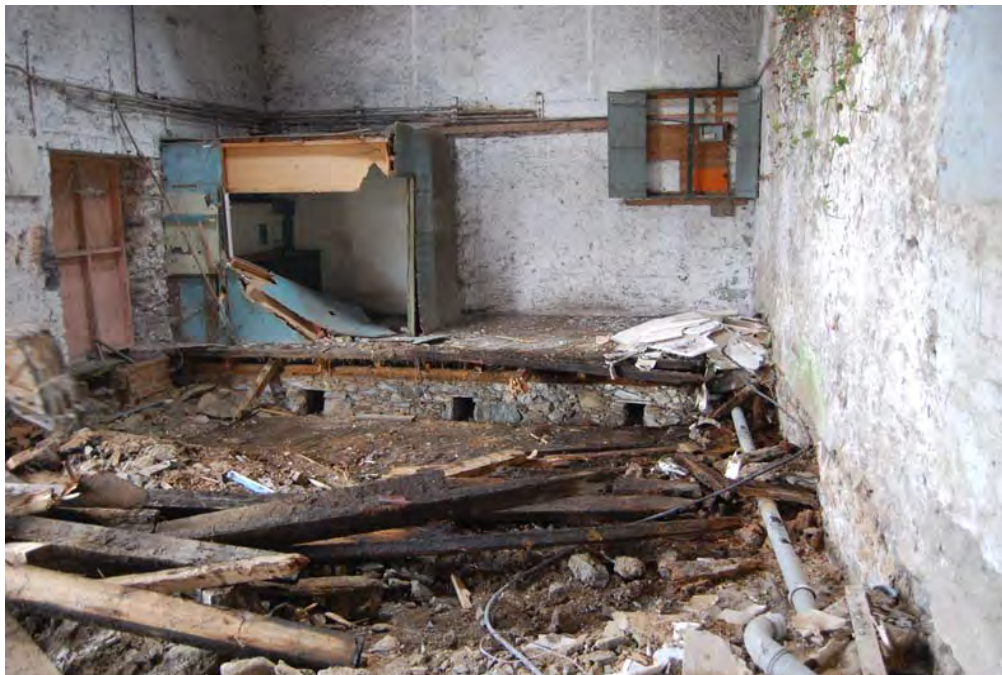
Plate 06: Dwarf Walls exposed during works. View from the NNW.

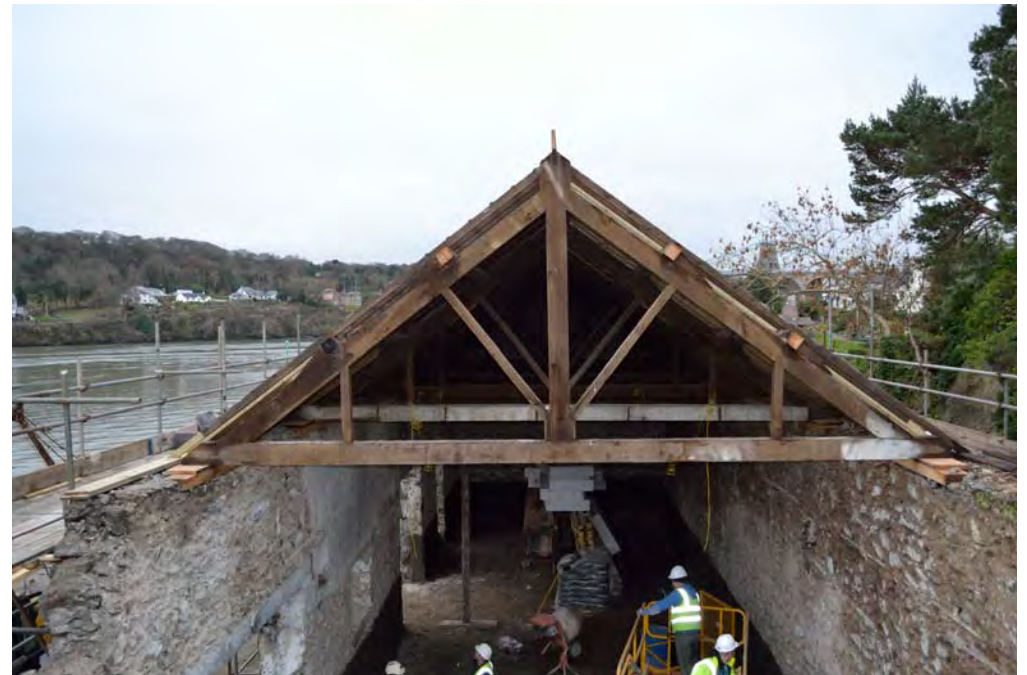
The roof tiles were also removed revealing the timber joists and 'A' frame timber trusses (Plate 8) partially built into the inner skin of the walls. The joists and trusses were in good condition with the exception of the truss at the gable end of the building which had to be removed for renovation.

Plate 08: Exposed roof timber trusses. View from the north.

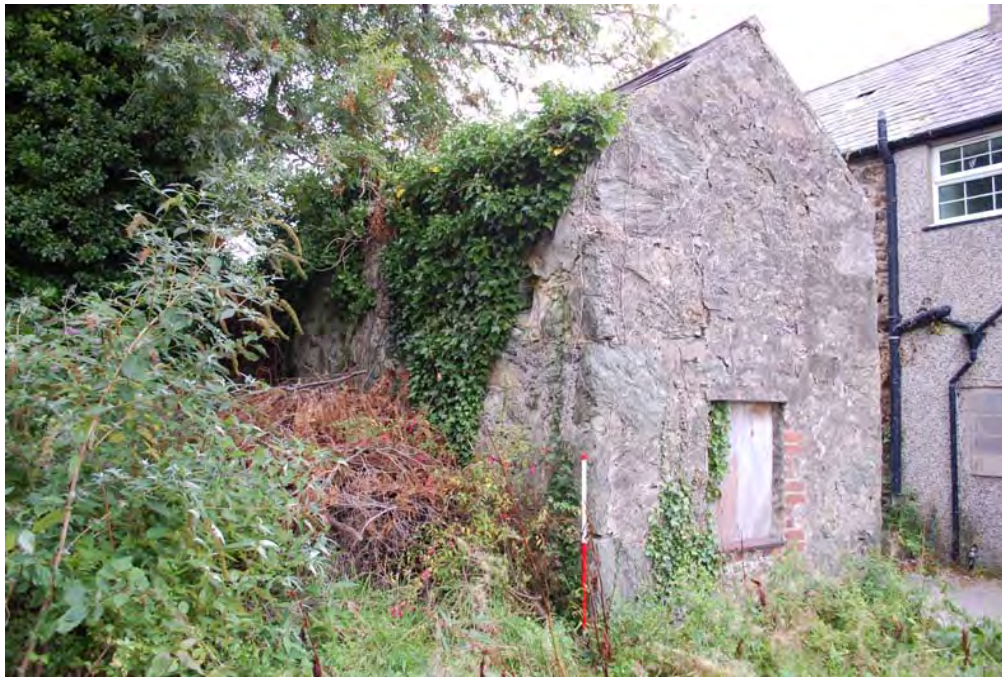
Plate 01: Outbuilding. View from the southwest.

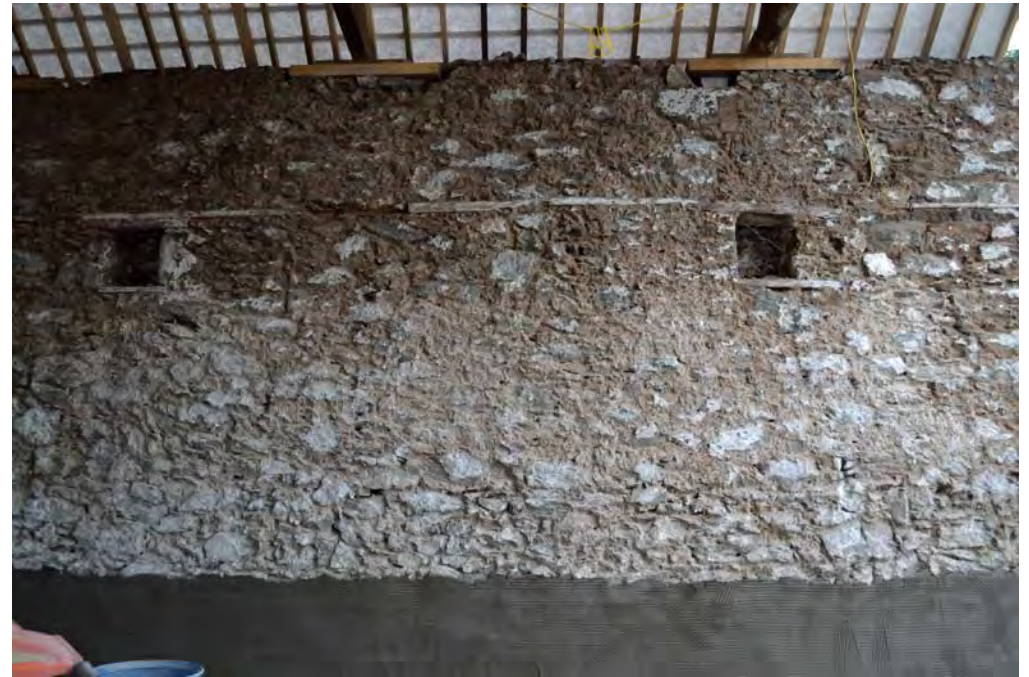
The cement render from the interior and exterior walls was removed revealing walls constructed of randomly coursed schist blocks. A number of recesses were visible within the internal elevations for the original first floor beams (Plate 3). A large crack was visible running vertically along the northern gable end wall of the warehouse (Plate 4), and was therefore partially removed and rebuilt. Removal of the gable end wall revealed no evidence of any phasing activity.

Plate 03: Internal western elevation wall with render removed showing recesses for first floor beams. View from the east.

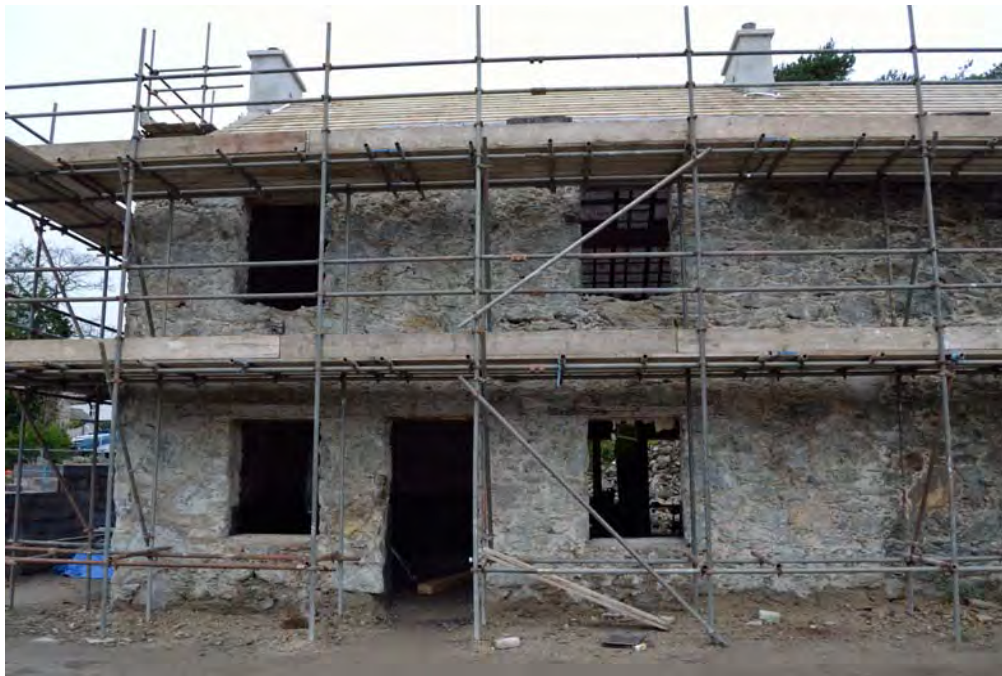
The Pier Master's house is attached to the southern end of the warehouse, although still part of the same larger building (Plate 2). The pebble dash render on the outside, and the cement render from the interior, was removed revealing walls constructed of randomly coursed schist blocks. The floors, ceiling, stairs, and all internal fixtures and fittings were all removed.

Plate 02: Pier Master's house, eastern elevation. View from the east.

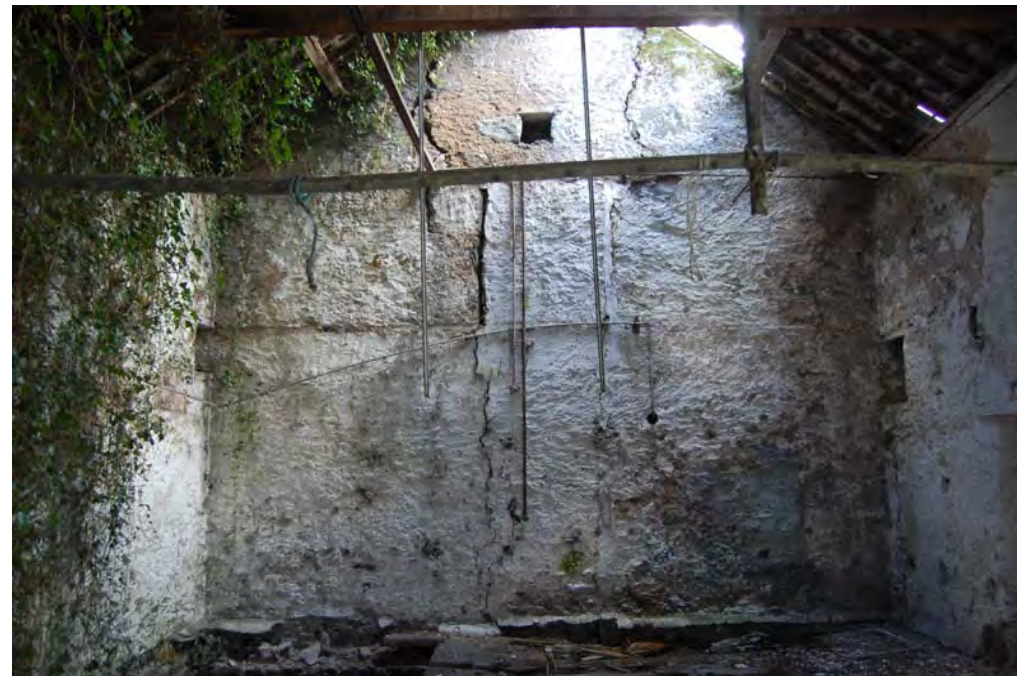
Plate 04: Internal northern elevation gable end wall. View from the south.
