HIGH STATUS MEDIEVAL SITES CASTELL CARNDOCHAN

Conservation and Assessment Excavation

Project No. G2366

Report No. 1213

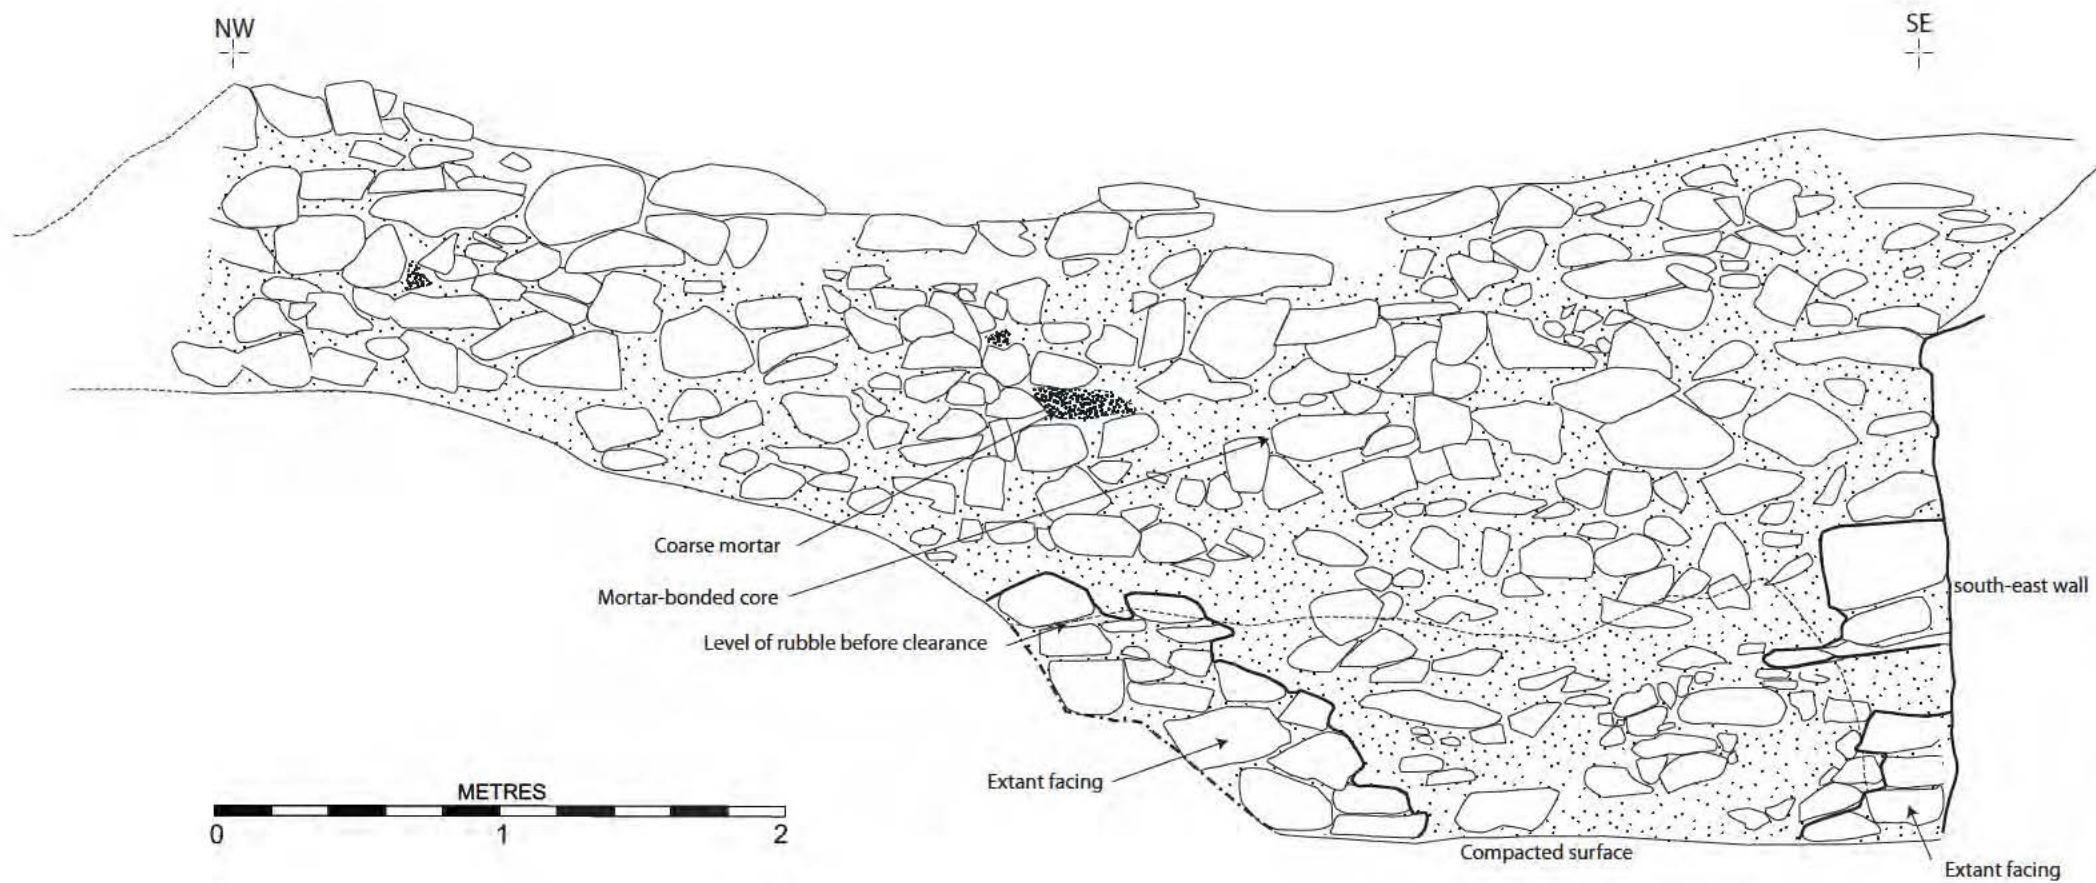
Fig. 4 Trench 1, Collapse A, elevation after clearance

The clearance revealed extant facing on the north-west side of the collapse (Plate 6). This contained some voids but appeared to be fairly stable. The central 1.3 m of facing had collapsed from the base. The masonry was not hand-drawn on site for health and safety reasons but a drawing was produced from rectified photographs and an orthographic projection from a 3D model (Fig. 3). The clearance of the loose rubble revealed a surface of compacted gravel and small stones which appeared to coincide with the base of the wall and could be the remains of a floor level. There were, however, small voids beneath all of the extant facing stones suggesting that the wall had been undermined by the early excavations and the floor levels disturbed. This was presumably a contributory factor in the loss of the facing. The exposed core at the base of the wall appeared to be mostly *in situ* but contained frequent voids and in its present state threatens the stability of the wall above (Plate 7).

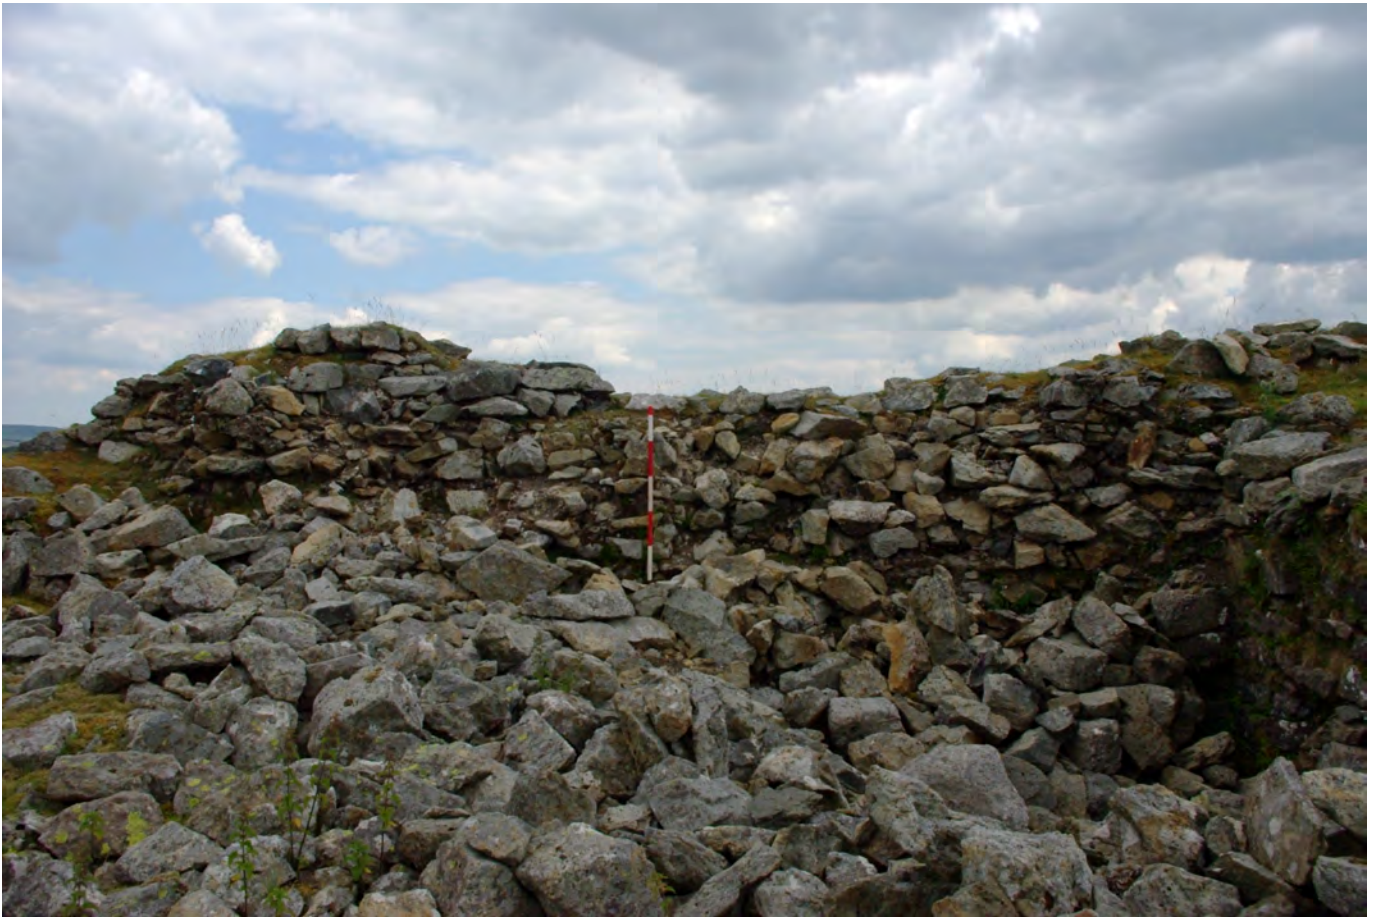
Plate 5 Trench 1, (collapse A) before clearance

There was a spread of un-weathered loose rubble in front of the collapse and there was some loose stone lying on the steep exposed surface of the core (Plate 5). The loose stone was first removed from the stable core to prevent it from falling into the trench during subsequent work. The core was stabilised with a temporary covering of wire mesh. The loose stone was then cleared from in front of the collapse while carefully monitoring the standing masonry for any signs of instability. The rubble was between 0.5m and 0.6m deep.

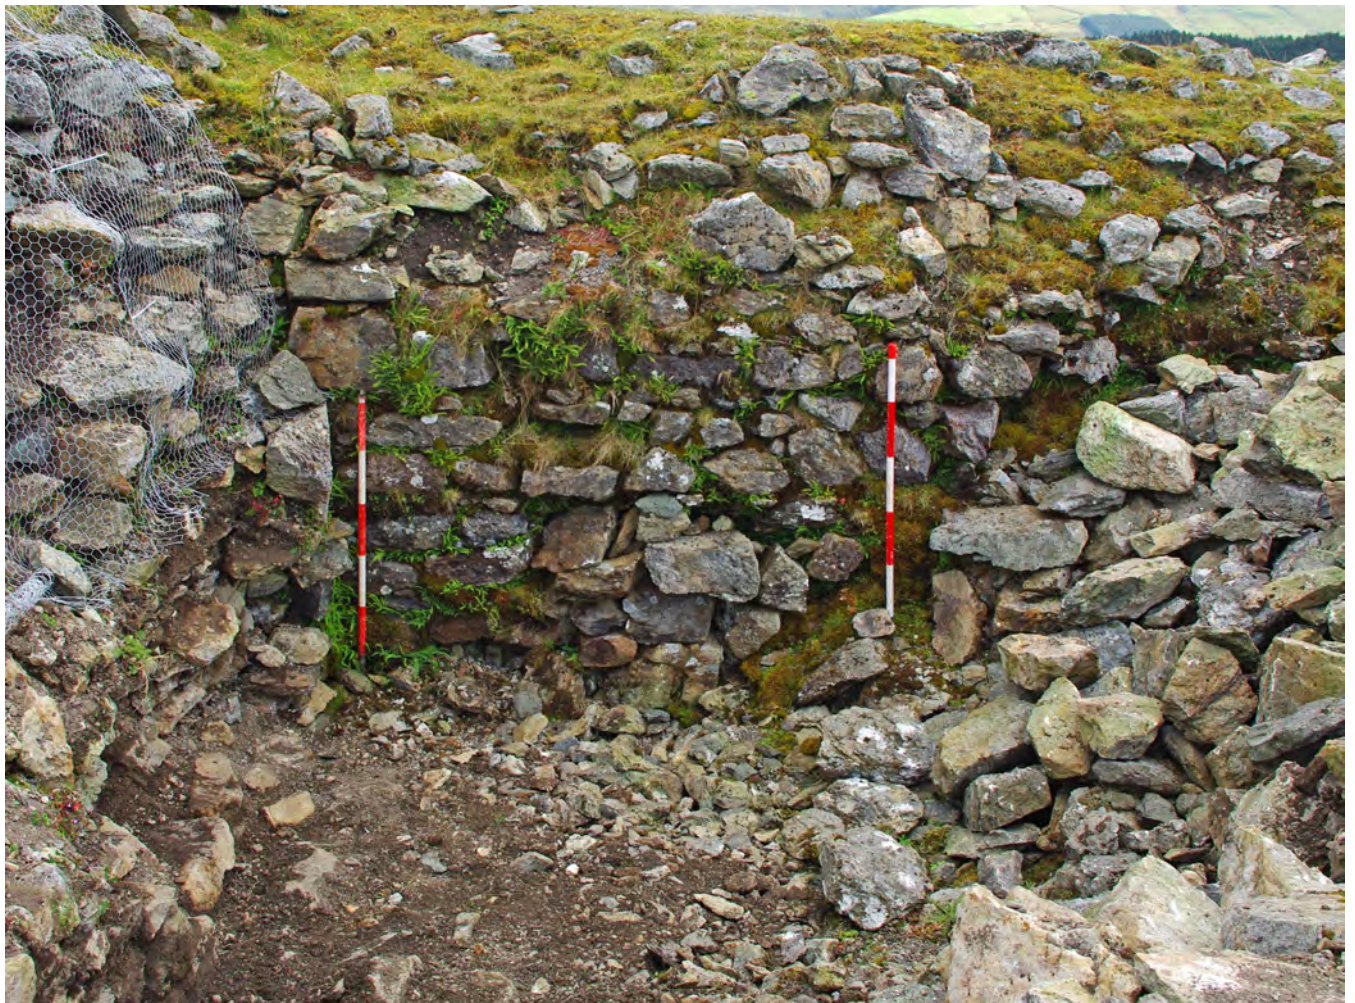
Plate 8 Trench 1, Collapse B after clearance

The south-eastern wall of the tower, adjacent to the collapse, survives to a height of c. 1.8m and appears to be reasonably stable (collapse B, see plate 8). There is, however, a large void close to the base, again probably a result of the wall being undermined. This has, at some time in recent years, been packed with dry-stone masonry. This was not disturbed during the clearance. This facing was partially obscured by vegetation and a drawn elevation was not produced.

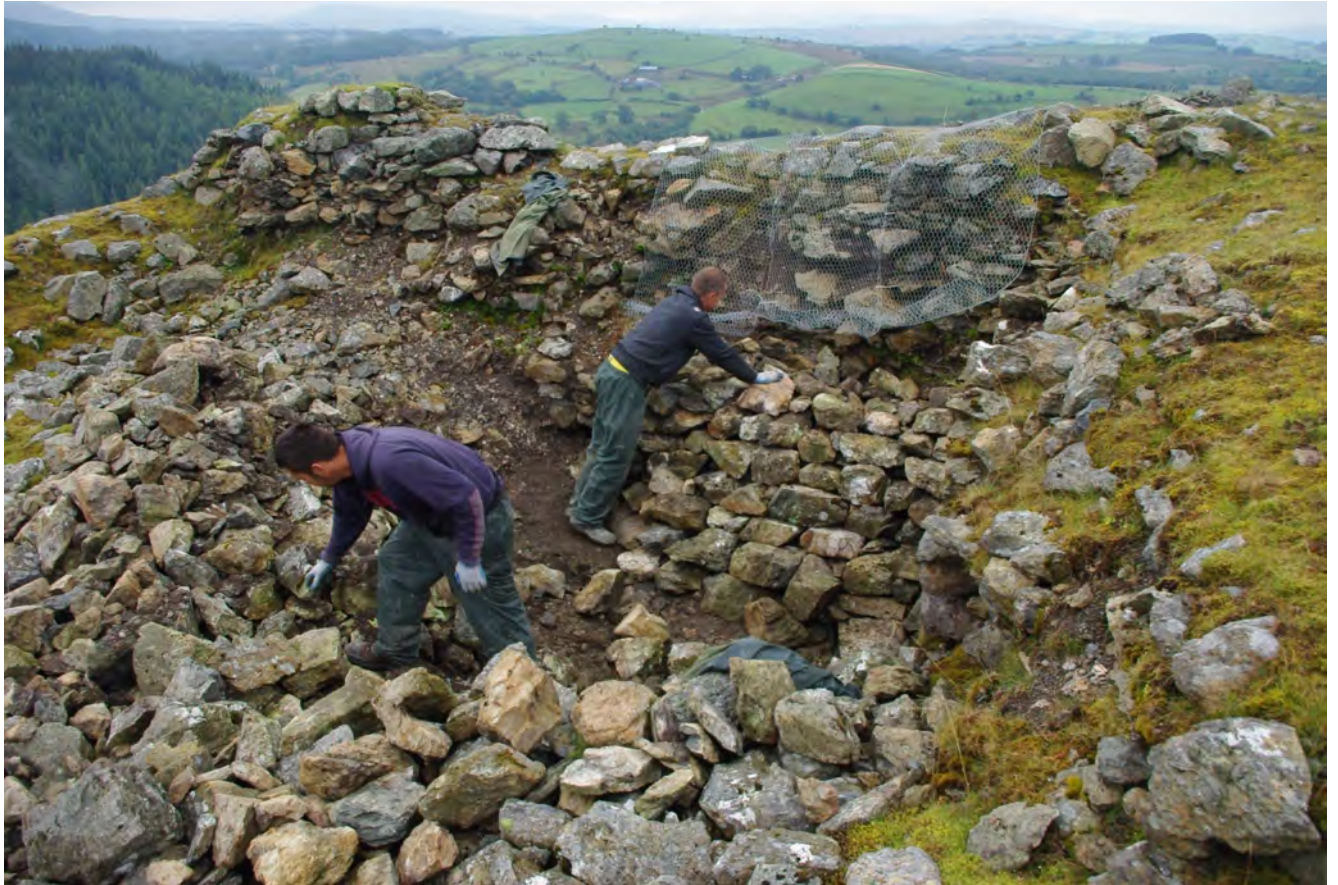
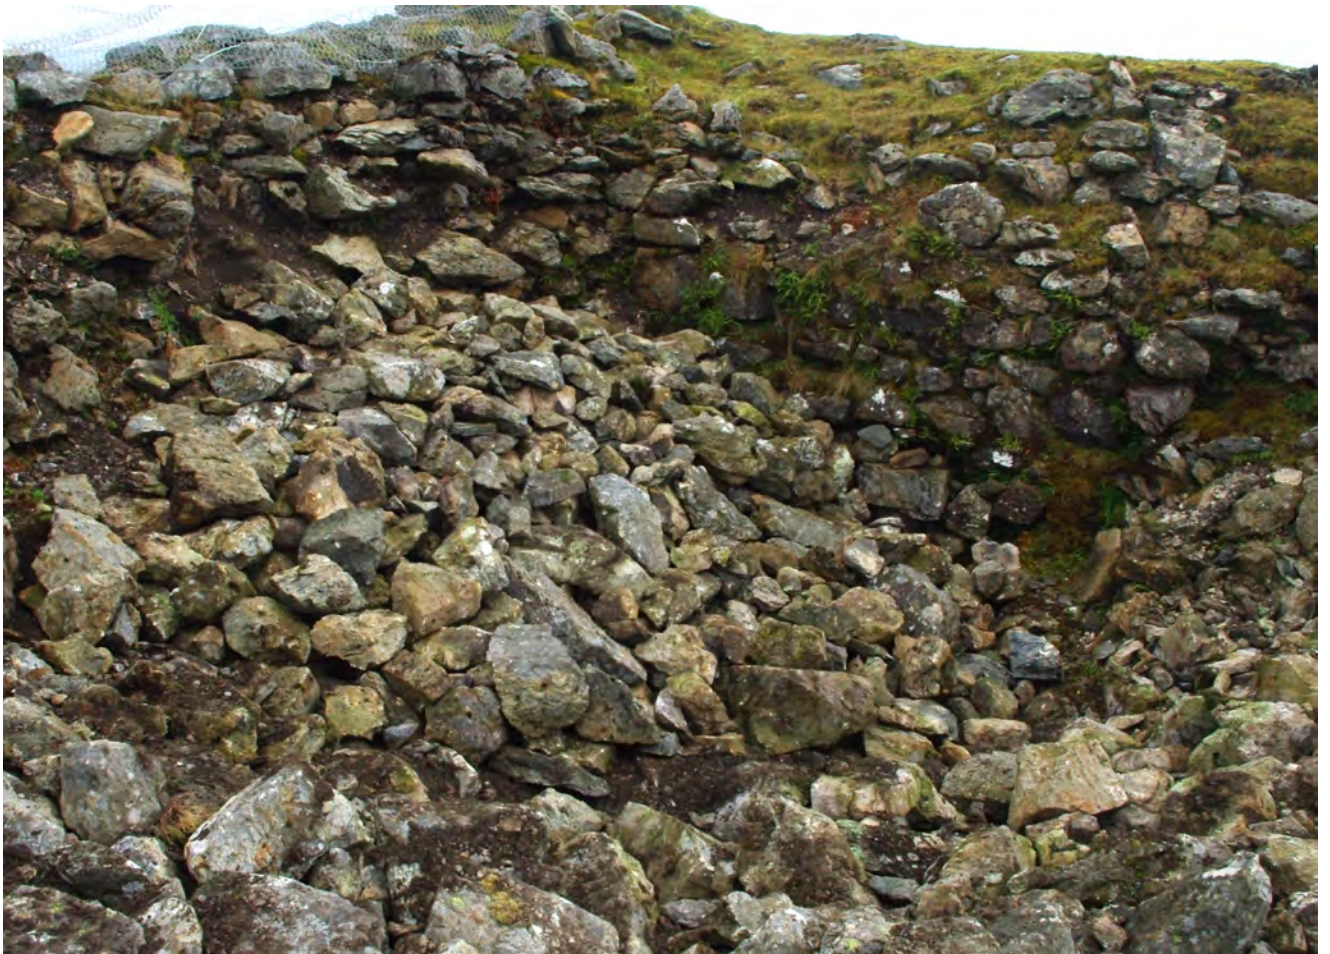
The stone from the clearance was packed back into the hole in the form of a deep buttress in order to retain the extant core in the lower part of the wall. This was covered with random stone in order to blend in with the rest of the interior (plates 9 and 10).

There is a stable surface at the base of the wall which provides additional options to those proposed by Mike Garner (appendix 2). Consideration should be given to pointing the extant facing and underpinning its base along with and packing and mortaring voids in the core. The photograph of the masonry that was extant in 1921 and 1949 demonstrates that there were no architectural features in the wall and this could be used as a guide for rebuilding at least the base of the facing if the architect considers that it would add to the long-term stability of the wall. Collapse B should be conserved as suggested in appendix 2 i.e. the packing stones should be removed from the void and replaced with mortared facing and the extant facing should be raked out and repointed. The supporting buttress will have to be at least partially removed in order to carry out the consolidation. This should be replaced in order to counterbalance the lateral thrust from the surcharge on the wall produced by rubble against the outer face.

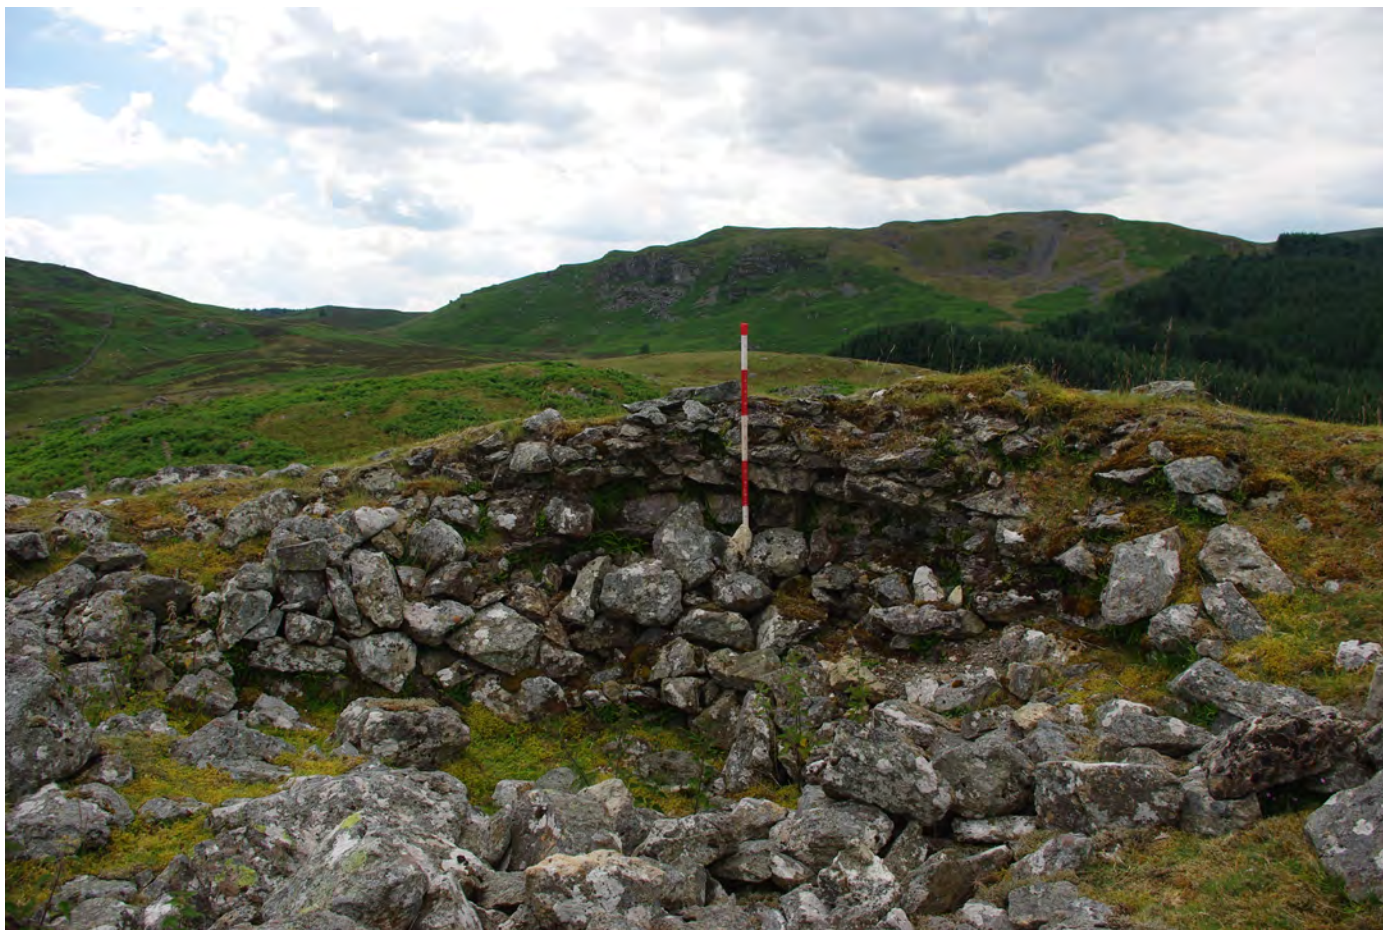
Plate 11 Trench 2, collapse C before clearance

This trench encompassed collapse C, in the middle of the apsidal end of the D-shaped tower, and investigated the masonry to either side. Before clearance there was a 2.2m wide collapse with

extant mortar-bonded wall-core standing to a height of 1.2m. This had eroded to a state of moderate short-term stability (Plate 11).

Reinstatement should be carried out as described by Mike Garner in Appendix 2. The eroding area should be built up with mortared core-work thus supporting the surviving masonry.

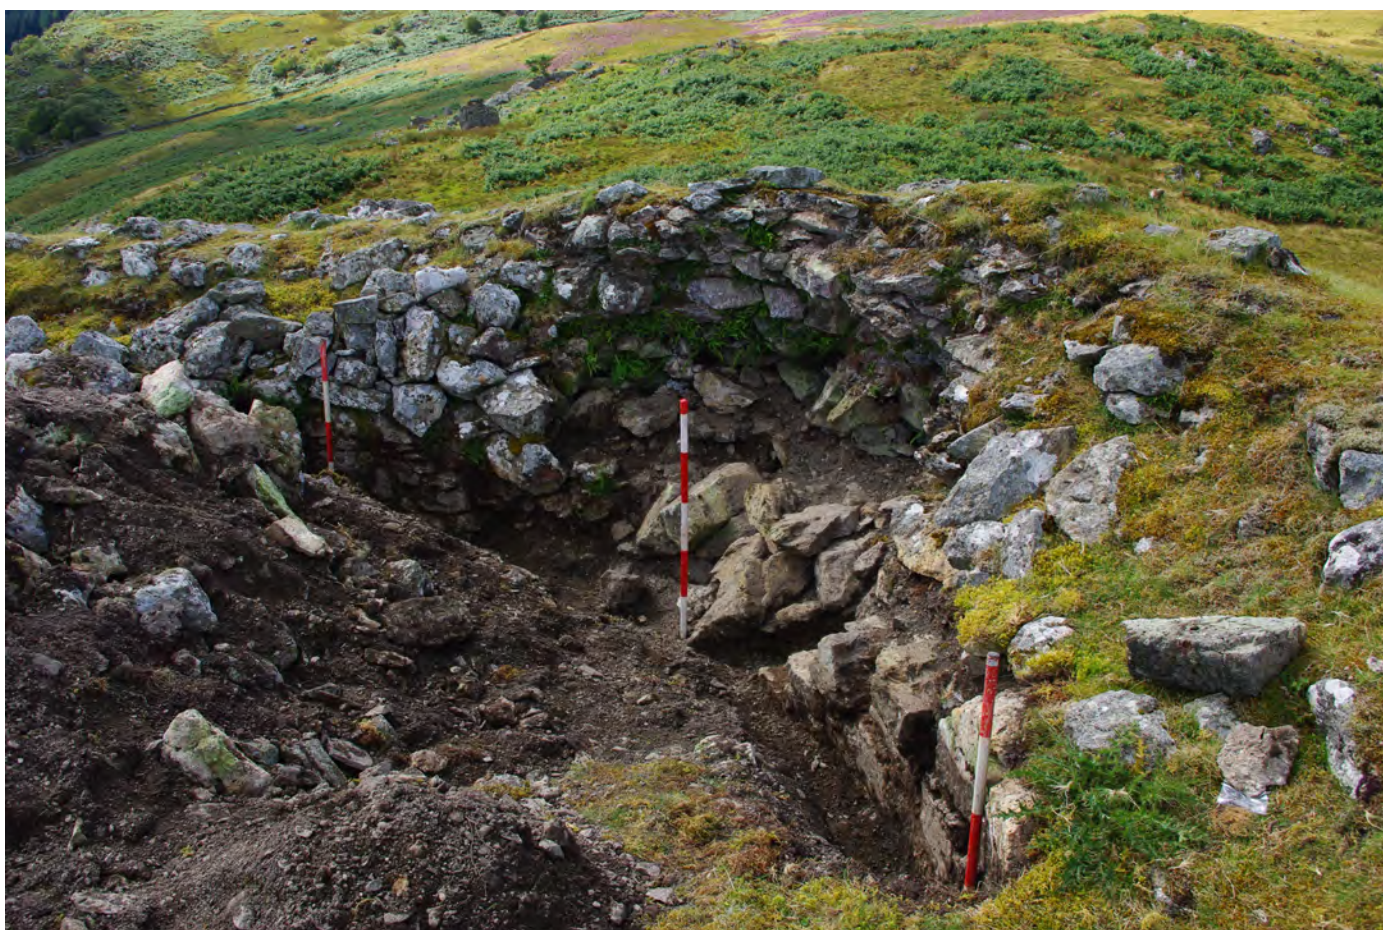
Plate 12 Trench 2, collapse C after clearance

After the trench was recorded it was backfilled to the level of the original ground surface and some of the previously cleared stone was packed against the exposed core in order to support and protect it (Plate 12).

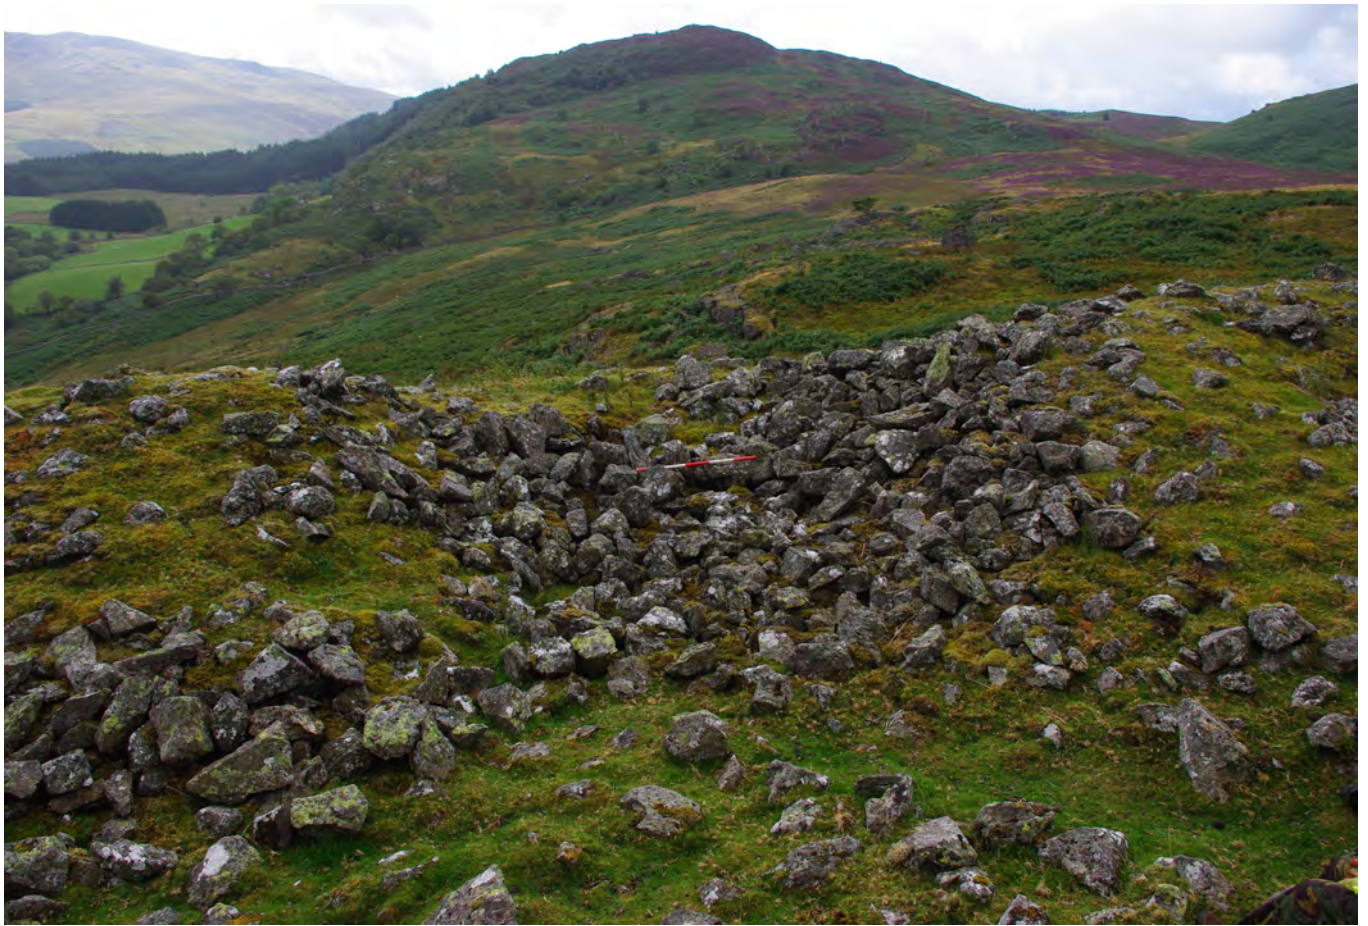
Plate 13 Trench 3 before excavation

This trench was excavated in order to investigate a fairly featureless area of rubble (Plate 13). This comprised a roughly circular bank of stone with a further amorphous bank to the west. This had been variously interpreted as a gate between turrets and a half-round tower (Hogg 1953-6). Cathcart King and Kenyon (2001, 407) suggest that Hogg's interpretation of a round tower may be correct and also suggest that the gate into the castle is likely to be between this and the D-shaped tower, concluding that "the determination of its position, and the exact plan of the half-round tower, are the principal questions which excavation would help to solve at Carndochan"

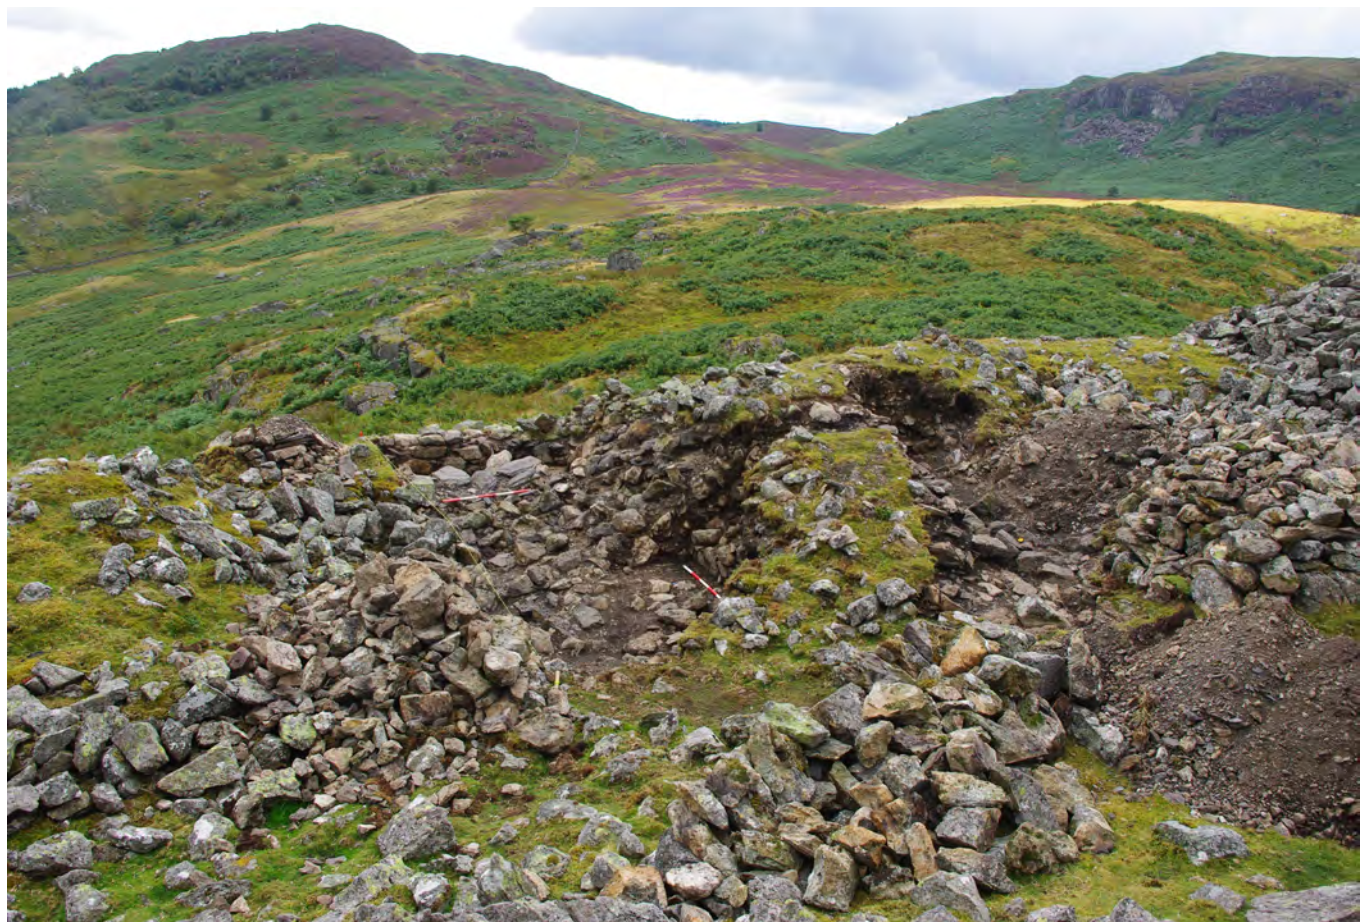
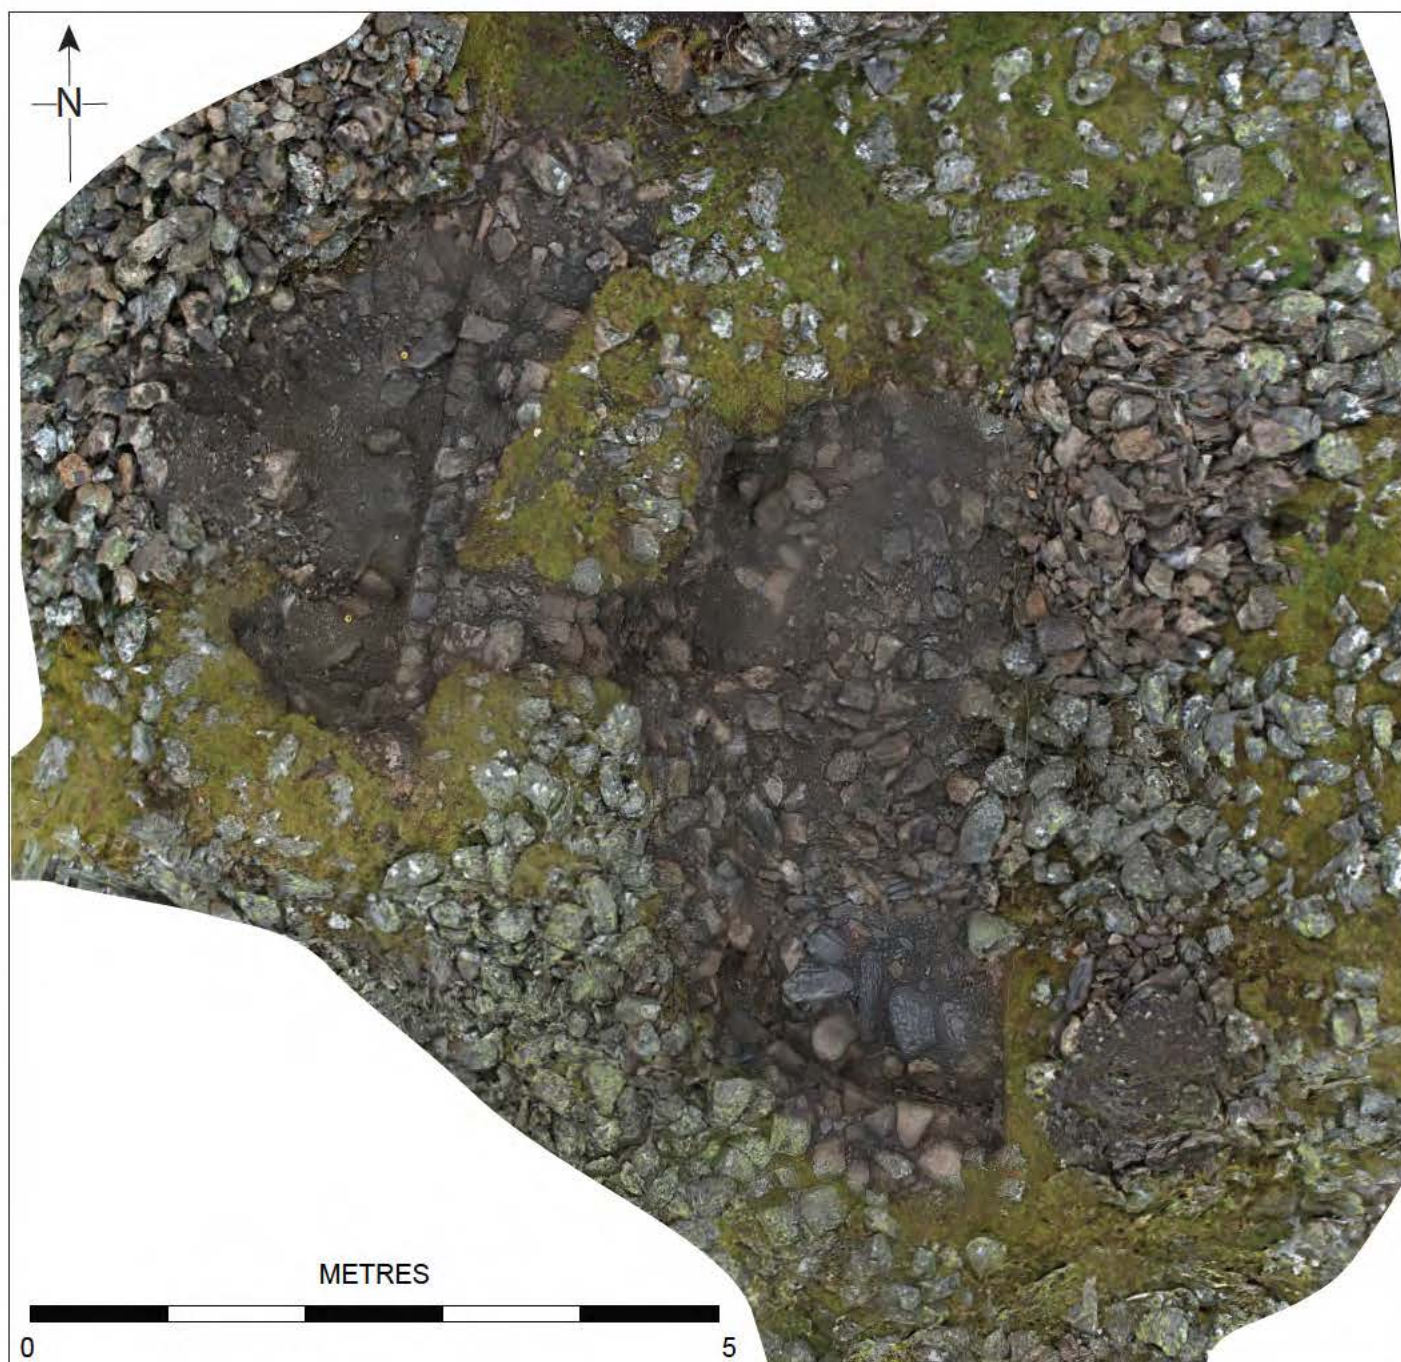
The upper layer of rubble, one or two stones deep, was removed revealing further randomly orientated stones in a matrix of fine sandy gravel, similar in many ways to the material found in trenches 1 and 2. In contrast, however, to the material from the D-shaped tower, this contained fragments of cockle shell as well as pieces of unburnt limestone. This was cleared to a sufficient level to reveal extant facing but no attempt was made to excavate it to its full depth or to expose stratified deposits (Plate 14 general and Plate 15 orthographic).

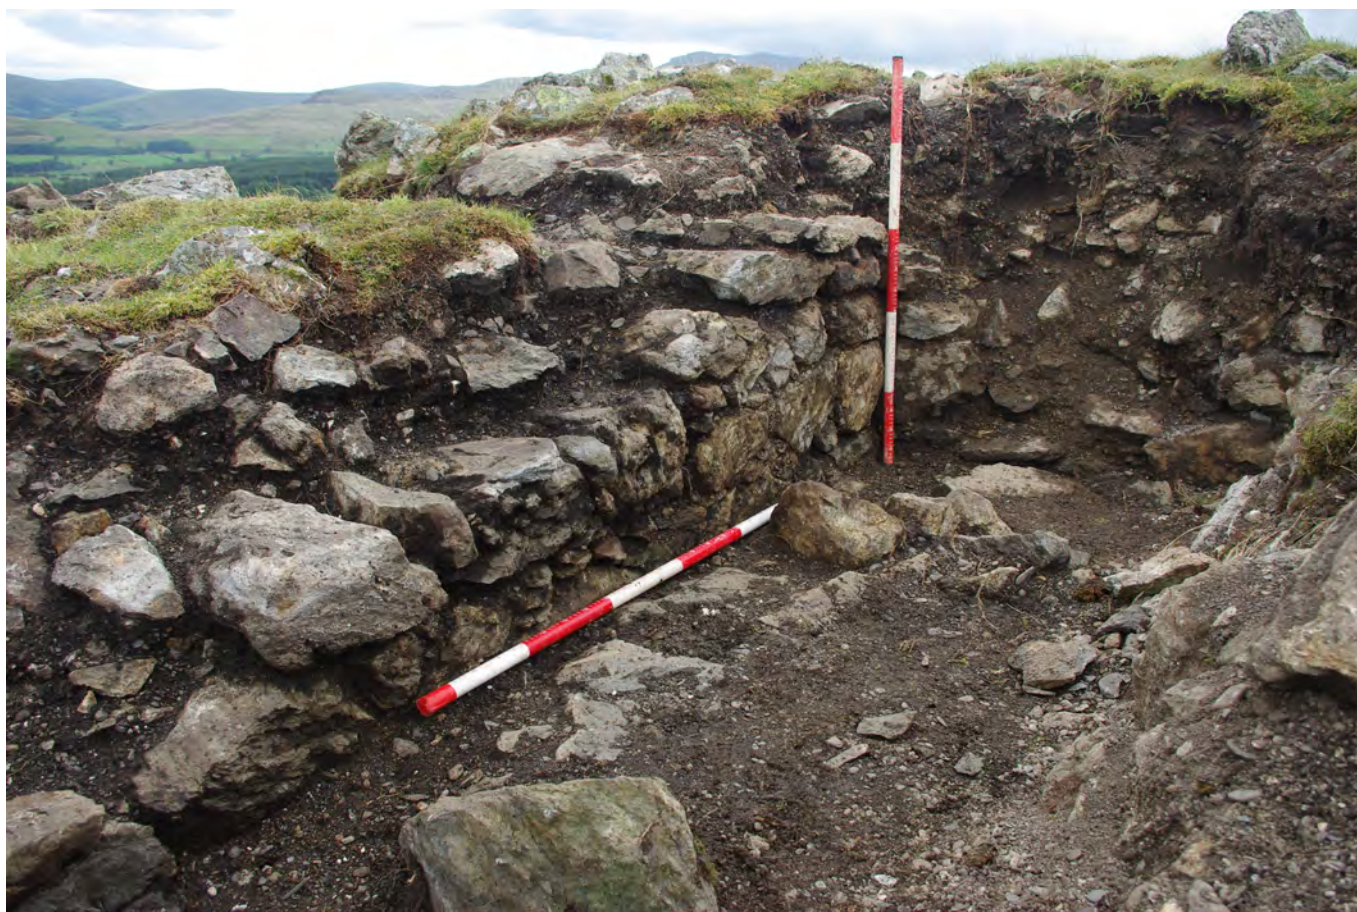
Plate 18 Trench 3, rectangular building after excavation

On the western side of the trench, a facing of similar masonry was identified, comprising what appears to be two sides of a rectangular structure (Plate 18). The eastern wall could be traced for 3.4m and the southern for 0.9m. The eastern face formed the outer face of the D-shaped tower 007. The eastern wall appeared to abut the southern although further clearance would be needed to confirm this and it is possible that the two walls could be bonded together. The full extent of this structure was not uncovered but the topography of the collapsed stone suggests dimensions of approximately 4m x 4m. The tumble was again not excavated to its full depth and only the top of the masonry was uncovered.

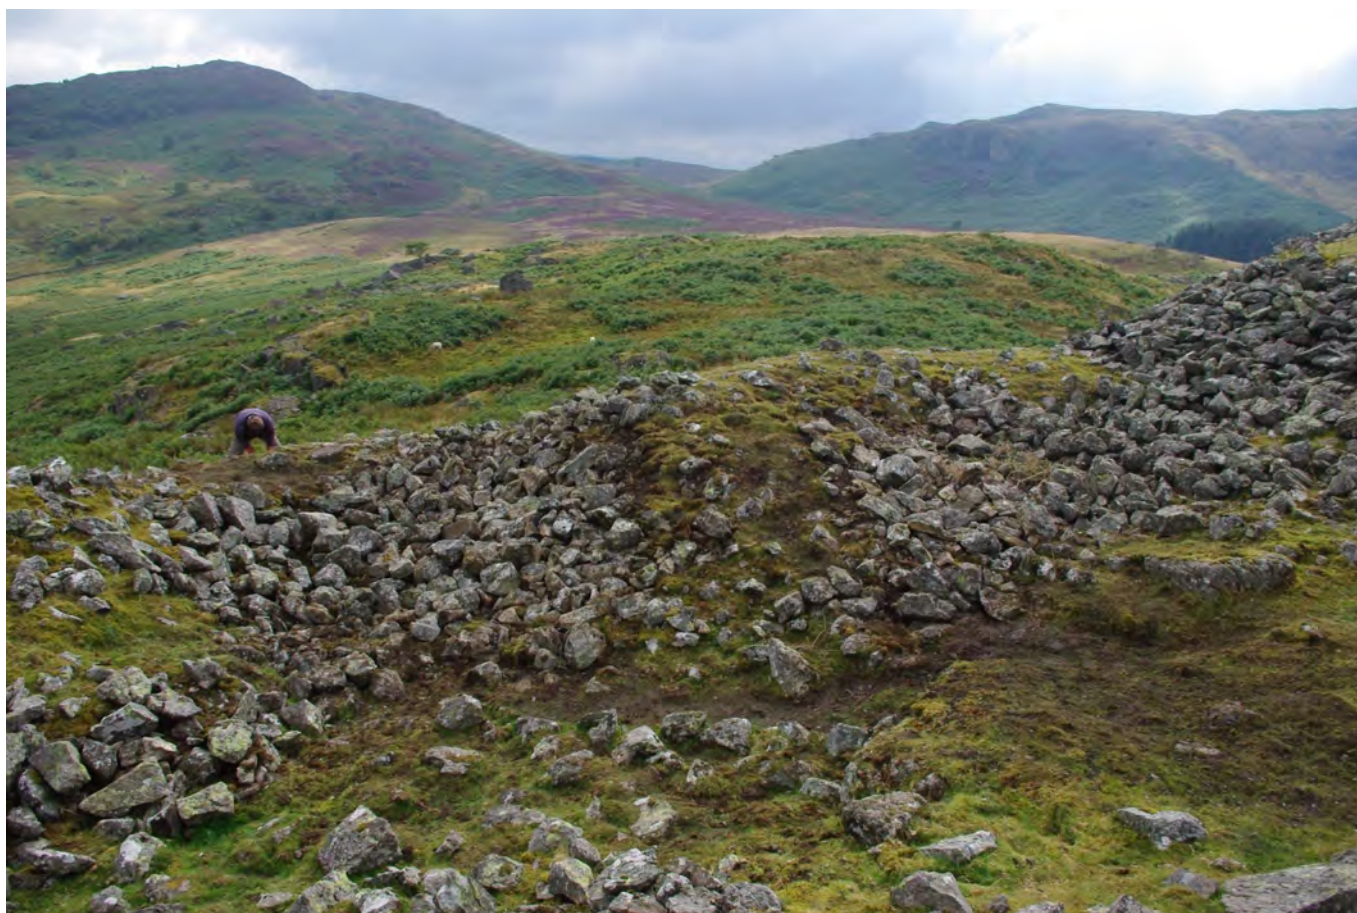
Plate 19 Trench3, after backfilling

The trench was reinstated by laying two sheets of geotextile at the clearance limit in the interior of the buildings and careful replacement of the stone and matrix following the original contours of the ground and replacement of the weathered and lichen-covered stone on the surface (Plate 19).

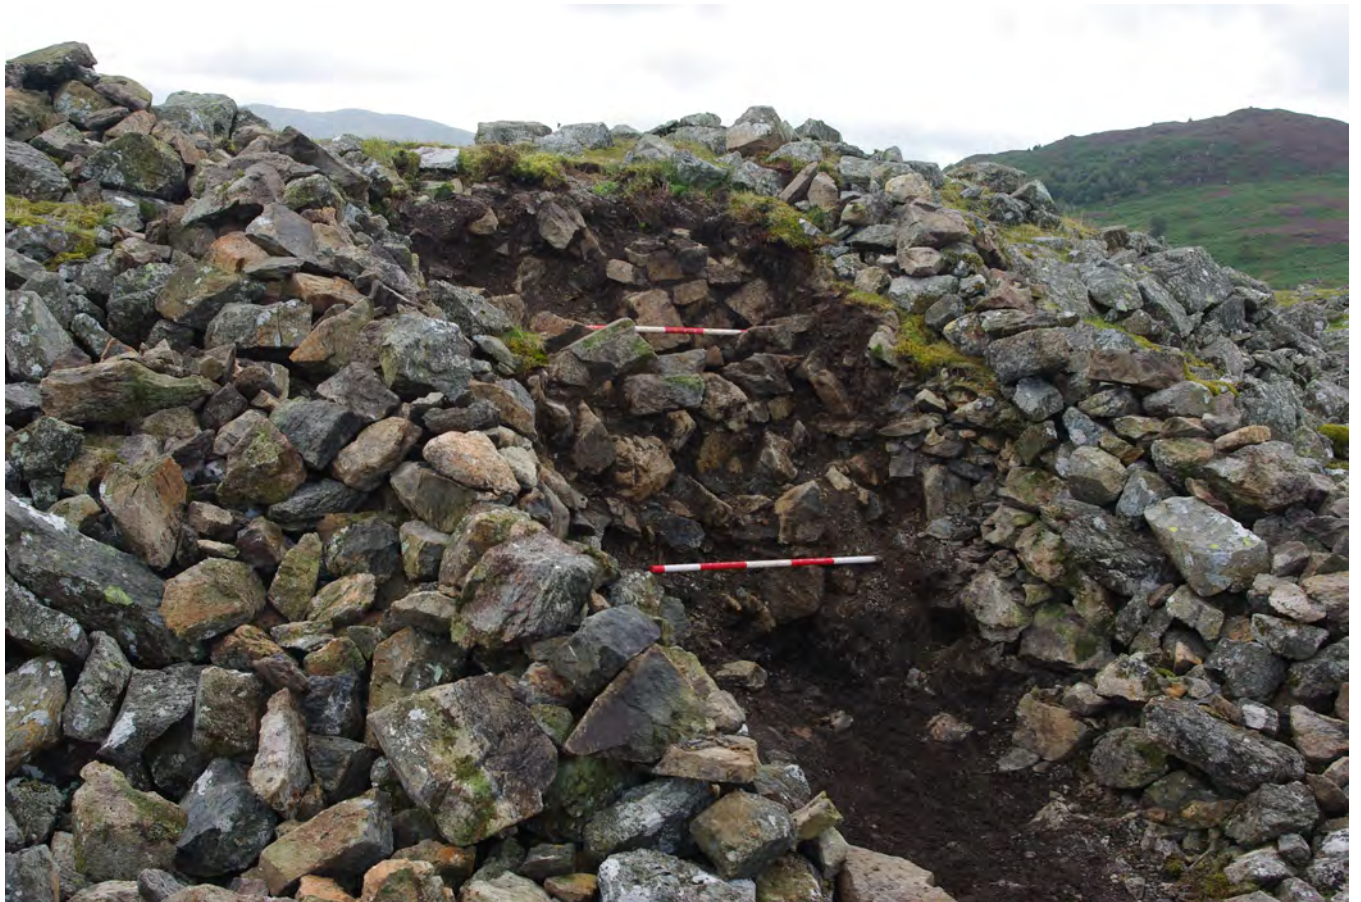
Plate 20 Trench 4, battered masonry and collapse at the base of the square keep

The rubble was cleared from a 1.7m x 5.0m area of the outer slope. Only loose stone and the gravel matrix were cleared. This revealed a more stable layer of stone and a line of semi collapsed facing. Plate 20 shows the trench after clearance. The stable masonry was stepped, with a line of possible facing at the top of the slope. There was little at this level that could be confirmed as original undisturbed masonry and therefore any interpretation should be seen as being provisional.

The stepped slope could be interpreted as either semi-collapsed core or alternatively as tumble with the face still surviving beneath the rubble. Unfortunately there was no opportunity to excavate further. If the former, it is possible that the tower had a battered base in a similar fashion to the round tower at Castell y Bere and that the facing stones have been lost. The possible facing at the top of the slope appears to be relatively slight and did not continue down into the rubble. It would indicate a wall width of about 1.7m. The base of the stepped rubble slope was sitting on bedrock.
