# TERFOR PIER, TREFOR, GWYNEDD

Level 2/3 Building Record

Prosiect Rhif / Project No. G2474

Adroddiad Rhif / Report No.1328

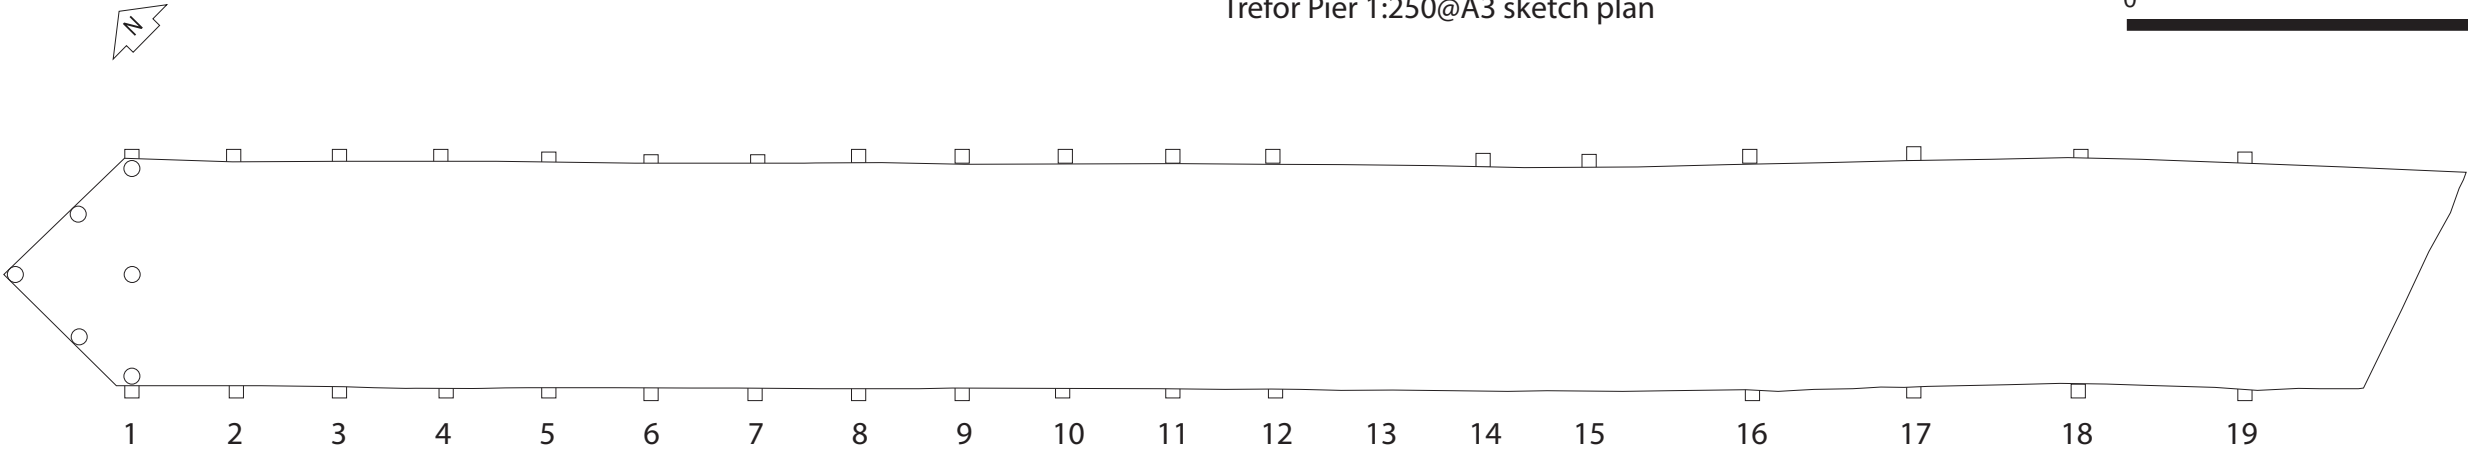
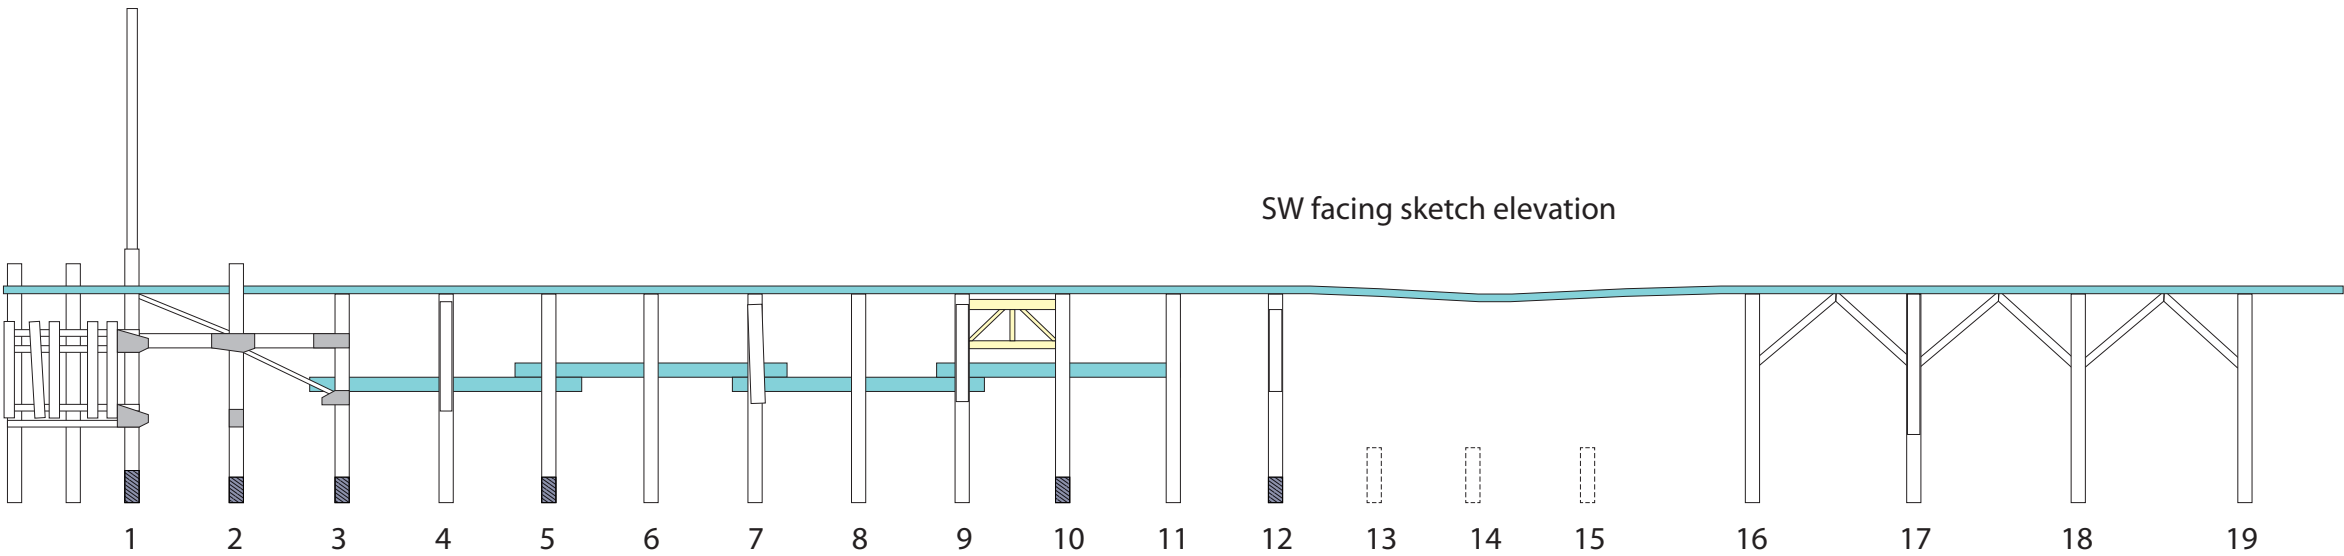
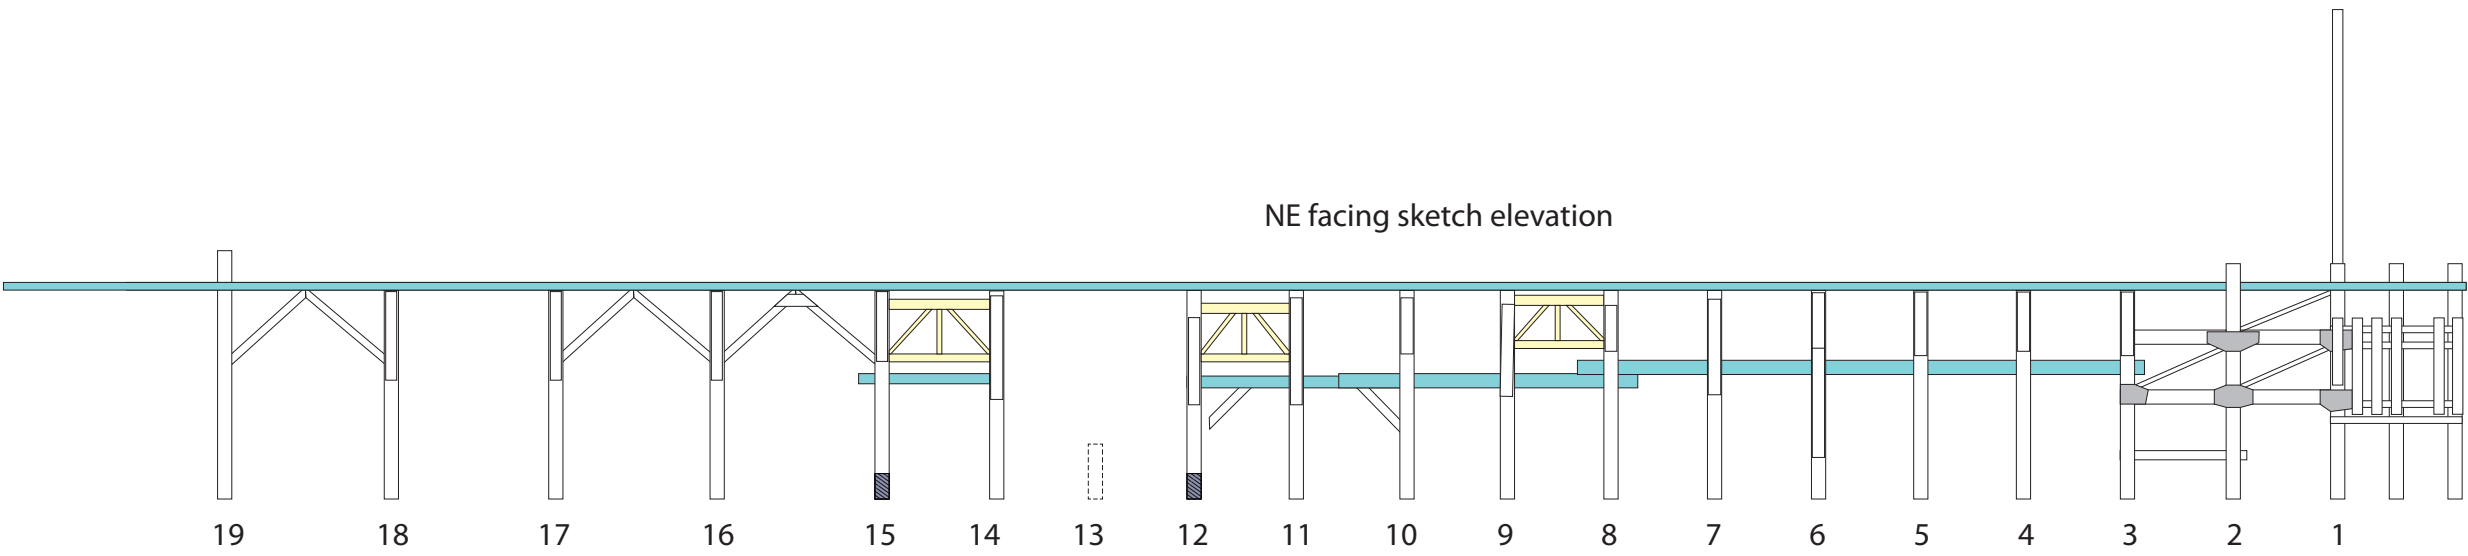
Figure 06: Trefor Pier sketch plan and elevations

nature, bolted to the upright posts but overlapping at the ends, and had collapsed around the lost truss 13 (Figure 06 [coloured blue]).

A walkway superstructure was built on top of the uppermost cross-beam joining the main pier uprights, which appears to be fairly modern replacement work (Figure 06). The details of the construction technique were not noted because access to the pier was impossible, but the walkway was covered in hardwood decking, with a modern galvanised metal barrier to its edges. Seven tying up posts survived at the north northwest end of the pier, which were in fact in four cases extensions to the main vertical posts above walkway level (Figure 06; Plate 16).

1980's repair

Probable 1960's metal feet

1912 - 1960's work

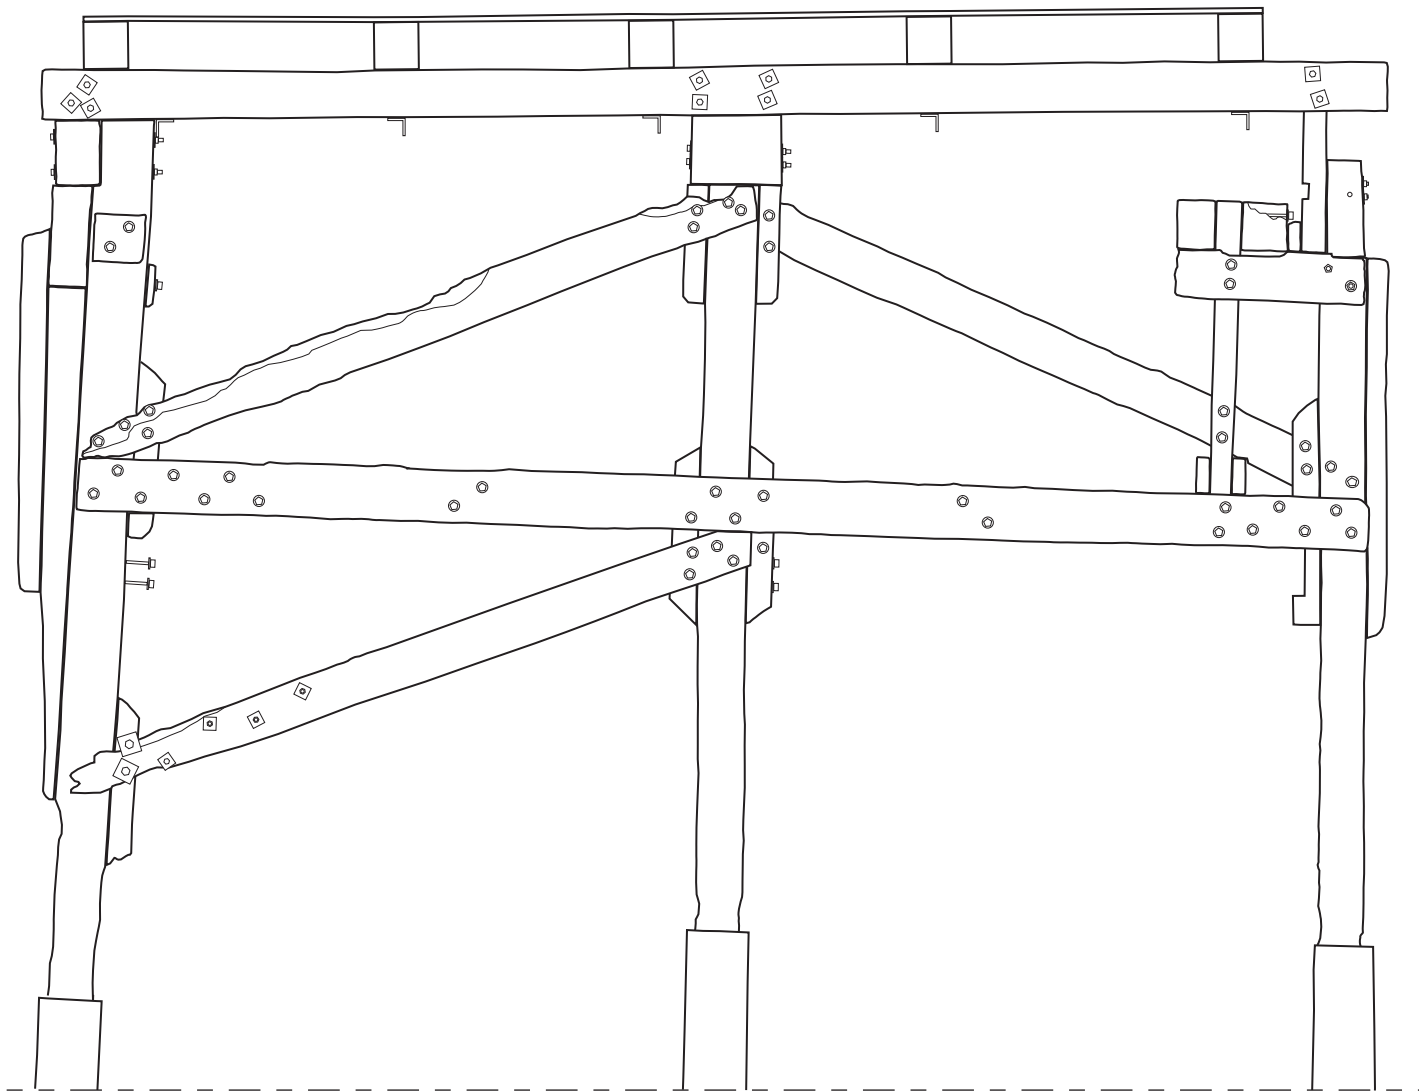
Evidence for significant repairs to the pier is clearly noted on Truss 12 (Figure 07). The decking has been braced and supported on the north-eastern side by wooden timbers, including an upright about 0.9m long, on the inside of the main pier to raise the level of the pier superstructure. This was done to level the pier decking, after it appears that the pier truss had subsided into the sea bed on the north-eastern side, making the decking of the pier slope at this point be uneven.

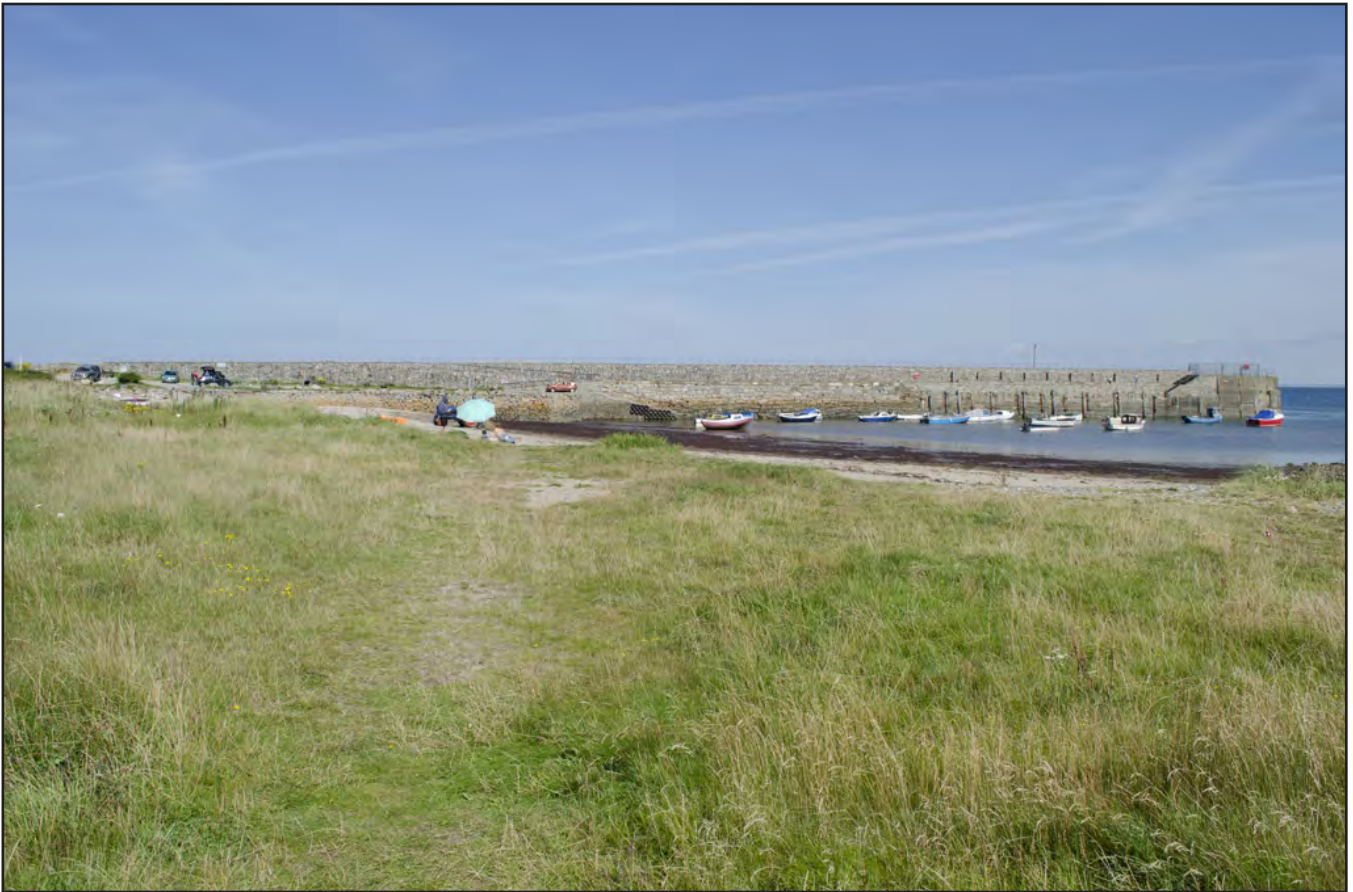
The stone pier at Trefor consists of a long stone section, faced on the north west side with a modern concrete facing about 0.5m wide, battered with a curved overhanging lip. On the south east side of the stone pier granite blocks of coursed stone were noted, up to 0.3m by 0.15m in size. These appear modern and to be part of the 1980s restoration of the pier. There is a walkway at a half level on this side of the pier, accessible by steps at both the north east and south west ends of the pier. This appears a modern feature, below which the original coursed stone surface of the stone pier can be seen (Plate 01).

Plate 01: General view from the south of stone pier viewed (archive image: G2475\_Trefor\_Pier\_001)

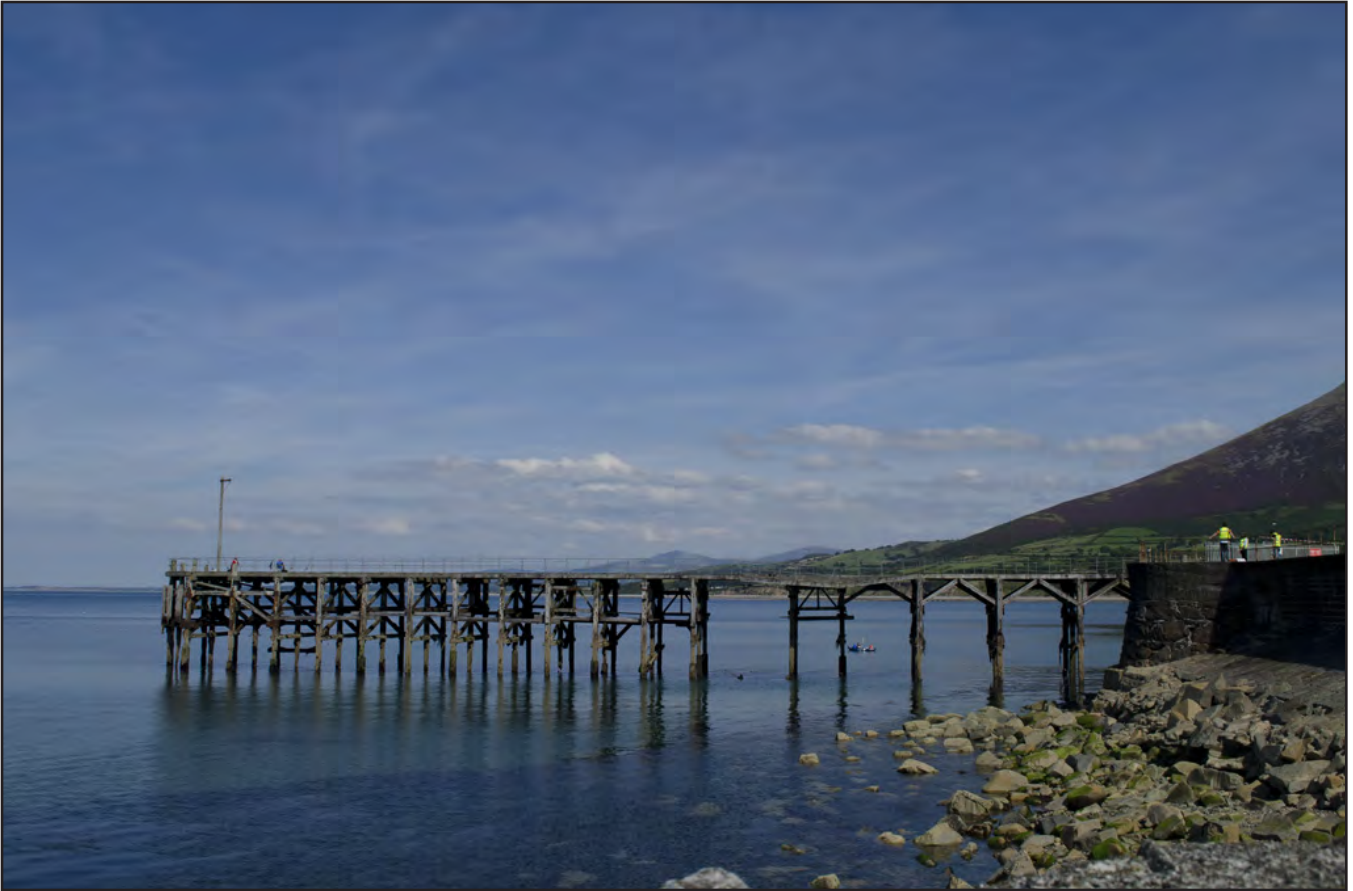
Plate 02: View of from the west of the southeastern side of timber pier (archive image: G2475\_Trefor\_Pier\_020)

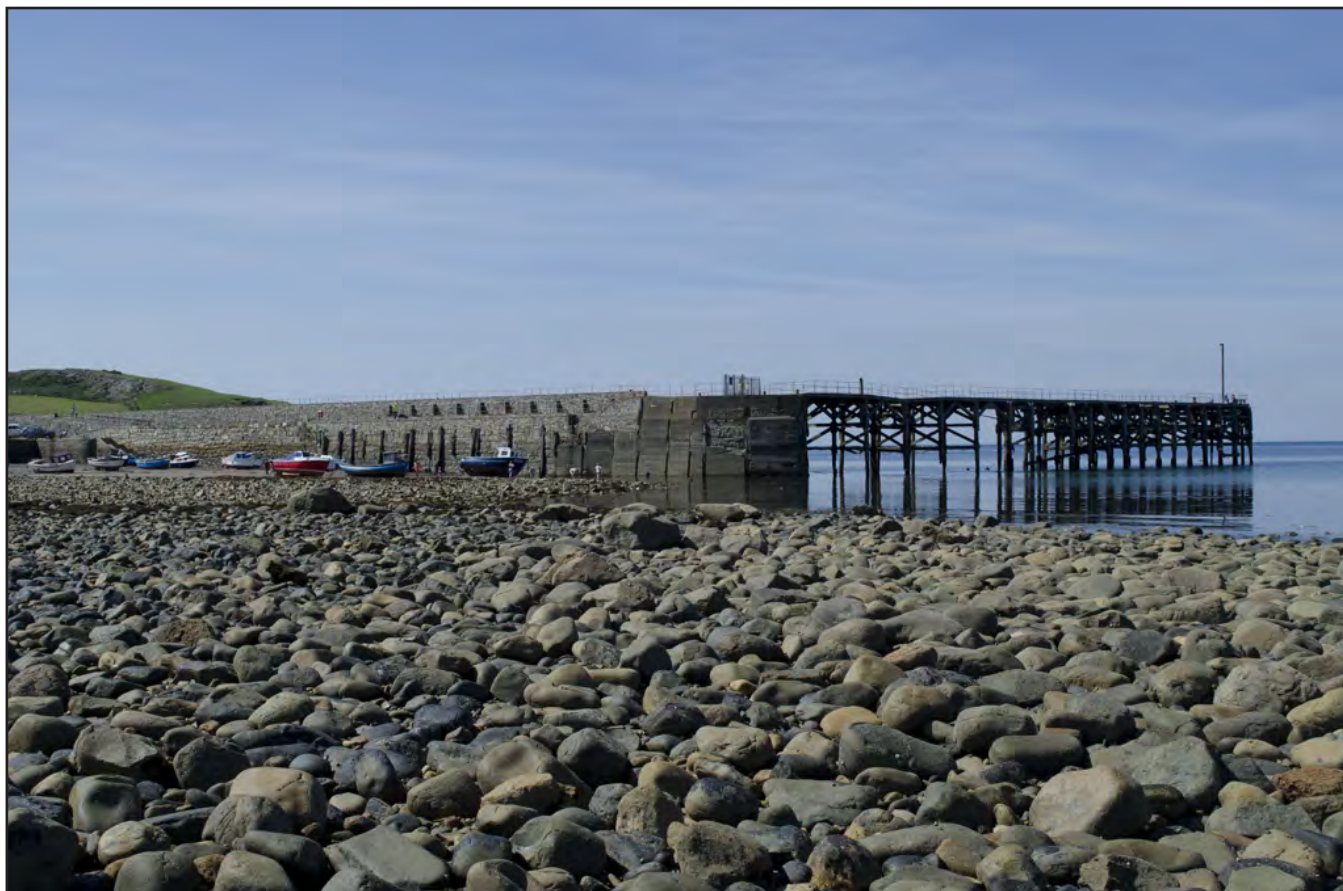
Plate 03: General view of the pier from the east (archive image: G2475\_Trefor\_Pier\_015)

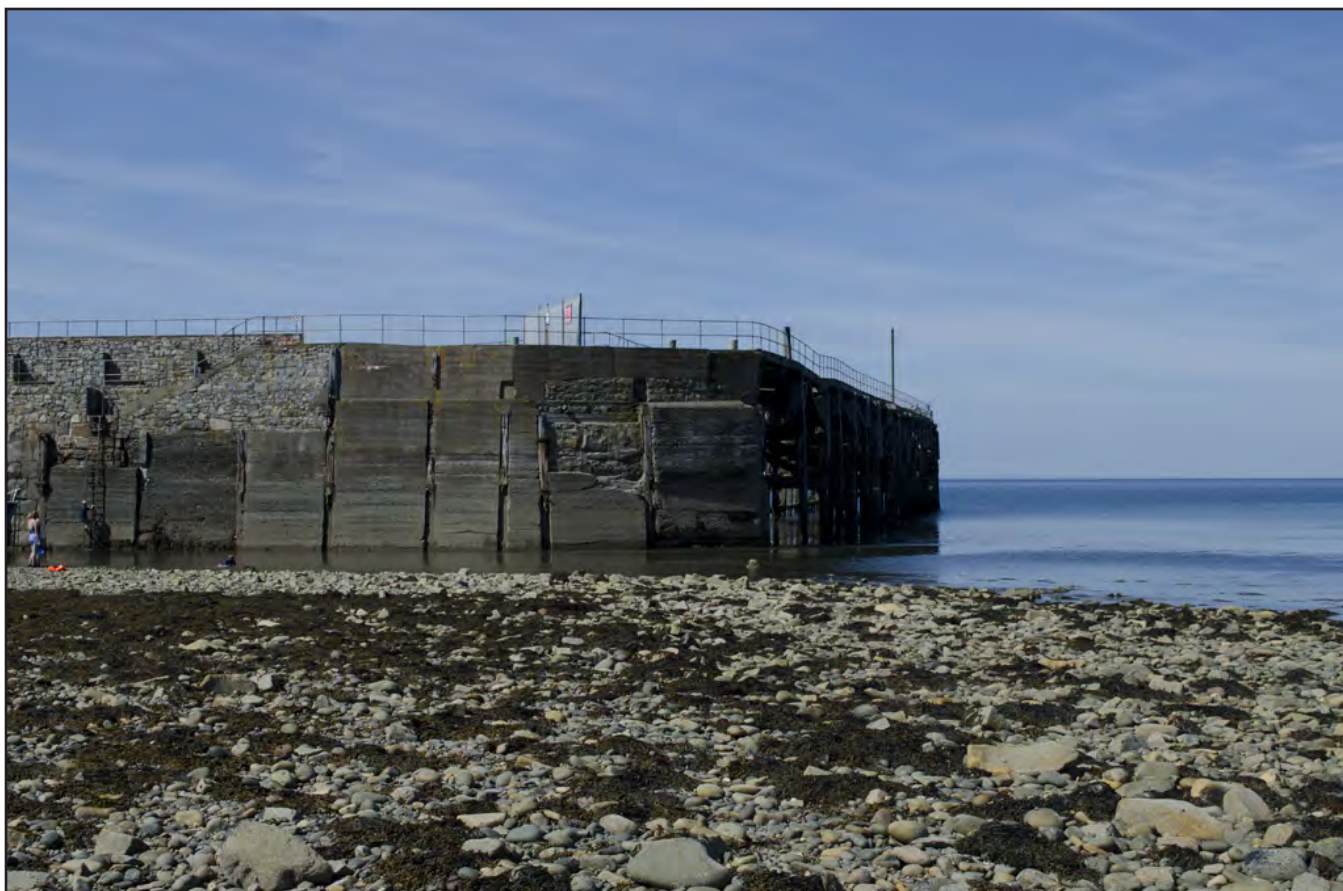
Plate 04: View of Trefor pier from the beach showing damaged northwestern side of the timber pier (archive image: G2475\_Trefor\_Pier\_016)

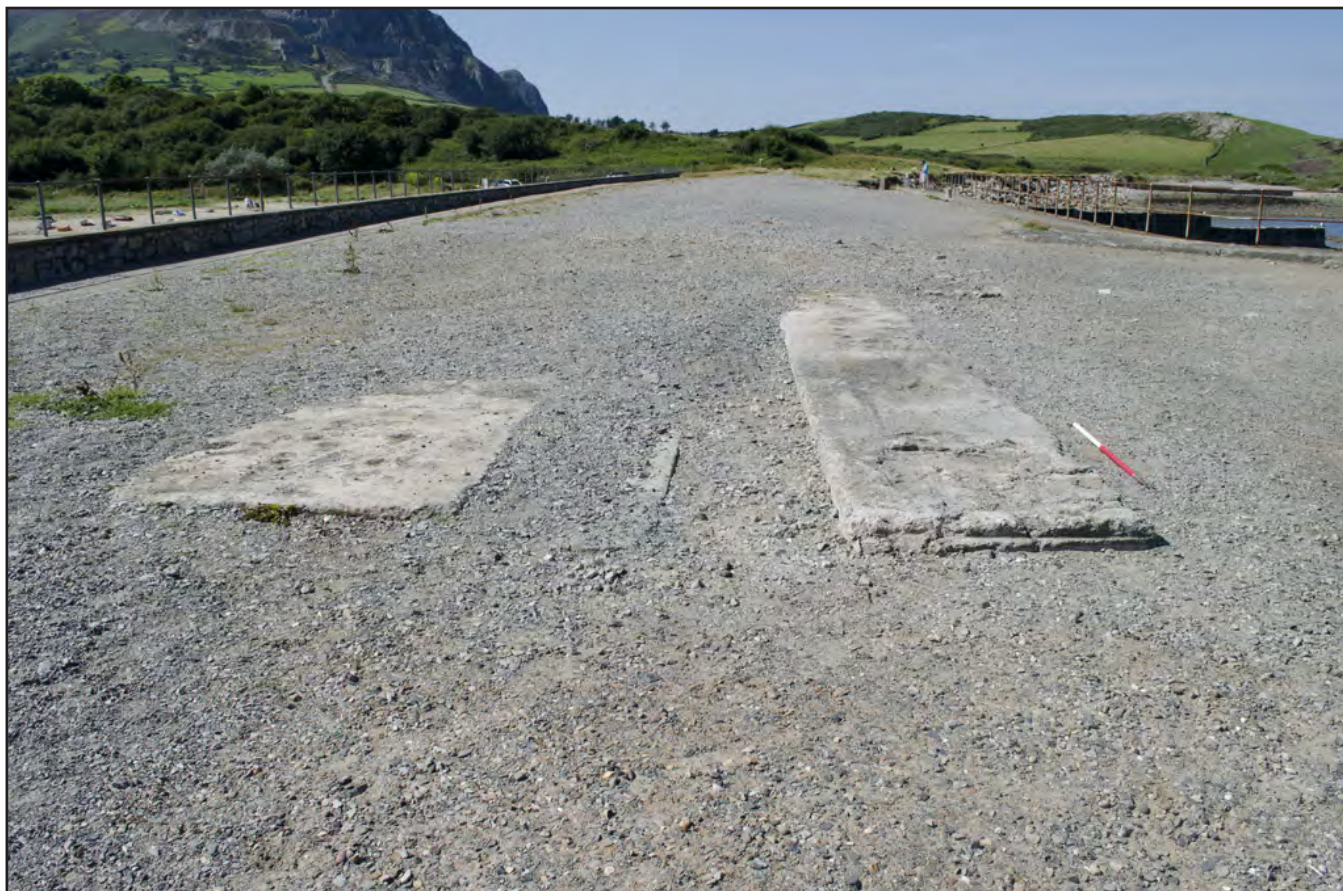
The surface of the stone pier is covered in gravel and granite chippings, however surviving concrete elements, in the form of pads on the stone pier surface (Plate 07) probably represent the footings of former industrial structures.

Plate 07 Detail of concrete pads in stone pier surface (Scale: 1 x1m; archive image: G2475\_Trefor\_Pier\_010)

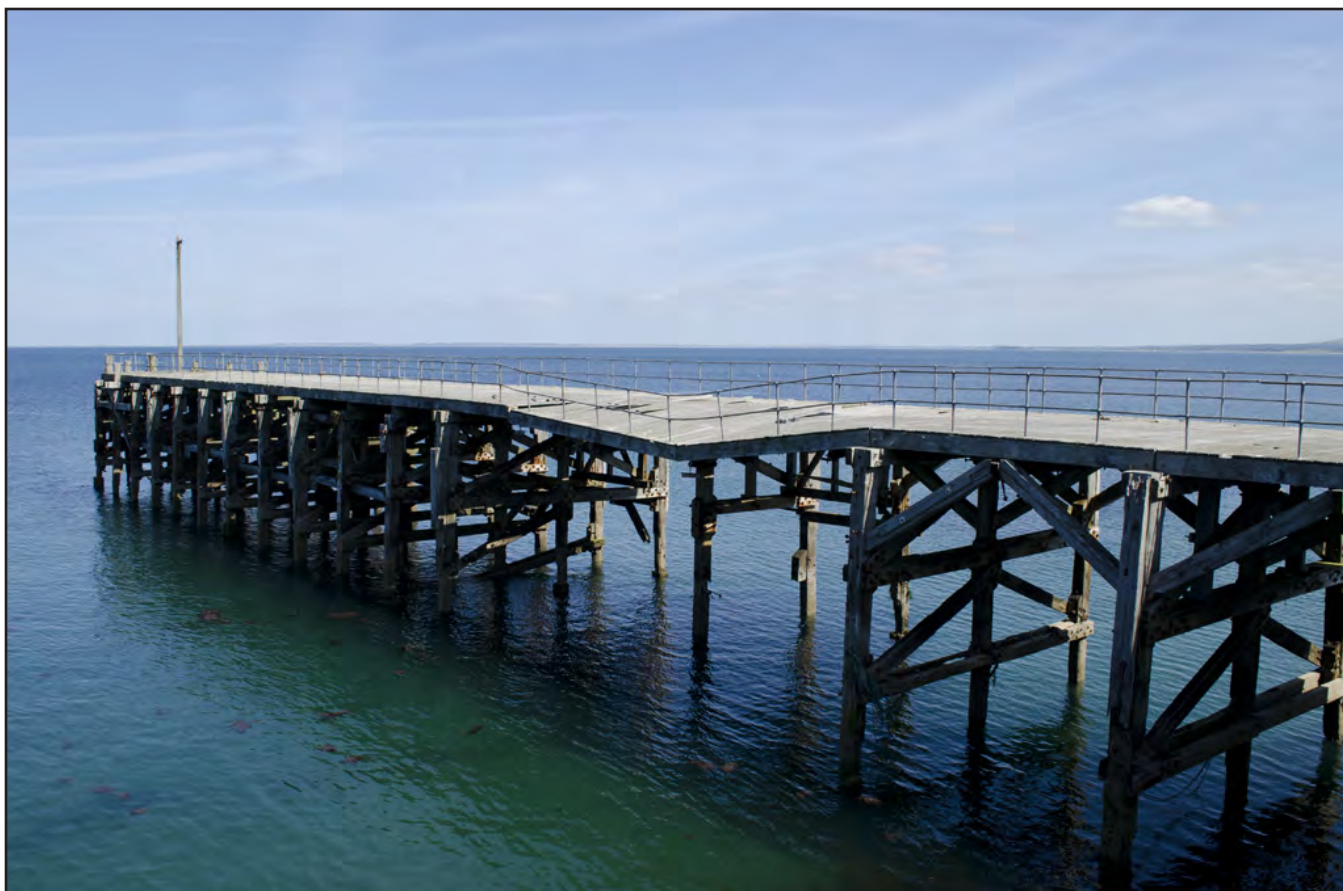
Plate 08: Detail of timber pier showing collapsed section (archive image: G2475\_Trefor\_Pier\_005)

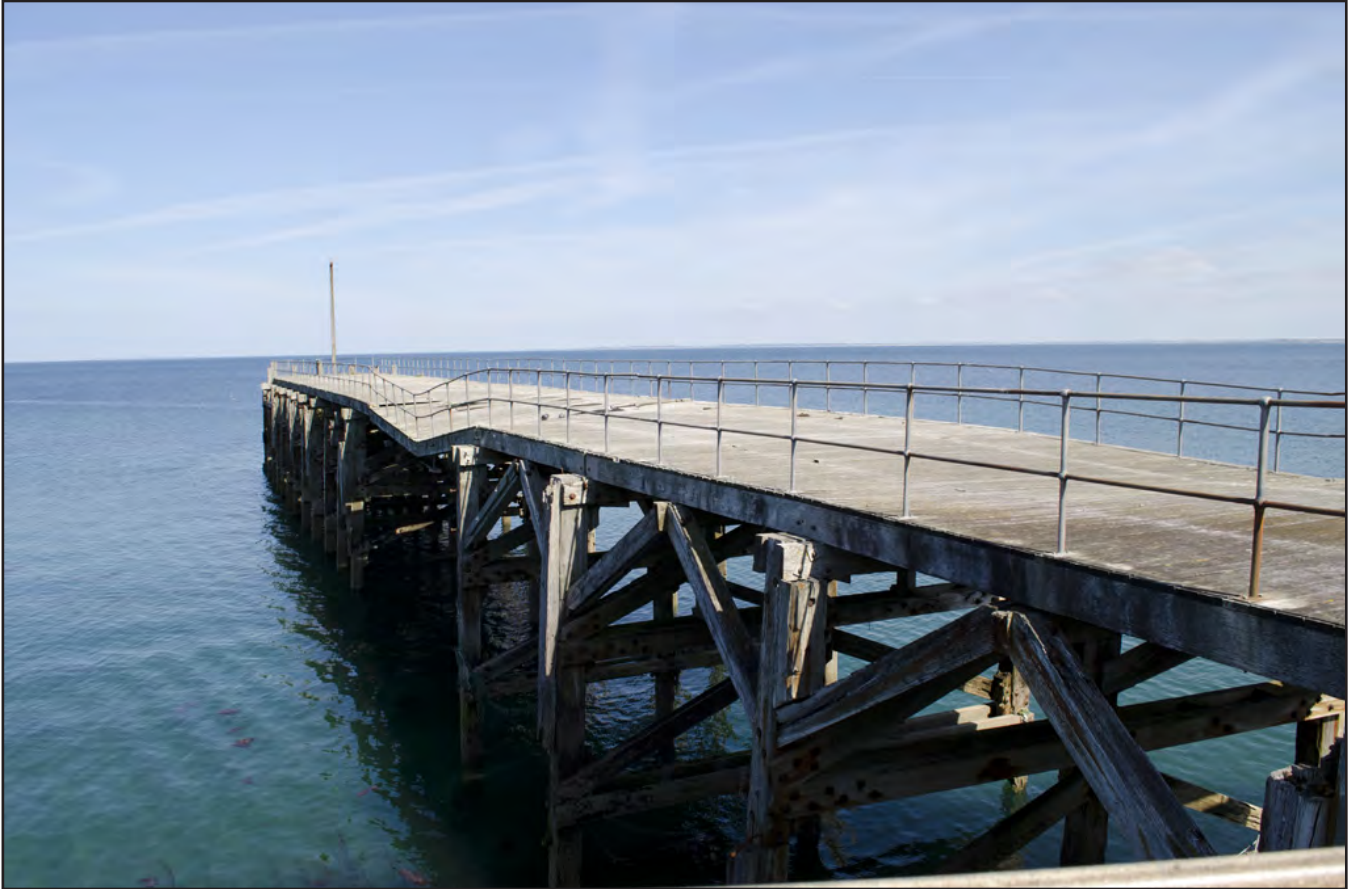
Plate 09: Detail of timber pier showing collapsed section (archive image: G2475\_Trefor\_Pier\_006)

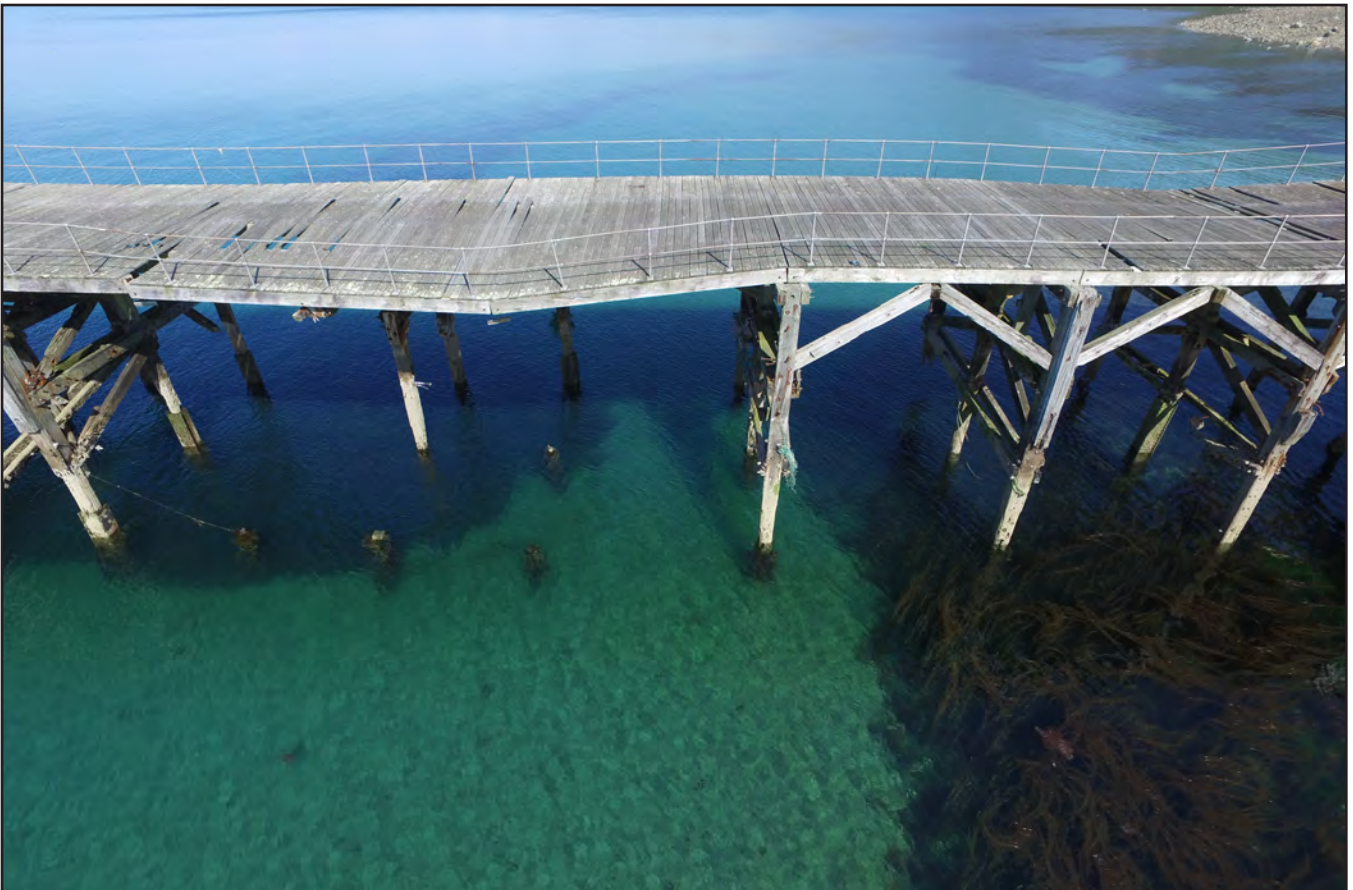
Plate 12: Aerial view of Trefor Pier from the east-southeast showing the condition of timber decking over collapsed trusses (Trusses 12 to 18) (UAV image: DJI\_0108)

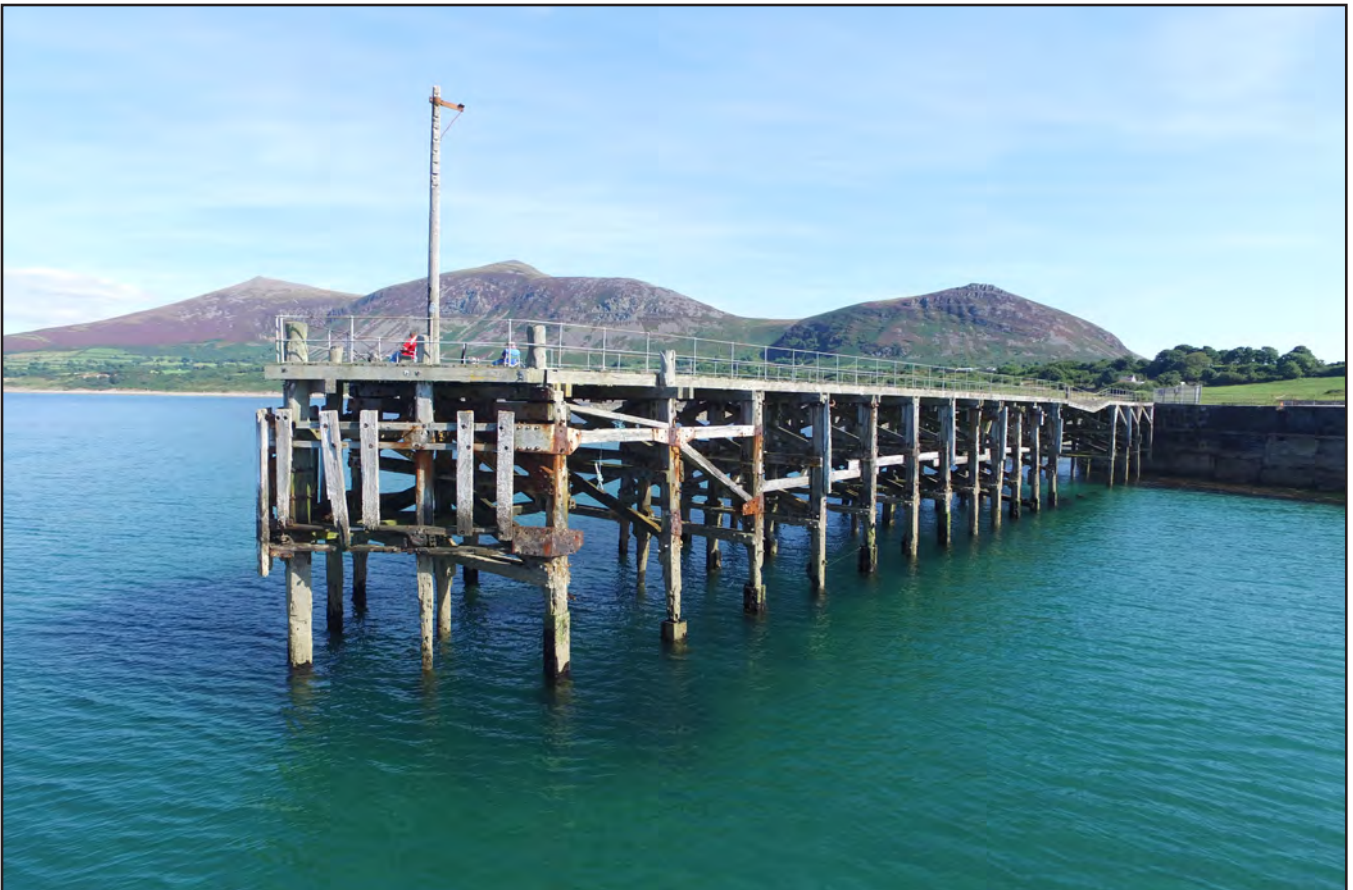
The north northwestern end of the pier consisted of a triangular end section with a central pier sunk into the seabed, with bracing woodwork behind (Plate 14, 16). The two triangular end surfaces had two horizontal cross beams between the end truss 1 and the central pier, attached to which were vertical rubbing boards, which appear to have been regularly replaced (Plates 16, 20). These had metal plates being used to reinforce the timber joints. The triangular section was also braced to truss 1 with horizontal timbers connected to the end central pier (Plate 16). At 5m from the end of the pier was a telegraph pole like post with a metallic bracket braced with a wire below it to the post. This relates to former telephonic communications between the pier and the quarry.

Plate 14: View of Trefor pier from the northwest showing the terminus and the trusses on the west-southwest side of the pier  
(UAV image: UAV image: DJI\_0153)

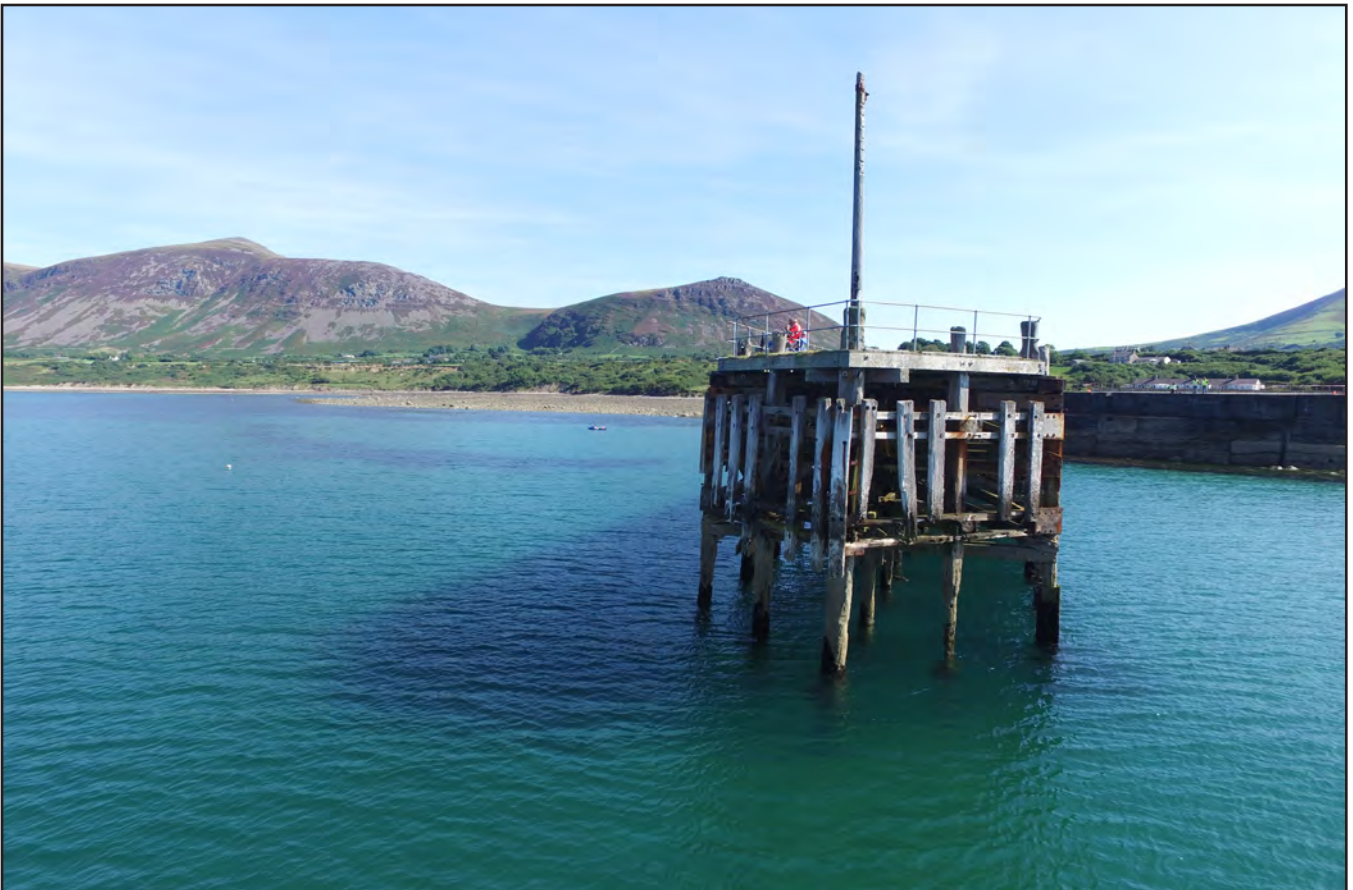
Plate 16: View of Trefor pier from the north showing the triangular pointed end of the pier (UAV image: DJI\_0156)

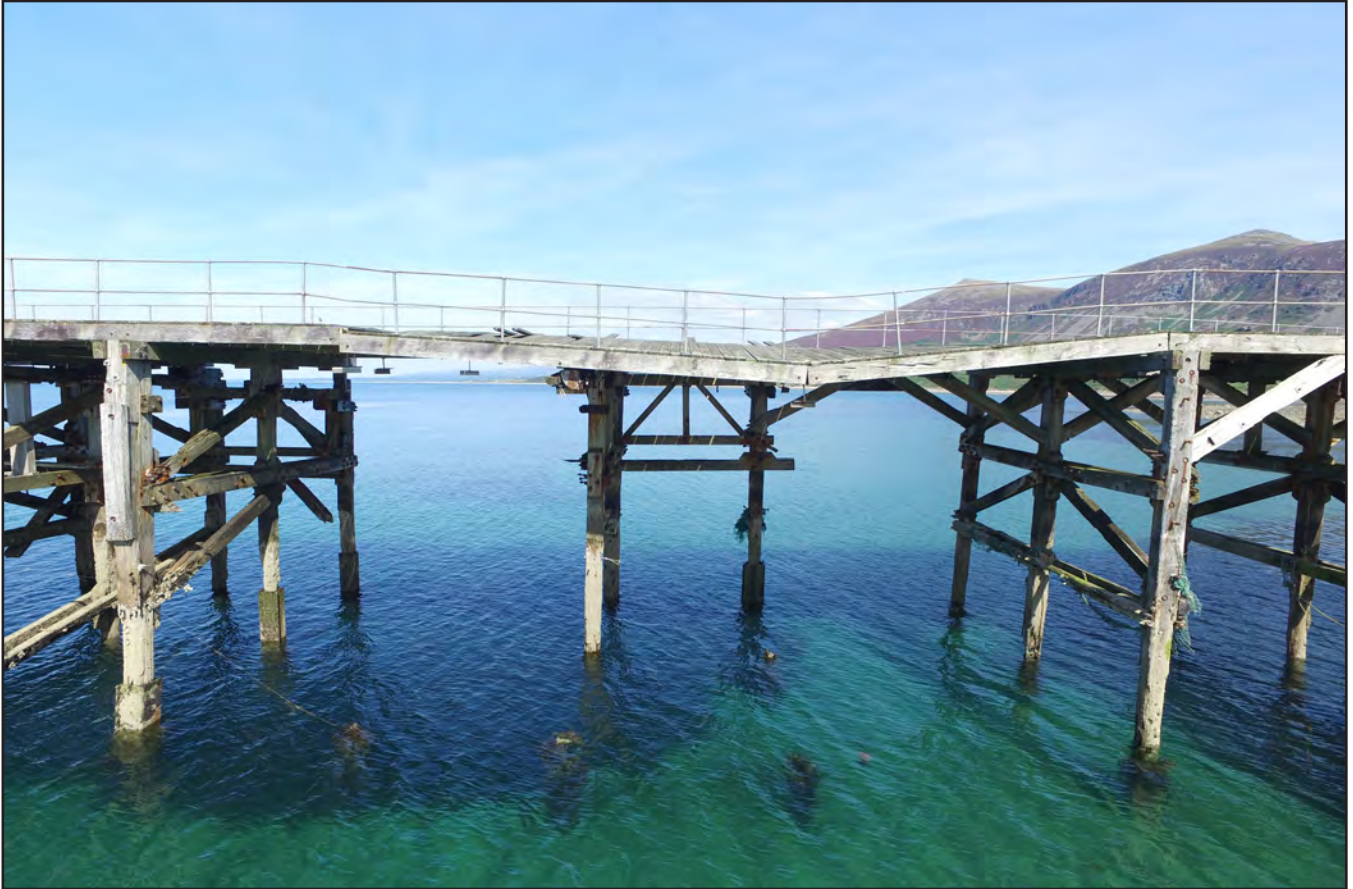
The timber pier was constructed of 19 trusses (Plates 02-03), of which the fifth to seventh ones from the shore (Trusses 13 to 15) had substantially collapsed on the east northeast side, resulting in the compromising of the integrity of the surface walkway, and the adjacent trusses were also damaged (Figure 06). Truss 13 was the most damaged, being mainly absent. The trusses were constructed using three double cross-beams, bolted to both sides of the main uprights, connecting the two main posts driven into the sea bed, along with central supporting piers between them, which were in turn braced with diagonal struts between them across the two upper voids created by the cross beams. The trusses were also braced to each other with diagonal struts between the trusses. Some trusses also had vertical struts in the upper void. The trusses were also braced with diagonal beams below the walkway level to the adjacent truss, particularly at the landward end of the pier between trusses 16-19 (Plate 02, 08-10, 12, 19). At the seaward end between trusses 1 and 3 additional angled bracing had been inserted on the south eastern side of the pier, but this seems to be part of a later repair, when the lower horizontal struts were lost between trusses 1 and 3. This is a repair to the style of bracing seen on the north eastern side of the pier, where the former bracing is still noted (Plates 14, 20).

Plate 17: View of Trefor pier from the east southeast showing the damaged section of the pier from trusses 13 to 15 (UAV image: DJI\_0143)

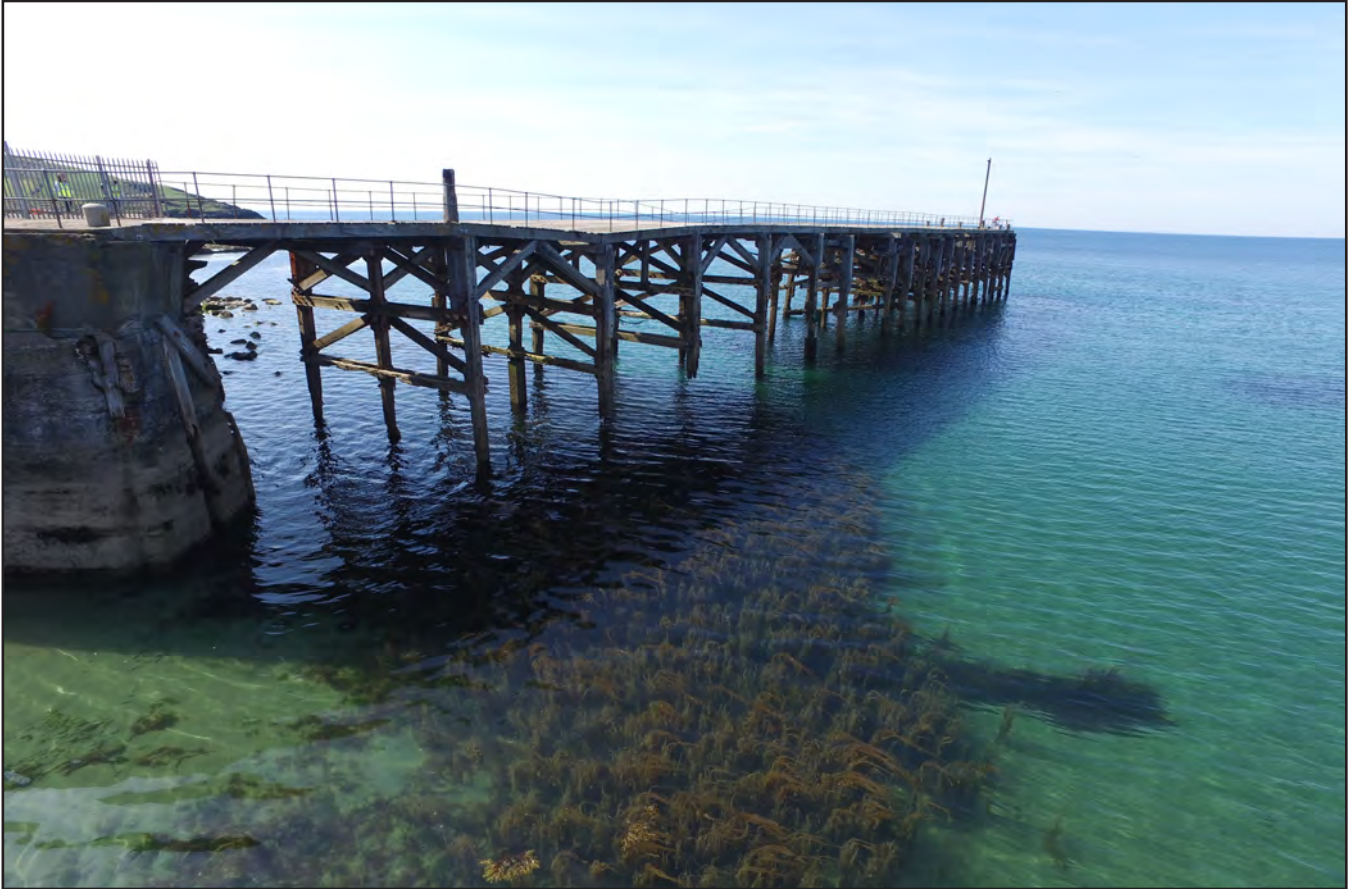
Plate 19: View of north-northwest side of Trefor pier showing rotted timber in the intertidal zone, most notably on Truss 17 (UAV image: DJI\_0233)

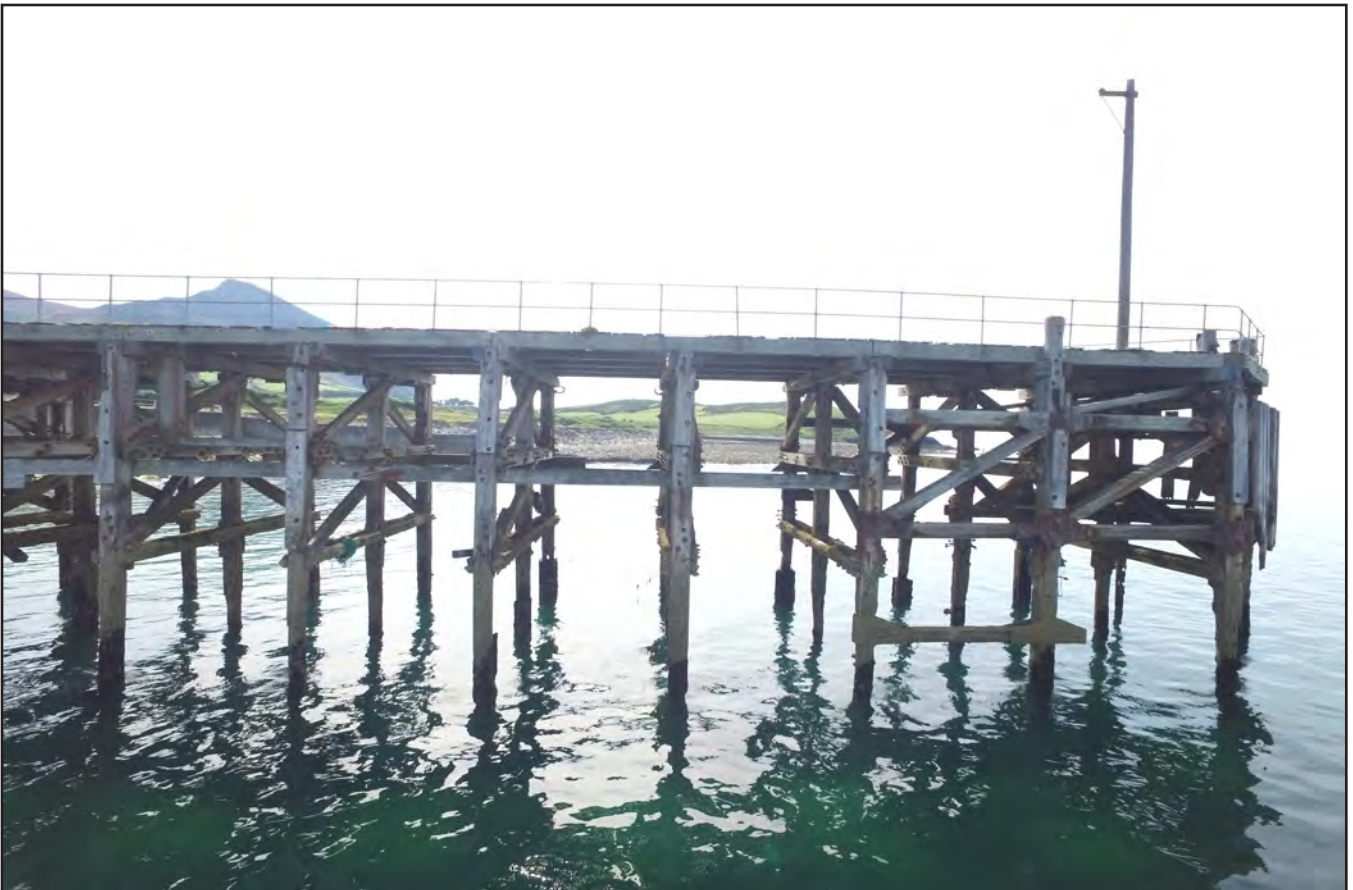
There was evidence of piecemeal repairs to almost all of the trusses. These were varied but had a number of common elements to them (Plates 08-14). At the intertidal level the main uprights had substantially rotted, which in places meant that they no longer provided significant support to the pier; these had in places been surrounded by a metal shoe, seen on trusses 1-3, 5, 10, 12 and 15 (Figure 06; Plate 19). Metal plates had also been attached to a number of the joints in the structure in order to provide additional support, and substantial quantities of timber had also been bolted on over elements of the structure in order to provide additional support. This includes some elaborate braced timberwork between trusses 9 and 10 on the west southwest side of the pier (Plate 13), which is also seen between trusses 8 and 9, 11 and 12 and also 14 and 15 on the north eastern side (Figure 06 [coloured yellow]; Plates 02, 21). This appears to have been a phase of repair work, although the date of this is unknown. However diagonal bracing between two struts between trusses 1 and 3 on both sides of the pier, with metal brackets used for additional support, appears to have been an original feature designed to provide additional support to the pier in an area where ships would be likely to be tied up (Plate 20).

Plate 20: Construction detail for the end of the pier (Trusses 1 to 7) (UAV image: DJI\_0713)
