# TERFOR PIER, TREFOR, GWYNEDD

Level 2/3 Building Record

Prosiect Rhif / Project No. G2474

Adroddiad Rhif / Report No.1328

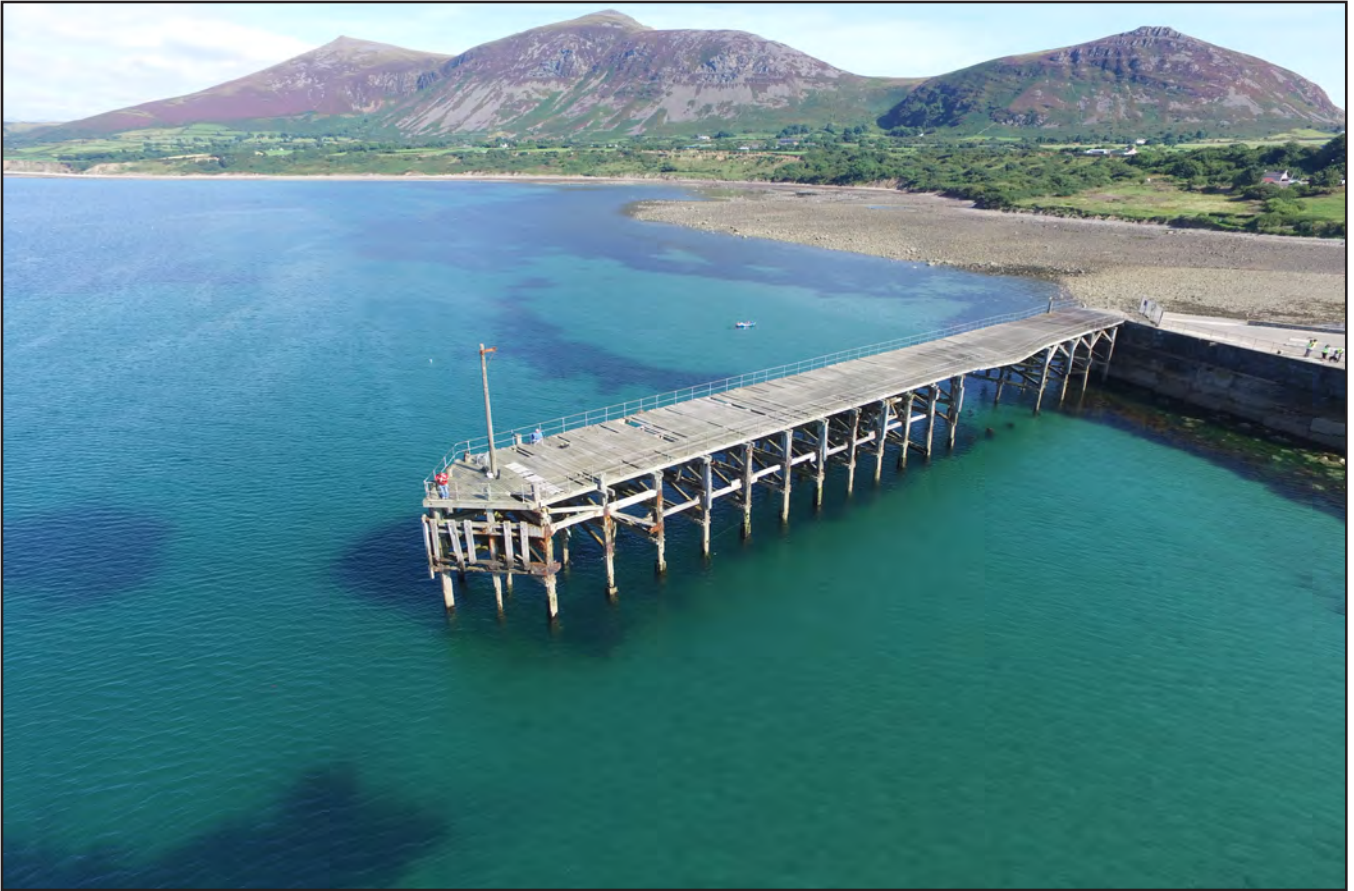
Additional bracing in the form of horizontal beams placed along the west south western side of the pier against the internal face of the main vertical piers below the second cross beams was also noted between trusses 3 and 15 (Plate 26). This appeared to have decayed to a lesser extent and therefore is likely to have been a more recent repair. It was of a very basic

Plate 26: General shot of pier from the northwest (UAV image: DJI\_0247)
